**Geophysical Survey
Baydon Tower
Water pipeline route**

**Abstraction and interpretation of
magnetometer anomalies -
Area 2**

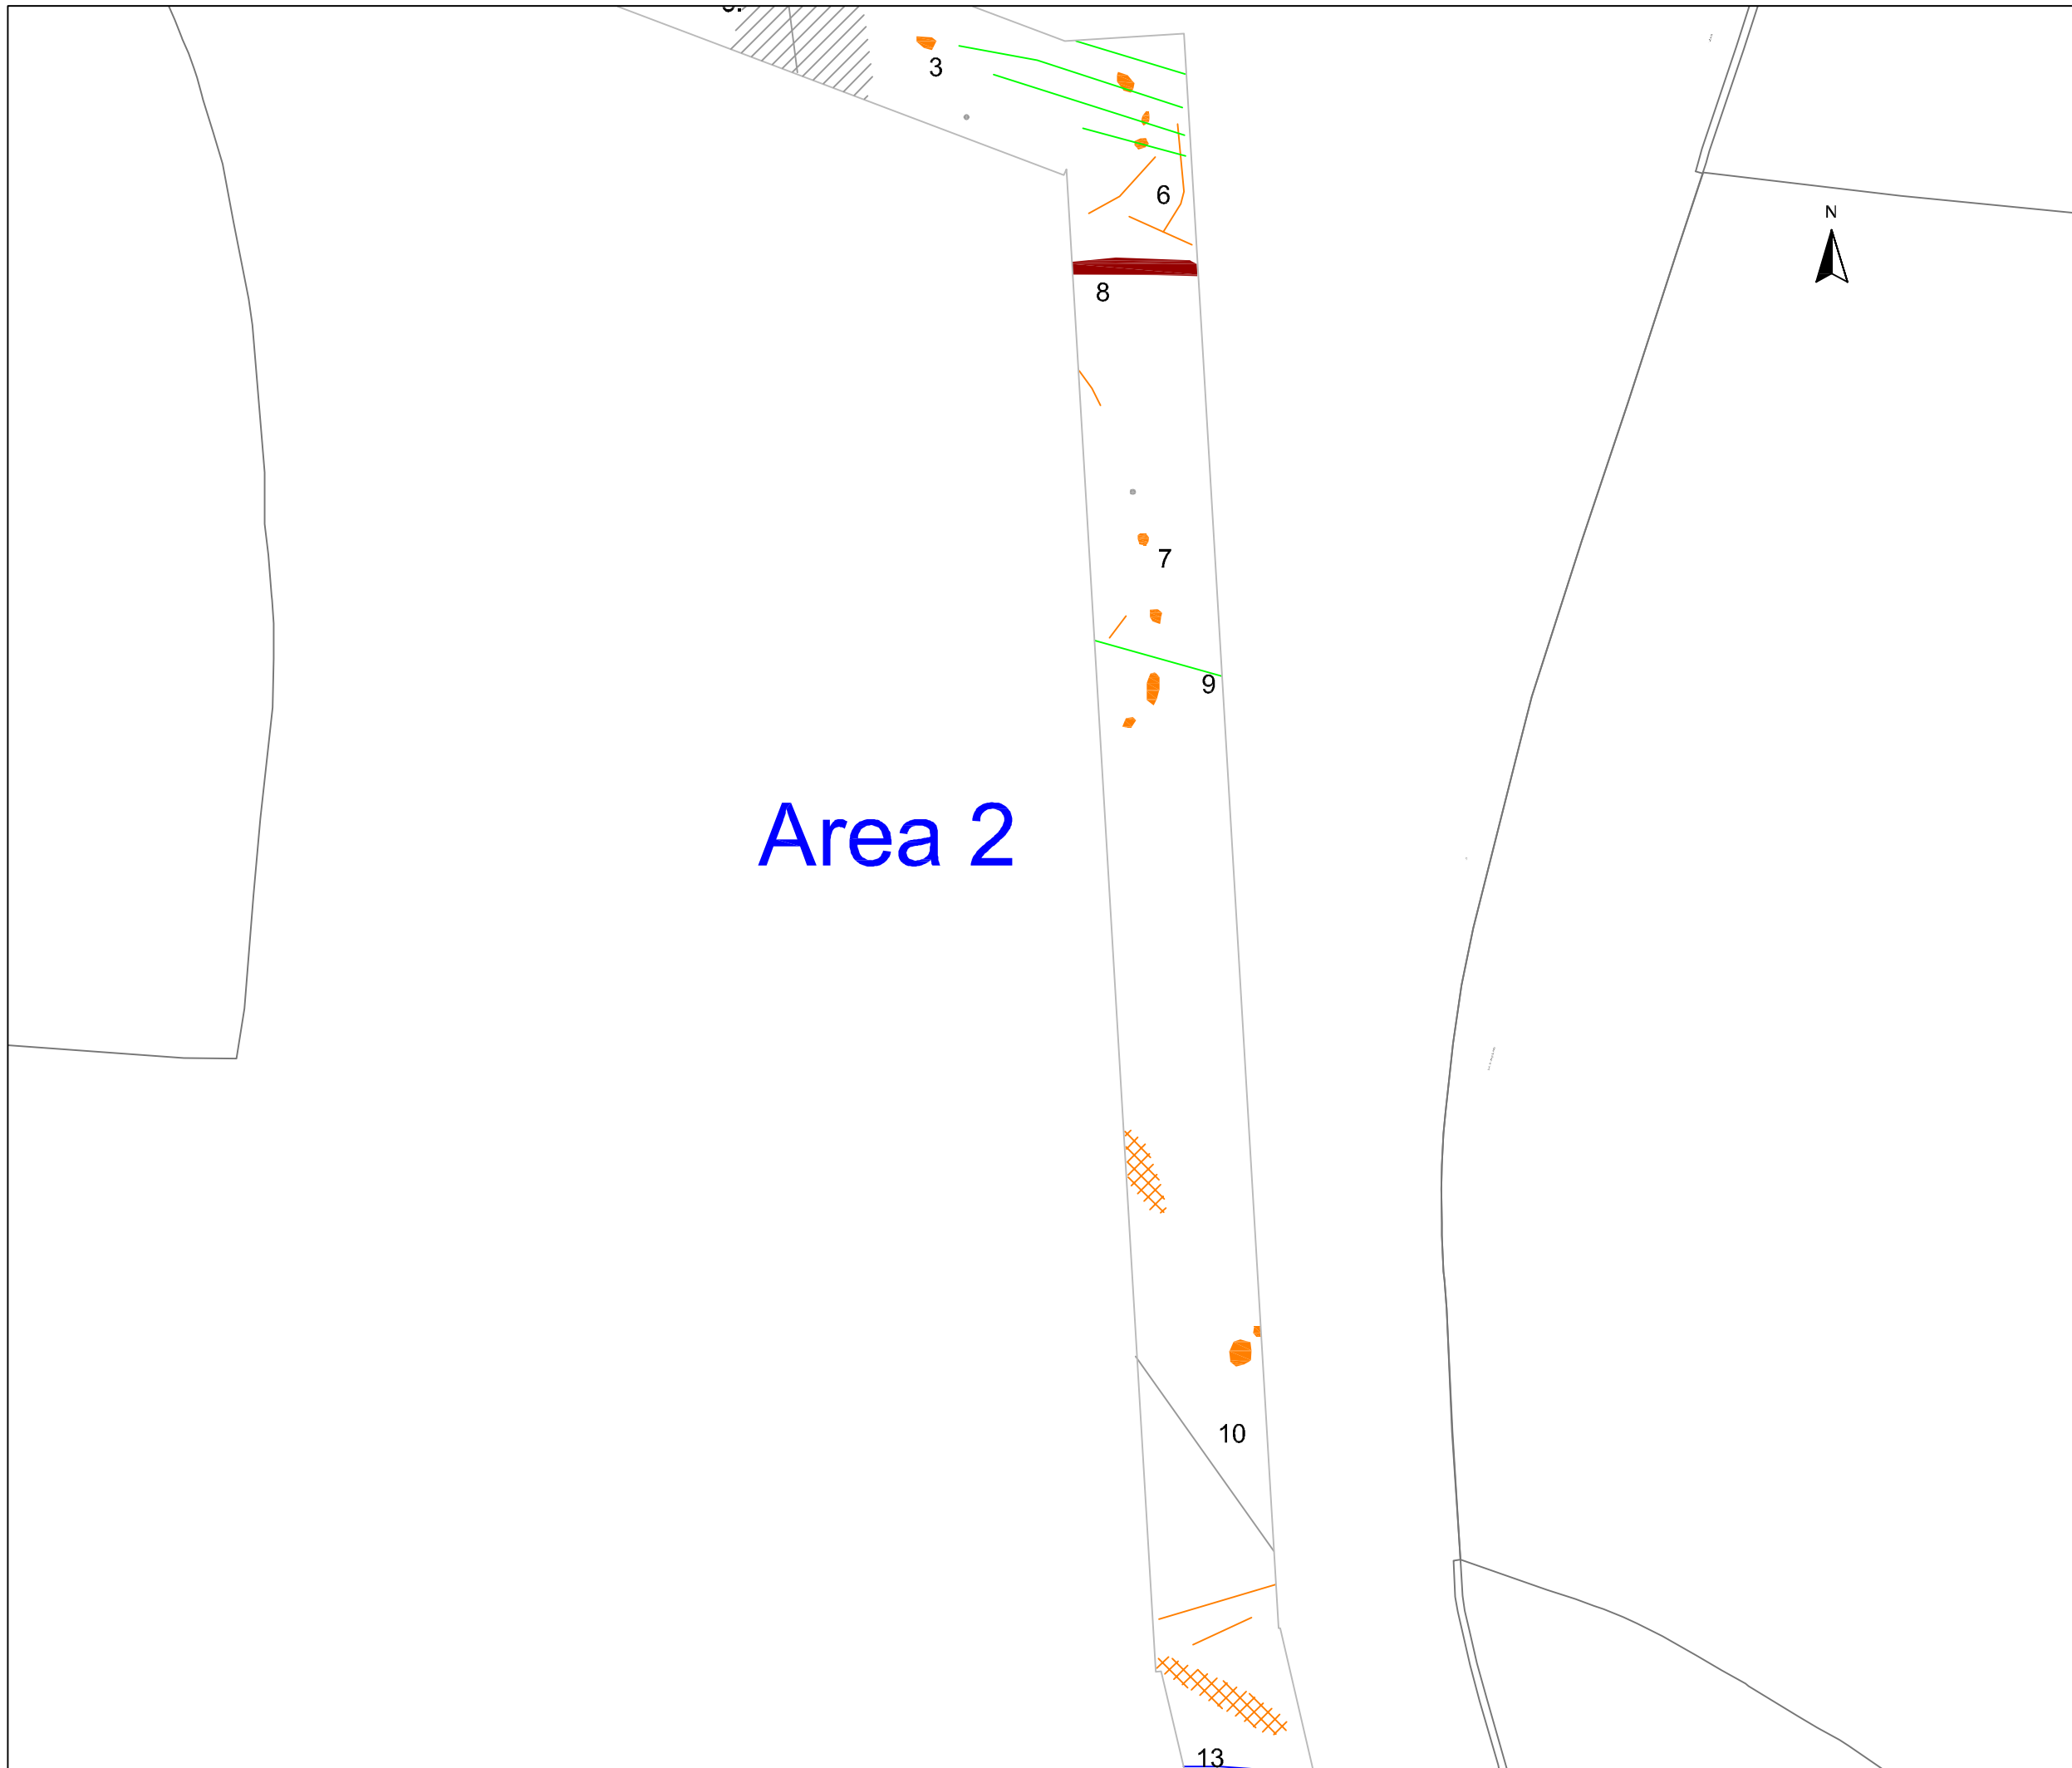
FIG 11

Positive linear anomaly - possible ditch-like feature
-

Linear anomaly - of agricultural origin
-

Positive linear anomaly - possible former field boundary
-

Discrete positive response - possible pit-like feature
-

Positive anomaly - magnetically enhanced material
-

Strong multiple dipolar linear anomaly - pipeline / cable / service
-

Strong dipolar anomaly - ferrous object
