**Metheringham Mains Replacement Scheme
Archaeological Monitoring**

**NGR: TF 0620 6146 - TF 0735 6120
Site Code: MMR 97
LCNCC Museum Accn No. 245.97**

Anglian Water Services Ltd

LAS Report No. 333

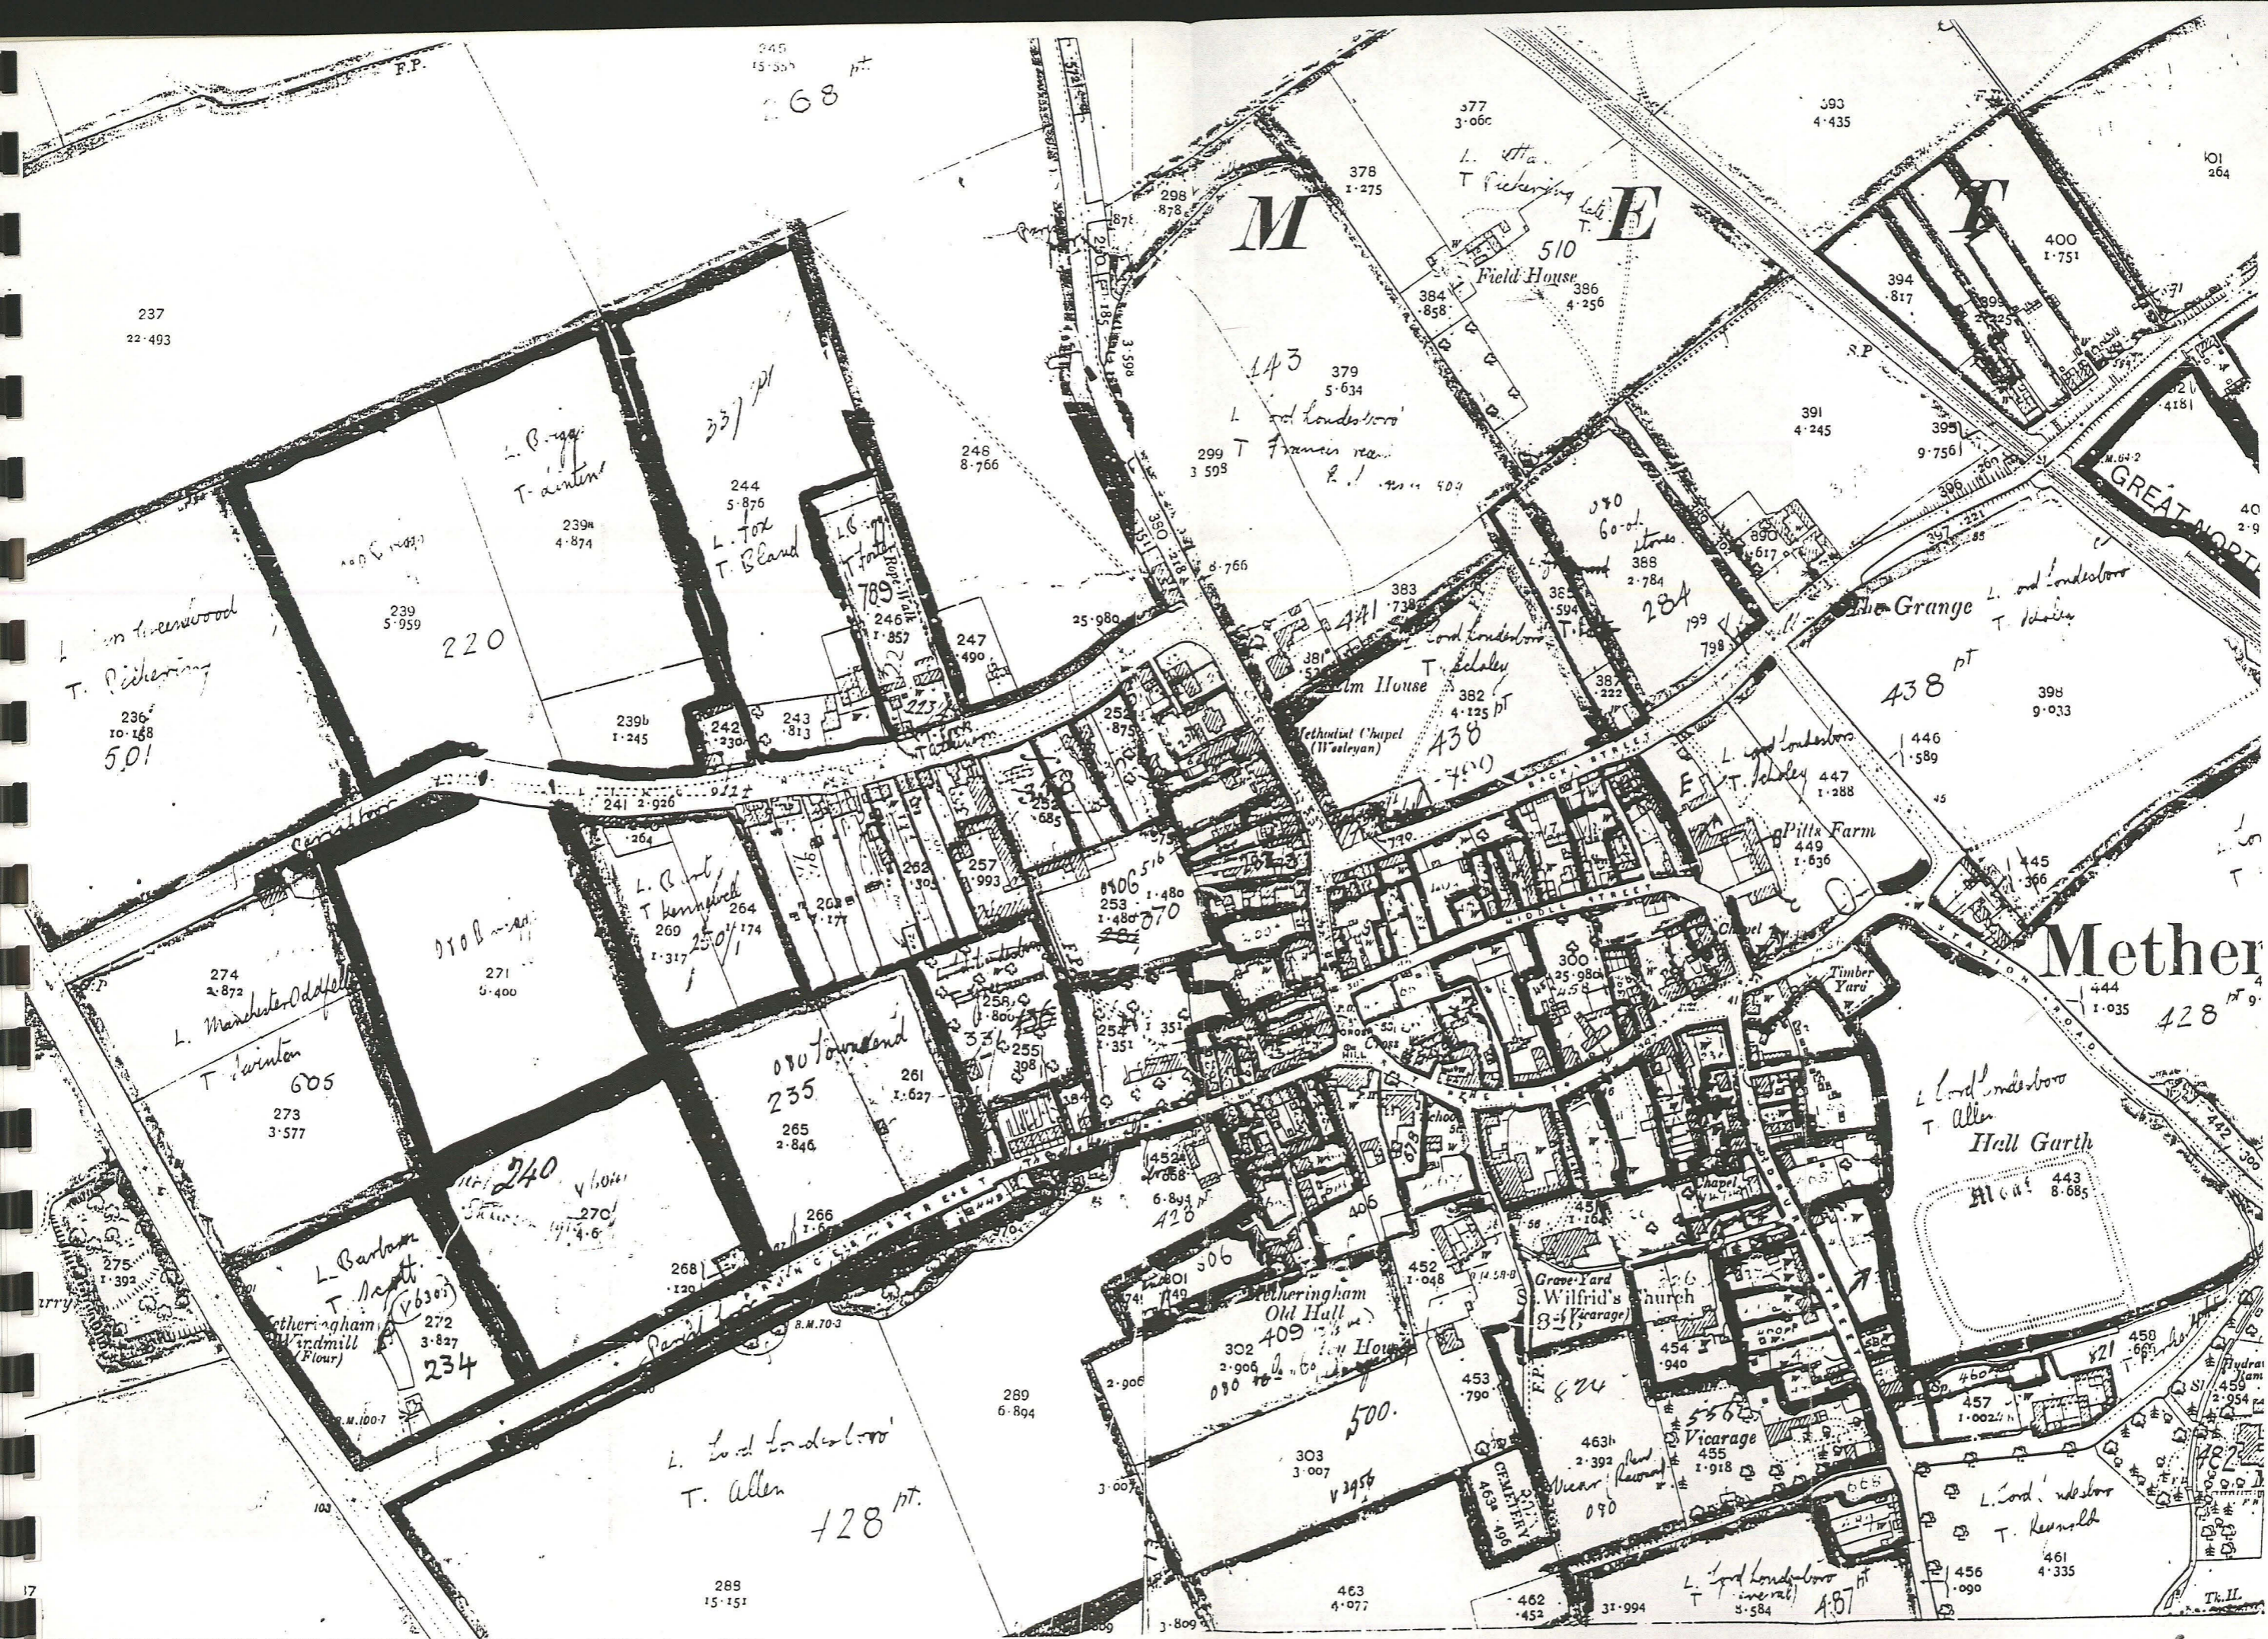
Fig. 3 O. S. 1:2,500 map of Metheringham, showing core of medieval settlement around High Street, Middle Street and Drury Street and moat at Hall Garth (built over in the 1960s). Surveyed 1887, revised 1904. (Reduced scale.)

It is clear that the modern village of Metheringham developed in the Anglo-Saxon period and the Domesday Survey of 1086 records that there were two manors (estates) centred on Metheringham which included a church, arable land, meadow and woodland Foster and Longley 1976 (entries 13/35; 31/18; 59/19; 68/4). There was also property belonging to an estate in Branston, which included land and two mills, and further land and a third mill belonged to an estate in Waddington. The focus of the medieval settlement and its Saxon precursor is presumed to have centred on the church and the moated site to its east. Little of the ancient street layout can be detected today because the village has expanded greatly since the end of the Second World War, with new housing estates being created in all directions. However, earlier Ordnance Survey maps provide evidence to show that High Street and Middle Street were at the centre of the settlement with Drury Street forming a link between the village and the manor to the south east (Fig. 3).

No watercourses are recorded on available maps of this part of Metheringham, but the 1904 OS map marks a large moat in the vicinity of the present Chaplin Close, with branches running south towards the road (Fig. 3). The western and eastern sides are plotted as extending to the south, either enclosing a further area or

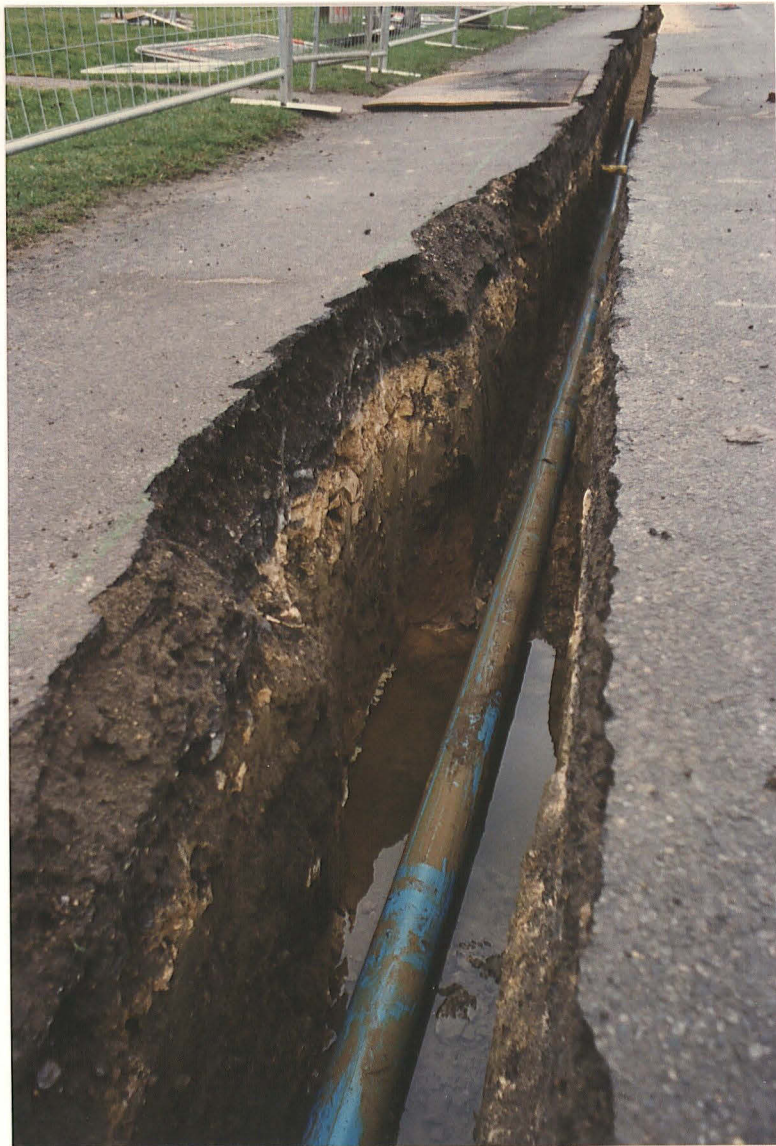
Pl. 1 Prince's Street, west of Princess Margaret Avenue. View looking west towards the Sleaford Road (B1188). Observation point 4 showing grey-brown clay/silt beneath road makeup of crushed limestone, probably part of a former watercourse.

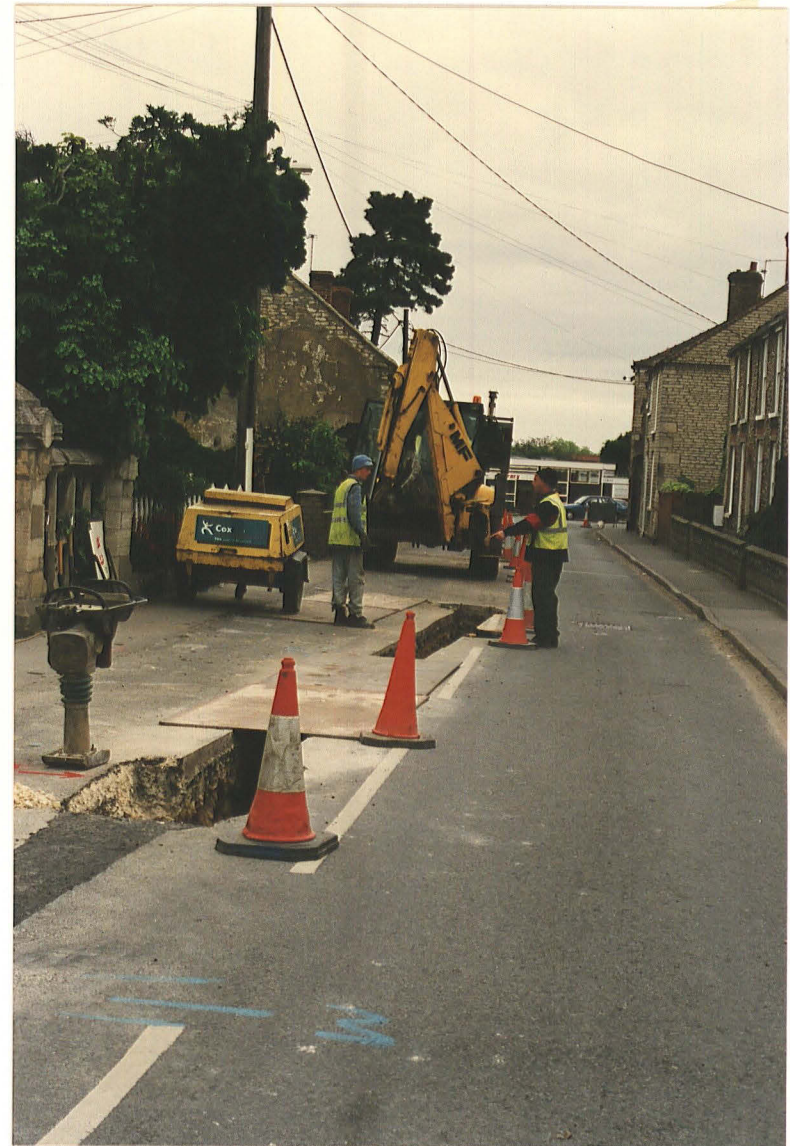
Pl. 2 Prince's Street, general view looking east towards High St, observation point 8 in foreground.

8. Outside the veterinary surgery, (no. 8) the tarmac and road makeup overlay a loose, weathered limestone (Pls. 2 and 3) which continued as far as the junction with High Street (Pl. 4).

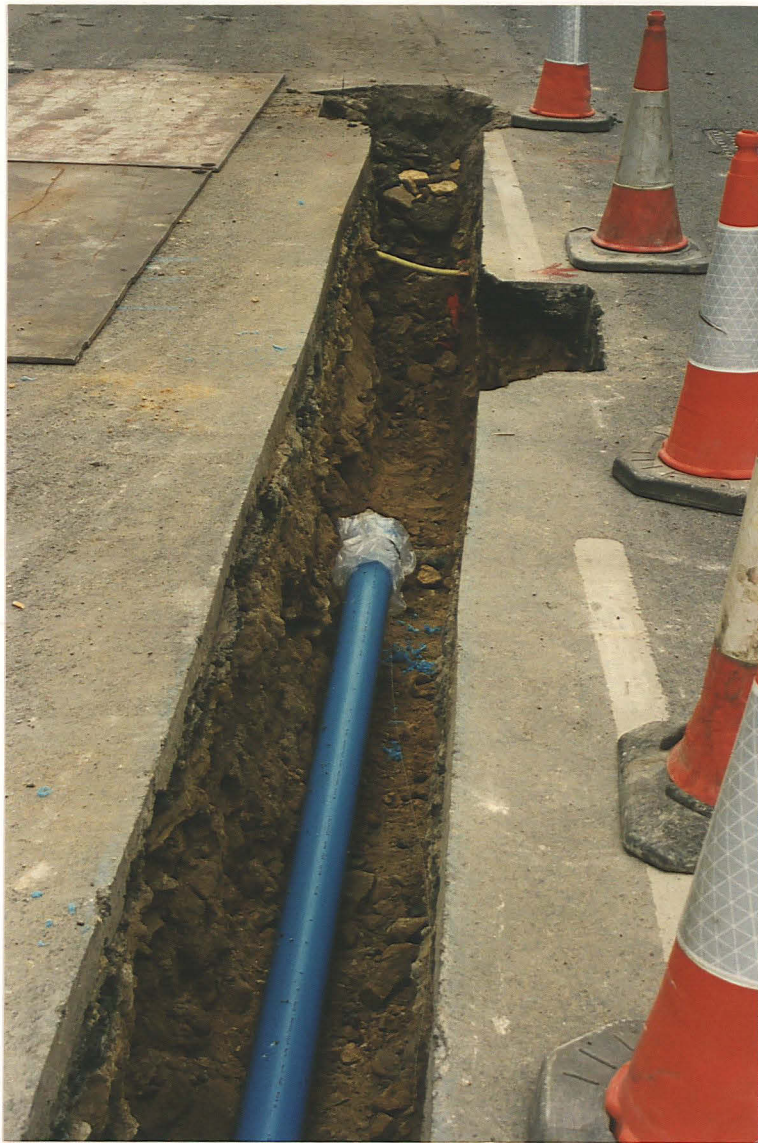
Pl. 3 Observation point 8, Prince's St, close-up.

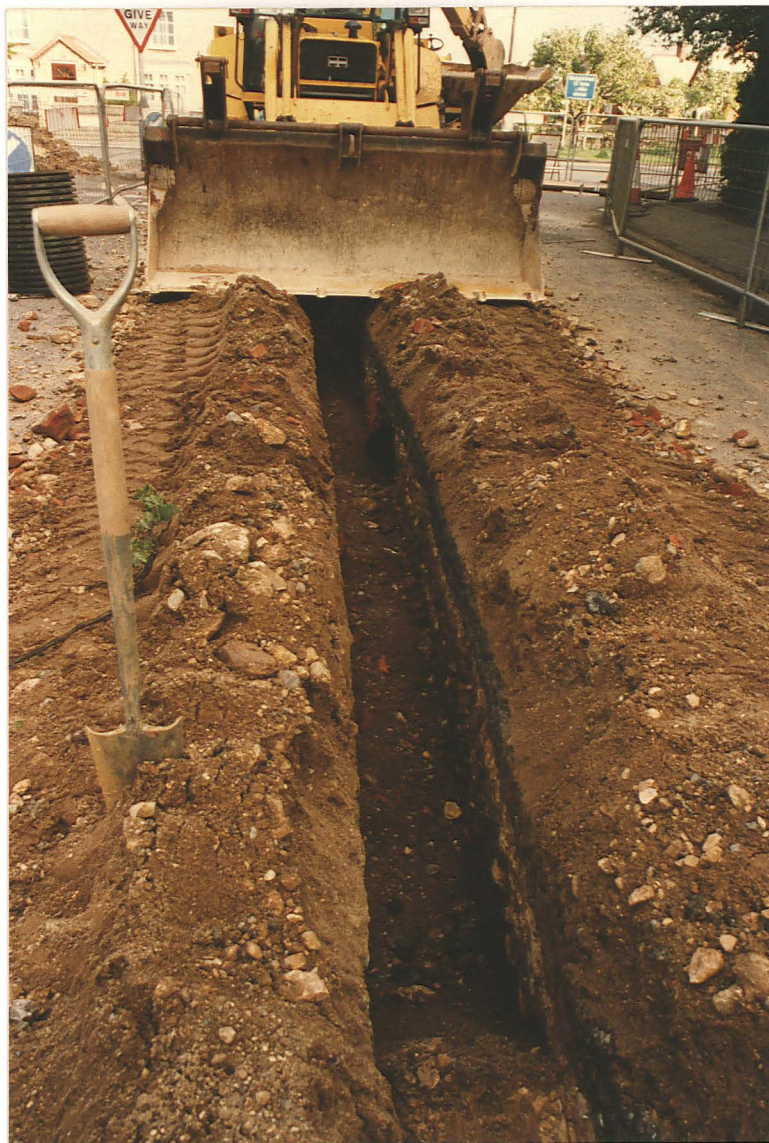
Pl. 5 North end of High St, looking north, showing brick culvert , observation 10, just below machine bucket.

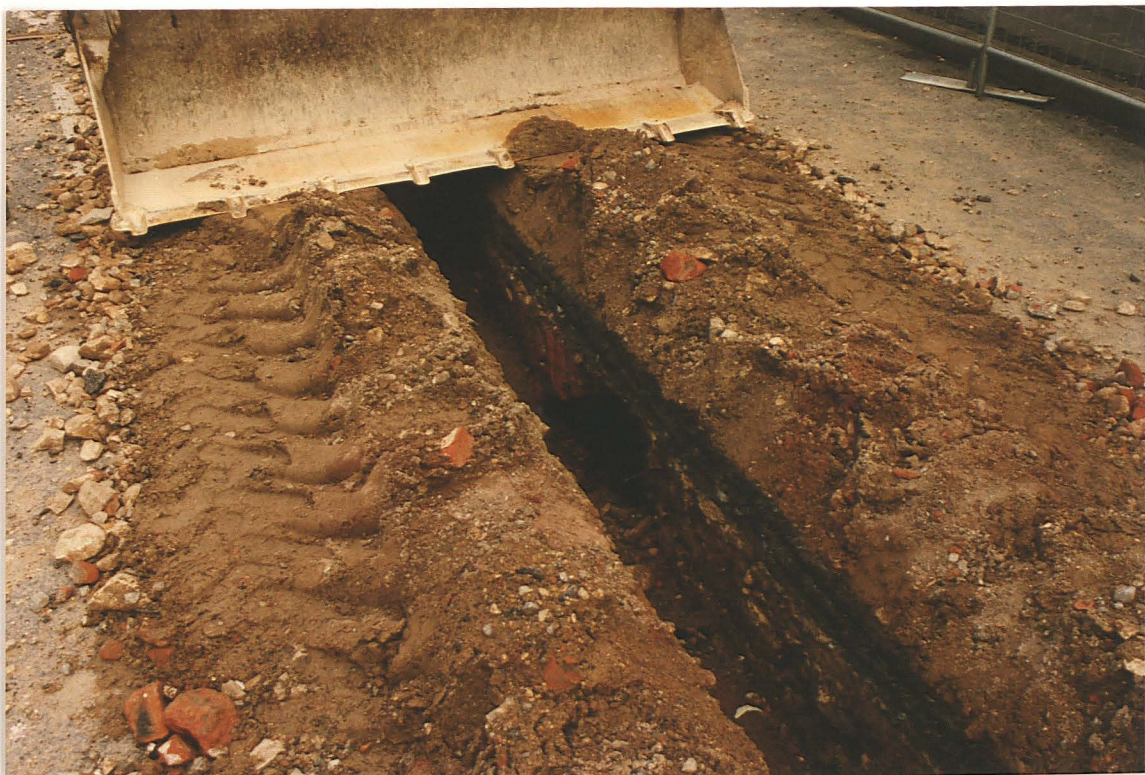
Pl. 6 Observation 10, close-up of brick culvert, truncated by modern road surface.

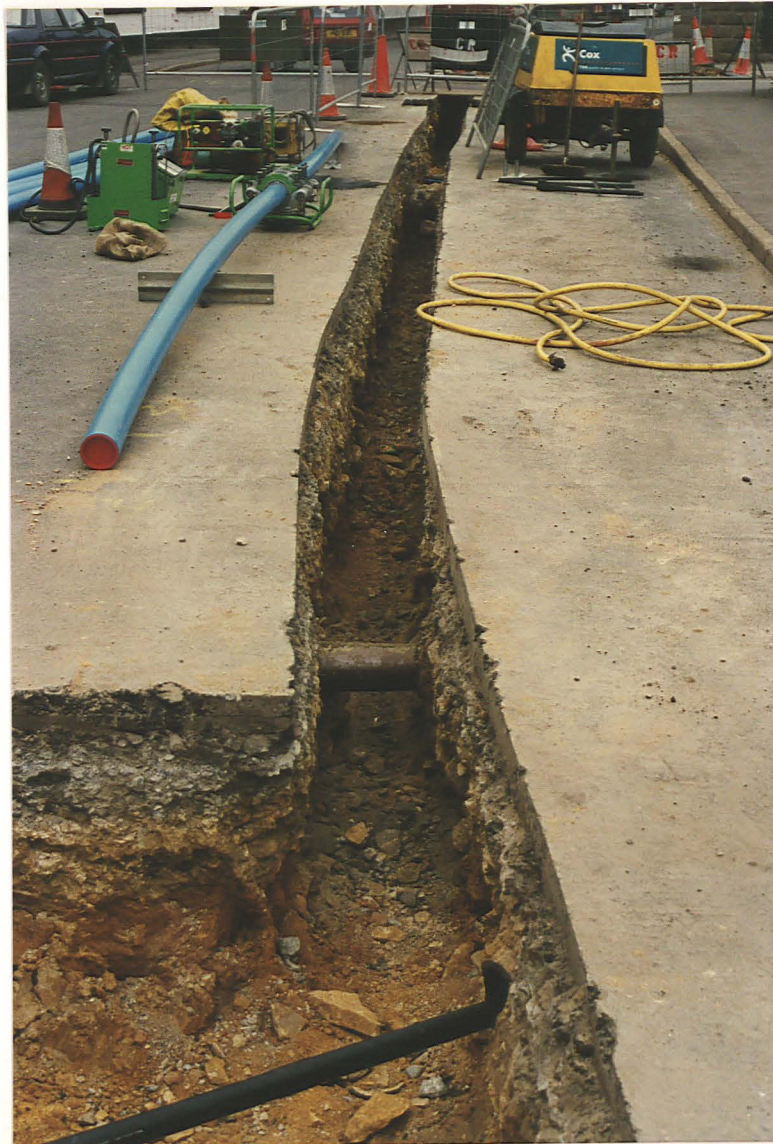
PI. 8 High St, view looking north from the Market Cross (observation 14), showing numerous services crossing the pipe trench

14. The solid limestone was observed past the war memorial and the medieval cross (Pls. 8 -10). There was no disturbance to the setting of the cross, which is protected as a Scheduled Ancient Monument under the 1979 *Ancient Monuments and Archaeological Areas Act*.

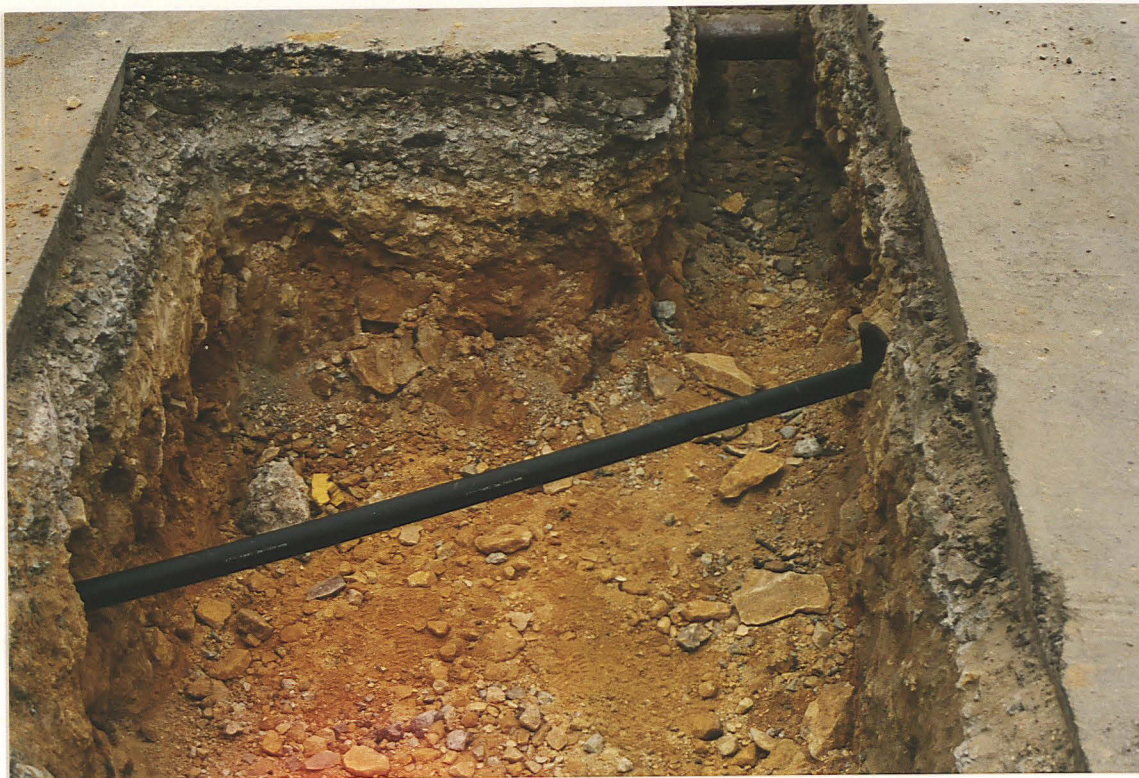
Pl. 9 Observation 14, close-up looking north showing limestone beneath modern road surfaces.

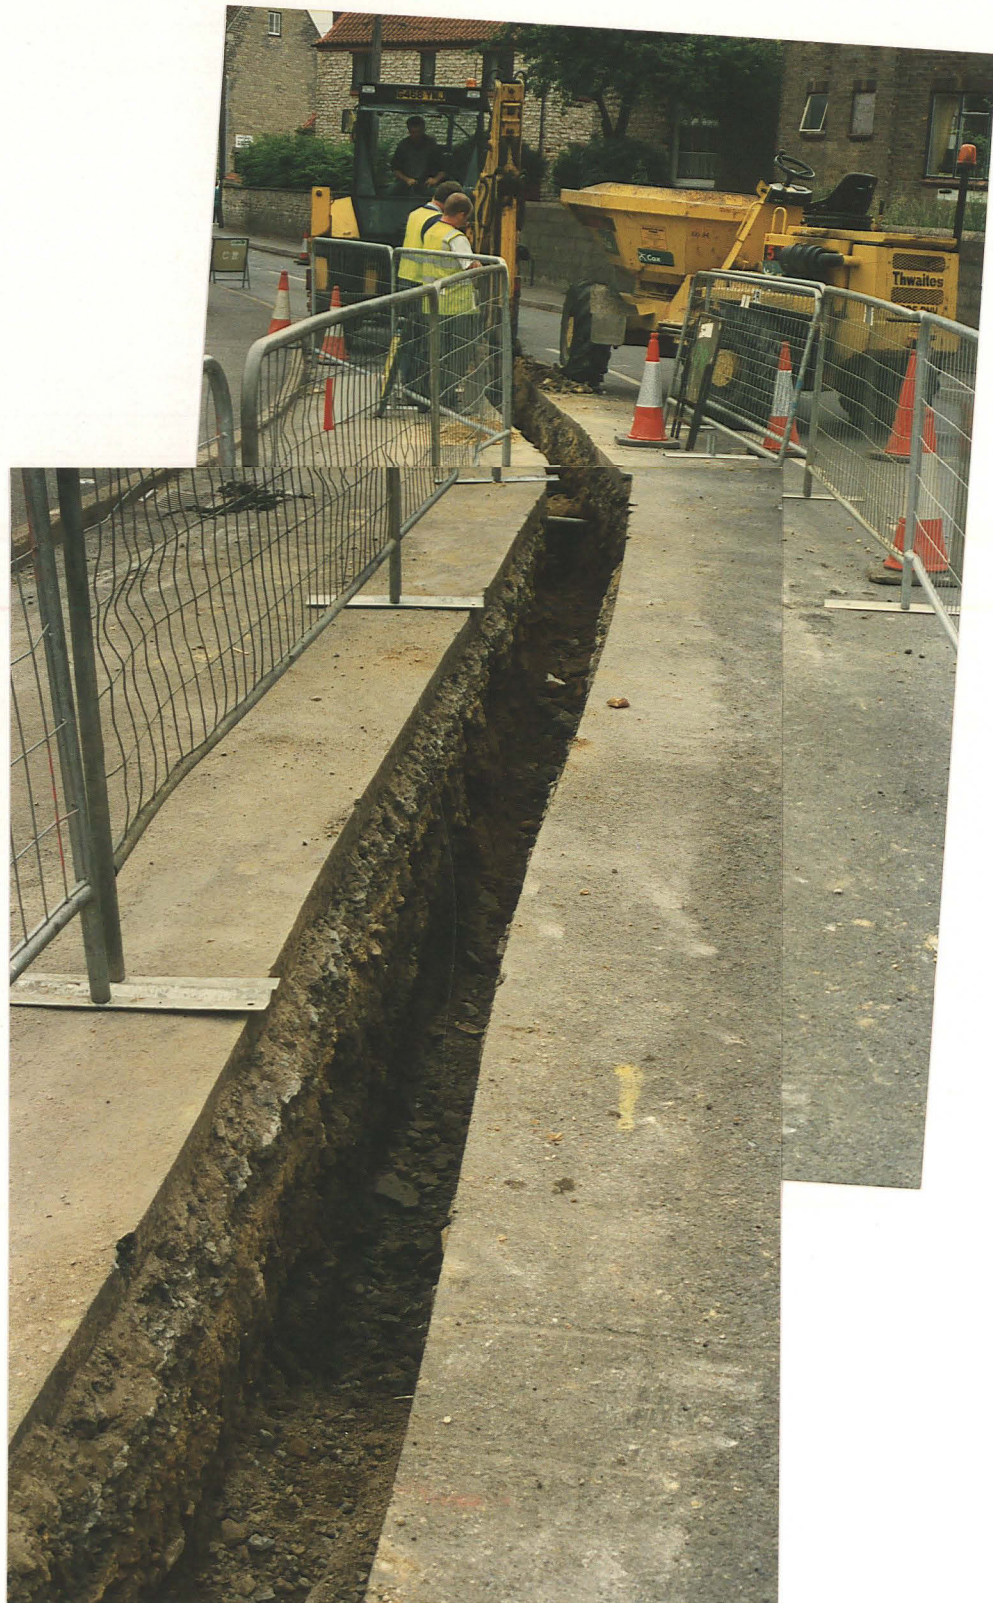
PI. 11 Observation 15, next to Library, showing grey fill of feature crossing the trench, looking south.

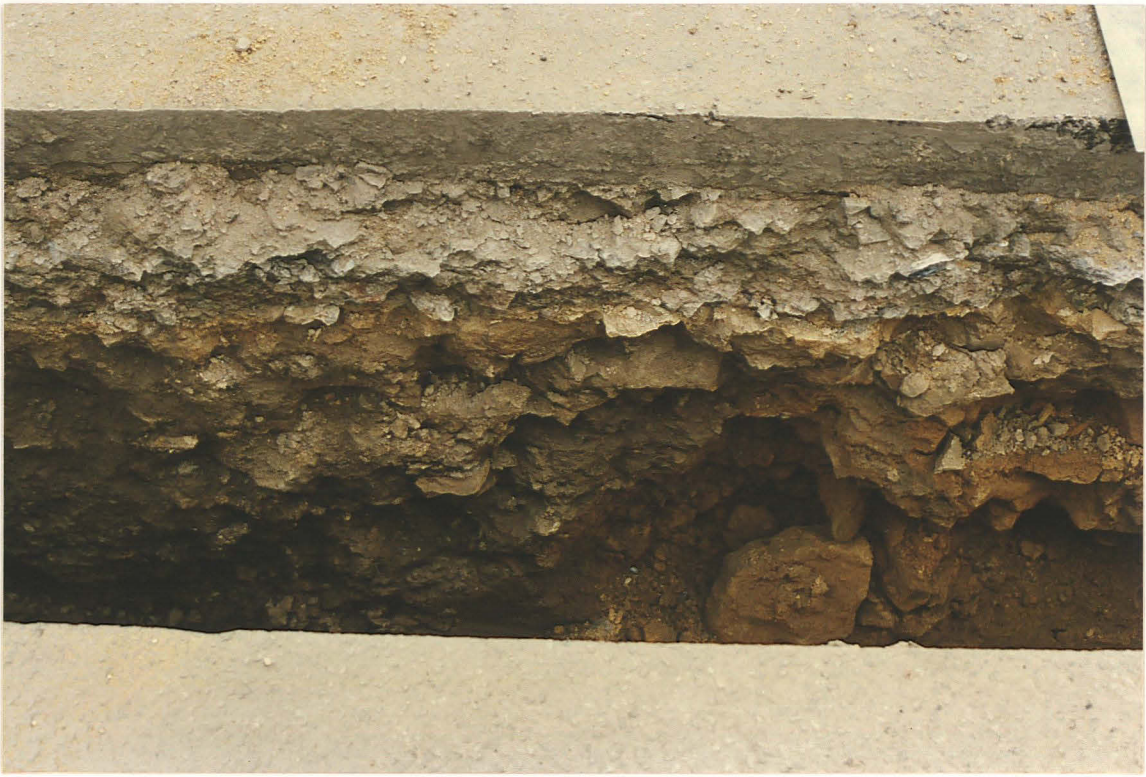
Pl. 12 Observation 15, close-up of feature containing grey fill.

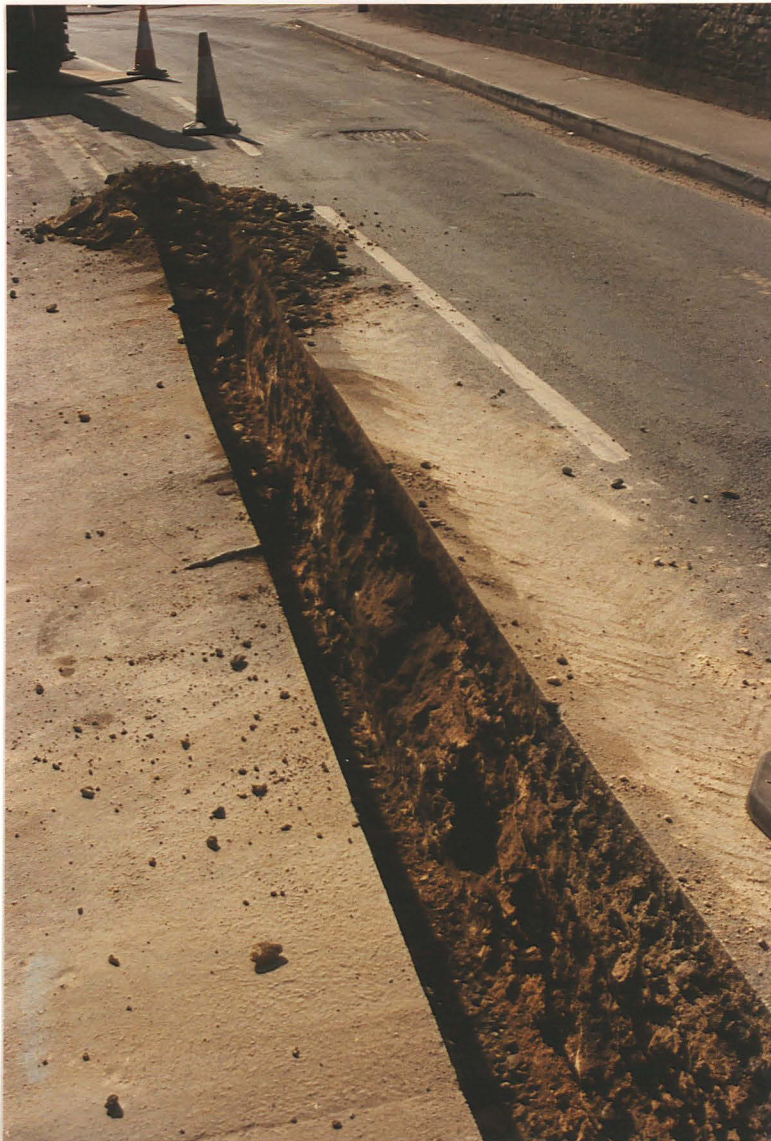
Pl. 13 High St, observation 16, opposite old school, showing small ditch or pit on right hand side of trench, filled with grey-brown clay, looking south.

16. Opposite the Old School a 2m wide ditch or pit was revealed, cutting through the limestone bedrock. The feature had been loosely backfilled with grey-brown clay. There were no associated finds (Pl. 13).

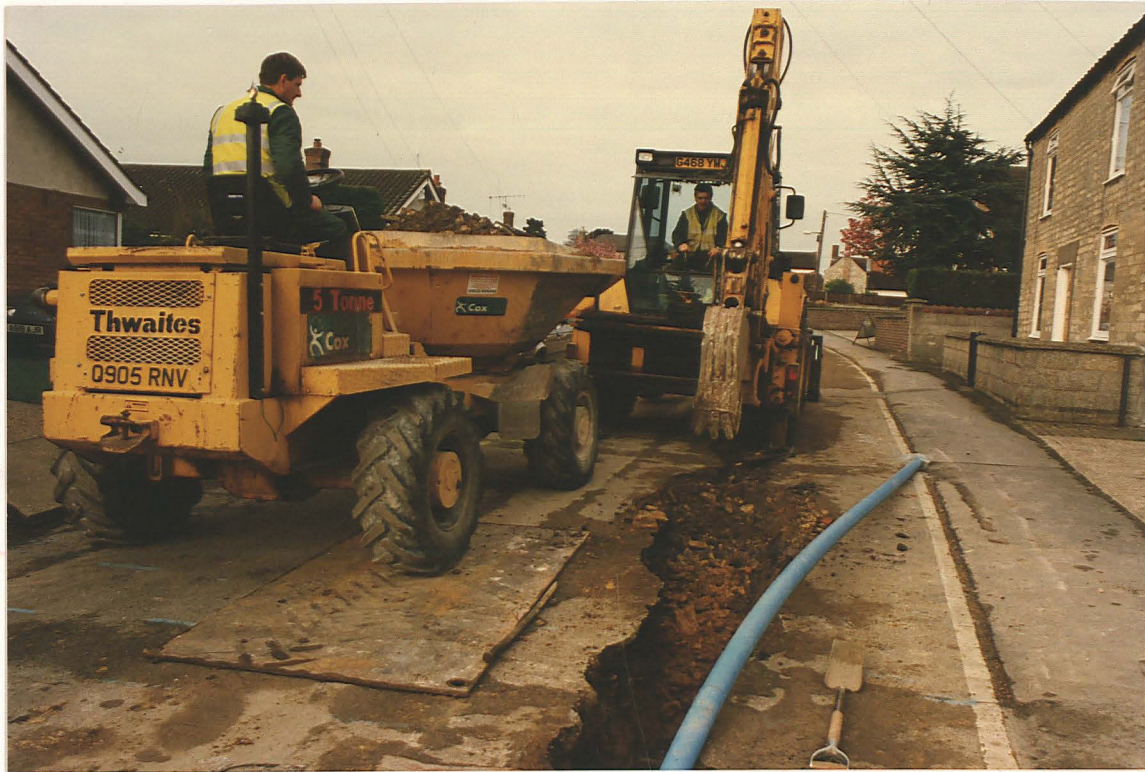
Pl. 14 Middle St, observation 18, showing limestone beneath road surface, looking west.

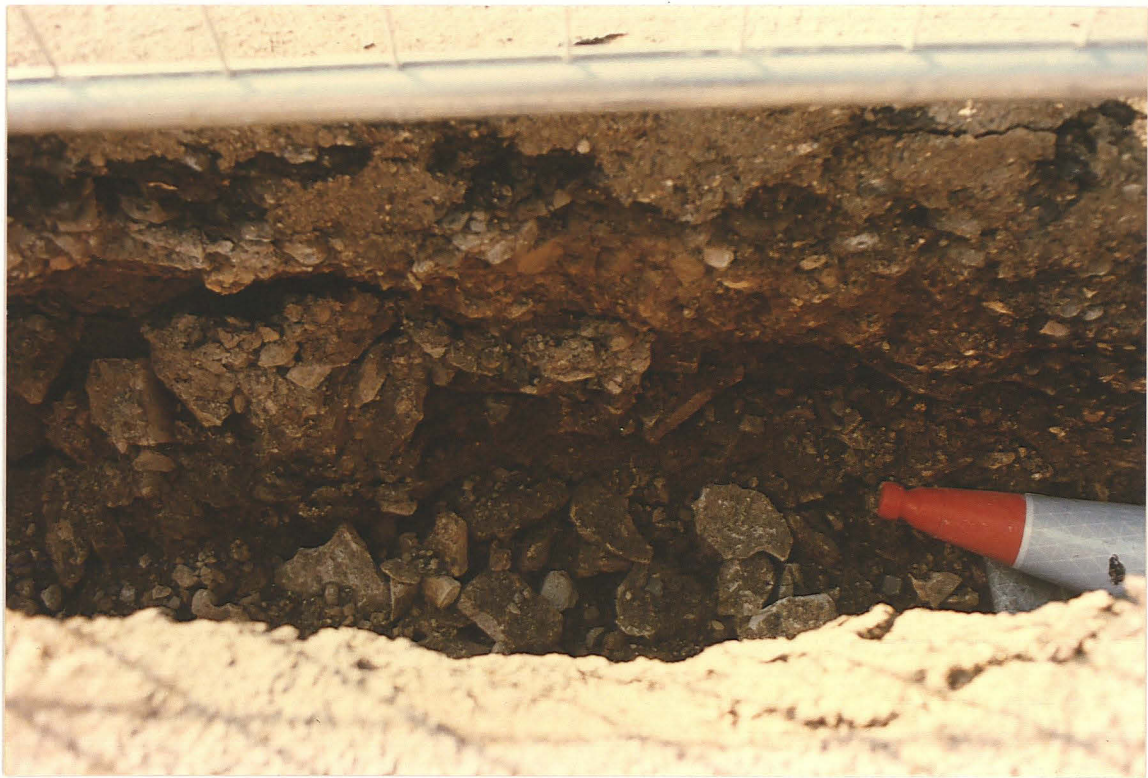
Pl. 16 Observation 19, close-up of limestone beneath road surface.

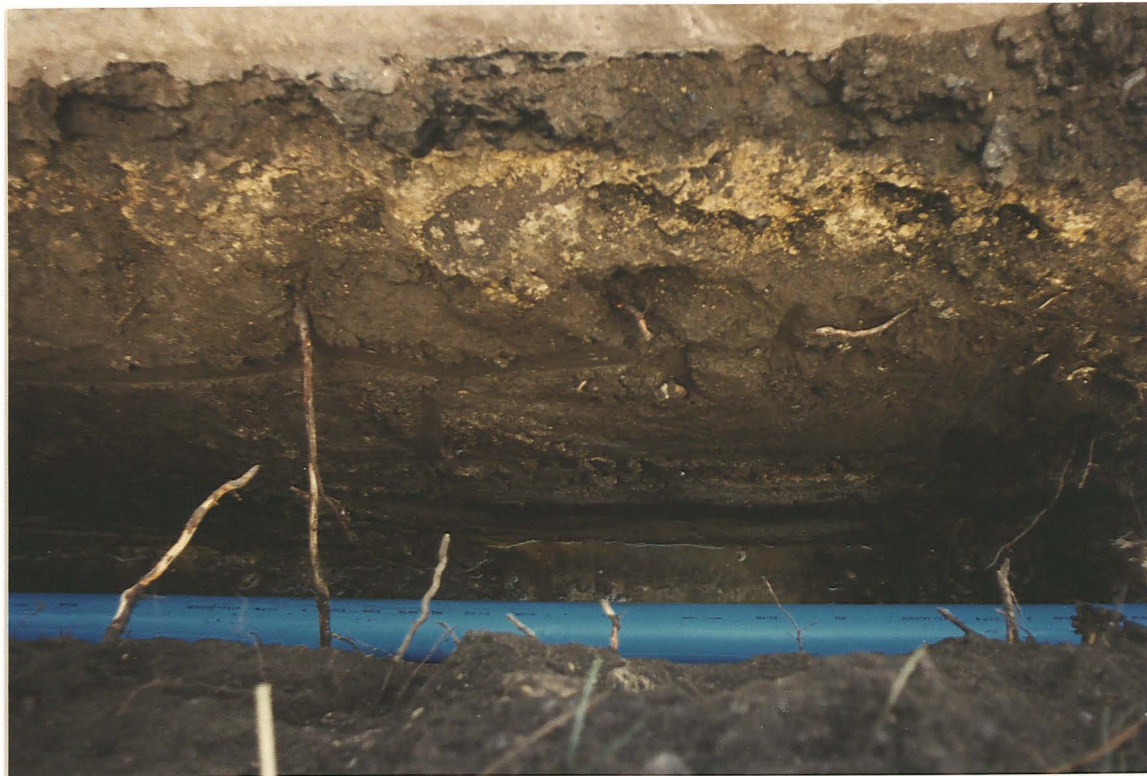
Pl. 17 Observation 20, west of Manor House, showing dark brown silty clay beneath road surface.

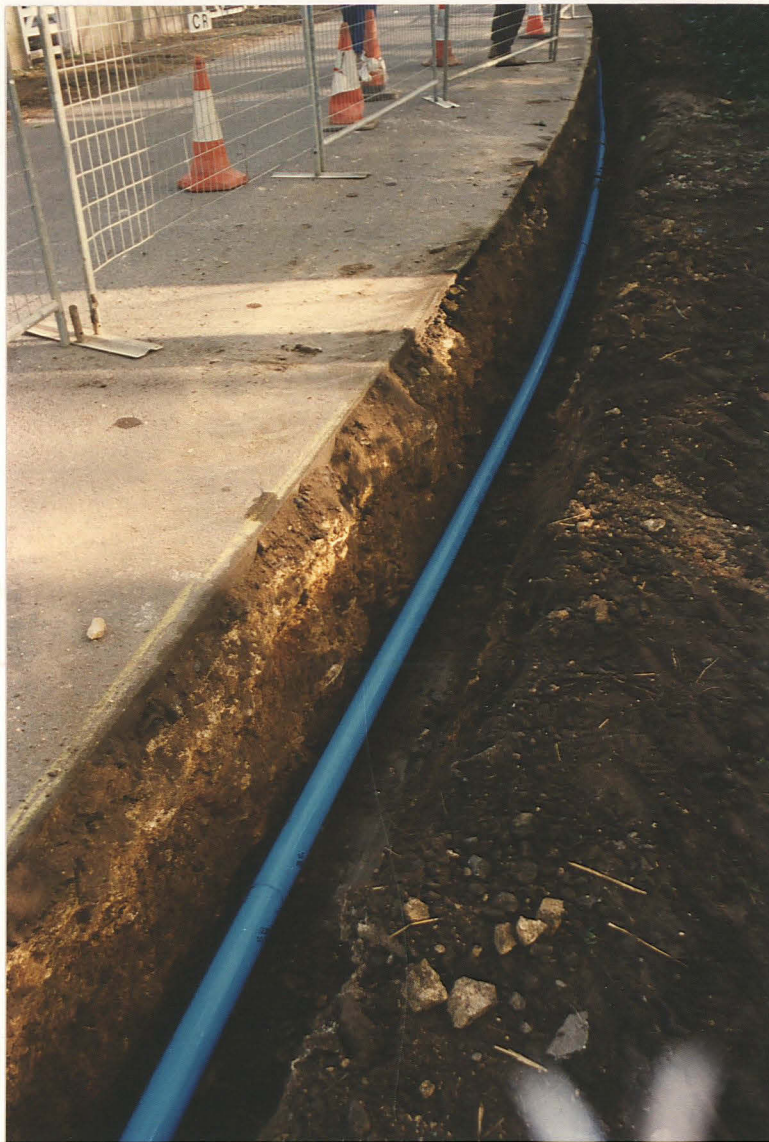
Pl. 18 Observation 21, looking east, showing continuation of organic silty deposits.

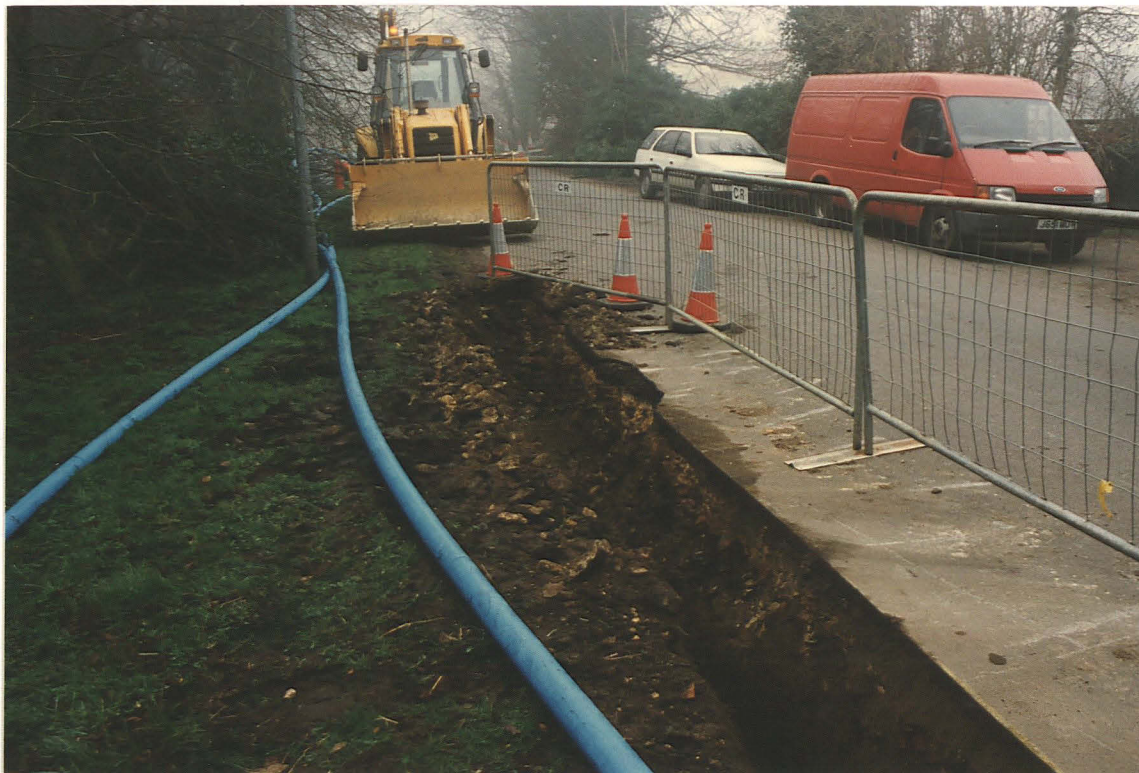
Pl. 19 Observation 22, looking west, showing limestone rubble deposit, a possible wall.

22. West of a field gate opposite a barn, a possible limestone wall foundation was recorded, apparently aligned at 45° to the road. This feature was 1.75m wide and cut through all the silty deposits below the road makeup (Pls. 19 and 20).

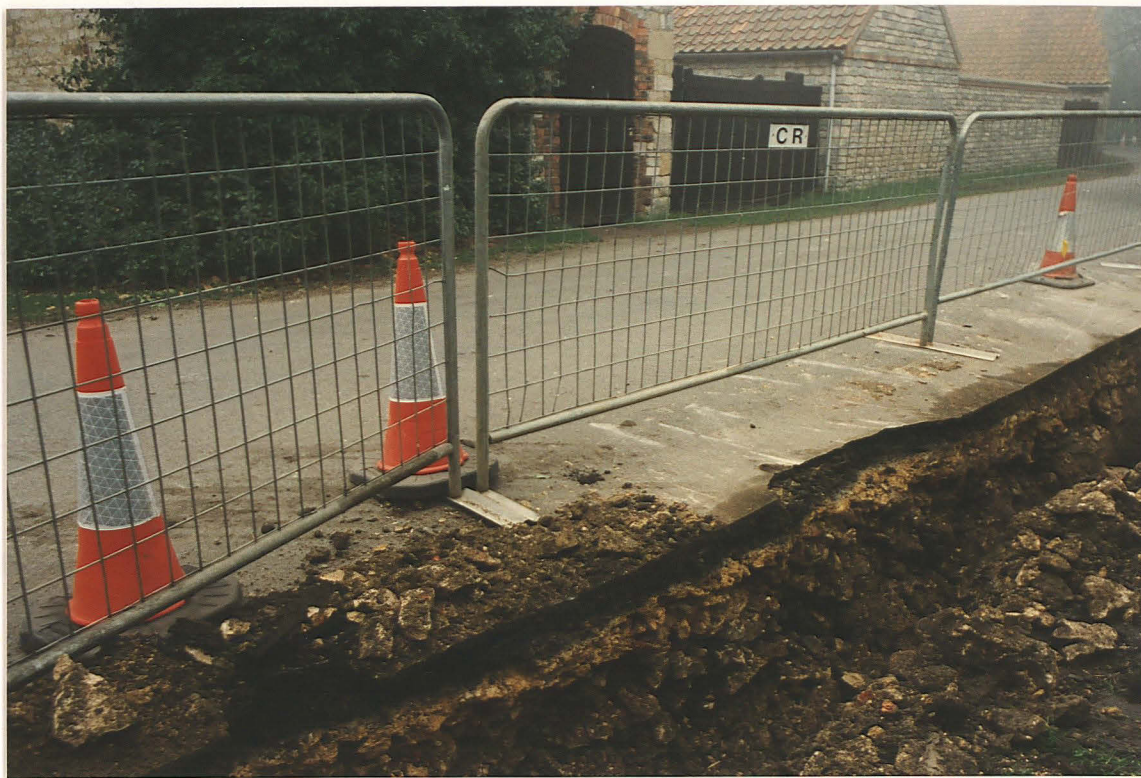
Pl. 20 Observation 22, close-up looking north-east, showing possible limestone wall.

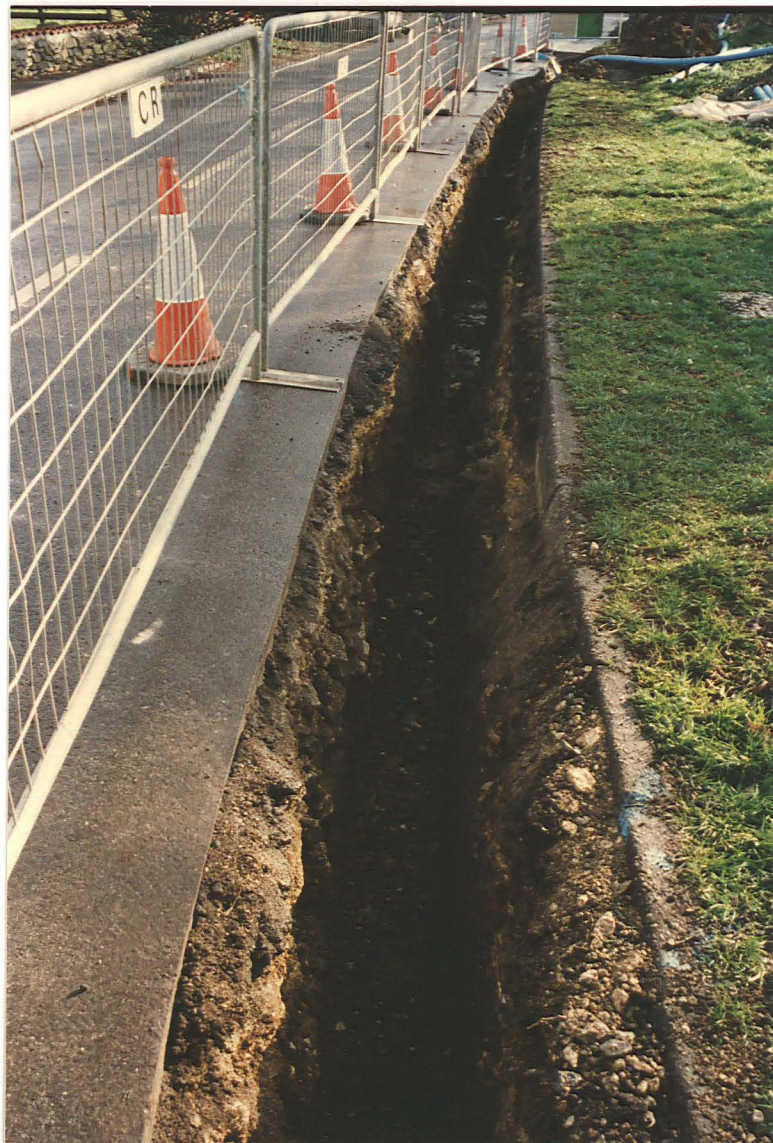
Pl. 21 Observation 24, limestone-filled depression.

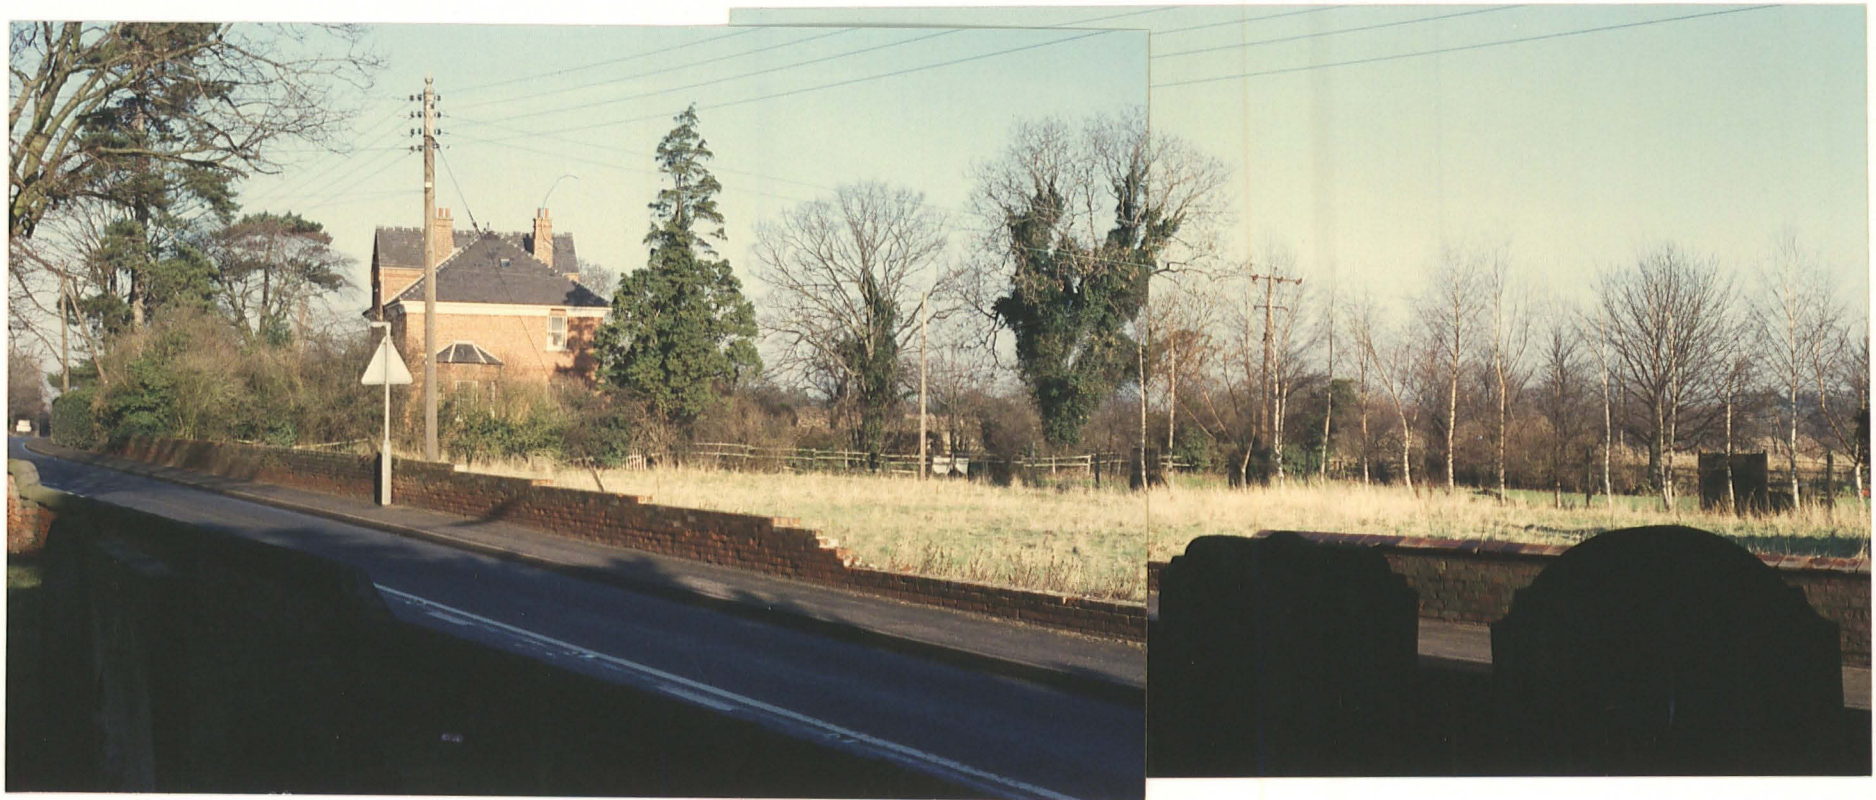
Pl. 22 View from Drury St looking north, showing undulation in fenceline between the ivy-covered trees, marking depression at observation 24, possibly a former watercourse.
