**ARCHAEOLOGICAL FIELD EVALUATION REPORT
THE CHAPEL SITE, CULVERTHORPE HALL**

Site Code: CCH98
LCNCC Acc No. 3.99
NGR TF 0232 4045

Report prepared for Mr RJ Clark
by CPH Palmer-Brown
March 1999

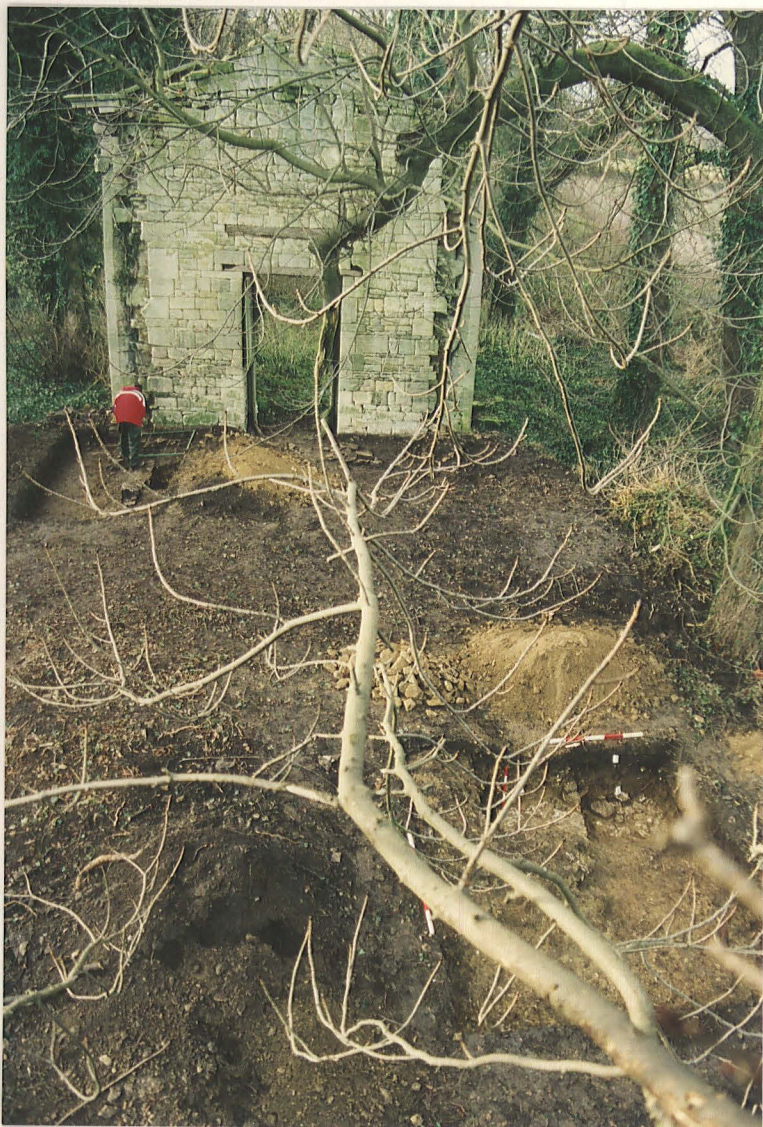
P1. Context view showing surviving facade, Trench 1 (background) and Trench 2 (foreground), looking west from above

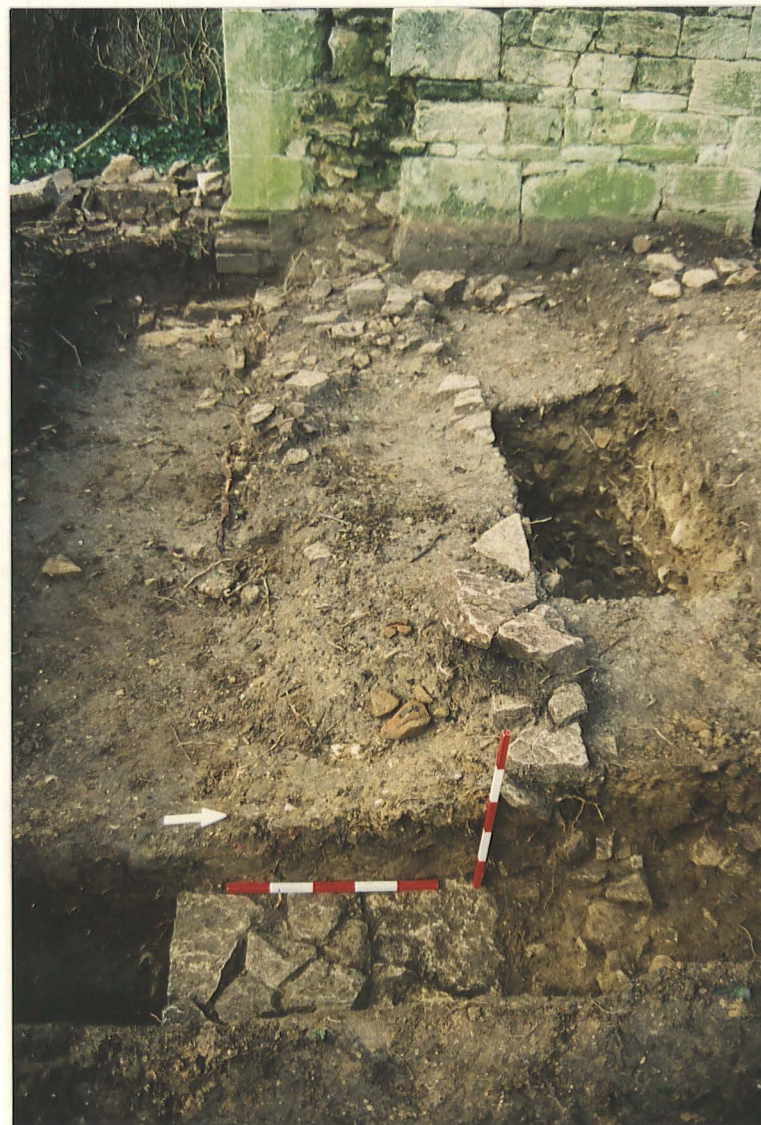
P2. Trench 1 looking west; in the foreground is chapel foundation 007, underlying destruction debris and the later wall 003

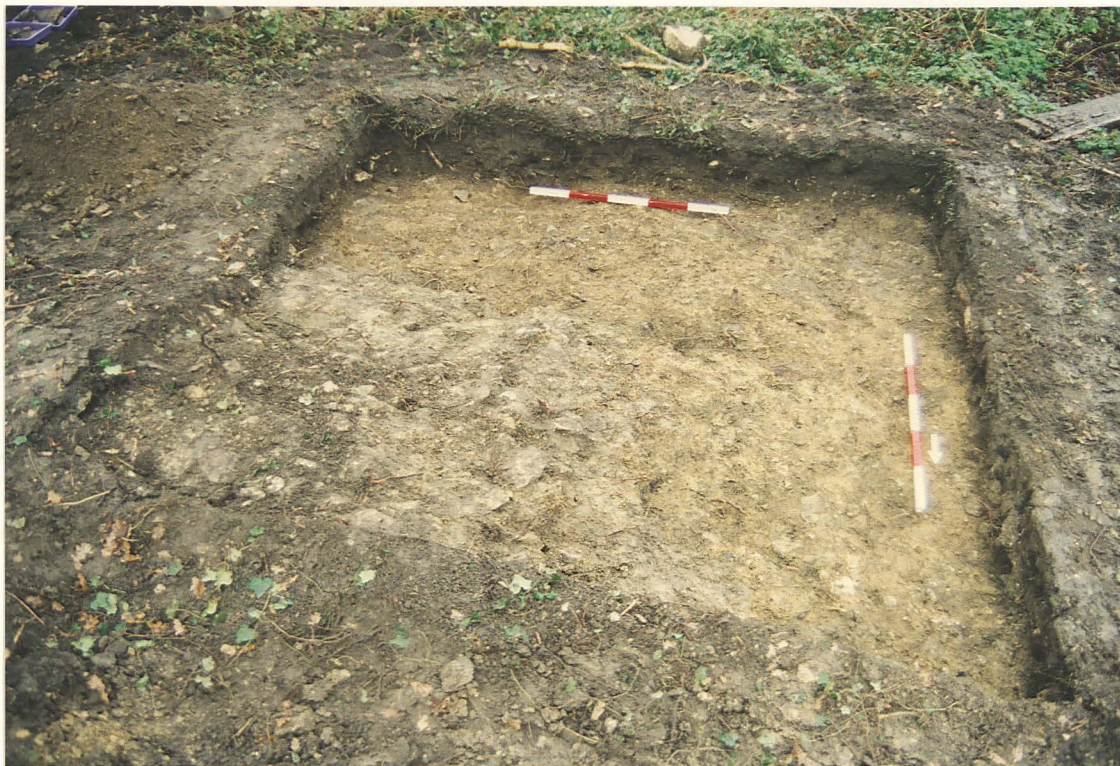
P3. Trench 2 following initial cleaning, looking north; in the foreground is the rubble mound associated with the robbing of the chapel; in the background and on the right is a possible robber trench that pre-dates the construction of the chapel
