**Bitchfield to Burton Coggles  
Mains Replacement Scheme  
Archaeological Monitoring in Burton Coggles**

Report prepared for  
Anglian Water Services Ltd

**LAS Report No. 357**

**May 1999**

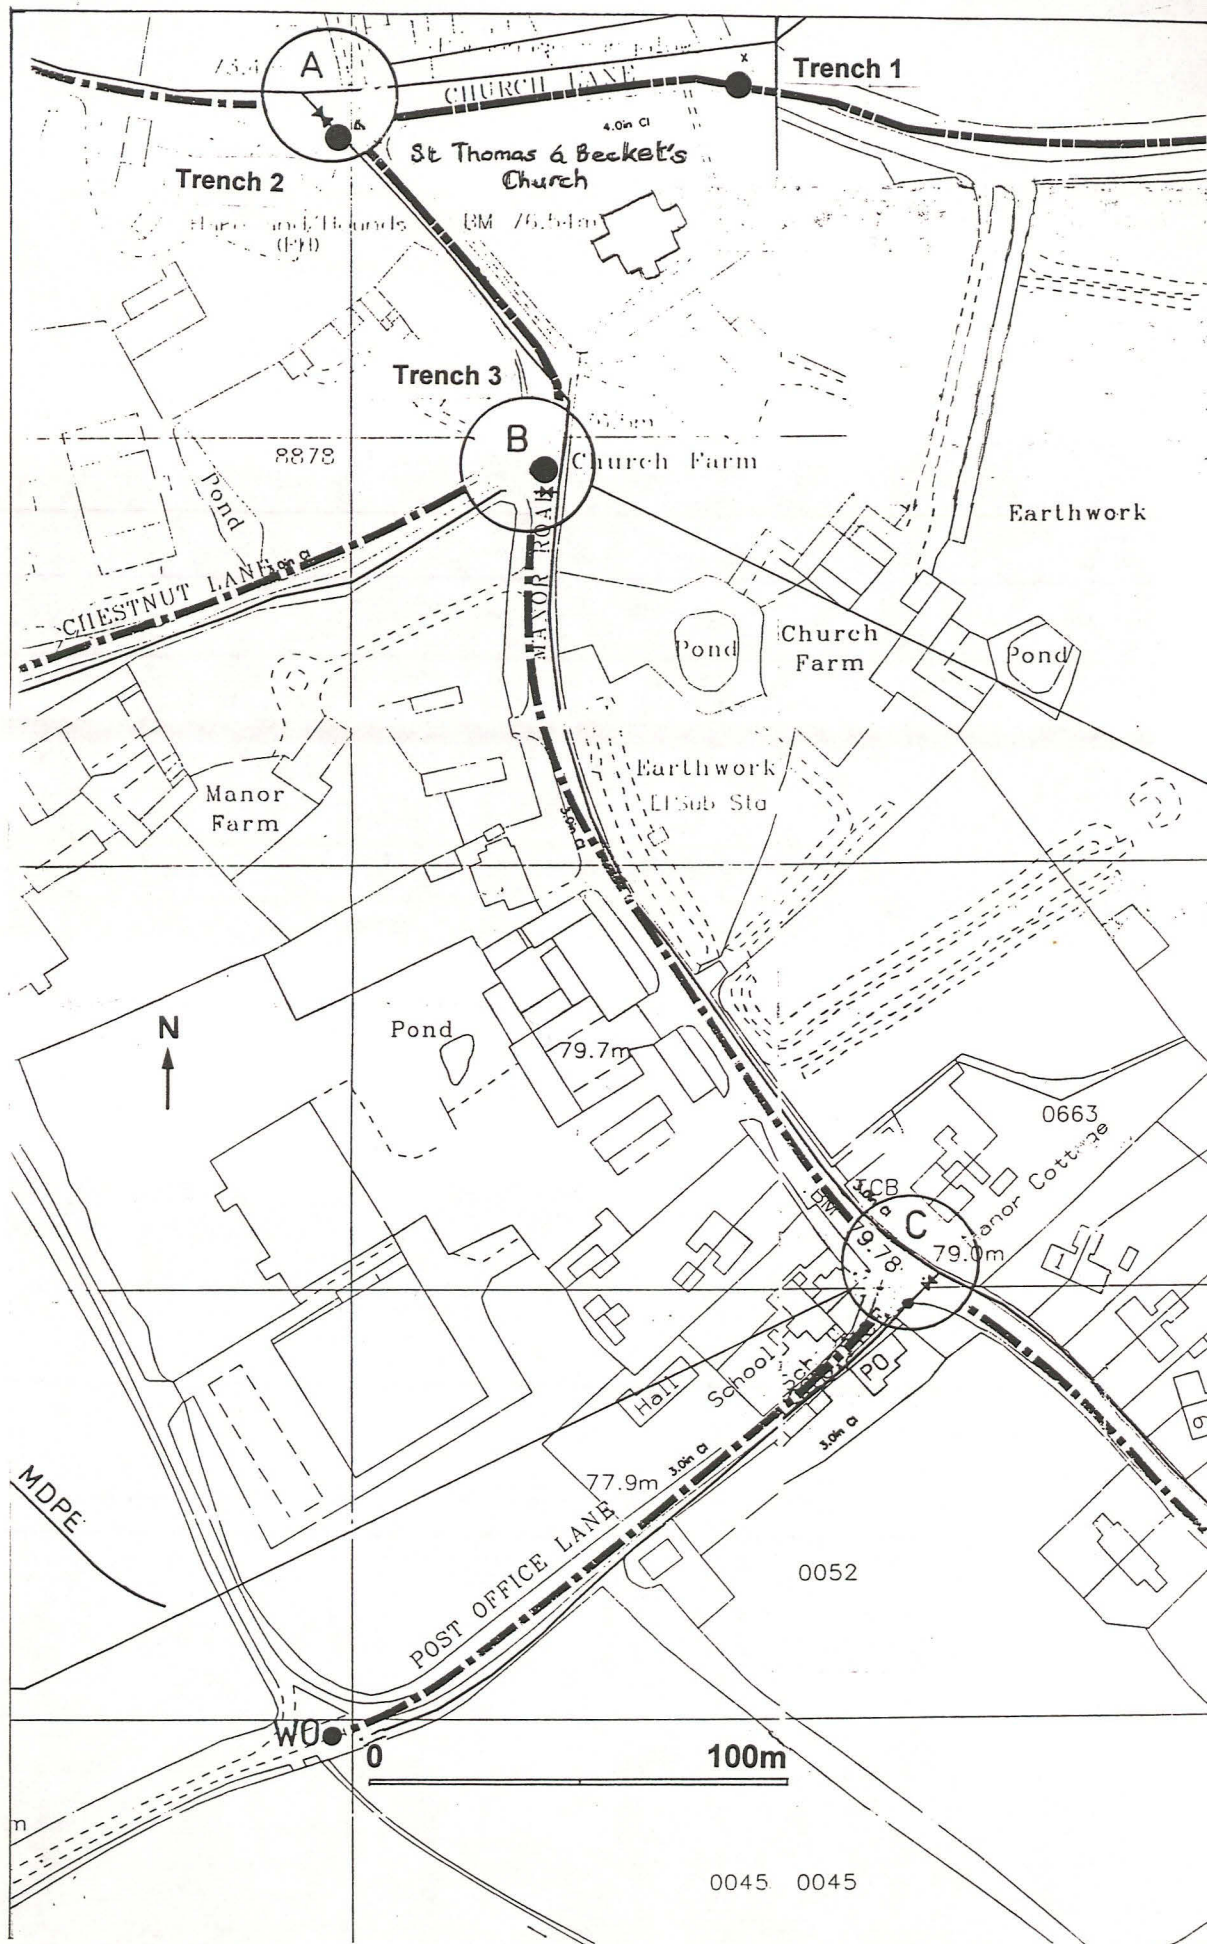
Fig. 2 The monitored trenches (based on the 1:2,500 plan dwg. no. 9721906/3 supplied by Anglian Water Services; © Crown Copyright, reproduced with the permission of the Controller of HMSO. LAS Licence No. AL 50424A).

**The Watching Brief (Fig. 2)**

Three moling access trenches were excavated by machine, and assigned numbers by LAS for recording purposes. The positions of the trenches are marked on Fig. 2.

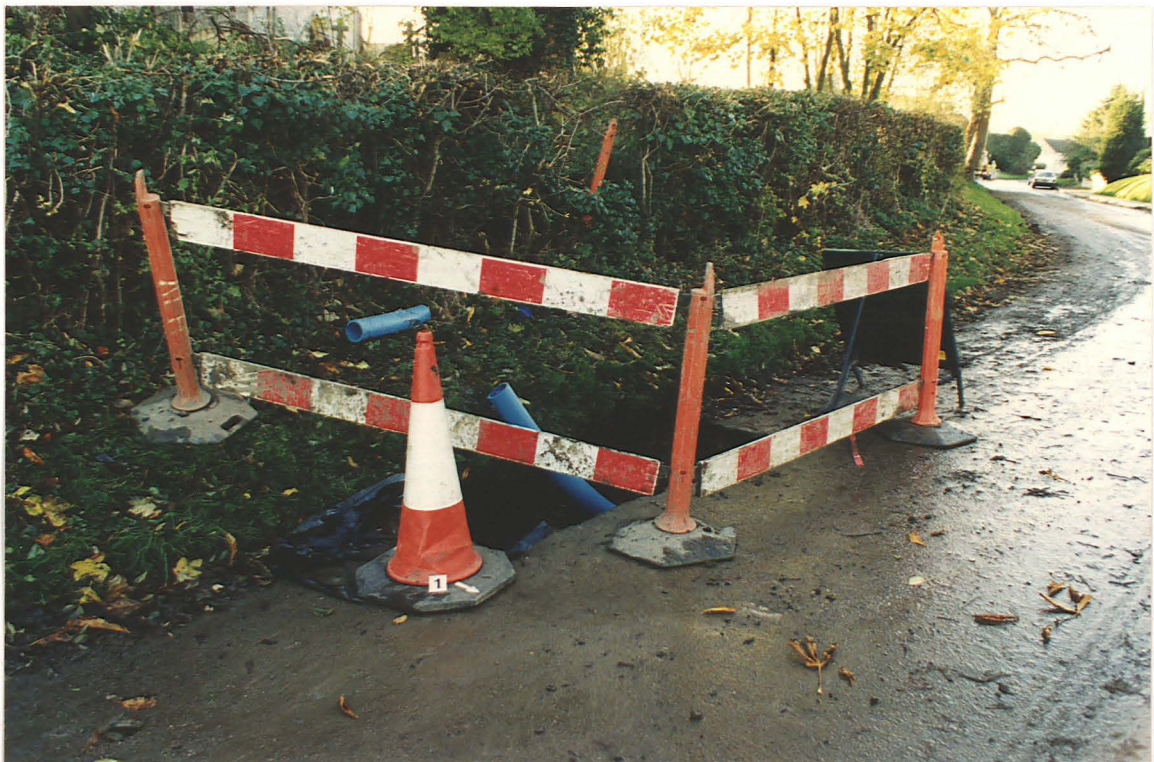
**Pl. 2 Location of Trench 1, southern side of Church Lane (looking west to junction with Manor Road).**

This 2m long and 0.8m wide trench was excavated in the southern edge of Church Lane, NE of the church but close to the churchyard wall (Pl. 2). The northern trench face revealed the eastern side of a broad, sloping feature **106** (Pl. 3). This survived to a depth of 0.5m and an exposed width of 1.7m, cut into brown clay. It was overlain by limestone rubble, either a post-medieval road or the foundation for the modern tarmac road. Its position so close to the road edge suggests it may be a recent road widening.

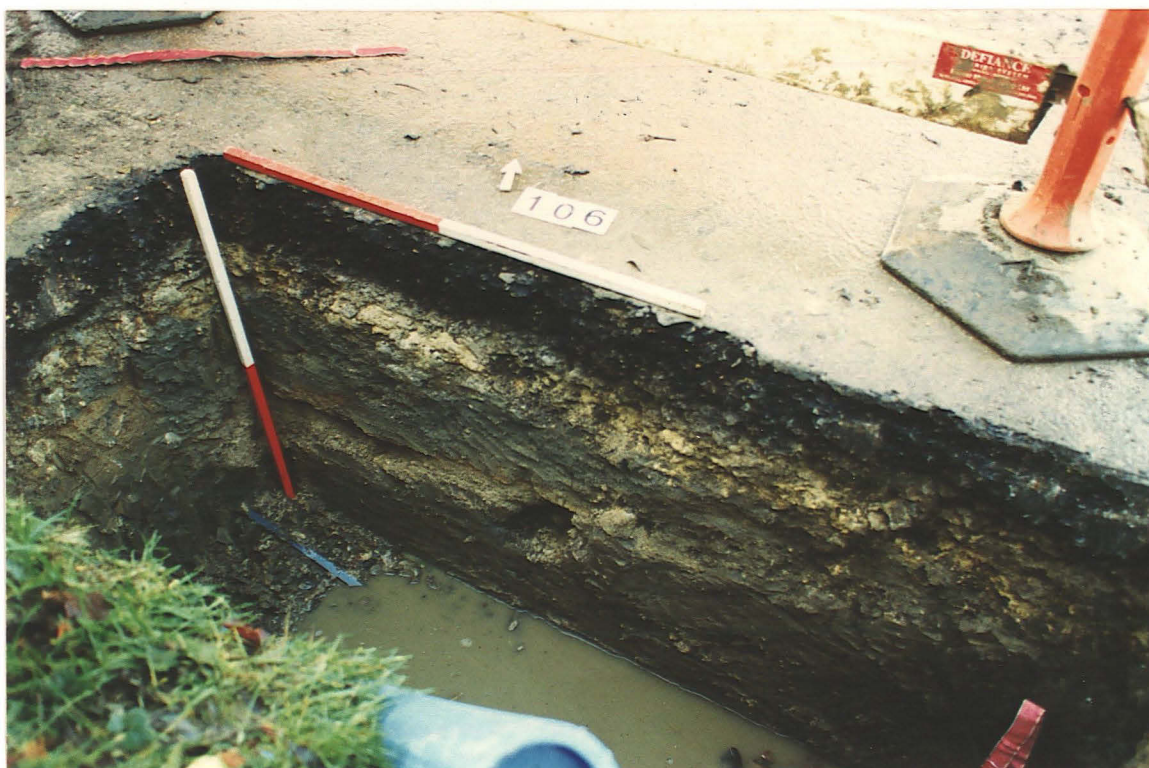
Pl. 3 Deposits visible in the north face of Trench 1. The grey clay (left) is filling the side of feature 106, possibly a natural stream channel. Looking north, scales 1m.

**106** was filled with a blue/grey silty clay, above primary silting of light yellow sand. The colour of the clay indicated gleying caused by waterlogging. The feature could possibly be a natural watercourse, surviving as a ditch north of the road and perhaps originally flowing through Church Farm to Manor Road.

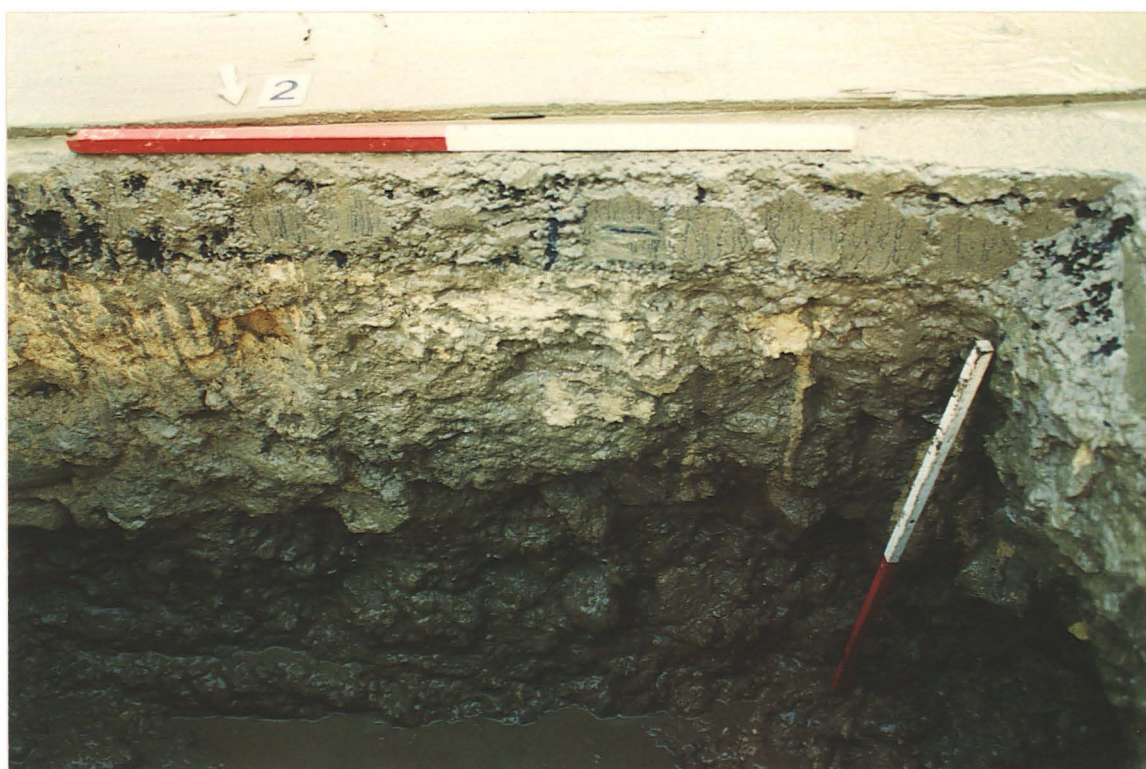
Pl. 4 Sequence of layers visible in Trench 2. Scales 1m.
