LINDSEY ARCHAEOLOGICAL SERVICES

**Ingoldsby to Pickworth
Mains Replacement Scheme
Archaeological Monitoring in Lenton, Keisby and
Osgodby**

Report prepared for
Anglian Water Services Ltd

LAS Report No. 358

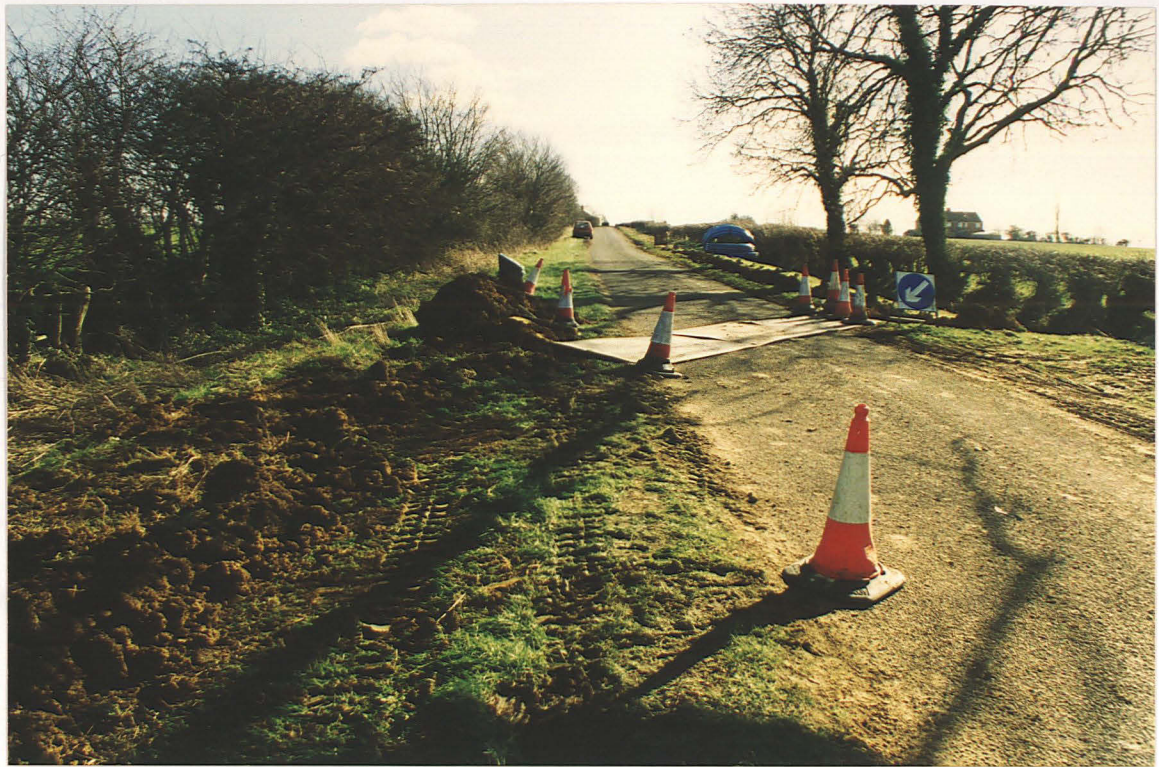
Pl. 1 View along the supposed alignment of King Steet, to south of the poultry farm, Hanby. The position of the trench and road crossing are evident (looking south).

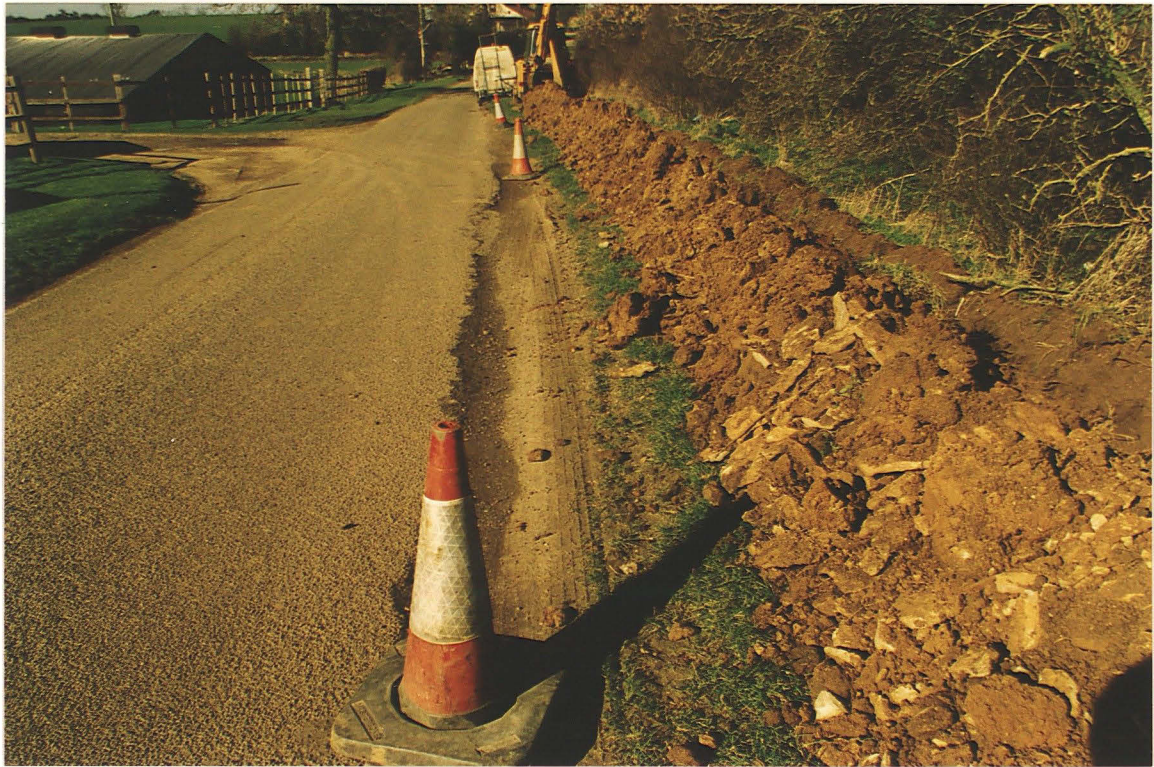
Pl. 3 Limestone pieces in the trench spoil, interpreted as post-medieval consolidation of a former watercourse.

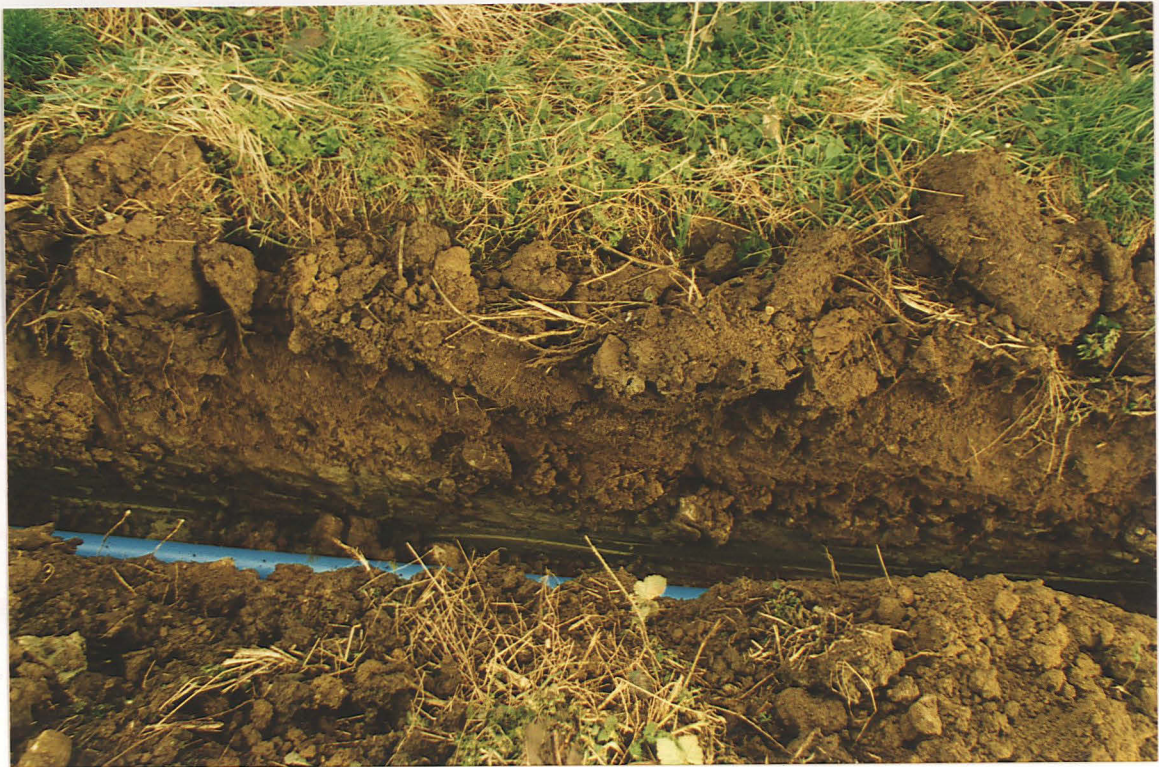
Pl. 5 Grey clay in the trench south of Dial Cottage.

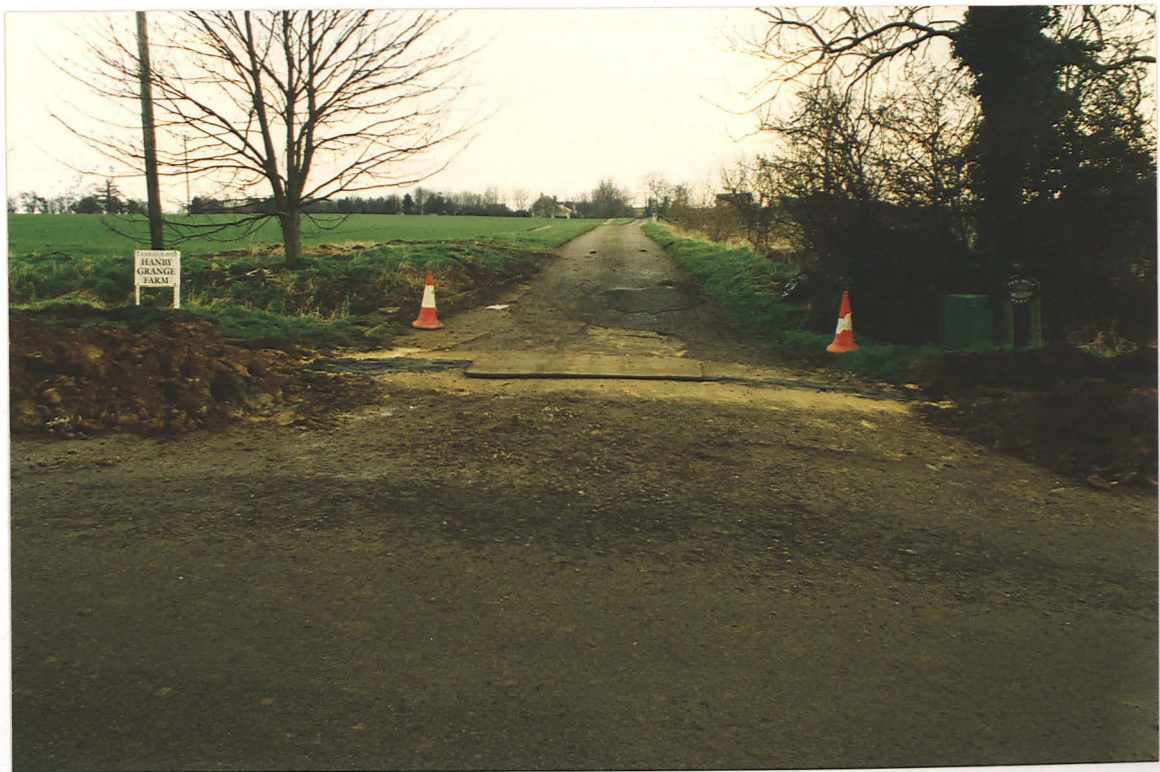
Pl. 6 The track to Hanby Grange Farm crosses north-south ridges which might reflect the actual course of King Street (looking east).

8. No obvious sign of Roman road metalling or flanking ditches was seen within any of the trenches dug for the new main. It was observed that the track to the east of the road, leading to Hanby Grange Farm, crossed slight north-south aligned ridges between the road and the farm (Pl. 6). Although any of these might possibly prove to be the course of the Roman road, all may be naturally formed undulations.

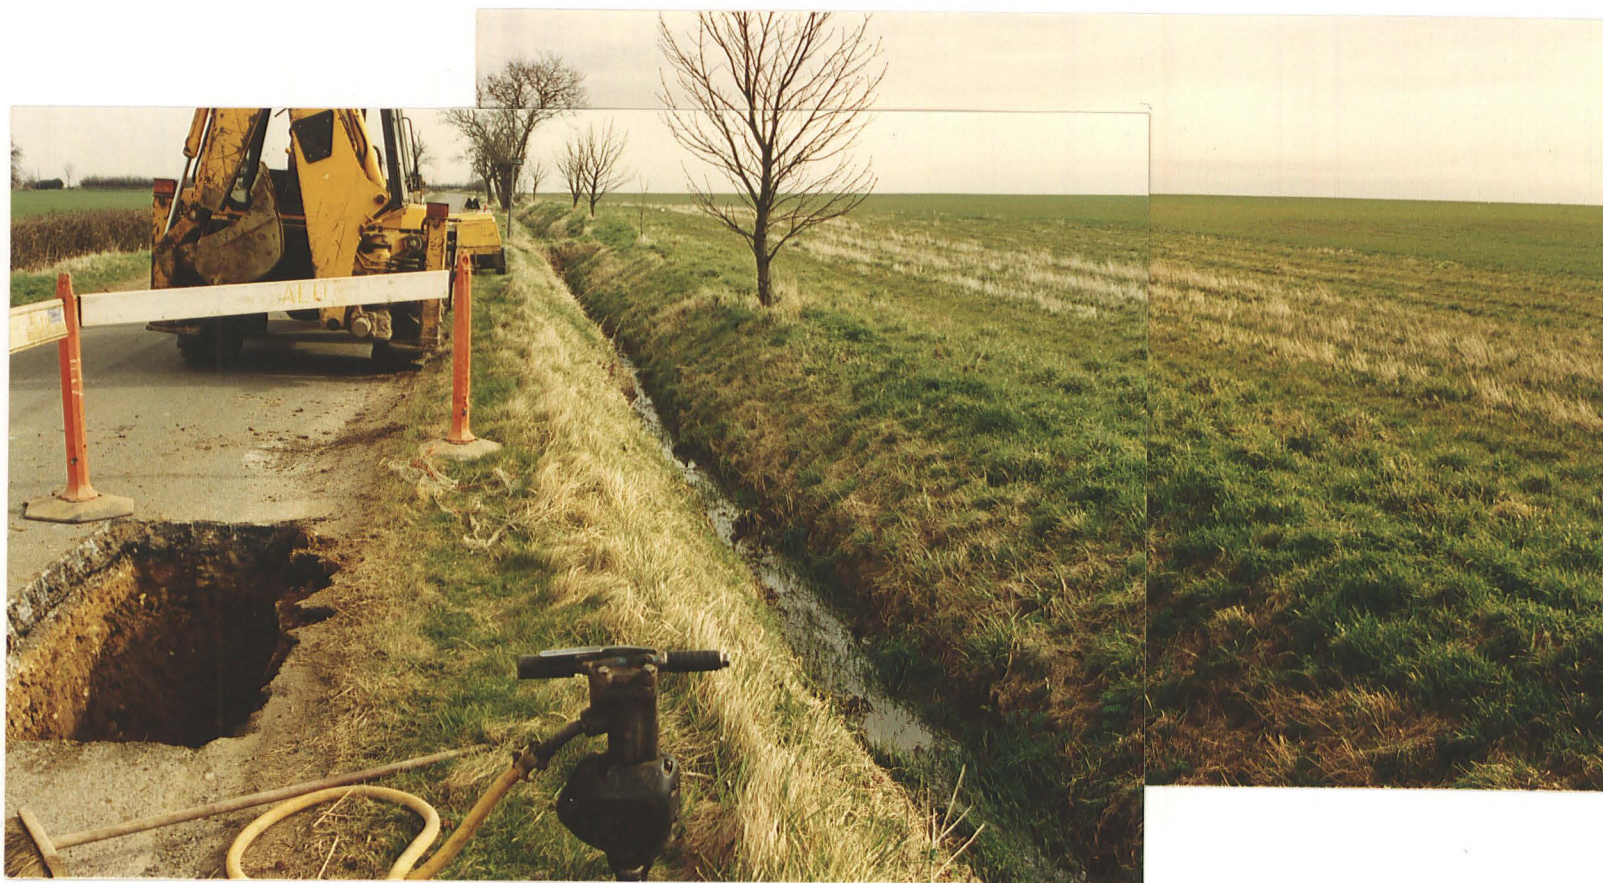
Pl. 7 Position of Trench 2, Lenton-Pickworth Road. No certain sign of the Roman road was evident at ground level in the adjacent fields (looking NE).

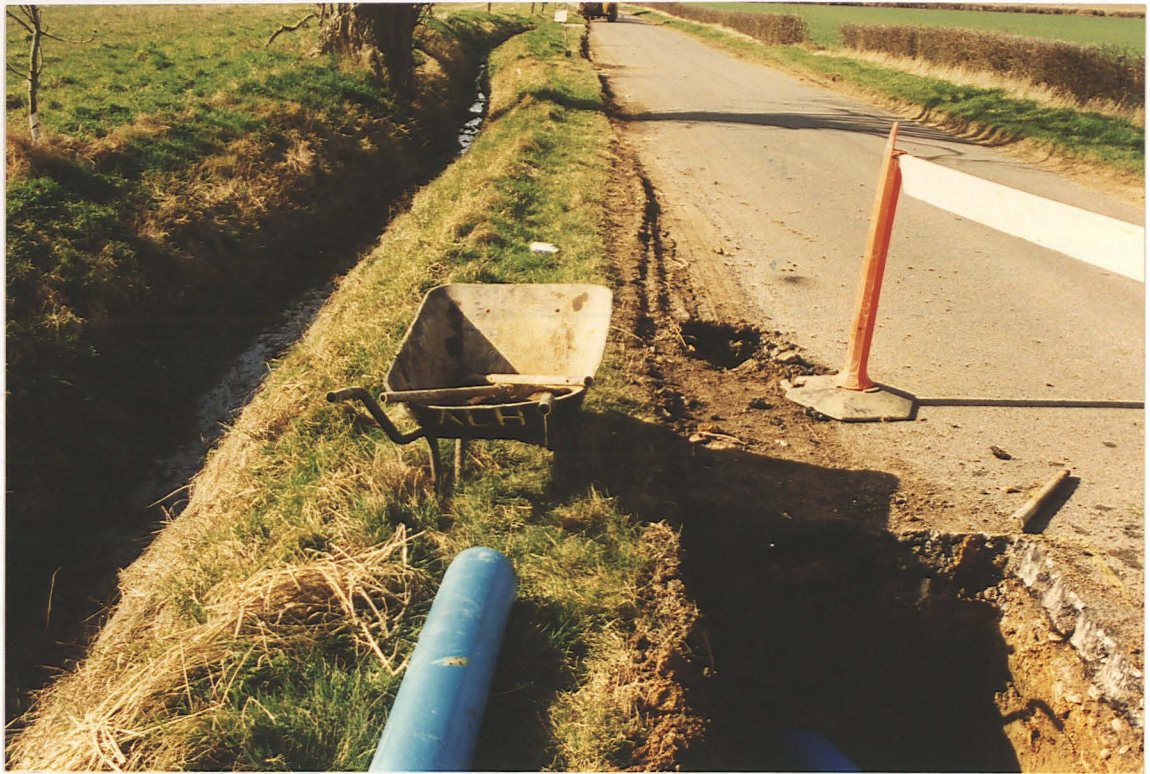
Pl. 8 Position of Trench 3, Lenton-Pickworth Road. The JCB is beside the footpath; the Roman road is thought to cross between these points (looking SW).

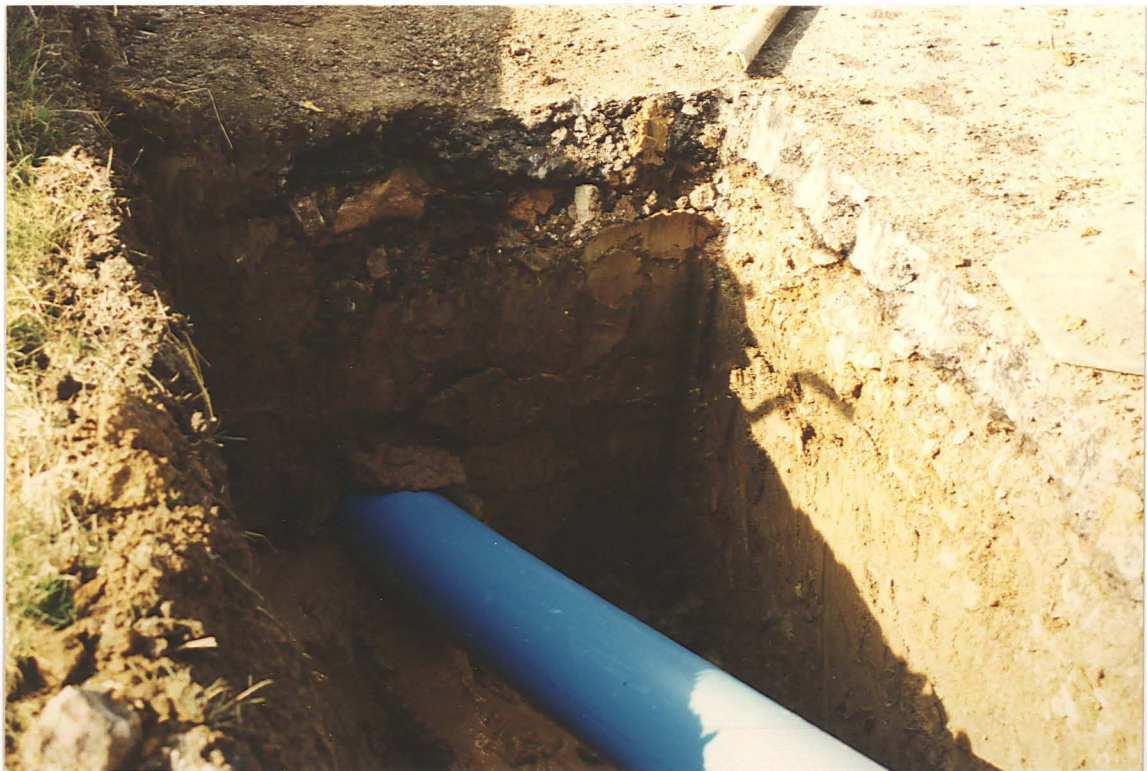
Pl. 9 Post-medieval road foundation above clay, Trench 3, Lenton-Pickworth Road.

deposit 0.18m thick. Beneath this was brown/dark brown clay. The limestone is probably a post-medieval road foundation.

The watching brief identified a crushed limestone road foundation 0.18m thick, beneath the 0.12m thick tarmac surface, and this was interpreted as a post-medieval road surface. There were no signs of a Roman metalled road and it was therefore not possible to confirm the traditionally accepted alignment. Close to Dial Cottage, the modern road enters a dip, with a small watercourse and waterlogged ground in the eastern verge. This natural feature would have required more metalling and its absence suggests that this is not on the alignment of a Roman road.

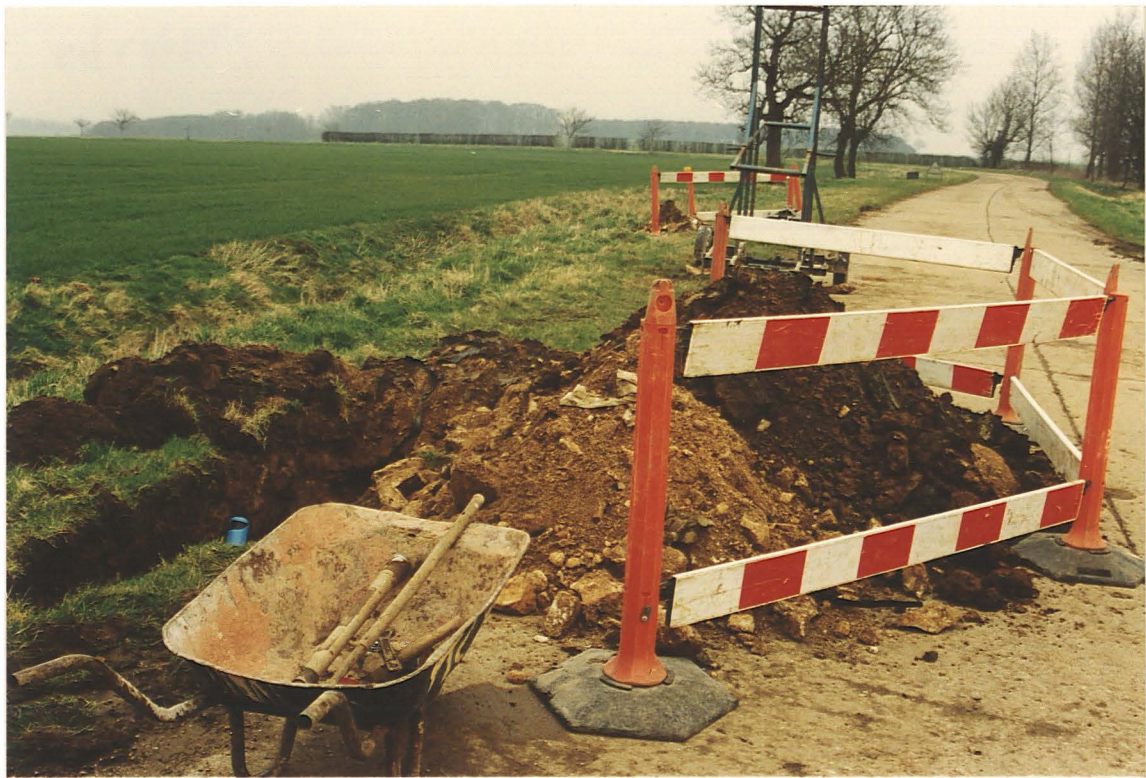
Pl. 10 Trench 2, Pickworth Airfield (looking NE). The verge beside the airfield road appears to have been extended over a backfilled field ditch; the existing ditch may be of wartime date.
