## A Report to Allott & Lomax, Consulting Engineers, Manchester

## **CASTLE-LAWN LINK**

ARCHAEOLOGICAL RECORDING

CLAU ARCHAEOLOGICAL REPORT NO: 45

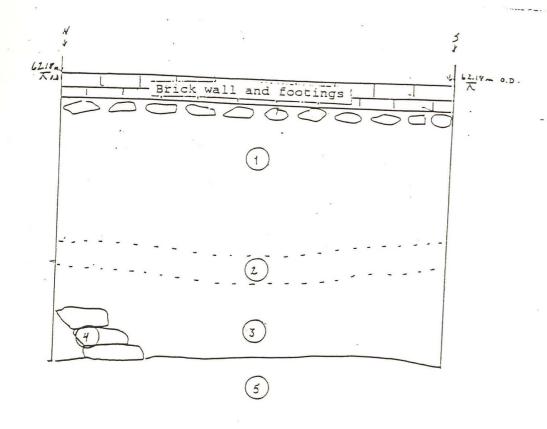
TP1

- 1. Light brown sandy clay occasional limestone fragments
- 2. Dark grey brown sandy silty clay
- 3. Yellow brown clay occasional limestone fragments
- 4. Possible wall
- 5. L.O.E. yellow clay with limestone fragments.

#### Trial Pit 1

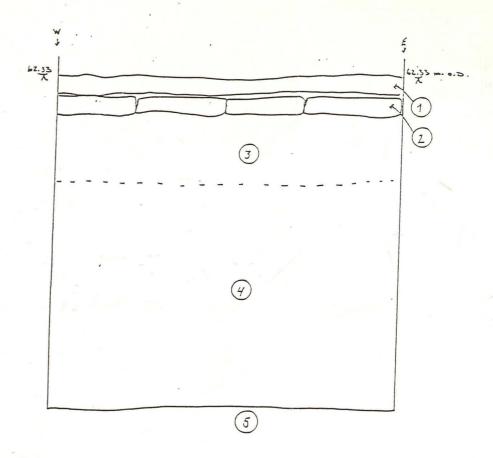
TPZ

- 1. Turf
- 2. Concrete
- 3. Compact dark orange clay limestone fragments
- 4. Compact orange clay limestone fragments
- 5. L.O.E.

CITY OF LIN	ICOLN ARCHA	EOLOGY UNIT
SITE CODE: LL9Z	PLAN/ELEY/SECT	
CLIENT: ALLOT + Lon	החד , וסש שעדשע בשבו	-46.46.7
DESCRIPTION:	1 / TRIAL PIT 2	
SCALE: 1:20	ARCHIVE NO:	
DRAWN BY: 190	CHECKED:	DATE: 12/5/92

#### Trial Pit 2

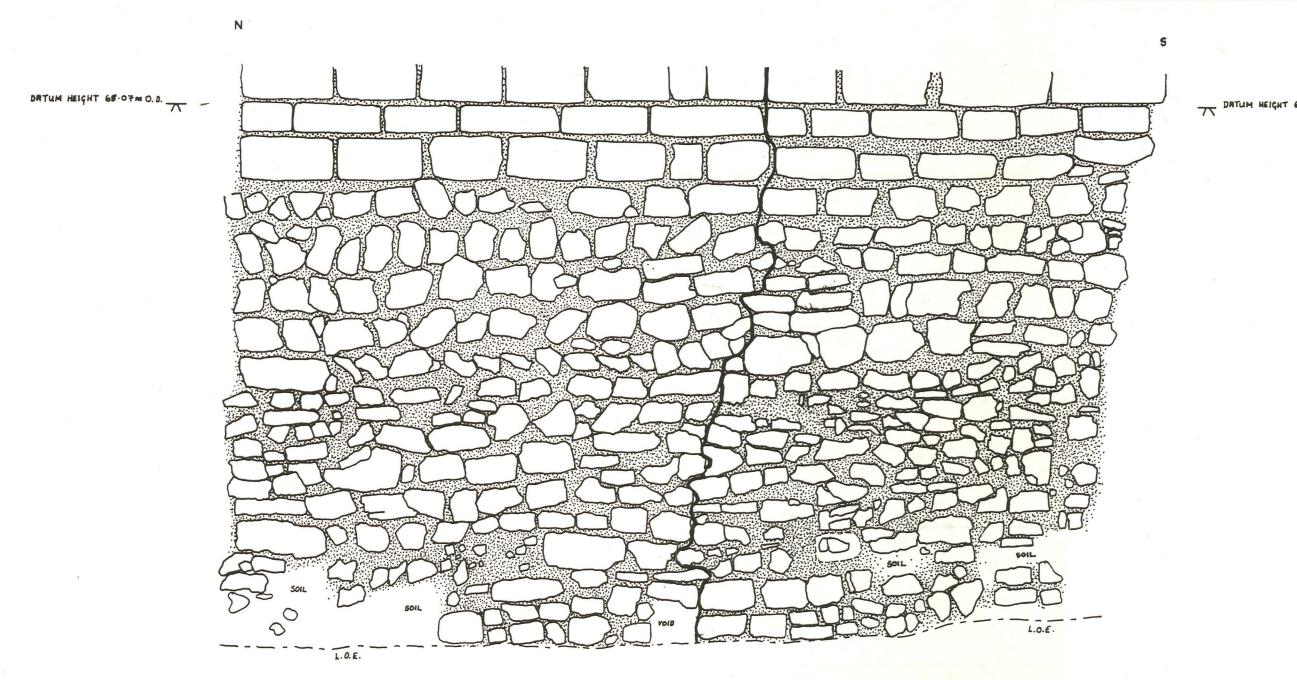
SITE CODE: LL92	PLAN/ELEV/SECTION NO: 12
CLIENT: ALLOTT & LOMAX A	ND LINES COUNTY COUNCIL RECREATIONAL SERVICES
DESCRIPTION:	
FOUND	PATIONS BELOW SILL, WEST GATE OF LINCOLN CASTLE.
SCALE: 1:10

that the layer was natural limestone brash. This supposition was proved incorrect as the excavation moved westwards revealing a more substantial foundation approximately 2m to the W of the gate entrance. It was considered that the platform extended across the whole of the area. However, during the actual work to build the bridge in 1992/3 it was discovered that the 'foundation platform' was actually a layer of debris probably created when a great crack in the foundations below the West Gate was repaired. Although there was no associated dating evidence, this recent investigation showed that the north and south foundation walls which extend westwards from the gate are probably contemporary with the foundations at the entrance of the West Gate, and not of a different phase as originally postulated (Fig 6).

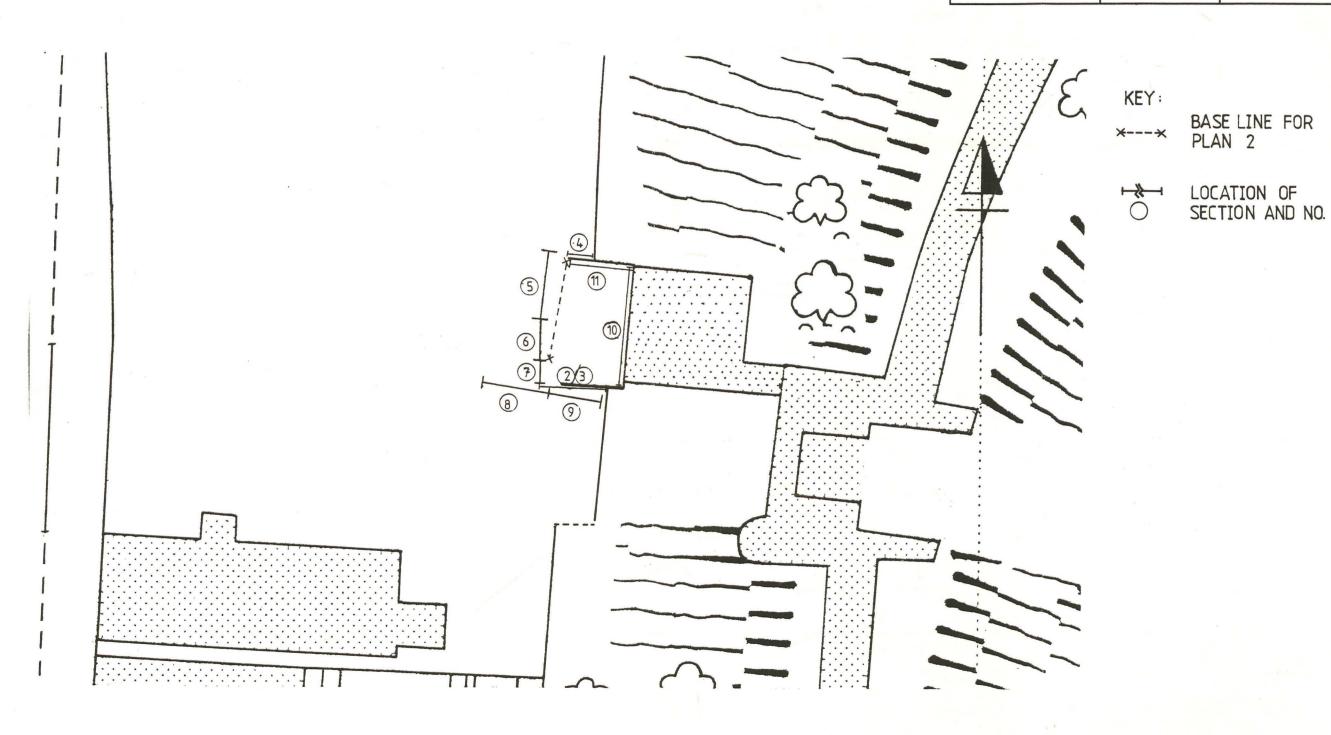
CITY OF LINCOLN ARCHAEOLOGY UNIT			
SITE CODE: LL 92	PLAN/ELEV/SECTI	ON NO: 4	
CLIENT: ALLOTT & LOMAX / L.C.C. RECREATIONAL SERV.			
DESCRIPTION: LOCATION PLAN FOR SECTIONS 2-11, AND PLAN 2.			
SCALE: 1:200 ARCHIVE NO:			
DRAWN BY: K.W.	CHECKED:	DATE: 02/11/92

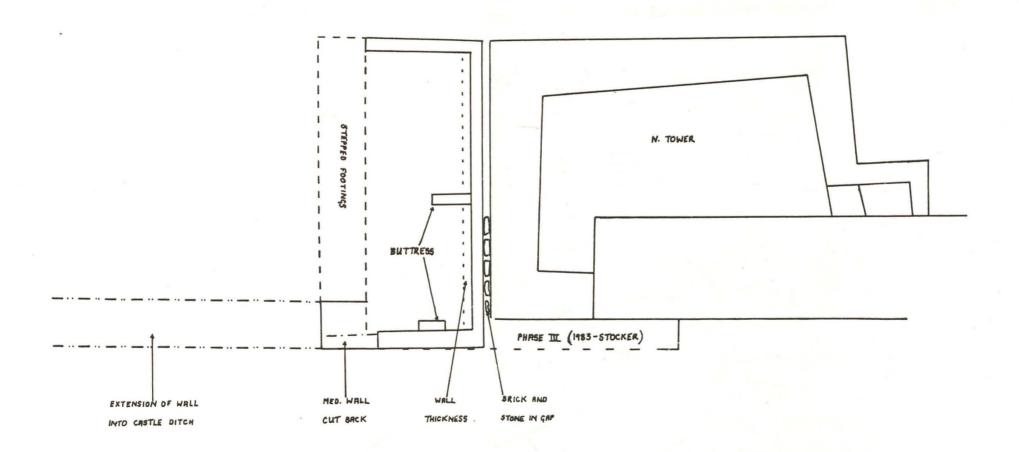
SITE CODE: LL92	PLAN/ELEV/SECTION NO: 10
CLIENT: ALLOT & LOMAX A	ND LINES COUNTY COUNCIL RECREPTIONAL SERVICES
DECODIDATION.	
	WALL OF LEAN-TO
DESCRIPTION: EAST

the west of the North Tower, shows three obvious building phases. The actual transition between the east and south walls of the lean-to does not show a right angle junction but is curving in plan on its internal face. It is possible that an existing wall was cut into and refaced in this curved manner at a later period. Approximately halfway down the wall it was discovered that the stone had been bonded to the west wall of the North Tower. This may have partly been an attempt to repair damage to the west wall of the tower which was observed when the lean to was partially dismantled (Fig 8).

An east-west stone and brick buttress had been built up to the East wall of the lean-to at a later date in order to strengthen the middle of this structure. It is possible, as the buttress lies directly below the repaired area of the North Tower, that this was a weak area of the lean-to. Because of the above, it was decided to retain parts of the later lean-to in order to create a more stable structure until further work could be carried out at the North Tower.
