# LINDSEY ARCHAEOLOGICAL SERVICES

CAISTOR GRAMMAR SCHOOL  
Technology complex Phase 2  
ARCHAEOLOGICAL WATCHING BRIEF

**Introduction**

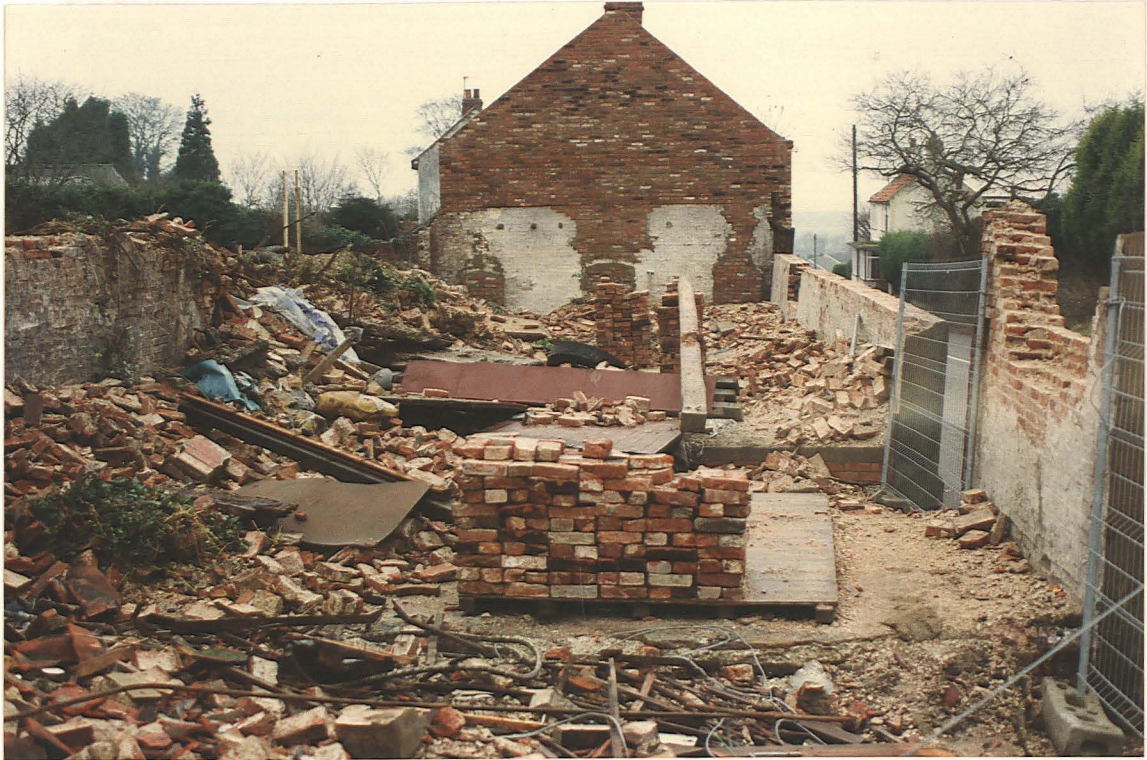
Pl. 3 Demolished barn showing varying concrete floor levels

Groundwork preparation necessitated the demolition of the single storey brick barn aligned east-west on the north boundary of the site (Fig. 1, Pls 1-4). This had been in recent use for storage of school furniture. The original use of this structure is not known but it had undergone a series of minor alterations and repairs, the most obvious being re-arrangement of internal divisions, insertion of new access points and windows and the blocking of earlier ones (Pls 5,6). Each bay had floors at varying levels and in different stages of concrete or brick.

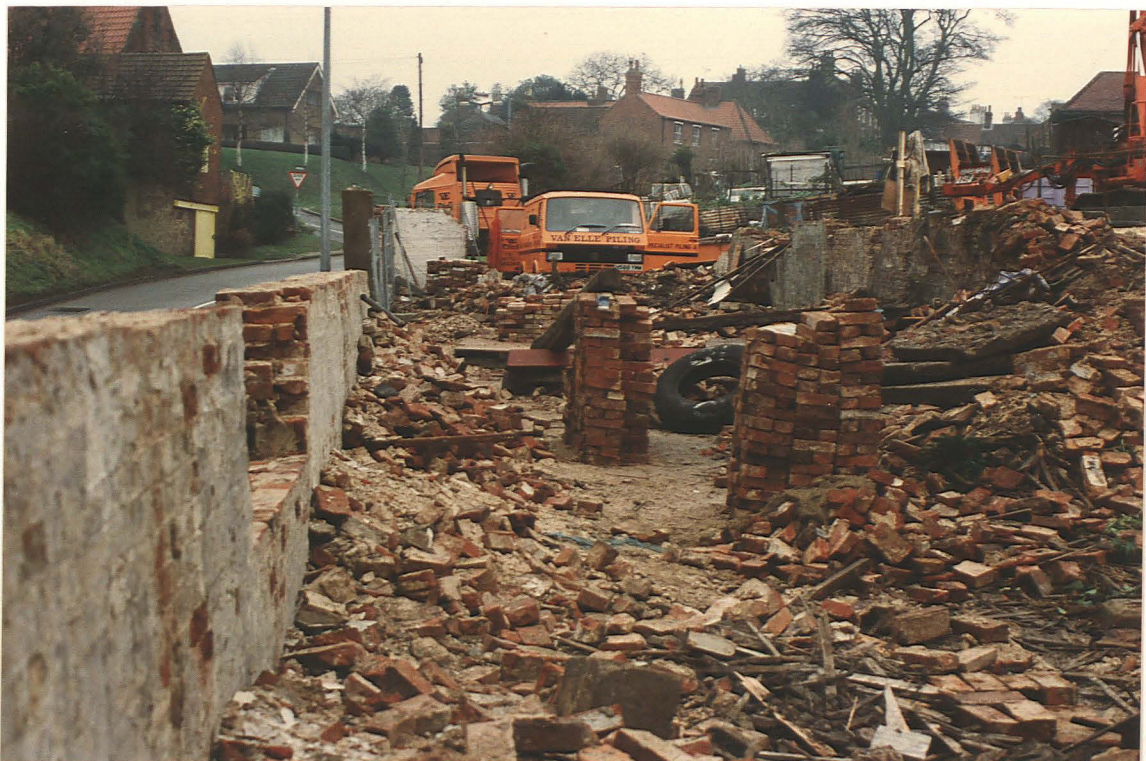
Pl. 5 Demolished barn S wall, internal elevation showing example of blocked openings

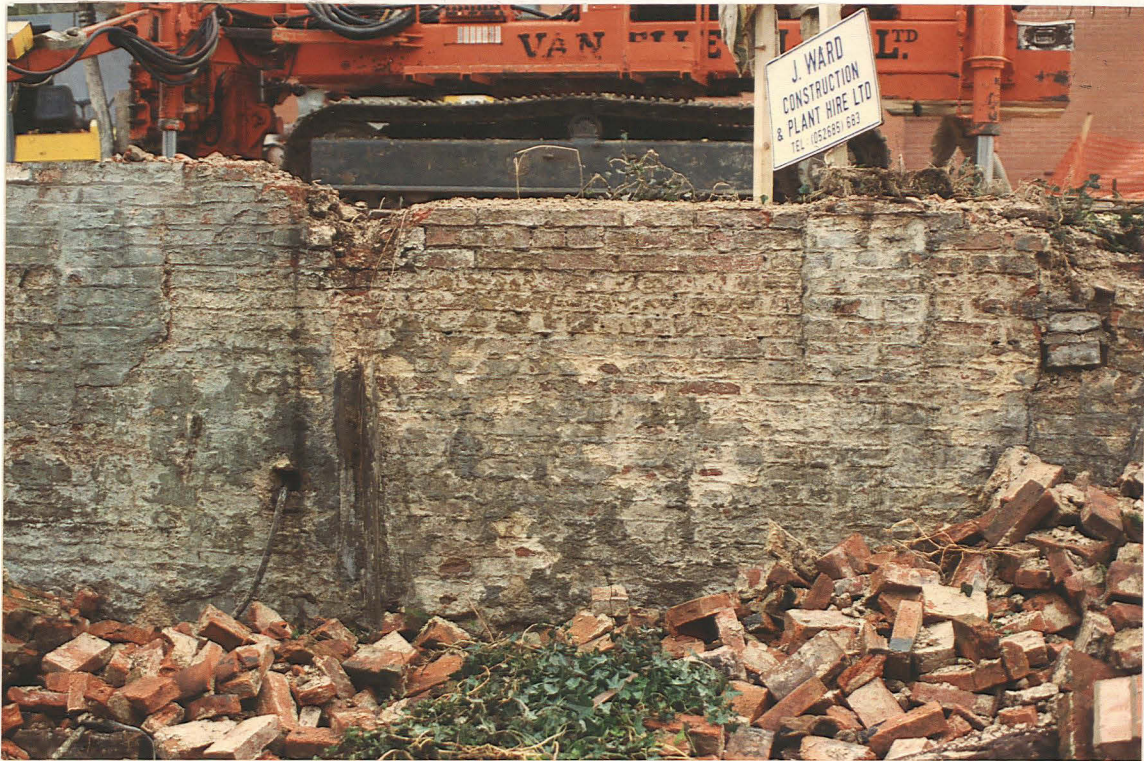
Pl. 6 E elevation of retained building showing blocked openings

There was no definite evidence for a west wall, this apparently having been formed by the east wall of the adjoining western building which displayed two low blocked arched openings. The walls were of 34cm thickness, with a more or less solid brick bond throughout (Pl.7). Four distinct sample brick sizes were taken from various places in the demolished rubble (Pl. 8); the earliest is unlikely to have pre-dated the late 18th century. There was no evidence for fireplaces and it is assumed that the burnt material found in the rubble was re-used or associated with various industrial processes carried out at different periods in the history of the building. As no conditions were made for the recording of any part of the structure only a cursory external examination was made before demolition. The only part of special note was the tumbled brickwork in the east gable, the style, together with the brick dimensions, bond and wall thickness, suggesting a late 18th century date. The arrangement and brick dimensions of the other footings on the site seemed to indicate a group of buildings that were nearly contemporary, and of which the northern range was possibly one of the earliest.

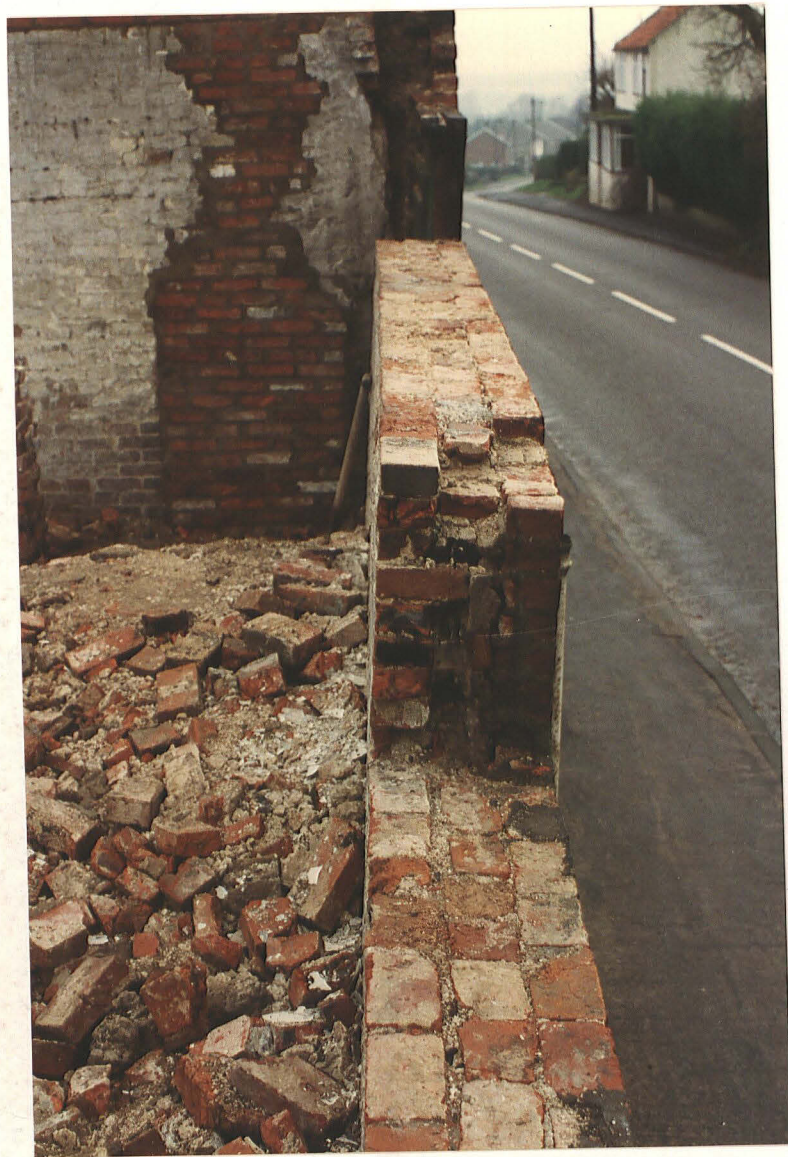
Pl. 7. Section of barn N wall

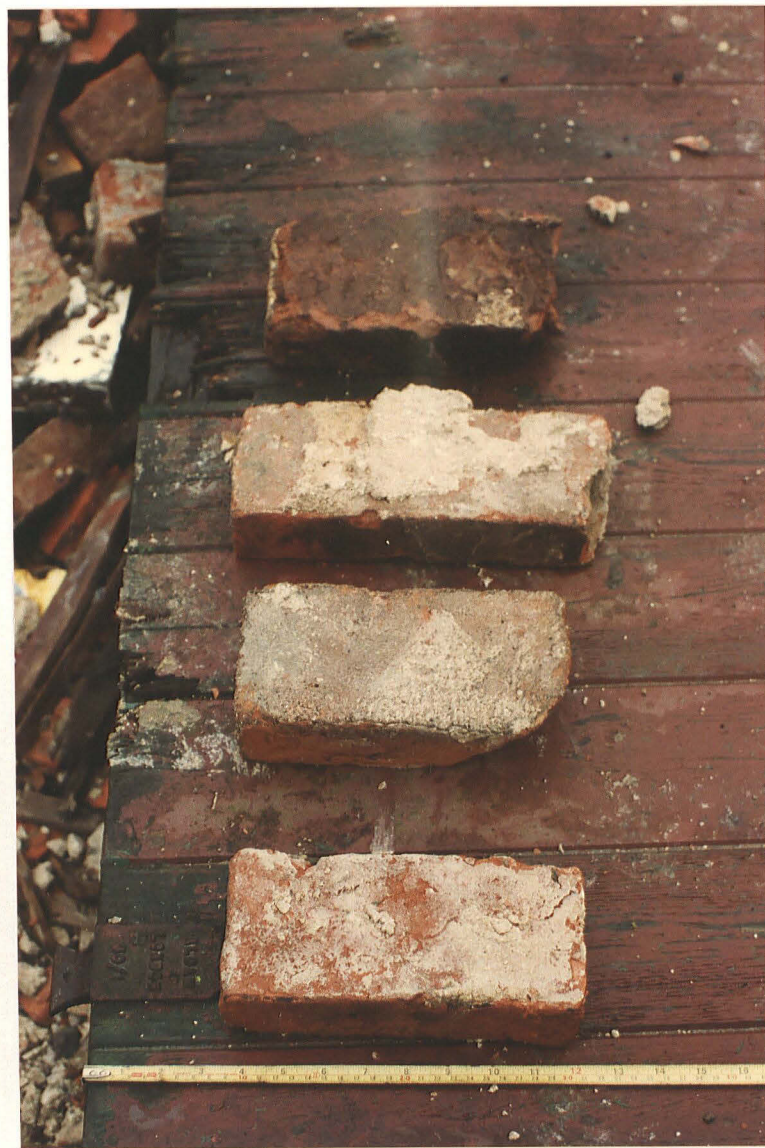
Pl. 8 Examples of bricks of different sizes from demolished barn

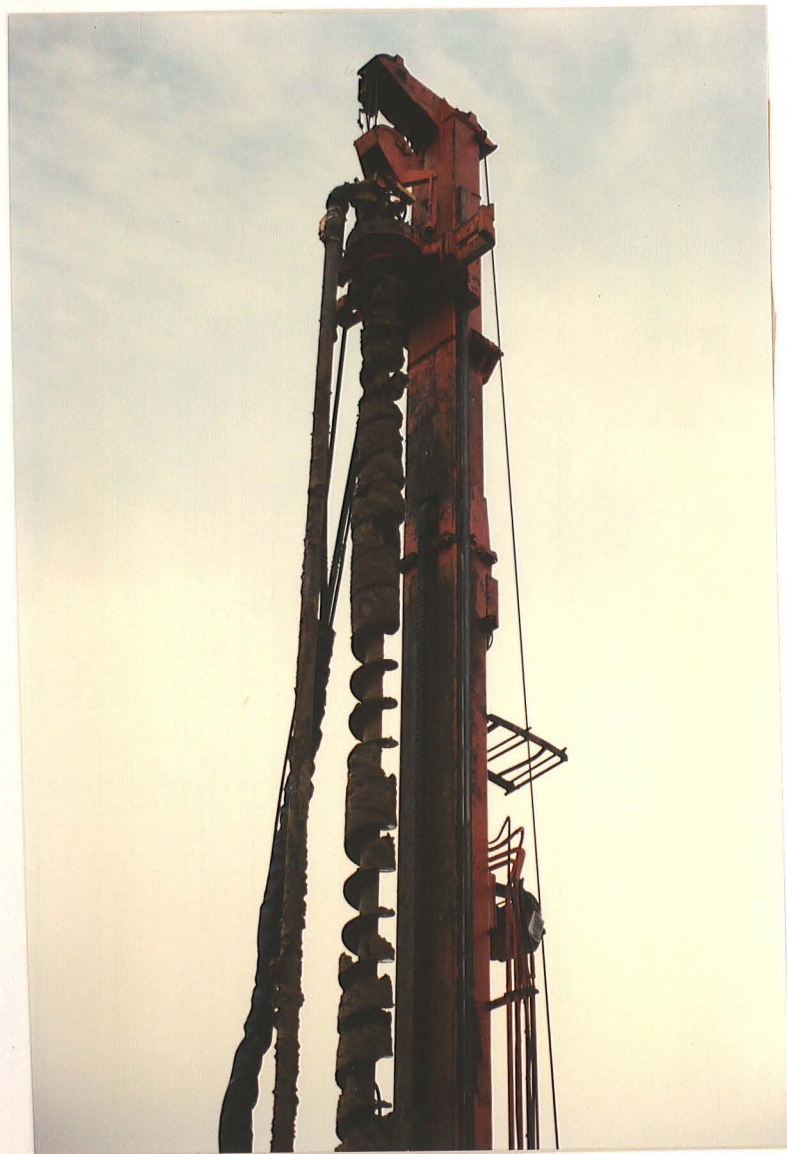
Pl. 13 Auger arm of Soilmec drilling rig showing concrete feed hose attachment at top centre of auger

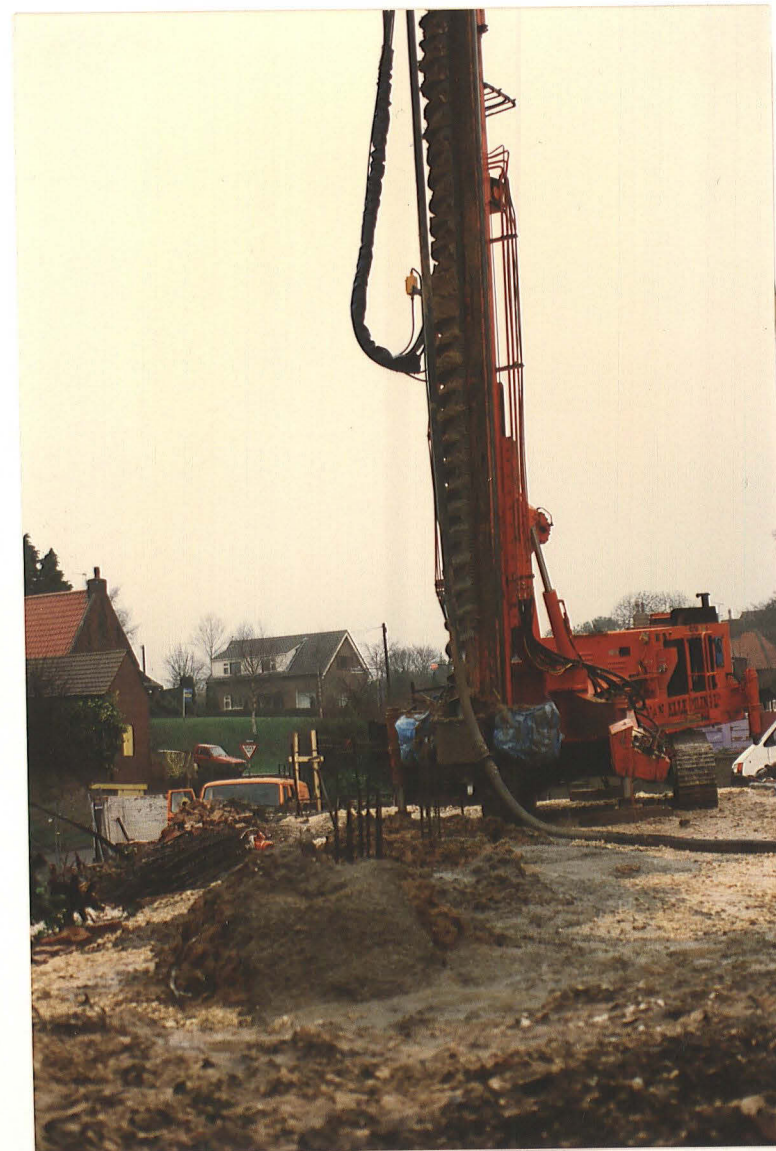
Pl. 14 Drilling in progress at Pile 5 , N end of site, view E.

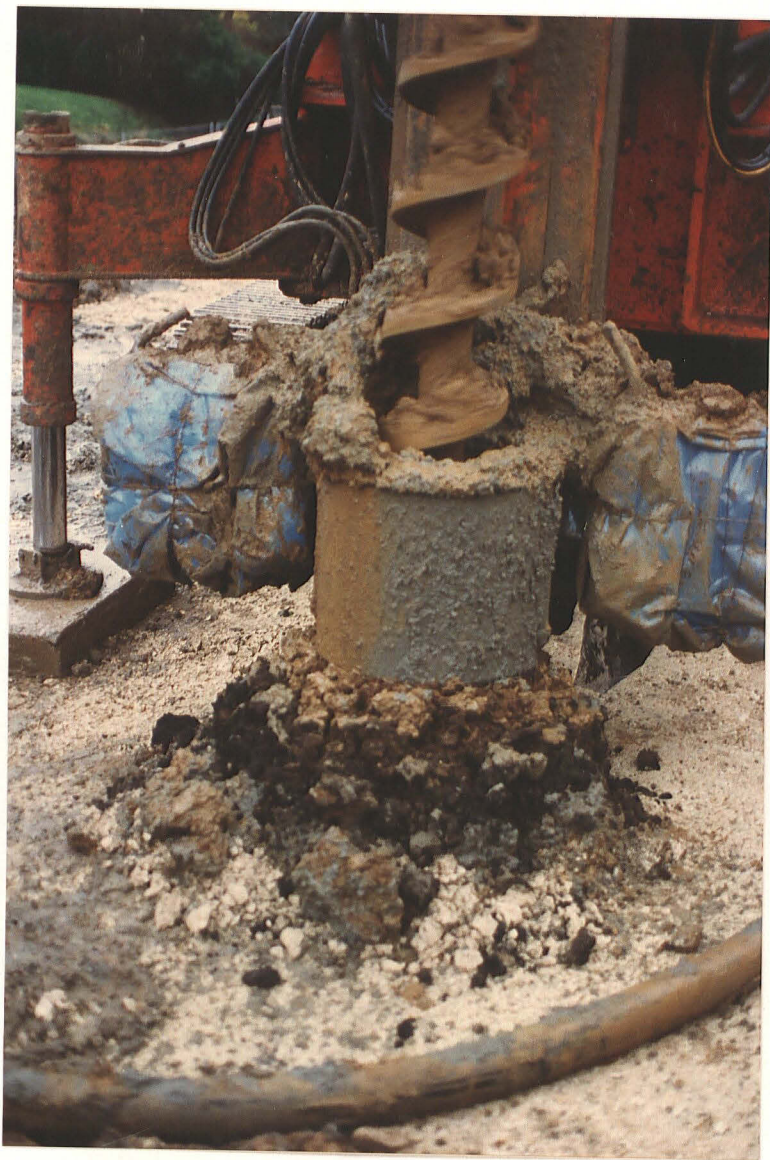
Pl. 15 Black spoil at Pile 11

Auger No.	Description
1-4	Not observed but c.1-1.50m of dark fill near the surface (observed by B. Chollerton) Depth c.9-9.50m
5	Mostly light brown sandy clay, occasional limestone lumps of up to c 50mm. Depth c.9-9.50m.
6	As 5
7	No noticeably dark spoil; water gushing from hole. Depth c.9.50m.
8	As previous. Depth c.9m
9	?Darker spoil to upper 2m, remainder light -brown sandy clay. Depth 9-9.50
10	Depth c.10m.
11	Black soil erupted from ground during upper 1-2m of augering (actual depth not known)(Pl.15).
12-17	All waterlogged from 5-6m downwards. Depth 9.50m generally.
18	Dark soil erupting at 1-2m. Water at 5m. Depth 10-10.50m.
19	Dark soil erupting while auger at depth of 6-7m (?from previous hole). (Photograph from south-west). At c. 3m dark green clay peeling from auger (from hole 18). Spoil wet. Depth c.10m.
20	At 2m, spoil from hole 19 darker brown. At 1-2m very dark soil erupting (from hole 19)

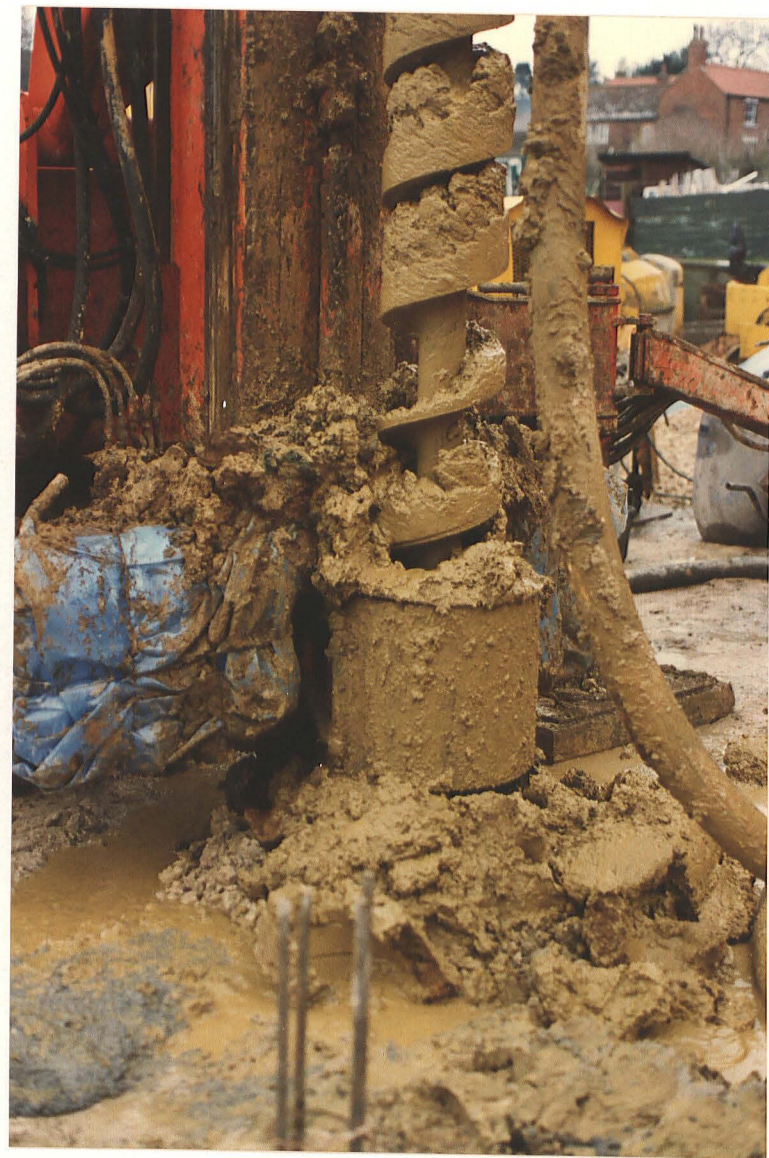
Pl. 16 Drilling in progress on S side of site
