**River Rase Improvement Scheme,  
Land Formerly Part of Market Rasen Golf Club  
and Race Course**

**Archaeological Evaluation**

**The Environment Agency**

**LAS Report No. 548  
August 2001**

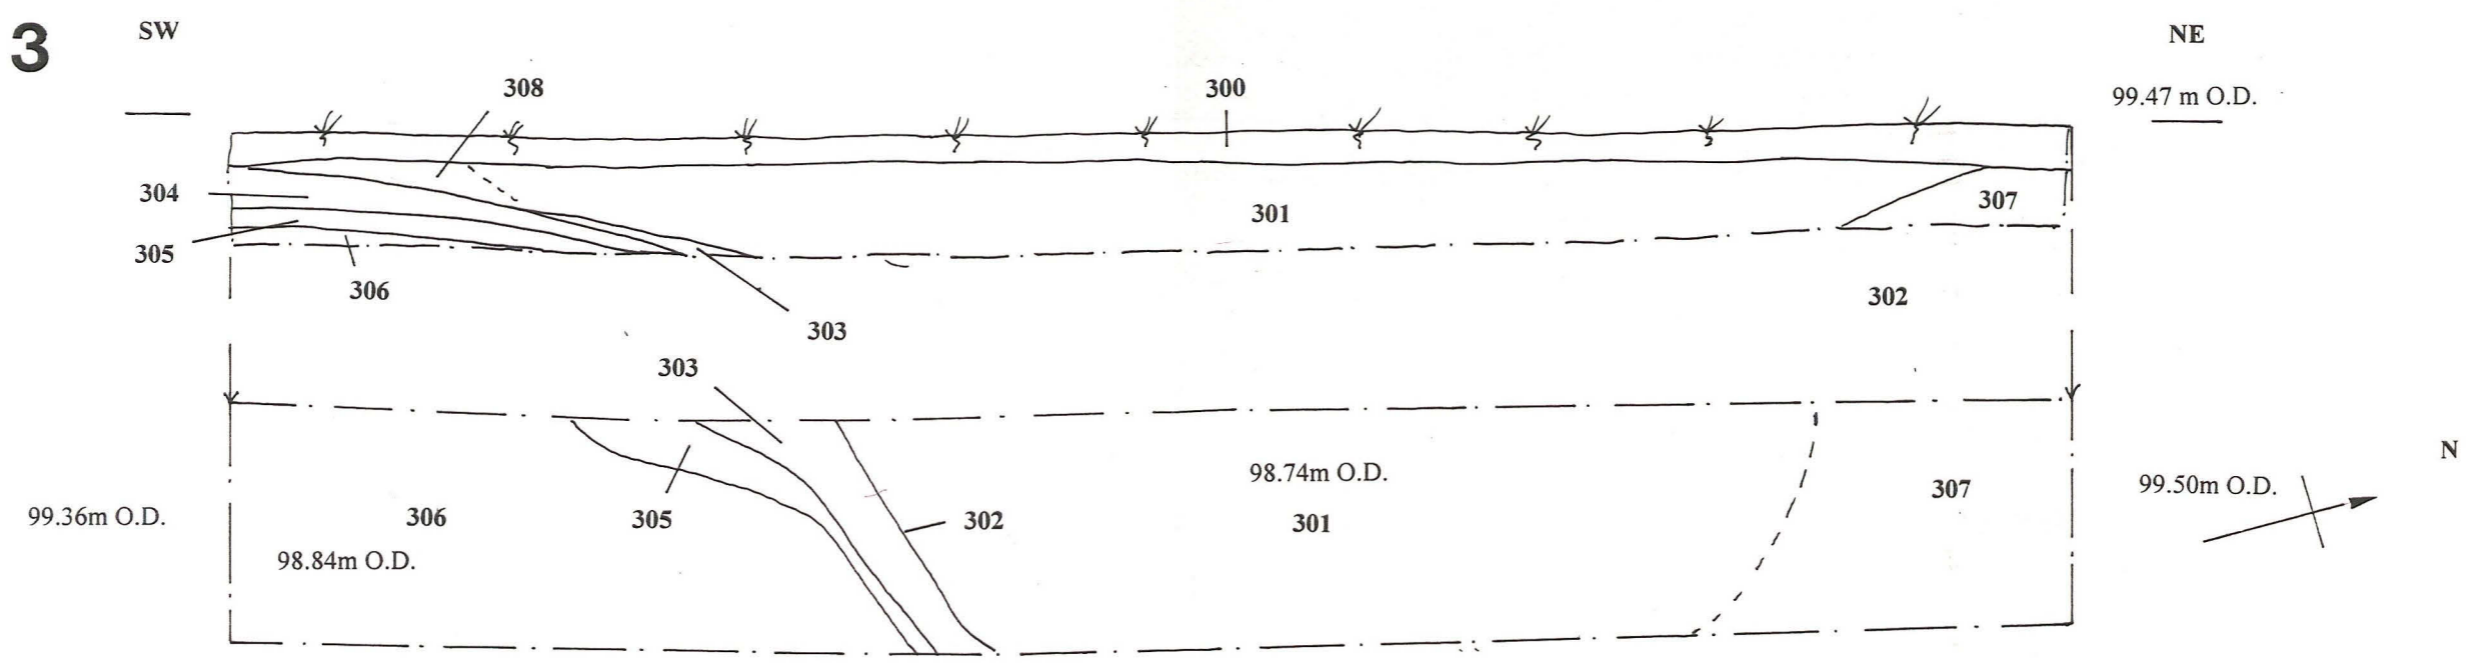
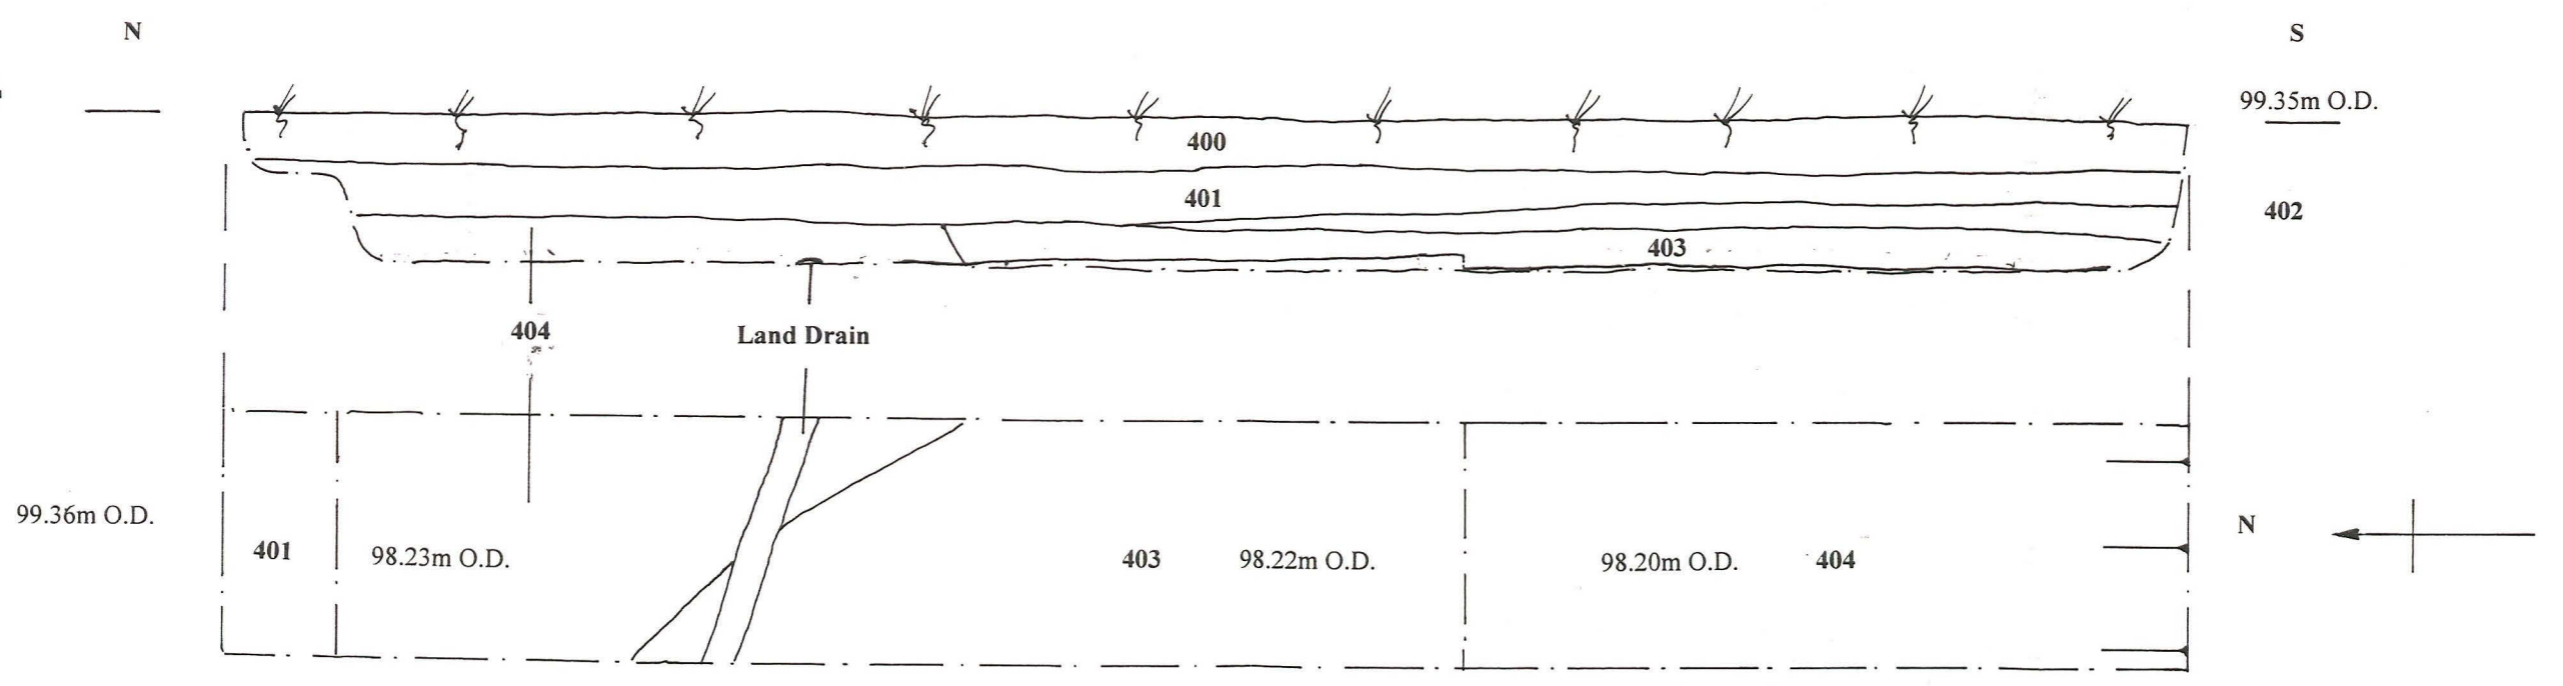
Fig. 4 Trenches 3 and 4. Plans and sections.

#### **Trench 3** (Fig. 4, Pls. 5, 9 and 10)

Trench 3 was closest to the eastern boundary of the old race course ground. Due to heavy rain and marshy ground conditions the JCB became stuck and could not continue excavating the trench. In freeing itself, it partially destroyed the trench, obscuring the northern end of the trench base.

#### **Trench 4** (Fig. 4, Pl. 12)

Trench 4 was the most northerly of the trenches in the grounds of the old golf course (Pl.11). Topsoil (**400**) depth was 0.30m. Light brown clay silt, **401**, was 0.30m deep. An electricity cable cutting into **401** was noted, so, the trench was stepped to prevent any further disturbance by machine. Beneath **401** was a grey-white sand, **402**, 0.22m deep, covering the southern half of the trench. Sealed by **402** was a black humic silt sand, **403**, a former topsoil. This layer followed the undulations of the natural grey white sand, **404**, which was higher to the north. **403** was partially removed to see if archaeological features were sealed beneath but none were seen.

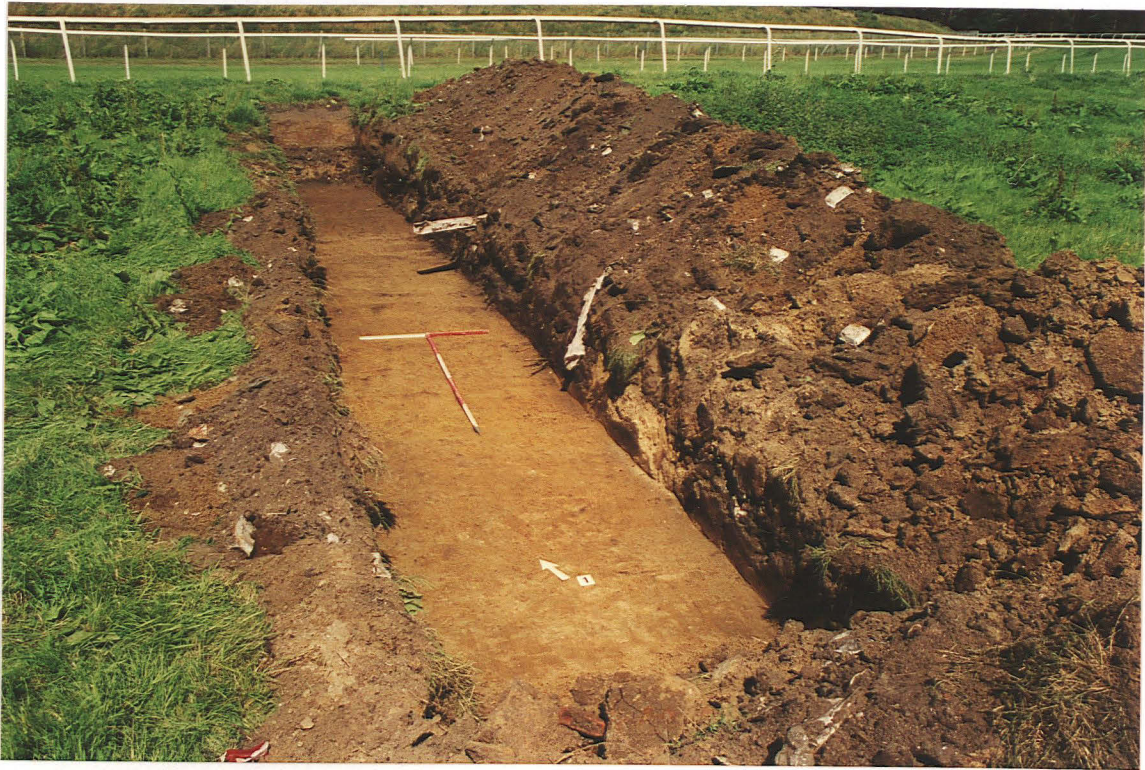
Pl. 3 Trench 1. Looking north east. Scales 1m and 2m.

ground owned by the Market Rasen race course. It was c.15m long. Beneath the 0.25m deep topsoil, **100**, was a light brown clay silt subsoil, **101**, 0.25m deep in places. A 1.50m wide, 0.60m deep, pit, **103**, containing a light brown to yellow sand, **102** (devoid of finds), was noted c.3m from the southern end of the trench. Pit **103** cut a mid brown to black silt sand deposit, **104**, which contained plastic, glass bottles, metal, concrete, polythene and coke bottles. This modern dump layer was 0.75m deep in places. A tree disturbance, **105** (Pl.4), which projected a metre into the north end of the trench, filled by a grey brown clay, **106**, proved to be no deeper than 0.05m, when excavated. Natural was a yellow brown clay at the north end of the trench, **107**, and a yellow grey sand with panning to the south, **108**.

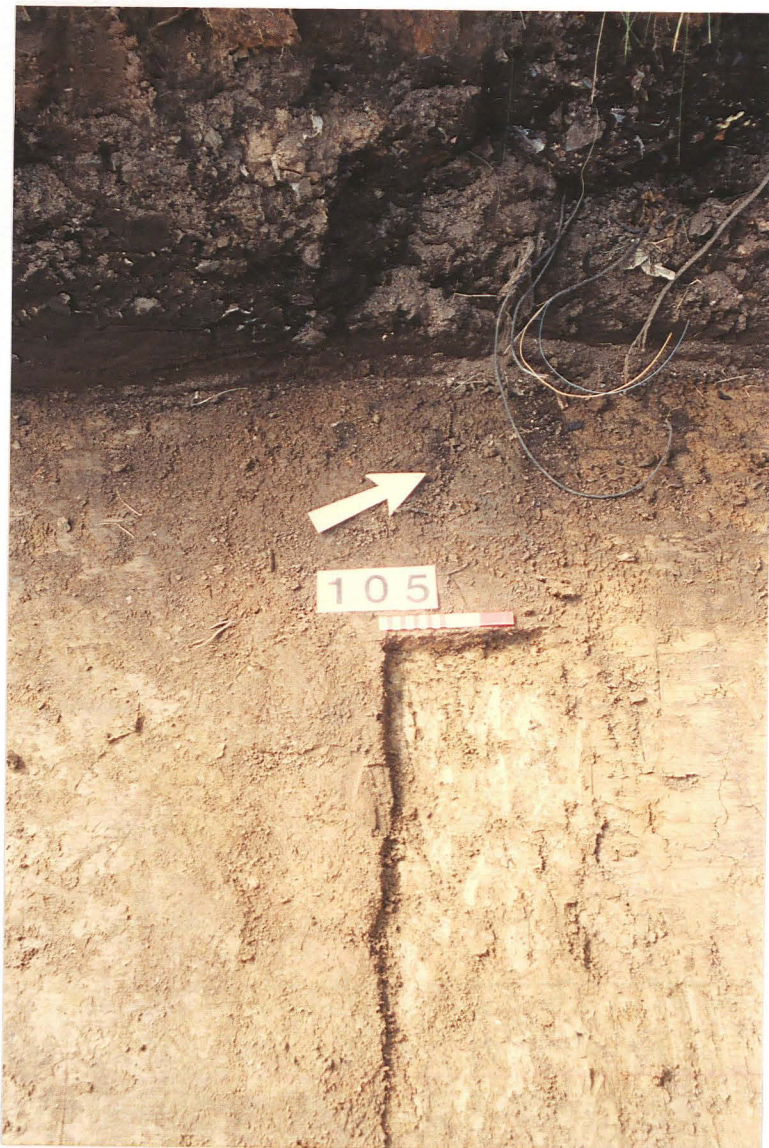
Pl. 4 Trench 1. Tree disturbance 105. Looking north west. Scale 0.30m

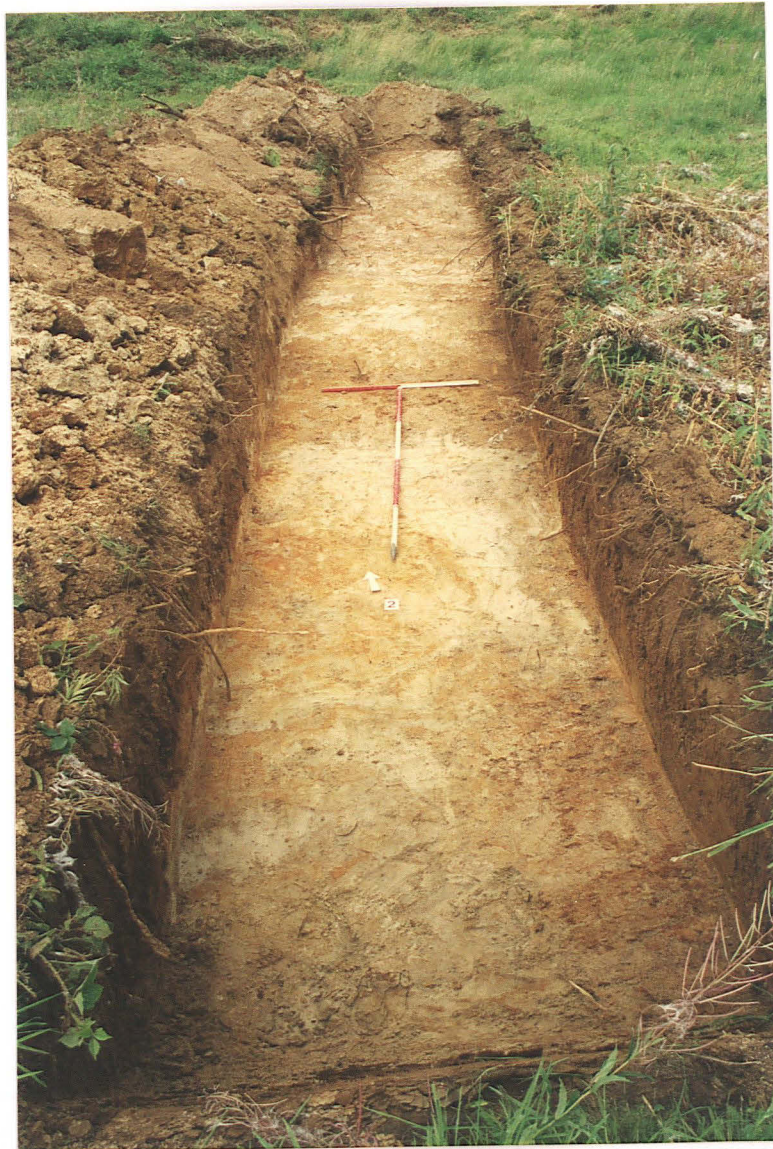
PI. 6 Trench 2. Looking north east. Scales 1m and 2m.

Trench 2 was located some 50m east of Trench 1. Trench 2 was positioned to expose three anomalies which were picked up during the geophysical survey. It became obvious during the initial topsoil stripping that these anomalies, **202** and **203** (Pls. 7 and 8) were the remains of tree disturbance, the stumps of the trees being present within the topsoil. The northernmost anomaly was not noted but extensive root disturbance was. Topsoil, **200**, had a maximum depth of 0.30m. Below topsoil was a light brown clay silt subsoil, 0.20m deep, **201**. Natural, **204**, was an orange white sand containing patches of clay.

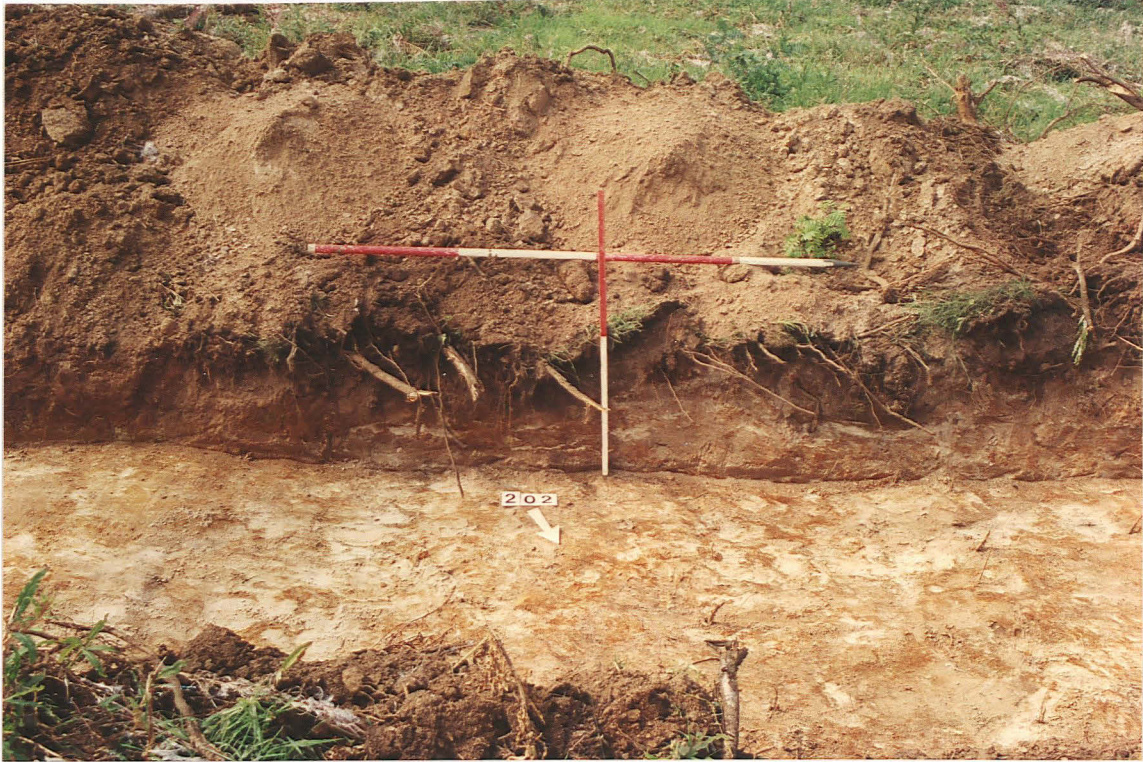
PI. 7 Trench 2. Tree disturbance 202. Looking south west. Vertical scale 1m, horizontal scale 2m.

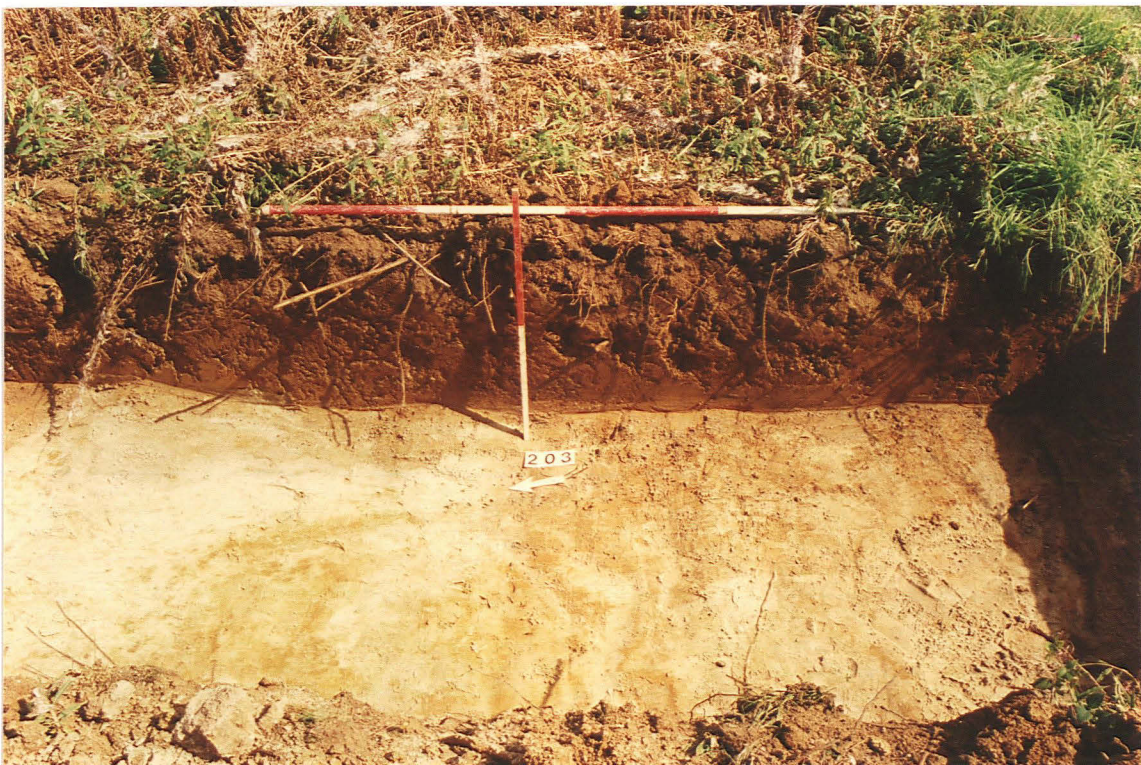
PI. 8 Trench 2. Tree disturbance 203. Looking east. Vertical scale 1m, horizontal scale 2m.

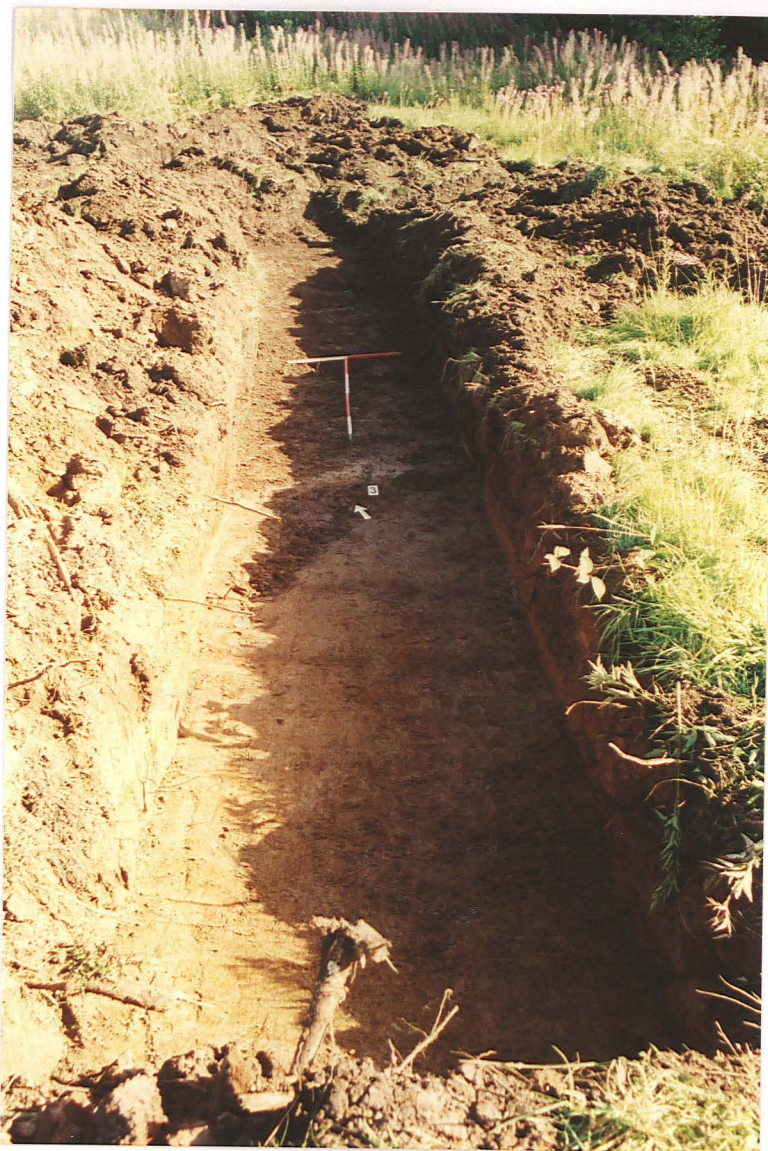
PI. 9 Trench 3. Looking north east. Scales 1m and 2m.

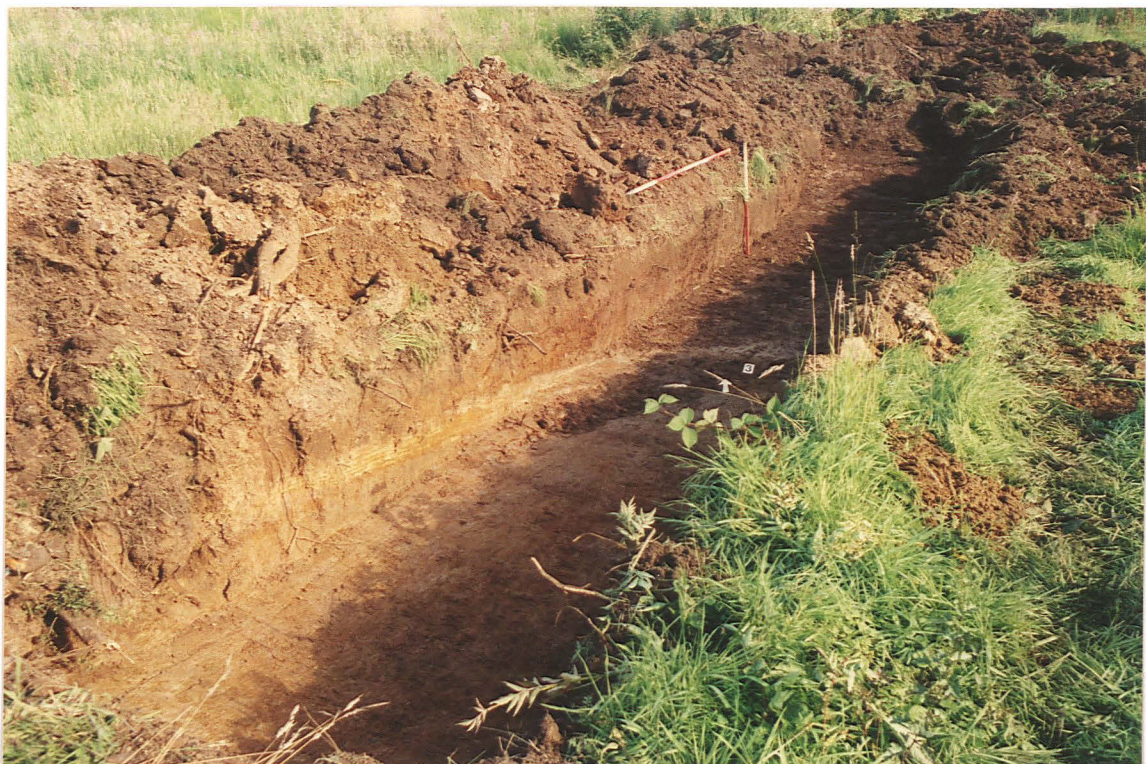
PI. 10 Trench 3. Eastern facing section. Vertical scale 1m, horizontal scale 2m.

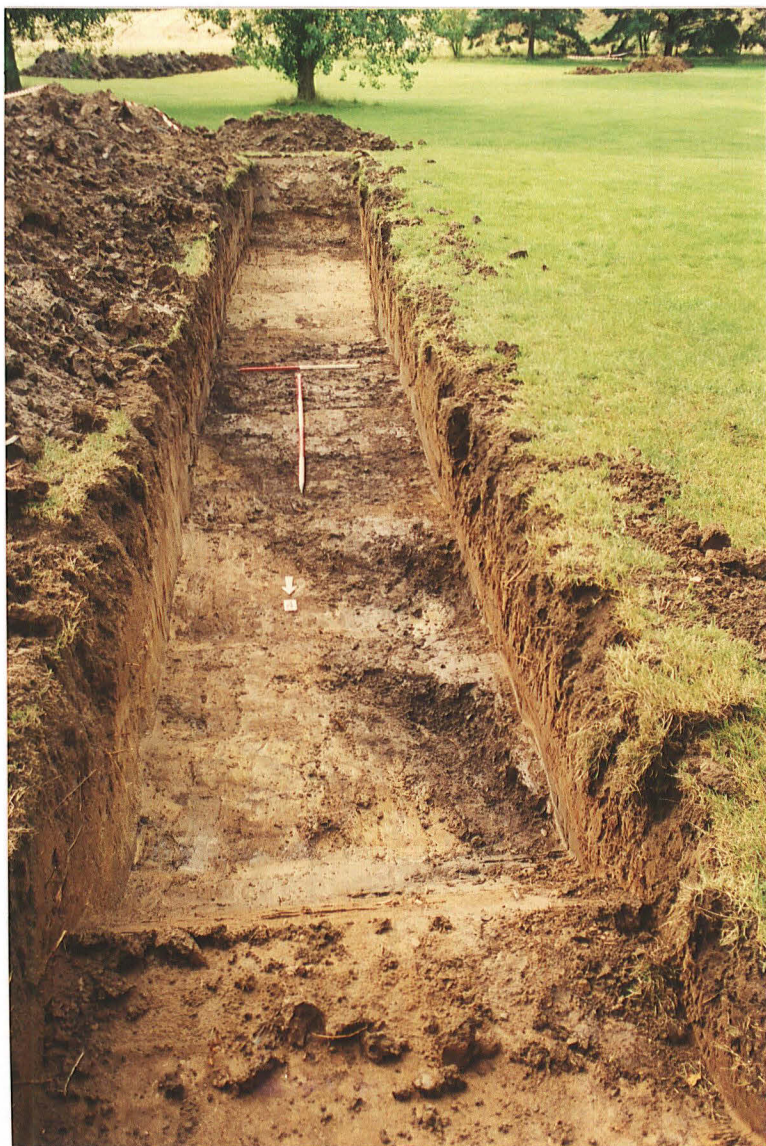
**Pl. 12 Trench 4. Looking south. Scales 1m and 2m.**

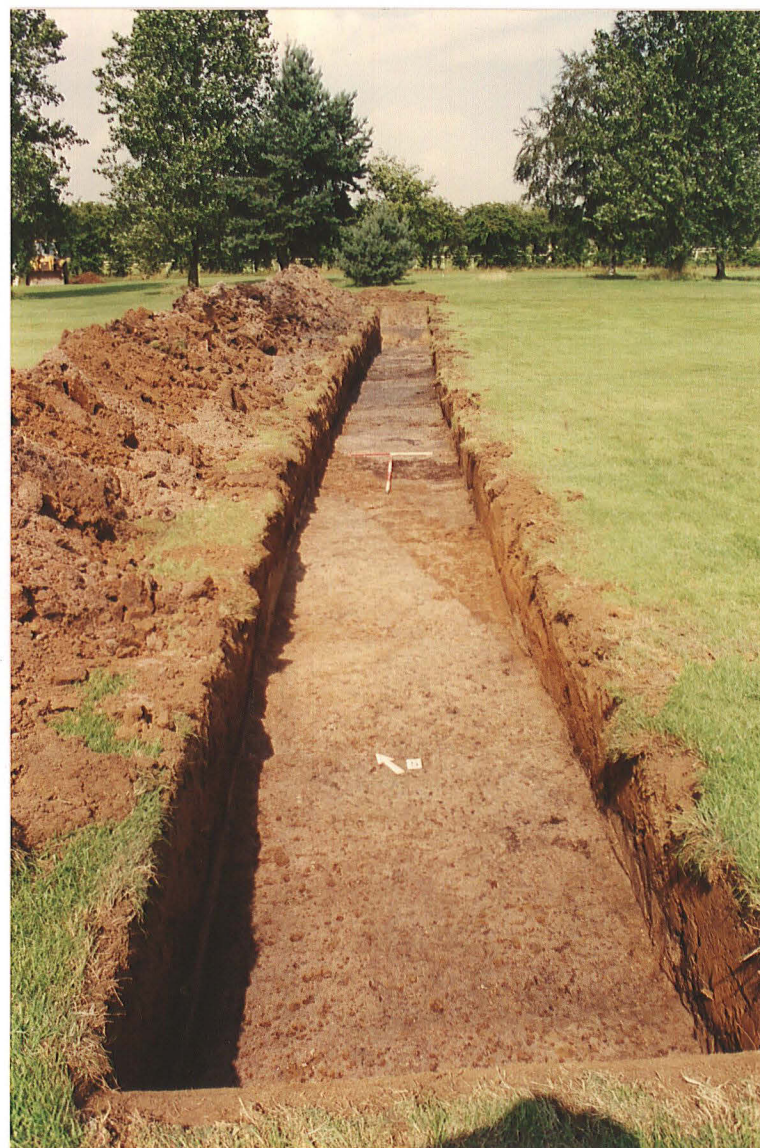
**Pl. 13 Trench 5. Looking north east. Scales 1m and 2m.**

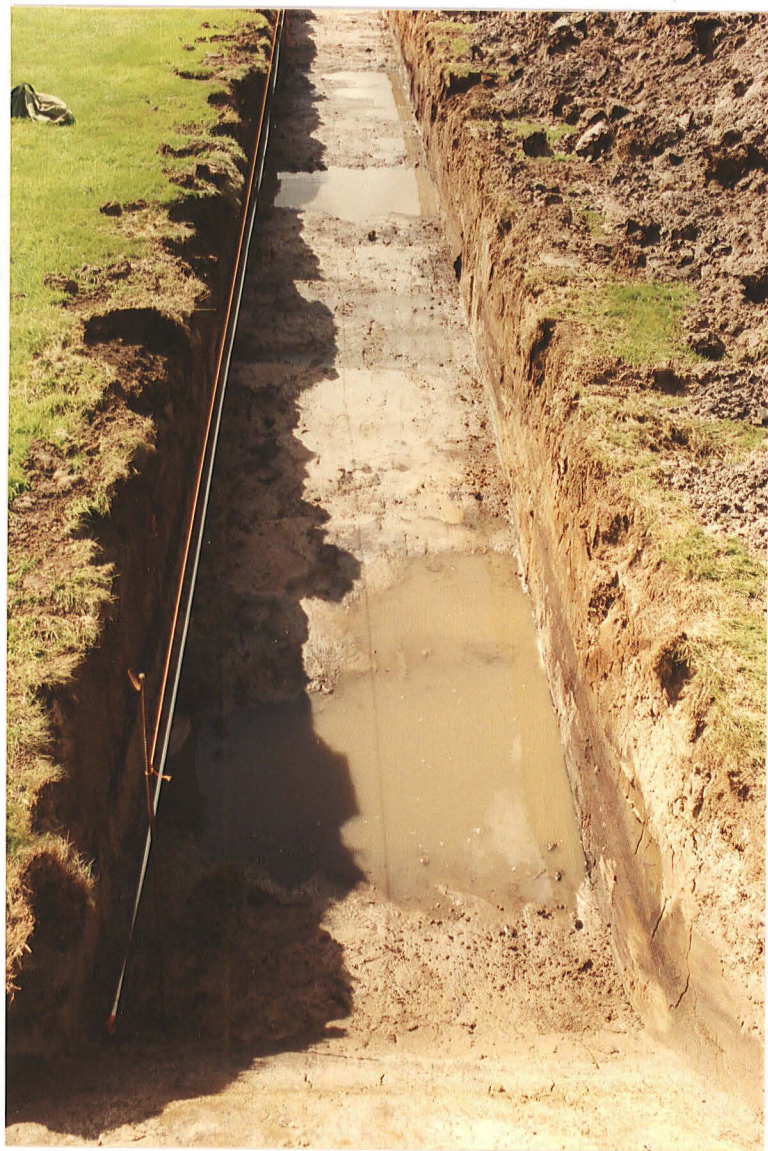
Pl. 14 Trench 5. Northern end. Standing water. Looking south west.

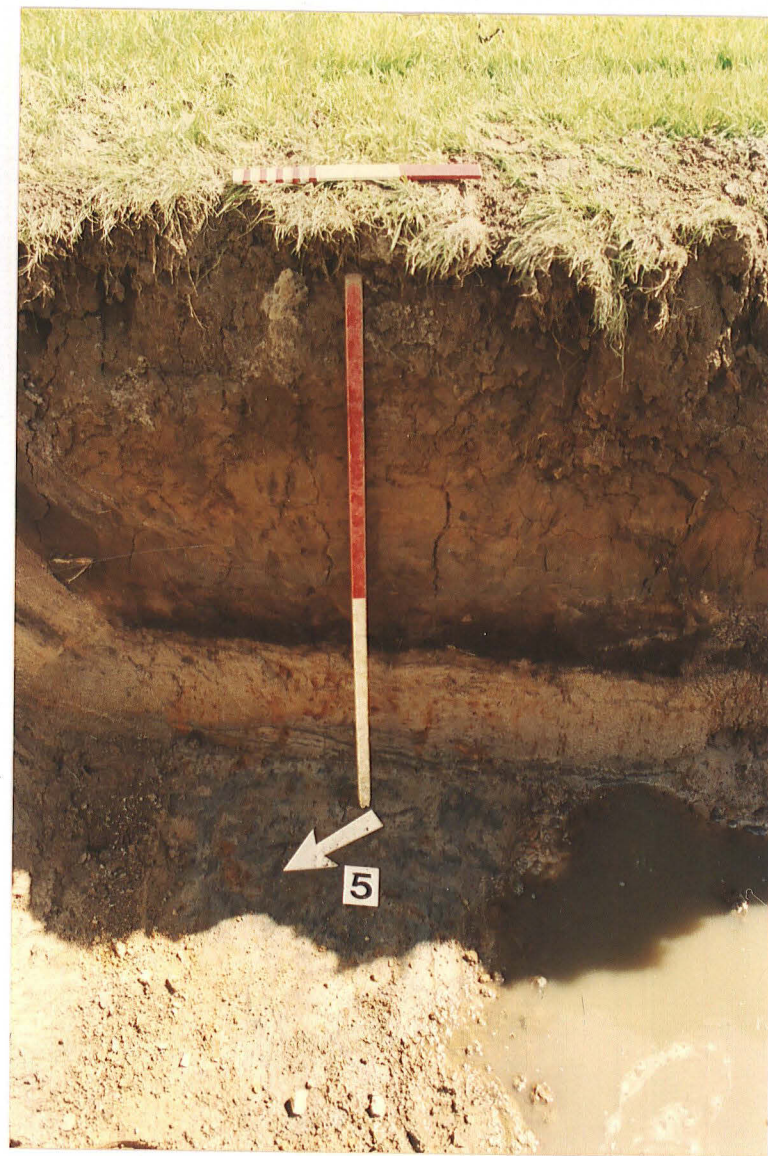
Pl. 15 Trench 5. General stratigraphy. Vertical scale 1m, horizontal scale 0.30m.

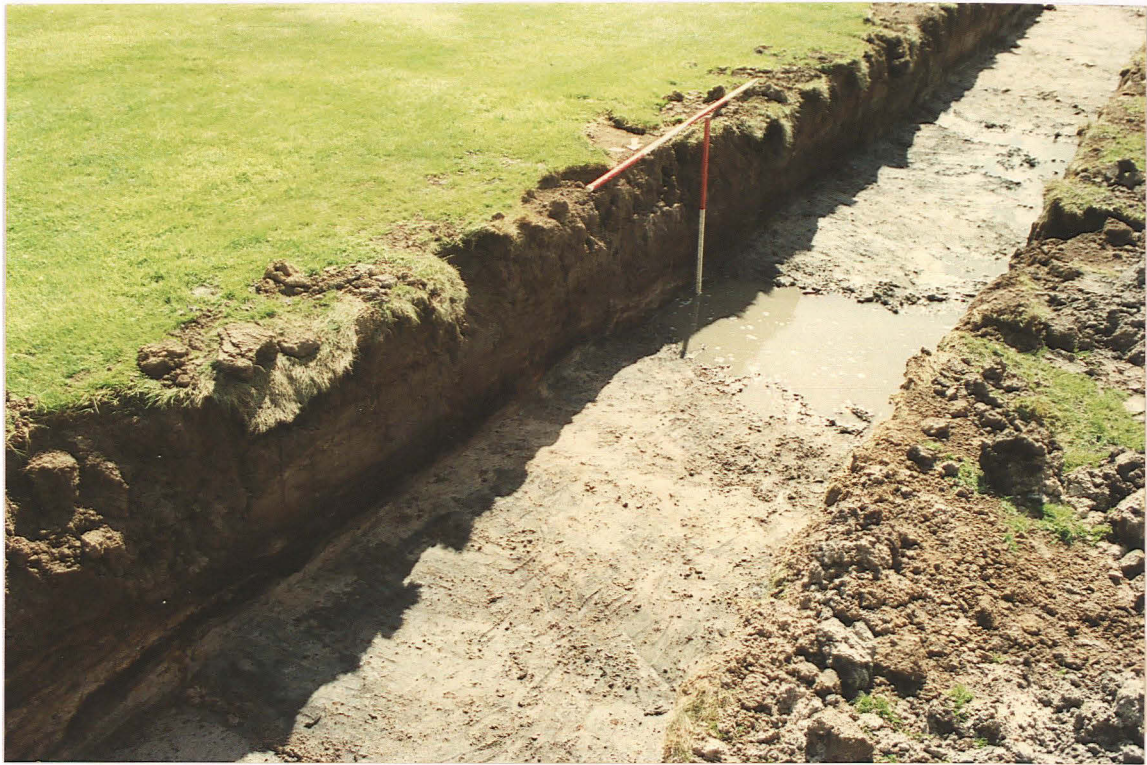
Pl. 16 Trench 5. Water channel 511. Looking north. Vertical scale 1m, horizontal scale 2m.

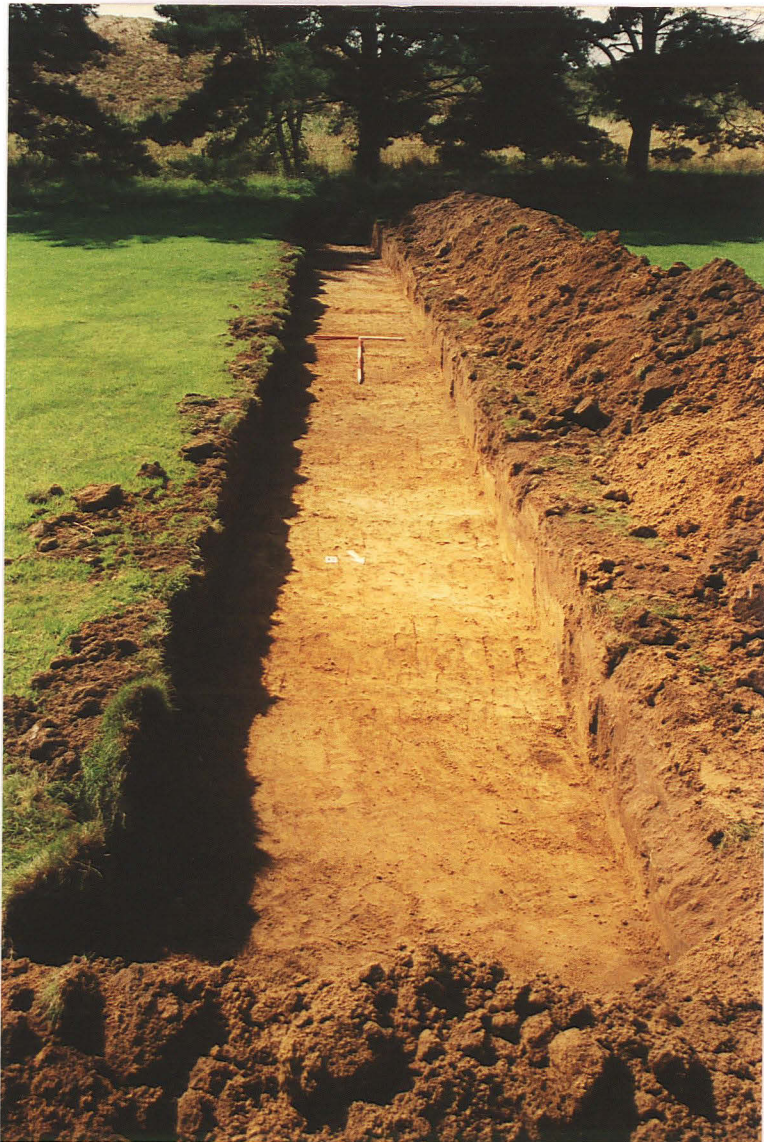
Pl. 17 Trench 6. Looking south west. Scales 1m and 2m.

Trench 6 was located closest to the south-west corner of the old golf course. It had to be moved further north due to the presence of trees to the south. Topsoil **600** was slightly deeper than elsewhere, being 0.35m deep. Root disturbance, **602**, was noted extending up to 2m into the southern end of the trench. The dark grey silt sand associated with the roots, **601**, indicated the disturbance was caused by existing trees. No subsoil was recorded in this trench. Natural was a washed grey white sand, **603**, projecting c.6m into the southern end of the trench and a yellow orange sand, **604**, to the north. Blue grey clay, **605**, was seen within **604**.

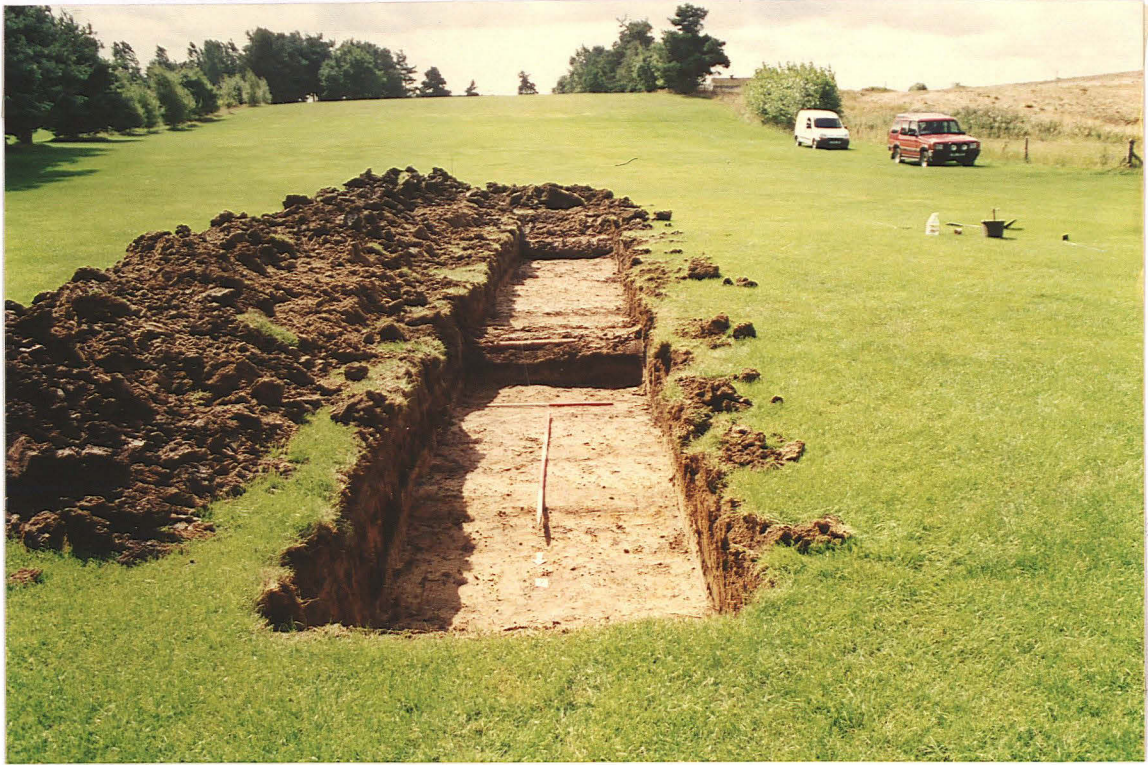
Pl. 18 Trench 7. Arrow points north east. Scales 1m and 2m.

Trench 7 was located north east of the corner of the golf course, east of Trench 5. Like Trench 6 it had to be moved south due to the presence of a tree. It had the now familiar sequence of topsoil (**700**, 0.30m thick), subsoil (**702**, 0.30m deep), a former topsoil (**703**, 0.10m in depth) and an undulating grey white sand natural, **704**. A yellow clay, **701**, was noted beneath topsoil **700**. This deposit is associated with the back filling of a land drain at the northern end of the trench. Two other land drains were observed and left *in situ*. This resulted in the trench being shortened by a metre.
