**Doughty's Mill Phase 4,  
Melville Street, Lincoln**

**Archaeological Evaluation**

**LAS Report No. 566  
January 2002**

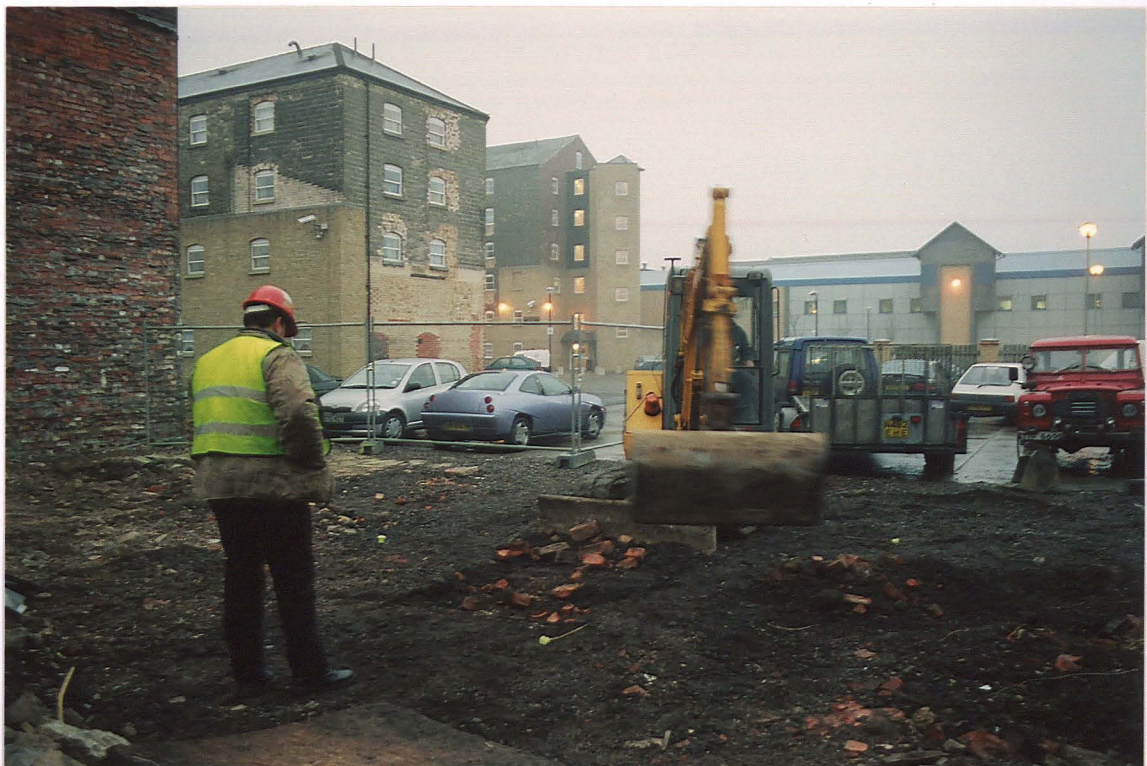
PI. 2 Machine excavation of trench under archaeological supervision.

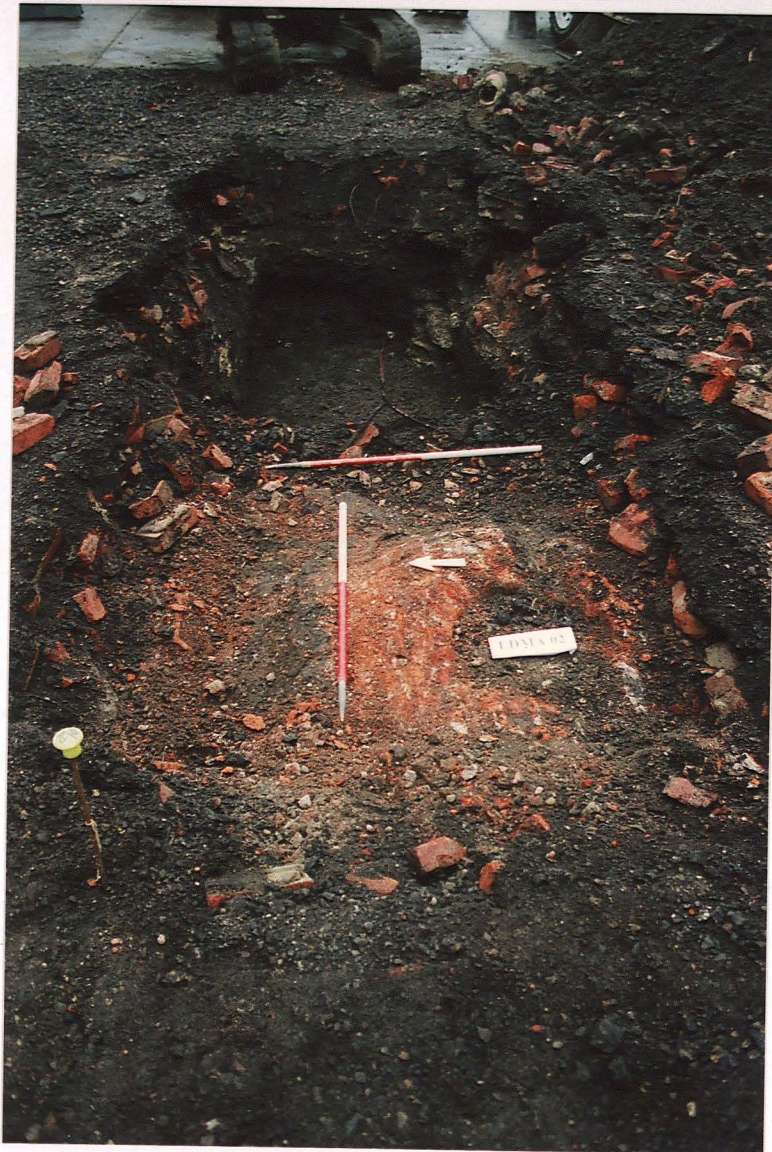
PI. 3 The evaluation trench after cleaning. Looking east. Scales 1m and 2m

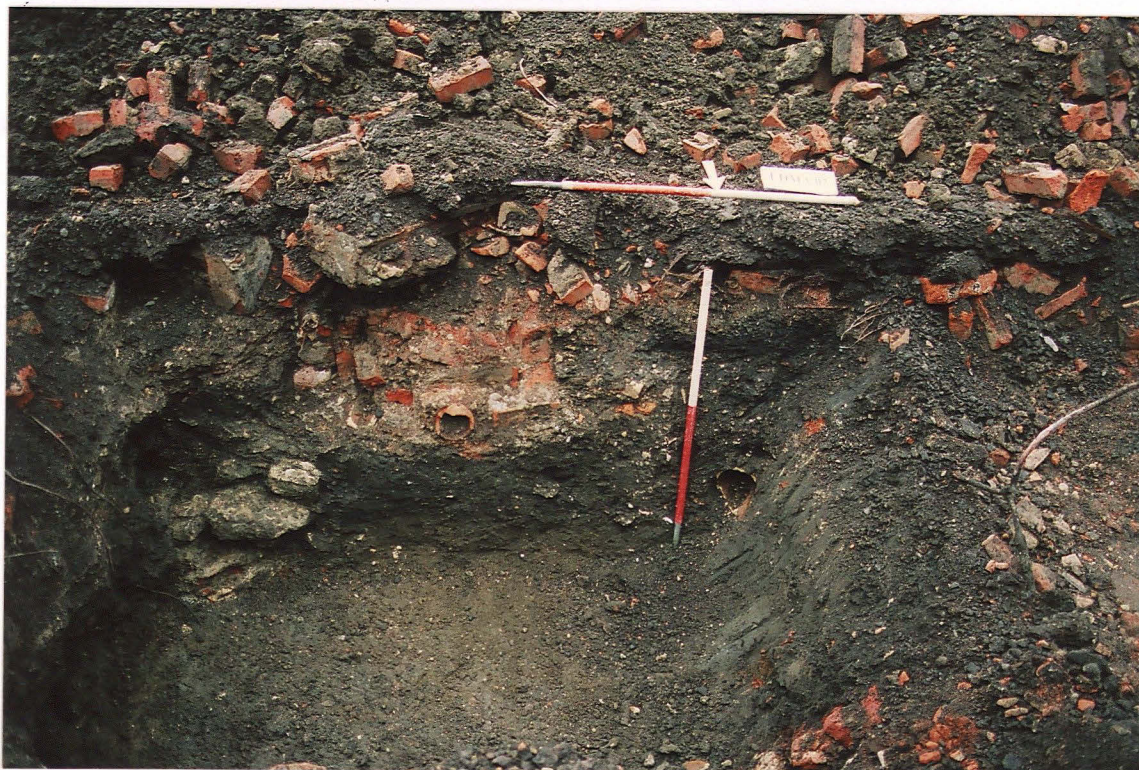
PI. 4 South section of the trench. Vertical scale 1m, horizontal scale 2m.
