REPORT ON A PROGRAMME OF
ARCHAEOLOGICAL FIELDWORK
UNDERTAKEN AT
BOSTON GRAMMAR SCHOOL,
BOSTON,
LINCOLNSHIRE.

NGR: TF 32914 43718

Site Code: BGSA 00

Report Prepared for
Lincolnshire County Council Property Division,
on behalf of Boston Grammar School
by Jim Rylatt

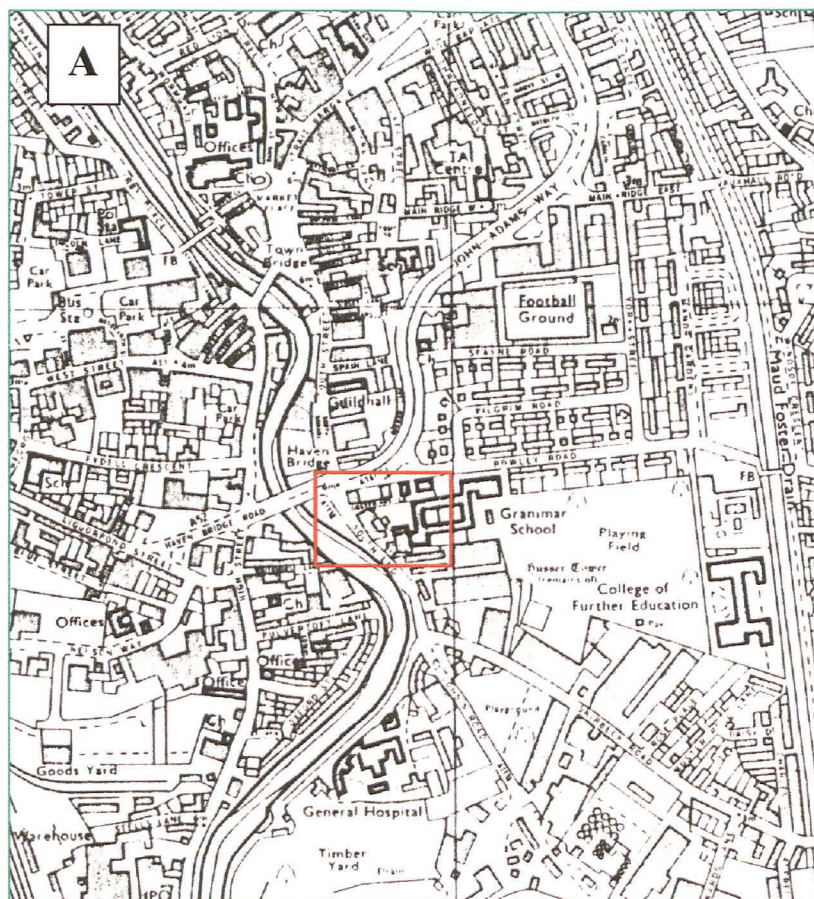
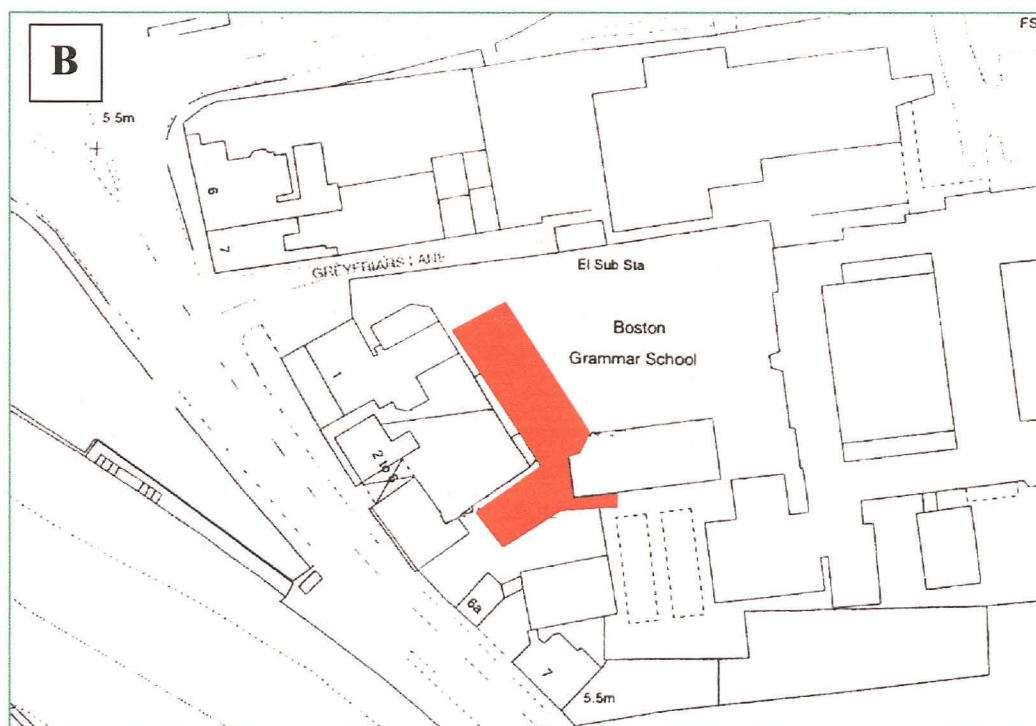
Figure 1 - A: Site location, with red outline indicating position of 'B' (1: 10,000) **B:** North-west corner of the grounds of Boston Grammar School, showing the location of the extension to the science block.

Figure 1 - A: Site location at 1: 10,000 B: North-west corner of the grounds of Boston Grammar School, showing the location of the extension to the science block.

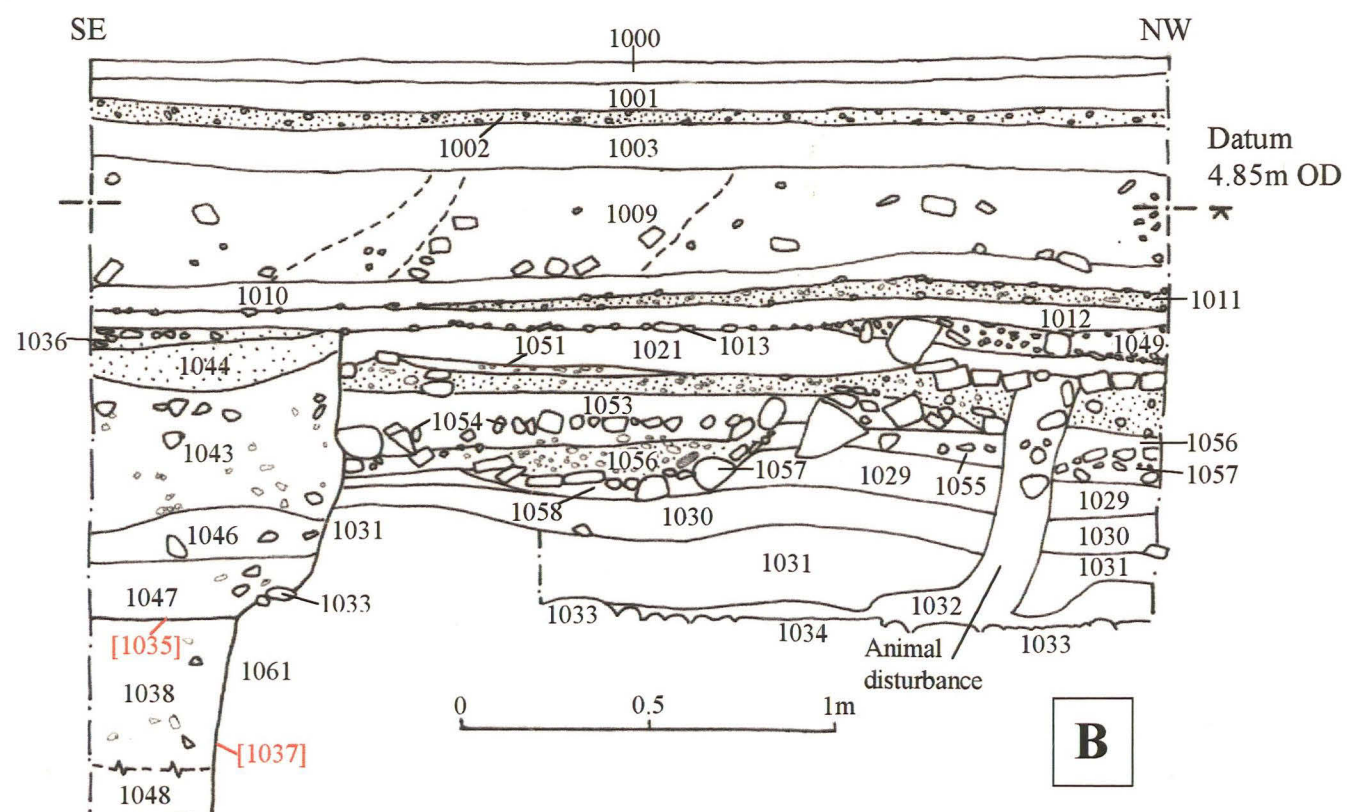
Figure 4 - A: North-west facing section of evaluation Trench 1, with sondage opened at south-west corner showing the sequence of former yard surfaces. **B:** North-east facing section of evaluation Trench 1.

Figure 4 - A: North-west facing section of evaluation Trench 1. B: North-east facing section of evaluation Trench 1.

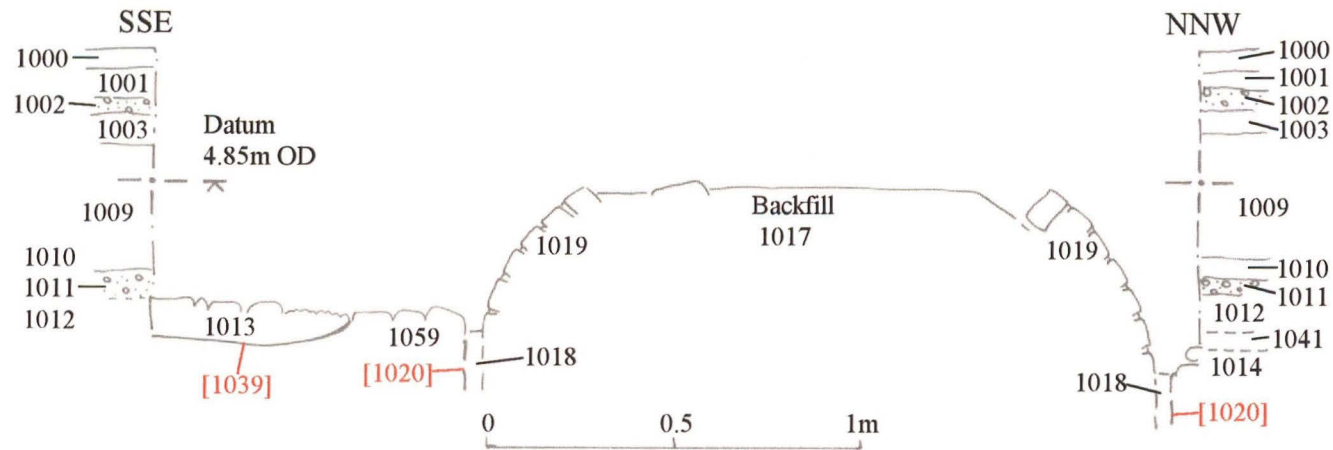
Figure 5: South-south-east to north-north-west profile across the centre of evaluation Trench 1, showing the form of the surviving element of soft water cistern (1019) and its relationship to cobbled surface (1014)/(1059).

Figure 5: South-south-east to north-north-west profile across the centre of evaluation Trench 1.

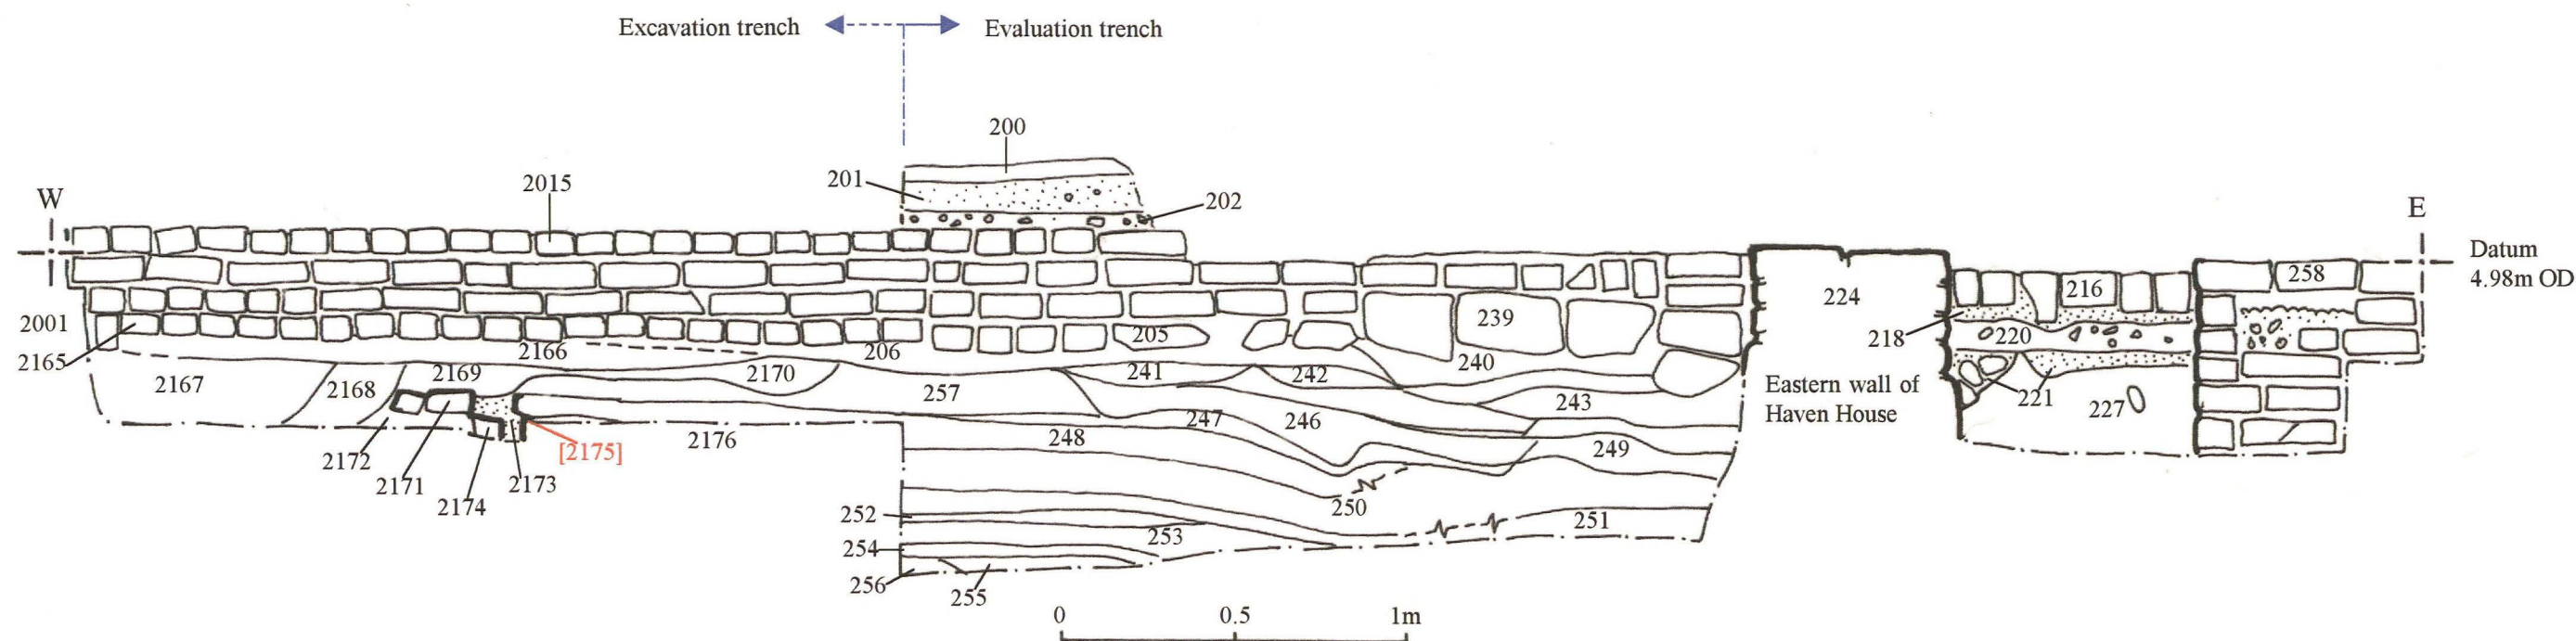
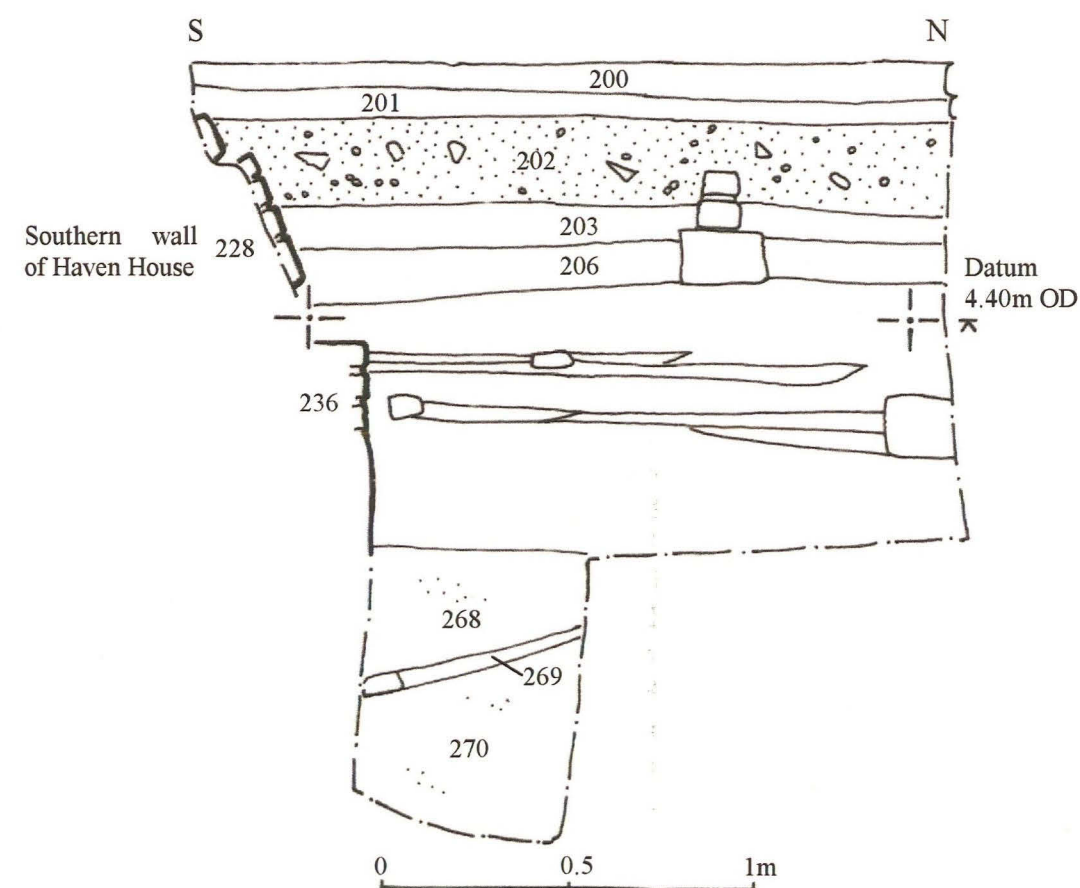
Figure 9 – A: South-west facing section of the central sleeper wall, (204)/(2015), that was inserted into the eastern ground floor room of Haven House. A limestone rubble foundation, (205)/(239), has been used at the eastern end, with bricks laid as headers supporting the remainder. The surviving elements of the original mortar floor of Haven House, (206), lie directly beneath the sleeper wall. Layers (247) to (256) are flood deposited silts and sands.

B: East facing section of evaluation Trench 2, showing the small sondage excavated at the south-west corner of the trench. Layer (268) contained relatively well-preserved organic material and five sherds of mid 13th and mid 14th century pottery, while (270) incorporated quantities of organic material, charcoal, bone and two sherds of pottery; one a fragment of 13th century North French monochrome ware.

Figure 9 - A: South-west facing section of the central sleeper wall, (204)/(2015). B: East facing section of evaluation Trench 2.

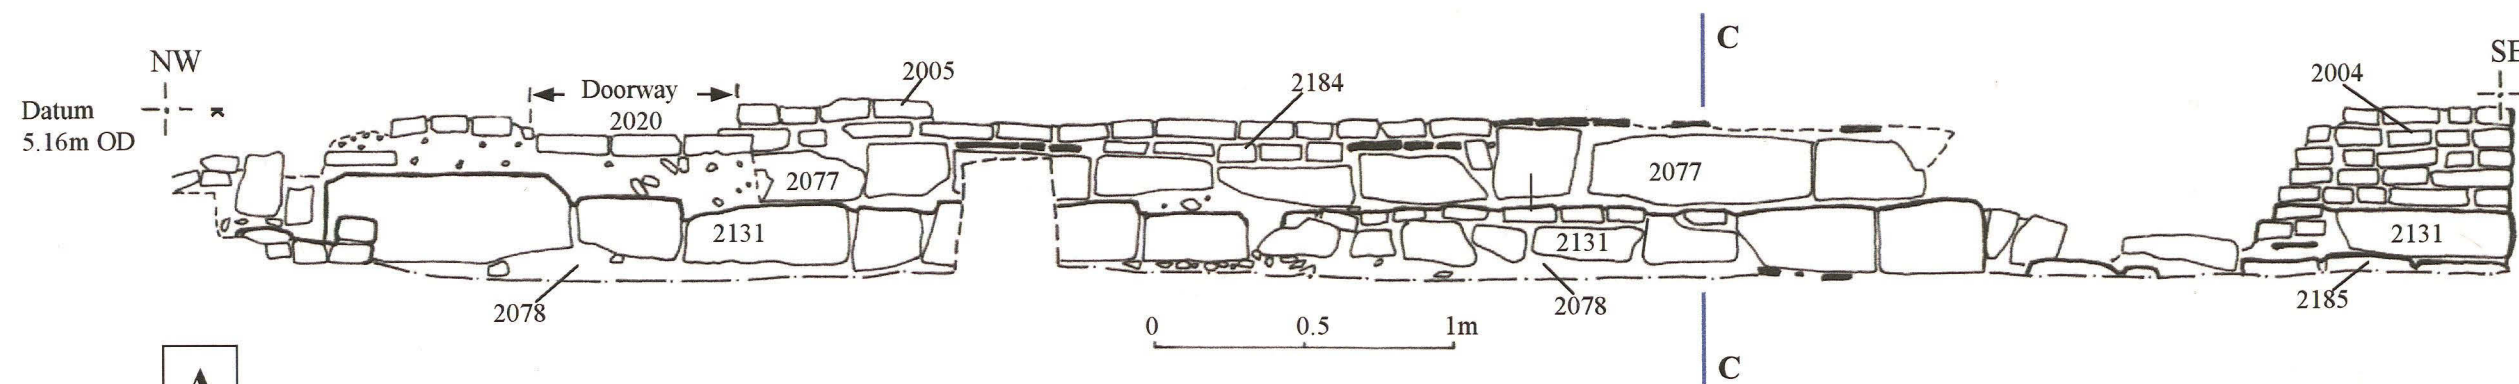
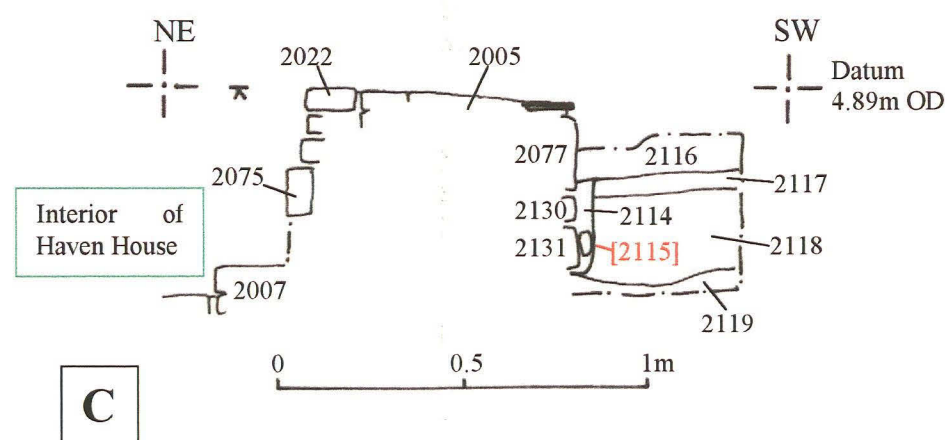
Figure 12 – A: External face of the southern wall of Haven House, (2005), showing complex build sequence, which is dominated by the large blocks of limestone rubble, (2131)/(2077). The tile bonding or damp proofing layer is depicted in solid black. The threshold of the main entrance into Haven House, (2020), is evident toward the north-west end of the section. The blue line, C-C, indicates the location of section 'C', below.

B: The internal face of wall (2005), most of which is obscured by the insertion of the 19th century sleeper wall (2022). The lowest course of bricks, (2076), had been laid in a 'herring-bone' pattern, which was possibly a deliberate decorative feature. Walls (2007), (2018) and (2025) are visible at the bottom of the section; they represent components of a structure predating Haven House, and are likely to be of 15th or 16th century construction.

C: A section across wall (2005), showing its relationship to the later sleeper wall, (2022), and the deposits that had built up against the external face of the building.

Figure 12 - A: External face of the southern wall of Haven House, (2005). B: The internal face of wall (2005). C: Section across wall (2005).

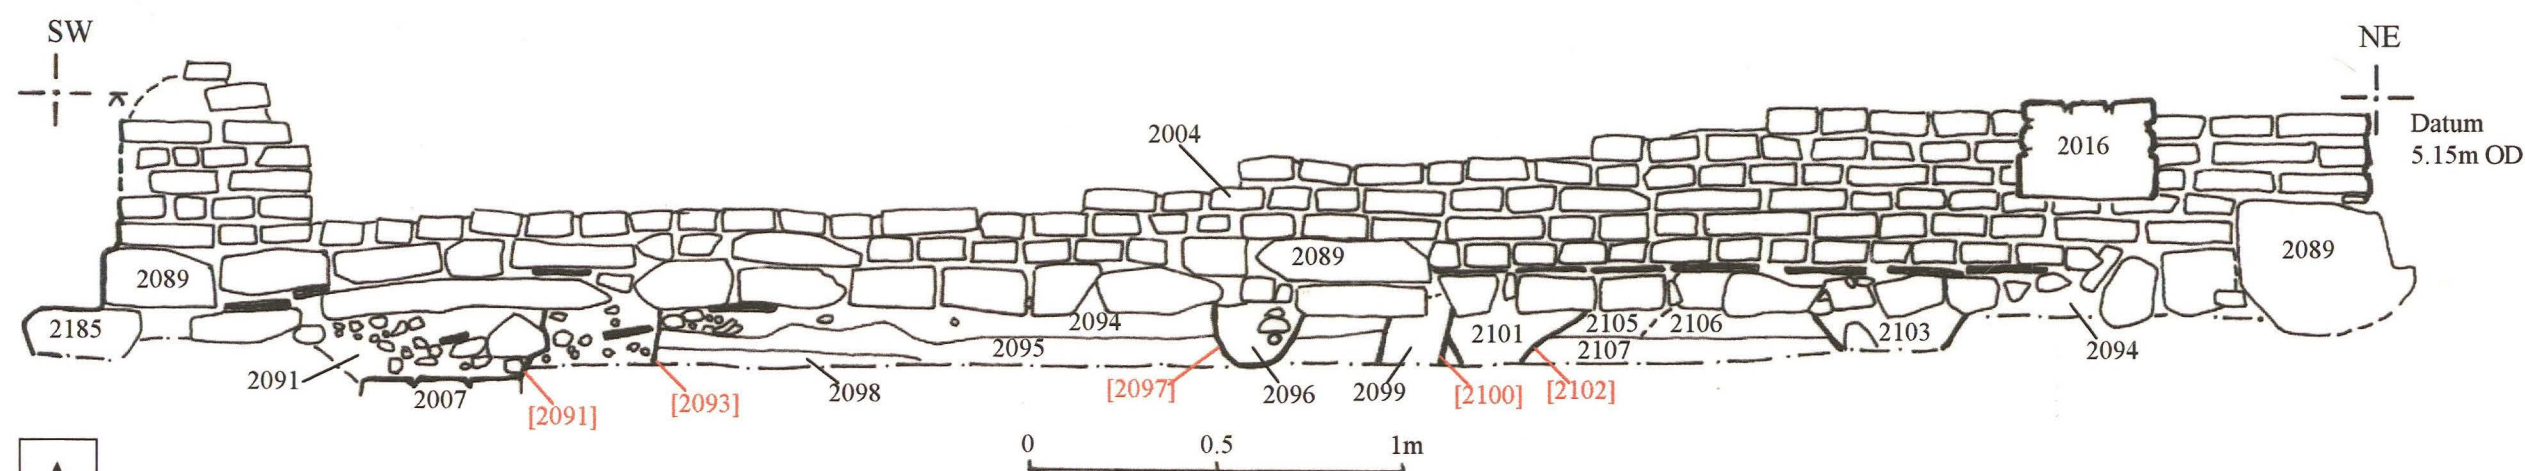
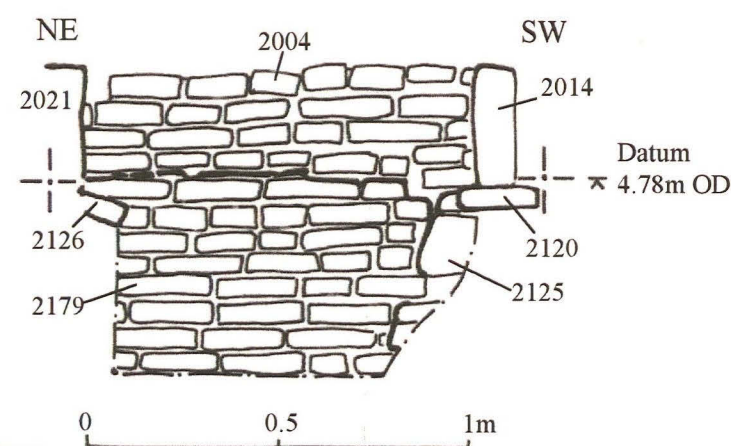
Figure 13 – A: External face of the eastern wall of Haven House, (2004)/(224), showing the complex build sequence. The blocks of limestone rubble, (2089), are sealed beneath a tile bonding or damp proof layer depicted in solid black. Wall (2016) separated the northern and southern rooms of the late 18th century or early 19th century eastern extension to Haven House. A series of postholes - [2097], [2100], [2102] and [2104] - are visible beneath (2004)/(224). These features evidently predate Haven House, but post-date the earliest brick-built building, part of which, (2007), is visible at the base of the south-west end of the section.

Figure 13 - A: External face of the eastern wall of Haven House, (2004)/(224). B: The north-eastern end of the internal face of wall (2004).

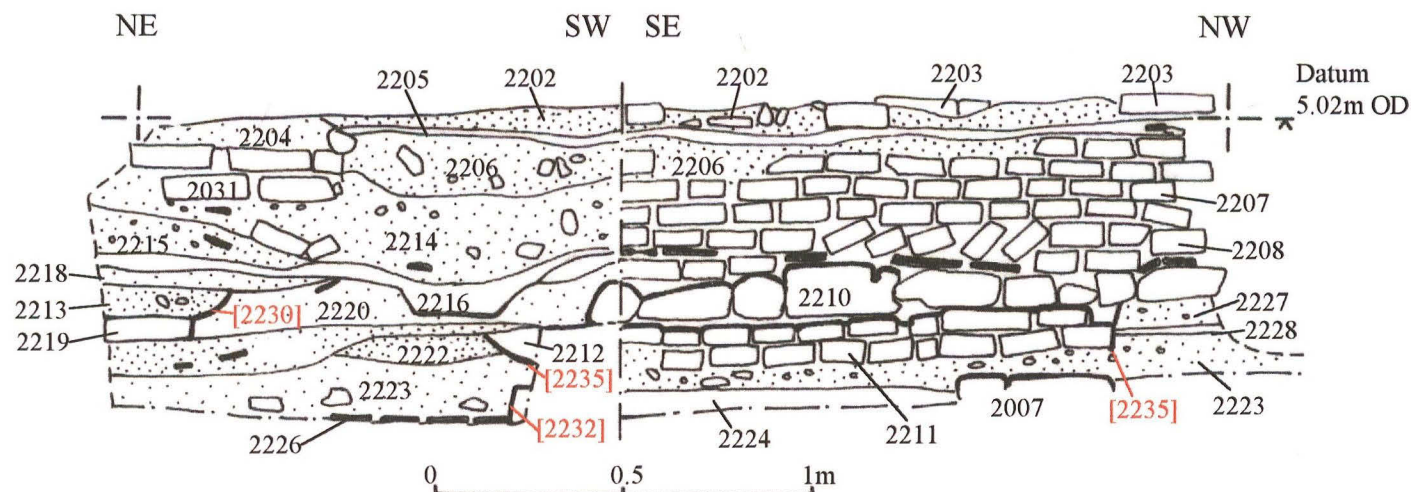
Figure 16: Adjoining north-west and north-east facing sections situated at the south-eastern corner of the excavation trench. The remains of a wall, (2207)/(2208)/(2209)/(2210), that was identical in form to the foundations of Haven House, is evident in the north-east facing section. It had been constructed upon an earlier wall foundation formed by two courses of unbonded handmade brick, (2211). This in turn overlay the remains of walls (2007) and (2009), which belonged to the large late medieval or early post-medieval building that extended westward beneath Haven House.

Figure 16: Adjoining north-west and north-east facing sections situated at the south-eastern corner of the excavation trench.

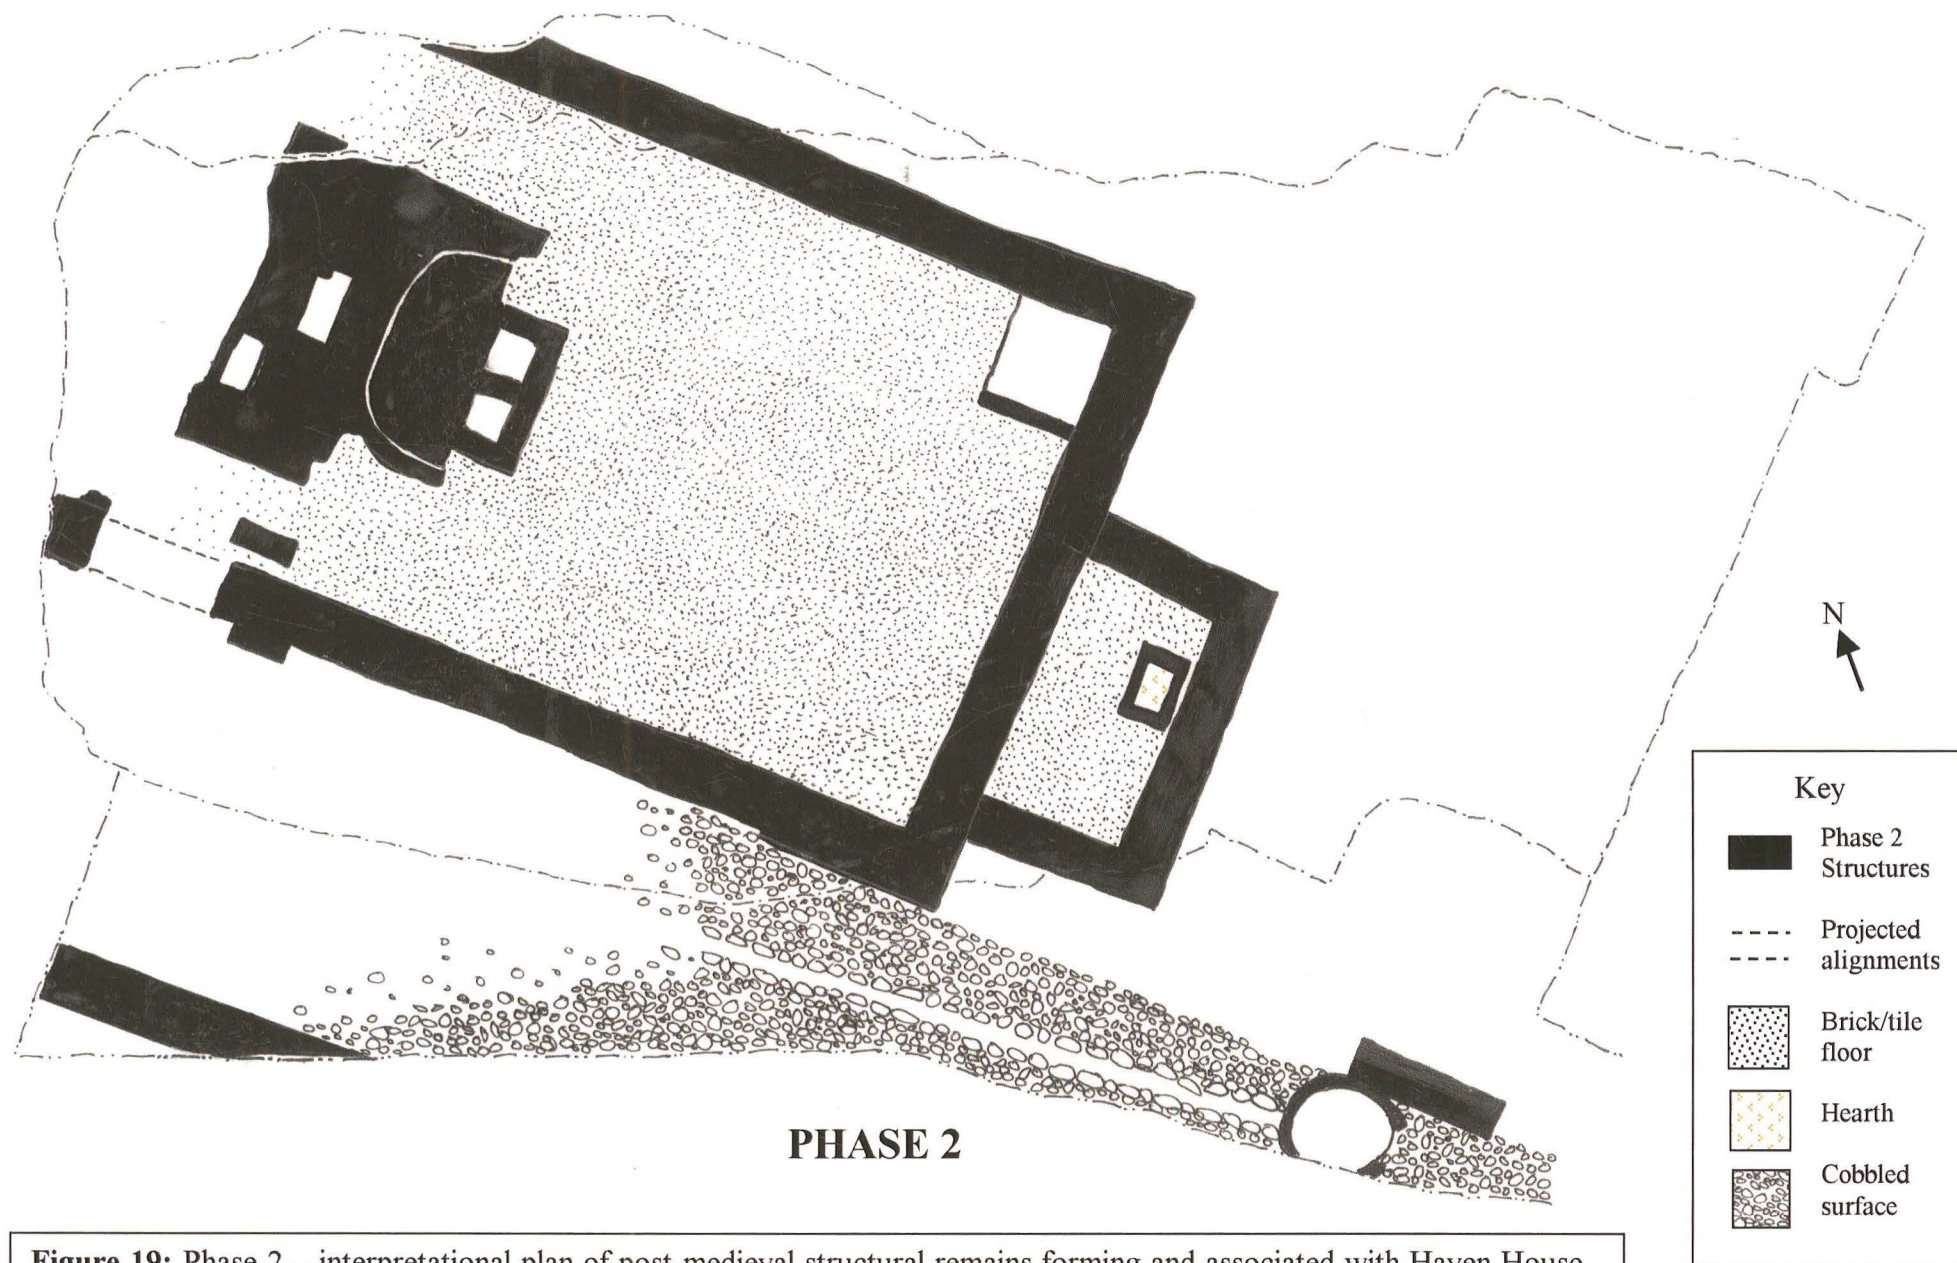
Figure 19: Phase 2 – interpretational plan of post-medieval structural remains forming and associated with Haven House - probably constructed in the mid to late 17th century.

Figure 19: Phase 2 – interpretational plan of post-medieval structural remains forming and associated with Haven House.

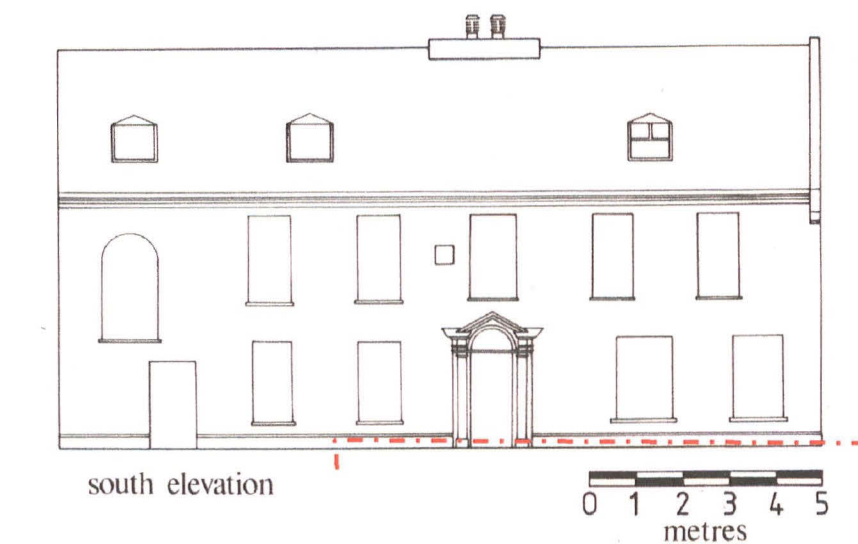
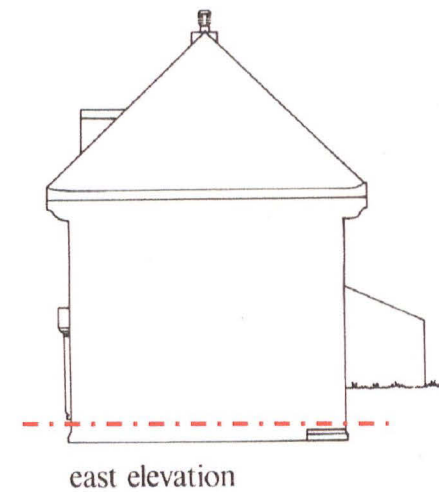
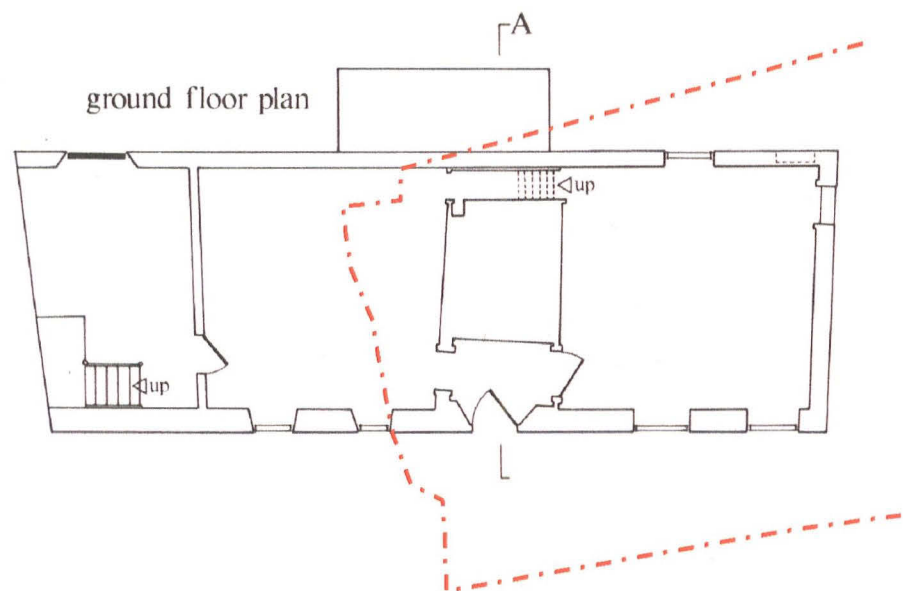
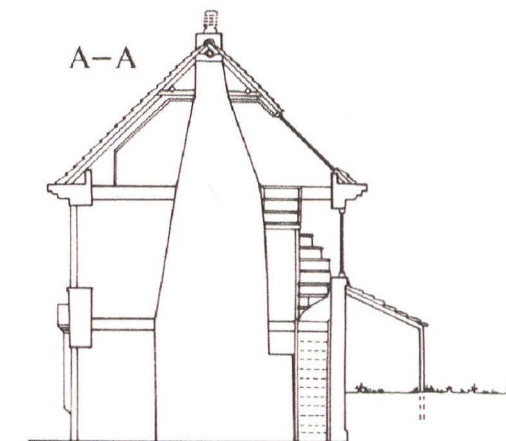
Figure 20: Plan and elevations of Haven House as it was immediately before demolition in 1979. The location of the archaeological trench opened in 2000 and 2001 is depicted in red (source: Vasey, 1980).

Figure 20: Plan and elevations of Haven House as it was immediately before demolition in 1979 (source: Vasey, 1980).

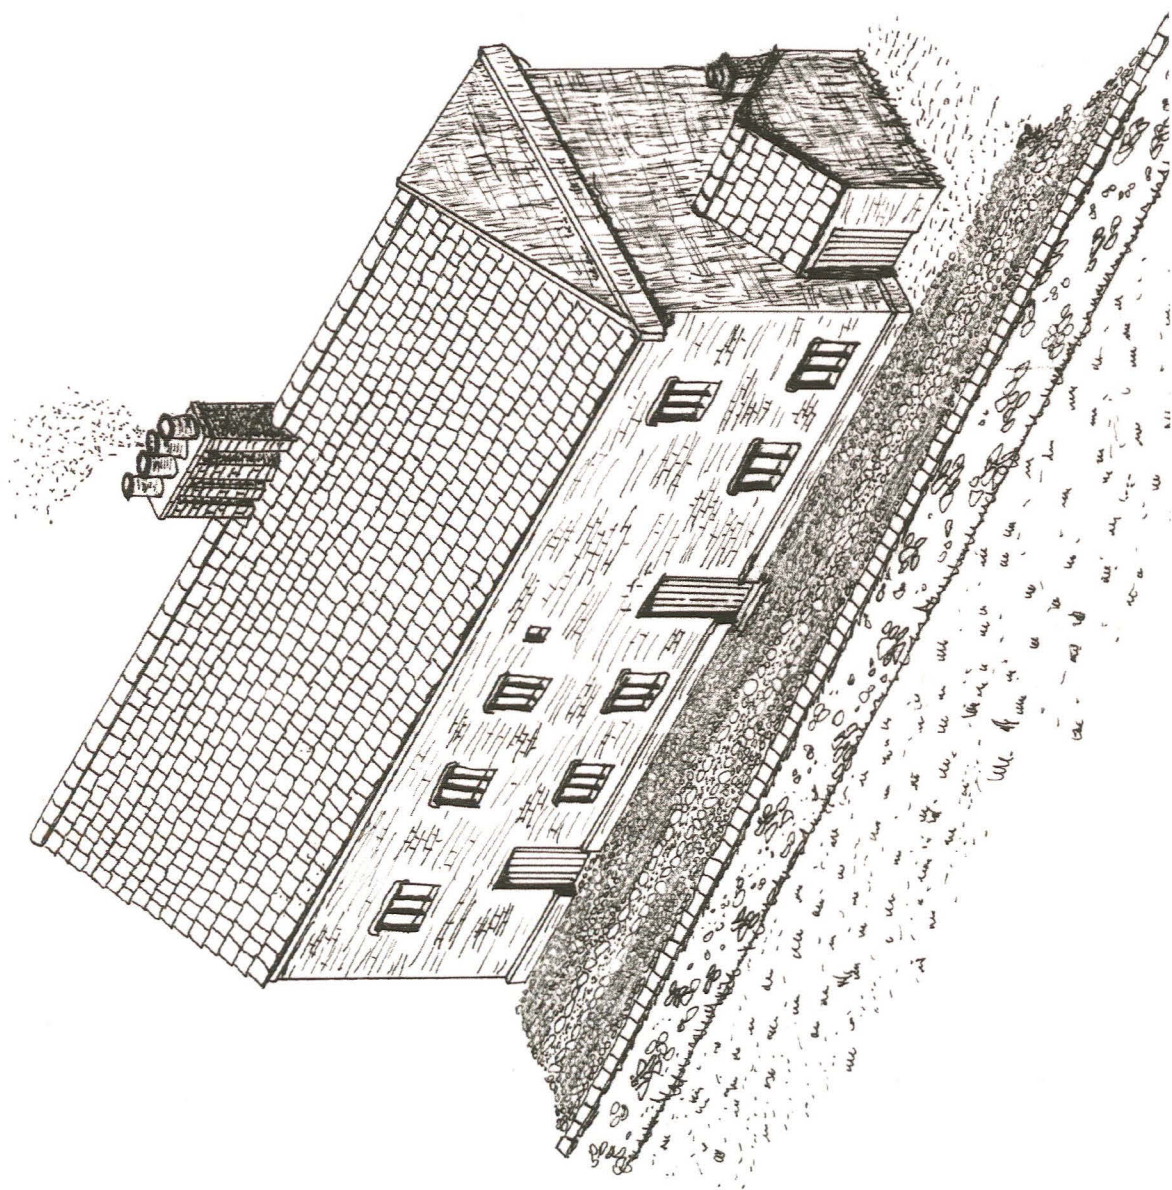
Figure 21: Putative reconstruction of Haven House, circa 1740, based upon the architectural survey and archaeological evidence (prepared from a drawing by D. Hopkins, Heritage Trust of Lincolnshire).

Figure 21: Putative reconstruction of Haven House, circa 1740, based upon the architectural survey and archaeological evidence (prepared from a drawing by D. Hopkins, Heritage Trust of Lincolnshire).

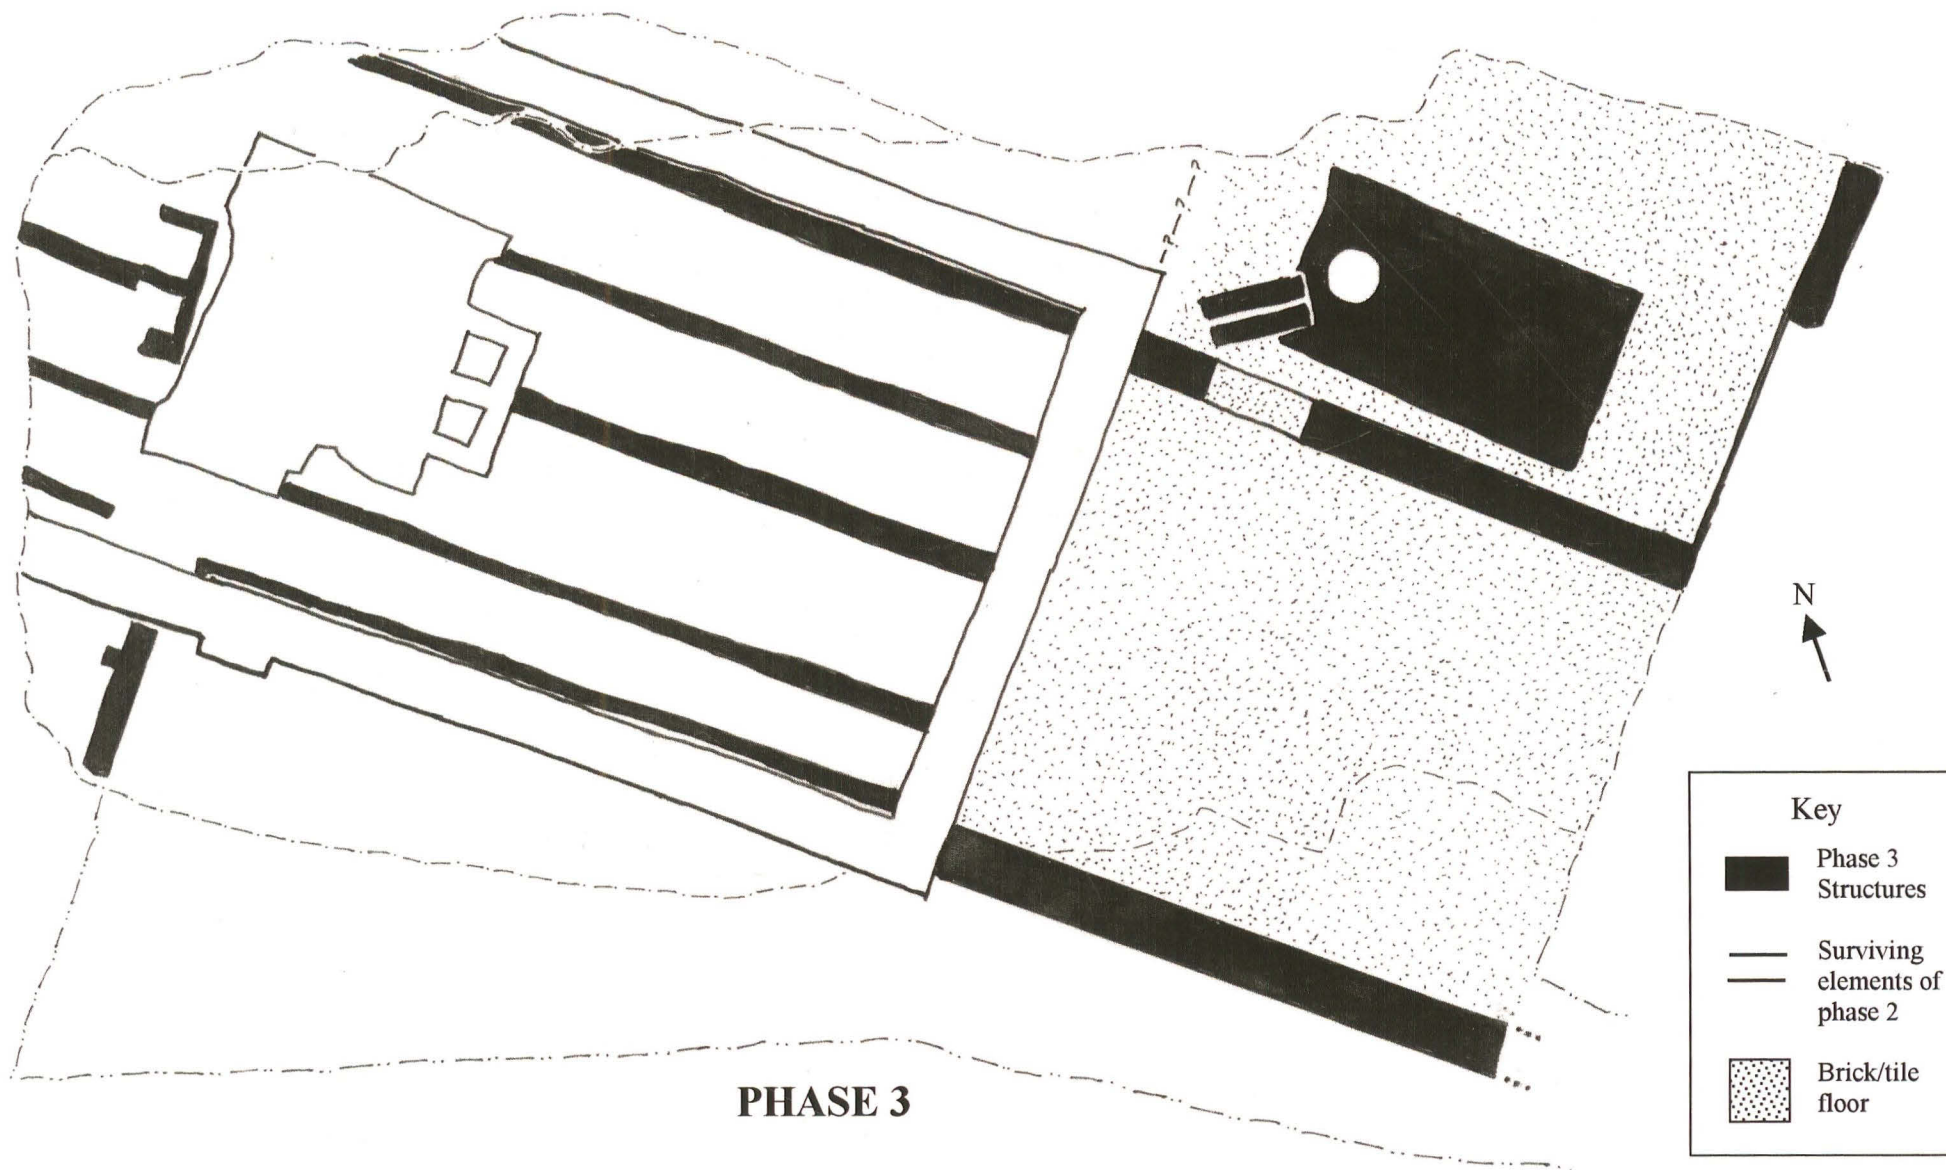
Figure 22: Phase 3 – interpretational plan of the early-modern structural elements added to the existing 17th century dwelling, Haven House – Phase 3 components were probably constructed in the late 18th to early 19th centuries.

Figure 22: Phase 3 – interpretational plan of the early-modern structural elements added to the existing 17th century dwelling, Haven House.

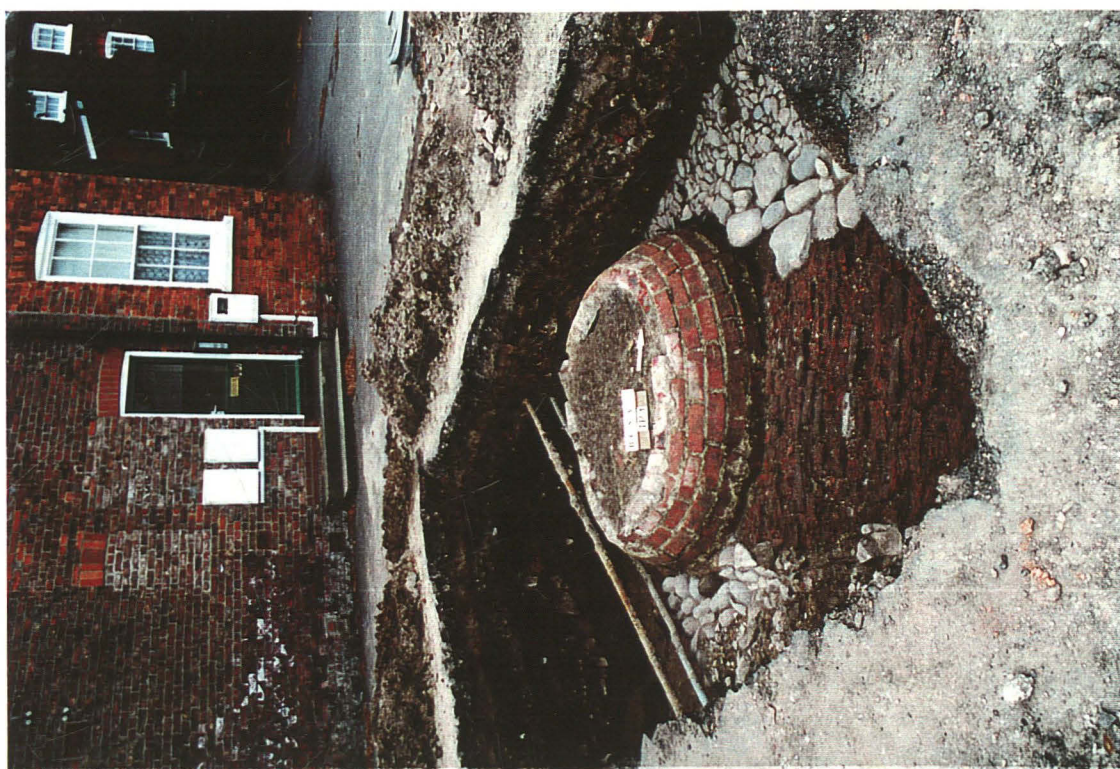
Plate 1: General view of evaluation Trench 1 following excavation, with soft water cistern (1019) at centre, truncating brick path (1016) and cobbled surface (1014)/(1015). The green door in the background is the rear entrance to the headmaster's former residence constructed in 1829, looking west.

Plate 1: General view of evaluation Trench 1 following excavation, with soft water cistern (1019) at centre, truncating brick path (1016) and cobbled surface (1014)/(1015).

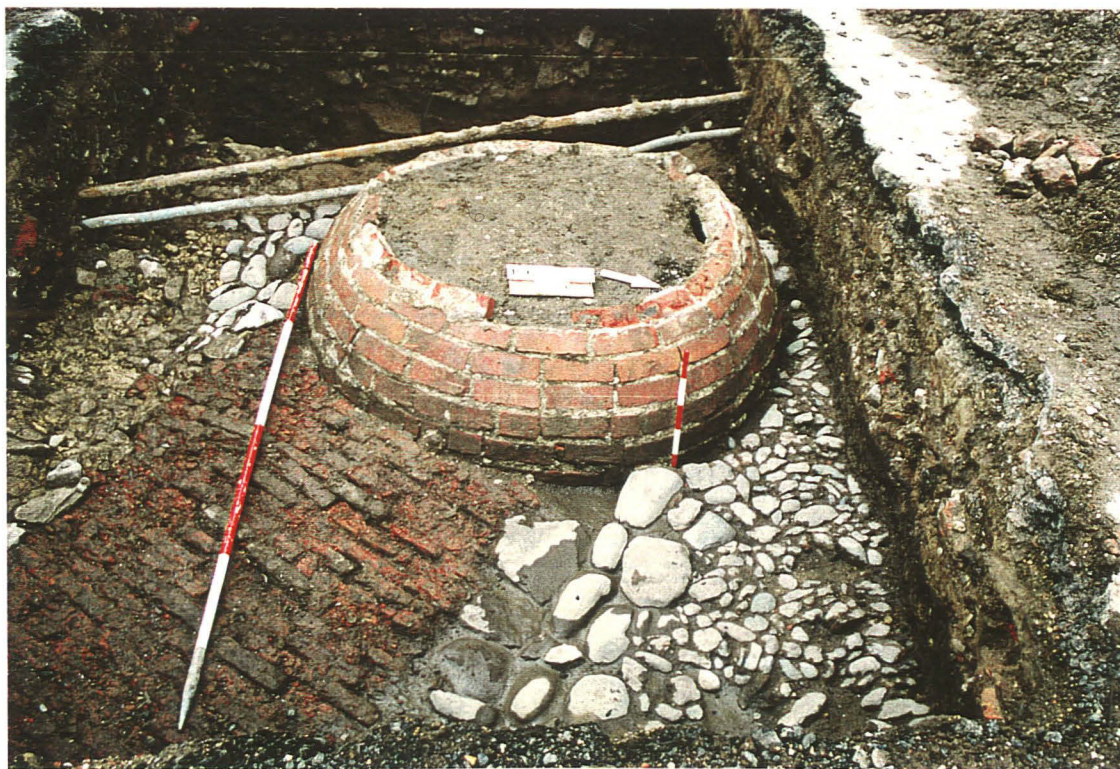
Plate 2: Evaluation Trench 1, east end of trench showing soft water cistern (1019) and brick path (1016), with cobbled surface (1014)/(1015) to right of path and repair (1013) to left, looking south-west.

Plate 2: Evaluation Trench 1, east end of trench showing soft water cistern (1019) and brick path (1016), with cobbled surface (1014)/(1015) to right of path and repair (1013) to left, looking south-west.

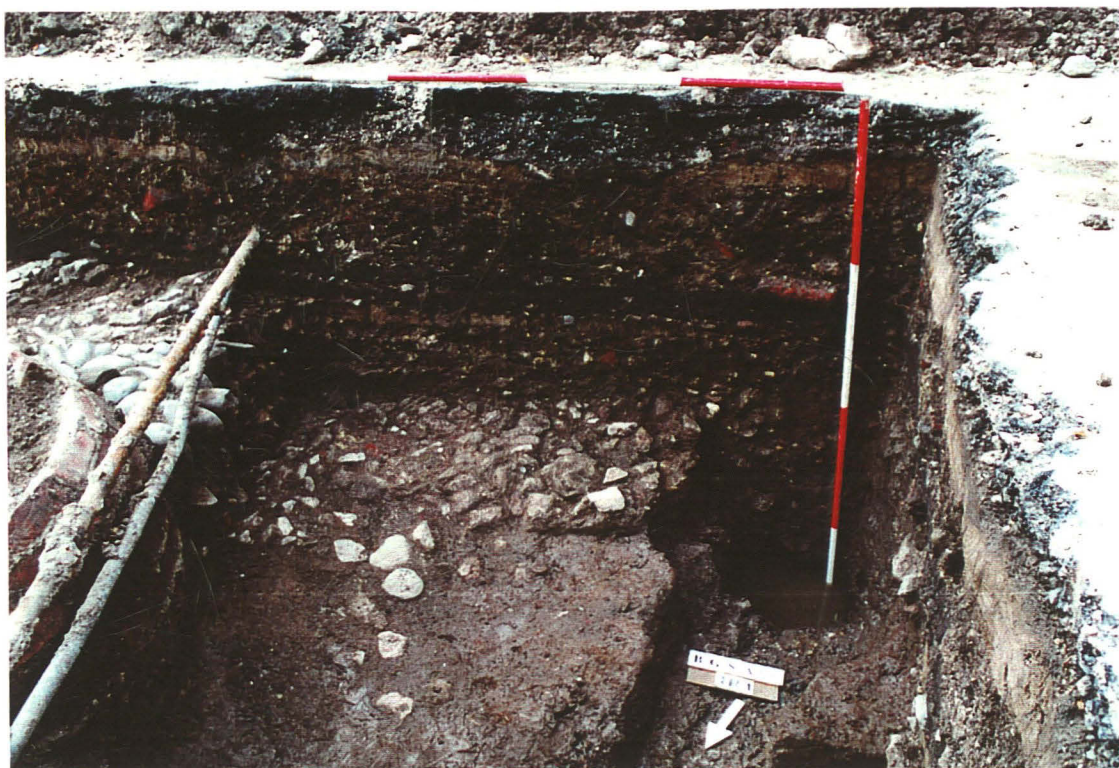
Plate 3: Evaluation Trench 1, north-west facing section showing sondage inserted at south-west corner. Note the series of yard surfaces evident in the section, with part of limestone surface (1028) exposed at the centre of the picture, looking south-east.

Plate 3: Evaluation Trench 1, north-west facing section showing sondage inserted at south-west corner, looking south-east.

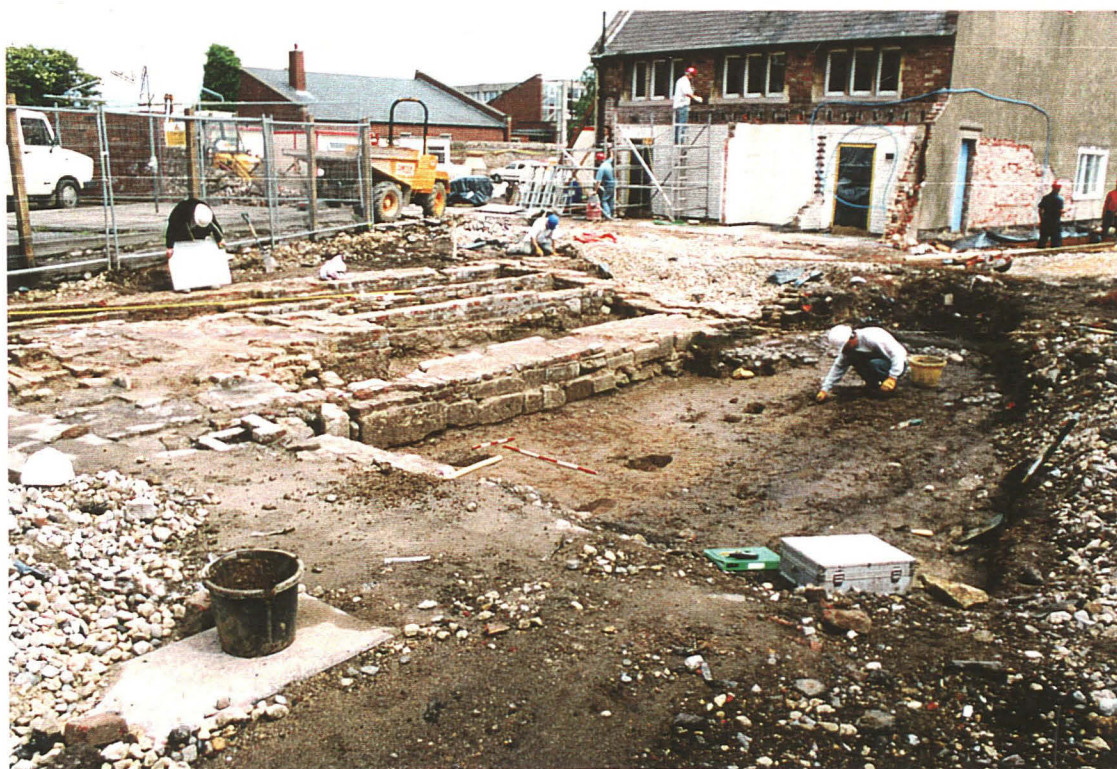
Plate 4: General view of Trench 2 during the Phase 2 excavation. The foundations of the eastern half of Haven House run from left to the centre of the image, and the existing science block lies at top right, looking east.

Plate 4: General view of Trench 2 during the Phase 2 excavation. The foundations of the eastern half of Haven House run from left to the centre of the image, and the existing science block lies at top right, looking east.
