REPORT ON A PROGRAMME OF
ARCHAEOLOGICAL FIELDWORK
UNDERTAKEN AT
BOSTON GRAMMAR SCHOOL,
BOSTON,
LINCOLNSHIRE.

NGR: TF 32914 43718

Site Code: BGSA 00

Report Prepared for
Lincolnshire County Council Property Division,
on behalf of Boston Grammar School
by Jim Rylatt

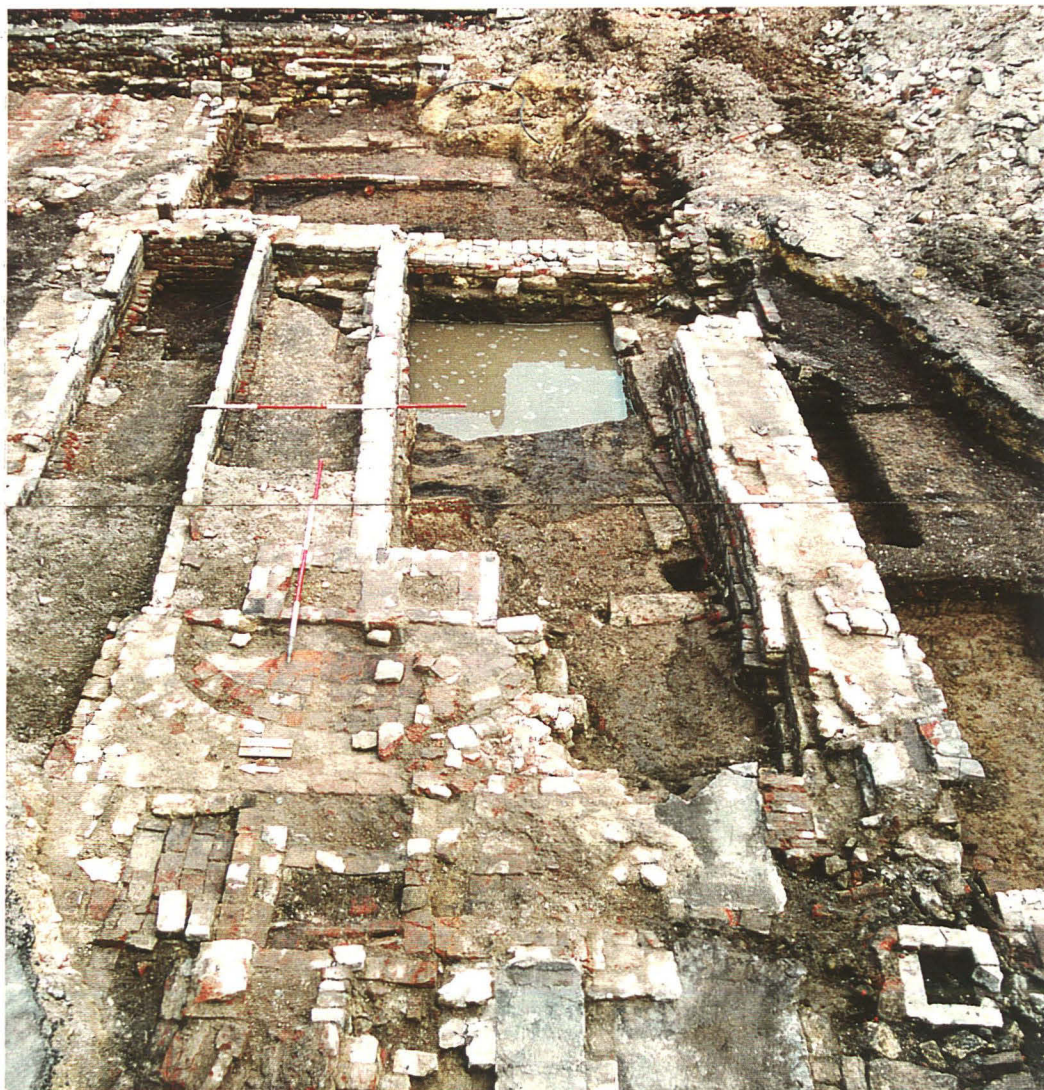
Plate 5: Composite image of Trench 2 during the Phase 1 excavation, with the foundations of the eastern half of Haven House occupying the majority of the image. The main entrance to the house, (2020), was situated immediately above the modern soak away at the bottom right hand corner of the image. The foundation for the chimneystack, (2001), occupies the majority of the lower left side of the image, with the large semi-circular hearth visible immediately below the lower photo scale. The pool of standing water marks the location of the evaluation trench, with garderobe (2179) in the opposite internal corner of the structure, looking south-east.

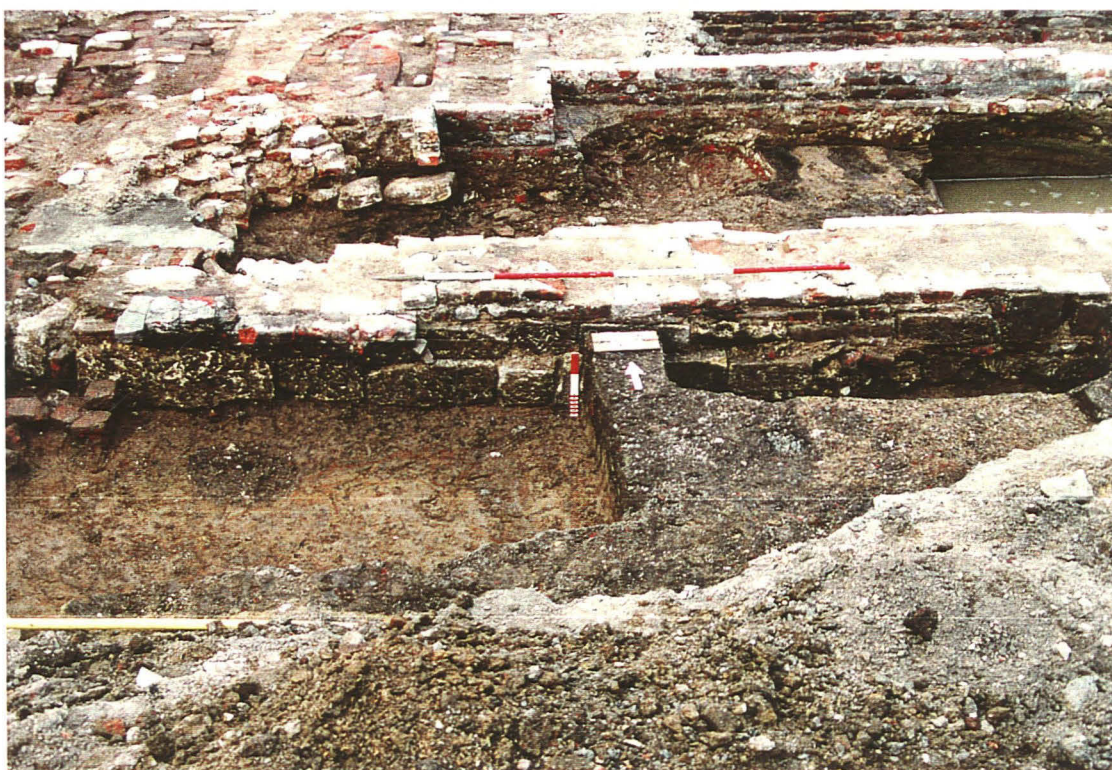
Plate 6: Trench 2, detail of the foundation of the southern wall, (2005), of Haven House following excavation, note the massive blocks of limestone reused as a foundation, (2131). The threshold of the main entrance to the house lies immediately to the left of the horizontal photo scale, with the foundation of the chimneystack, (2001), occupying the top left corner, looking north-east.

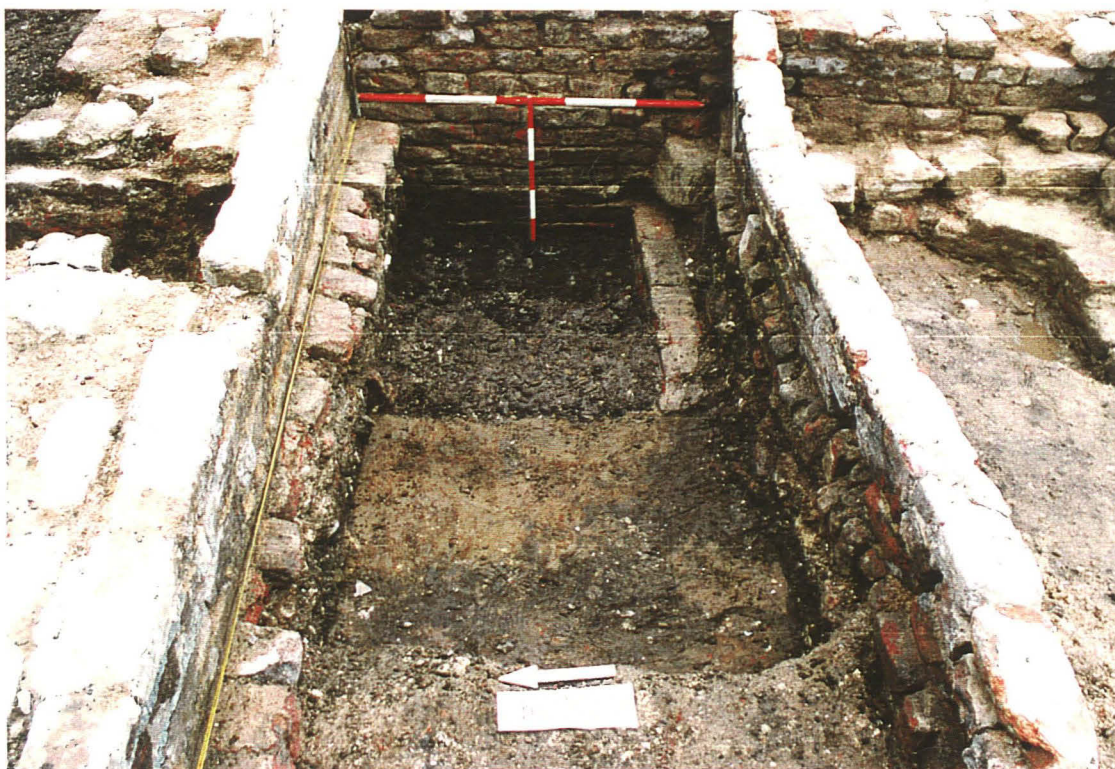
Plate 7: Trench 2, probable garderobe (2179) situated in the internal angle of the south-east corner of Haven House, looking south-east.

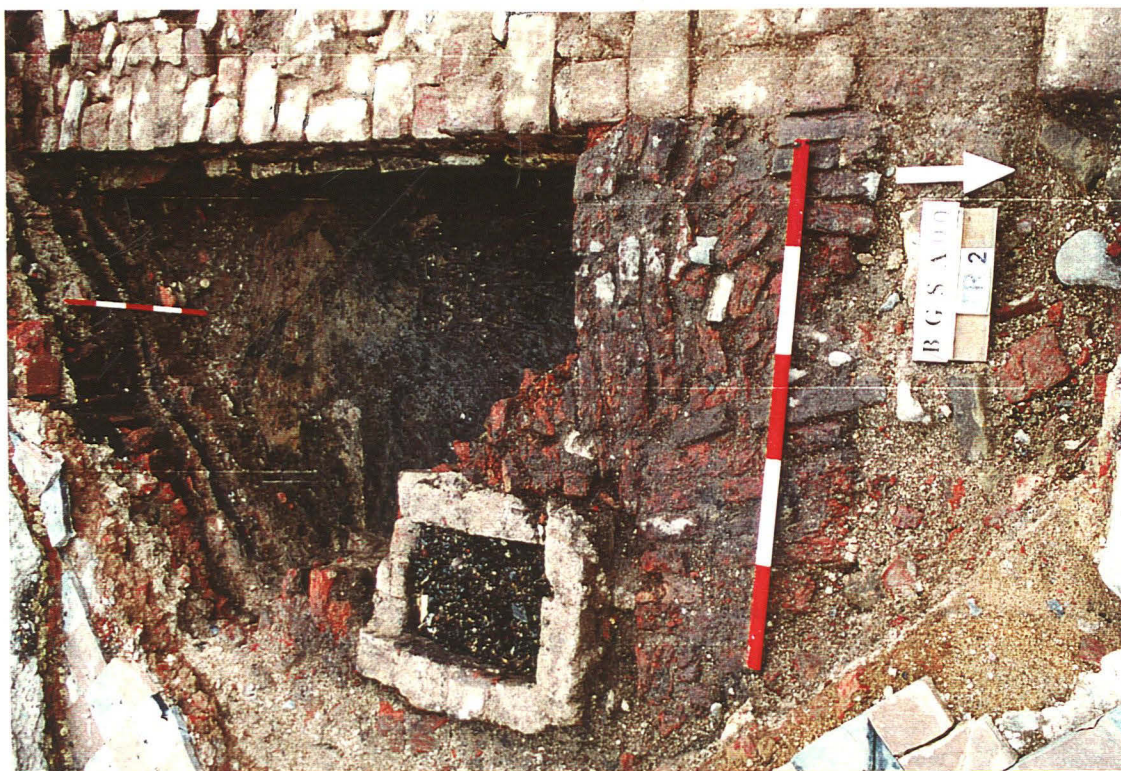
Plate 8: Trench 2, brick floor, (216), abutting the eastern wall, (224)/(2004), of Haven House, which runs along right side of photo. The floor surrounded a small brick built hearth, (258), which still contained the ash from its last firing. Both features had probably been enclosed within a small structure, looking south-west.

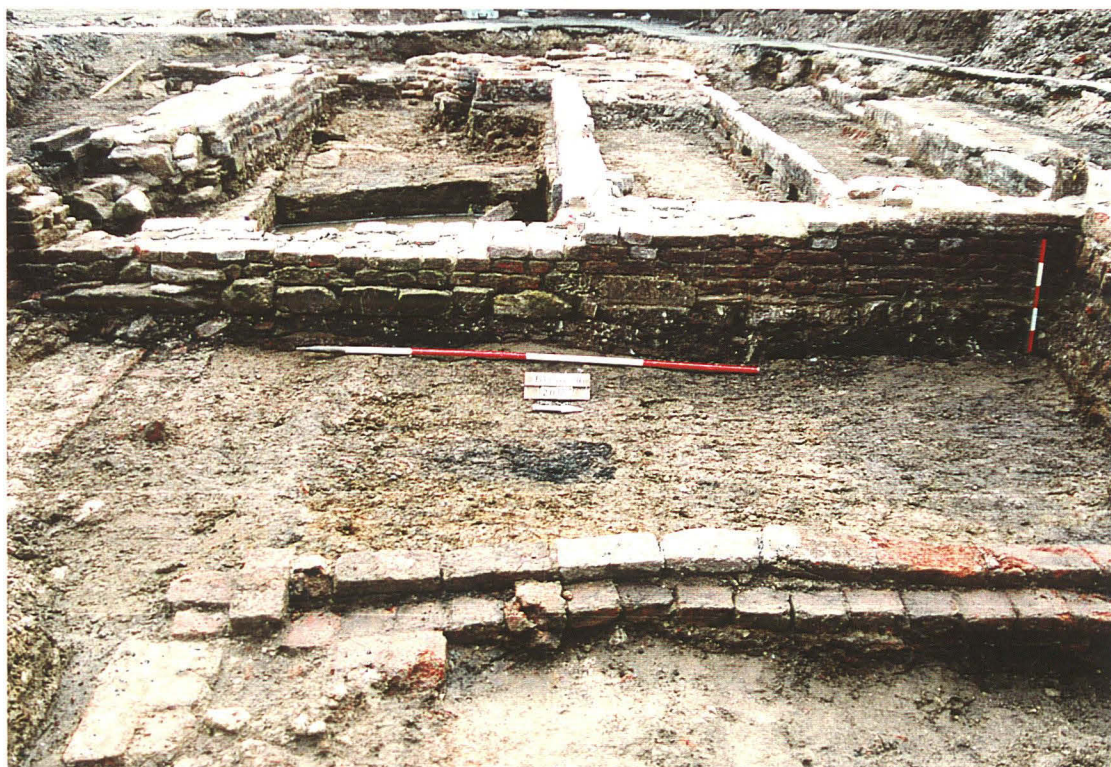
Plate 9: Trench 2, with the eastern wall, (224)/(2004), of Haven House running across the centre of the image. Wall (2008) and floor (2029) are situated in the foreground, both being part of a structure of late medieval or early post-medieval date, looking north-west.

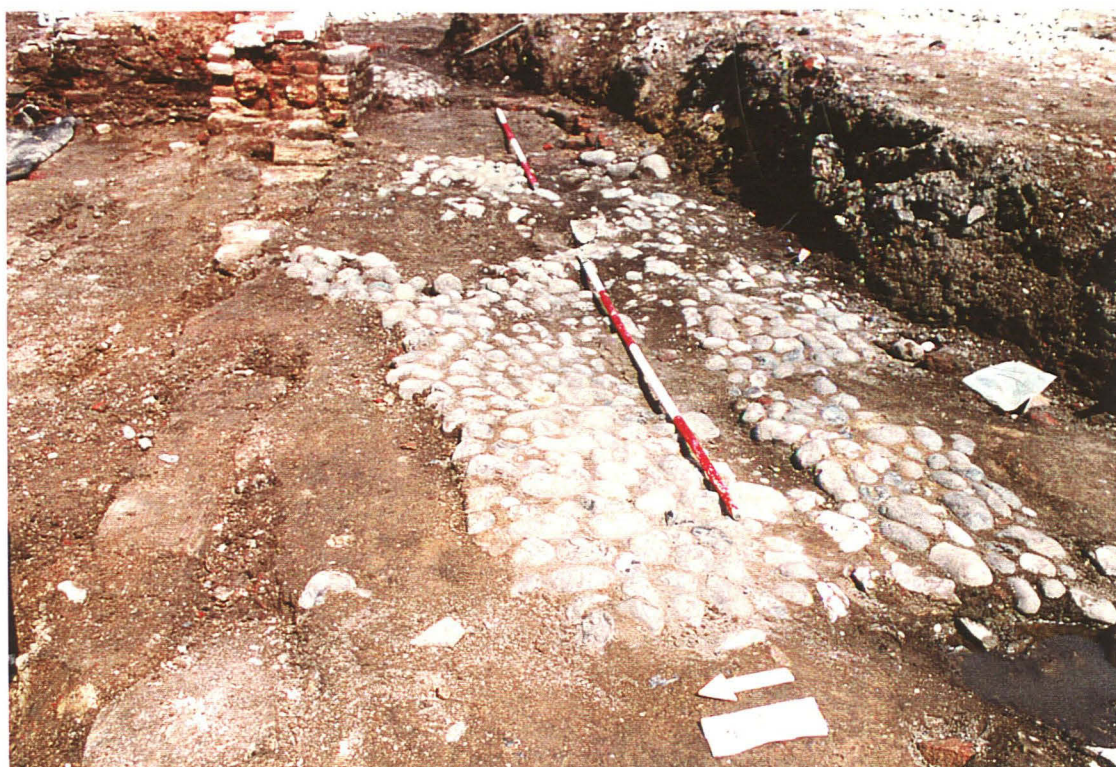
Plate 10: Trench 2, cobbled surface (2161), which was situated to the south of and abutted (2005), the southern wall of Haven House; the latter has been removed, the south-east corner of the building surviving at the top left corner of the photo. This yard surface was drained by [2165], the channel running immediately to the right of the photo scales, looking south-east.

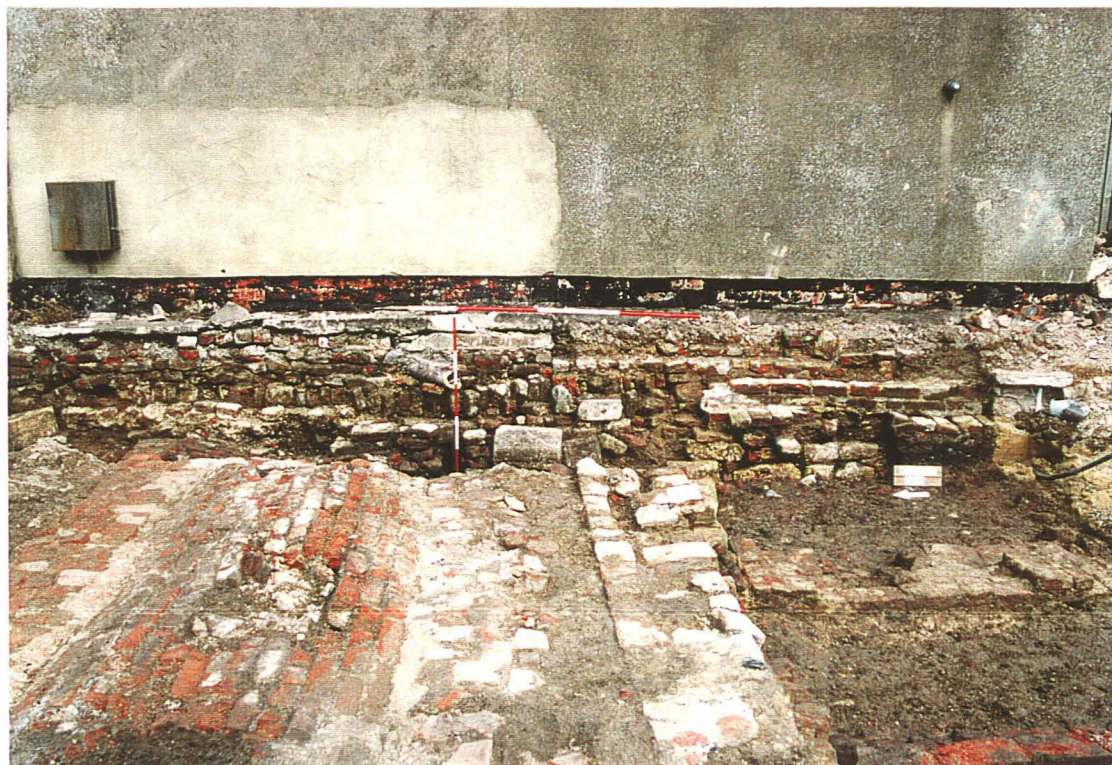
Plate 11: Trench 2, eastern end of the trench prior to the demolition of the end of the existing science block. Soft water cistern (2000) is visible at bottom left, while wall (2016), which divided the eastern and north-eastern extensions to Haven House, runs up the centre of the image. Running across the centre of the image are a complex of superimposed walls representing at least four phases of activity, looking south-east.

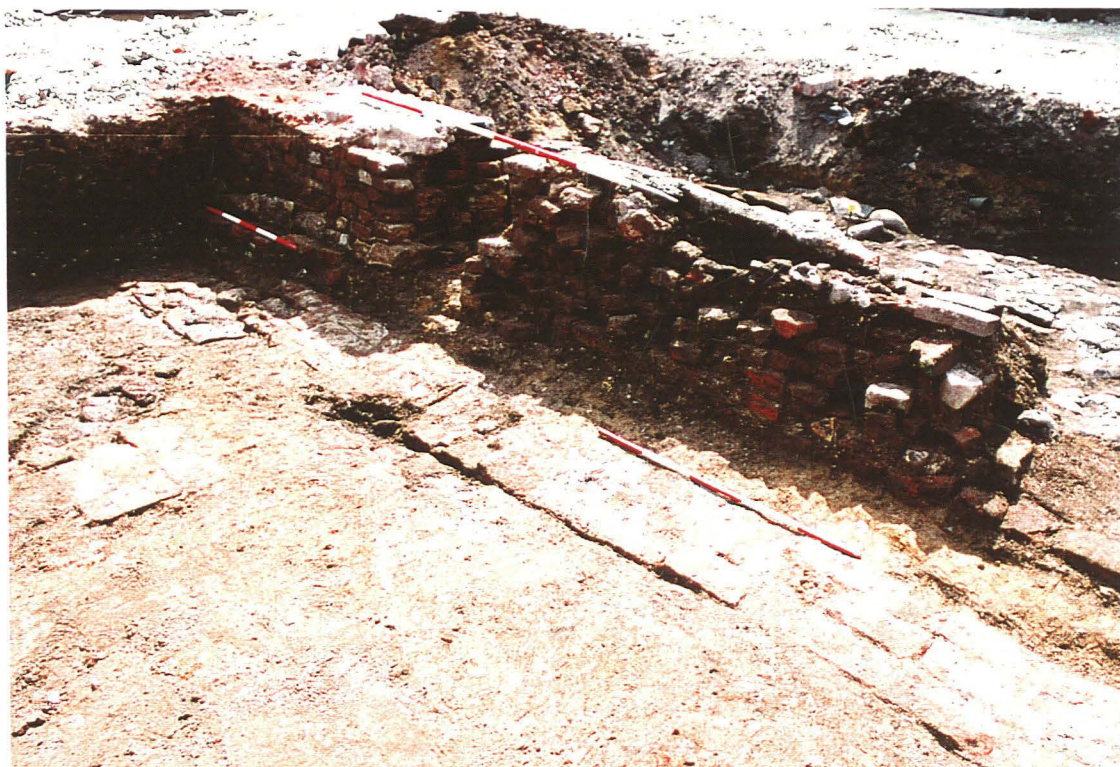
Plate 12: Trench 2, wall (2207)/(2208)/(2209)/(2210) is the short section of wall toward the top left corner of the image (adjacent to the short photo scale); the form of the construction was comparable with the external walls of Haven House, suggesting that it was erected in the 17th century. The 'continuation' of the wall to the right is actually modern and supports a conduit for a ceramic pipe. The top of wall (2007), pre-dating Haven House, is also visible running from the bottom right corner, looking south.

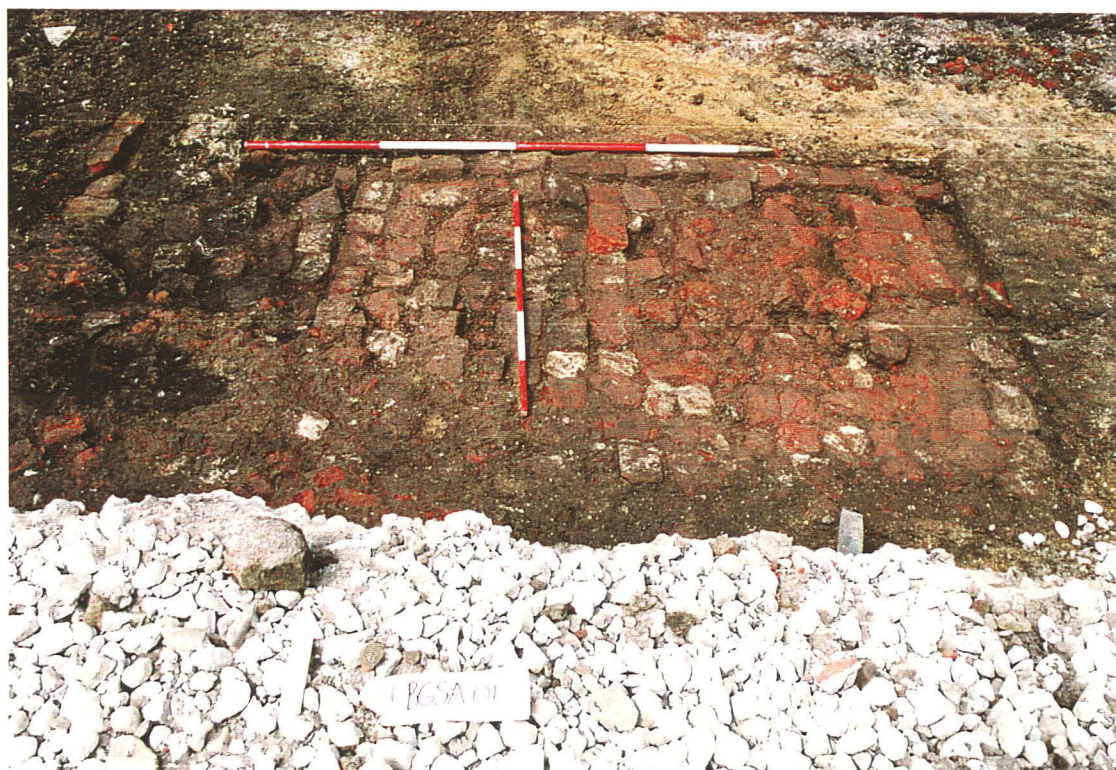
Plate 13: Trench 2, surface (2134) formed by unbonded, handmade brick, probably the floor of an outbuilding associated with Haven House. The north-west corner had been disturbed, with the bricks being burnt *in-situ*, implying that the building had contained a hearth, looking north-east.

Plate 13: Trench 2, surface (2134) formed by unbonded, handmade brick, probably the floor of an outbuilding associated with Haven House, looking north-east.

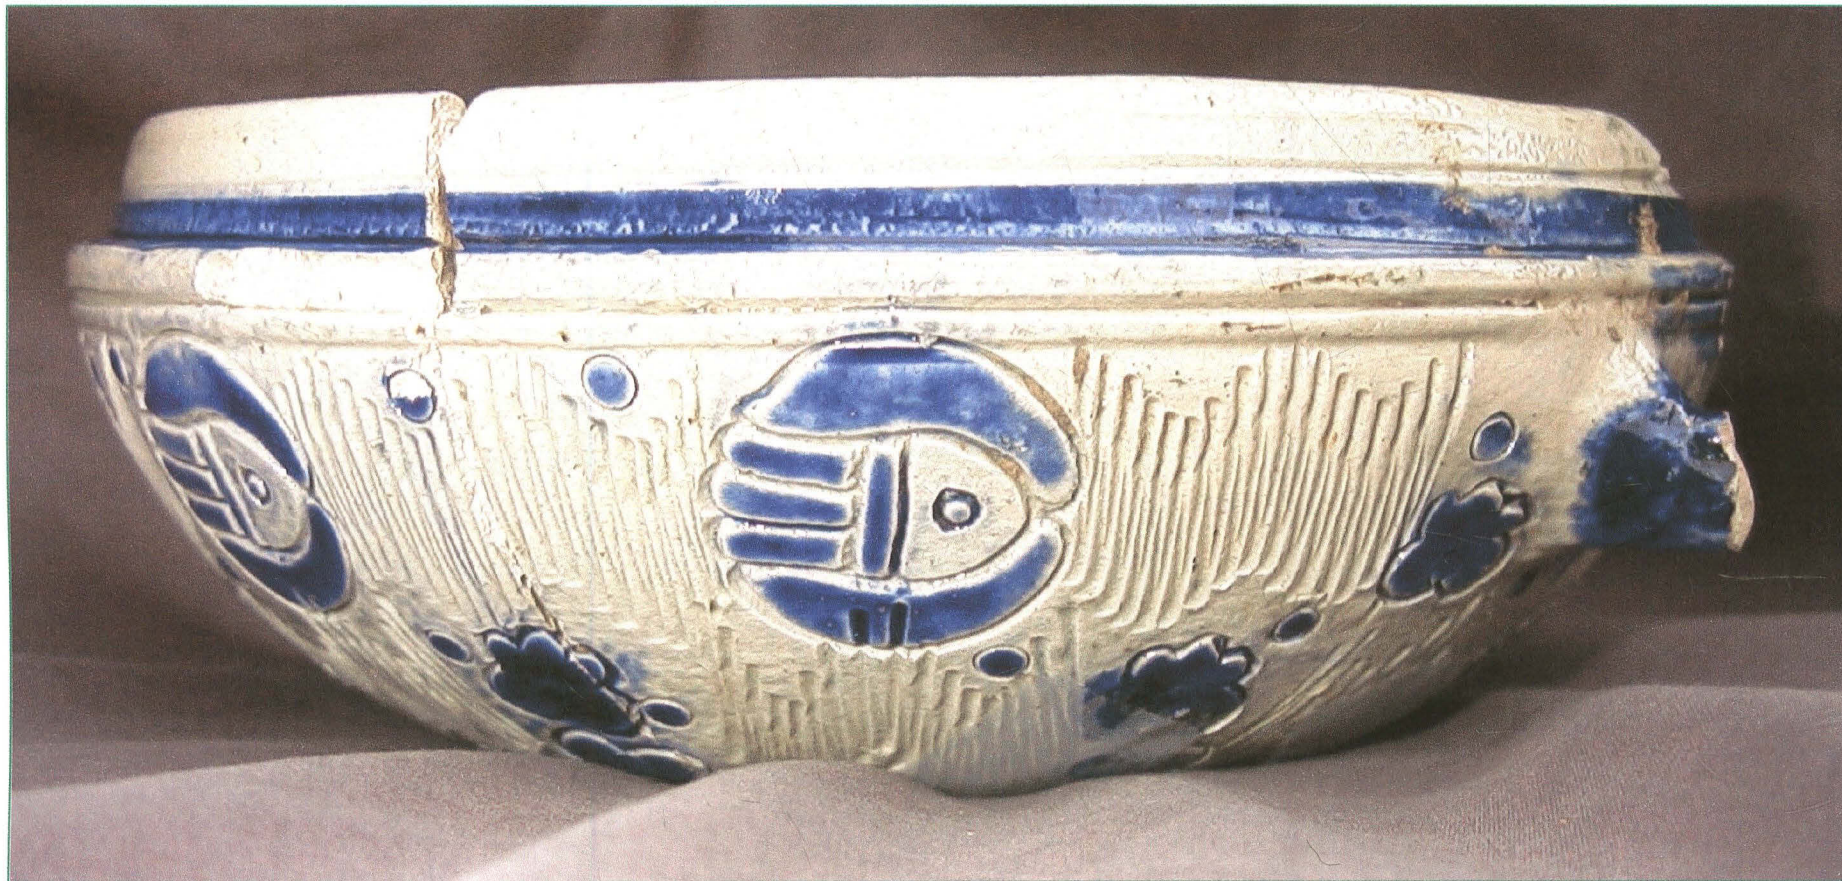
Westerwald stoneware bowl from (2160).
© 2002 AVAC. Photographer: Kate Steane

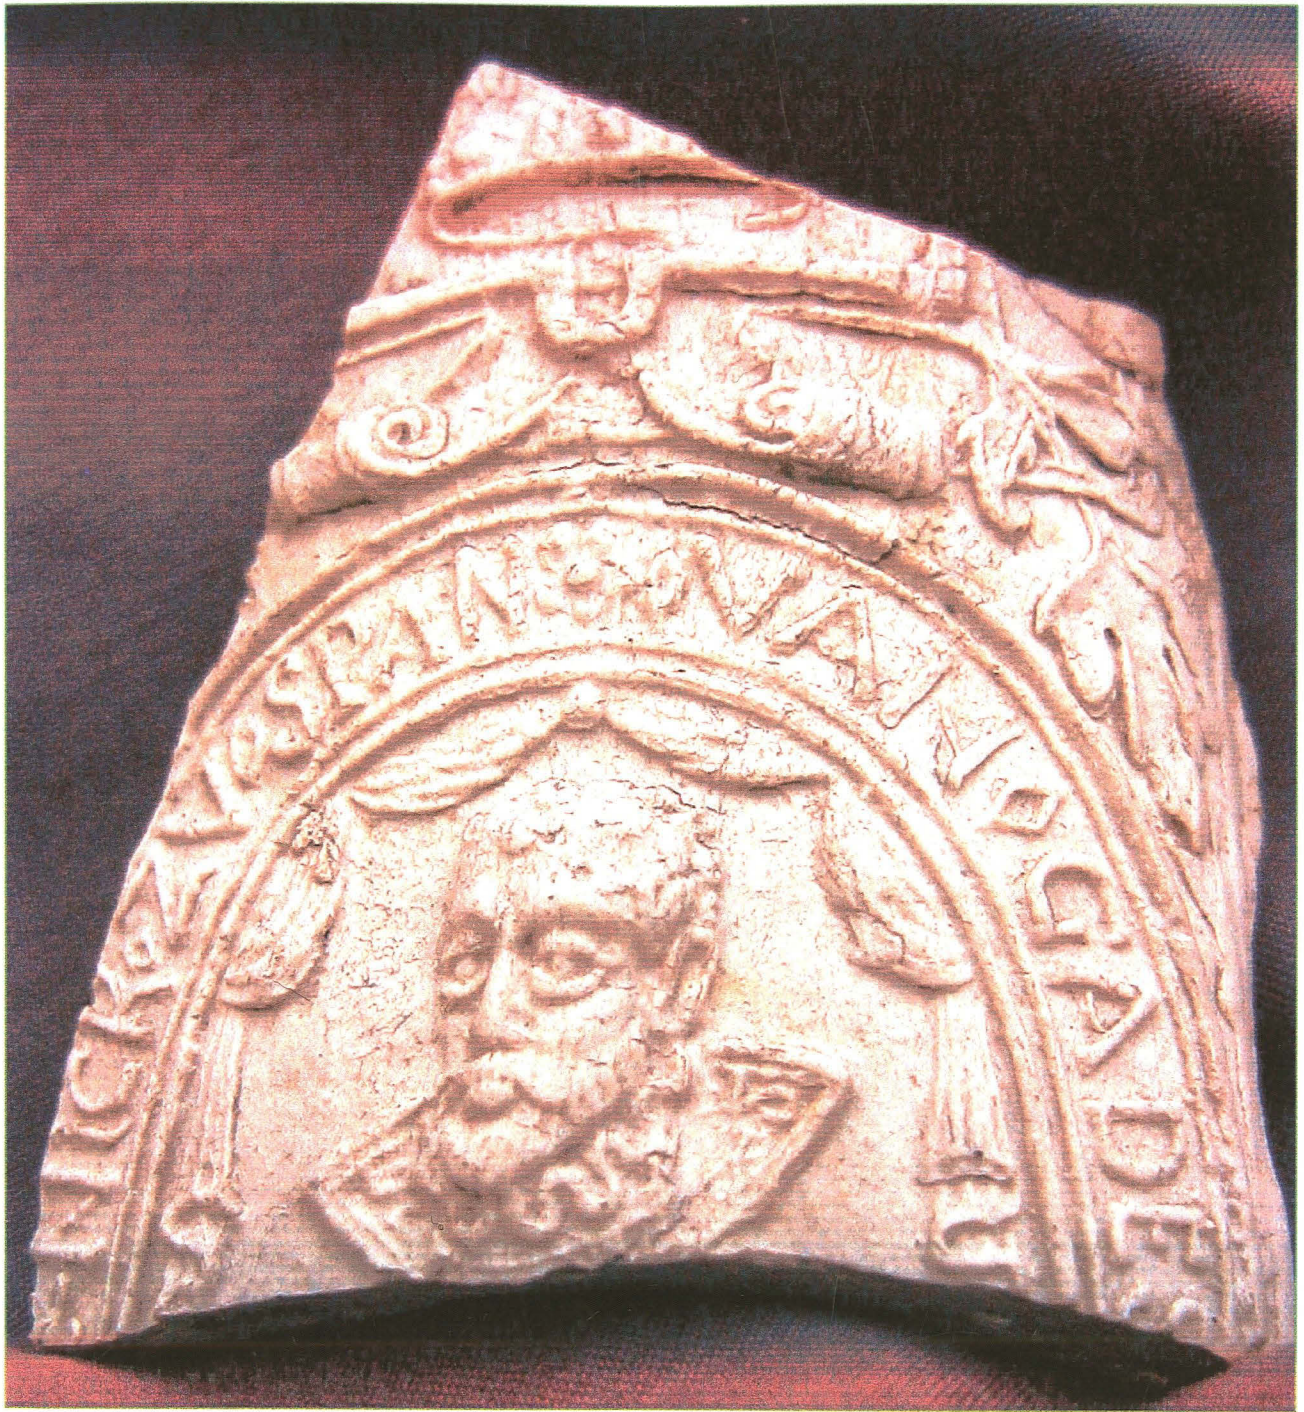
Decorated panel from a Siegburg stoneware *schnelle*,
from (2162).
