LINDSEY ARCHAEOLOGICAL SERVICES

**Market House, 11-13 Market Street,
Long Sutton Lincs.
Archaeological Evaluation
Planning Application No.: H11/0044/02
NGR: TF 431022310 04 4312 2304
LCNCC Accn No.: 2002.472
Site Code: LSMS 02**

**Report for
Purcell Miller Tritton
on behalf of
Longhurst Housing Association**

**LAS Report No. 633
December 2002**

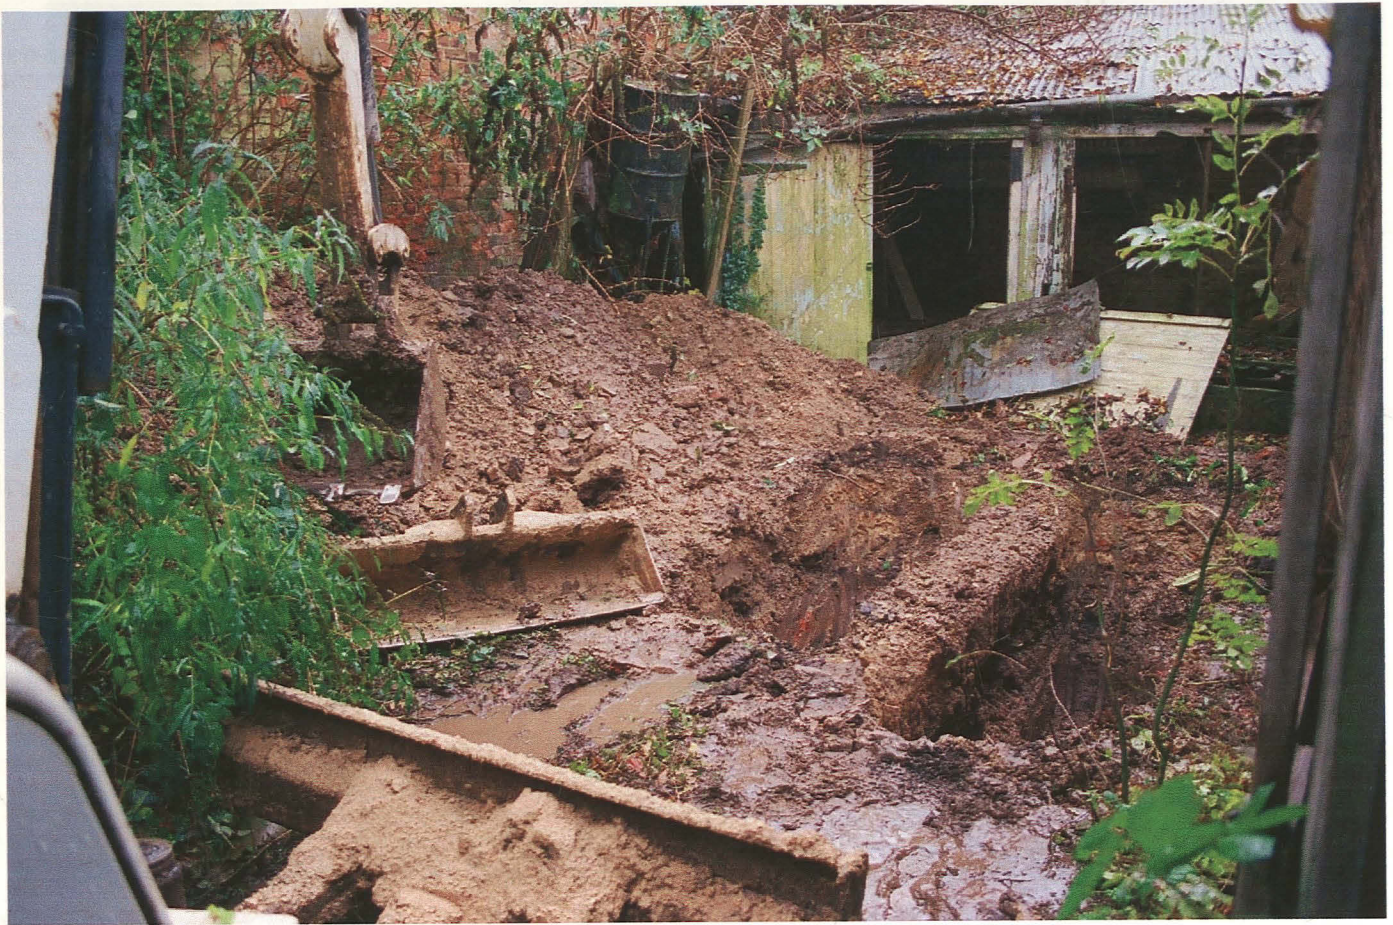
Pl. 4 General view of trench with sewer pipe running through centre, looking southeast.

A north-south trench measuring 3.5m x 2.50m wide was excavated 1m from the west and southern boundaries (Fig. 2, Pl. 4). The trench was positioned just south of a borehole excavated in 2001 as part of the geotechnical investigation of the site (Pl. 5). The trench was excavated to a depth of 1.50m to establish date, character and survival condition of the deposits. Archaeological recording was carried out by a team of 2 experienced archaeologists. The trench was machine excavated using a toothless ditching bucket, after breaking out of the concrete and hardcore surface. A full photographic record was made during the progress of the excavation.

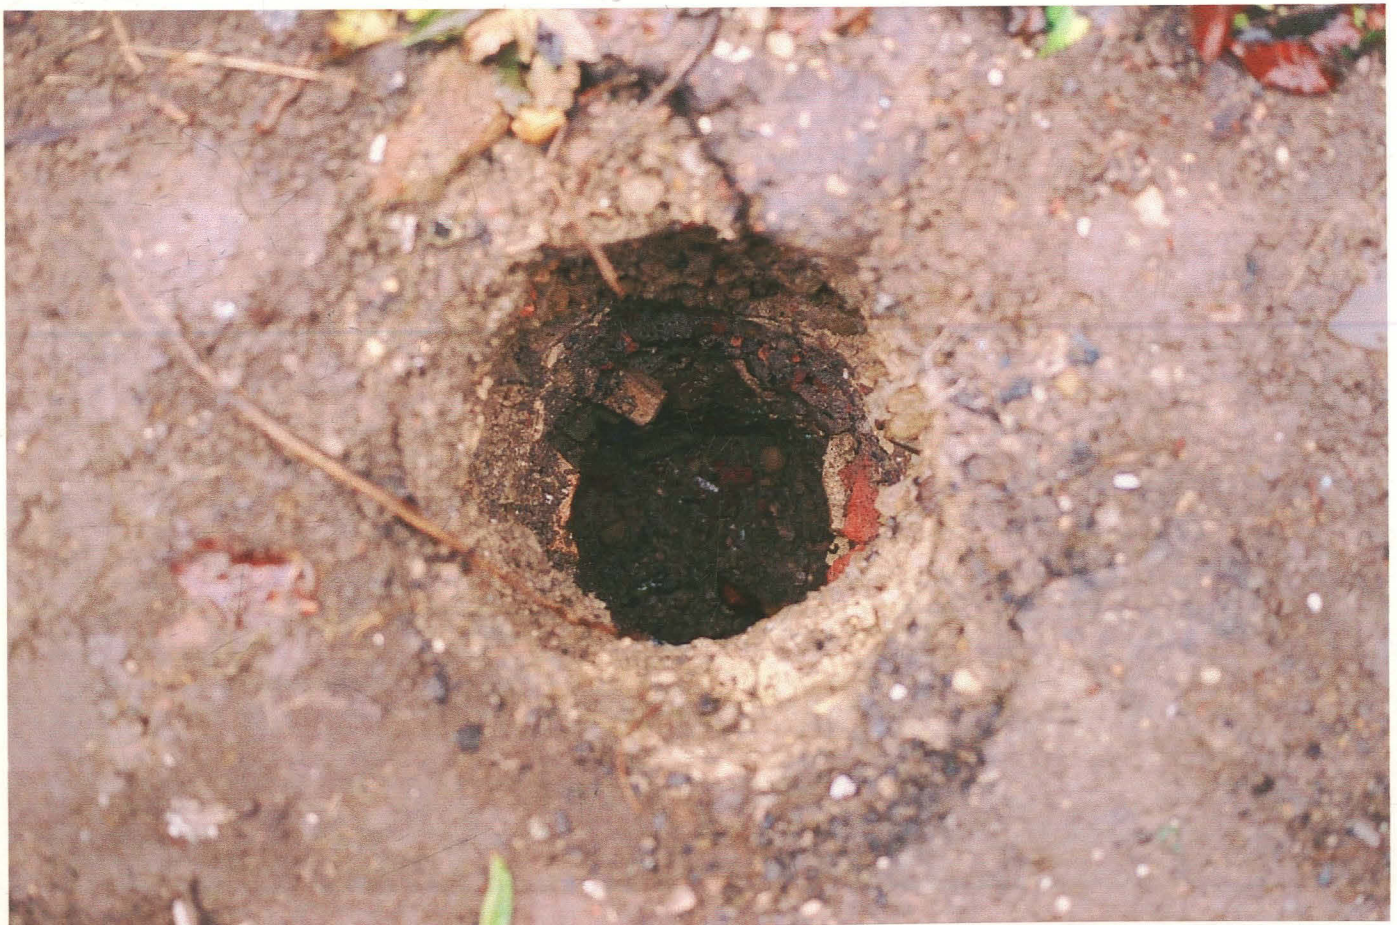
Pl. 5 Borehole adjacent to trench showing brick rubble in sides.

The borehole survey indicated the presence of brick rubble to a depth of 1.70m, and the excavations revealed rubble to a depth of 1.20m. The brown silt in the base of the trench contained brick flecks but unsafe ground conditions precluded further investigations. At first it was thought that this might represent the fill of a soakaway but the excavations showed that the deposit was more extensive than would be expected for a soakaway, with all sides of the trench showing the same sequence of layers, perhaps associated with the construction of the Market House or other 19th century buildings. The area opened up was too small to be certain as to how the material came to be deposited but the ground levels on Market Street and Bull Lane are roughly the same so it is unlikely to have been part of a general site levelling operation.

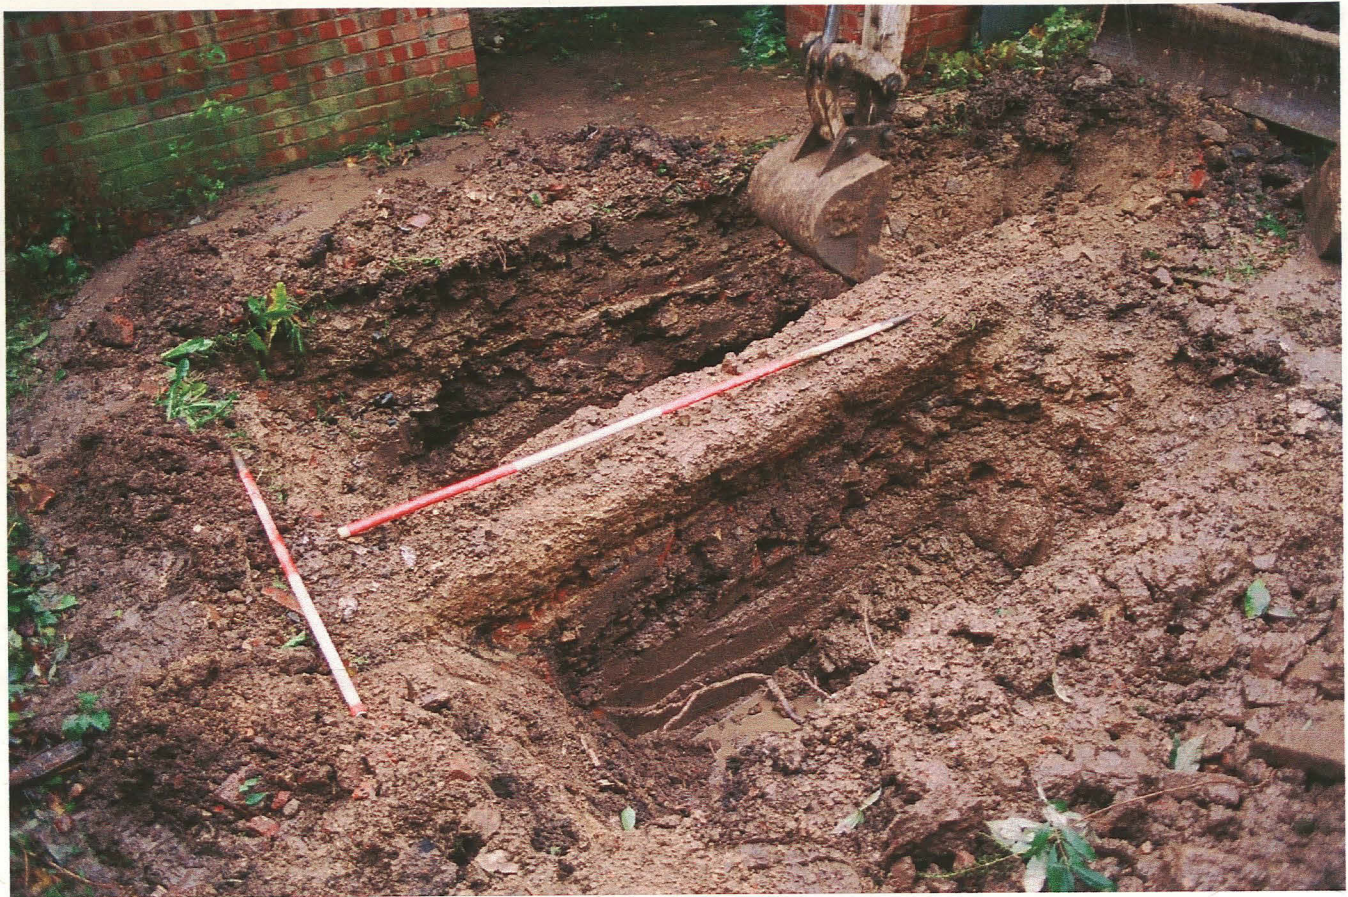
Pl. 6 General view of trench with sewer pipe running through centre, looking southeast.

brick rubble (Pls 6-8). Beneath the layers containing brick rubble was a deposit of mid-brown silt containing a few flecks of brick. The base of this layer was not reached as it was unsafe to excavate any deeper. The small size of the trench, coupled with the depth (1.50m) and the wet conditions made it unsafe to enter the trench so detailed recording was not possible. No cut features were observed.

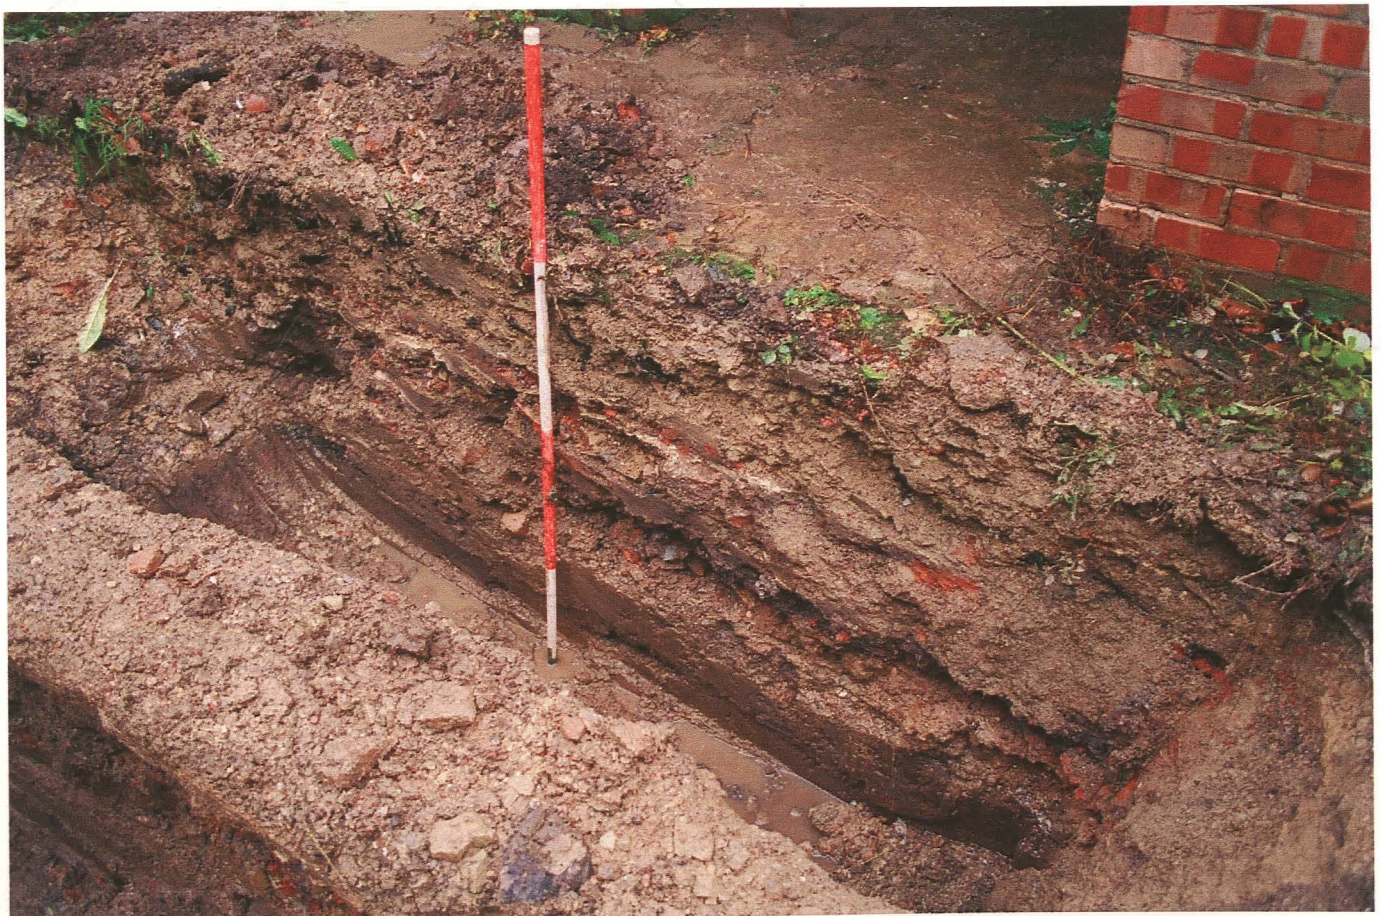
Pl. 7 View of west side of trench showing sequence of deposits, brick rubble fill over mid brown silt. Scales 2m.

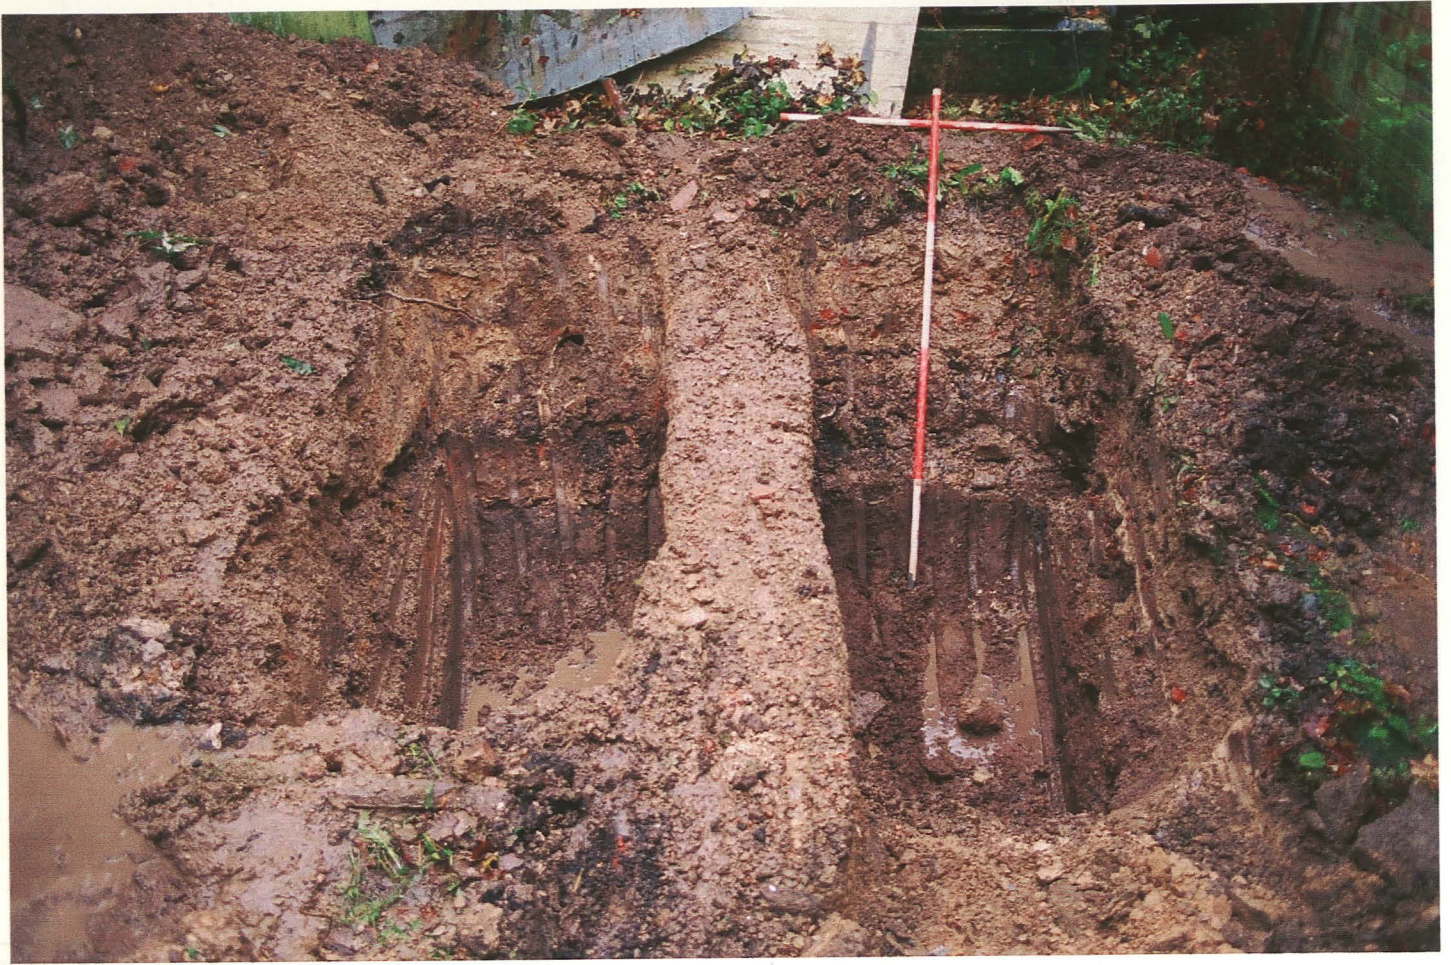
Pl. 8 View of south side of trench showing sequence of deposits, brick rubble fill over mid brown silt. Scales 2m.
