## Linwood, River Rase Improvement Scheme

*South Branch Site TF 1265 8825  
Site Code: LRRS 02  
LCNCC Museum Accn No.: 2002.200*

### Archaeological Watching Brief

**LAS Report No. 587**

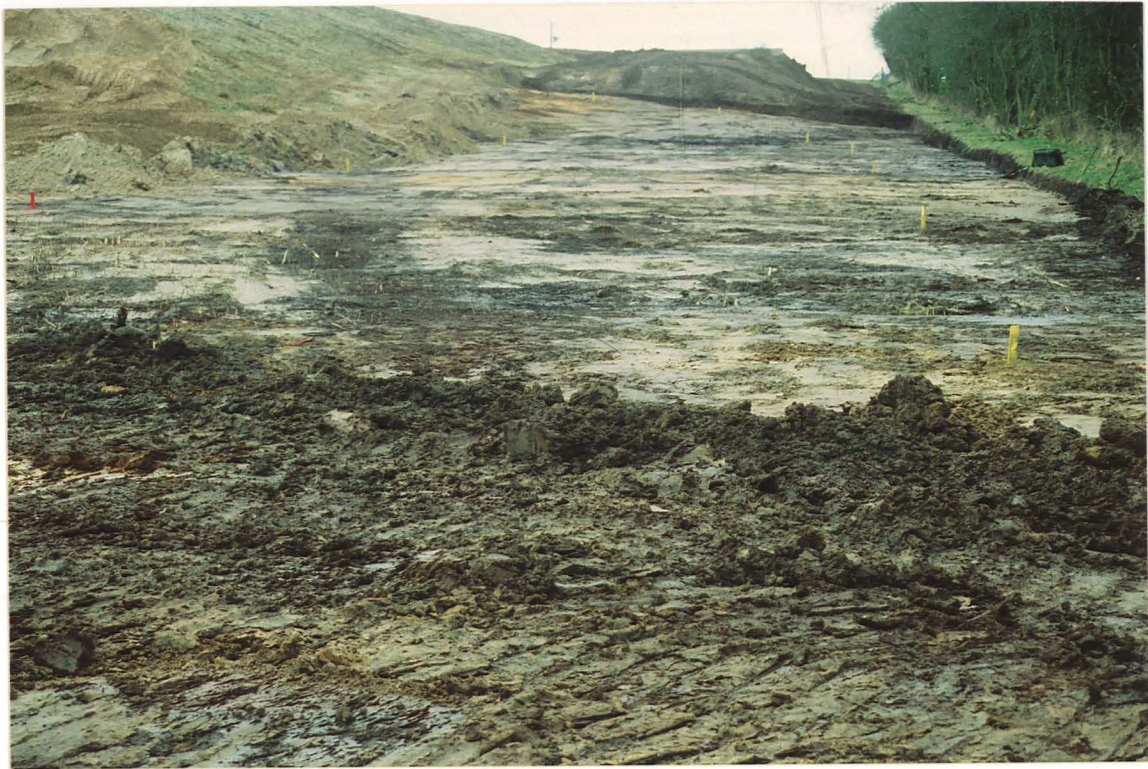
PI. 1 The monitored area, after topsoil stripping (looking south, with the western site boundary hedge to the right).

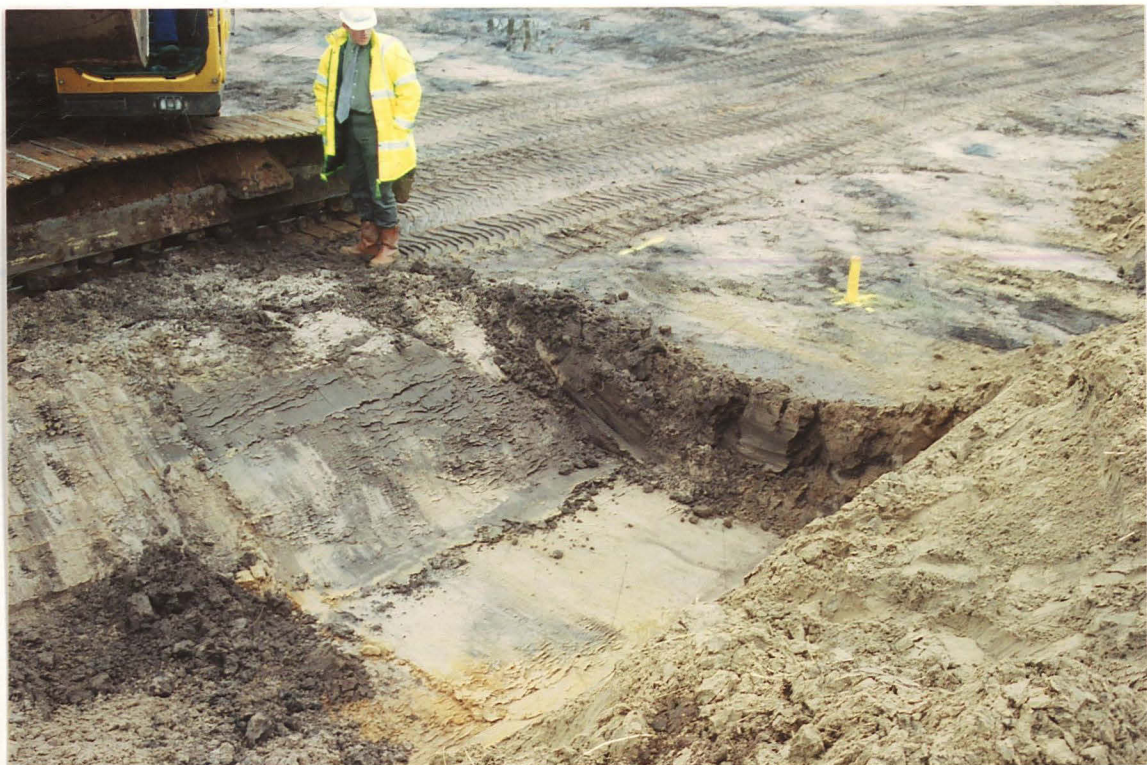
PI. 2 A deeper trench was excavated along the eastern edge of the stripped area (looking NW, with the grey fill of 836 visible in the trench sides).

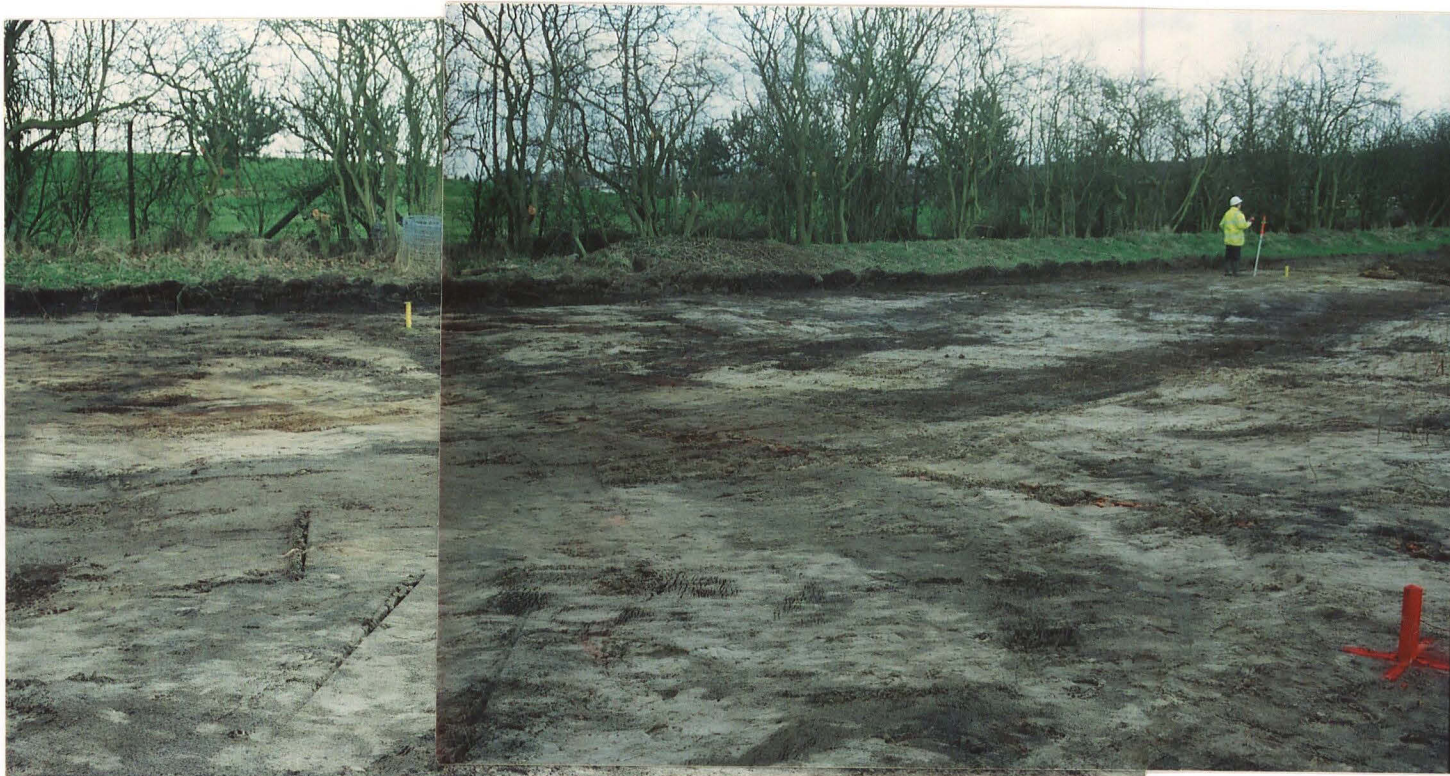
**Pl. 3** Dark fills of the backfilled ditches contrasted with the sand. Ditch 800 crosses the photograph from left to right; ditch 809 runs between the red peg and the hedge, and part of ditch 811 is visible behind 800. Looking NW.

The most extensive feature recorded was a 1.5m wide NW-SE aligned ditch **800**, backfilled with a dark brown/black loamy sand **801** (Pl. 3). A 50m length of this ditch was revealed, cutting the backfill of ditch **812**, but otherwise earlier than the other ditches and land drains. In the deeper trench, the rounded base of **800** was found to be 0.5m below the stripped surface (Pl. 4). This feature may have been a precursor of the existing western site boundary, on a different alignment.

To the north of ditch **809**, an 8m length of a NW-SE aligned 0.6m wide ditch **811** was visible (Pl. 3). Its alignment was roughly similar to parts of ditch **800**, but no association was suspected. At its southern end, it was overlain by a 0.05m thick spread of heat-affected red/orange sand **807** (Pls. 9 and 10). The spread extended over an area about 8m x 6m, but it had been disturbed by ditch **809** and several land drains; some material may have been redeposited. A single small piece of ironpan concretion was found with the discoloured sand, but there were no indications as to the cause of the feature. It may represent a post-medieval bonfire during routine hedge maintenance, perhaps for a boundary alongside ditch **800**.

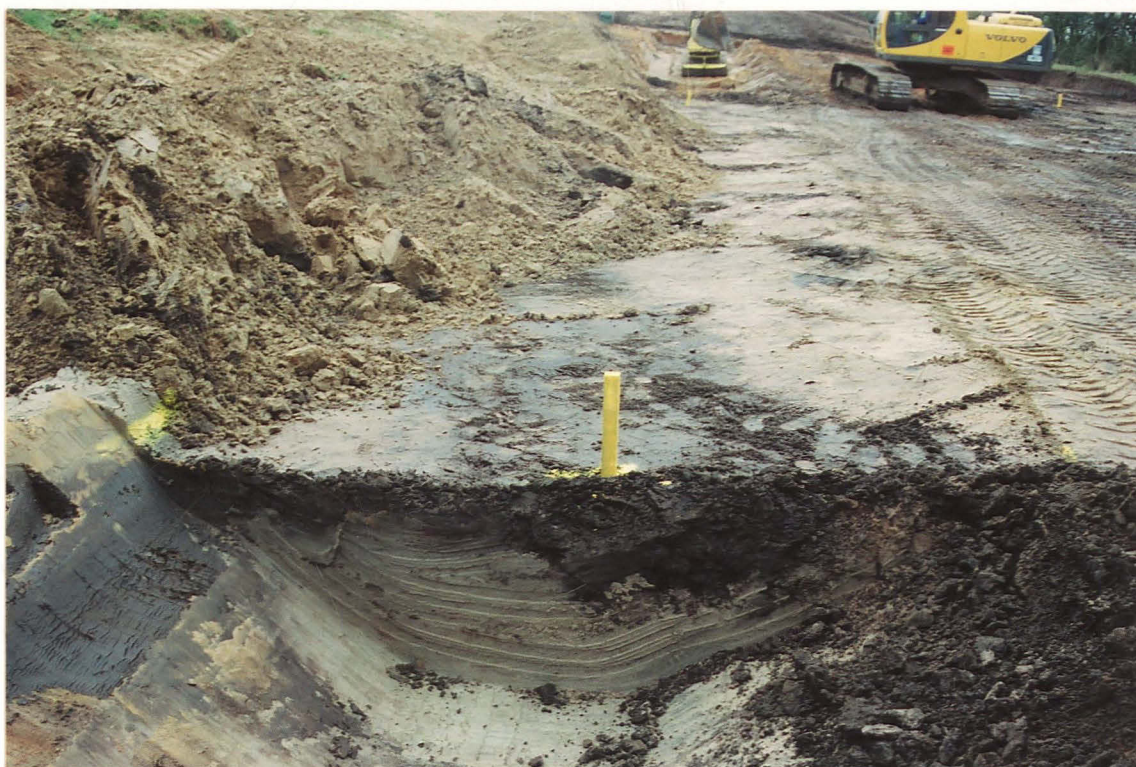
**PI. 4** Dark fill at the broad, rounded base of ditch 800 showing in the deeper trench (below the peg), with the pointed base of 840 in the trench side (left). Looking south.

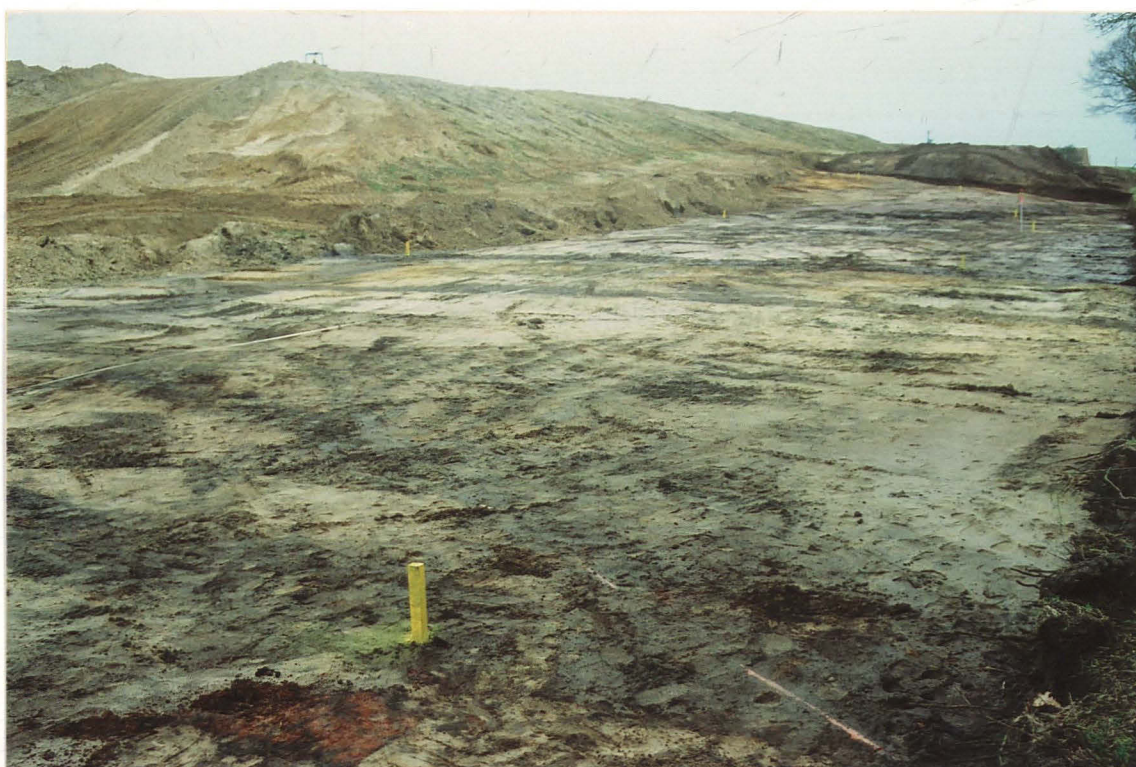
**PI. 5** Ditch 809 crosses the immediate foreground, beside burnt sand 807. The two ditches parallel to 809 (814, 840) cross the centre of the stripped area, and may mark the line of a track. Ditch 812 runs at an angle from the bottom right. (Looking SE).

- Pl. 5** Ditch 809 crosses the immediate foreground, beside burnt sand 807. The two ditches parallel to 809 (814, 840) cross the centre of the stripped area, and may mark the line of a track. Ditch 812 runs at an angle from the bottom right. (Looking SE).

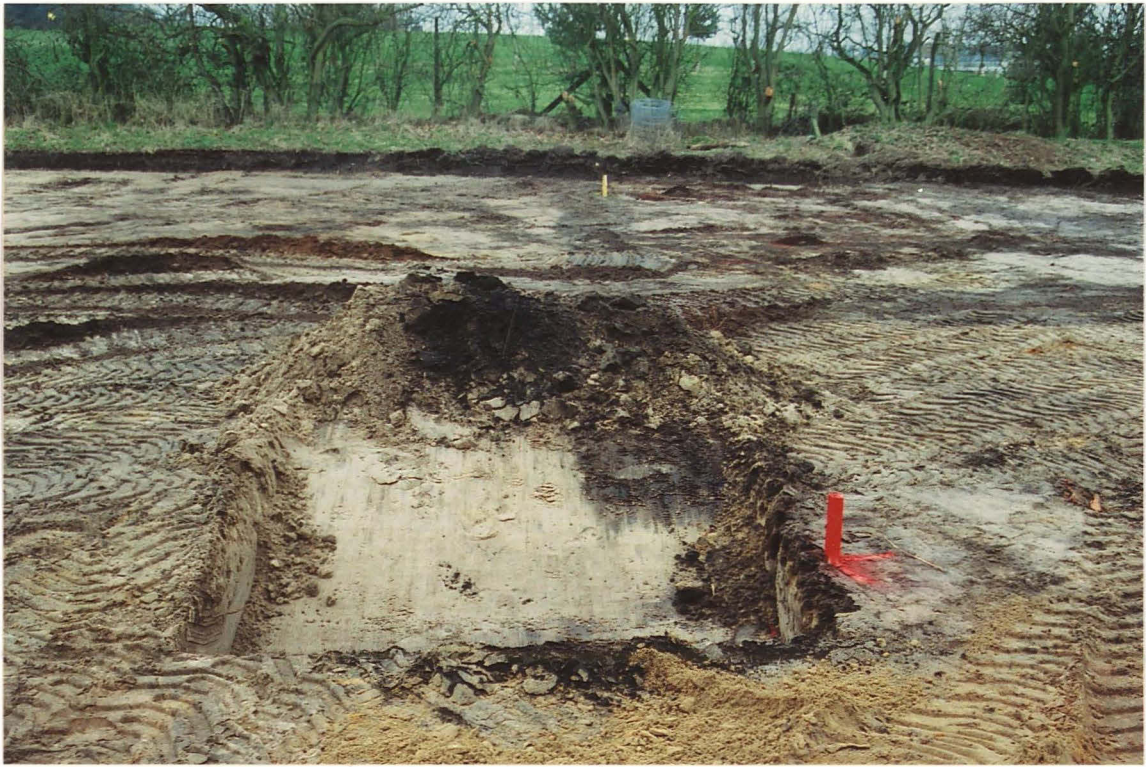
Pl. 6 Dark fill of ditch 809 showing in the side of the deeper trench (looking west; the concrete fence post right of the rolled fence marks a recent field subdivision).

they did not form part of an extensive series. Ditch **809** was 0.8m wide, with a pointed base 0.35m below the stripped surface (Pl. 6). Its fill **810** was a black sandy loam with infrequent burnt flint fragments. **814** was 1m wide, but was not seen in the deeper trench. **840** was 1.5m wide, 0.6m deep, with a pointed base; its fill contained root and twig remains (Pl. 7). The parallel but very different feature **830** was 2m wide, but was not seen in the deeper trench.

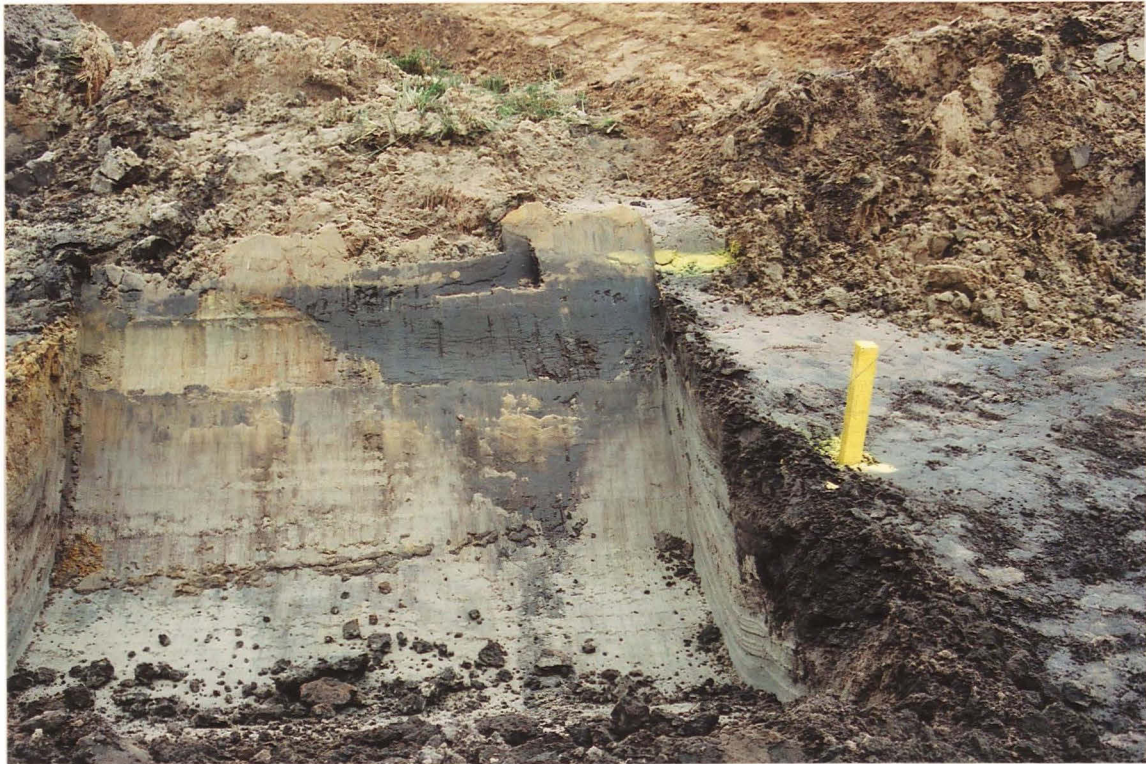
Pl. 7 Dark sandy silt, filling ditch 840 (looking east).

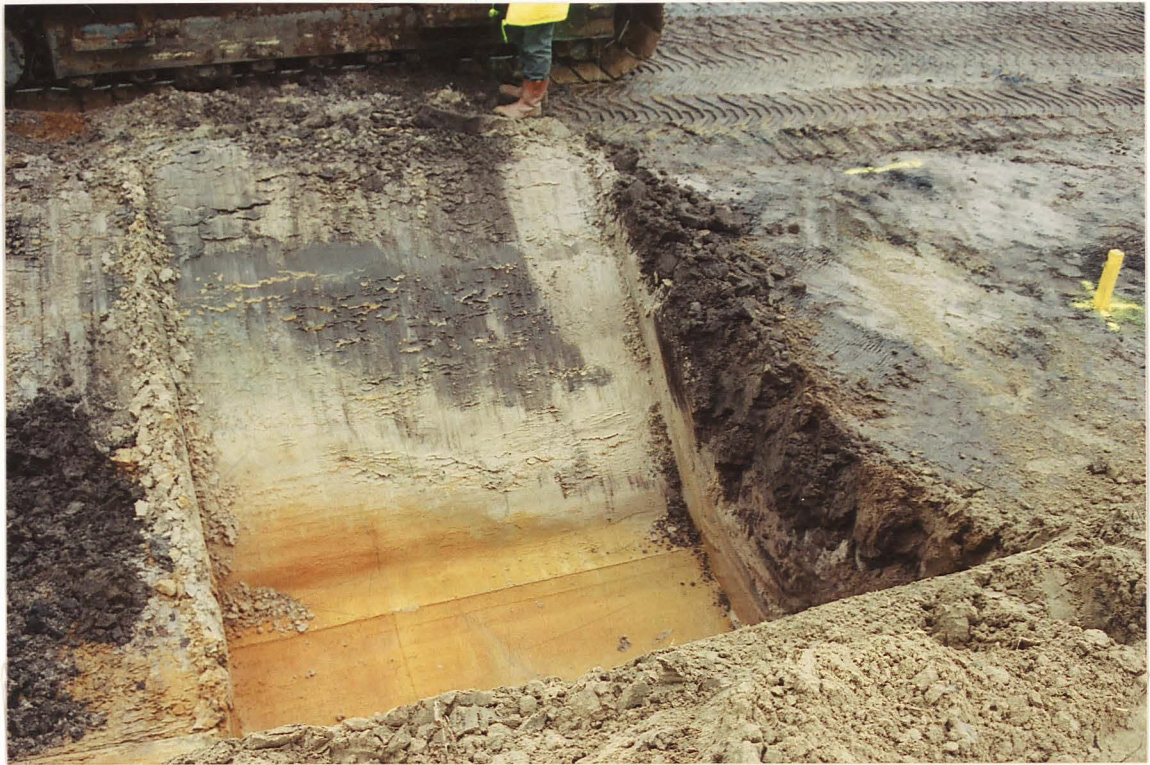
Pl. 8 Ditch 836 at the change of slope, visible in the side of the deeper trench (looking west).

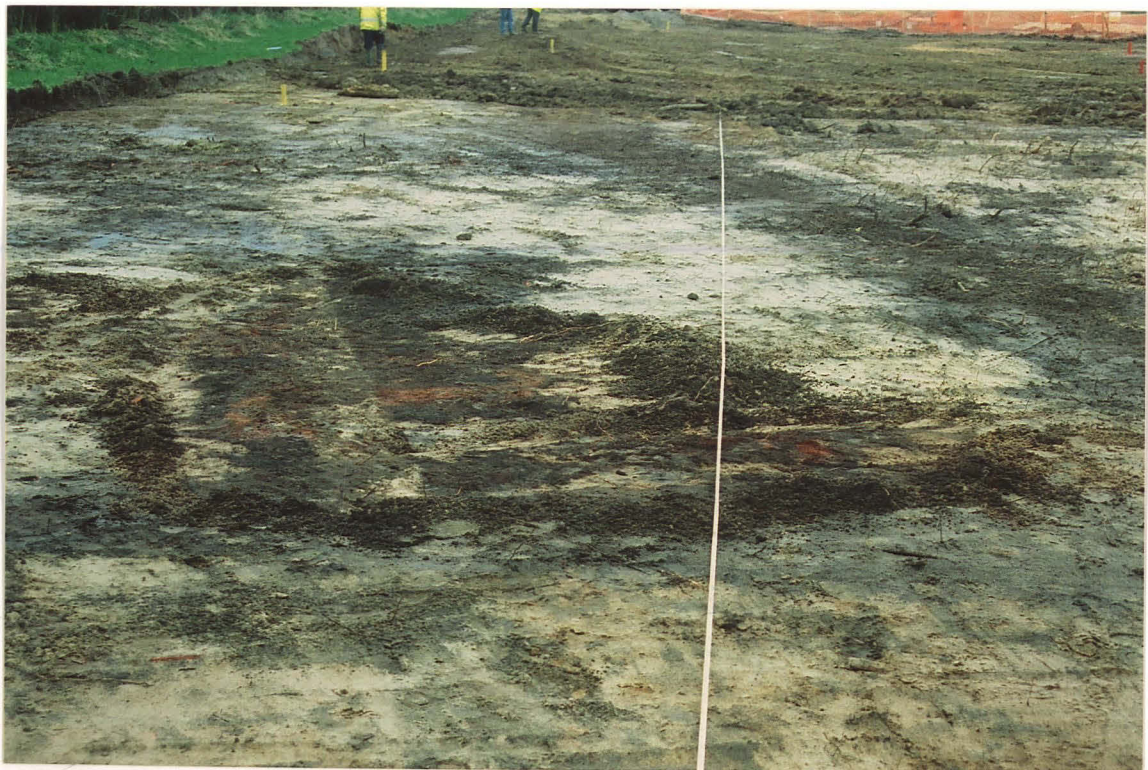
Pl. 9 Area of red burnt sand 807, removed by ditches and land drains (looking north across ditch 809 in foreground, with ditch 800 to right).

- Pl. 9** Area of red burnt sand 807, removed by ditches and land drains (looking north across ditch 809 in foreground, with ditch 800 to right).
- Pl. 10** Detail of the red burnt sand layer 807, with straight edges cut by later land drain (looking west).

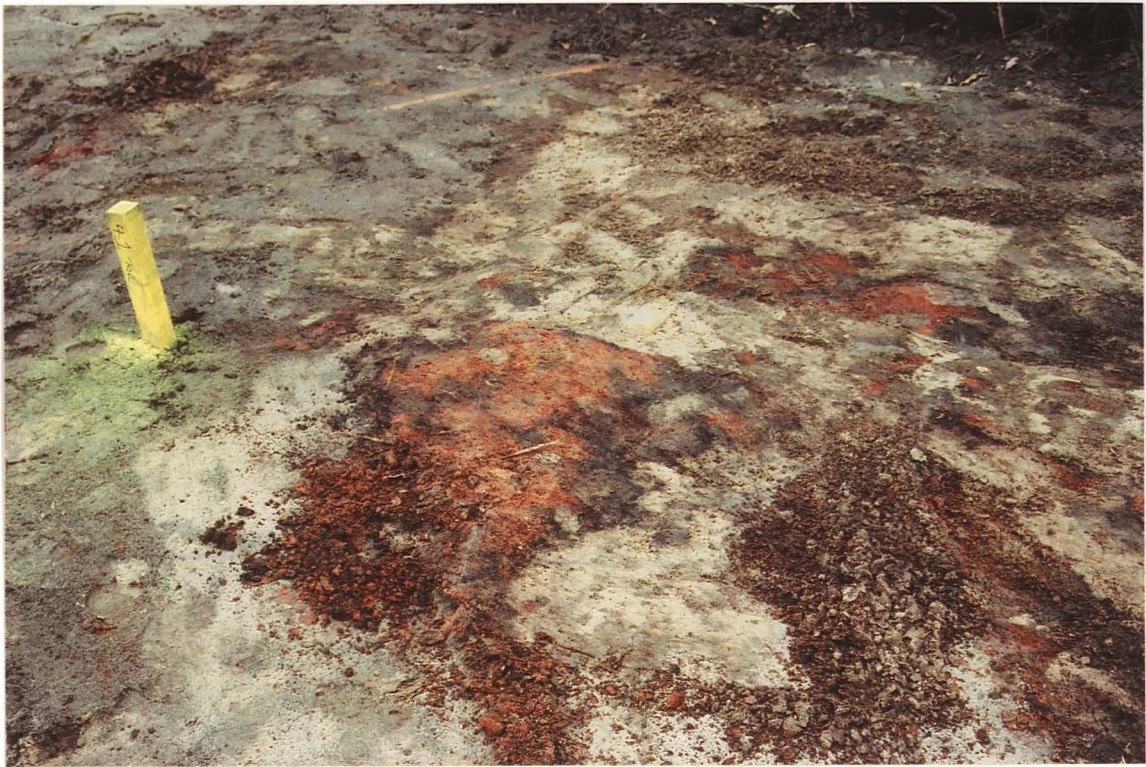
**Pl. 10** Detail of the red burnt sand layer 807, with straight edges cut by later land drain (looking west).

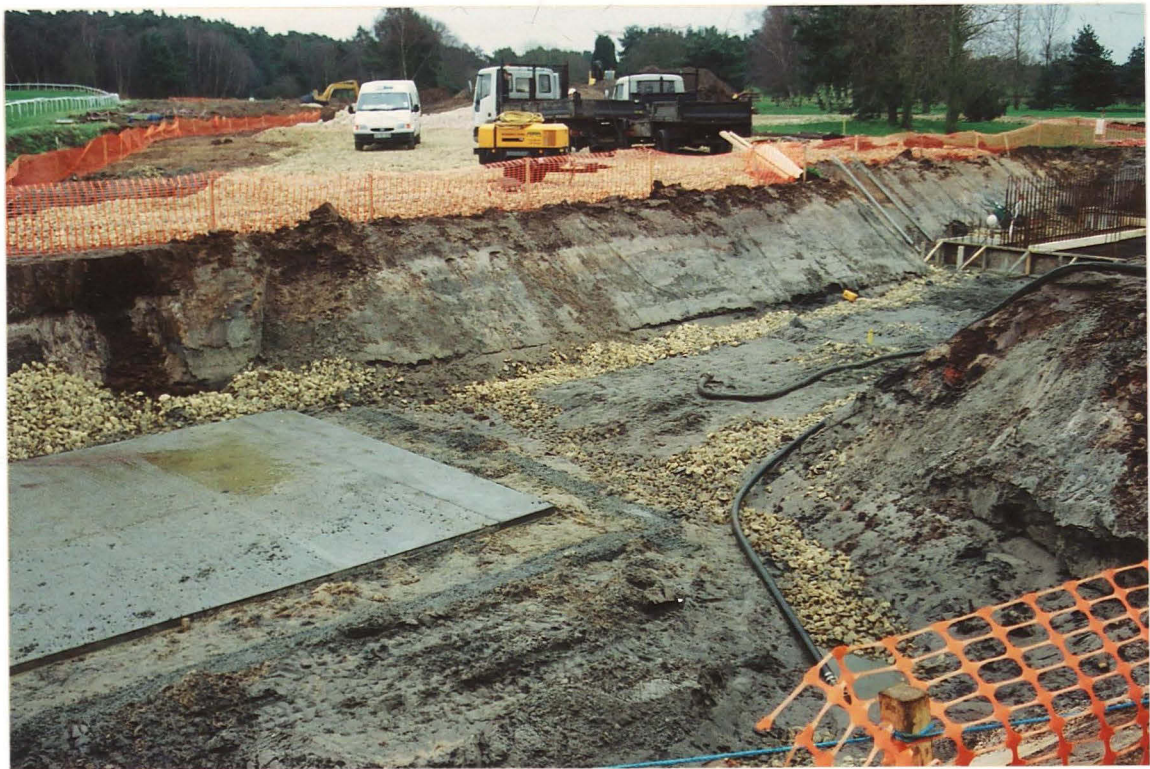
**Pl. 11** Soil profile at the northern side of a trench excavated for new flood defence structures, north of the monitored area (looking NE).
