### Installation of CCTV Cameras, Usher Gallery, Lincoln.

## **Archaeological Watching Brief**

Report prepared for Hyder Business Services

LAS Report No. 715
December 2003

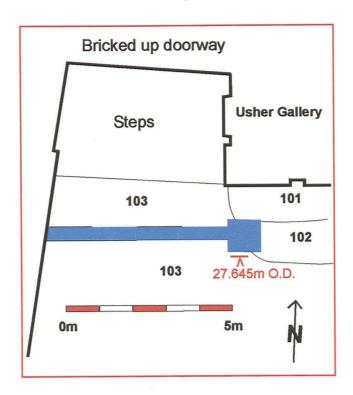
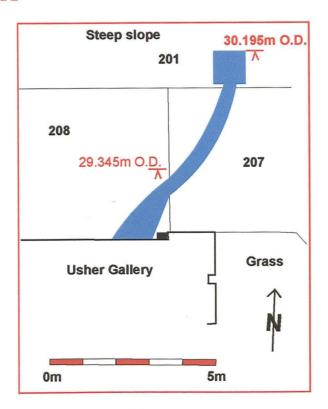
Fig. 2 Detailed location of camera positions A and B. Sky blue shows area excavated. (after plan provided by client)

#### The Watching Brief (Fig. 2)
