LINDSEY ARCHAEOLOGICAL SERVICES

Asgarby Hall Farm

Archaeological Watching Brief during Groundworks for a New Lake

September 1995

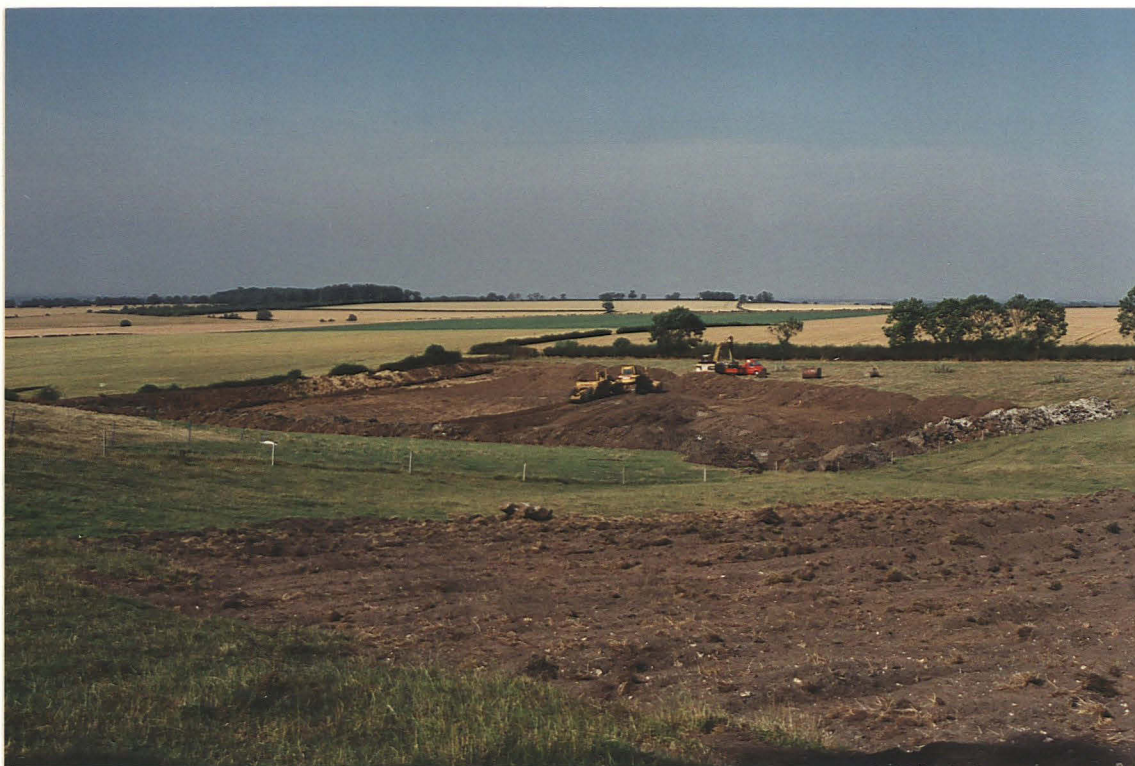
Pl. 1 Groundworks in progress for the new lake at Asgarby Hall; note the water diversion trenches on the north and south sides of the lake area. Looking SW.

Before excavation of the lake took place, trenches were cut around the north, east and south sides of the site to deflect surface water from springs and natural drainage. The faces of these trenches were inspected but the only observed features consisted of a brick structure (described below) and a spread of fragmentary brick rubble with possible burnt daub pieces close to the southern hedge boundary. The rubble spread was also located beyond the trench, in the lake area and below the turf to the east of the new lake. No dateable finds or brick fragments with measureable dimensions were found in the spread, but the rubble was identified as demolition material (perhaps from a post-medieval mud-and-stud type building) imported as hardcore for a field entrance.

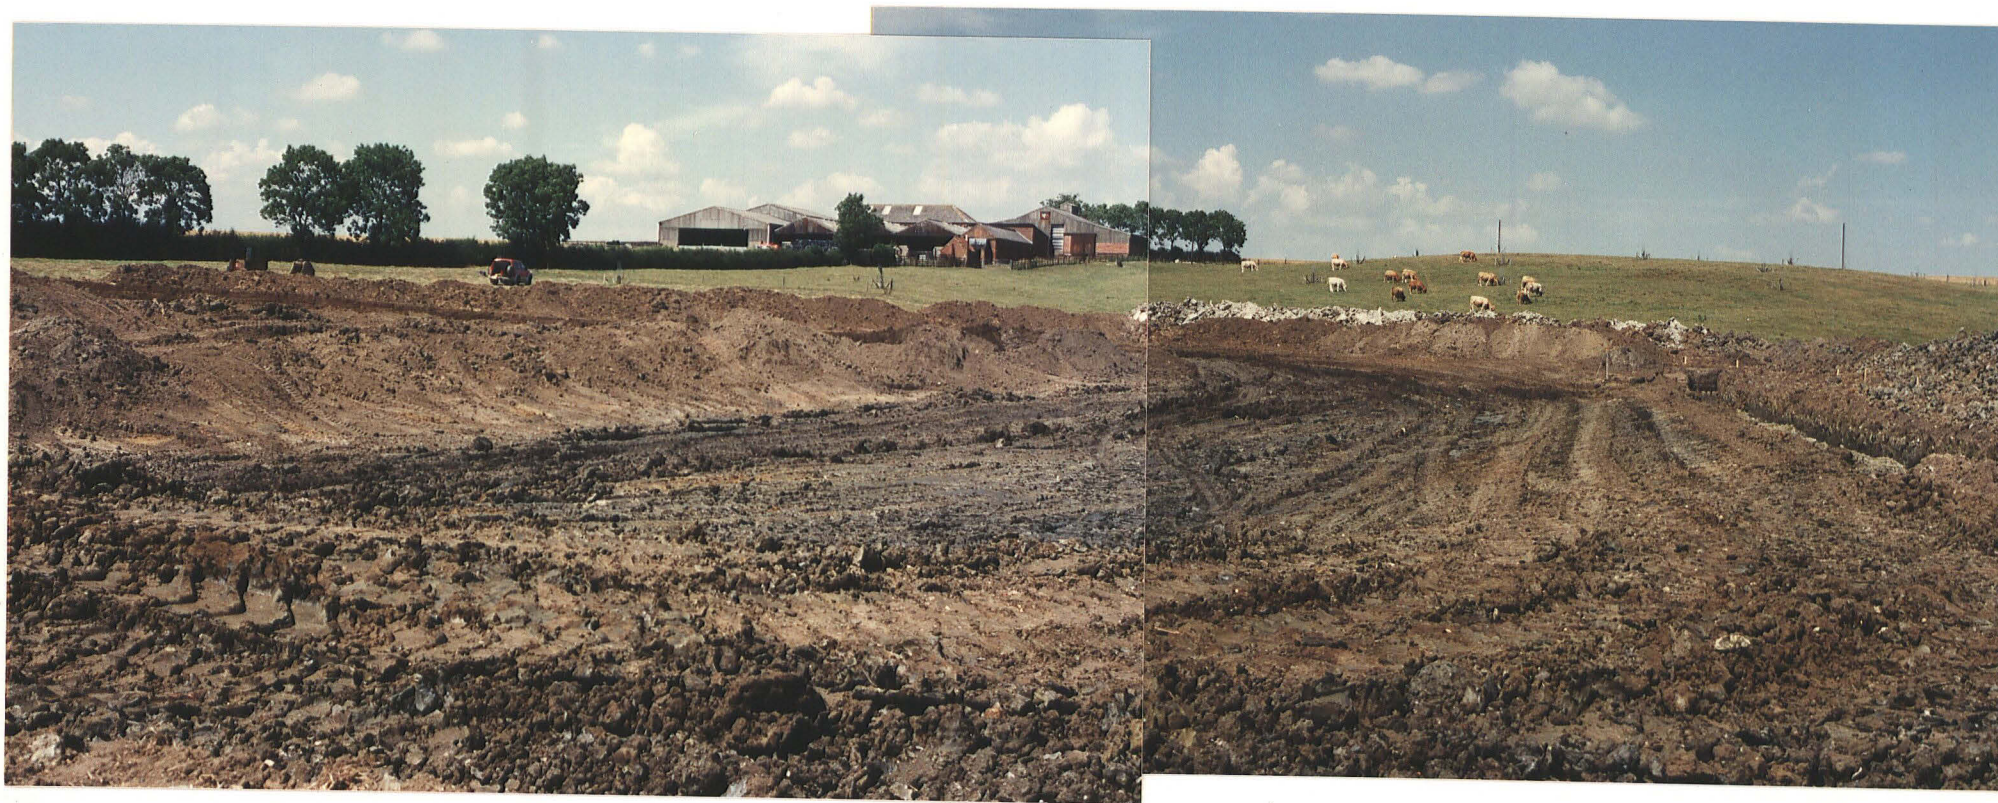
Pl. 5 Grey clay, apparently natural, in the valley bottom. Looking NW towards Hall Farm.

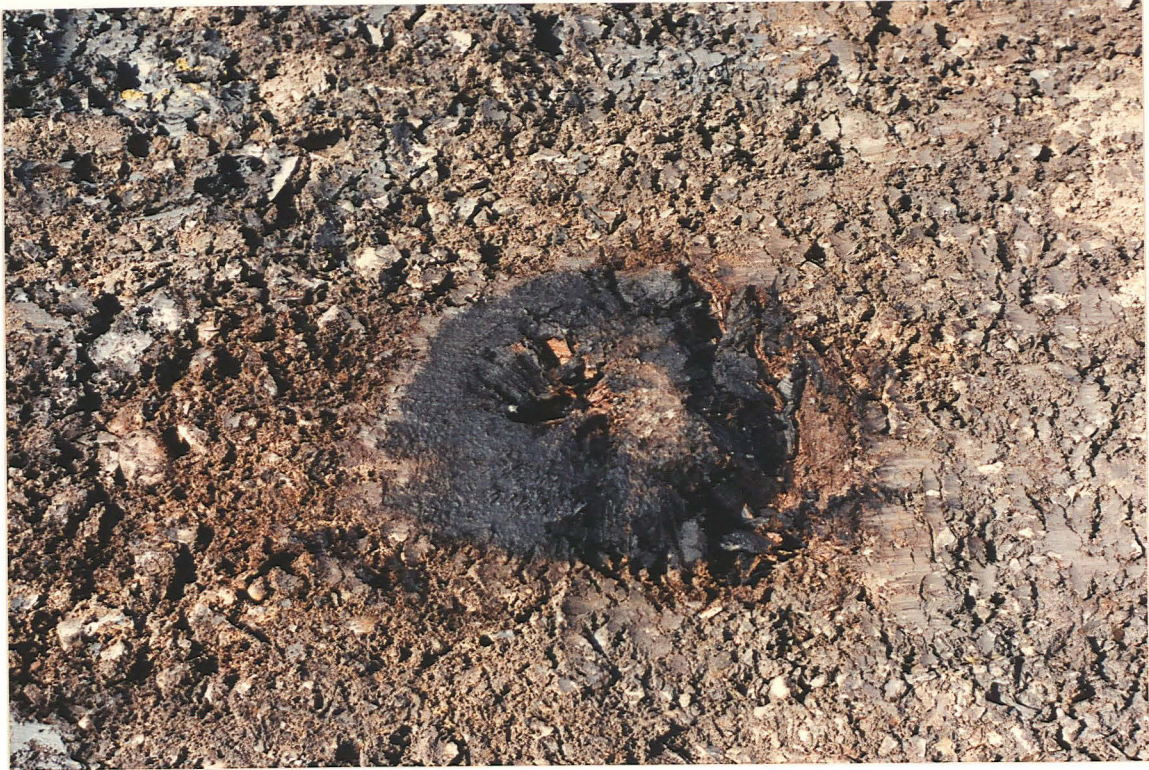
Pl. 6 Truncated timber 3 in the valley bottom.

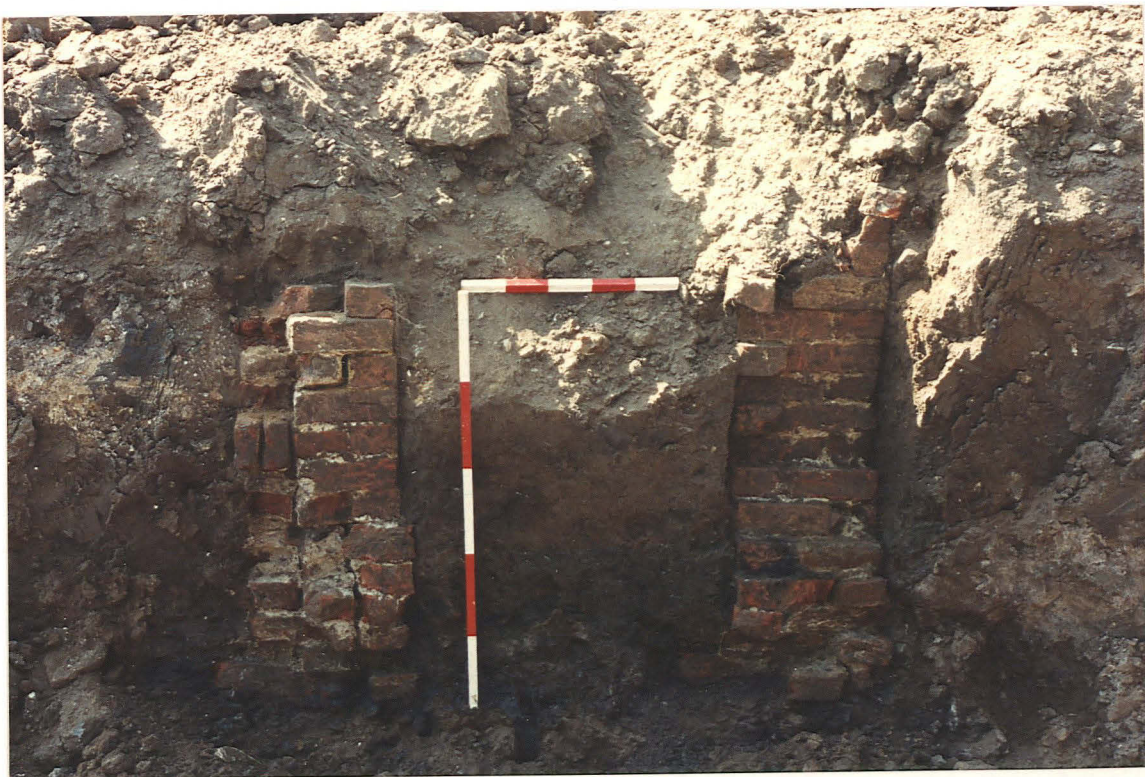
Pl. 7 Brick structure 4, visible in the southern trench (looking south; scale divisions v: 0.2m; h: 0.1m).

Two north-south aligned brick walls were revealed in the south trench face close to the field hedge, approximately at the deepest part of the valley (Pl. 7; Fig. 6). The mortared walls were 0.35m wide and survived to 16 courses; the unfrosted red brick dimensions were 222mm x 110mm x 70mm. Between the walls was a gap 0.75m wide east-west, with a probable base 1.5m below ground level. There was no obviously constructed base for the feature although the base brick course of each wall projected slightly to the east. The west wall was well bonded, but the east may have been extended or one wall butted against another. The structure had been positioned on the gravel horizon seen elsewhere on the site, assumed to be a natural deposit produced by water movement along the valley.

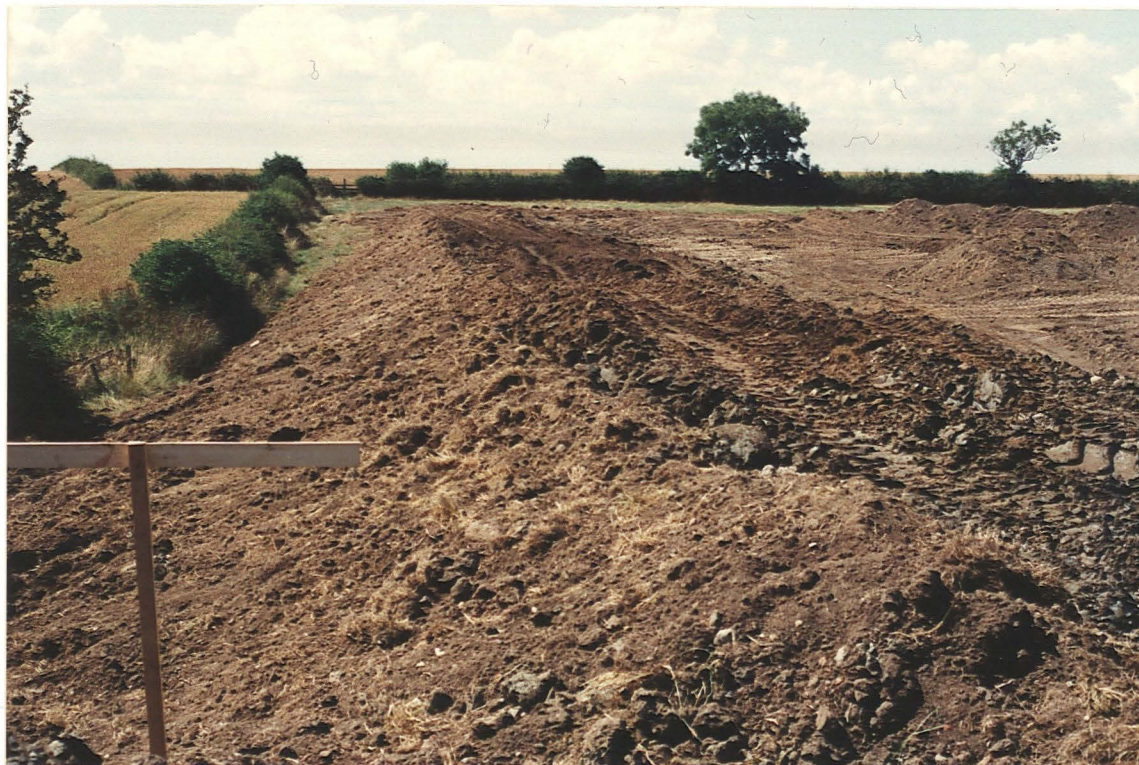
Pl. 9 Upcast embankment on the southern edge of the new lake, covering brick structure 4. Looking west.

The only certain structure found during the groundworks was the brick-sided channel (4) at the southern side of the field. It is not possible to identify the exact use of the structure, although it certainly acted as a narrow outlet to a larger open area - a drain or a sluice seems probable. Assuming that some ponds remained in use when the channel was built, it could have served a post-medieval fishpond, a watermill, tanning ponds or sheep-washing ponds. The extent of the channel is unknown but it may have continued to the present field boundary about 7m to the south. This stretch is now covered by the lake embankment, but the brick structure probably remains, protected by the upcast heap (Pl. 9).
