**37 Bailgate Lincoln  
Conversion of Outbuilding  
Archaeological Watching Brief**

Site Code: LBG 96

**Robin Bradley Building Design  
on behalf of Mrs C. Lloyd**

**December 1996**

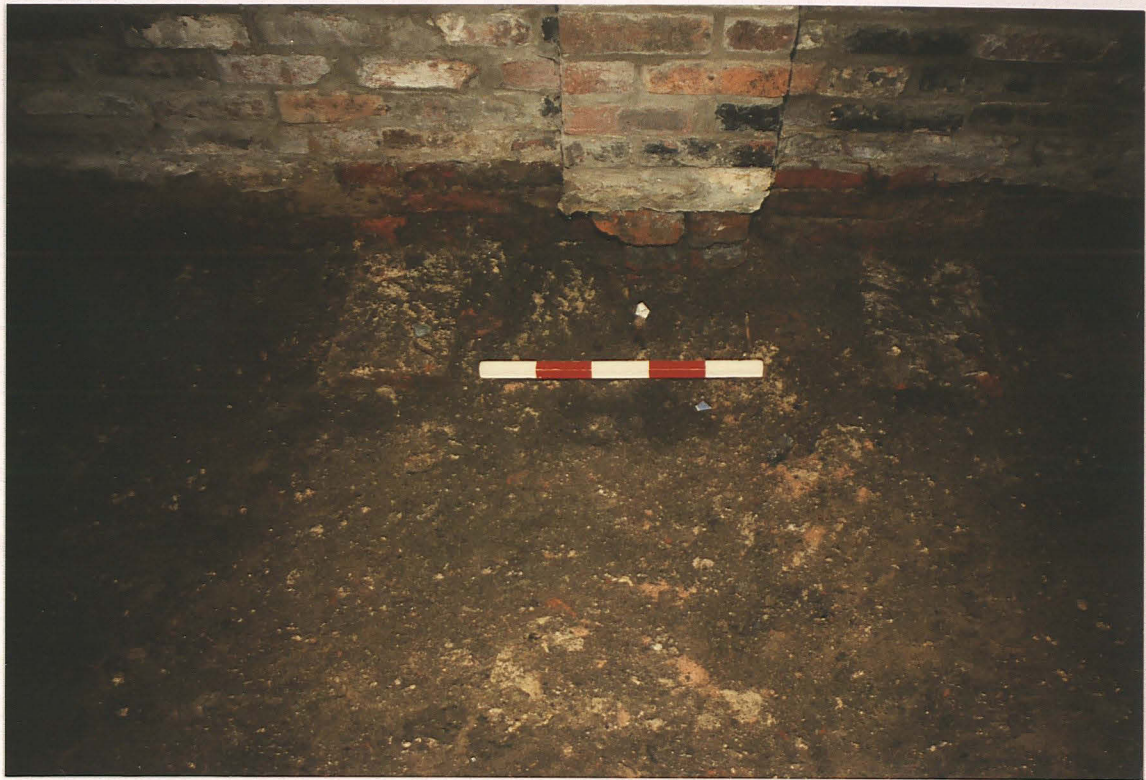
Pl. 10 Post-hole, 23, with post butting north wall of west bay.

A post-hole (23) measuring 330mm east-west x 250mm north-south, and c.250mm deep, cut through surface 21 (Pl. 10). It was not established whether it was sealed by or cut through the brick floor (19), but it respected the lowest visible courses of wall (2), although it is not known if these courses were the originals or part of ?rebuild (2). It contained the rotted stump of a timber of rectangular cross-section, c100 x 50mm; held upright by a few stones and a brick fragment, the latter of dark red with small uneven sunk and lipped margins. The fill was loose dark grey soil with occasional small chalky fragments. A fragment of a porcelain handle was retrieved from the bottom of the fill. Although no other post remains were observed during the removal by the contractors of layer (21) and below, (23) may have been part of a system of temporary supports related to the rebuilt wall (2) and of late 19th century date.

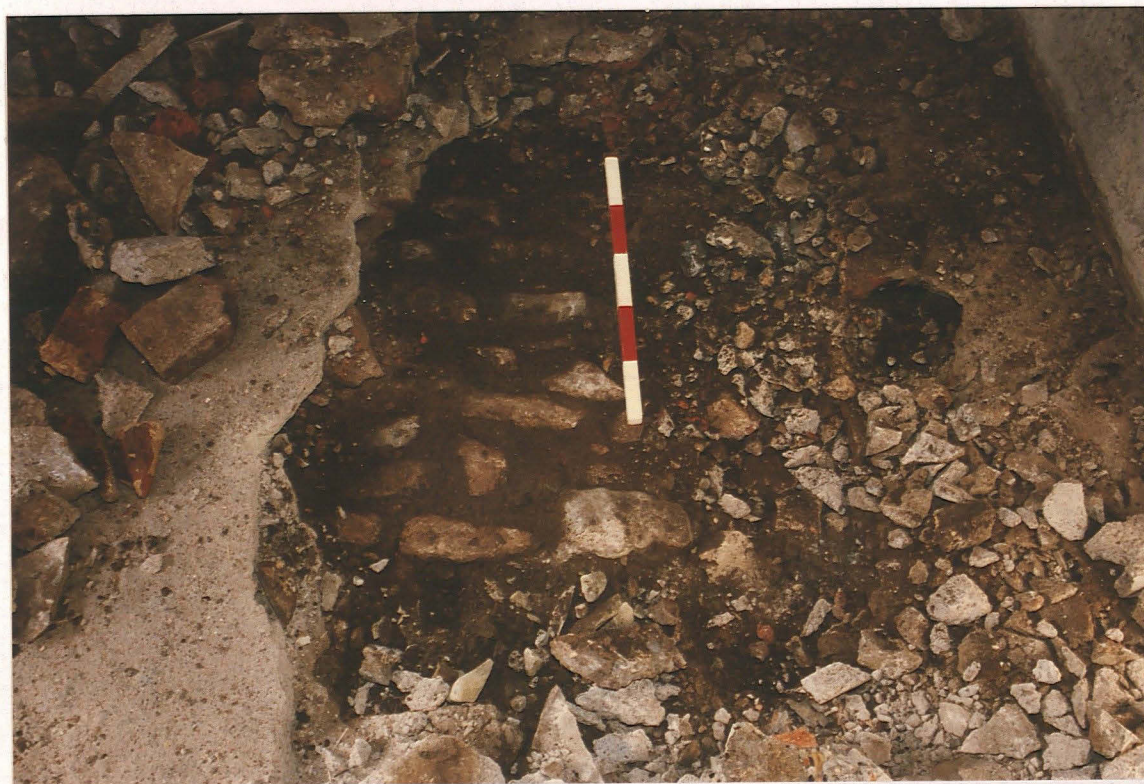
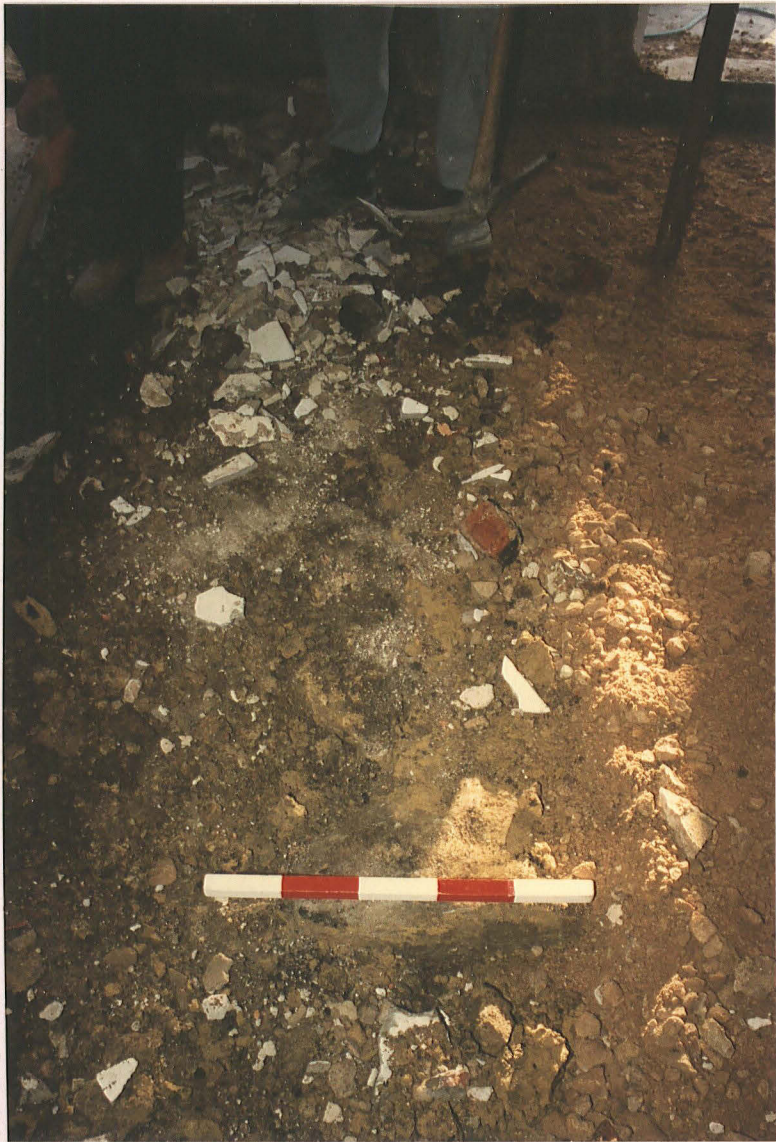
Pl. 13 Stone slab, 10, foundation beneath partition wall.

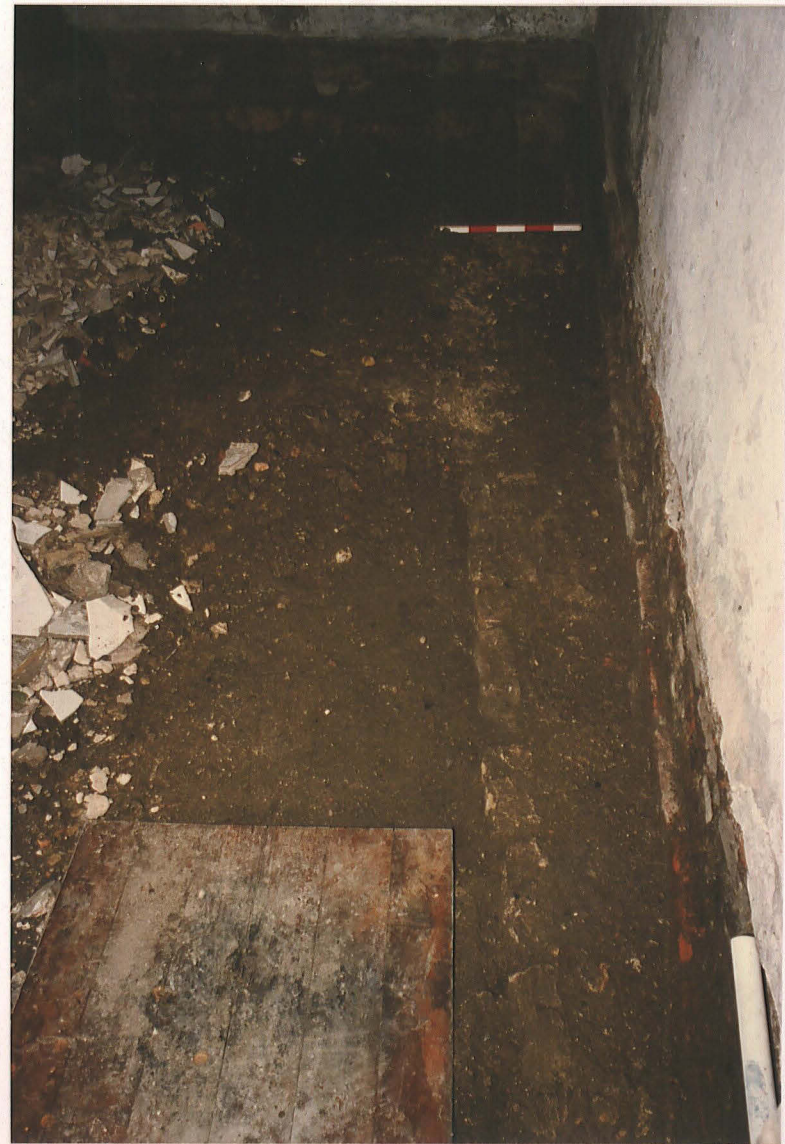
Pl. 14 East bay, stone kerb, 11, along north wall.

Sealed beneath (12) was an alignment of edge-bedded limestone slabs and blocks in the form of a 'kerb' (11). This ran from near the south-east door jamb to the east bay about 300mm west of wall (5); to a point c700mm west of wall (5) at the north end, and ending some 500mm short of wall (2), with no evidence of having extended to it (Pl. 14). North of this end the layer or lens was dark and similar to layer (21) in the west bay. The layer to the east of the 'kerb' was probed, but no evidence of any solid bed (eg for a gutter) was found. The underlying layer to each side of the 'kerb' appeared to be (24). It is possible that the 'kerb' was only to a pre-outbuilding garden area. The requisite depth for the new floor base had already been reached, precluding further investigation.
