LINDSEY ARCHAEOLOGICAL SERVICES

Hemingby, Lincs.
S98 Resewerage Scheme:

Archaeological Monitoring

March 1997

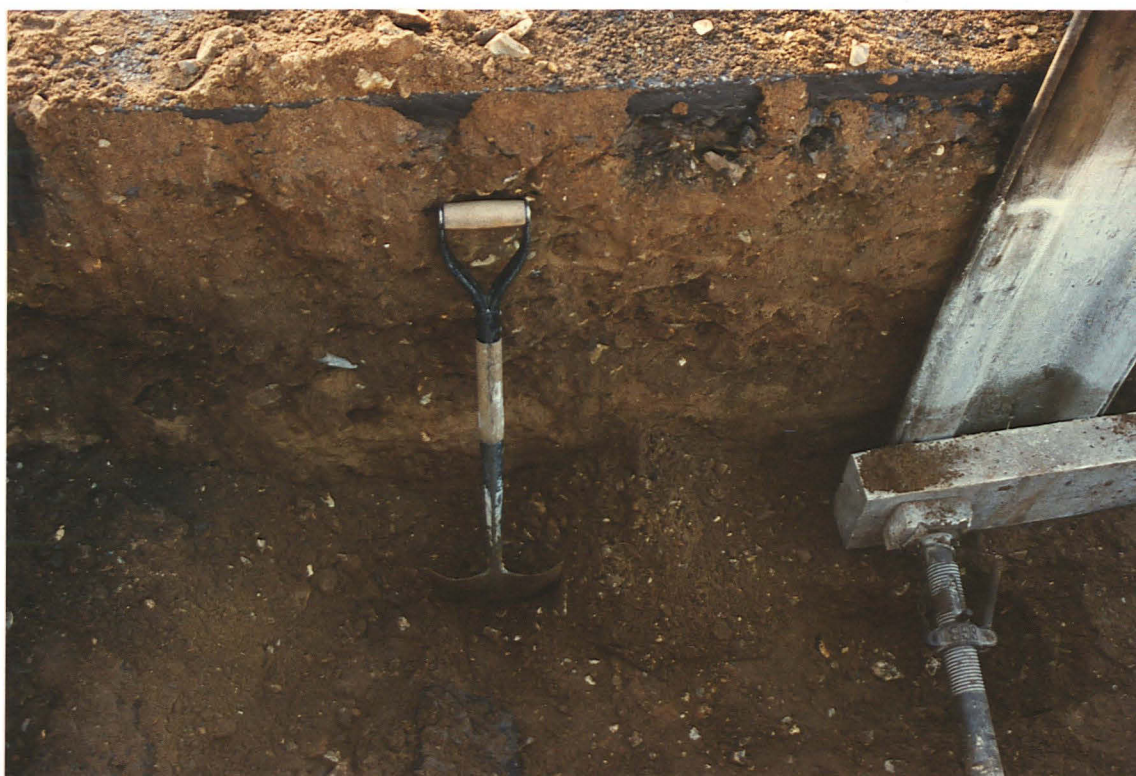
Pl. 2 Natural sand and gravel deposits in the trench face at 5. The thin gravel layer beneath the tarmac may be a post-medieval road surface.

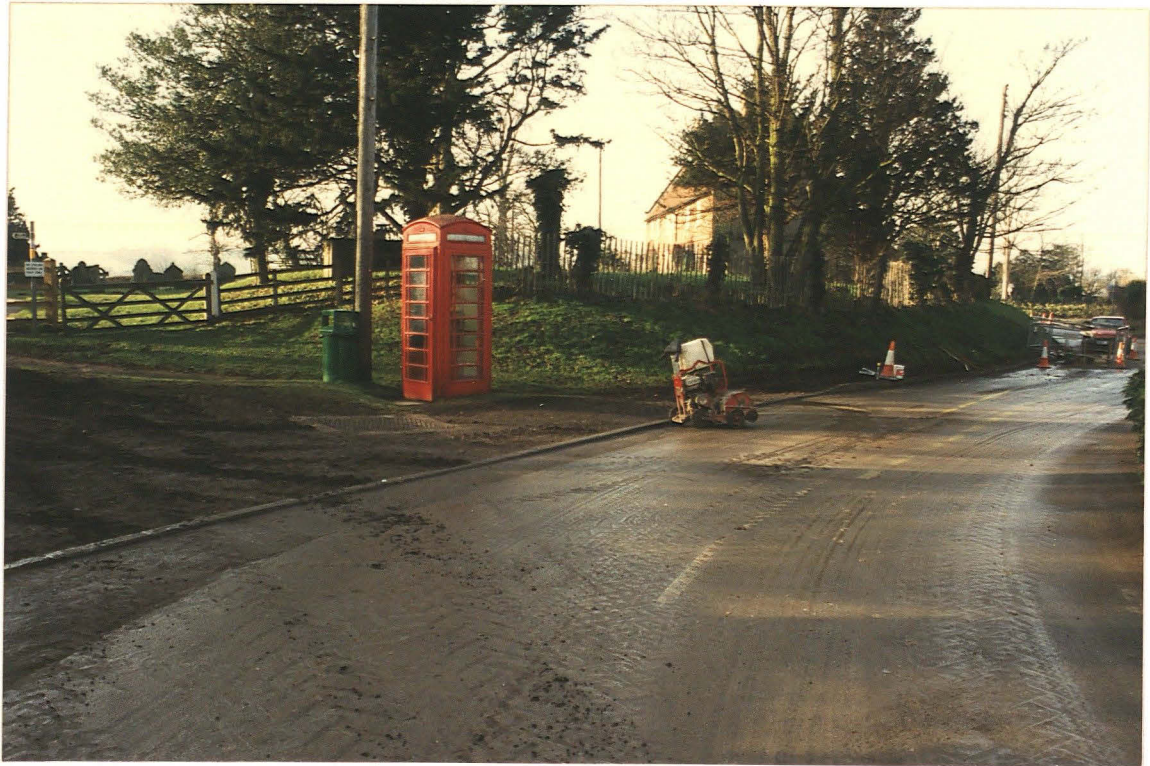
PI. 3 Location of 6 (trench beside cones). The field entrance on left leads to the medieval village earthworks and overlies a former street. (Looking NW).

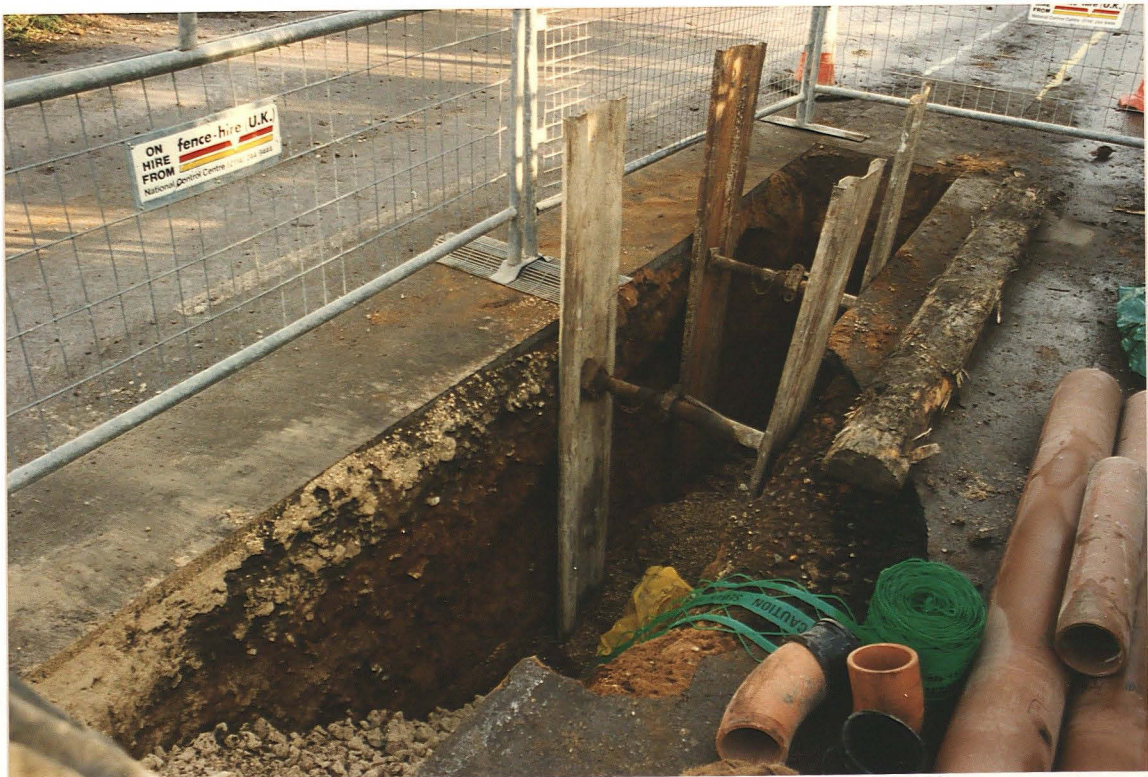
PI. 4 Natural gravel layers at 6.

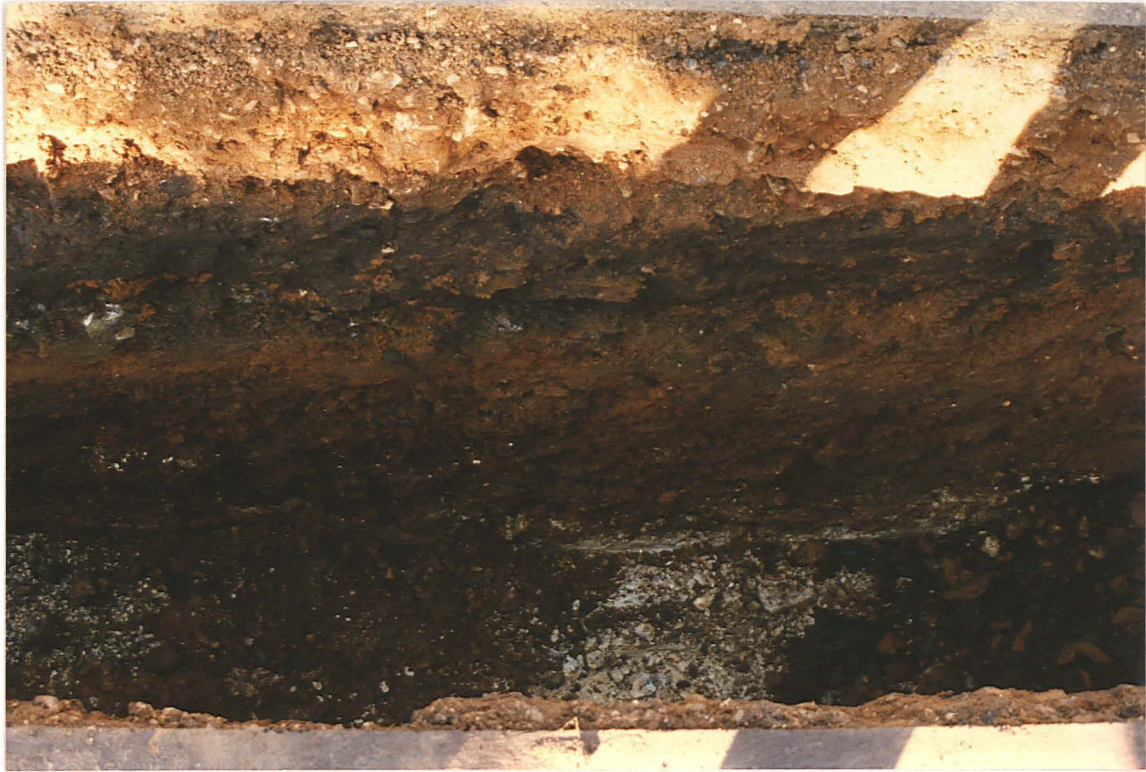
PI. 5 Sequence of deposits at 7, showing post-medieval gravel road metalling covering black soil and a thin underlying band of green loam, possibly derived from cess. Natural chalk is visible at the trench base.

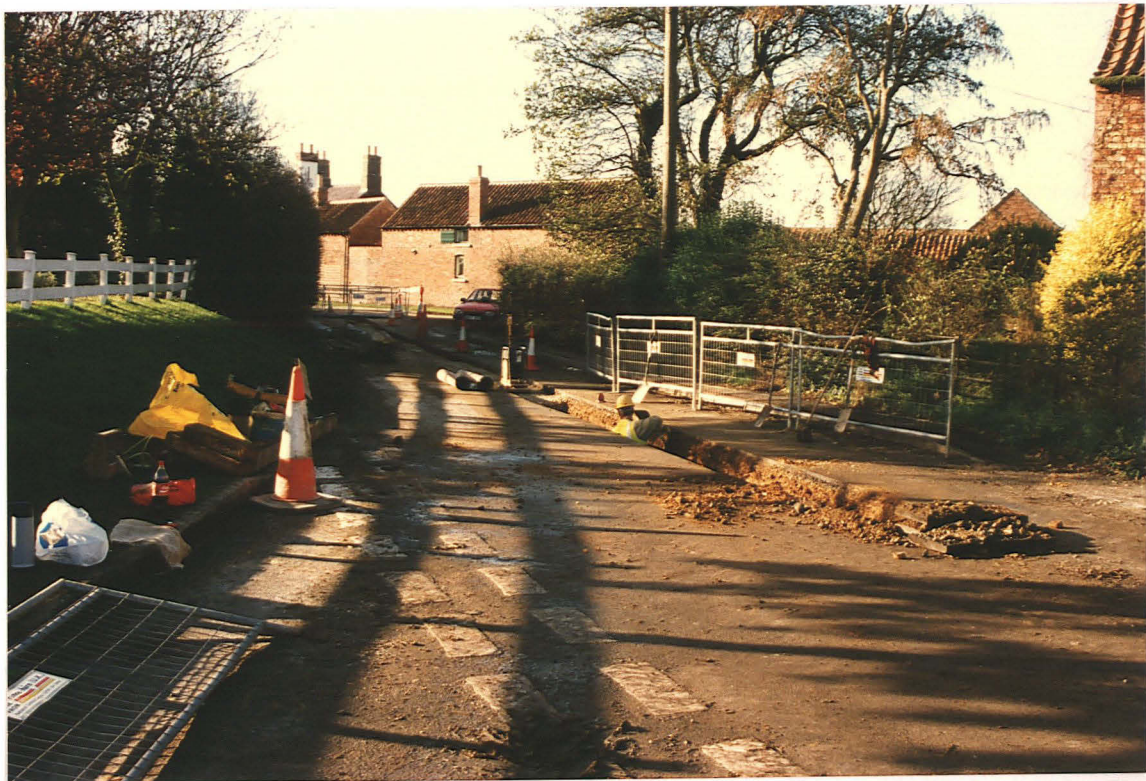
PI. 6 Trenching at 8 close to the junction of Louth Road and Chapel Lane (looking SW).

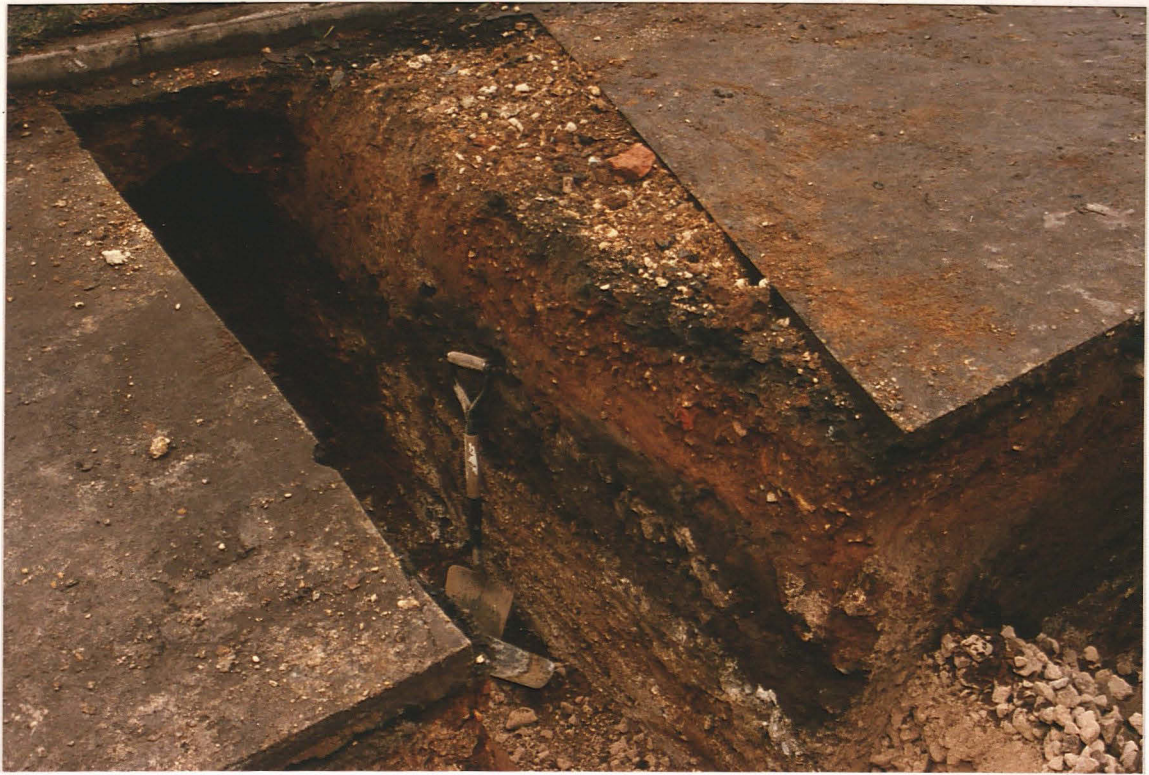
Pl. 7 Stratigraphy of the trench at 9. Brick fragments were incorporated into the gravel road surfaces above the black soil layer (looking west).

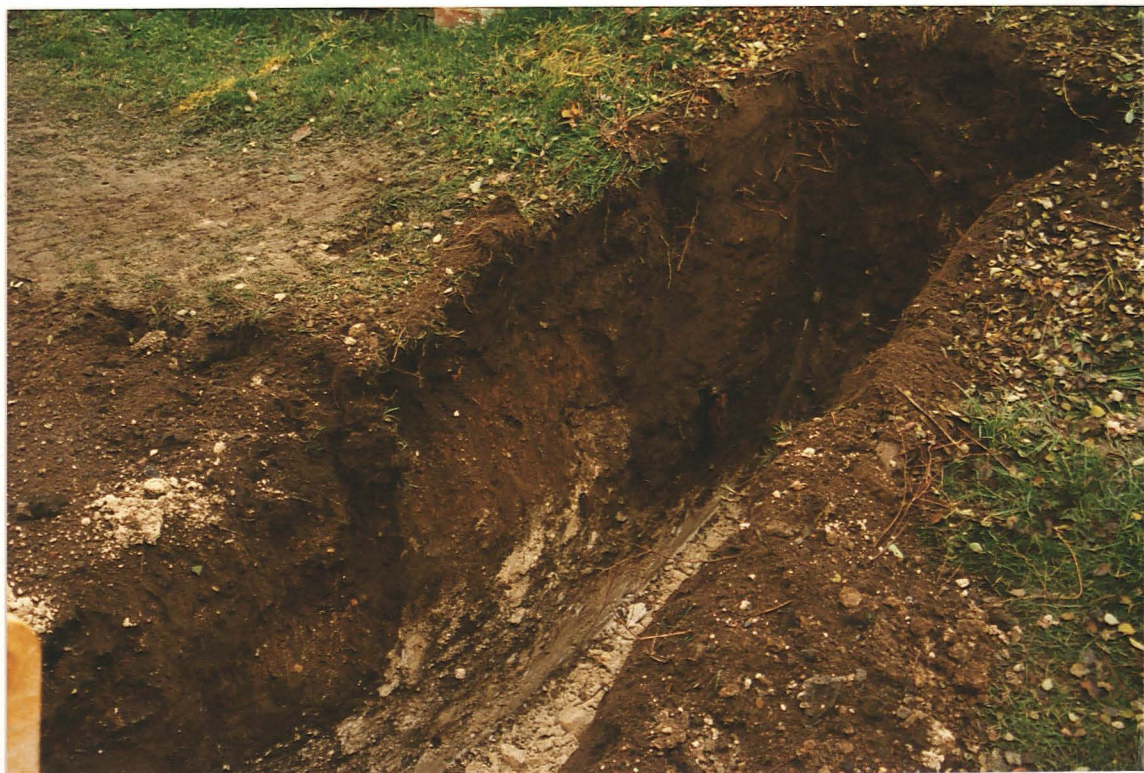
Pl. 8 To the east of the Methodist Chapel in Chapel Lane, a backfilled boundary ditch (top right) was identified, coinciding with the existing brick wall frontage (centre top). The other disturbance (front left) may be ruts created by medieval and later traffic (looking NW).

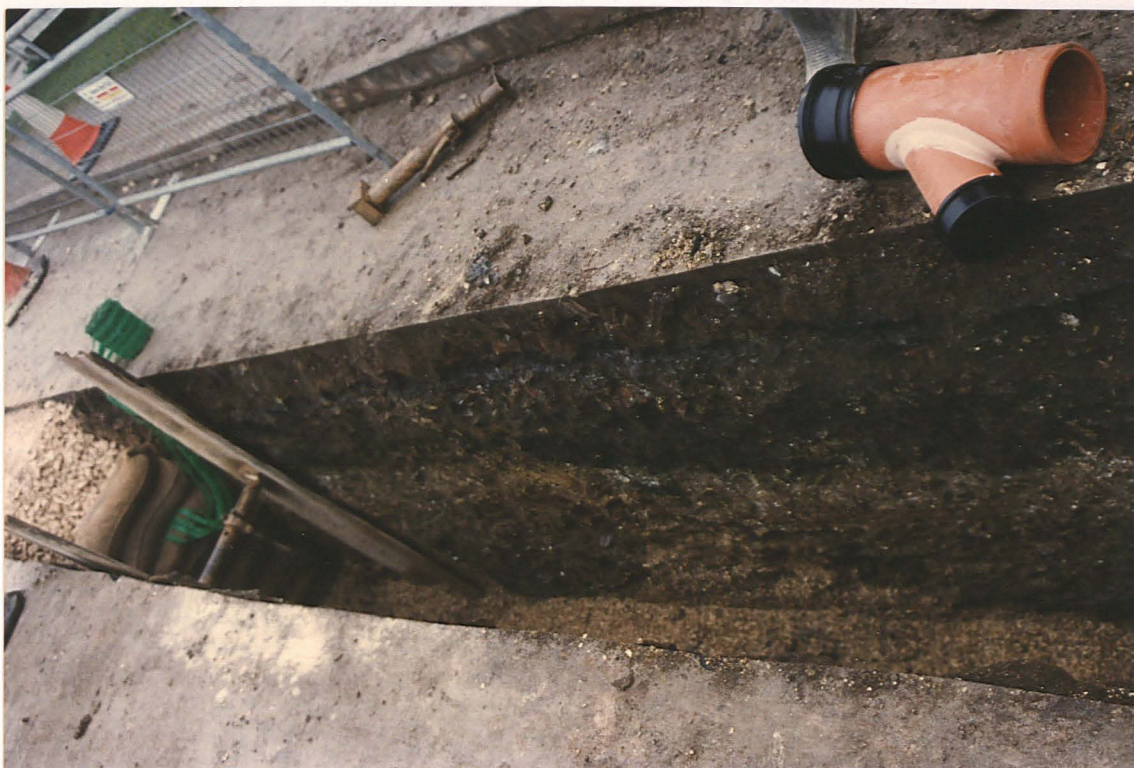
Pl. 9 Uneven layer of dark mixed soil overlying natural chalk at 11, south of Brook House Farm. The post-medieval road may have been laid over levelled ridge and furrow undulations (looking W).

11. Along much of Chapel Lane, chalk was encountered at a depth of between 0.5m and 0.85m below the modern road level. It is conceivable that the greater depths (parallel to Hemingby Beck) were in archaeological features such as ditches or plough furrows, but no dateable remains were found (Pl. 9). South of the track to Brook House Farm a layer of black soil 0.27m thick was present between the road metalling and the chalk; this may have been a buried topsoil. The underlying chalk was quite mixed with clay but this was probably caused by geological factors.

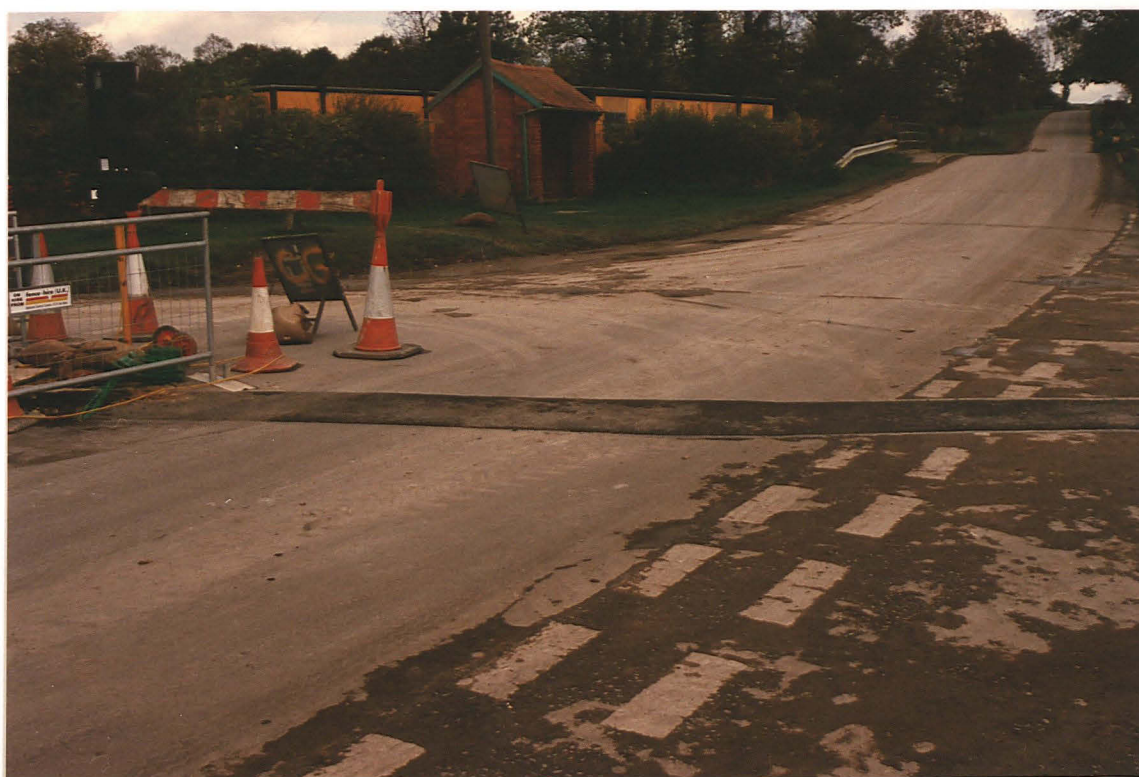
Pl. 10 Horncastle Road, Hemingby, at the junction with Chapel Lane (left) and New End (right). The bridge across Hemingby Beck can be seen. Observations at 12 and 13 suggested that the stream may once have flowed closer to the junction.
