LINDSEY ARCHAEOLOGICAL SERVICES

The Moat House, Sutton Rd, Markby
NGR: TF4885 7899
Site code: MPH 97
LCNCC Museum Accession No. 75.96

Investigatory Trenches

Report

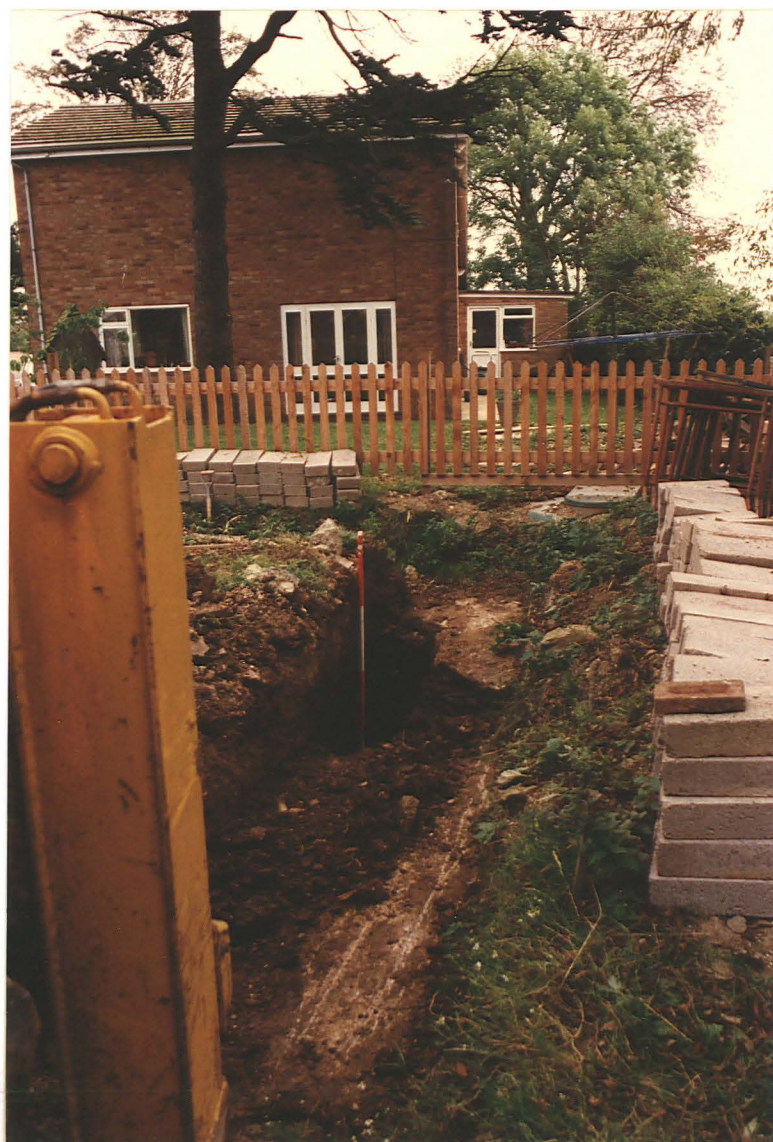
PI. 6 Trench 1, shared septic tank cover below fence. Priory House in background. Tree-lined drainage ditch to right. From west.

The first trench, MT1, maximum surface length 2.90m, was machine-excavated alongside the north side of the concrete footings to the proposed garage (Pl. 6). Horizontal layers of moat fill were revealed, almost identical to those found in the house footing trenches in 1996, and at similar depths. These were photographed but not drawn (Pl. 7). The second trench, MT2, maximum surface length 7m, was excavated alongside the west side of the concrete east footing, perpendicular to MT1 (Fig. 3). The exposed section was photographed and drawn (Pls. 8 and 9; Fig. 4). No samples were taken, as representative samples of peat and silt were retained in 1996. There were no finds.

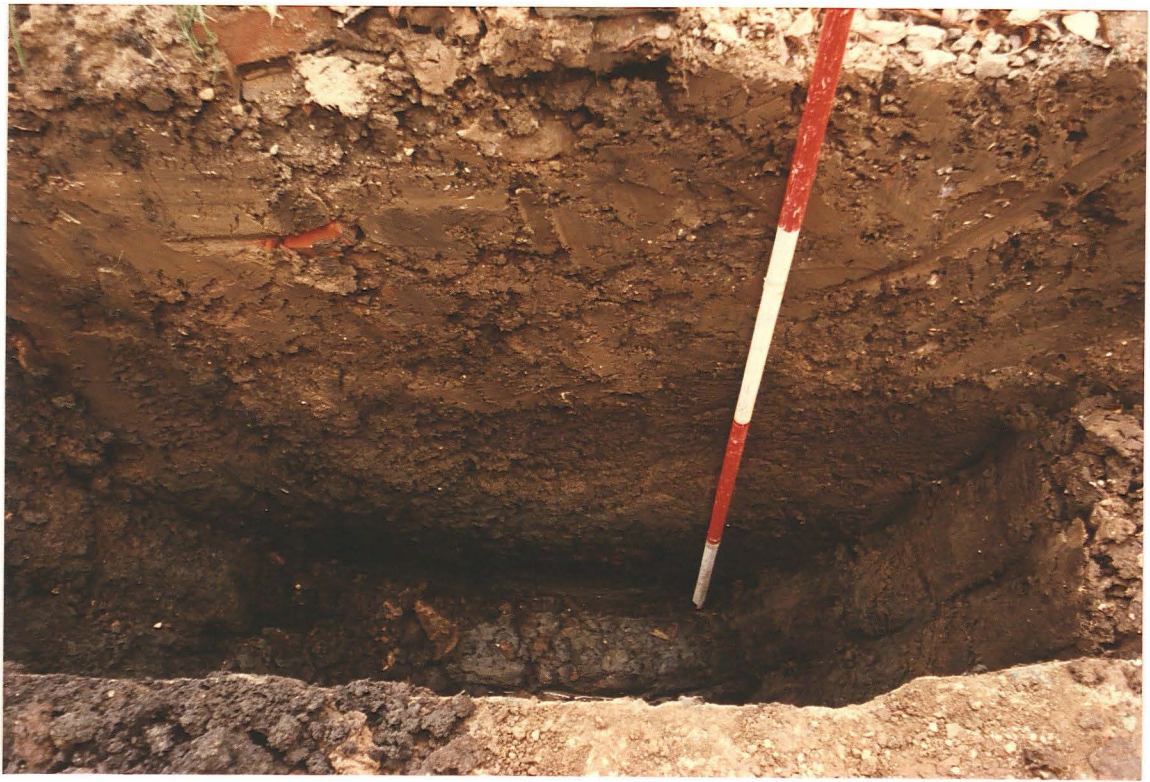
Pl. 7 Trench 1, east-west section. Primary silts (7) at base; organic layer (6) over. From south.

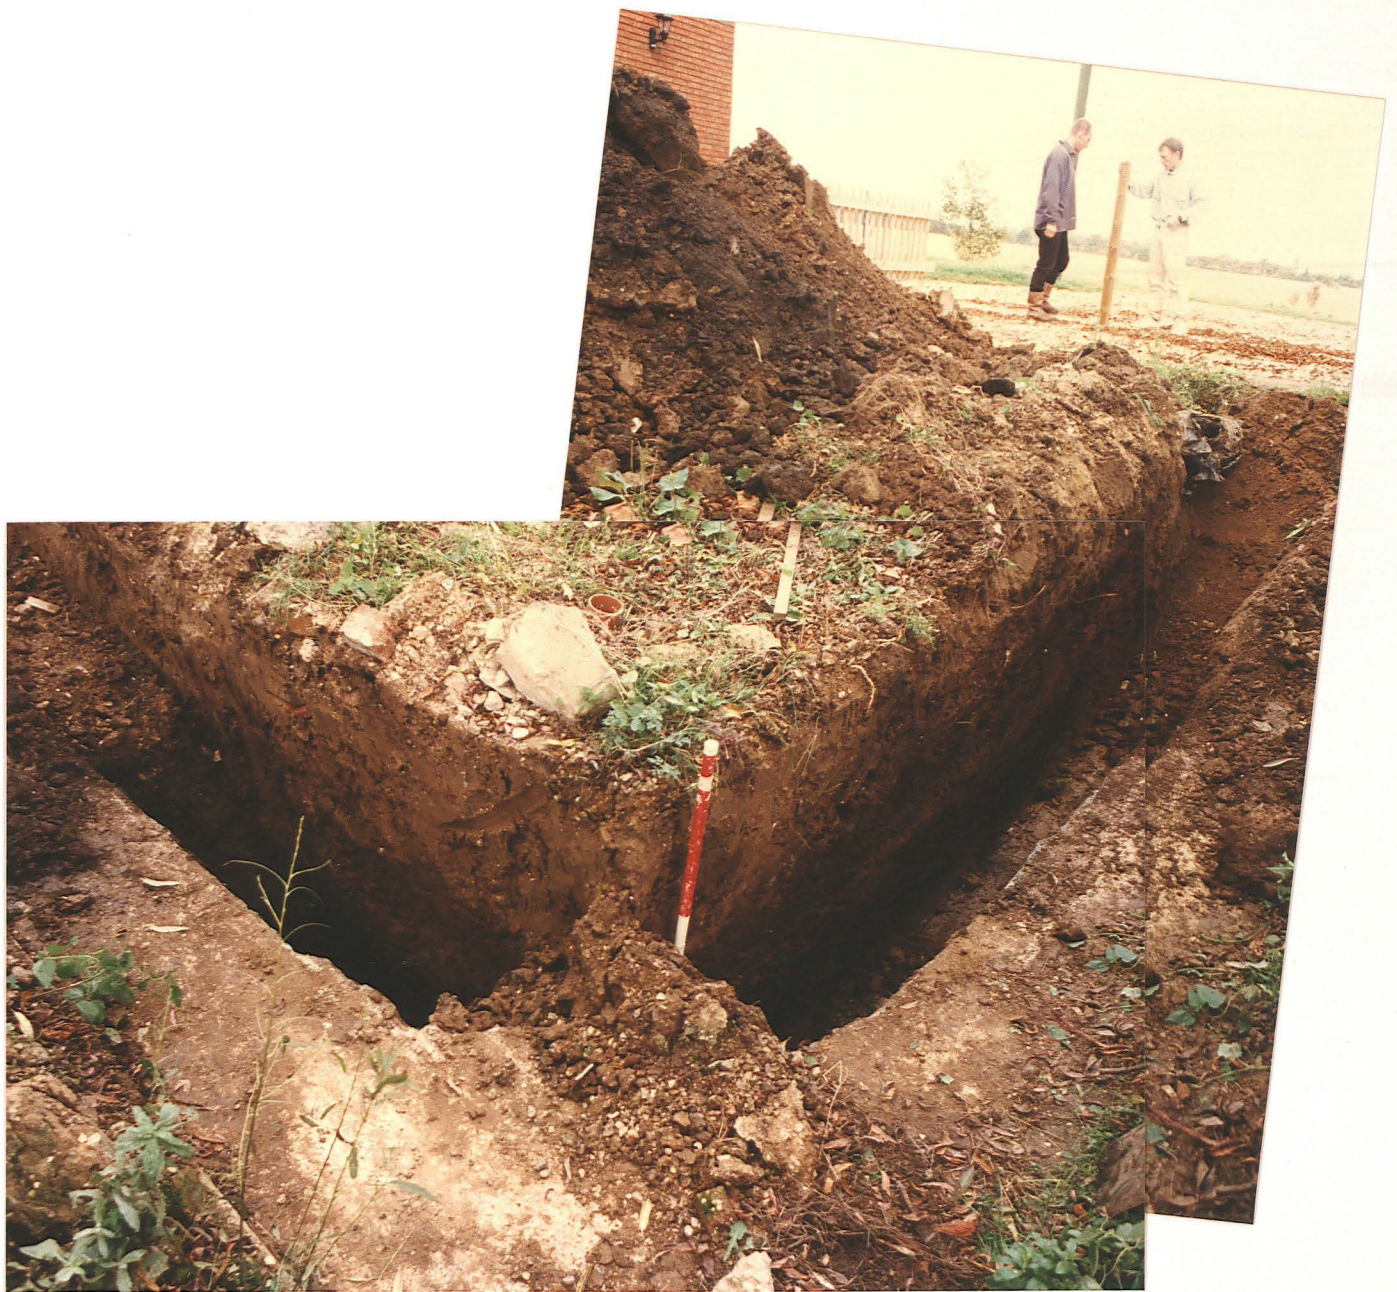
Pl. 8 South-east angle of garage footing; trench 1 (left) and trench 2 (right). From south-east.
