ADEN COUNTRY PARK, ABERDEENSHIRE, AB42 5FQ

Data structure report (29 April-12 May 2019 excavation)

**Alison Cameron
Cameron Archaeology
13 June 2019**

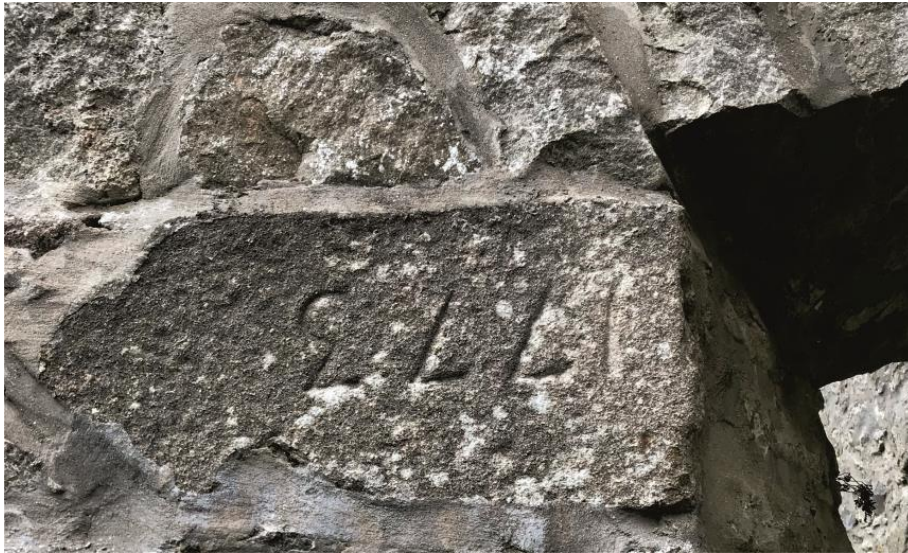
Illus 2 1773 incised date stone reused upside down as the springer for an arch; facing W

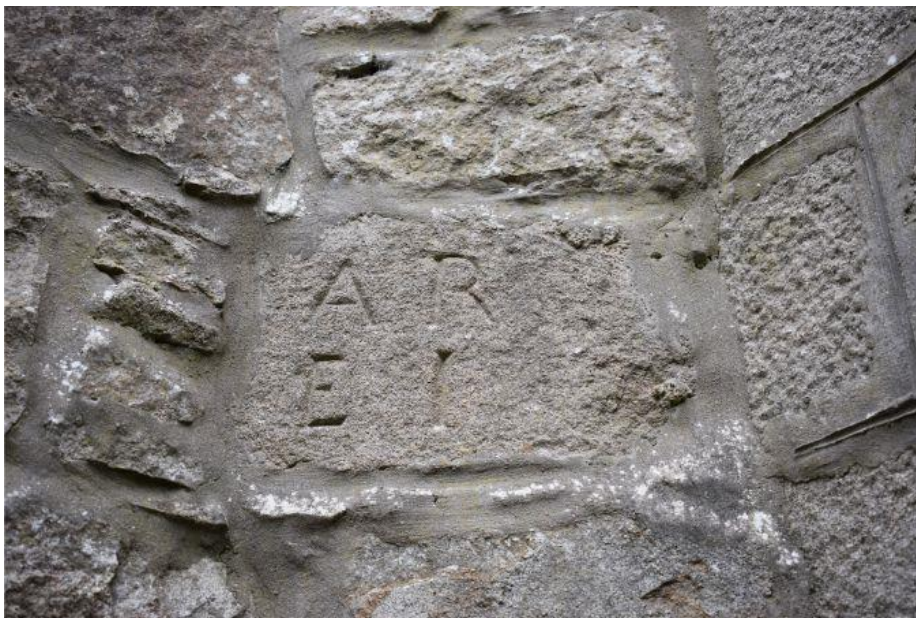
Illus 3 AR (Alexander Russel) and EI (Eliza Innes) inscribed stone; facing SE

rebuilt W elevation is symmetrical with two bays on each side of a Roman Doric colonnaded bow, formerly with a dome, and a large top lit atrium in the centre of the house accommodated a library. It originally had fireclay balustraded parapets, but these were removed (possibly in 1983) along with the roof and many internal walls. The building was requisitioned as a billet for troops during World War II. In 1975 the house and grounds were acquired by the then Banff and Buchan District Council. There are a number of reused stones within the structure including a 1773 inscribed stone (Illus 2) possibly dating to the date of building by Alexander Russel of Montcoffer and an initial inscribed stone (Illus 3) AR (Alexander Russel) and EI (Eliza Innes) who was his second wife who he married in 1767.

Trench 6 was located at a corner of the house on the N wall where there is an unusual stone feature angled at 45 degrees to the current house with a stone inscribed 'AR/EI' (Alexander Russel and Eliza Innes, Illus 3). The trench had layers of slate, coal and linoleum on top of *in situ* drain pipes and dumped stone and loam. Under the current structure is what appeared to be a stepped foundation but removal of drain pipes revealed that it was the corner of an earlier building (611/612; Illus 22-23).

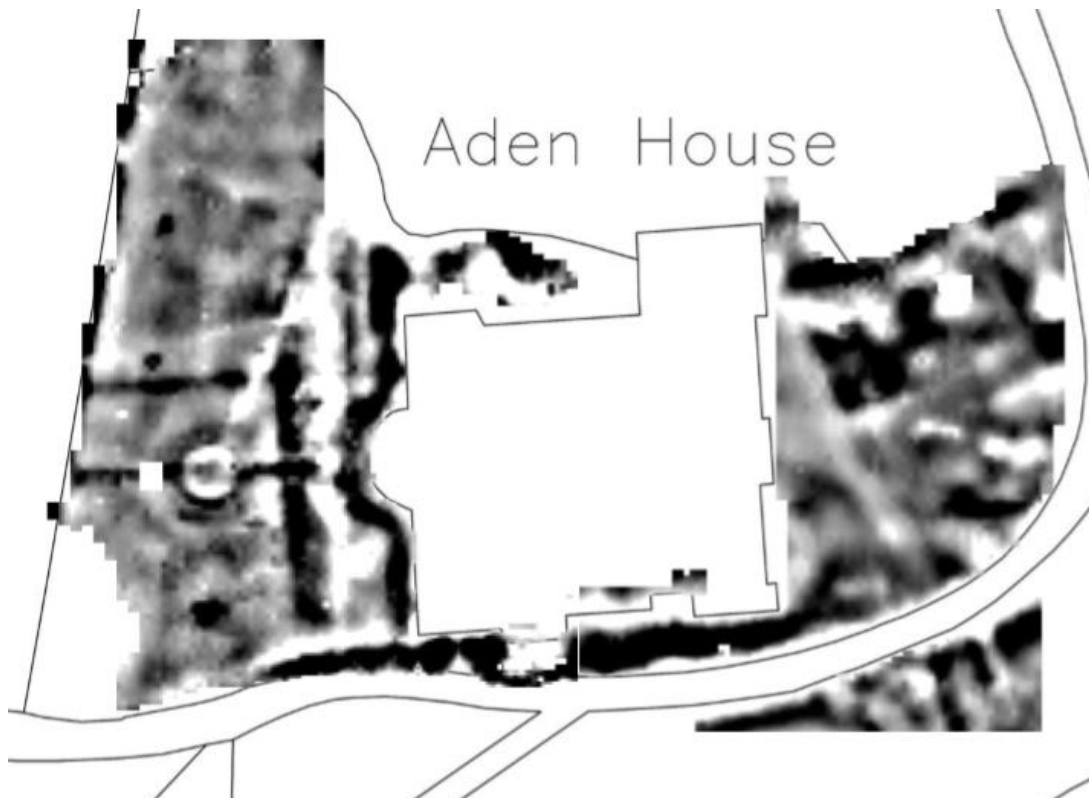
Illus 4 Resistivity survey results, Rose Geophysical Consultants

Previous work at the site included geophysical survey by Rose Geophysical Consultants (Illus 4, 5)

Trench 1 was 15 x 11m in size and positioned on the W side of Aden House to identify the anomalies seen on the geophysical survey (Illus 4, 5). Large stone-lined drain was recorded in Trench 1. The capping stones (124) were at least 0.8m long and the stone-lined passage was 0.6m wide at the top, 0.3m wide at the base and 1.05m deep (Illus 10-13). There was a silt layer in the base which was sampled, and the base had a layer of at least 0.4m of sand which was trenched but not bottomed. The capping stones were traced through Trench 1, into Trench 2, Trench 9, 11, 18 and 19 (see below). The sides are constructed of larger fieldstones with smaller packing stones.

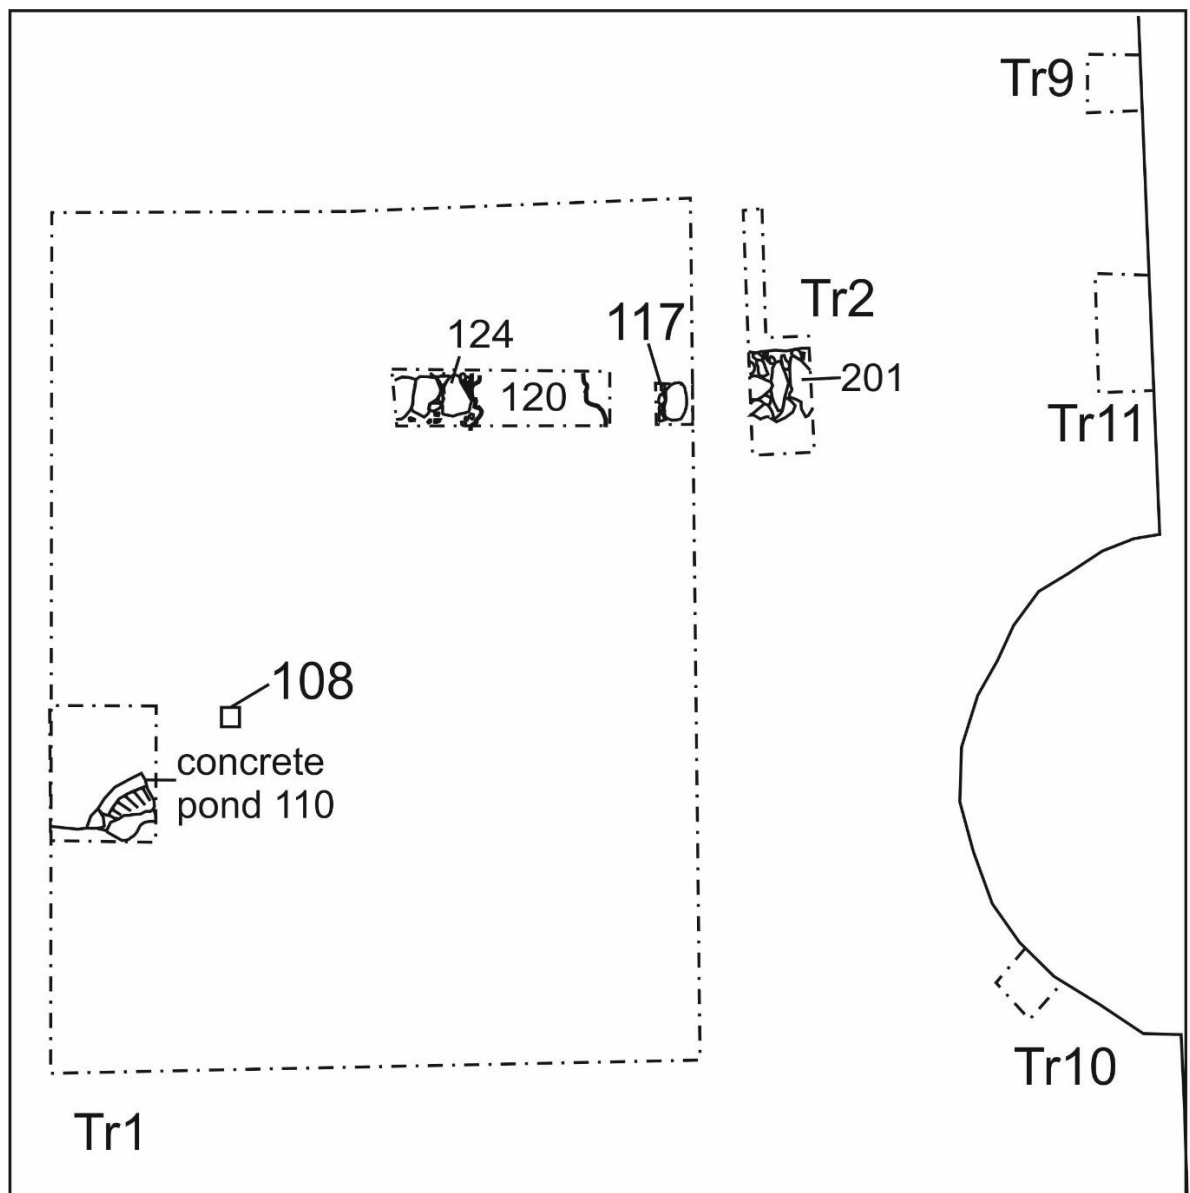
Illus 9 W side of mansion showing trenches and main features

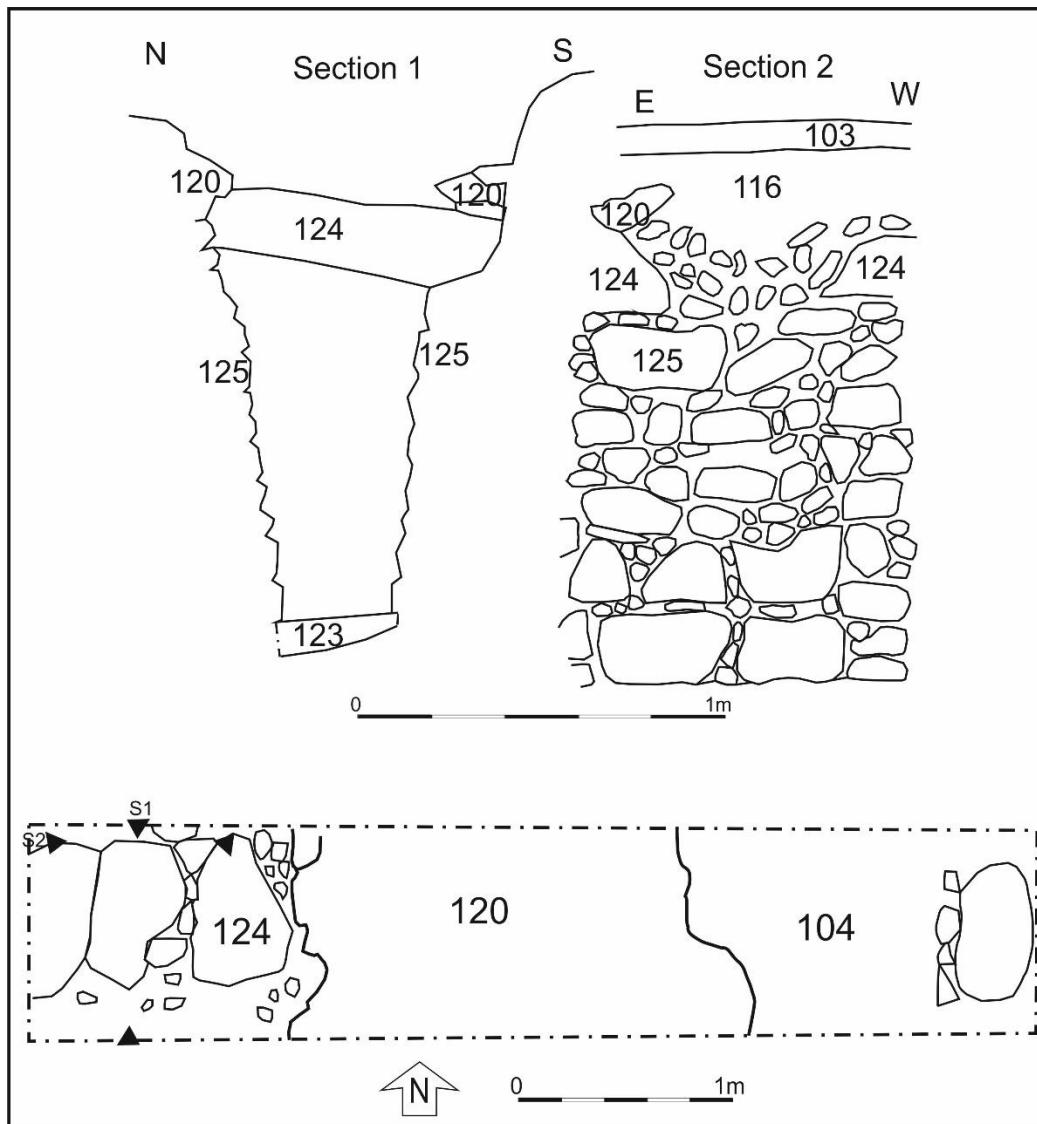
Illus 10 Section and side elevation of drain 122

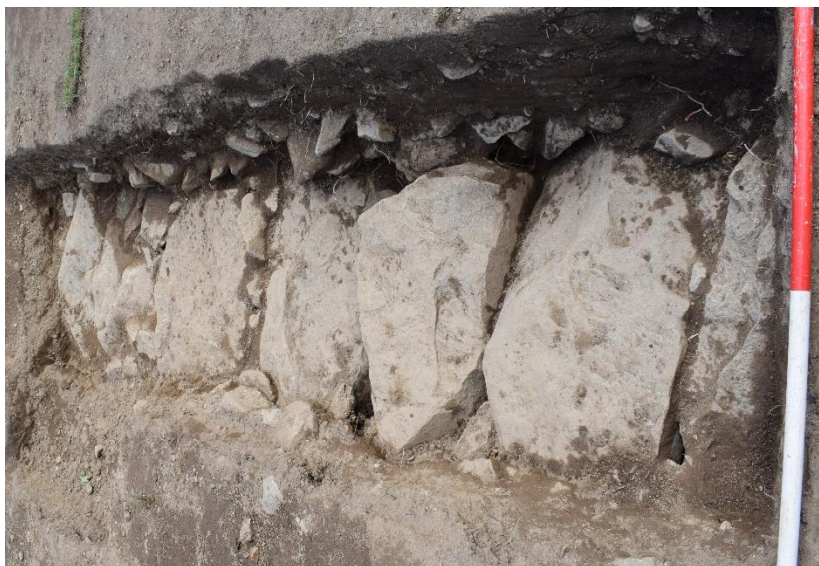
Illus 11 Capping stones drain 122; facing E

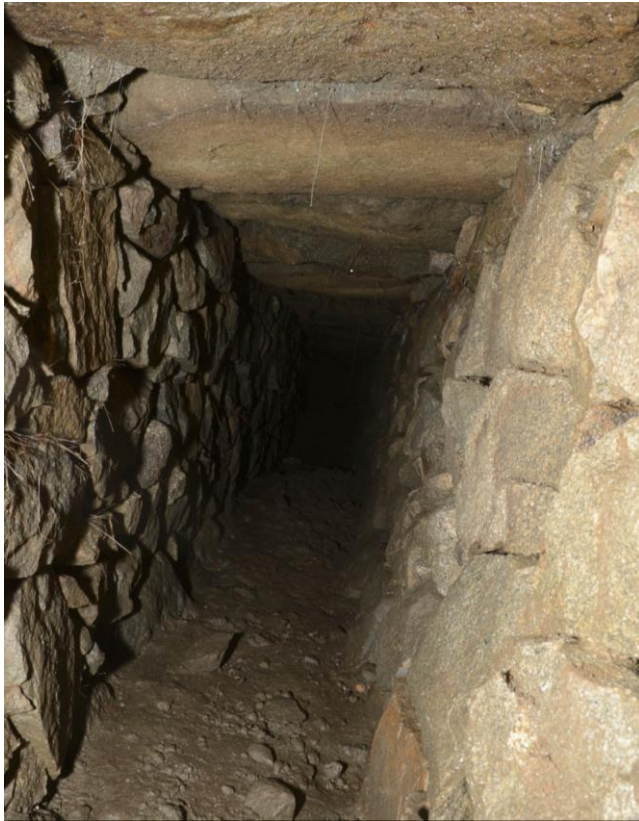
Illus 12 Drain 122 facing W (thanks to Jamie Cutts, Aberdeenshire Council)

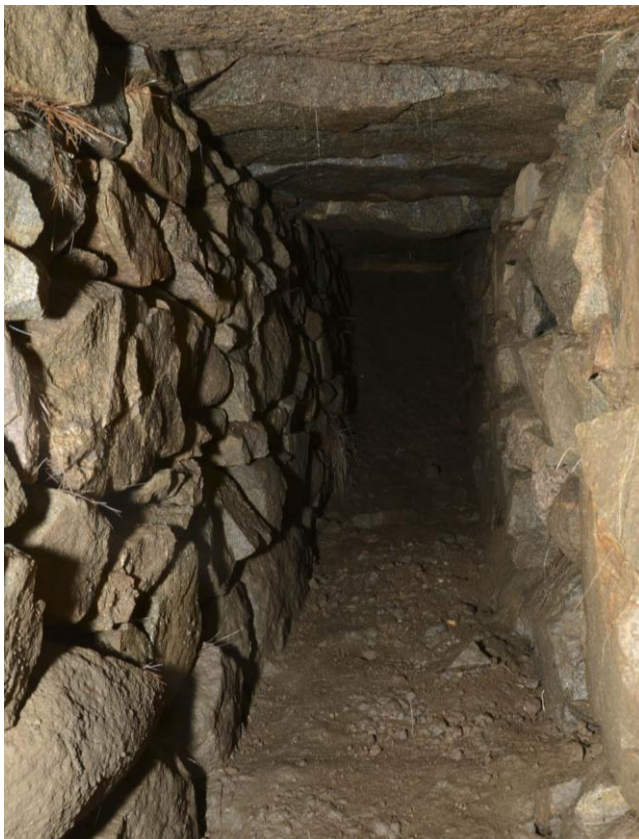
Illus 13 Drain 122 facing E (thanks to Jamie Cutts, Aberdeenshire Council)

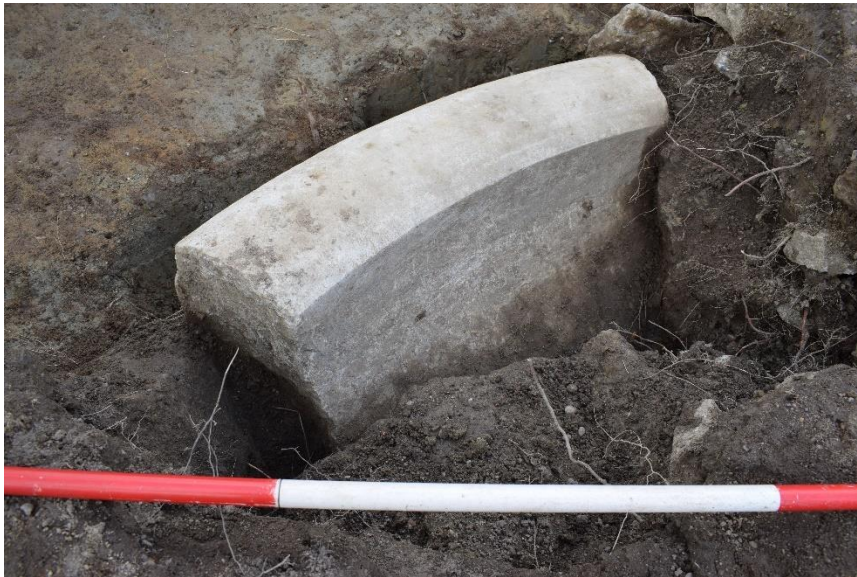
Illus 14 Concrete fountain base 110; facing N

The resistance survey showed a possible fountain or pond (Anomaly 2; Illus 5) and a central focus can be seen on the w side of the house on the First Edition OS map (Illus 15). A circular 4m diameter 0.7m deep pit had been cut into the centre of the garden aligned with the central bay window on the W façade. The pond was not *in situ* but a large section of concrete fountain base (Illus 13) was found dumped into the base of the pit. The base had been 3m diameter internally and probably dates to the late 19th or early 20th century. By the mid 20th century photographs (eg Illus 14) the pond and fountain have been removed. During removal lumps of concrete foundation, fountain base, ceramic garden ornaments and bricks had been dumped into the foundation pit. A cast iron valve box was uncovered (108; Illus 17) which would have regulated the water going into the fountain.

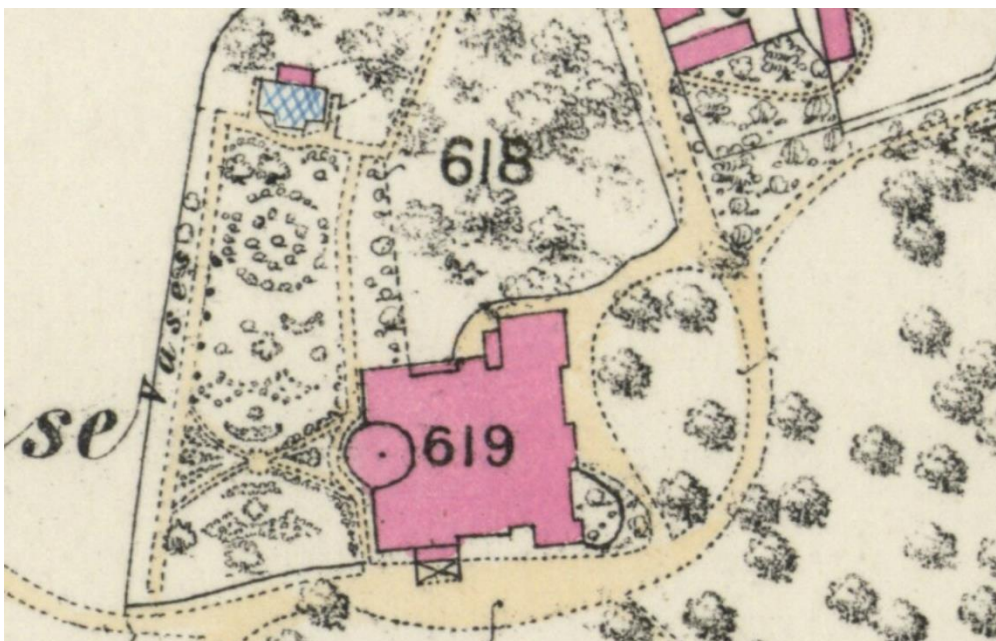
Illus 15 First Edition OS map showing garden layout (copyright National Library of Scotland)

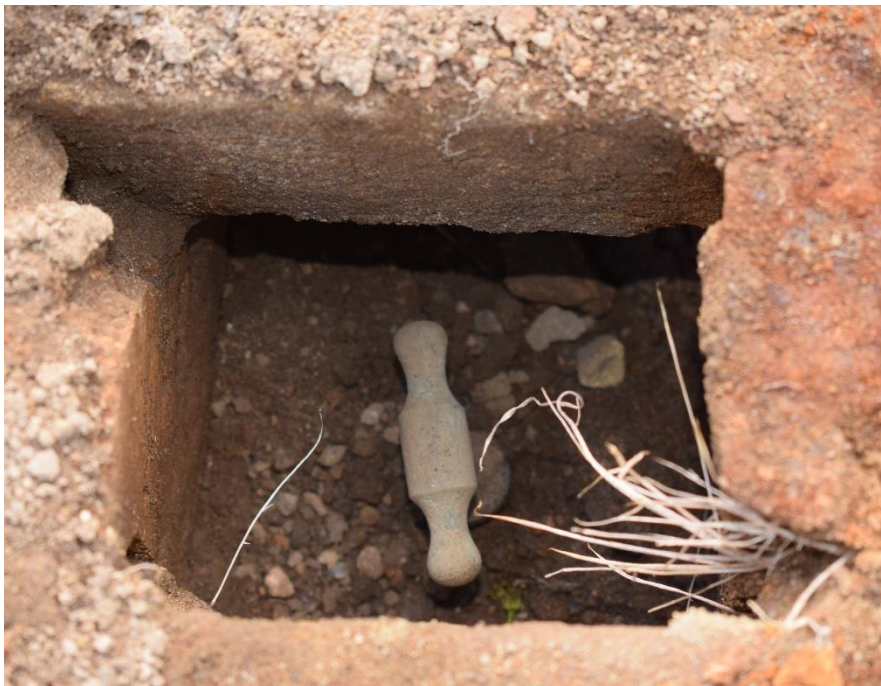
Illus 17 Cast iron hatch 108 with copper tap at base for regulating water to the pond 110; facing E

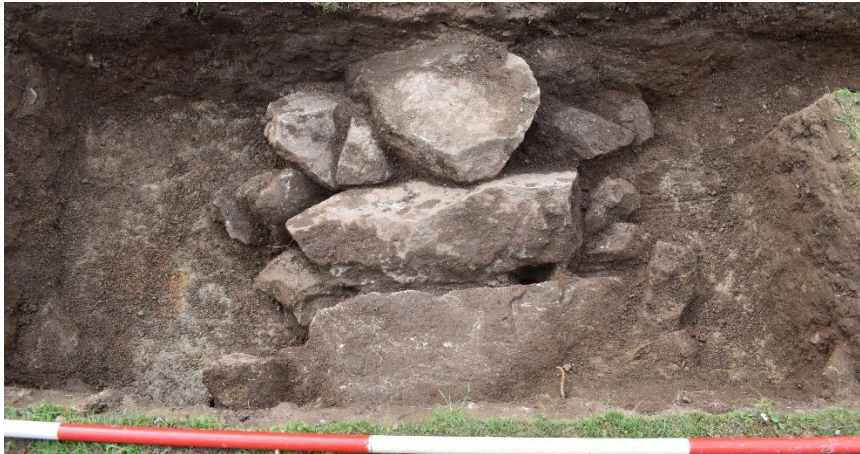
Illus 18 Trench 2 drain capping stones 201; facing W

Trench 2 was excavated between Trench 1 and the mansion house to investigate the drain feature 122. Capping stones 201 (Illus 18) were uncovered but they were not lifted and the trench was backfilled.

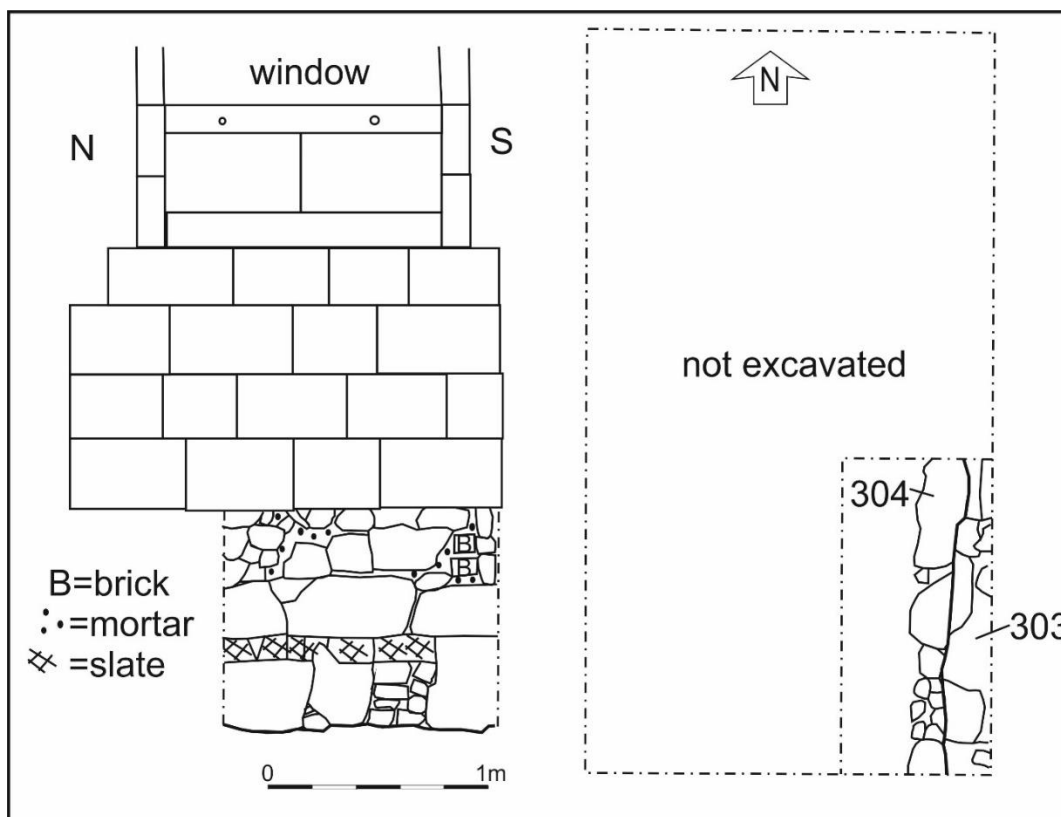
Illus 19 Trench 3 plan and elevation

Trench 3 was excavated on the W side of the house to investigate the foundations and any earlier structures. A mortared stone stepped foundation (304; Illus 19) was uncovered and it is possible that this is from an earlier structure.

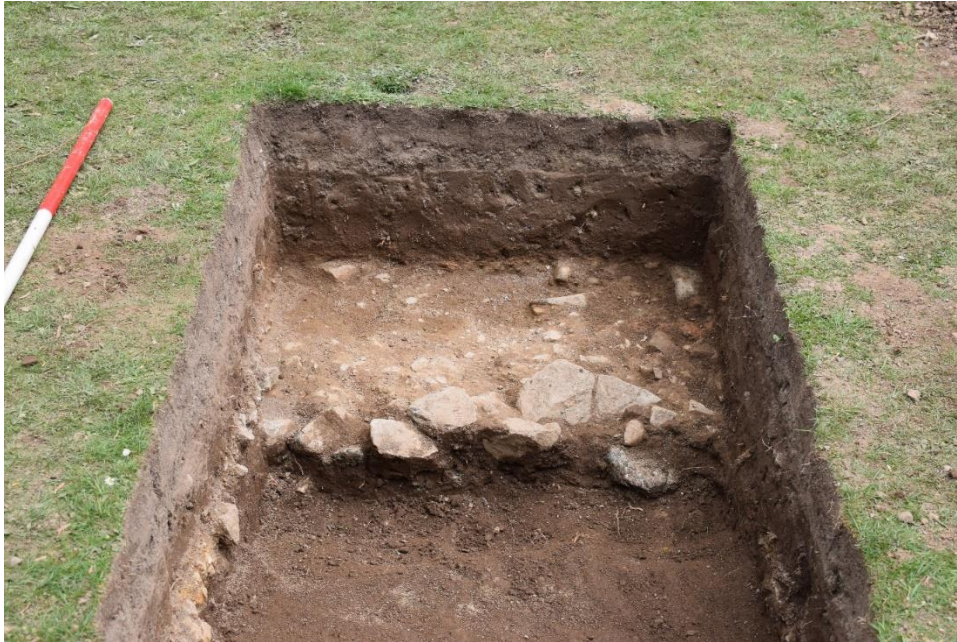
Illus 20 Trench 4 spread of stone and mortar; facing E

Trench 4 was excavated to investigate an anomaly on the geophysical survey (Illus 4, 5). There was a demolition layer of small stones and mortar (401) at the E end of the trench (Illus 20) with garden soil above and below. This may have been laid as a path or surface.

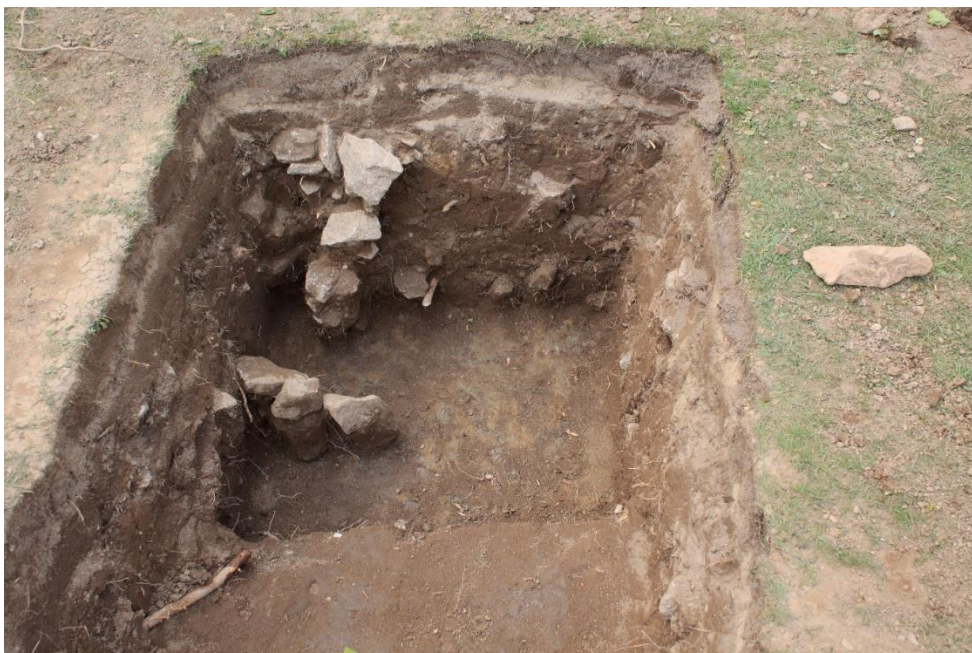
Illus 21 Tr 5 showing garden soil and loose stones; facing W

Trench 5 was excavated to investigate an anomaly on the geophysical survey (Illus 4, 5). Here was 0.5m of garden soil with a dump of stones at the W end (Illus 21) but no other archaeological deposits were recorded.

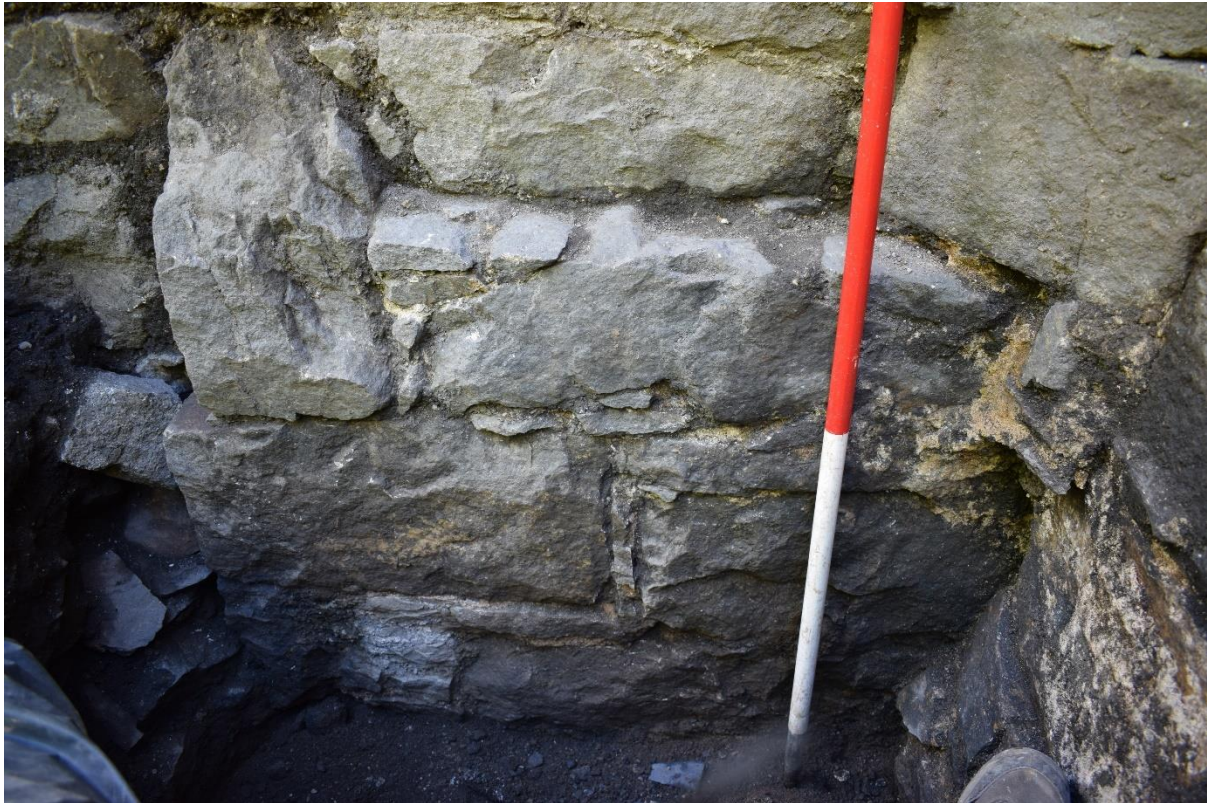
Illus 23 Trench 6 wall 610 (bottom right); not the stone top right is angled at 45 degrees to the current building and features AR/EI incised stone above; facing S

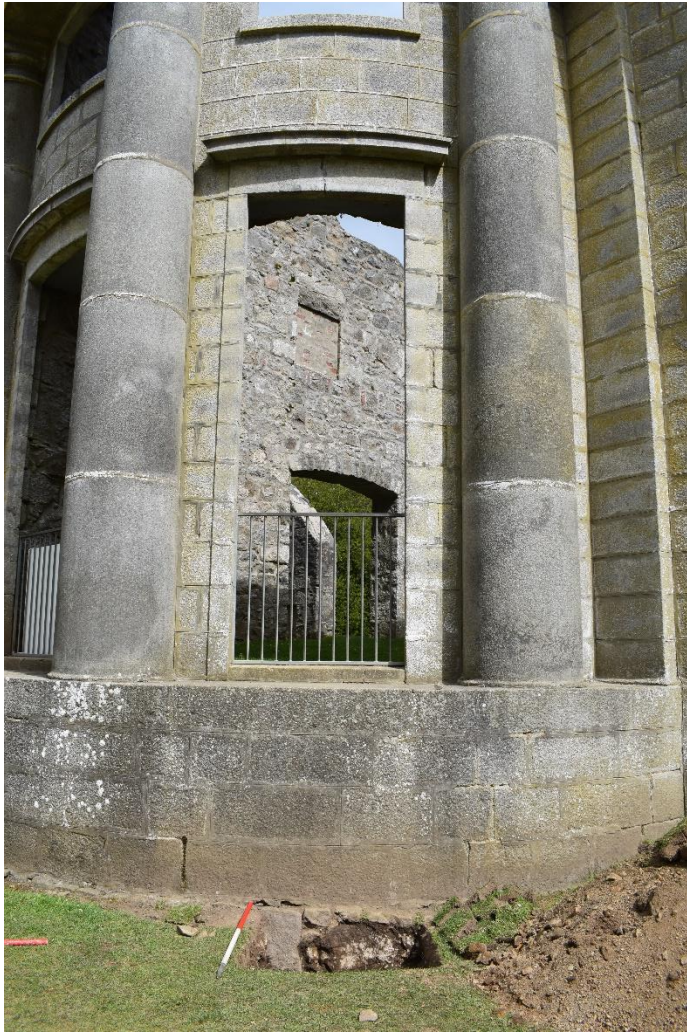
Illus 24 Trench 10 location under ashlar bay window; facing NE

Trench 10 was excavated on the bay windows on the W wall of the mansion house (Illus 24) to investigate the foundations of this structure. The stone foundation was 0.3m deep and built onto the natural bedrock (Illus 25).

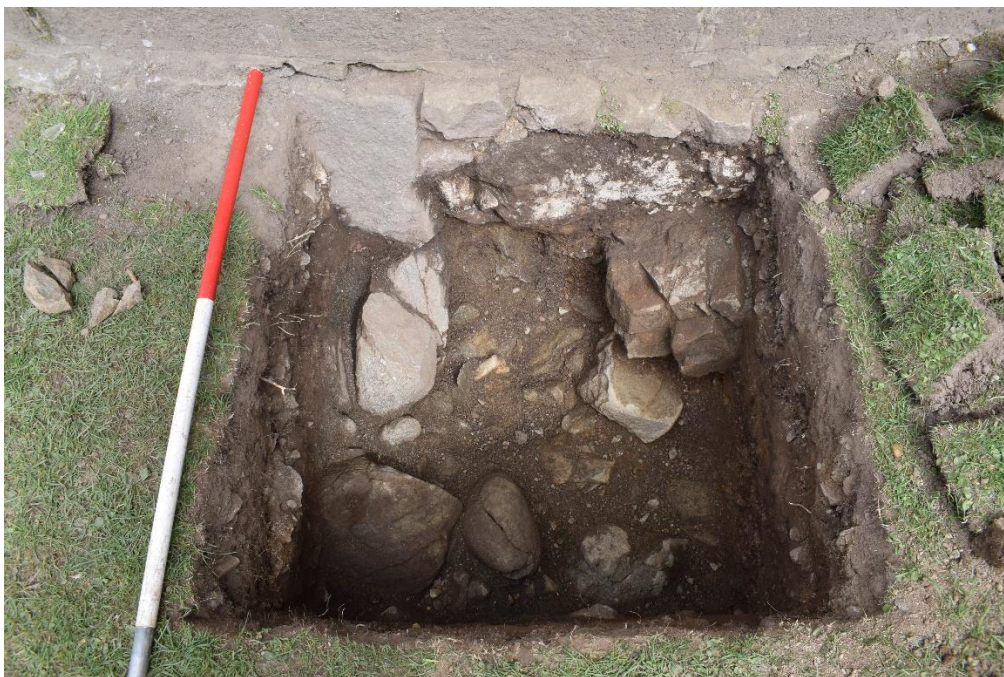
Illus 25 Trench 10 foundation of bay window (top); facing NE

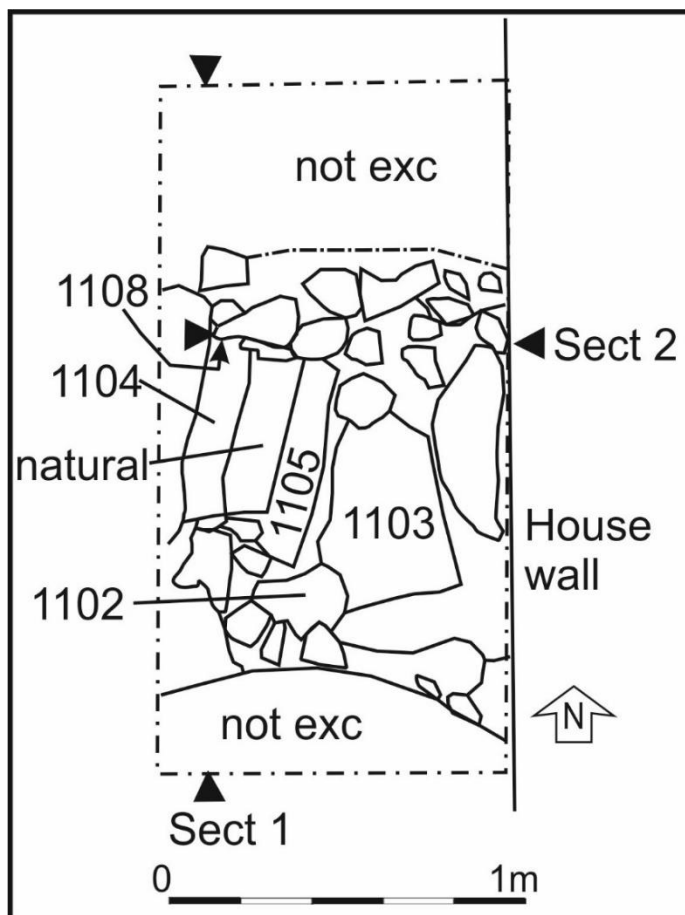
Illus 26 Trench 11 plan

Trench 11 was excavated next to the W wall of the mansion house to investigate the drain feature 122 and the foundations of the house. Two drains were recorded in this trench. One (1106 runs W-E and joins with the drain in Trenches 1 and 2 (Illus 26, 28). It is stone-lined and 0.5m wide and 1.25m high although to the W of this trench the roof lowers to 0.95m deep. This may be the original height of the drain and the deeper section was rebuilt when a drain was joined in from the N. This is drain 1109 which is 0.45m wide and at least 0.6m deep; the capping stones of this drain were recorded in trenches 9, 11 and 18. All drains are stone lined with large granite capping stones. There was little access to the interior of the structure and drain rods with camera which were inserted into all structures was partially successful but no photographic recording of this was captured (as it was thought to be being recorded on an SD card but there was nothing on the card).

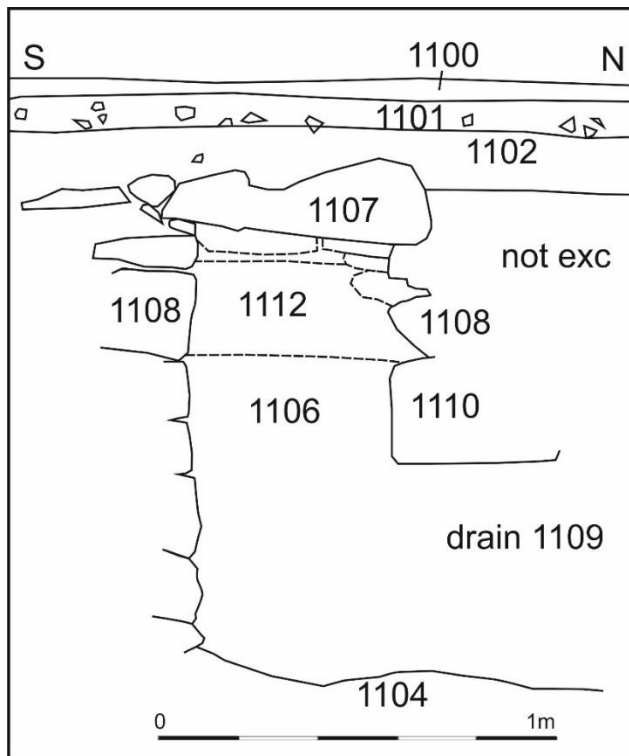
Illus 27 Trench 11 Section 1

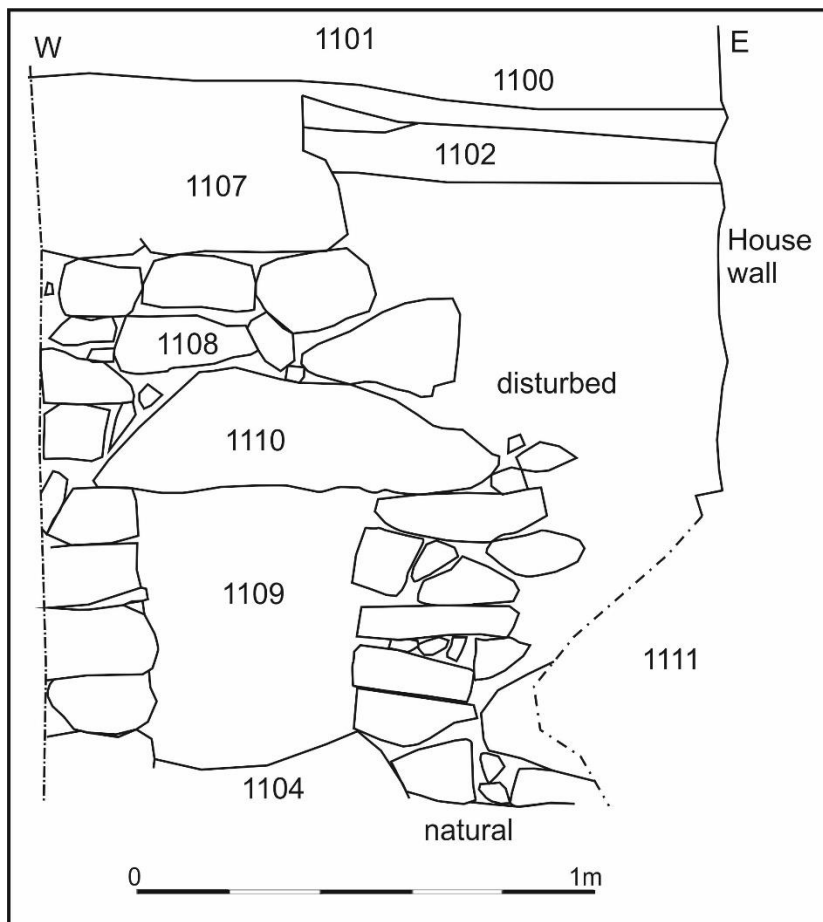
Illus 28 Trench 11 Section 2

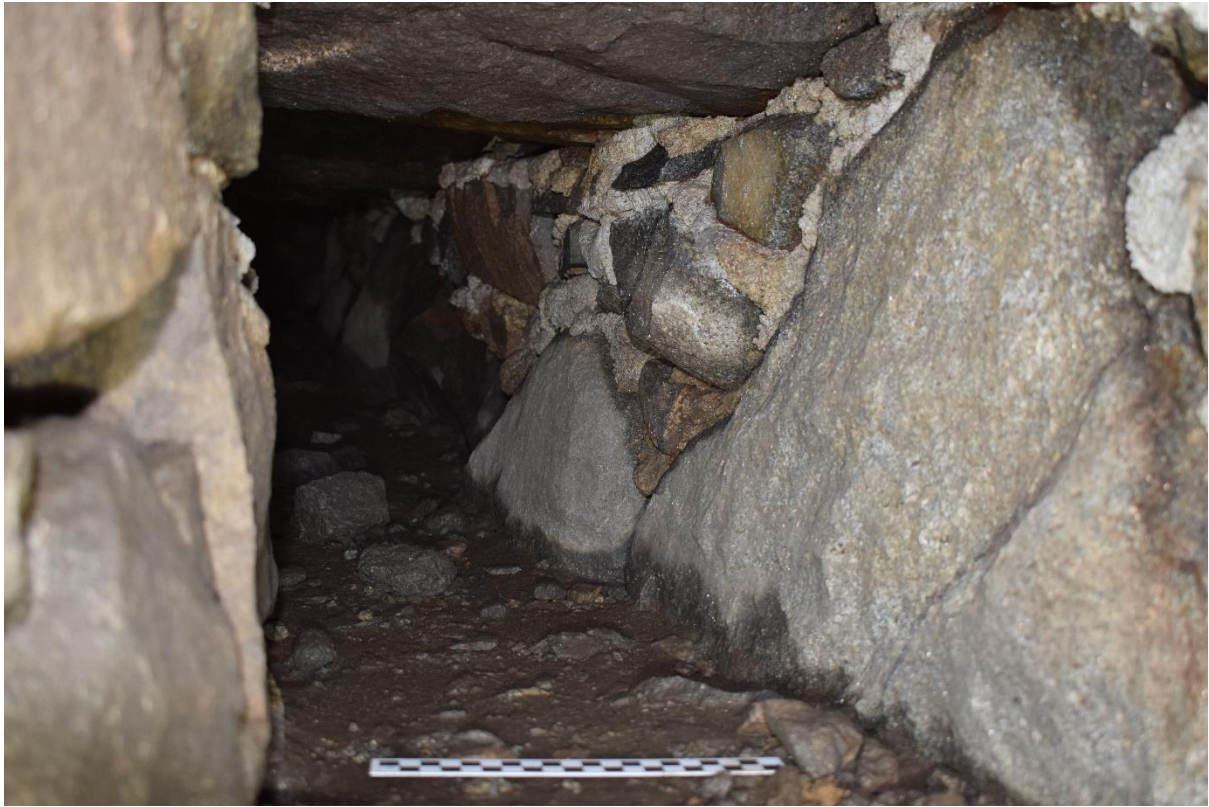
Illus 29 Trench 11 drain 1109 E wall mortared into Mansion W wall foundation

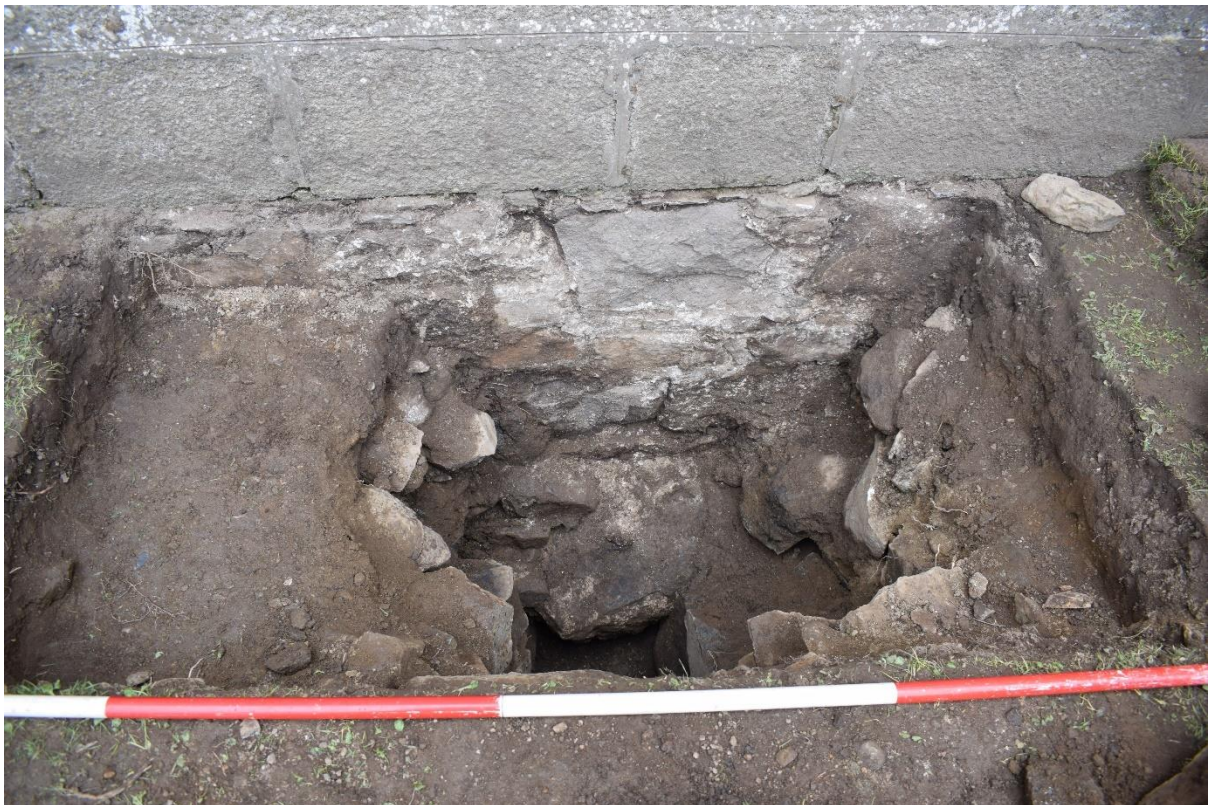
Illus 30 Trench 11 relationship of Mansion wall and foundation to drain 1106; facing E

The N drain 1109 comes from the N and possibly around the NW corner of the house. It may be for taking excess water from the mid 18th-century laundry or from the laundry attached to Aden House. The W-E drain 1106 was blocked by the W foundation of the house (Illus 30) and is therefore associated with this structure or earlier than the house. Excavation within the house may reveal further evidence of the drain as it is too deep to appear on the ground radar survey.

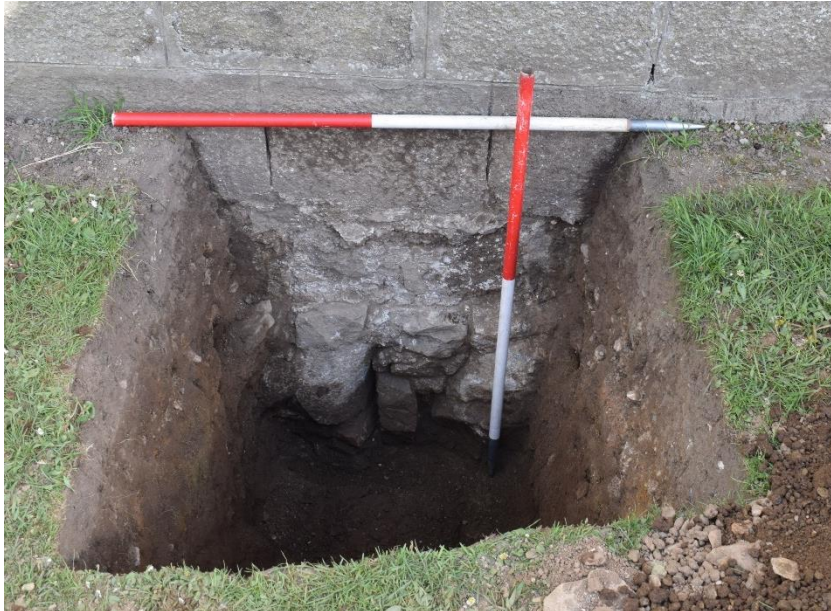
Illus 31 Trench 12 showing foundation of Mansion 0.6m deep; facing E

Trench 12 was excavated on the S side of the house to investigate the foundations and any earlier structures. There was a layer of iron, pottery, glass and other rubble under the turf and above the sand natural subsoil. The foundations were 0.6m deep (Illus 31) and there was no suggestion of an earlier structure in this trench.

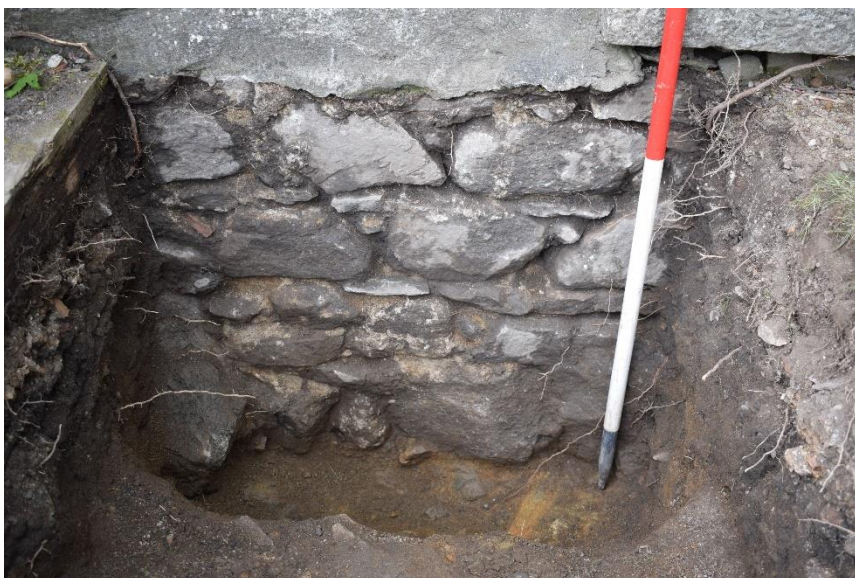
Illus 32 Trench 13 0.6m deep wall foundation under mid 18th-century Mansion wall; facing W

Trench 20 was excavated on the E side of the house to investigate the foundations and any earlier structures. The foundation was 0.6m deep (Illus 32) but there was no evidence of an earlier structure.

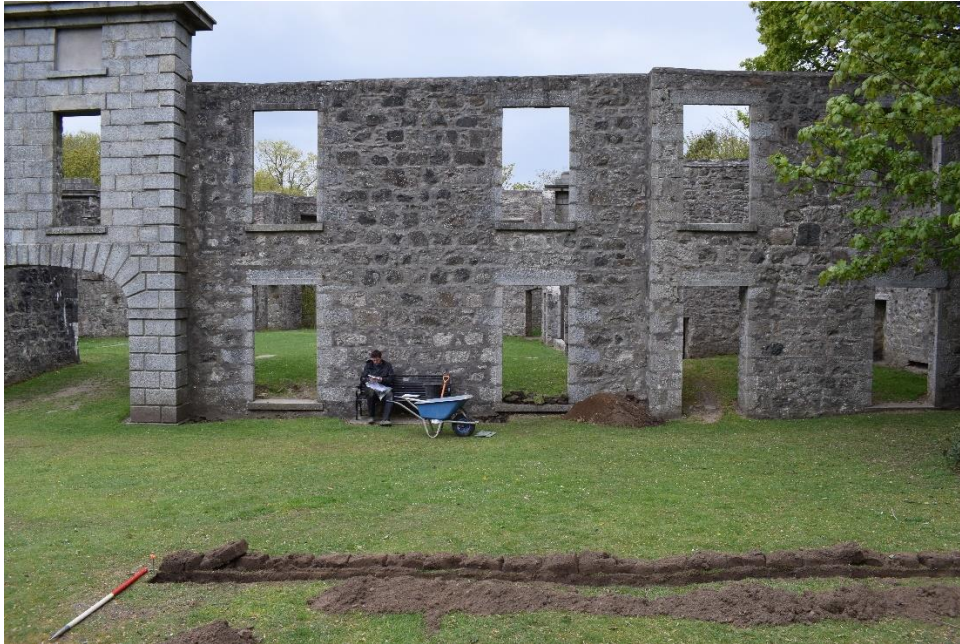
Illus 33 Trench 14 with Mansion E wall in background; facing W

Trench 14 (Illus 33) was excavated on the E side of the house in an area of possible archaeological deposits. The turf was underlain with 5sm of soil on top of natural clayey sand and the trench was recorded and backfilled.

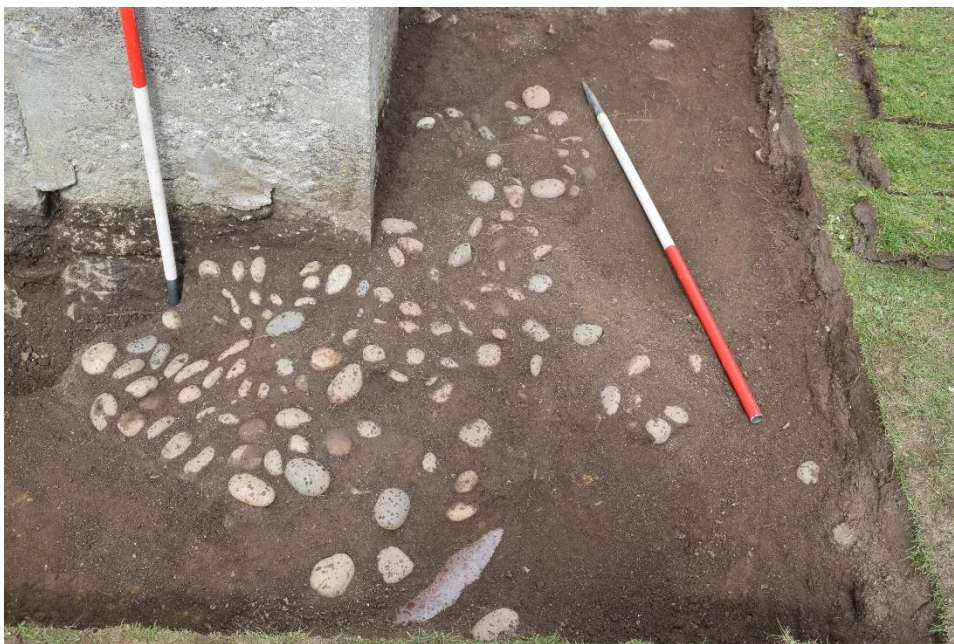
Illus 34 Pebble surface 1502; facing N

Trench 20 was excavated at the SE corner of the house to investigate the foundations and any earlier structures. The foundation of the Mansion is only one stone (0.3m) deep and there is no evidence of earlier structures. There were loam garden soil layers under the turf and a waterwashed pebble surface (1502; Illus 34). These were stratigraphically late in date (mid 20th century) and may have been laid around planting beds as a decorative feature.

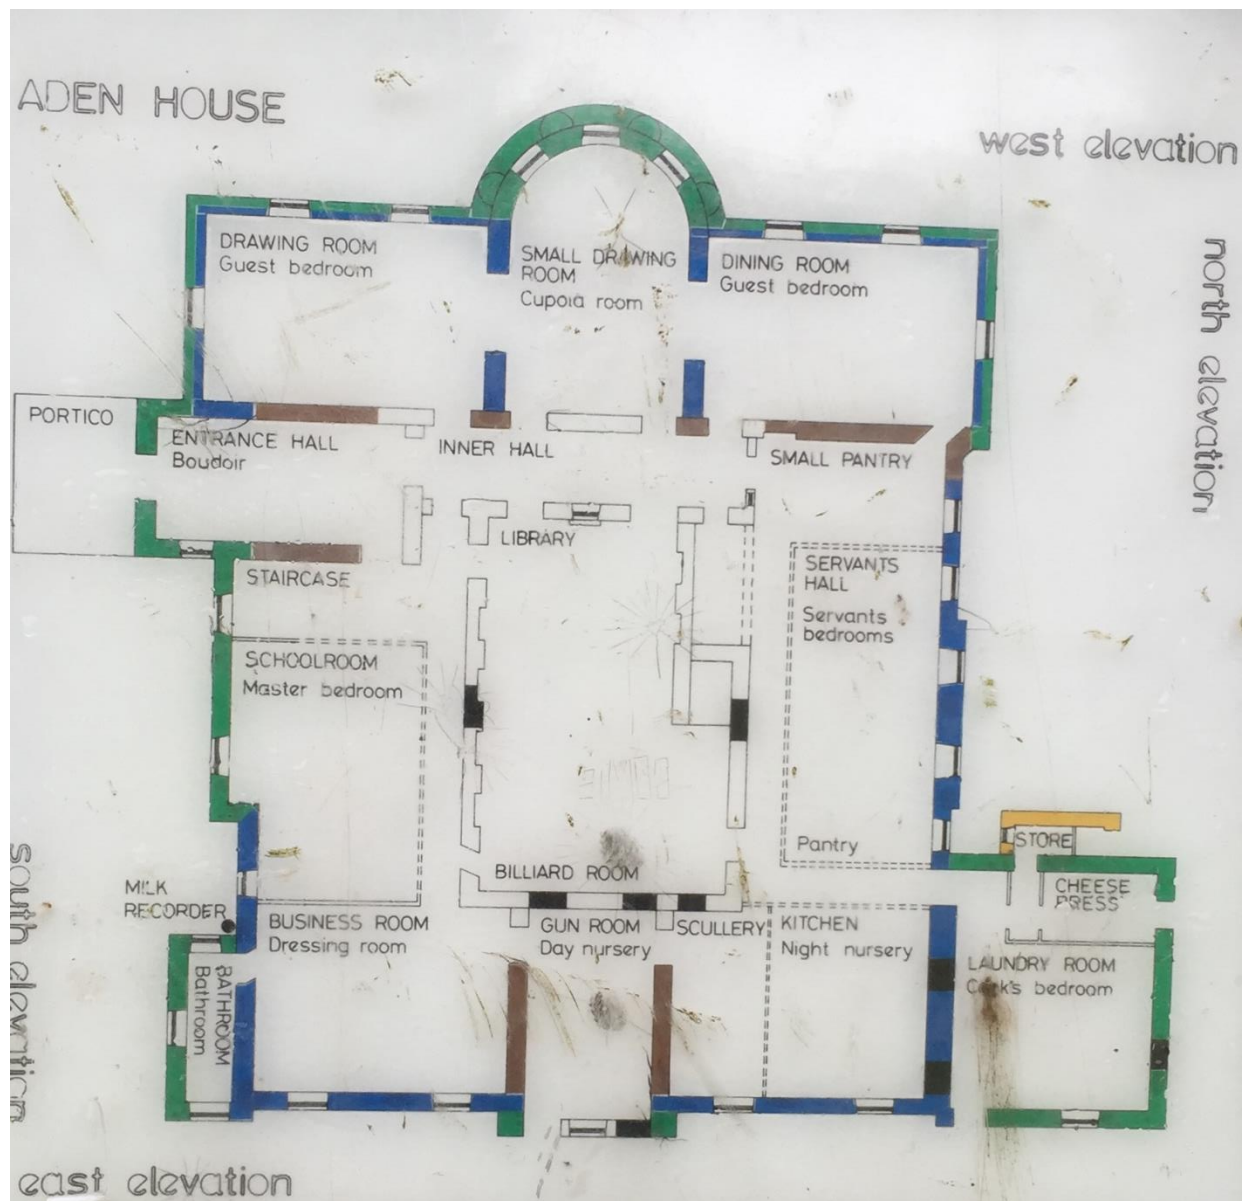
Illus 35 Plan on board within Aden House showing room names

Trench 17 was excavated in the cart door entrance to The Gun Room (Illus 35). Under a concrete floor (1702) was a stone floor (1706, possibly from the mid 18th-century house). The cart door had been blocked with wall 1703 and edged with bricks 1705 (Illus 36-37). This blockage can be seen on the mid 20th-century photograph (Illus 38). This is an area for further study as this cart door led into a central courtyard in the mid 18th-century house.
