ADEN COUNTRY PARK, ABERDEENSHIRE, AB42 5FQ

Data structure report (29 April-12 May 2019 excavation)

**Alison Cameron
Cameron Archaeology
13 June 2019**

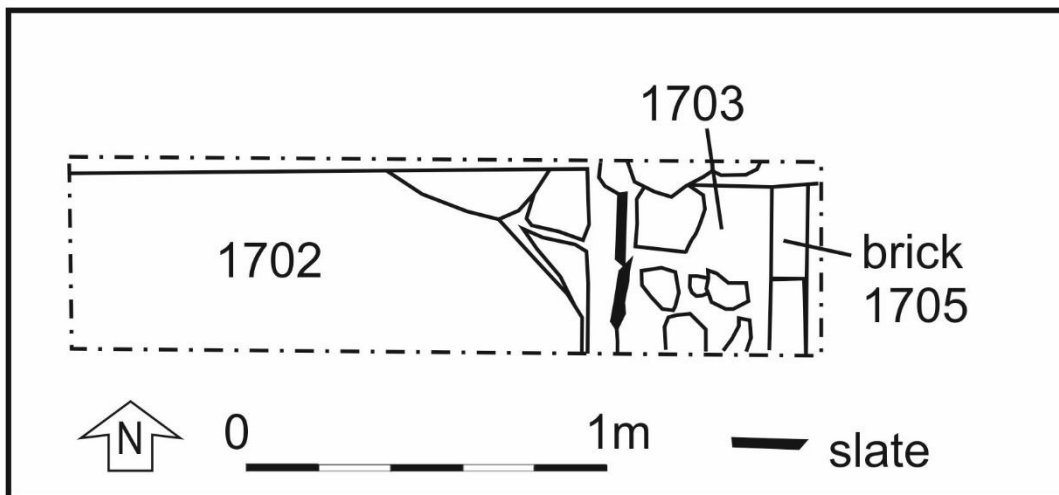
Illus 36 Trench 17 features

Trench 17 was excavated in the cart door entrance to The Gun Room (Illus 35). Under a concrete floor (1702) was a stone floor (1706, possibly from the mid 18th-century house). The cart door had been blocked with wall 1703 and edged with bricks 1705 (Illus 36-37). This blockage can be seen on the mid 20th-century photograph (Illus 38). This is an area for further study as this cart door led into a central courtyard in the mid 18th-century house.

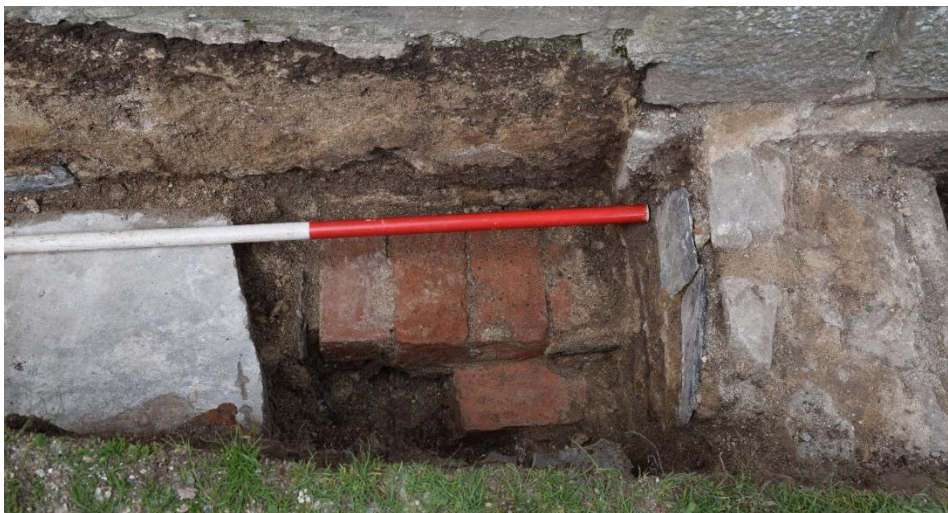
Illus 37 Trench 17 concrete floor 1702 (left) bricks underneath and stone wall foundation 1703 (right); facing N

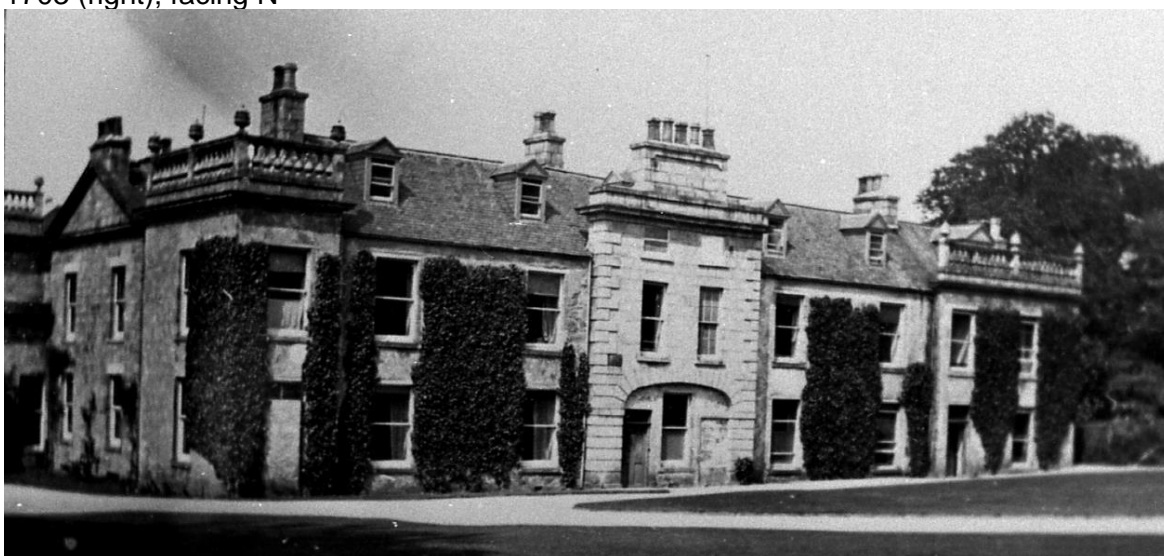
Illus 38 Cart door (centre) showing infilling with stone and brick wall (1703); facing NE (copyright Aberdeenshire Council)

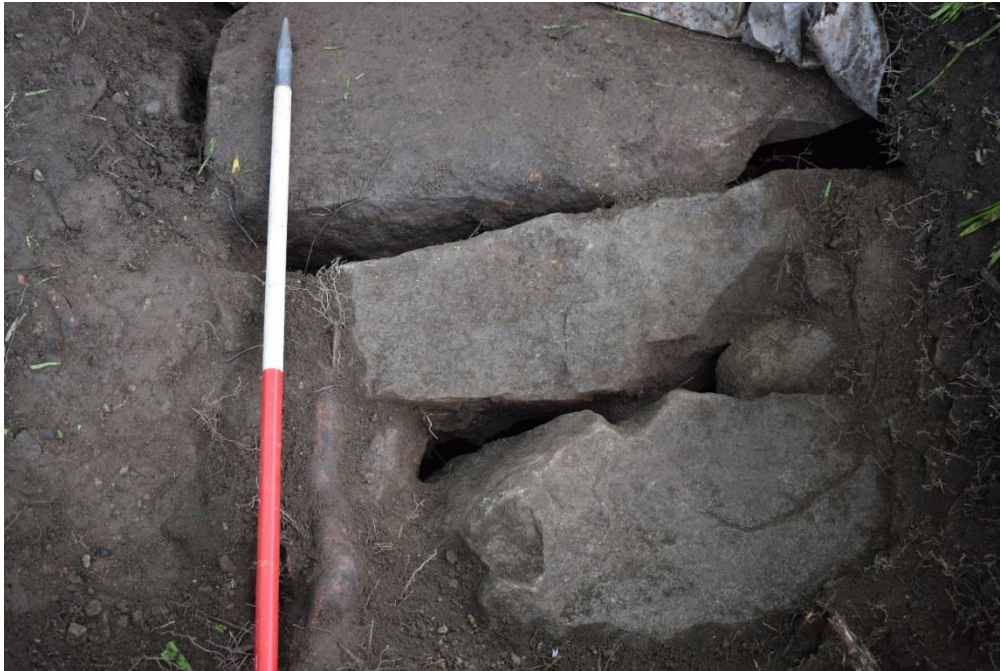
Illus 39 Stone drain capping 1901; facing NE

Trench 19 was excavated at NJ97885 47790 at the location near the river that Jack Grant (park manager) dug and found a stone drain.

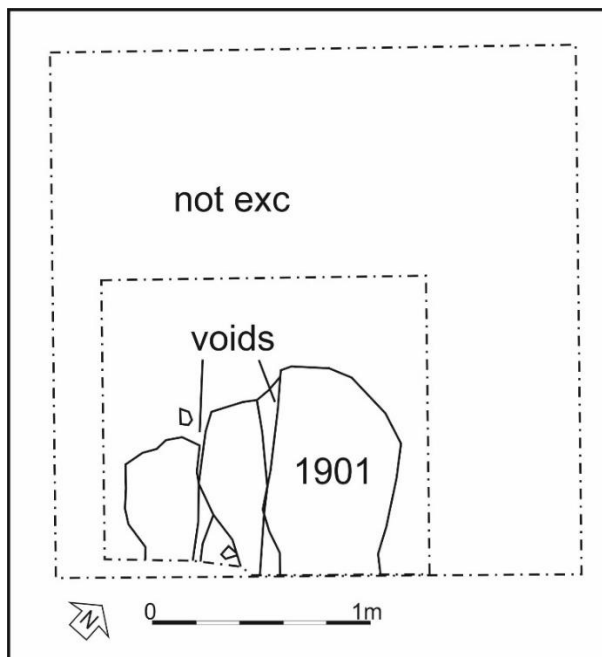
Illus 40 Drain capping 1901

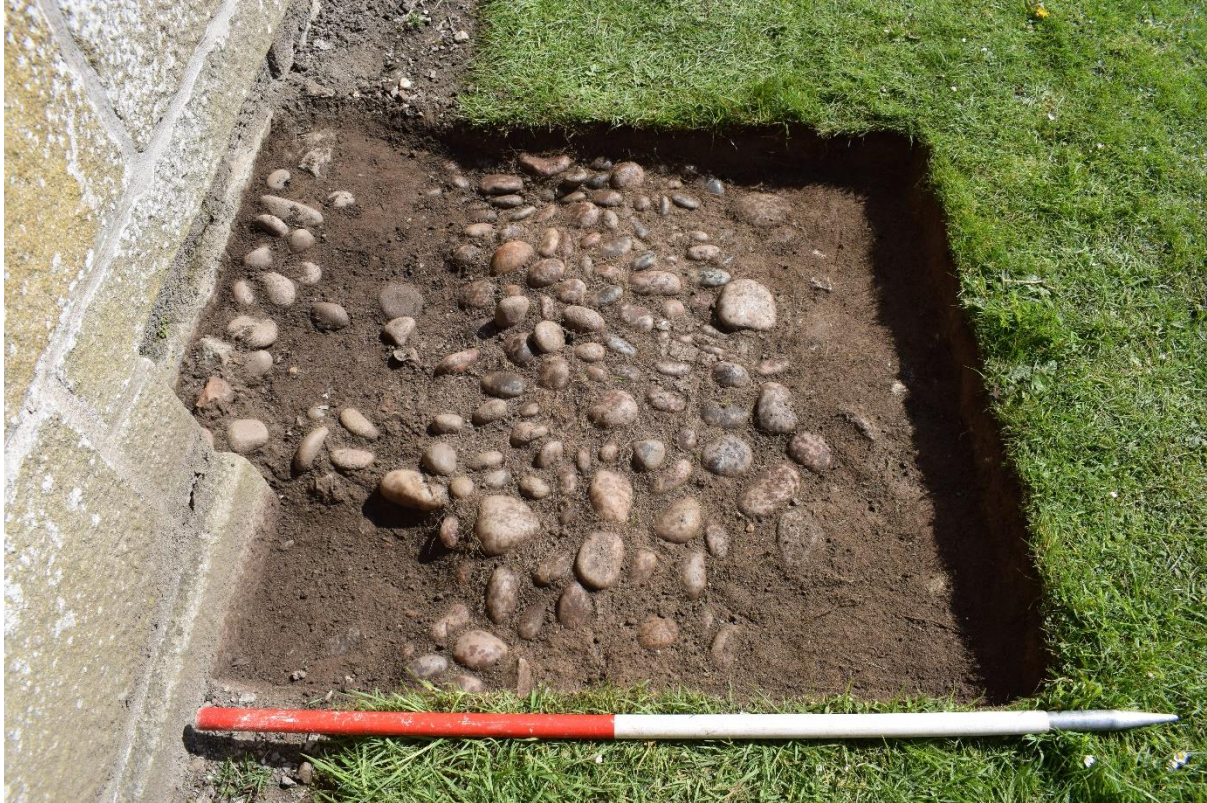
Illus 41 Trench 20 pebble surface 2002; facing E

Trench 20 was excavated on the S side of the house to investigate the foundations and any earlier structures. A shallow 0.3m foundation was recorded and a waterwashed pebble surface (Illus 41) like that seen in Trench 15. These were stratigraphically late in date (mid 20th century) and may have been laid around planting beds as a decorative feature.

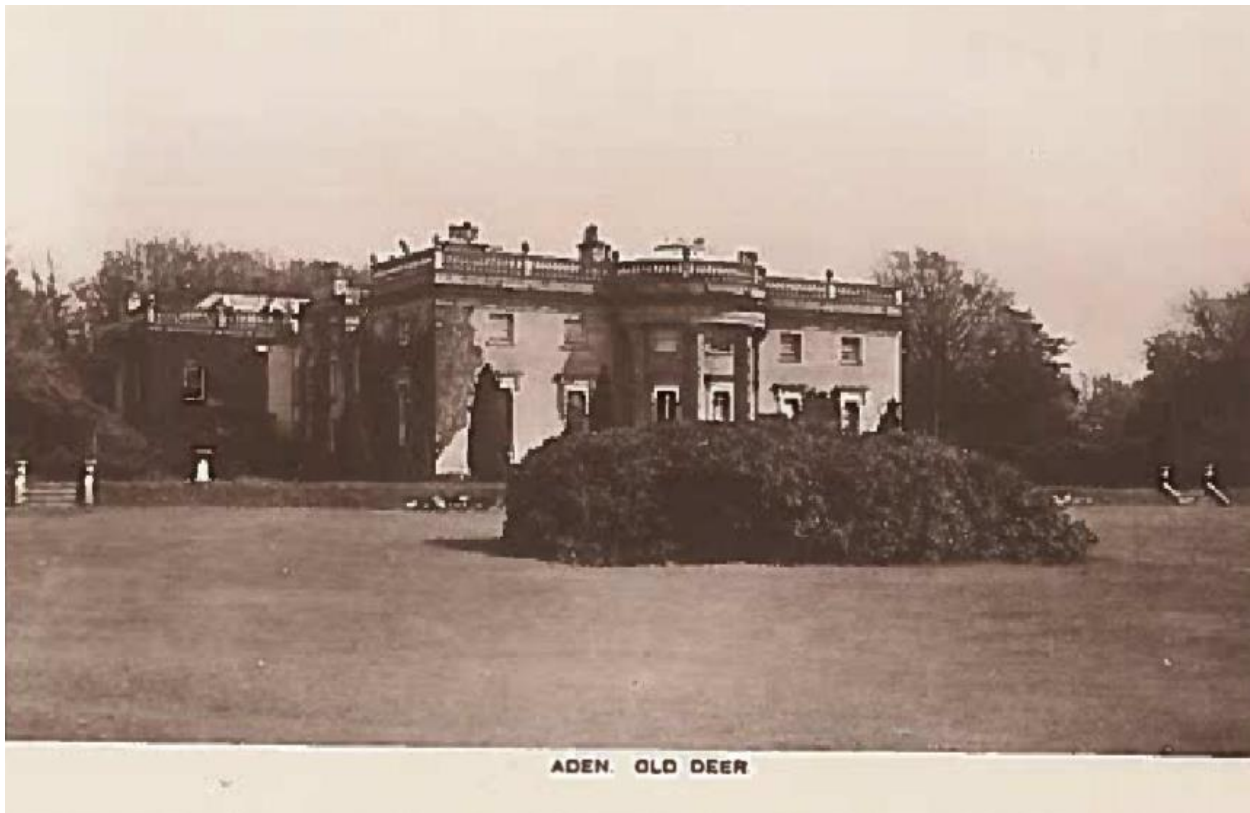
Illus 42 Postcard kindly copied by owner David Elrick showing two sets of steps from the W garden, no fountain but a smaller bird bath/planter NW of the house outwith the excavation area.

garden. These show that the Ha-ha wall (Illus 8) which is still *in situ* did have two sets of steps to access the lower gardens. These can be seen on photographs (for example Illus 43).

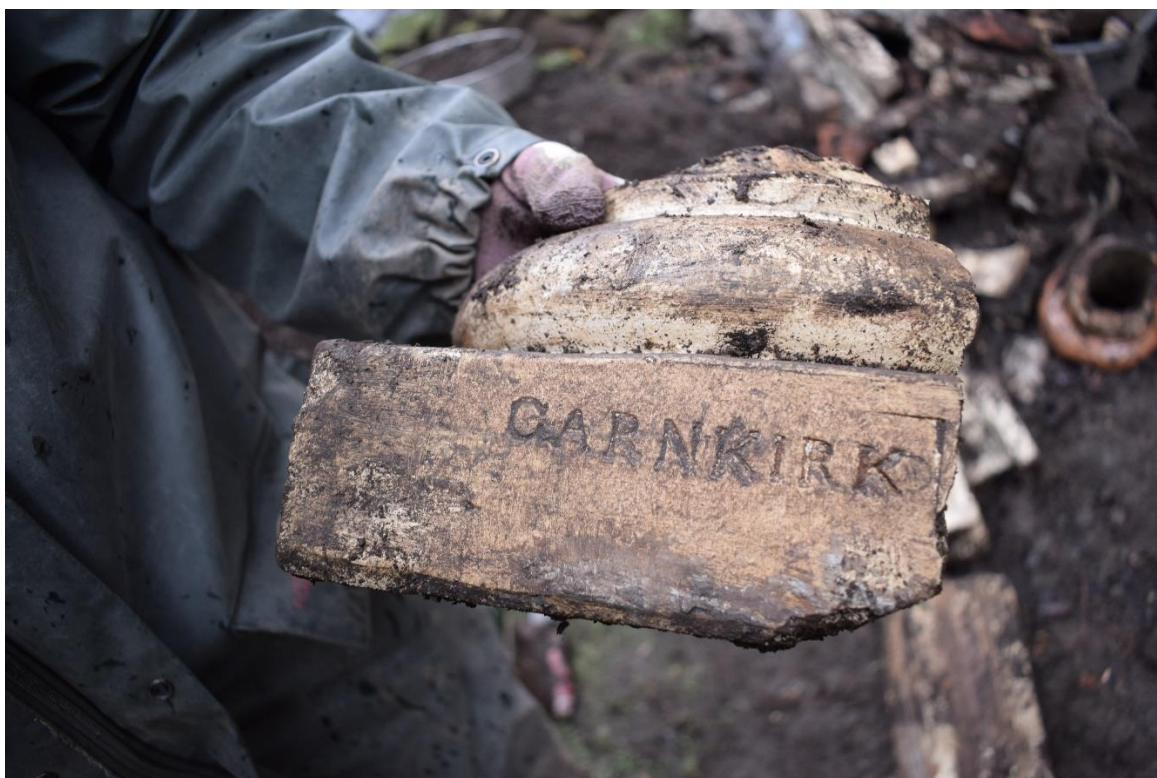
Illus 43 Garnkirk stamped fireclay roof furniture from Trench 8

Finds include 18th and 19th-century domestic waste including pottery and glass, building material including window glass, brick, ceramic roof furniture (Illus 43, 44) and garden furniture including ceramic garden planters (Illus 45) and plant pots, and concrete pond fragments.

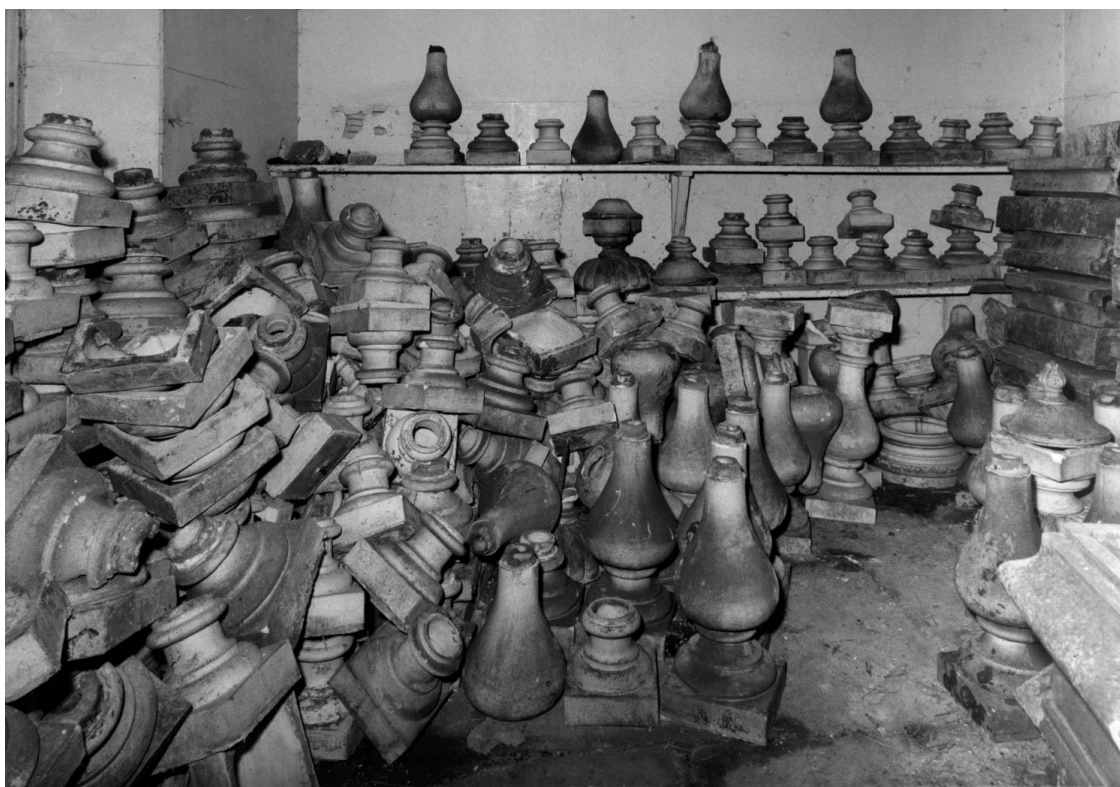
UNIT C (INTERIOR VIEW EXTREME RIGHT FROM NORTH
FIRECLAY PIECES FROM ROOF OF ADEN HOUSE)
NEGATIVE NO.

Illus 44 Fireclay pieces from the roof of Aden House photographed in mid 1970s when Aberdeenshire Council carried out a survey of the buildings; they then disappeared.

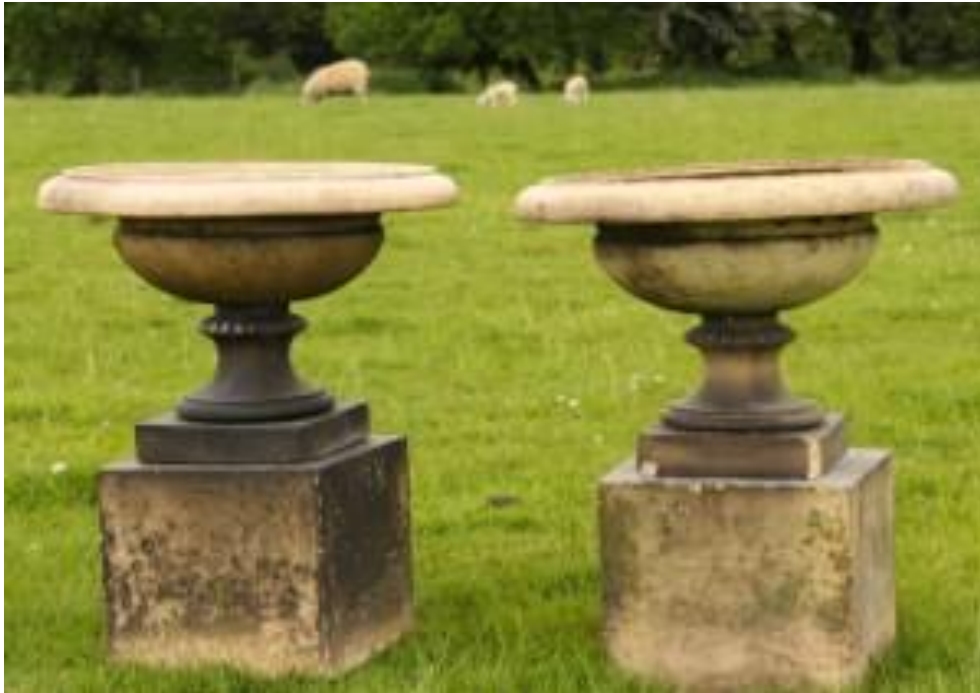
Illus 45 Garnkirk pedestal planters (years of activity 1831-1898)
<https://www.scottishbrickhistory.co.uk/garnkirk-fireclay-works-garnkirk-north-lanarkshire-history/>

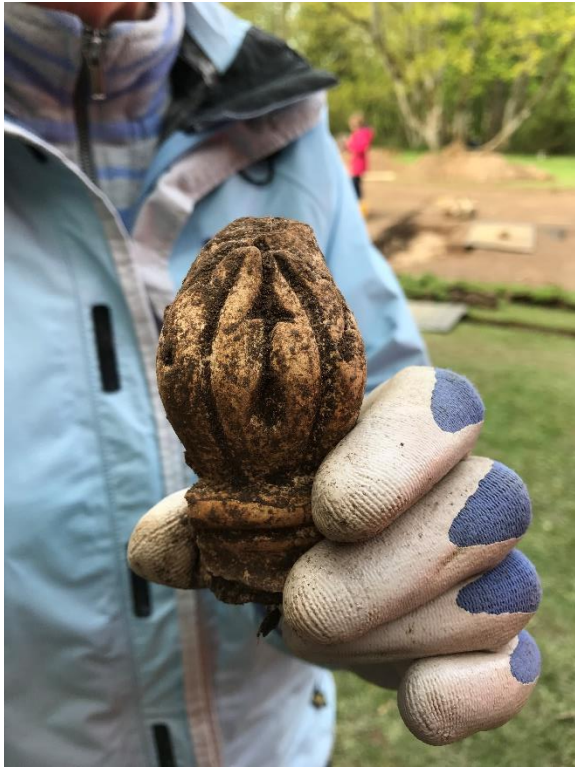
Illus 47 Fireclay finial from roof furniture
