Witham Archaeology

A Report to Mr and Mrs Toulson

**BULWARK FARM, CHURCH LANE, SCREDINGTON,
LINCOLNSHIRE**

Historic Building Recording

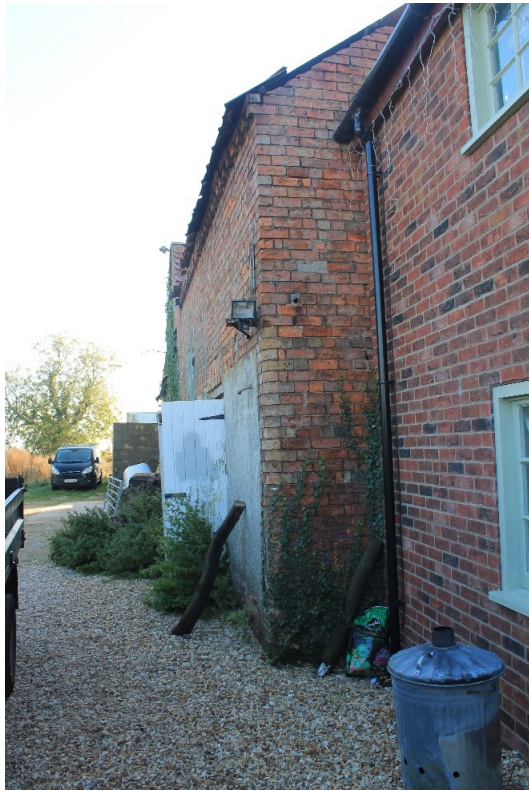
Plate 2 Northwest corner of outbuilding A showing slight coaching corner (modern farmhouse extension at right), looking east.

The north elevation of this range was generally of English garden wall bond brickwork (three stretcher courses to 1 header course) (Plate 3), and this brick bond was used throughout the majority of the buildings. Rounded bricks were used to form a slight coaching corner at ground floor level at the northwest corner of the building (Plate 2). At eaves level was a single course of straight dentils topped by a projecting string course of brick. The west gable end of this building was almost entirely obscured by the modern farmhouse extension immediately adjacent to it.

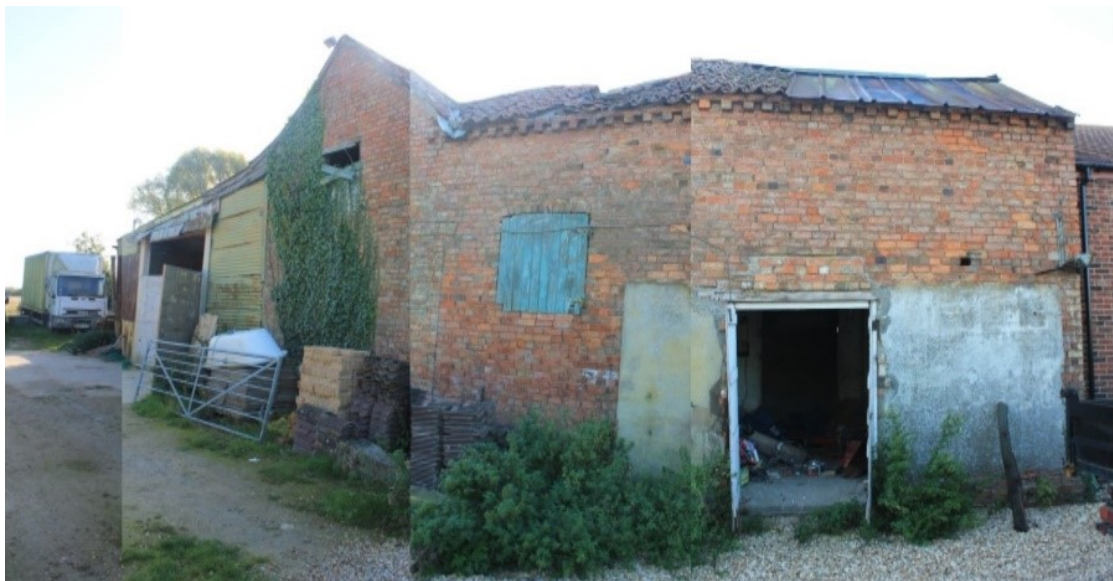
Plate 3 North elevation of surveyed outbuildings, dovecote and stable A at right, animal accommodation B at centre, Barn C at left and shelter shed D at far left, looking south and southeast.

A postulated lean-to structure H, adjoining the north elevation of range A and B, is represented by external render at ground floor level, in addition to a single small hole in the brickwork above the render which may have formed part of this structure (Plate 3). A lean-to structure is visible in this position on a 1970s aerial photograph of the site (Figure 6).

The north external gable met building B with a straight join, apart from the uppermost 8 courses which were keyed-in (Plate 3). This gable was largely obscured by ivy, but included a single opening at first floor level, which had a wood surround and wooden planks secured over it. No additional features were noted in this gable internally (Plates 16 & 17).

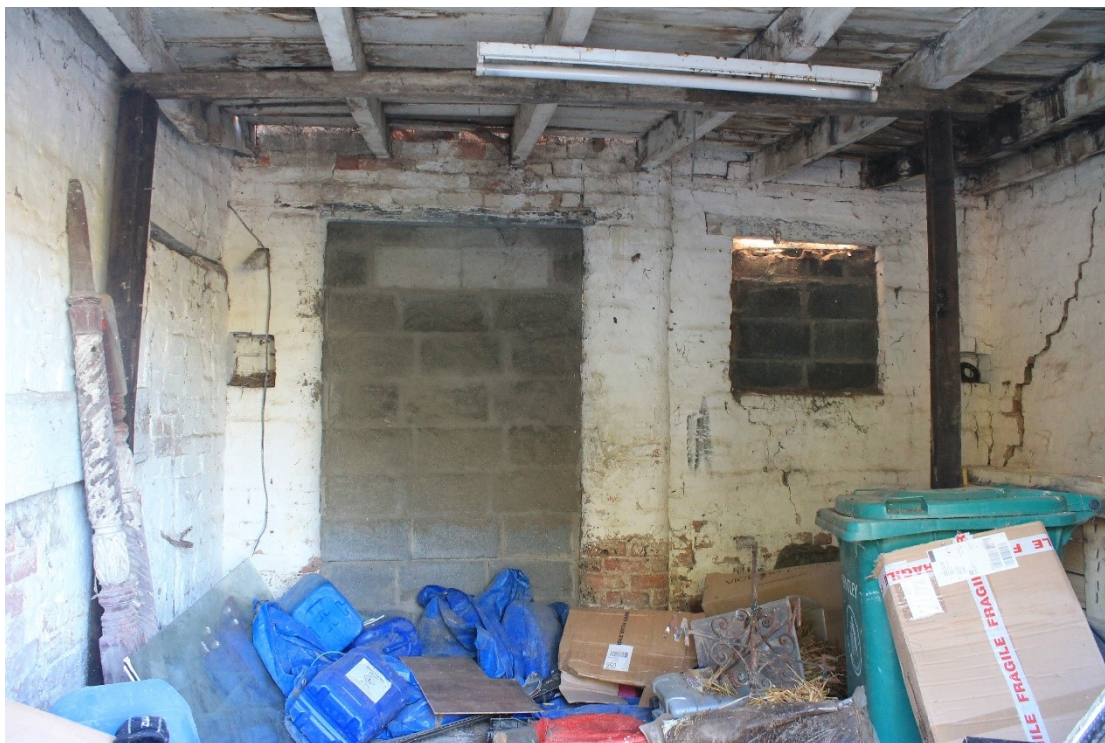
Plate 4 Ground floor interior of stable A, showing blocked door and window, tack hook and recesses in south wall, blocked door and timber of east wall visible at left, looking south.

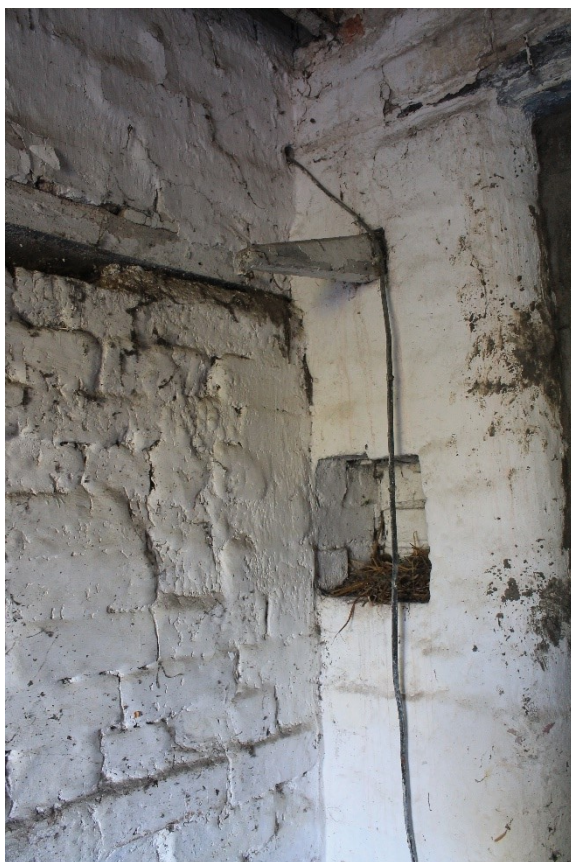
Plate 5 Interior of ground floor stable of building A showing tack hook and recess associated with use as stable, looking southeast.

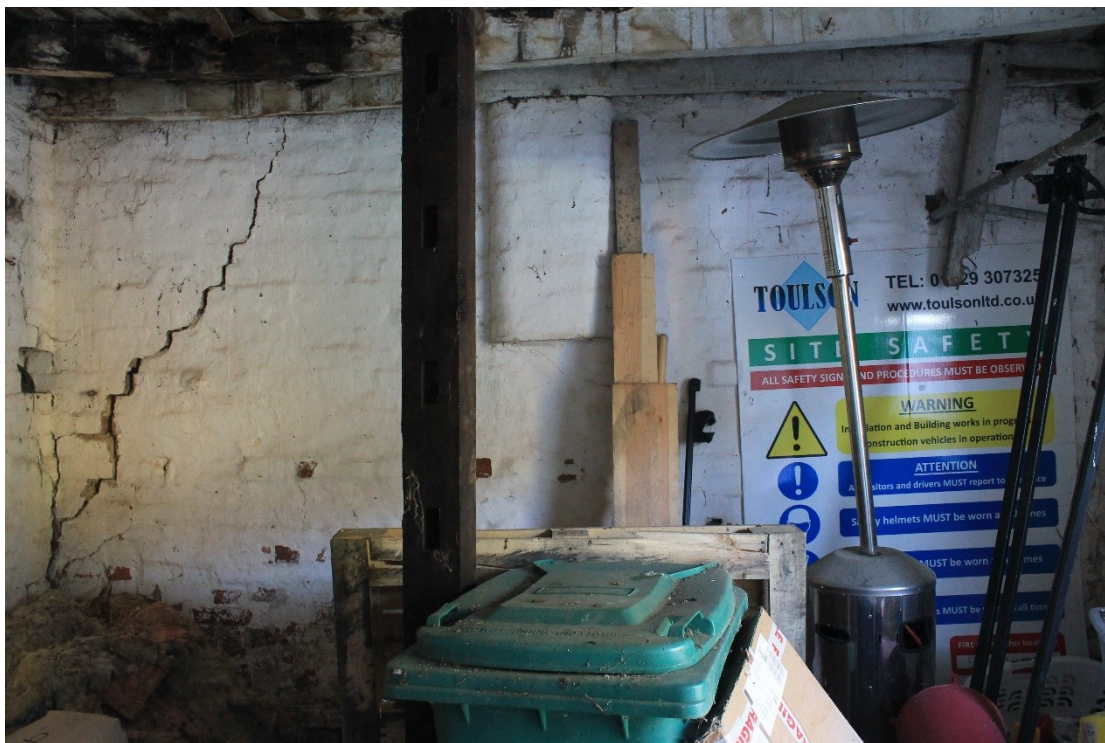
Plate 6 Interior of ground floor stable of building A showing brickwork of western wall, looking west.

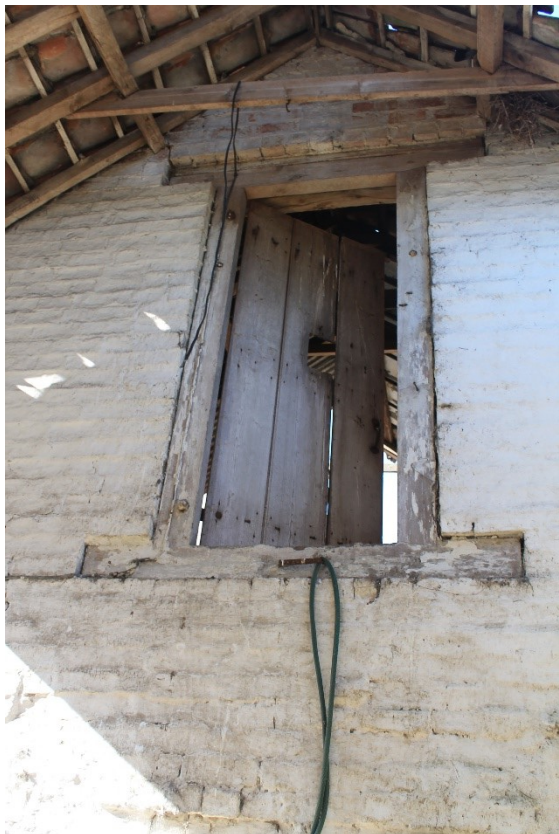
Plate 8 Doorway from room B leading to building A upper storey dovecote showing dove hole in plank door, looking west.

The upper storey of building A comprised a purpose-built pigeon loft. Within farms, such lofts are often located in the upper storey of other buildings such as stables or coach houses (Hansell and Hansell 1988, 163). In the 18th century it was even recommended that positioning pigeon lofts above stables or cowhouses would help the birds keep warm in the winter months and encourage early spring breeding, although by the 19th century their position in farmyards was random (Hansell and Hansell 1992, 64-66). The Bulwark Farm pigeon loft or dovecote included numerous brick-built nest boxes in each of its four walls, each with a small brick-built landing stage. It originally had a large opening in the west gable end. This had been largely removed by the time of the survey, but is evident on aerial photographs of the farm dating to the mid to late 20th century. In an aerial photograph dating to the 1970s this opening appears to be blocked, perhaps with wood, within which is a smaller access hole for birds. Three further dove holes were recorded in the brickwork of the south wall of the building. The room was accessed via a door in the east wall, presumably via a ladder leading up from ground floor room B. This planked door also included a small access hole for birds.

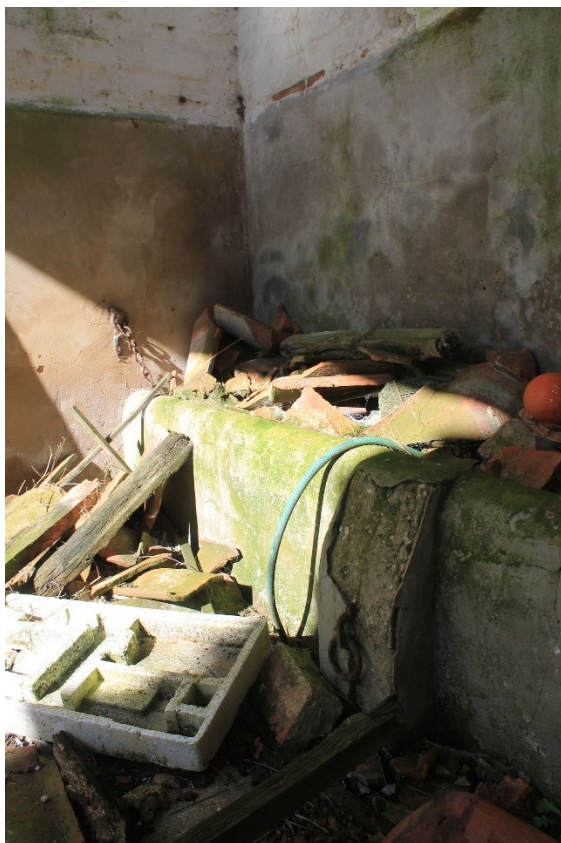
Plate 9 Interior of room B, detail showing rendered walls, concrete manger and iron tethering rings associated with use as cattle accommodation, looking northwest.

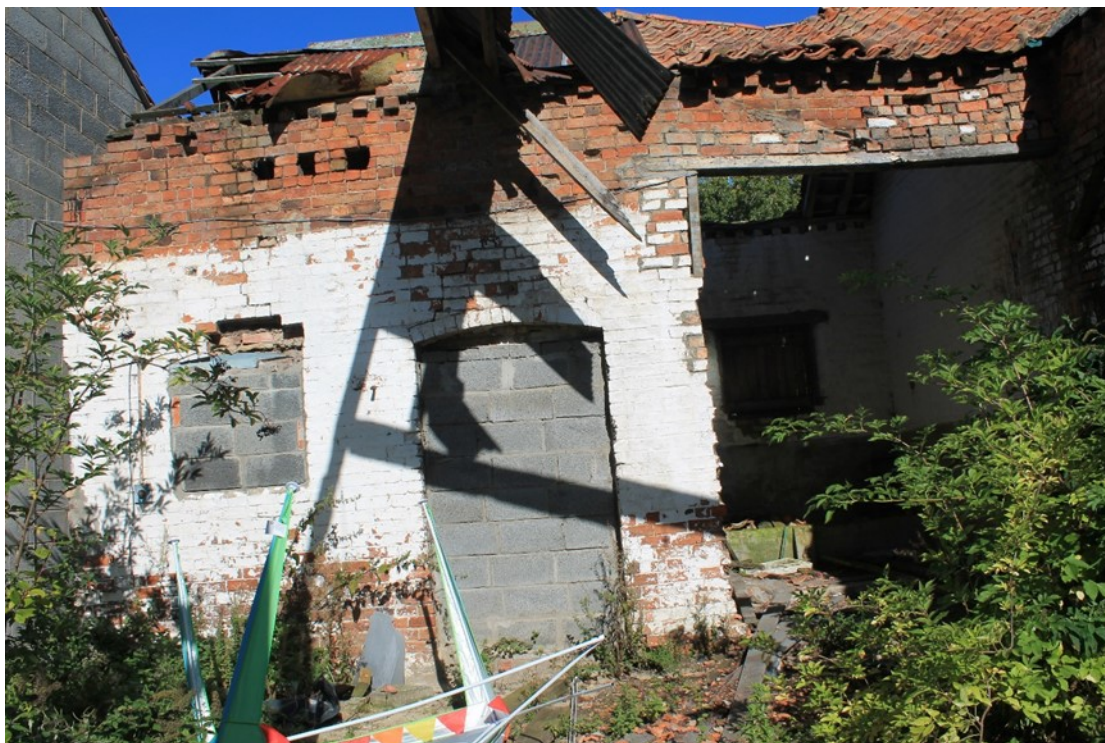
Plate 10 South external elevation of buildings A and B showing blocked openings of building A stable at left and three dove holes in brickwork at first floor level.

The south external elevation of A revealed brick segmental arches over both the ground floor blocked window and door, although the arch over the window had partly collapsed (Plate 10). Shaped bricks had been used at the southwest corner of this building to form a coaching corner at ground floor level, mirroring that of the northwest corner of the building.

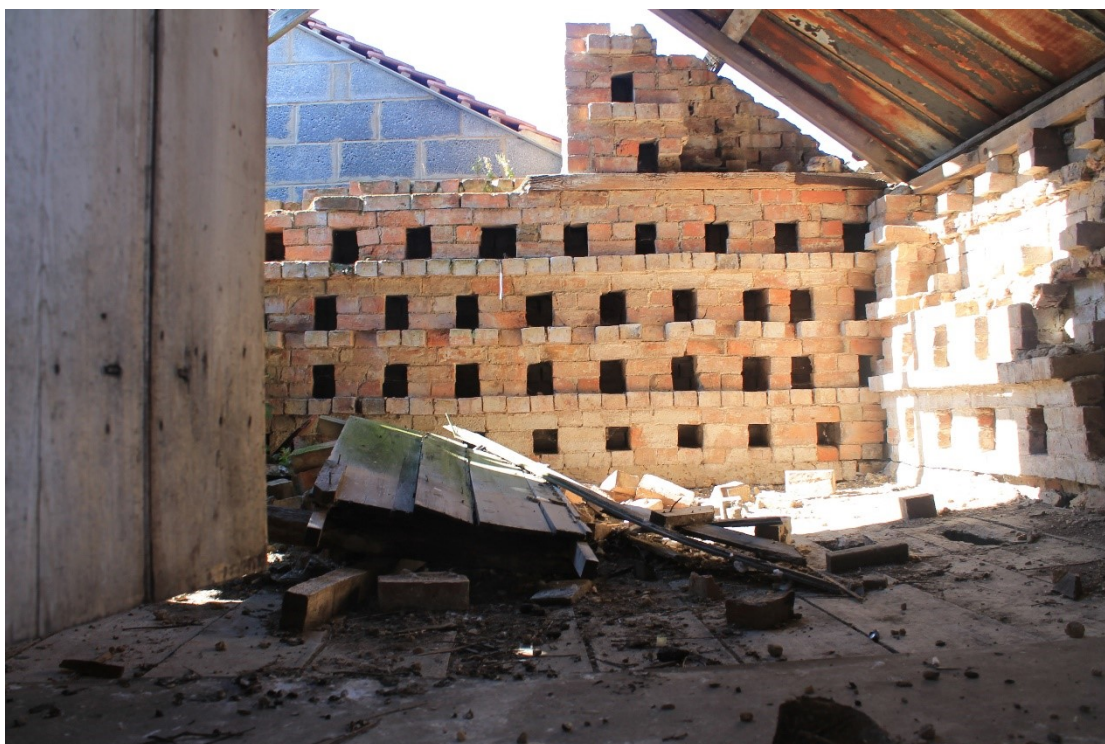
Plate 11 Interior of first floor dovecote or pigeon loft of building A as viewed from doorway, looking west.

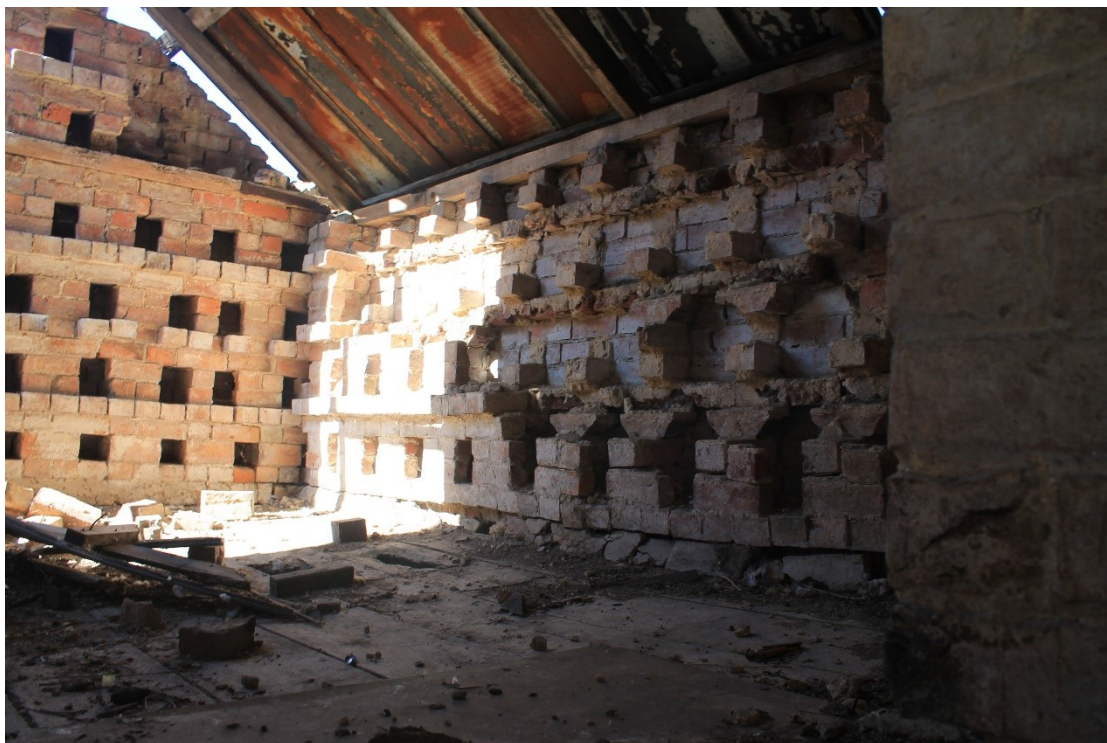
Plate 12 Interior of first floor dovecote or pigeon loft of building A as viewed from doorway, looking northwest.

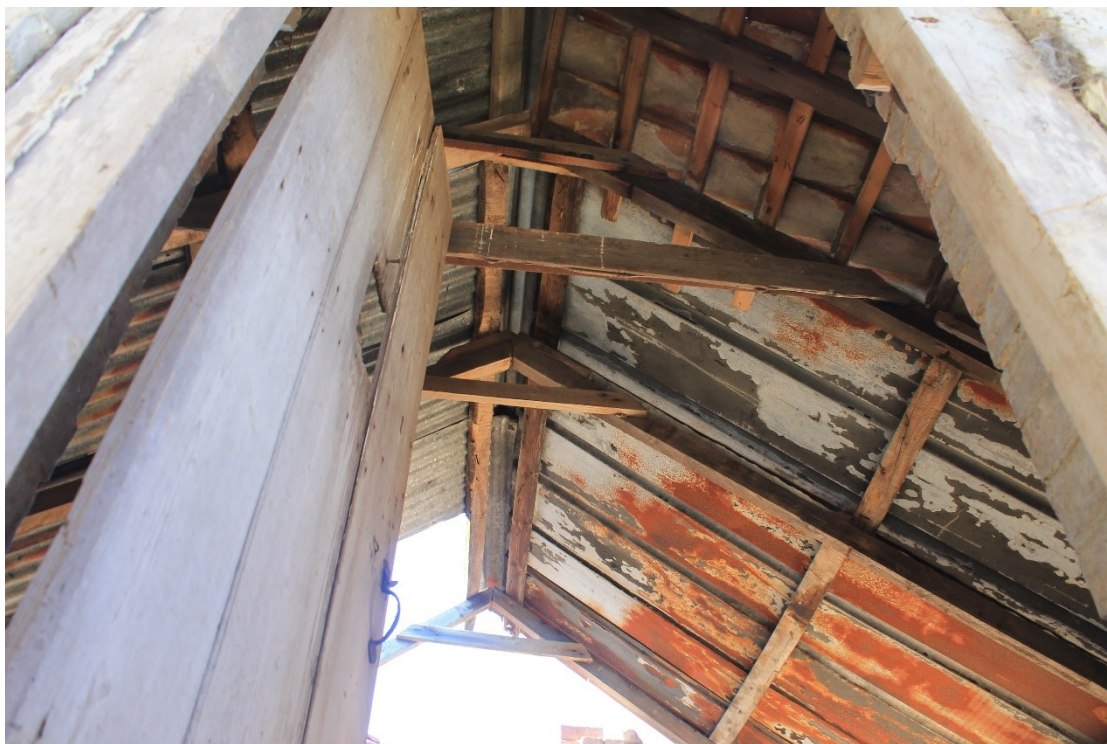
Plate 13 Interior of first floor dovecote of building A as viewed from doorway showing roof structure, looking west.

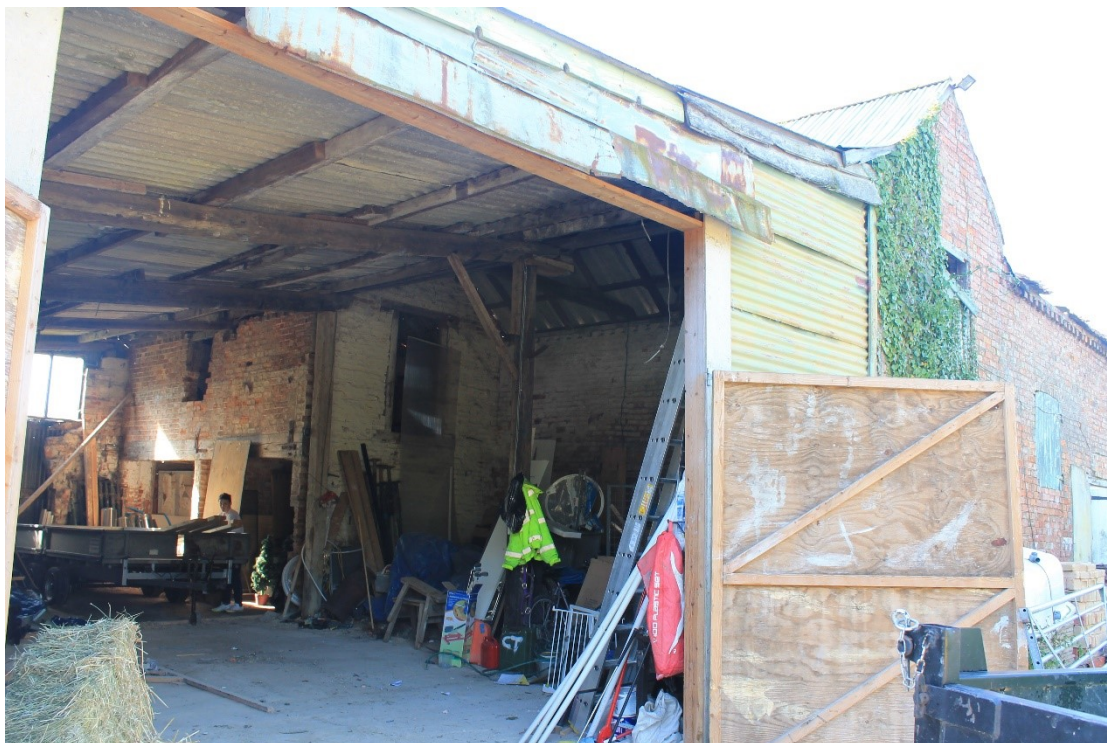
Plate 14 View of barn C, including external north gable end at right and south gable end now within shelter shed, looking southwest.

The east wall of barn C had been entirely removed and replaced by three wooden supports. Two of these were of telegraph pole type, and a third of squared, possibly reused, timber (Plates 14-16).

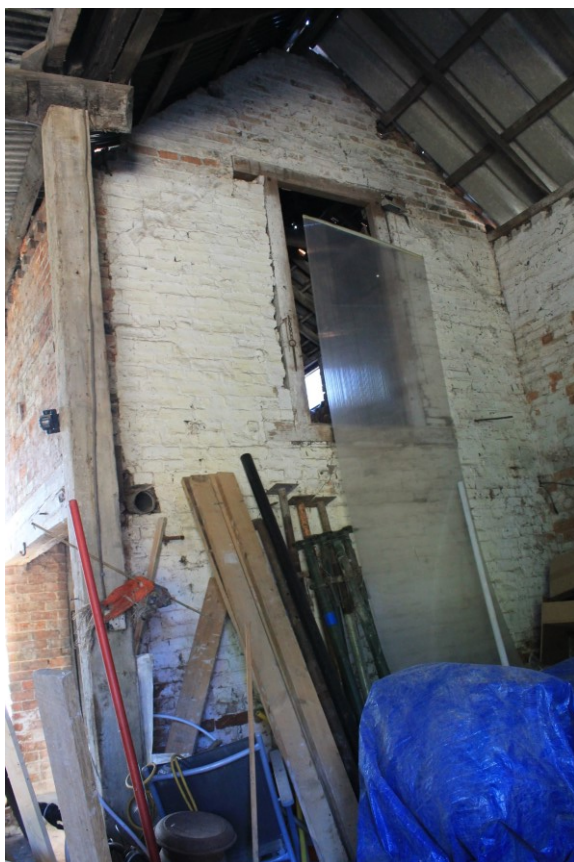
Plate 15 South gable end of barn C (also forming north gable of building E), looking southwest.

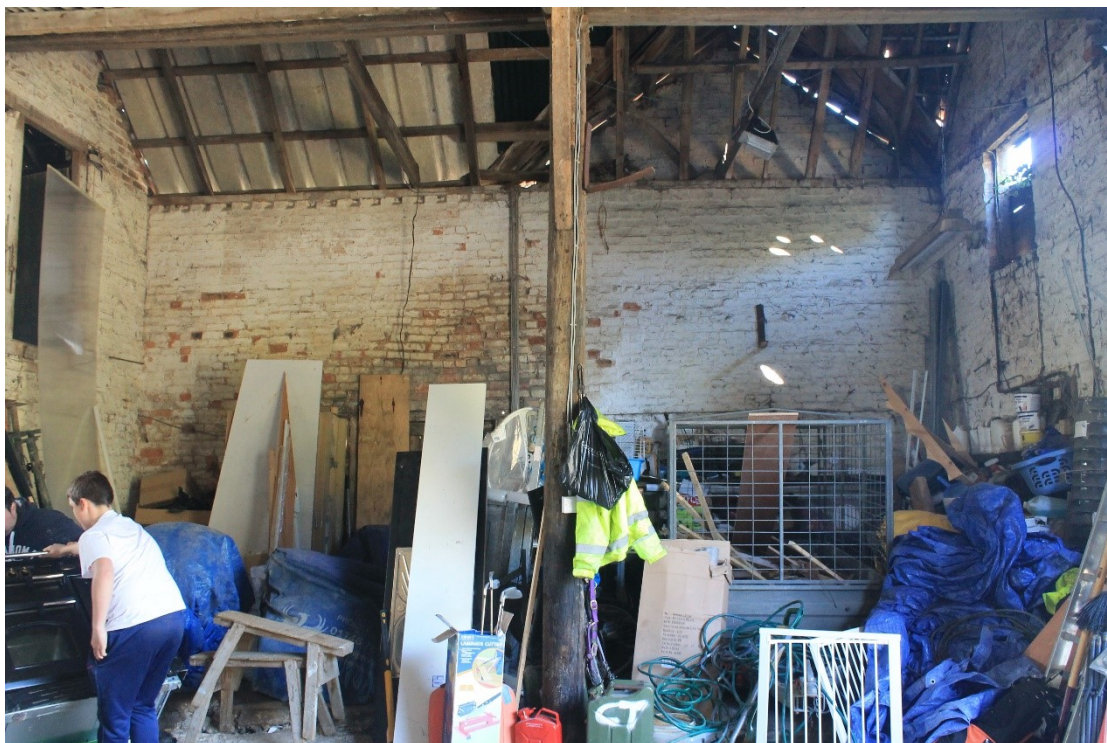
Plate 16 Internal view of west wall of barn C as seen from inside shelter shed D, looking west.

The long west wall of barn C (Plate 16) had a single wide door opening with a plank door and wood surround. As viewed externally, this doorway had a brick segmental arch over it, and clearly replaced an earlier doorway, also with a brick segmental arch, which it partially overlapped at its northern edge (Plate 18). This doorway was probably moved when the adjacent range A and B was constructed, the southern wall of this range forming a scar in paintwork on the west wall of barn C.

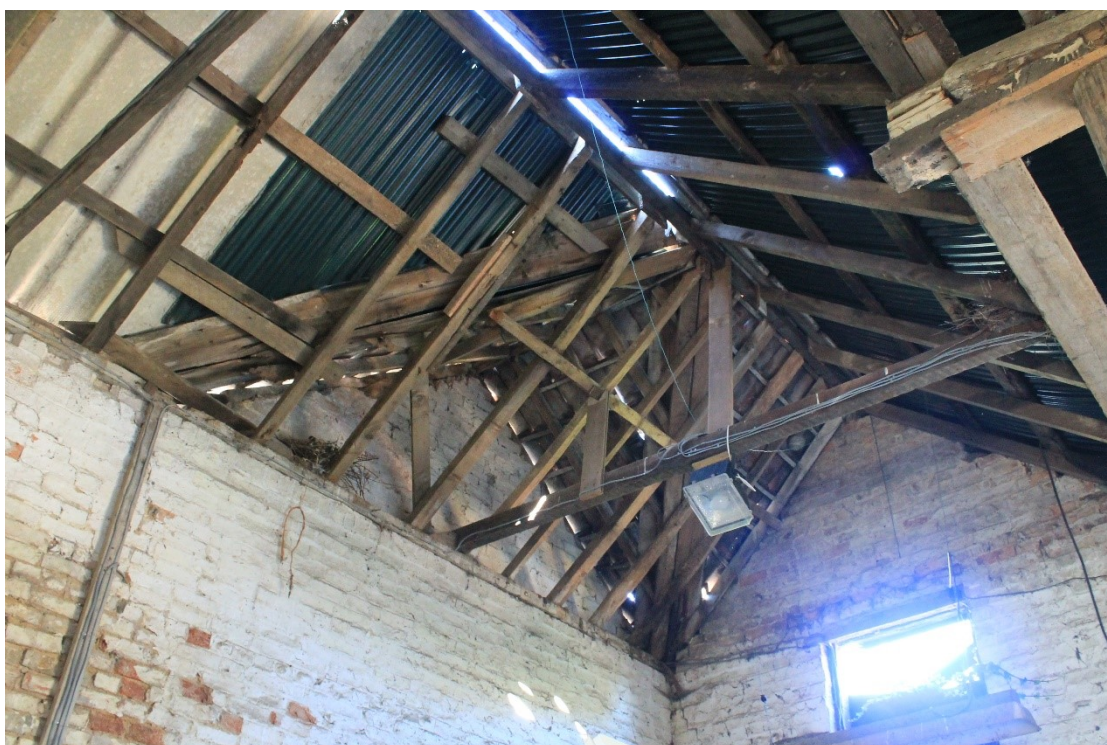
Plate 17 Interior of barn C (gable at right), detail of roof structure at junction with adjacent building B (gable at left), looking northwest.

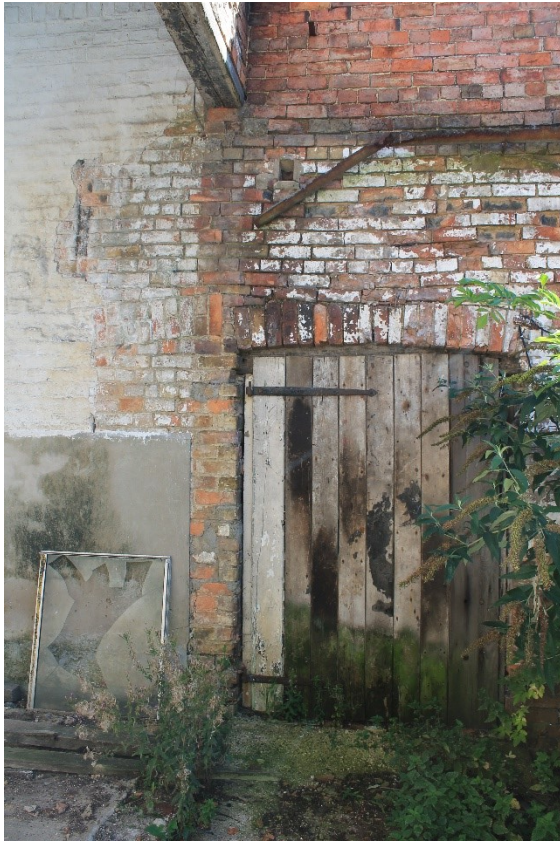
Plate 18 Detail of east wall of barn C, showing doorway, earlier blocked doorway to left, and position of southern wall of building B visible as vertical scar in whitewash, looking east.

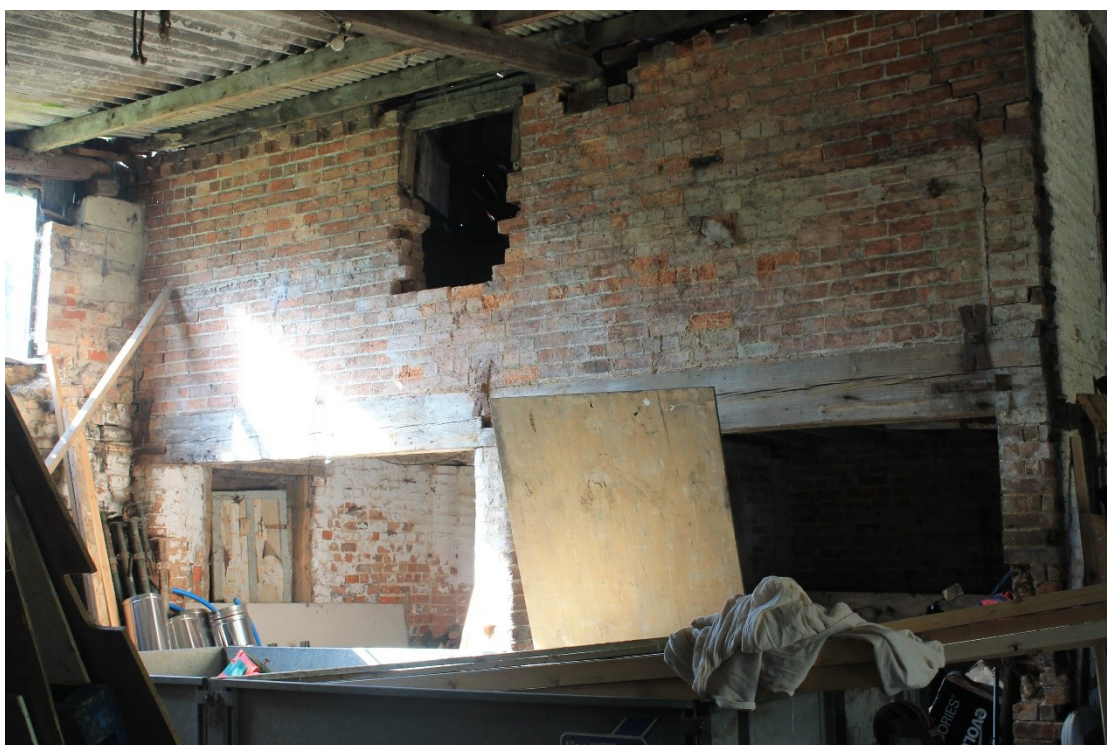
Plate 20 Cart shed and possible granary E, as viewed from inside shelter shed D, looking southwest.

The upper floor of building E included an opening in the western elevation which retained part of a wooden frame and shutter (Plate 20). This opening appeared to have been enlarged at some time with the removal of an irregular area of brickwork immediately beneath it. A further high opening was recorded in the west elevation of the building (Plate 29) and this is probably a later insertion to the building.

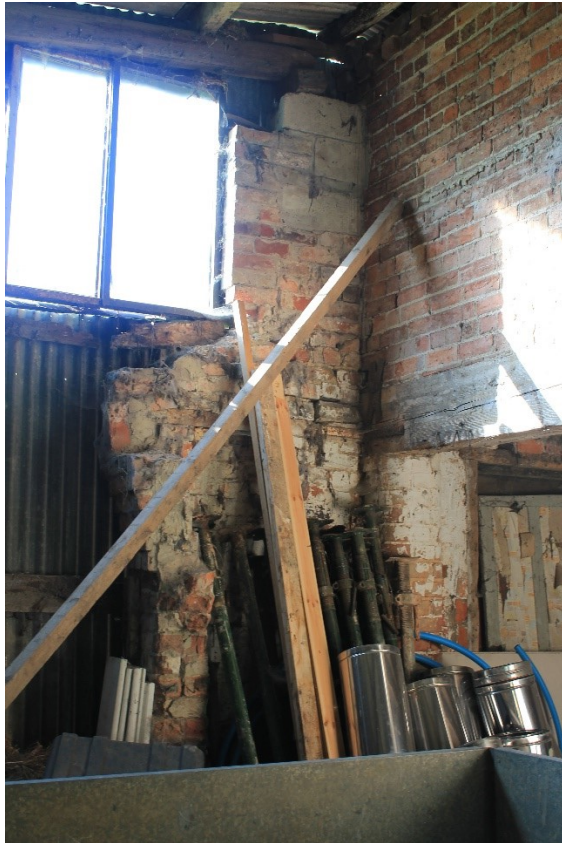
Plate 21 Detail of fragmentary masonry of structure G, apparently forming passageway associated with conversion of cart shed E to stables, looking southwest.

At the southeast corner of building E was an attached stretch of walling with a short return G (Plates 21 and 28). Internally, this appeared to include the scar of the pitched roof of a lean-to and possible traces of a doorway. This seems likely to be an addition to building E and would have formed a corridor along the eastern side of building E as part of the conversion to stables. The majority of extension G had been demolished on the construction of adjacent shelter shed D, and the remaining fragments of walling had been much repaired at this time.

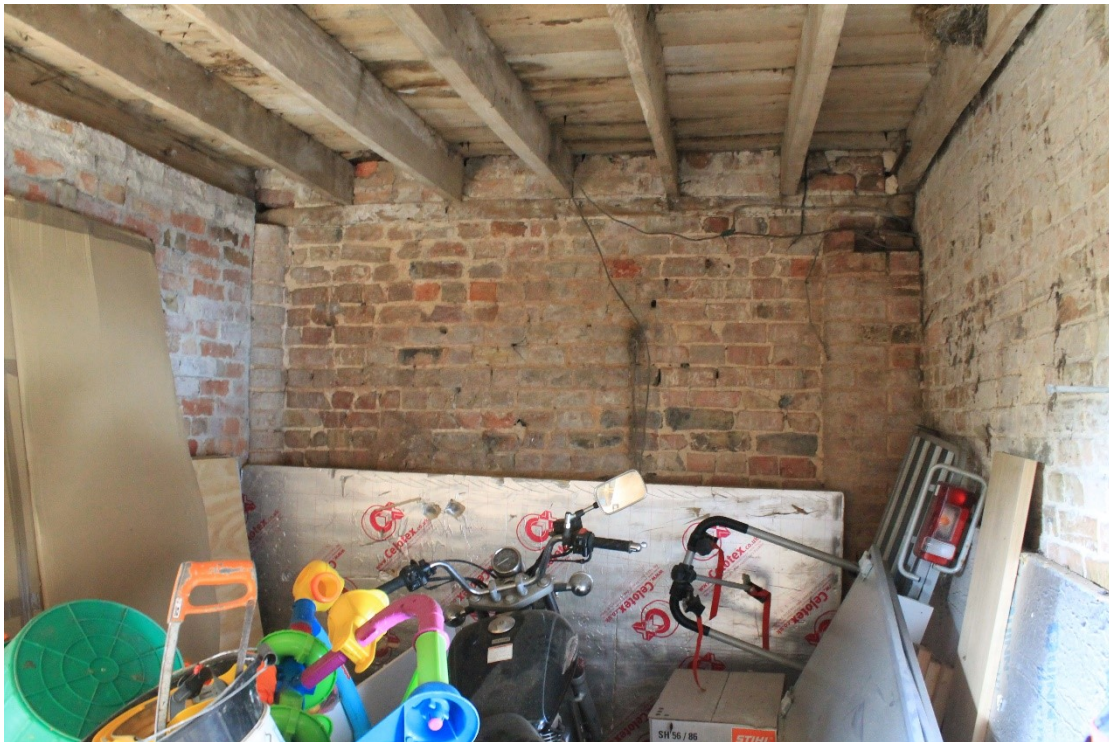
Plate 22 Interior of north bay of cart shed E, showing infilled brick wall at left and wooden joists and flooring of upper floor over, looking west.

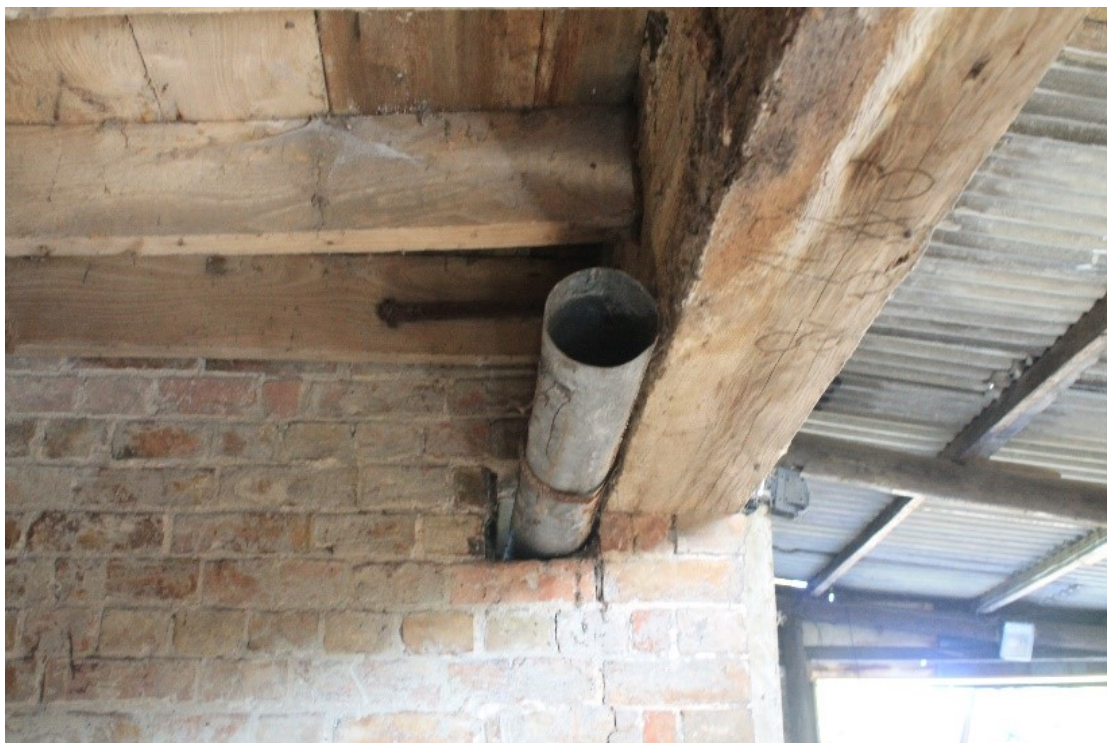
Plate 23 Interior detail of north bay of cart shed E, showing metal pipe exiting north wall of bay, possibly associated with former stove within this room during use as a stable, looking north.

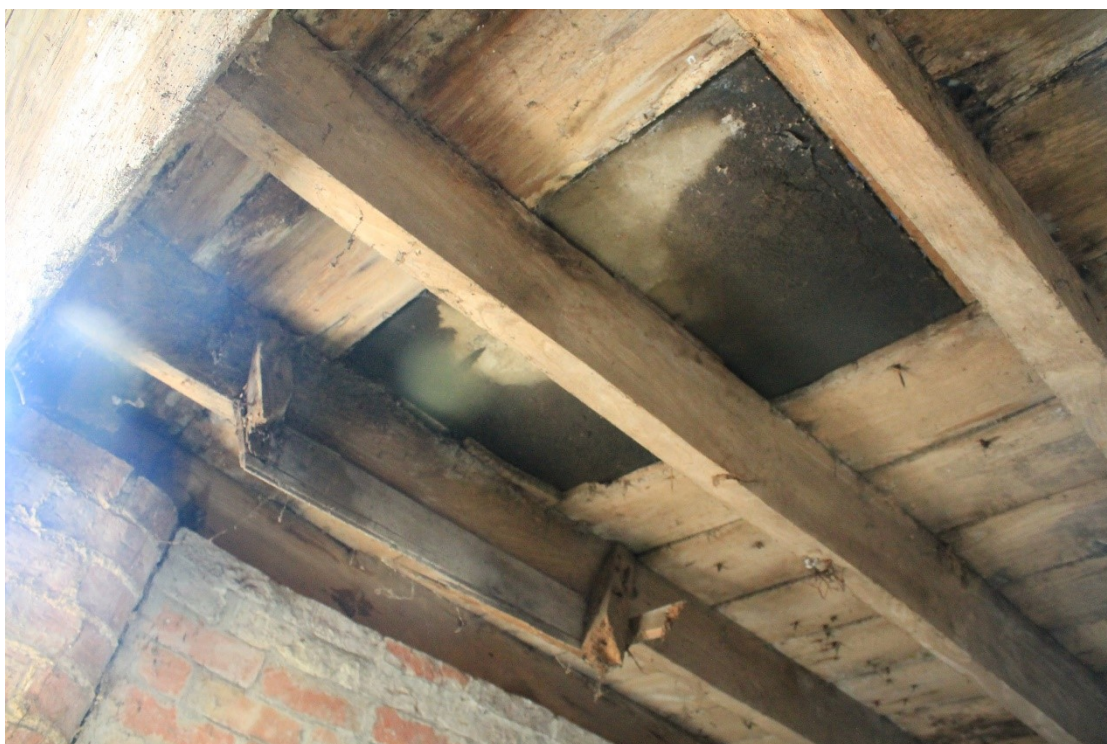
Plate 24 Interior detail of north bay of cart shed E, possible trapdoor in ceiling and possibly associated woodwork attached to joist, looking south.

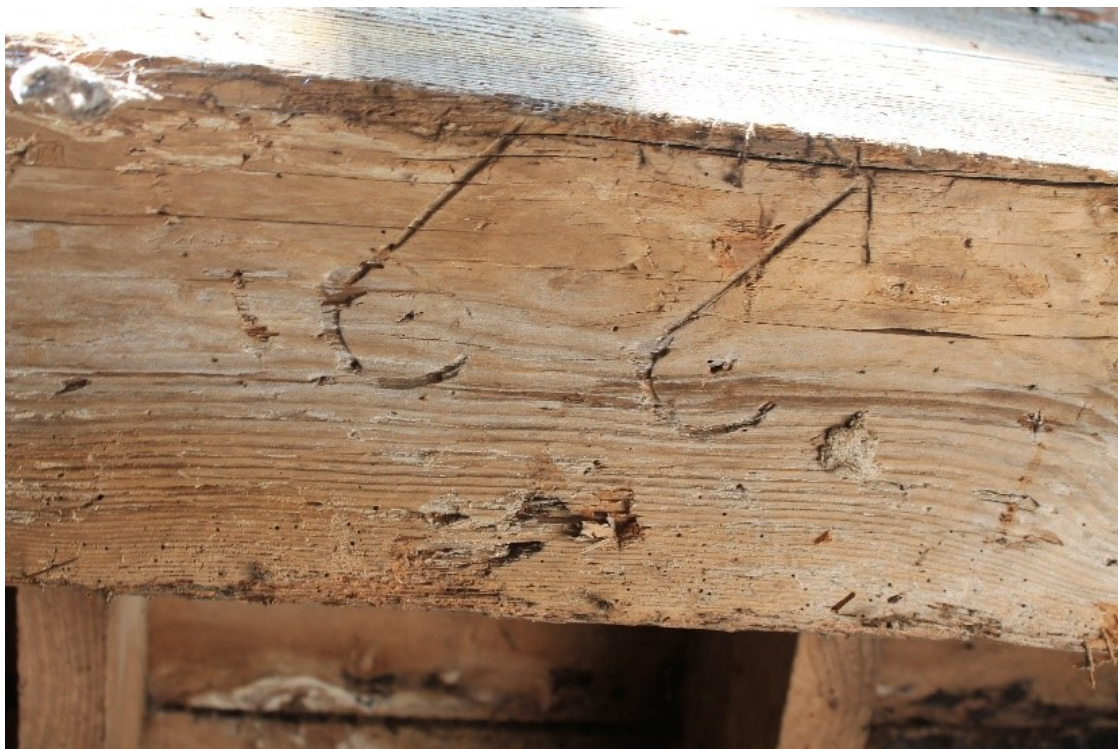
Plate 25 Possible carpenters marks or graffiti on underside of cart shed lintel (south bay), looking west/up.

Marks were observed in the underside of the large lintel of the cart shed opening, in both the north and south bays (Plates 25 and 26). These do not appear to be carpenters marks but have been made with some care. These comprise a mixture of circular arcs produced by a compass or similar implement and straight lines. These are potentially graffiti, perhaps dating to the use of the building as a cart shed and the underside of this beam would be easily reached from a cart.

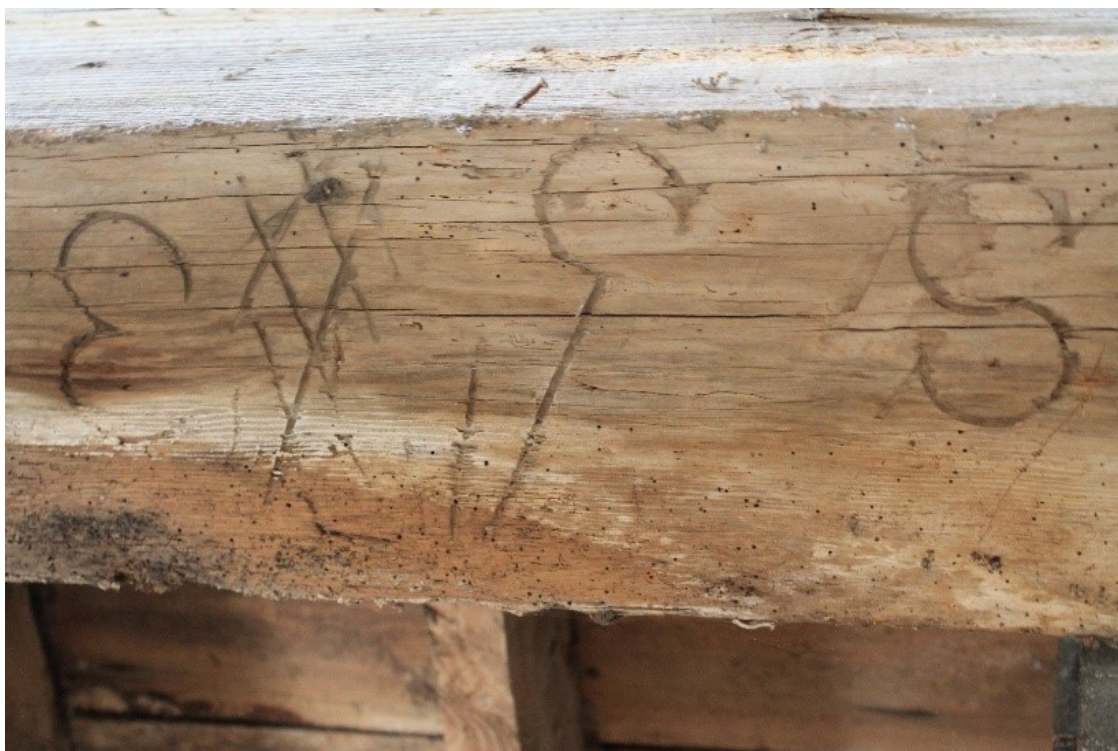
Plate 26 Possible carpenters marks or graffiti on underside of cart shed lintel (north bay), looking west/up.

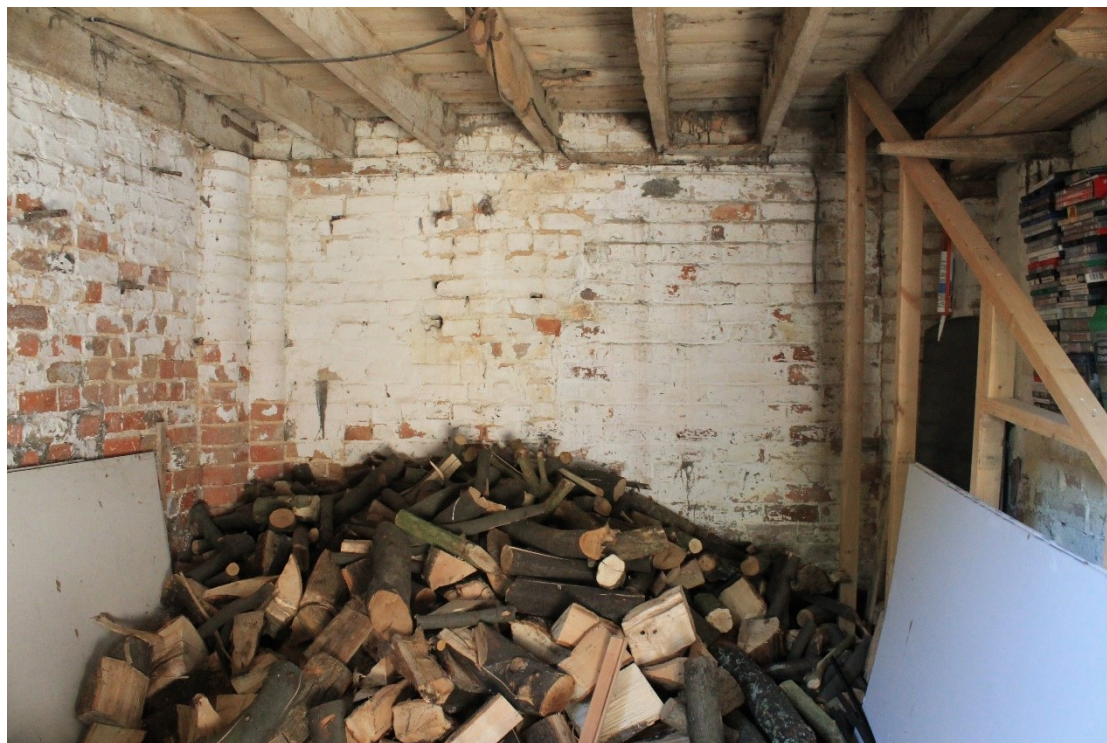
Plate 27 Interior of south bay of cart shed E, showing use of curved bricks at corners of building, possible tack hooks associated with later use as a stable at right and blocked doorway in west wall, looking west.

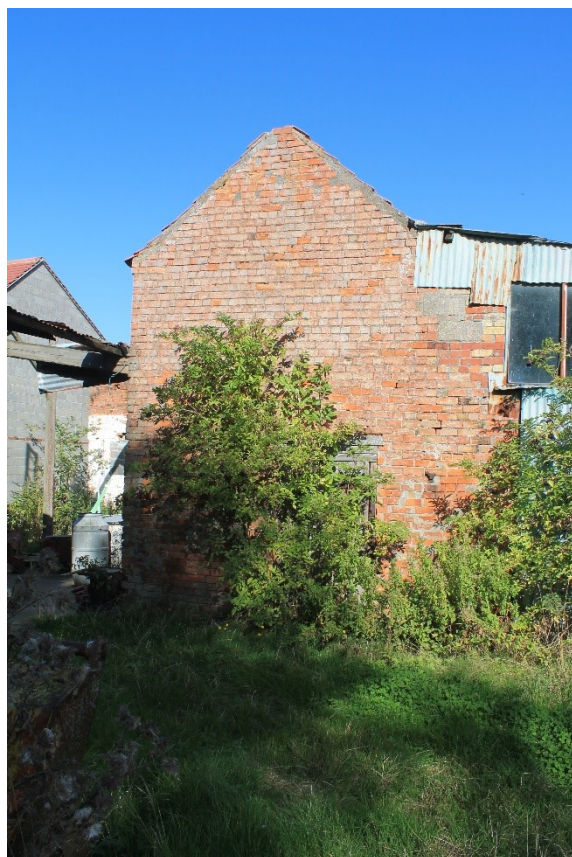
Plate 28 South gable of building E and adjoining structure G, looking north.

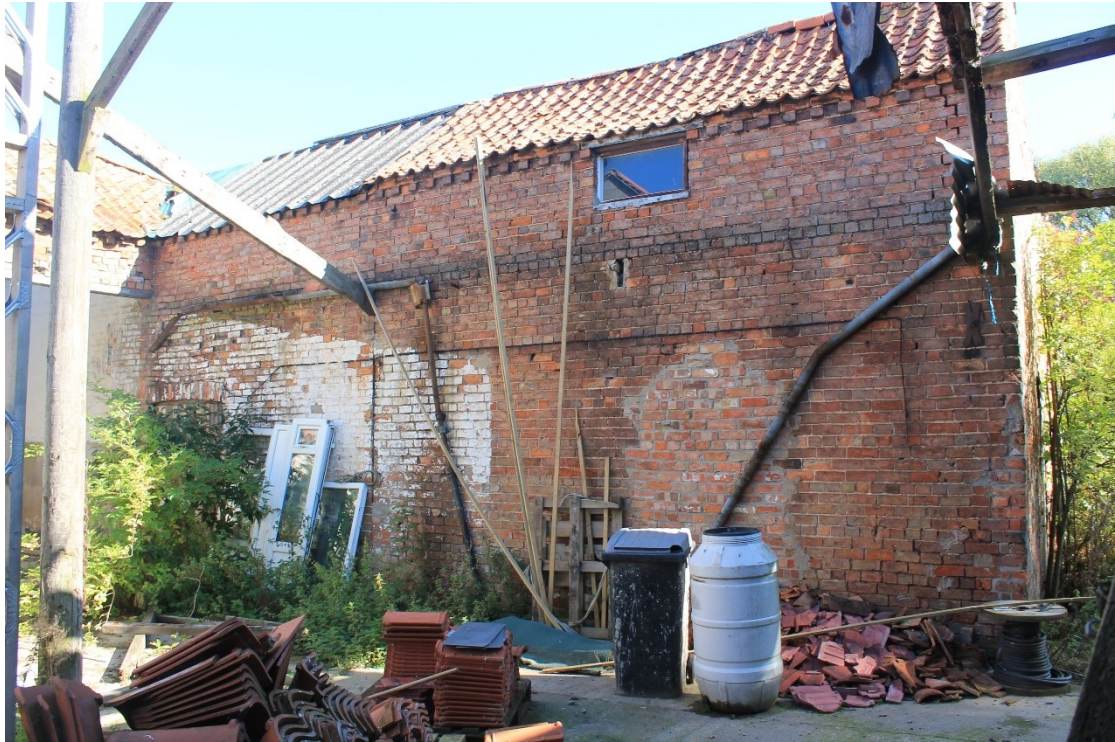
Plate 29 West external elevation of building E and barn C, looking east.

Building I had apparently been demolished and replaced by a large shelter shed F. The northern portion of this shelter shed, between buildings A, B, C and G, was largely collapsed at the time of the survey (Plate 29), but the southern portion of the structure survived (Plates 33 and 34).

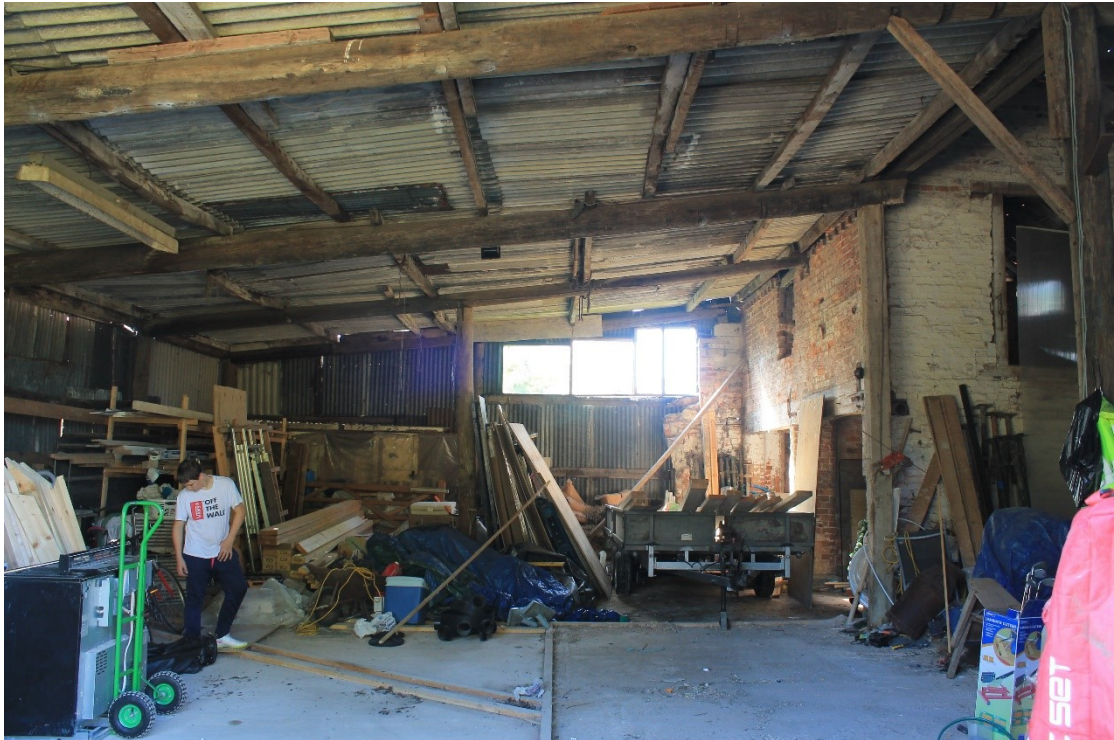
Plate 31 Interior of shelter shed D, with buildings C, E and G partially preserved within western side of building D at right, looking south.

Shelter shed D had been built onto the eastern side of barn C and buildings E and G, the eastern walls of both barn C and building G having been removed to facilitate its construction. This building almost entirely comprised wood and corrugated sheeting.

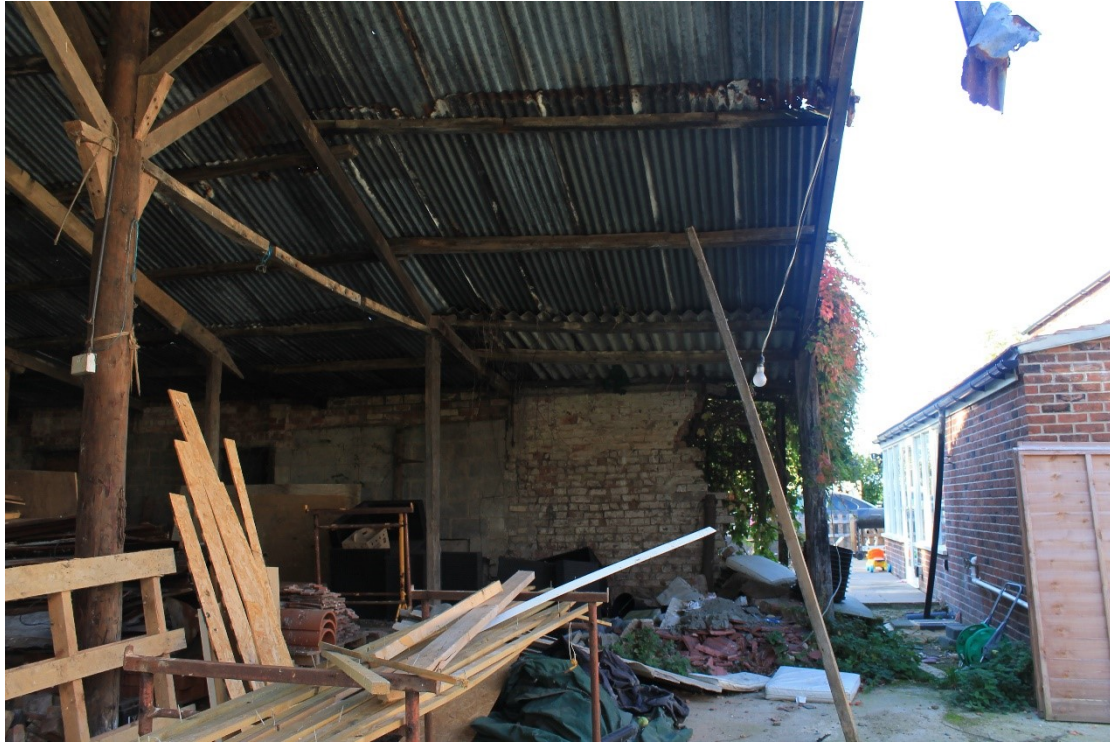
Plate 33, Interior of shelter shed I showing brickwork of western wall, conservatory and modern extension of farmhouse visible at right, looking west.
