Witham Archaeology

A Report to Mr and Mrs Toulson

**BULWARK FARM, CHURCH LANE, SCREDINGTON,
LINCOLNSHIRE**

Historic Building Recording

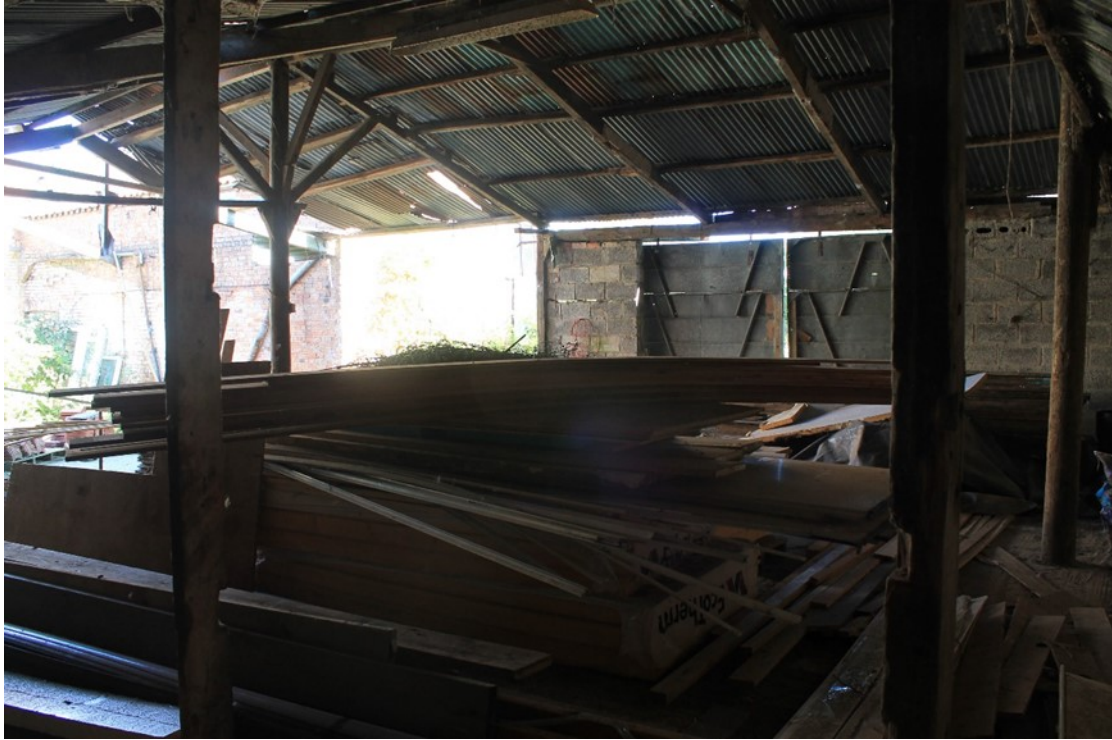
Plate 34 Interior of shelter shed I, showing wood, corrugated sheeting and breeze block construction, buildings E and C in background at left, looking northeast.

Building I had apparently been demolished and replaced by a large shelter shed F. The northern portion of this shelter shed, between buildings A, B, C and G, was largely collapsed at the time of the survey (Plate 29), but the southern portion of the structure survived (Plates 33 and 34).

The majority of structure F comprised timber and corrugated sheeting, with south and east walls of breeze block, and a pair of garage doors at the east side (Plate 34). The west wall was viewed internally, where this was also largely of breeze. The north end of this west wall was of a separate block of brickwork, with somewhat haphazard brickwork generally of the same English garden wall coursing as seen elsewhere on the farm (Plate 33). Traces of an east-west joining wall were noted at the south end of this wall fragment, in addition to traces of pantile at the top of the wall. This suggests that this may be part of an earlier outbuilding to the farmhouse, possibly a privy or shed. The external elevation of this wall was obscured by shrubs and climbing plants and so could not be examined.

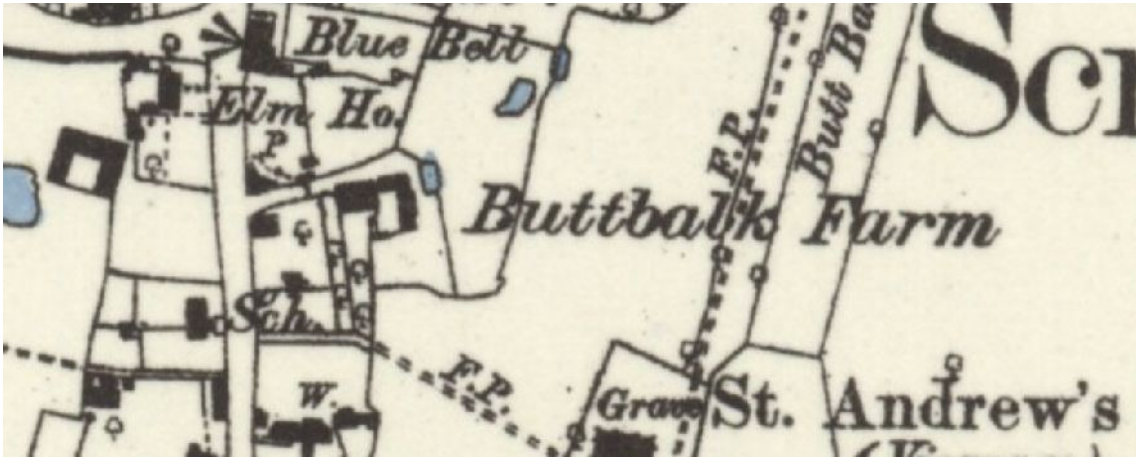
Extract from Ordnance Survey 6" map 1888

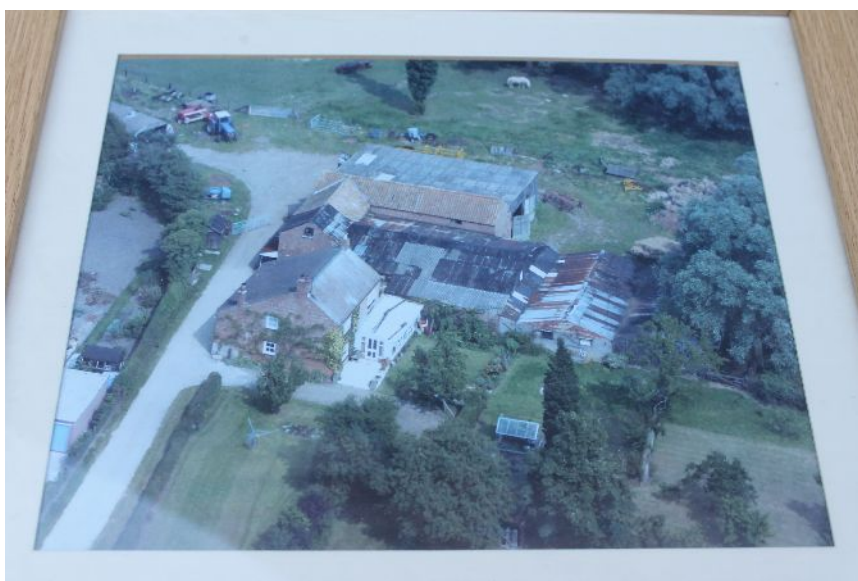
Oblique aerial photograph looking east, apparently dating to 1970s, provided by client
