# CHURCH OF ST PETER AND ST PAUL, WIDMERPOOL, NOTTINGHAMSHIRE

ARCHAEOLOGICAL WATCHING BRIEF 2013

Project Code: WCN/Report Number: 097/2013

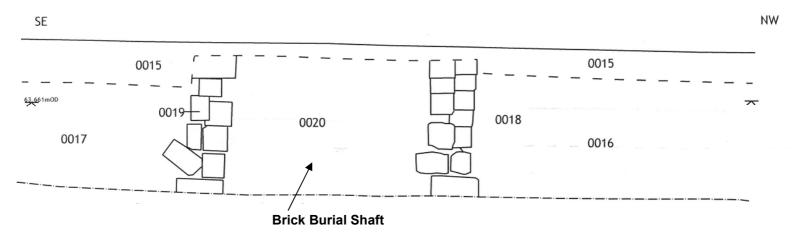
Figure 10: Representative North facing section Area 02 (Top)

Figure 11: Representative East facing section Area 03 (Middle)

Figure 12: Representative South-west facing section Area 04 (Bottom)

## 5.2. Area 02 Drainage Trench (Plate 7, Figure 10)

#### 5.3. Area 03 Drainage Trench (Plates 8-9, Figure 11)

#### 5.4. Area 04 Drainage Trench (Plate 10, Figure 12)

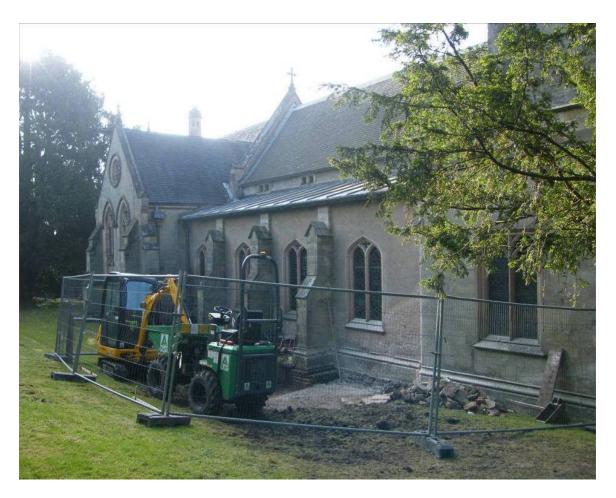
Plate 1: Area 01 looking south-east, showing north aisle with buttresses.

Plate 1: Area 01 looking south-east, showing north aisle with buttresses.

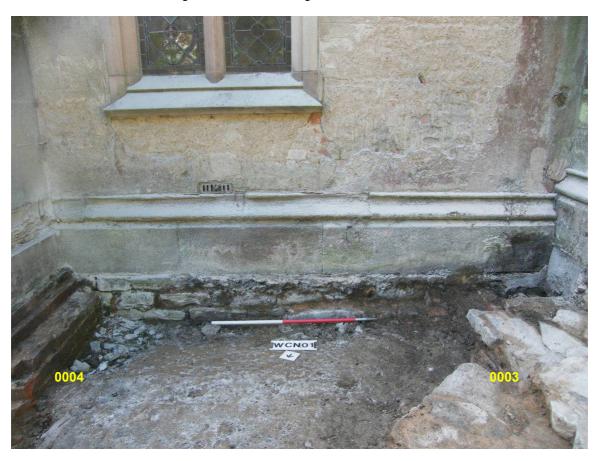
**Plate 2:** Area 01 looking south, showing brick buttress foundation 0004, stone diagonal tower buttress 0003 and the stone foundations of the north aisle.

**Plate 2:** Area 01 looking south, showing brick buttress foundation 0004, stone diagonal tower buttress 0003 and the stone foundations of the north aisle.

#### North Aisle Wall Foundation (Figure 7, Plate 2)

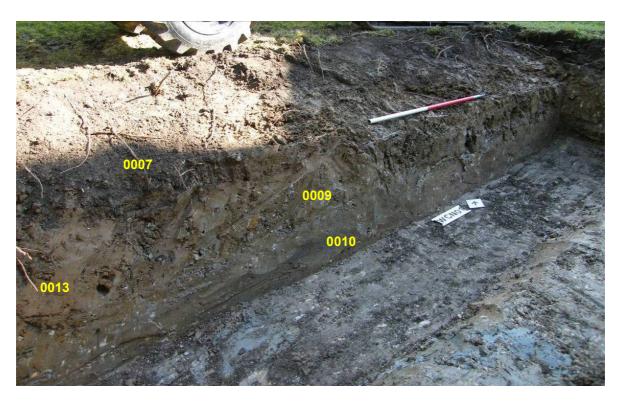
Plate 3: Area 01 looking north-east, showing south-facing section.

**Plate 3:** Area 01 looking north-east, showing south-facing section.

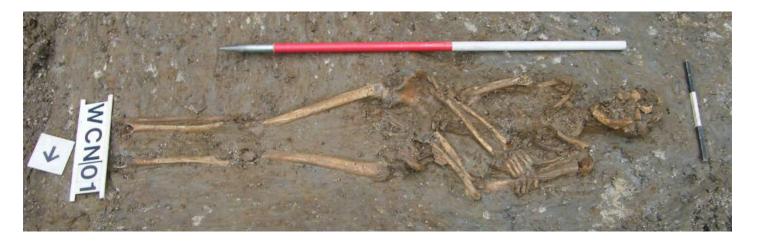
Plate 4: Area 01 showing skeleton SK0002 aligned east-west.

Plate 4: Area 01 showing skeleton SK0002 aligned east-west.

## Skeletons SK0001 to SK0004 (Figure 3, Plate 4)

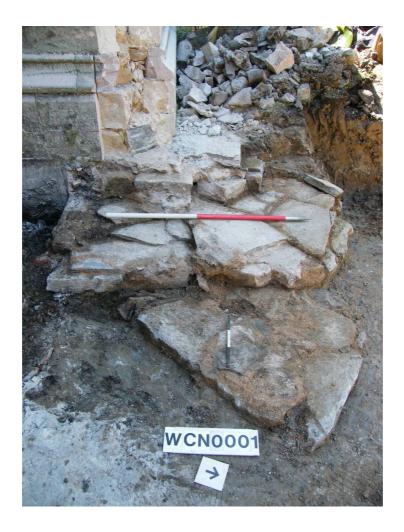
Plate 5: Area 01 looking west, showing stone diagonal tower buttress 0003.

Plate 5: Area 01 looking west, showing stone diagonal tower buttress 0003.

## Tower Buttress Foundation 0001/0002 (Figure 5, Plate 5)

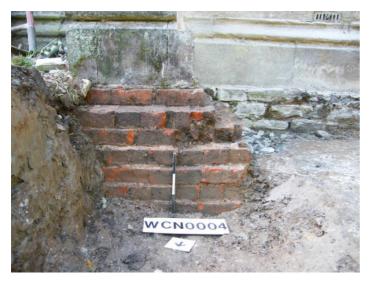
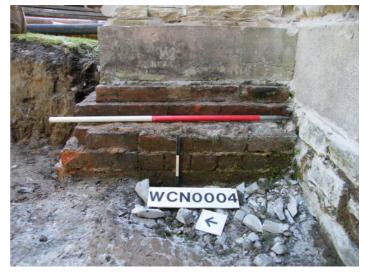
Plate 6: Area 01 looking south (left) and east (right), showing brick buttress foundation 0004.

Plate 6: Area 01 looking south (left) and east (right), showing brick buttress foundation 0004.

#### North Aisle Wall Buttress Foundation 0004 (Figure s 8-9, Plate 6)

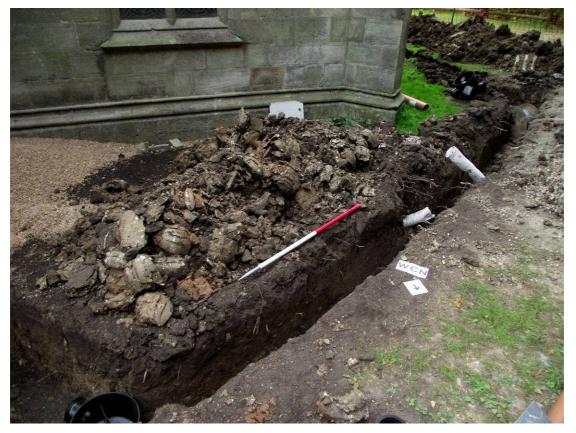
Plate 7: Area 02, north-west facing section. Looking south-west.

Plate 7: Area 02, north-west facing section. Looking south-west.

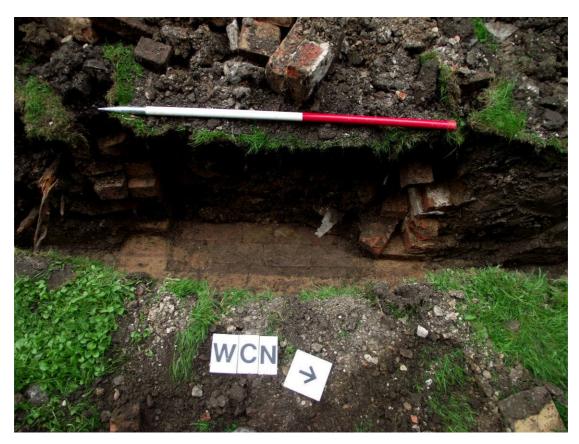
Plate 8: Area 03 east-facing section showing brick burial shaft 0018/0019.

Plate 8: Area 03 east-facing section showing brick burial shaft 0018/0019.

#### Brick Burial Shaft 0018/19 (Plates 8-9, Figure 11)

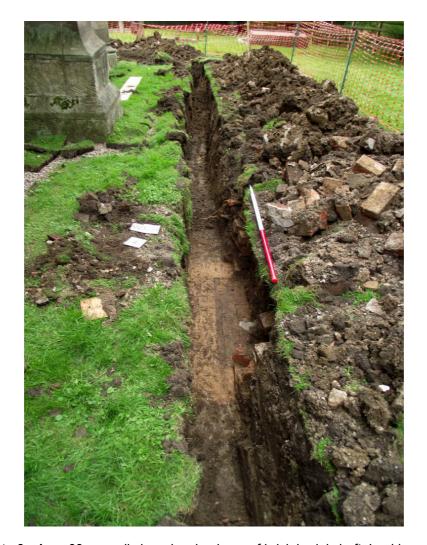
Plate 9: Area 03, overall view showing base of brick burial shaft. Looking south.

Plate 9: Area 03, overall view showing base of brick burial shaft. Looking south.

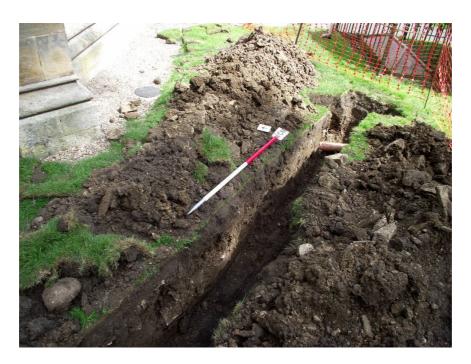
Plate 10: Area 04 overall view with modern drain at eastern end. Looking south-east.

Plate 10: Area 04 overall view with modern drain at eastern end. Looking south-east.

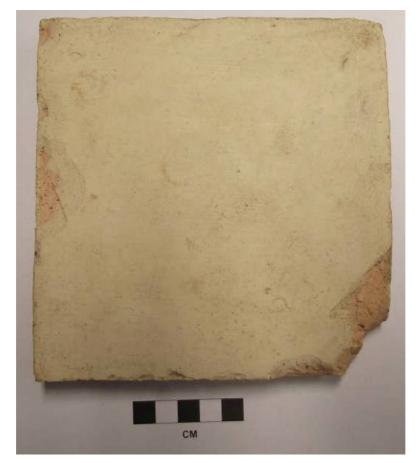
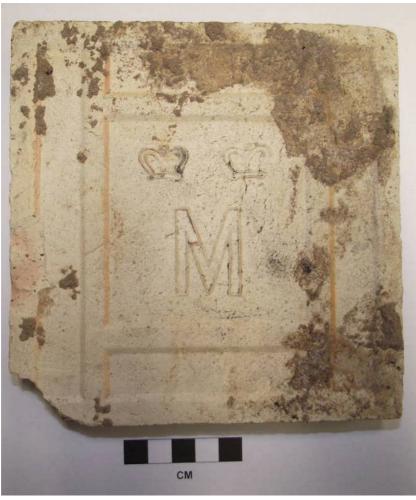
**Plate 11:** Area 03 plain unglazed tile with makers mark on reverse (large M below two crowns). Found within brick burial shaft 0018/0019.

**Plate 11:** Area 03 plain unglazed tile with makers mark on reverse (large M below two crowns). Found within brick burial shaft 0018/0019.

- 5.3.4. No covering slab was present over the shaft which was cut from below the topsoil. No human remains were present in the shaft which had been apparently backfilled with a mixture of clay loam, tile (Plate 11), yellow sand and large stone fragments (0020).
