**MARY ROSE NEW MUSEUM
PORTSMOUTH HISTORIC
DOCKYARD
PORTSMOUTH
HAMPSHIRE**

**ASSESSMENT OF AN
ARCHAEOLOGICAL WATCHING
BRIEF**

**Archaeological Watching Brief at the Mary Rose New Museum,
Portsmouth Historic Dockyard, Portsmouth, Hampshire**

Site Code: PMRP 08 (Phase III)

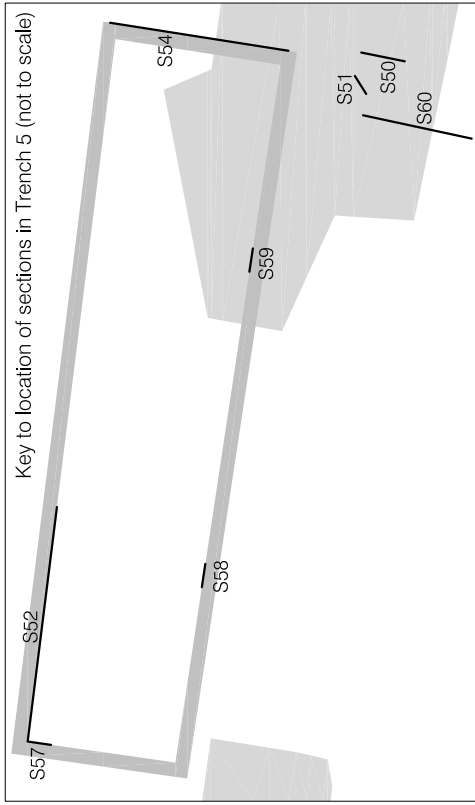
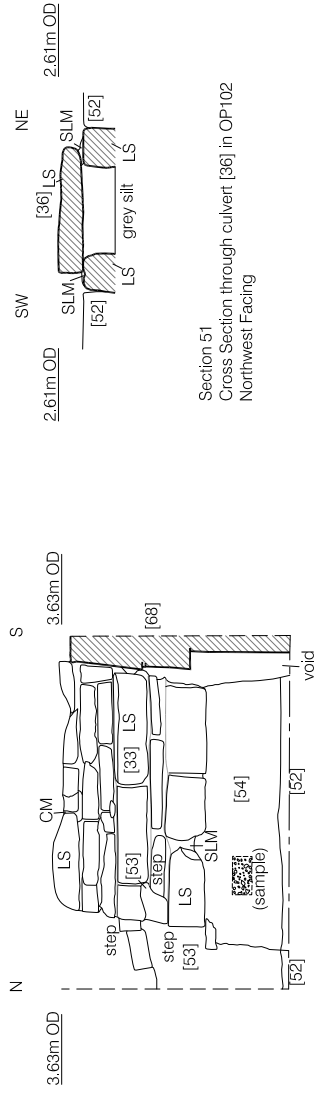
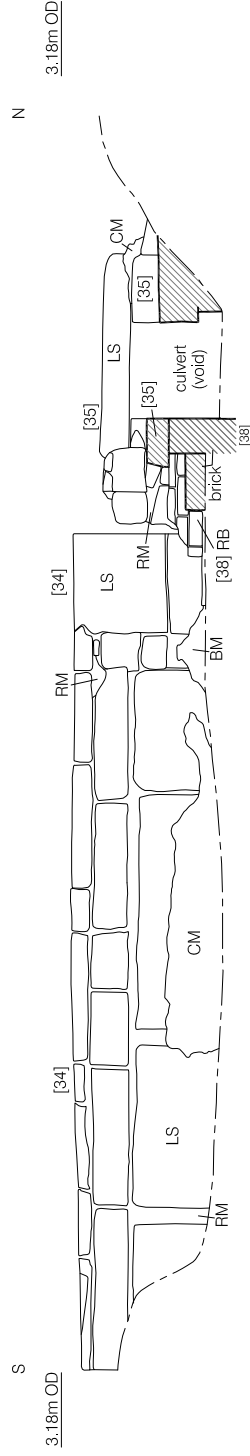
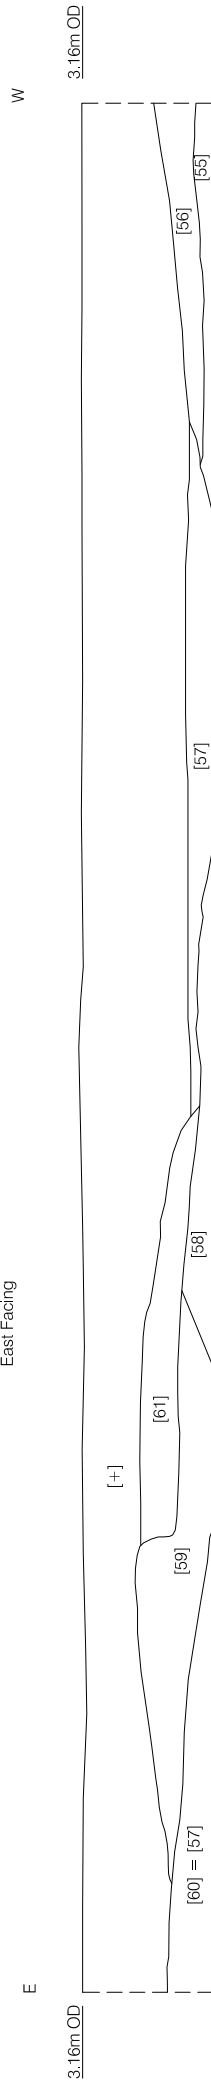
Figure 10
Sections 50 to 54
1:40 at A4

Section 50
Stone Foundation Pad [33] in OP102
West Facing

Section 51
Cross Section through culvert [36] in OP102
Northwest Facing

Section 53
Elevation of [37] in Area B
East Facing

Section 52
Trench 5 North
North Facing

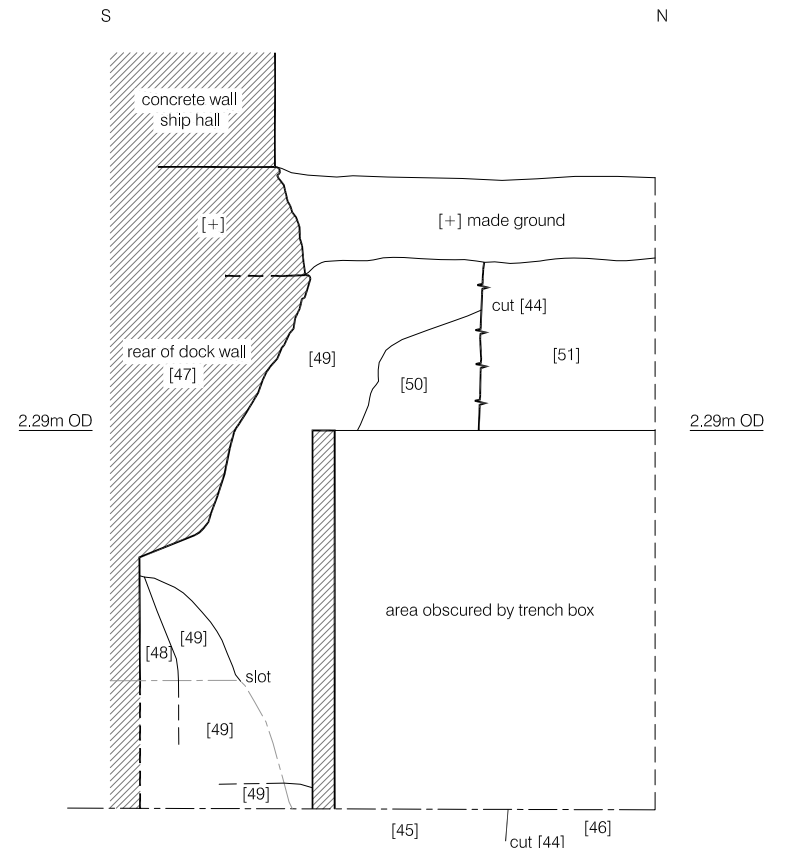
Section 56
Cross Section Profile of Dry Dock No 3; Back Wall in OP101
East Facing

7.4.1 A natural geological deposit [46] was observed in the base of OP101 (Fig. 11 Section 56, plate 3). This was a soft light yellowish brown with green/grey hue medium sand with no inclusions and is interpreted as part of the Bagshot sands. The top of this deposit was recorded at 0.19mOD, 3.40m below ground level. This deposit had been truncated by the construction cut [44] for the dry dock which is discussed below.

7.6.2 Part of the outer face of the dock wall [47] was exposed in the north facing section of OP101 (Fig. 11 Sections 55 & 56, plate 2). This had two distinct forms to its construction. The lower part consists of regularly coursed 300mm by 200mm limestone blocks, laid as a vertical wall bonded with off white lime and sand mortar. The vertical drop began at 2.10m below ground level at 1.57mOD and was observed to continue down to at least 2.70m below ground level at 0.97mOD. The upper section of the wall was crudely built with a more rubble like appearance and formed a convex overhang that projected 0.9m to the north, and was encountered at 0.60m below ground level at 3.07mOD. This part of [47] was constructed from roughly shaped rectangular limestone blocks of varying size, the average measuring 200mm x 100mm, laid in irregular courses and bonded with the same mortar as the lower section. Part of the rubble overhang was removed to accommodate the pile cap in OP101 exposing 0.60m of its internal structure which demonstrated it was built in the same rubble form and was not masking a continuation of the vertical part of the wall, at least to that depth. Both these sections of wall constitute the outer wall of Dry Dock No. 3.

- 7.6.3 Abutting the lower vertical section of wall [47] was a band of clay [48] (Fig. 11 Section 56, plate 2). This was a very fine plastic pinkish red clay with occasional inclusions of flint and organic matter applied in a narrow band 0.20m thick at a consistent depth of 2.20m below ground level at 1.47mOD. This band of clay was observed to continue parallel with wall [47] along the full east-west extent of OP101, and was also observed at similar depths abutting the lower parts of the chutes and staircases in OP102 and OP104. This band of clay [48] is interpreted as a layer of puddle clay, acting as a waterproof membrane around Dry Dock No. 3.

- 7.6.4 The above deposits were sealed by a sequence of 19th century dump layers [49], [50] and [51] totalling 3.0m thick, as made ground deposits (Fig. 11 Section 56). These in turn were sealed by a 0.40m thick layer of modern made ground, the top of which formed the current ground level at 3.67mOD.

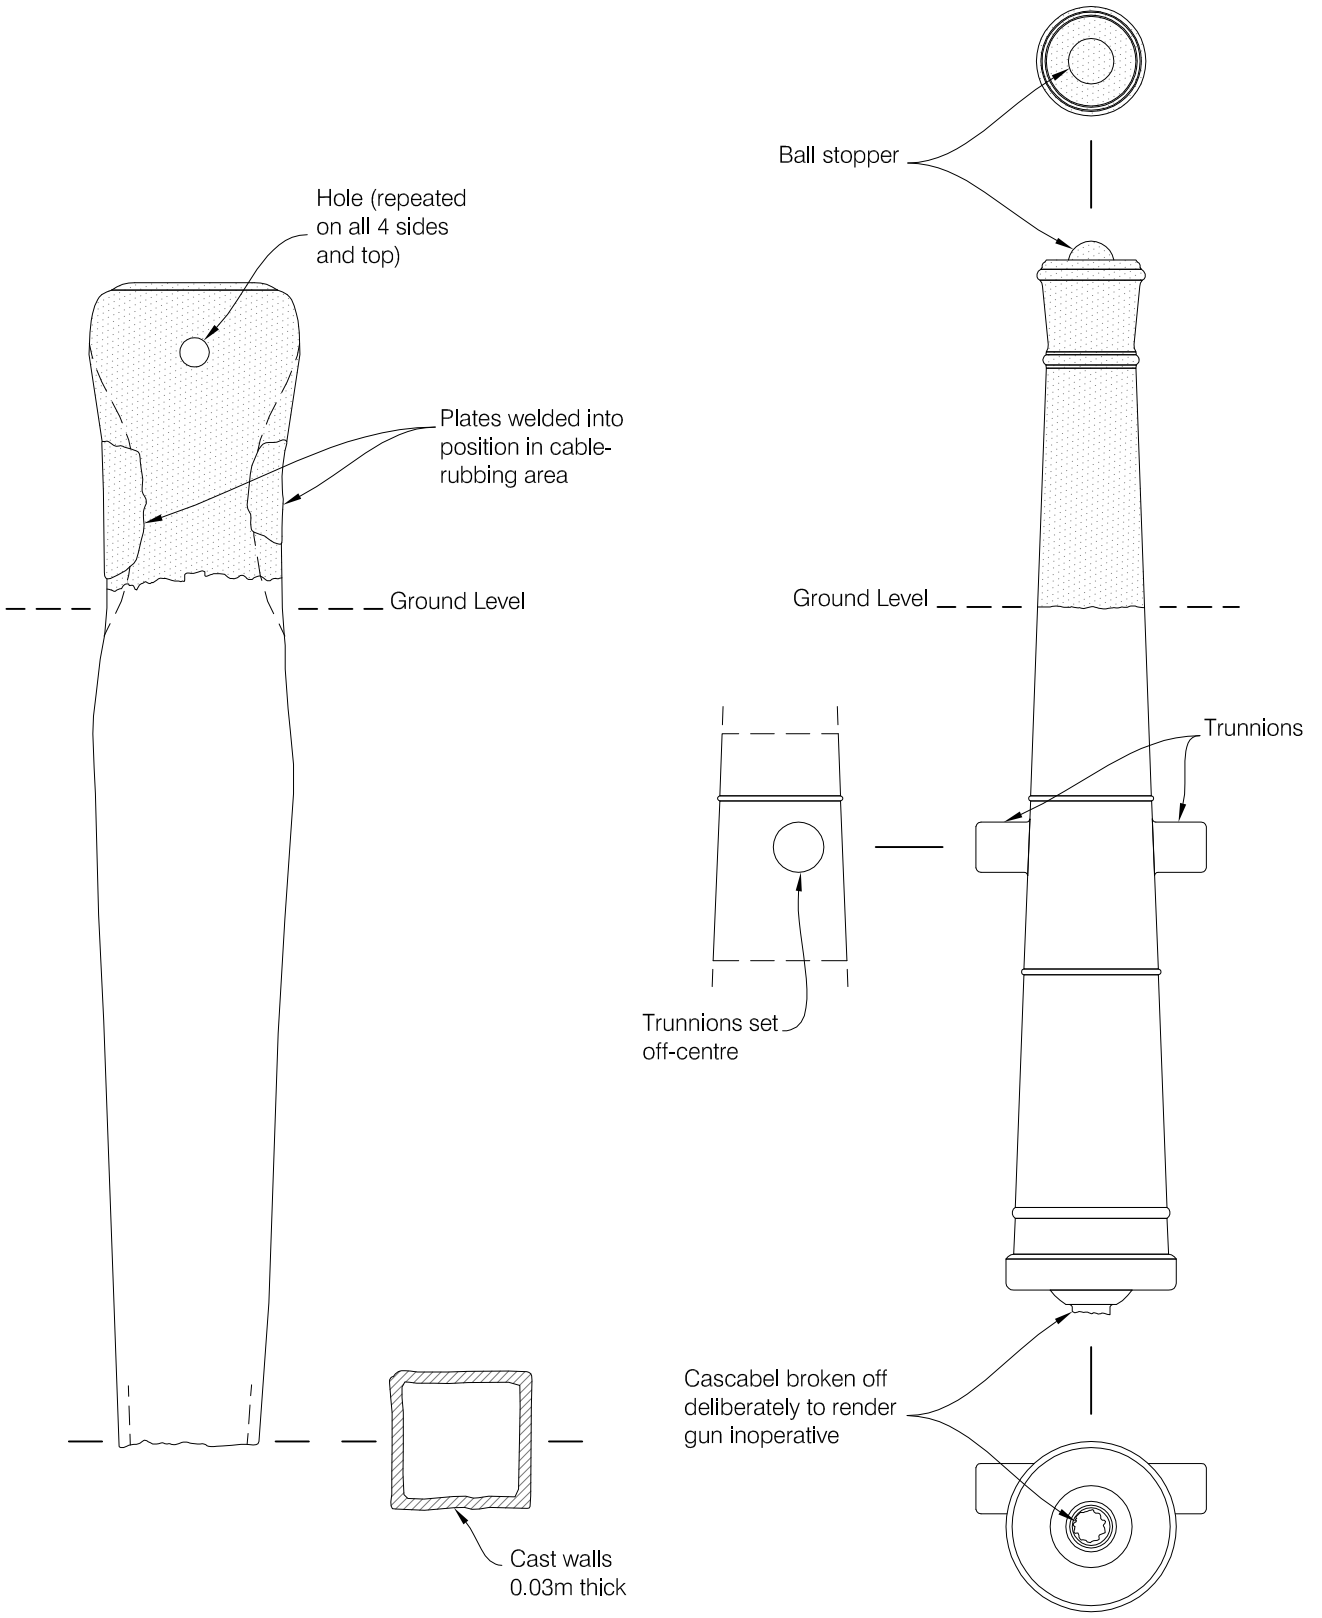
Figure 12
Bollards 01/S/D4 and S/D3/3
1:20 at A4

Bollard - 01/S/D4

Bollard - S/D3/3

Area of white paint

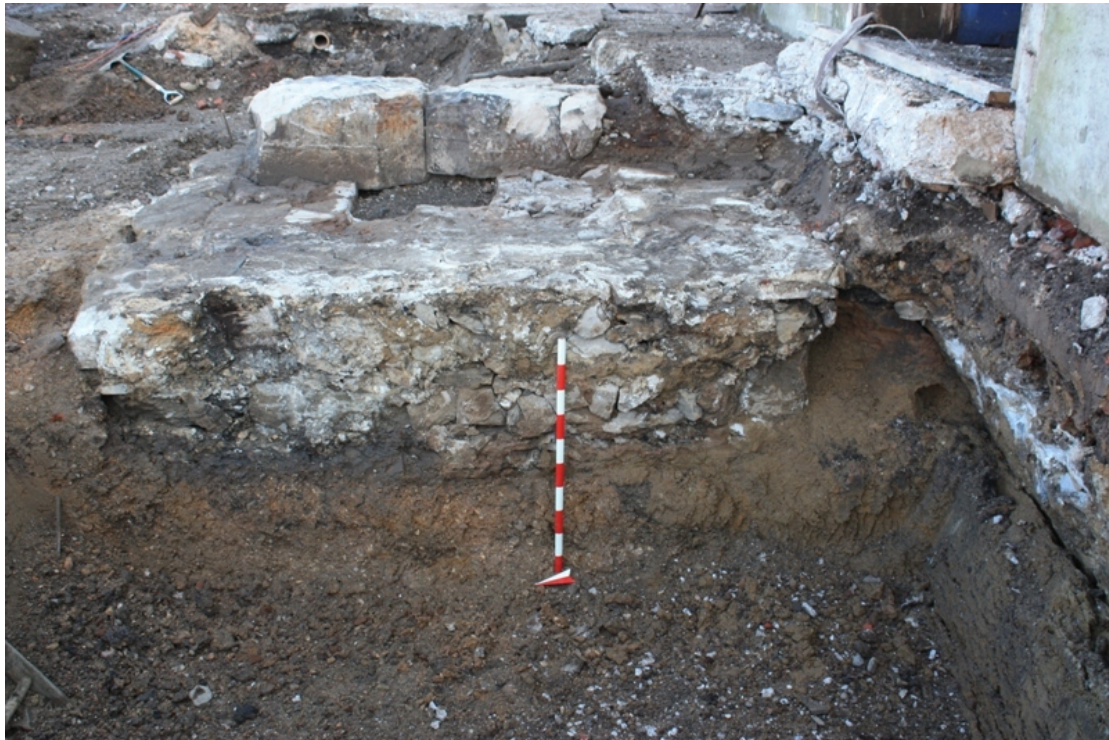
Plate 1. OP101. Capstan base [40]. Scale 1.0m, looking east.

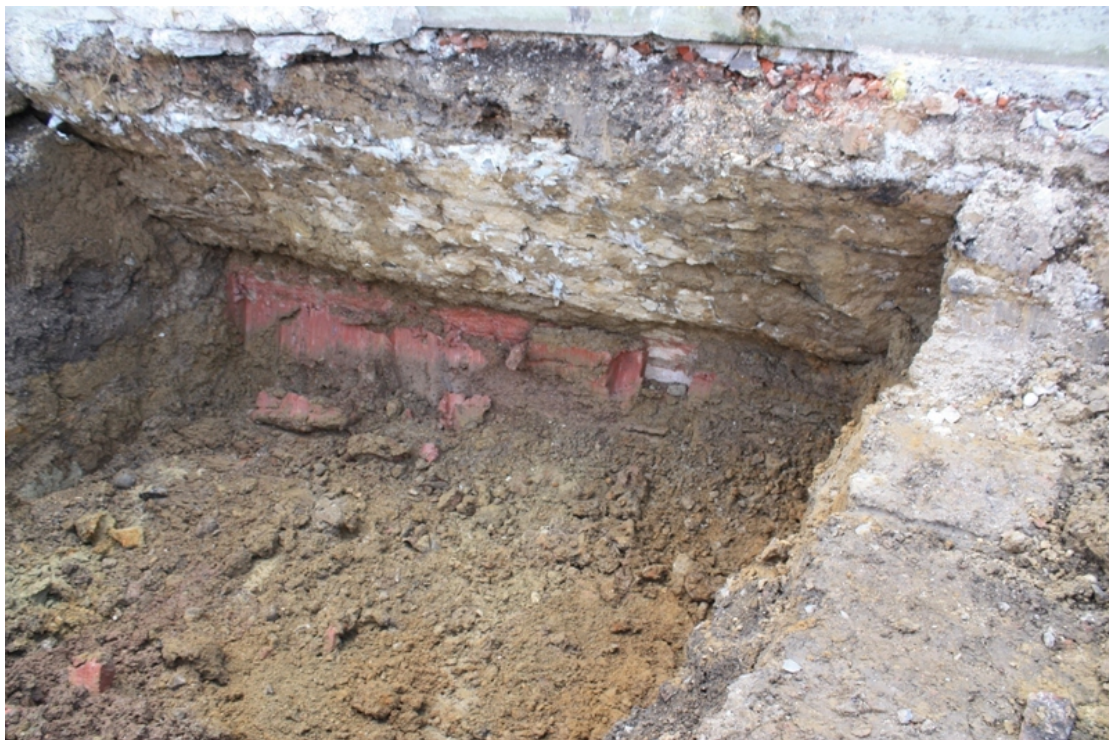
Plate 2. OP101. Dock-wall [47] illustrating the overhang and puddled clay lining [48]
Looking south.

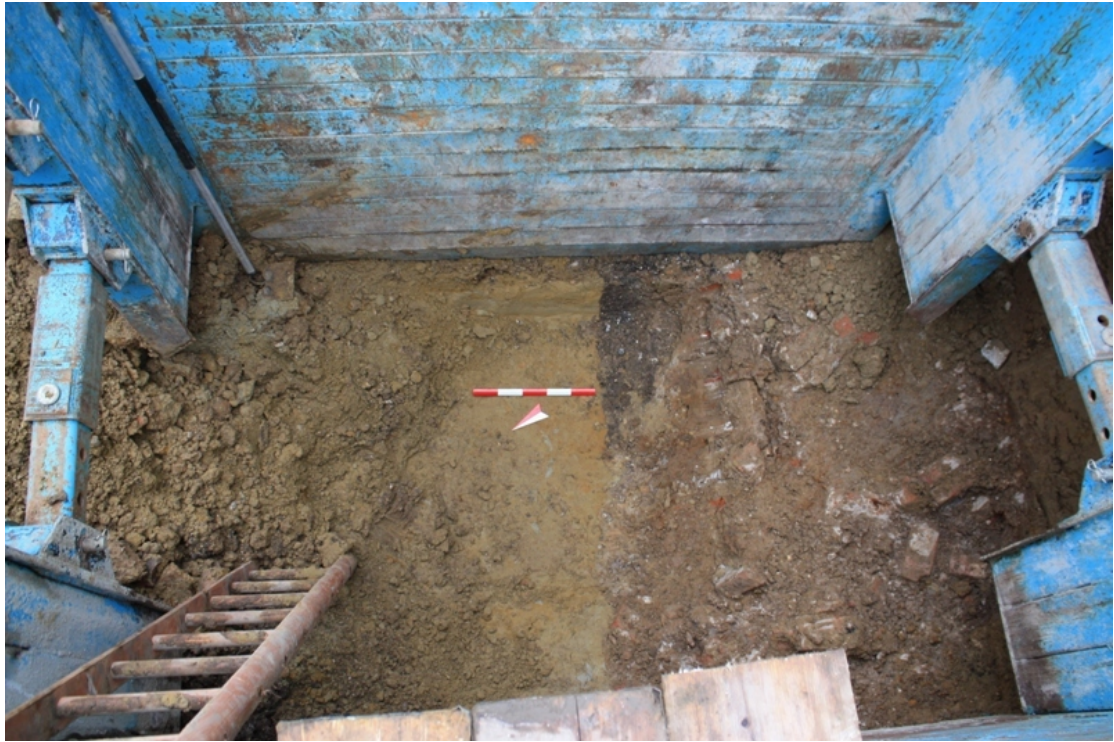
Plate 3. OP101. Natural deposit [46] to the left, cut by construction cut [44] for the Dry Dock. Scale 0.5m, looking south-east.

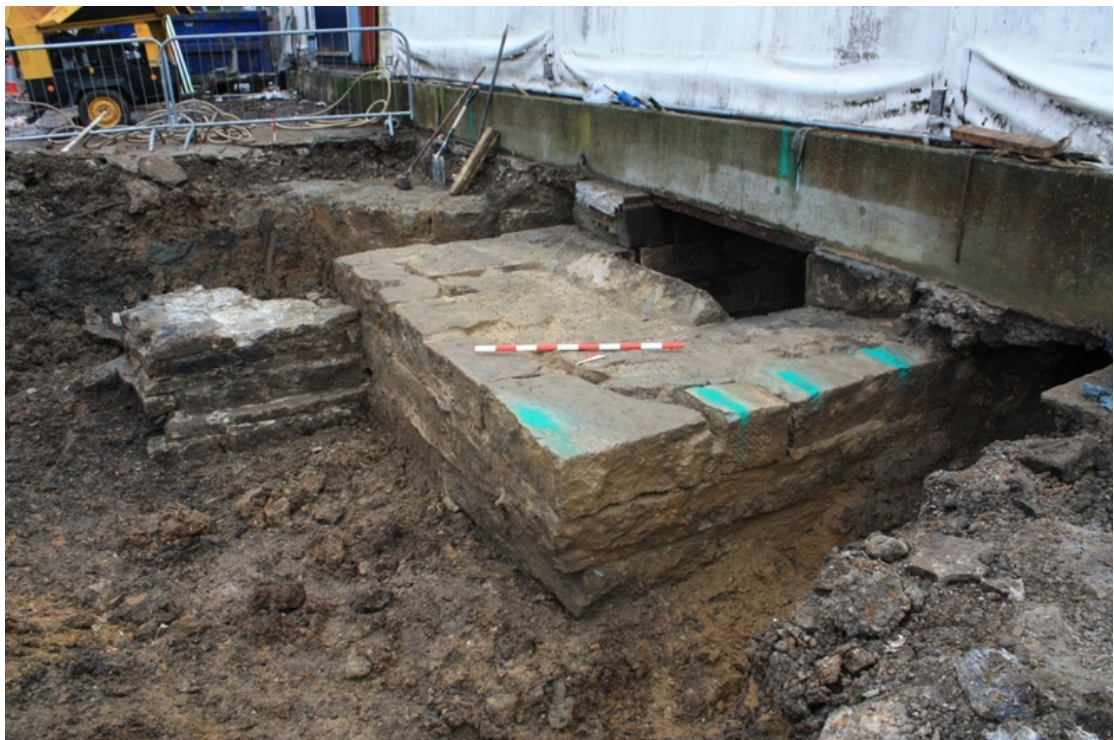
Plate 4. OP102. Chute/buttress structure [68] at an early stage of dismantling. The stone foundation [33] is to the top left. Scale 1.0m, looking south-east.

- 7.6.5 The principal feature in OP102 was a stone built chute, [68], part of Dry Dock no 3 (Figs. 3, 6 & 11 Section 60, plates 4 & 7). This was visible as a surface feature at ground level and consisted of rectangular granite headstones marking the top of the granite chute, which angled down into Dry Dock No. 3 by approximately 50°. The top of the structure measured 1.60m north-south by 3.00m east-west. Individual stones varied in size between 500mm by 700mm by 300mm deep and 500mm by 500mm by 300mm deep. The granite stones had a fine dressed finish and were laid very tight to each other, no mortar being used in the vertical bedding planes. Iron slats were used to close off the chute when not in use which were fitted into rebates cut into the stone. The top of this feature (which also formed the current ground level) was recorded at 4.25mOD.

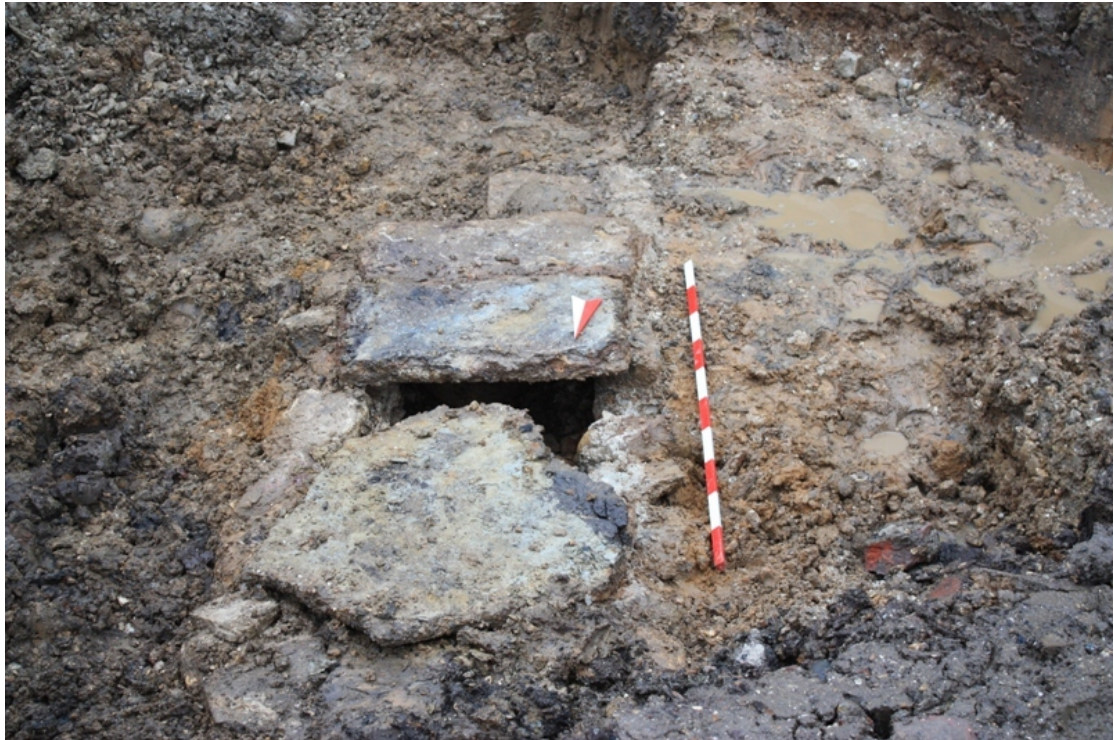
Plate 5. OP102. Culvert [36]. Scale 1.0m, looking south.

7.5.1 Exposed in the base of OP102, adjacent to the north-west corner of chute [68] was a stone built culvert [36] (Figs. 3 & 6, plates 5 & 6). Constructed from limestone slabs (measuring 600mm by 300mm by 113mm thick) these spanned a stone- and cobble-lined channel part filled with a fine grey silt. The slabs were regularly laid and bedded with soft earthy brown mortar, spot dated to 1750-1850. The walls of the culvert were very crudely built from a mix of limestone and cobbles to a height of at least 0.30m. The culvert was aligned at an angle of c. 45° in relation to the Dry Dock and was exposed for a length of 2m in the first instance and later observed (during the extension of OP102) to continue on the same alignment for at least another 5m. The southern end of [36] had been truncated away, probably by the construction of chute

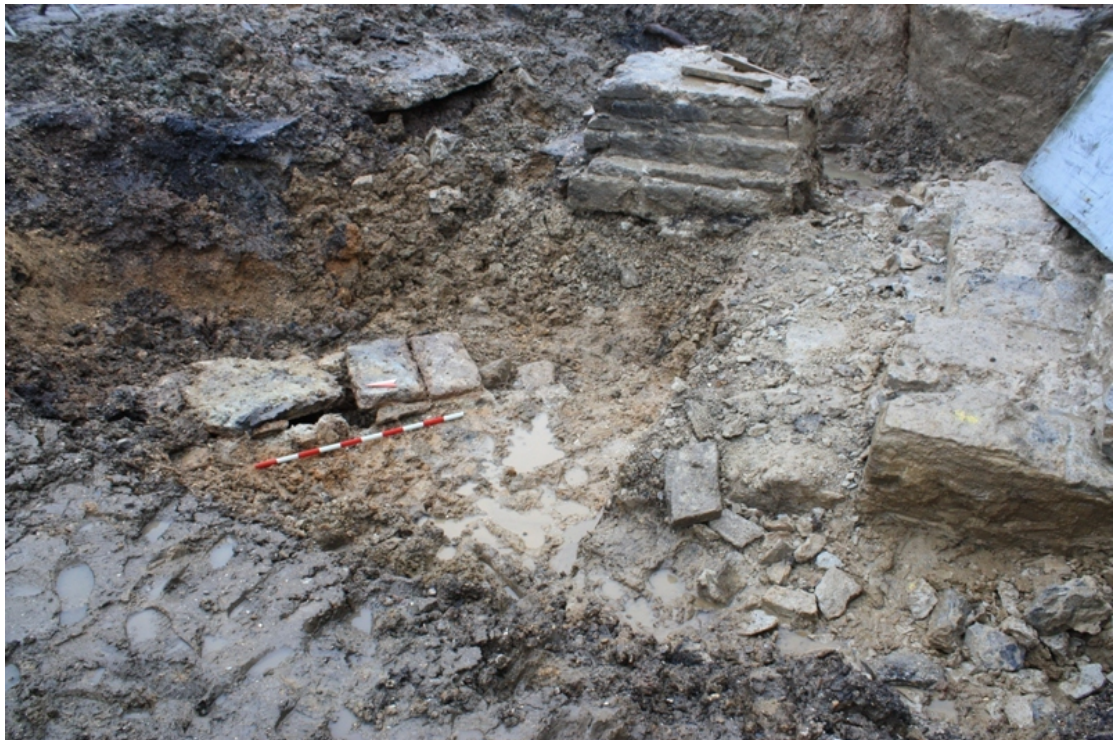
Plate 6. OP102. Culvert [36] in relation to [33] and [68]. Scale 1.0m, looking east.

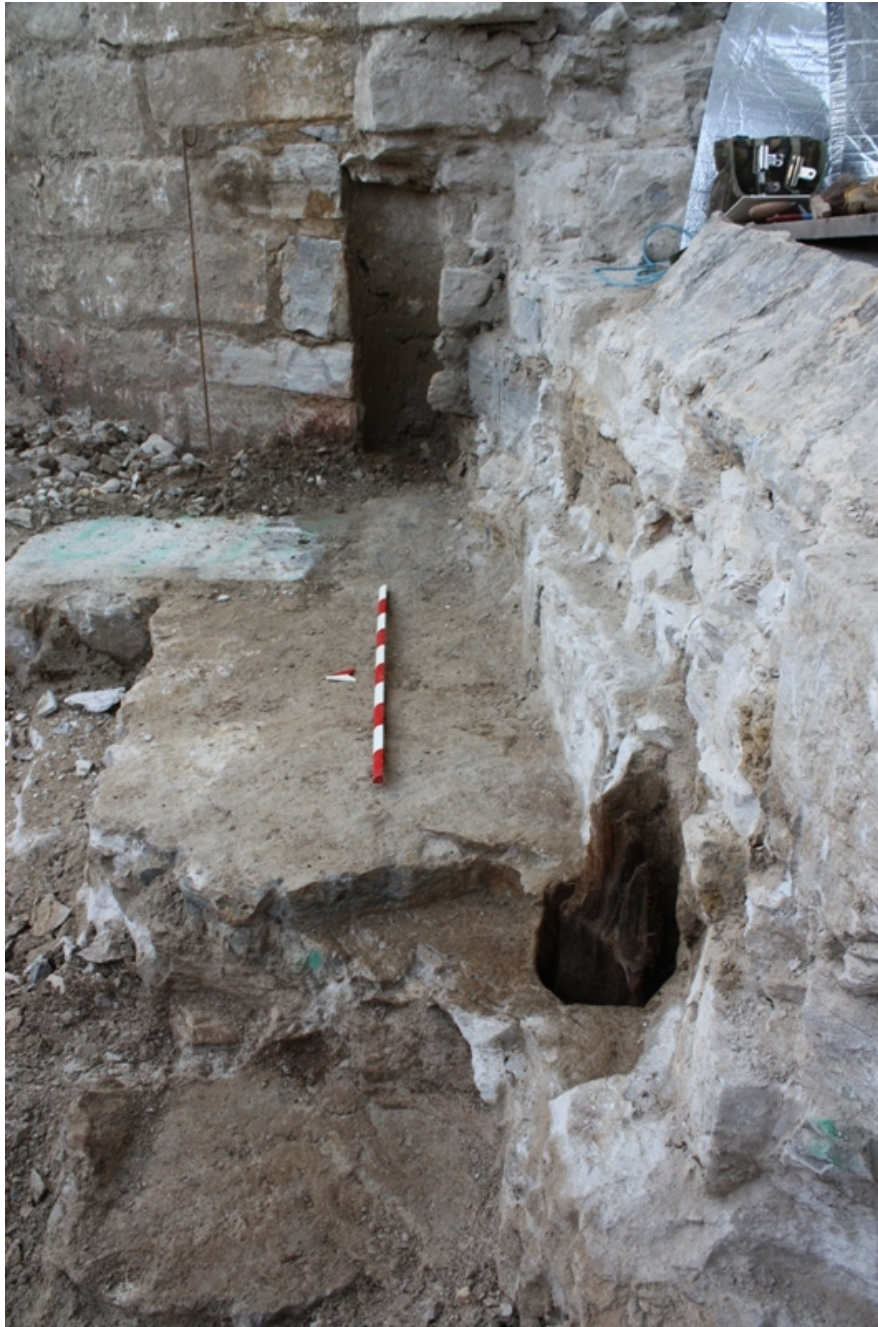
Plate 7. OP102. Chute [68] with timber post [78] in foreground at a later stage of dismantling. Staircase [85] with post hole [77] is in background. Scale 1.00m, looking east.

- 7.6.7 Cut into the stone of the 9th course of the chute, at 2.72m below ground level, was a circular post hole, [76], containing a timber post [78] (Figs. 6 & 11 Section 60, plate 7). Placed slightly west of centre and towards the southern side of the chute, the post hole [76] was cut into the stone by semi-circular cuts over four corners forming a 0.23m diameter hole, with vertical sides at least 0.80m deep but continuing down to an unknown depth. The level on the top of the cut was 1.53mOD. Within the post hole was set a vertical timber post [78]. It was in good condition, although the top was decayed and it measured 0.20m in diameter. While only 0.80m of its length was exposed it was observed to continue vertically down to an unknown depth, and the level on the top of the post was recorded at 1.45mOD. In cross-section the post was an un-converted whole and the species was identified as Spruce (*Picea*) possibly native grown or as a Baltic import¹². The post and its hole were sealed by the next course (course 8) and it is presumed that this functioned as an aid to construction.

- 7.6.10 A second post hole, [77], was observed cut into the western edge of the staircase [85] (Fig. 6, plate 7). This had a semi-circular profile, with an open face to the west but

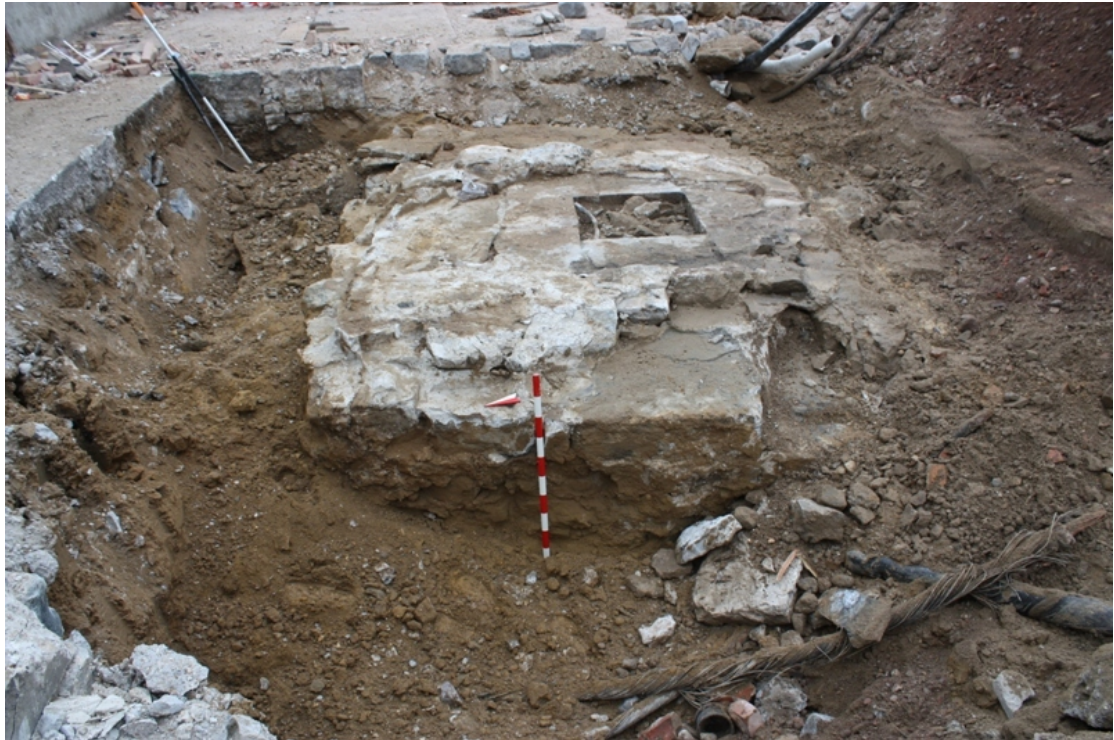
Plate 8. OP103. Capstan base [80]. Scale 1.0m, looking east.

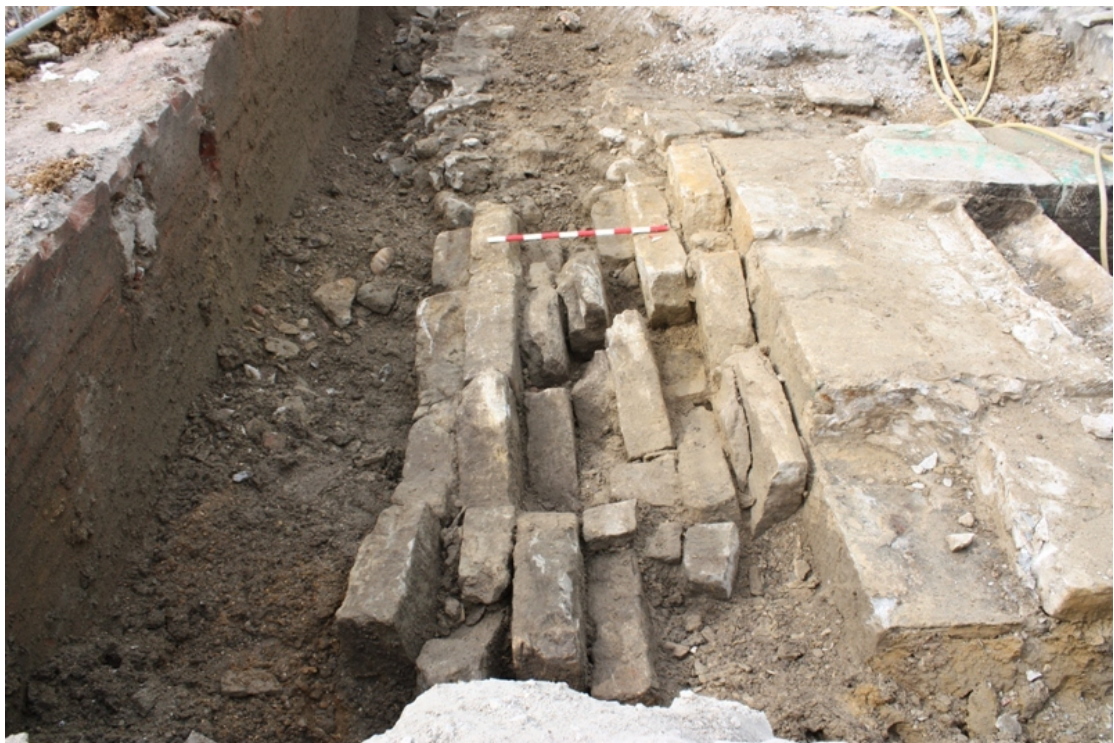
Plate 9. OP104. Vertical stone support slabs [79] edging southern side of chute/buttress [74]. Scale 1.0m, looking west.

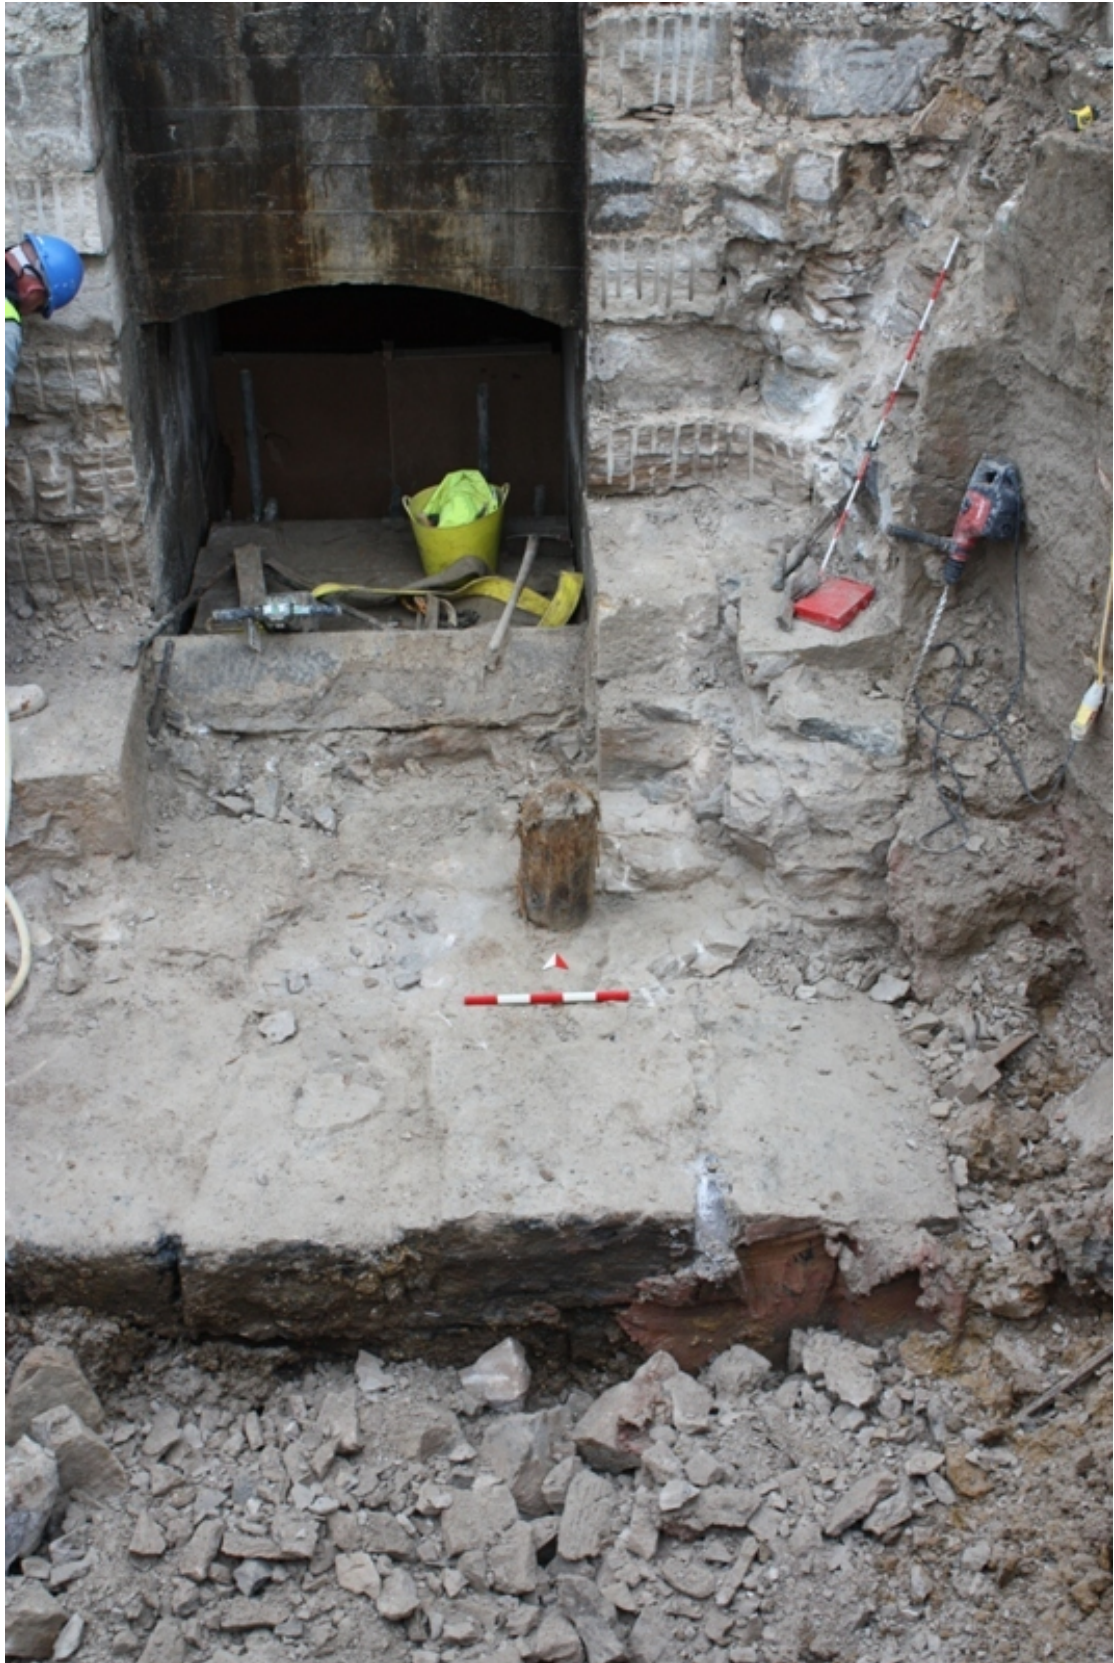
Plate 10. OP104. Chute/buttress [74] with timber post [82] at a later stage of dismantling. Scale 0.5m, looking north.

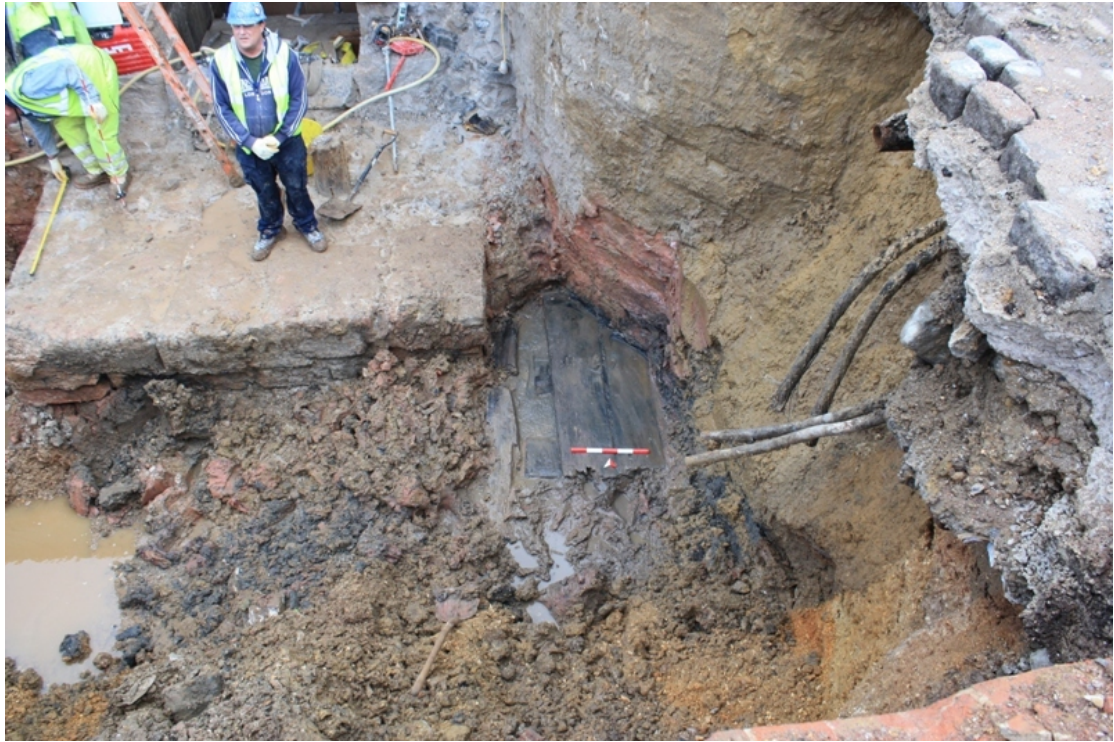
Plate 11. OP104. Timber deck [83] to right of chute/butress [74]. Scale 0.5m, looking north.

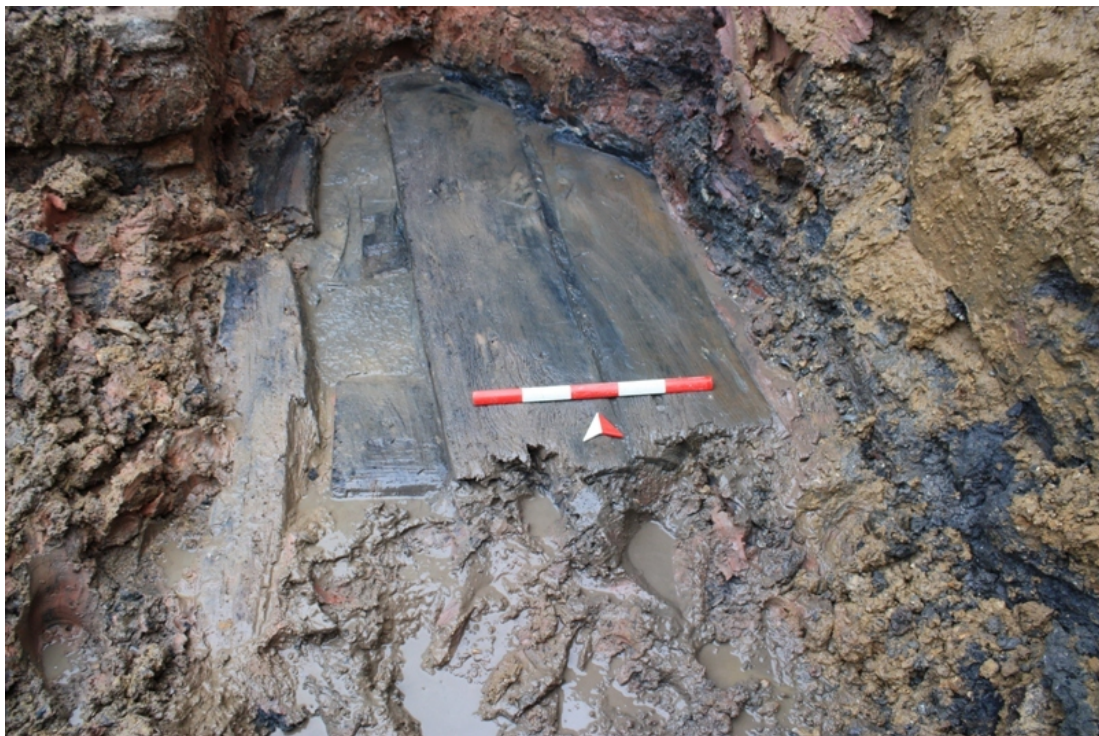
Plate 12. OP104. Detail of timber deck [83]. Scale 0.5m, looking north.

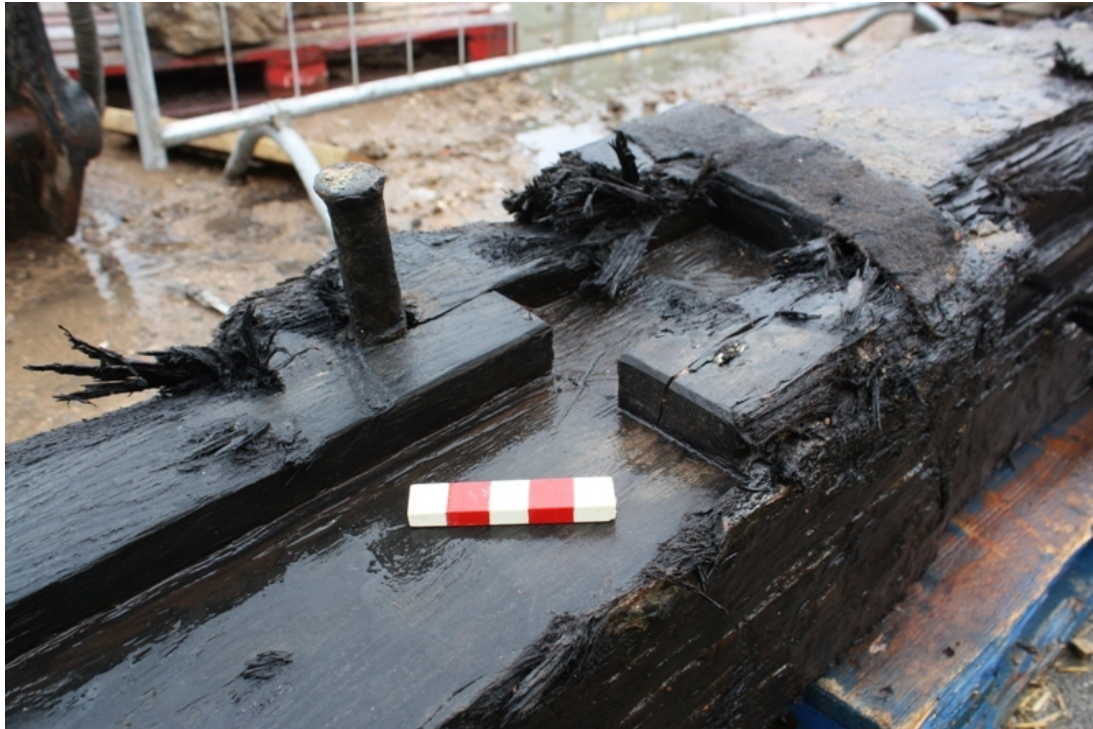
Plate 13. OP104. Detail of timber joist from deck [83], after removal. The piece of cloth mentioned in paragraph 7.6.19 is to the top right. Scale is 10.0cm.

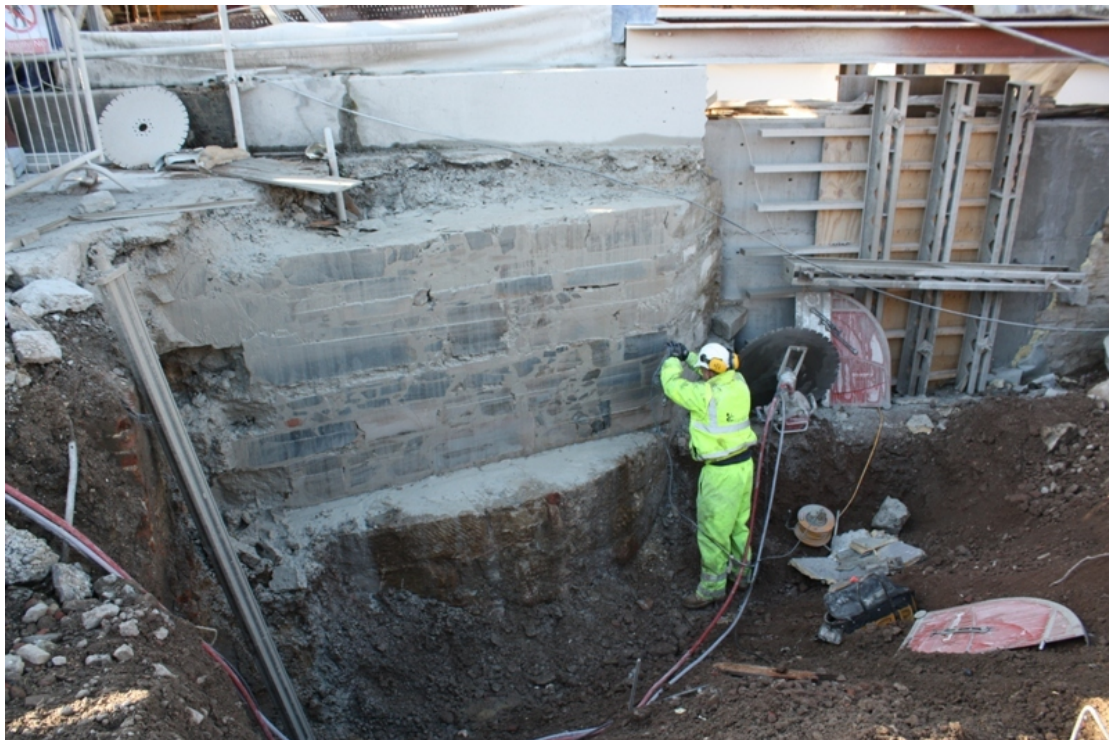
Plate 14. OP104. Cutting of staircase [86]. Looking south.

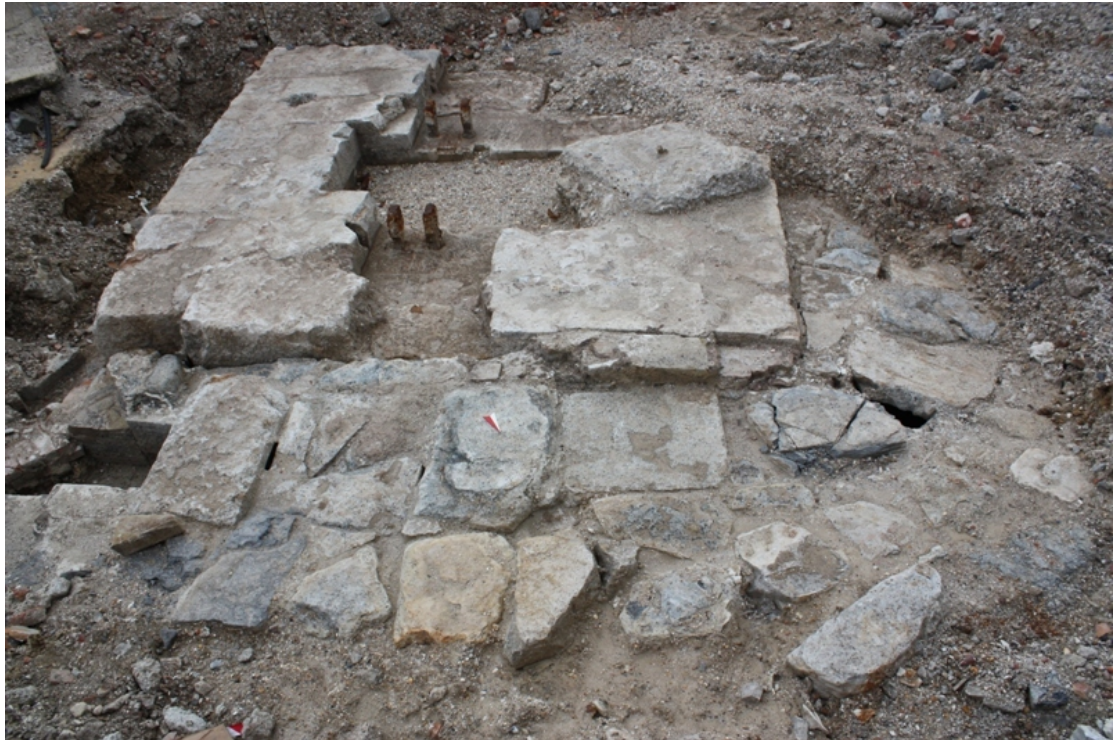
Plate 15. Area B. Structure number [37], presumed to be a 19th century hydraulic power system. The stone foundation [34] is in the background, the associated culvert system [35] is in foreground. Looking south-west.

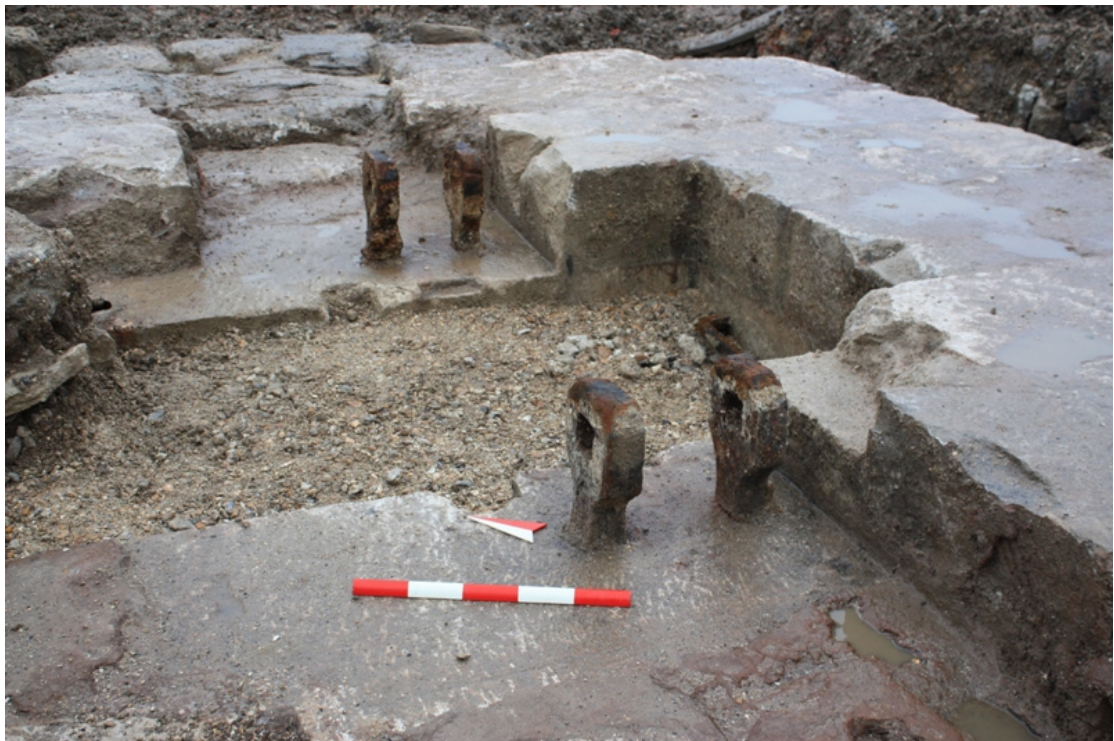
Plate 16. Area B. Detail of stone foundation [34]. Scale 0.5m, looking north-east.

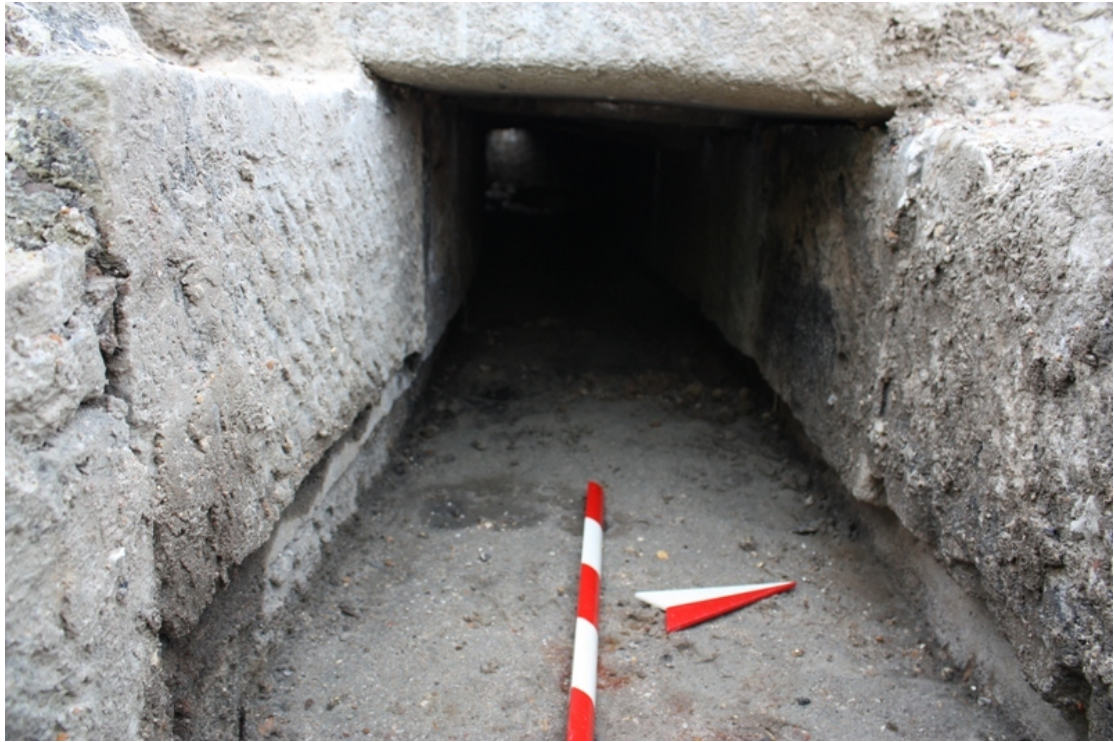
Plate 17. Area B. Detail of culvert [35], part of structure [37]. Scale 0.5m, looking west.

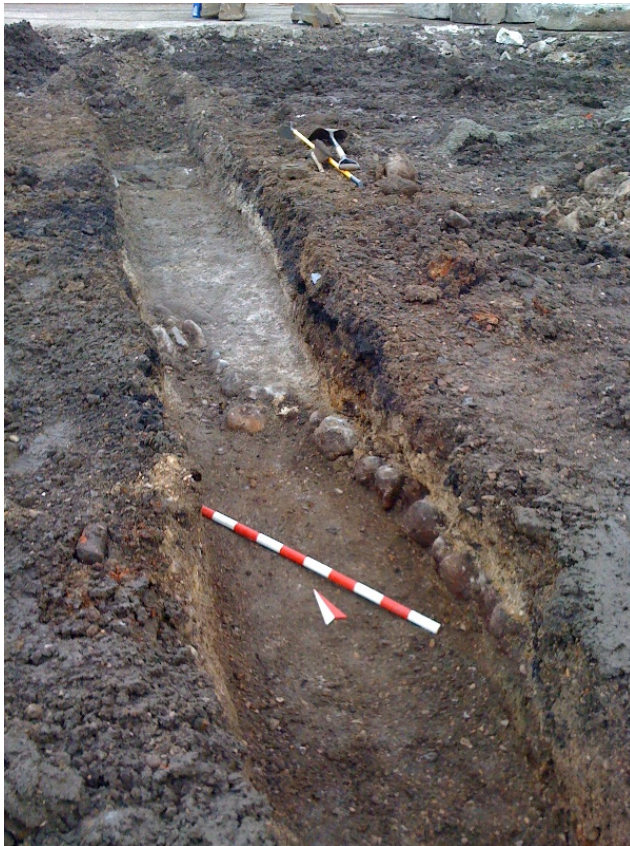
Plate 18. Trench 1 east. Structure [39] with cobbled floor surface [42]. Scale 1.0m, looking north.

3.53mOD. Both these layers were overlain by a floor surface given the overall structure number [39] (plate 18), consisting of cobble stones, [42], a mortar bed, [66], a mortar layer, [43], and at the northern end of the trench a wall, [41], which was encountered at 0.25m below ground level. A 0.12m thick band of rounded cobbles of dark reddish brown stone, [42], between 80mm and 180mm in diameter, (highest level 3.55mOD) which had been laid on a 0.10m thick bed of dark reddish brown silty mortar, [66], (highest level of 3.62mOD) was observed. Both these features extended the entire length of the trench to 5.00m and width of 0.60m. These in turn were overlain by [43], a 0.25m thick bed of soft light grey lime mortar, the highest level of which was recorded at 3.76mOD. At the northern end of the trench and abutted by [43] was [41]. This was the remains of a wall built from small irregular shaped and roughly finished blocks of limestone, Granite, cobble stones (identical to those in [42]) and very occasional timber. The overall effect was of a very crudely built structure that measured 0.50m north-south by 0.62m east-west and survived to a height of 0.08m recorded at 3.59mOD. While not exposed in the trench itself, this floor surface was seen to abut the brick foundation wall of building 1/92 approximately 2.00m to the south-east of Trench 5 east (plate 19). The building (demolished as part of the enabling works) dates to c. 1901 and the floor surface appears to be associated with it, and is thus ascribed to the early modern period. The remainder of the sequence in Trench 5 east consisted of interleaved layers of 19th-20th century made ground deposits [64], [65], [67] overlain by a 0.10m thick layer of modern made ground, the top of which formed the current ground level at 3.81mOD.
