**MARY ROSE NEW MUSEUM
PORTSMOUTH HISTORIC
DOCKYARD
PORTSMOUTH
HAMPSHIRE**

**ASSESSMENT OF AN
ARCHAEOLOGICAL WATCHING
BRIEF**

**Archaeological Watching Brief at the Mary Rose New Museum,
Portsmouth Historic Dockyard, Portsmouth, Hampshire**

Site Code: PMRP 08 (Phase III)

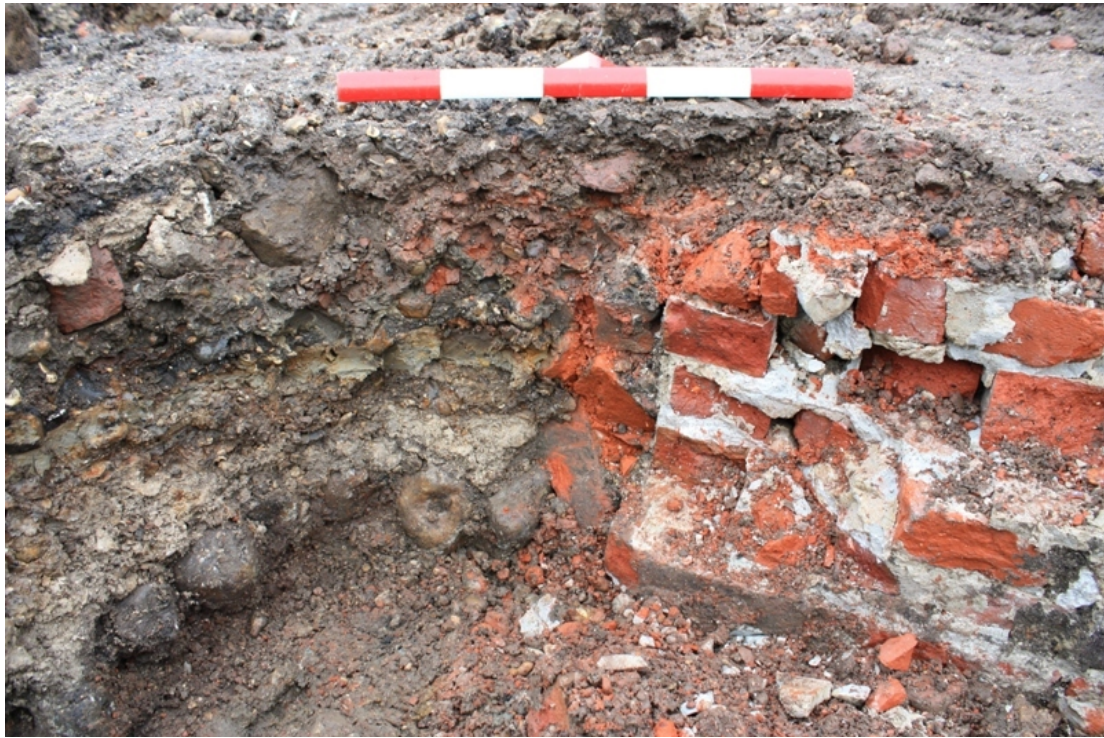
Plate 19. Detail of cobbled floor [42] abutting foundation wall of building 1/92, south-east of Trench 5 east. Scale 0.5m, looking north.

Plate 19	Detail of cobbled floor [42] abutting foundation of building 1/92	56
