# Archaeological Recording

**St MICHAEL'S CHURCH,  
KINGSTEIGNTON, DEVON**

*By R.W. Parker*

**REPORT No. 2015.03**

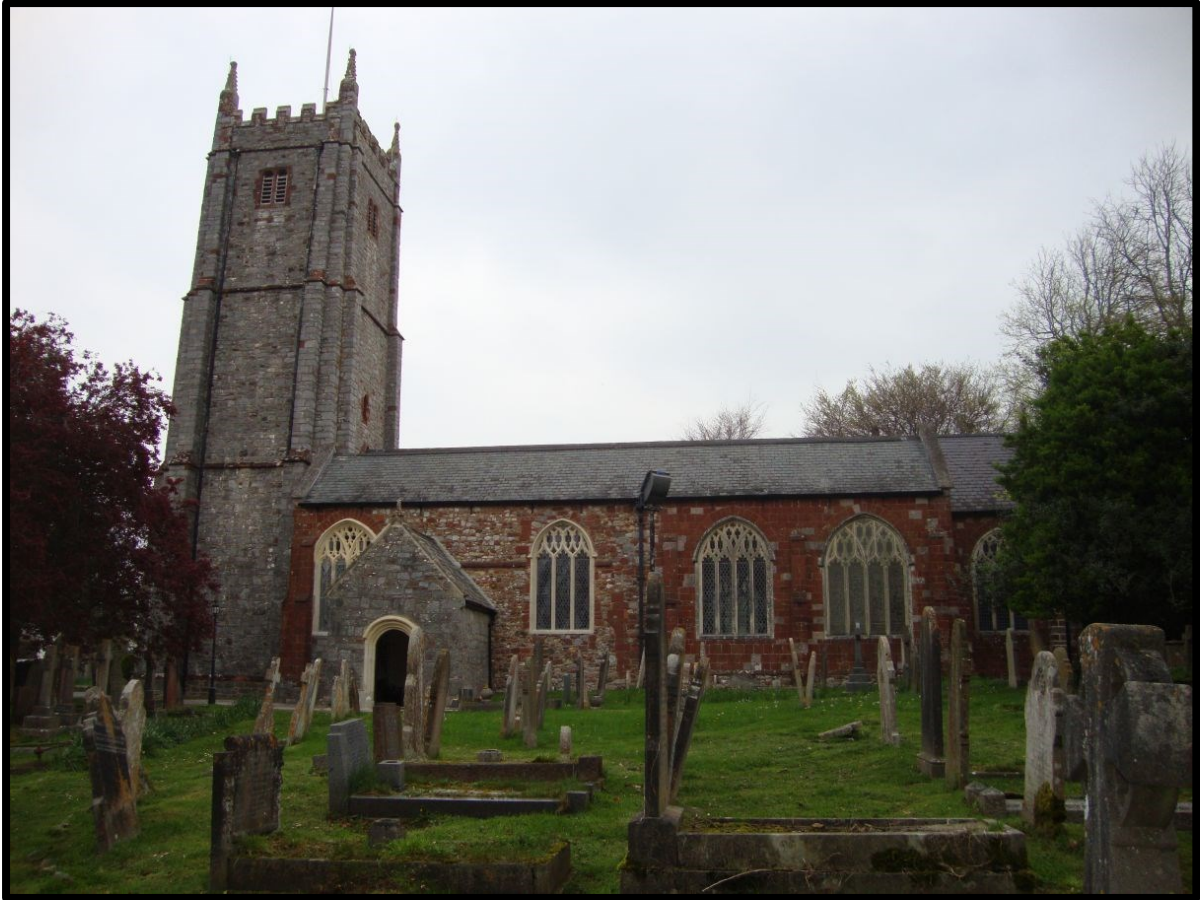
Fig. 1 General view of St Michael' Church from the south showing the mixture of red sandstone and grey limestone employed in the fabric.

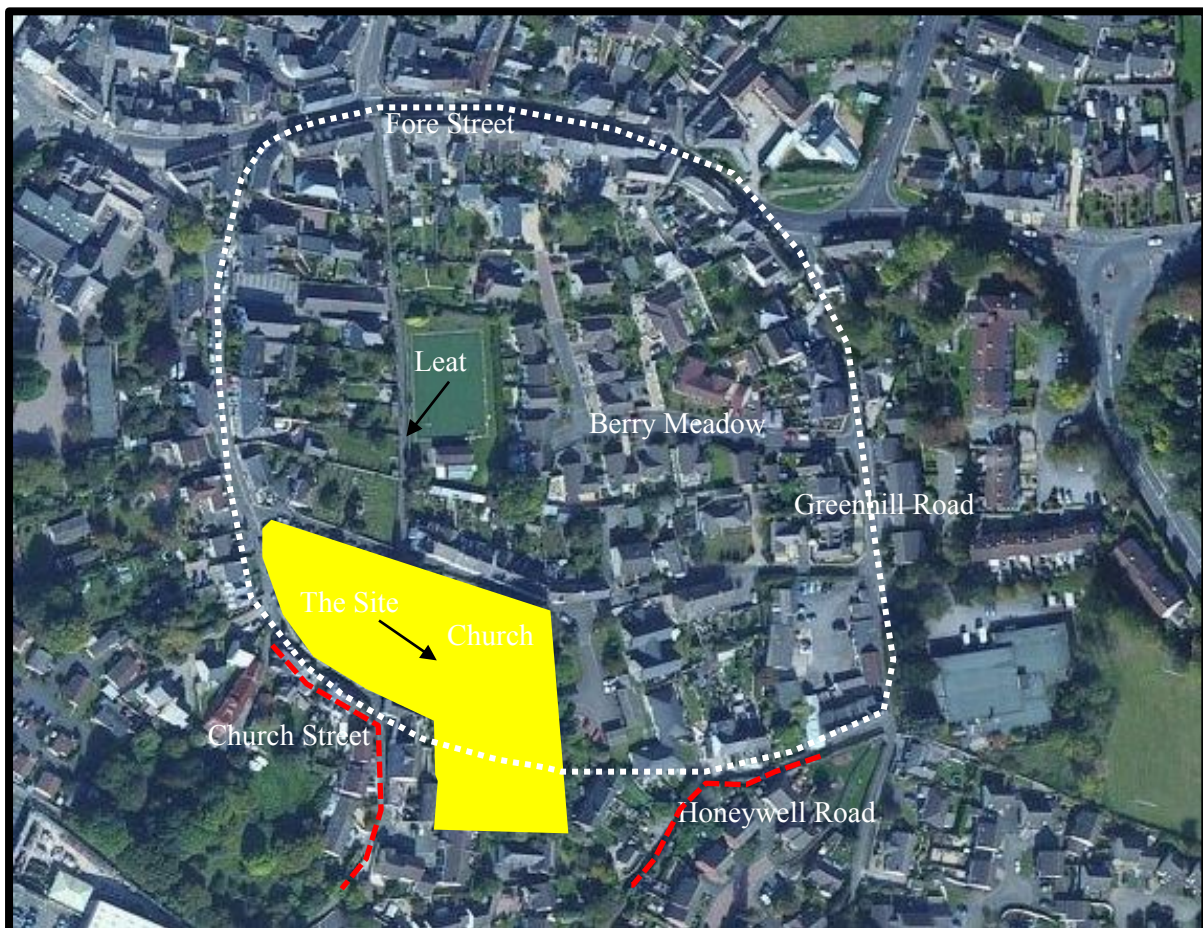
Fig. 3 Aerial view of central Kingsteignton showing the circular outline possibly representing an early fortified settlement or enclosure. The church and church yard (highlighted in yellow) lie close to this boundary in the south-western quadrant. The diversions of Church Street and Honeywell Road (represented by red dashes) away from this boundary, around a sub-rectangular protrusion

of the churchyard, may preserve the outline of lands or precincts pertaining to a Saxon minster church.

Other topographical features may preserve evidence of the early church complex and its lands. Church Street and Honeywell Road, (which may formerly have run continuously along the southern edge of the earlier circular enclosure) seem to have been diverted away from this boundary immediately to the south of the church, to avoid a large, raised rectangular area on the south side of the building (Fig. 3). Although this area today presents the appearance of a relatively late addition to the burial ground, it is possible that it had been church property from an early date and thus it may preserve the outline of an enclosure or precinct relating to the minster church, overlying the earlier circular enclosure. This is perhaps the most likely site for the communal buildings of the minster, assuming the northern parts of the churchyard, nearer the centre of the settlement, to have been open burial grounds. Water management is also a characteristic feature of medieval ecclesiastical sites and, at Kingsteignton, the presence of a leat passing through the churchyard immediately to the west of the church tower is of particular interest. Although its main function in modern times has been to power the mill lying to the south west of the church it is conceivable that it also once provided a water supply for the minster community. Further watercourses and springs survive to the east of the church which may also have supplied or drained the conventual buildings.

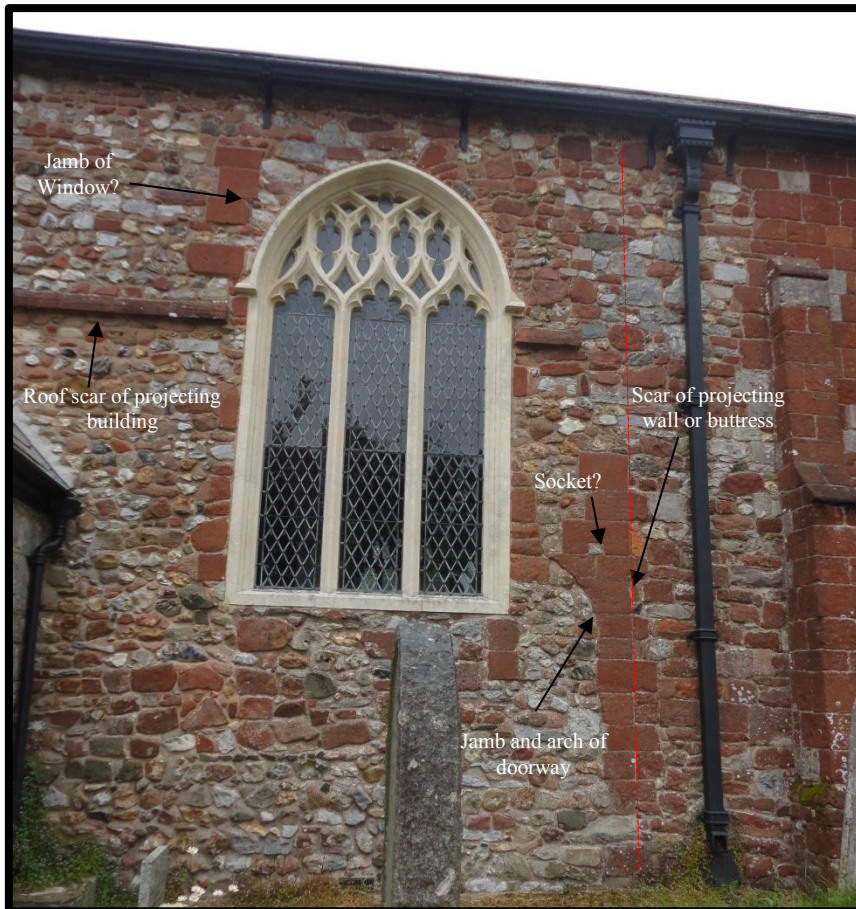
Fig. 4 Elevation of the west end of the south aisle showing features of possible early-medieval date cut by late medieval windows.

The south aisle is a particularly interesting part of the building and contains the earliest surviving fabric. Although the two eastern bays and much of the western gable are constructed of blocks of squared red sandstone and are probably of late-medieval date, the western part of the south wall, near the entrance porch, is clearly much earlier and contains a number of enigmatic features (Fig. 4). This part of the church is of mixed, random rubble including small blocks of limestone, sandstone and chert, reflecting the extremely complex geology of the area. The main south door of the church has a richly-decorated late medieval archway, but this is crude in outline and appears to be cut from a single block of stone, set within an earlier round-headed opening with a broad internal splay. It is possible that the head of the arch may be cut out of an earlier solid tympanum, which may imply the modification of a Romanesque doorway of 11th or 12th-century date. Within the masonry to the east of the porch are a number of blocked openings, cut by the Beer stone dressings of a large three light window with 15th-century style reticulated tracery (probably representing a 19th-century restoration of a late-medieval window). At ground level, well to the east of the porch, a vertical row of red-sandstone blocks can be seen ending in a curved form which suggests the jamb and curved head of a low archway. This is not large enough to represent the opening to an arcade, but is perhaps another doorway. Unfortunately insufficient evidence remains to show whether this had a pointed or round arch; both are possible. Since no trace of chamfering or moulding remains attached to these blocks, it is likely that the opening had separate dressings within the arch; it may have had several orders of colonnettes or, since there appear to be no voussoirs as such, a solid tympanum surrounded by a raised moulding. This doorway is perhaps also of 12th-century date, and its position towards the east end of the early fabric might suggest a priests' door. The red sandstone blocks forming the jamb are staggered as though to form the quoins of a returning wall, projecting to the south of the present aisle. This might be interpreted as a buttress, or possibly a much larger structure projecting beyond the south wall of the present church, such as a transept or porticus, now demolished.

At a higher level, above the head of the inserted window, the jamb of a further opening is visible above a horizontal string course running across the elevation. This may represent a small window. Its position very high in the wall is also suggestive of an early date, but the most unusual feature is the horizontal string course below it. This appears not to be a decorative feature articulating the elevation, but instead has the appearance of a drip course above the roof of a structure extending still further south beyond the limit of the existing church. This may represent a lean-to aisle, since a few blocks remain to show that it formerly extended to the west of the roof of the porch. A socket in the head of the blocked doorway might have housed a tie connected with this roof structure. The windows above the string course may have been set so high to provide light to the body of the church above the roof of this building. The implications of this will be discussed in the conclusion, but this does show that the ground in the immediate periphery of the church is likely to contain traces of long-demolished buildings for which no visible evidence remains above ground.

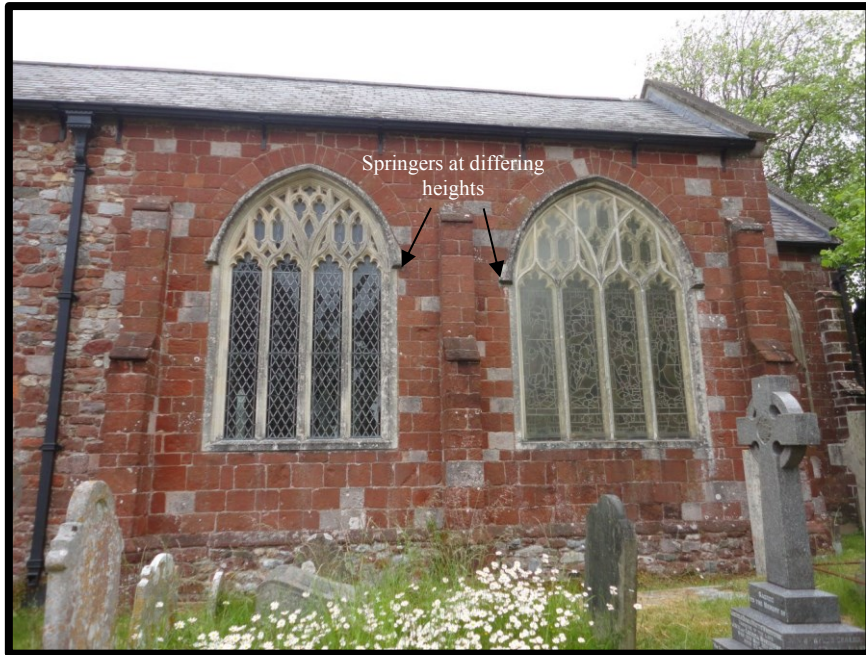
Fig. 5 Elevation of the east end of the south aisle showing evidence of discontinuity in otherwise apparently homogenous fabric.

obscured much of the evidence for the form of the early building. Some clues remain, however, to show that, despite the apparent homogeneity of the fabric, it was also the product of successive accretions. The two bays of red sandstone fabric forming the east end of the south aisle have fabric and window tracery which initially appear continuous and of a single phase (Fig. 5). Closer examination reveals that this is not the case; there

are slight differences between the two windows, which are of different sizes and have springers at different heights. This may show that the two eastern bays of the aisle are of different periods. The eastern bay might represent a chapel added beyond the east wall of an earlier southern transept which was later incorporated within a continuous aisle. This conjecture raises the possibility that the church originally had a cruciform plan. The earlier western bays of the aisle may thus be interpreted as a nave aisle added to the west of this putative transept, which would explain the very different character of the fabric in this area, but raises interesting questions as to the nature of the lean-to structure formerly built against it.

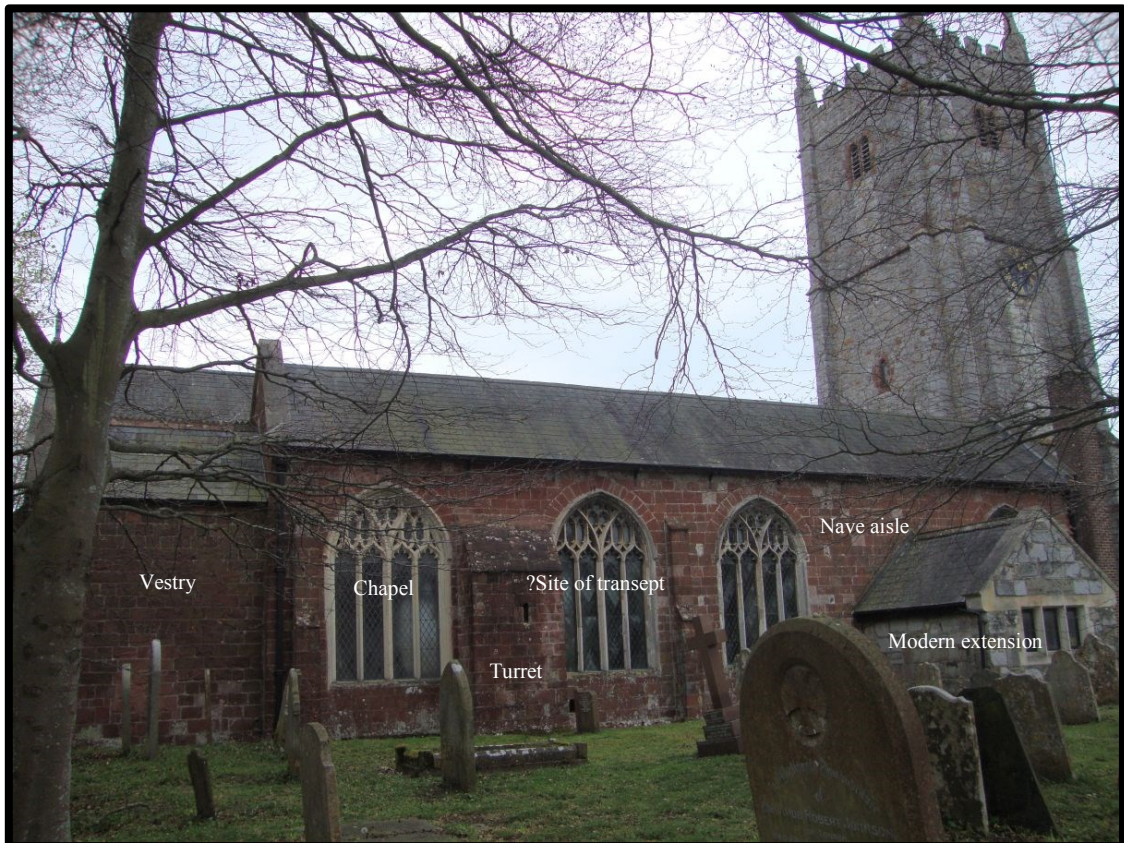
Fig. 6 Elevation of the north aisle showing apparently homogenous fabric with minor variations in the width of the windows. The easternmost bay represents a 19th-century vestry. The projecting turret for a rood stair might mark the eastern wall of a possible north transept.

Unfortunately the fabric of the north aisle is less instructive: though there are clear differences in the size of the windows, the tracery is of similar character and the western bays are all of red sandstone (Fig. 6), with no helpful indications of earlier fabric or openings. The eastern bays contain a projecting stair turret for the rood stair which marks the position of the late-medieval rood screen. It is possible that this also betrays the position of an earlier east wall of a north transept, with a chapel beyond to the east, now recognisable by a slightly larger window. Inspection of the interior of the church shows no very obvious anomalies in the nave piers and arcades beyond a slight variation in the width and span of the arches and, though this does not preclude a cruciform church with transepts, it certainly provides no evidence unequivocally supporting this conjecture. The two windows in the central bays of the north aisle are of similar character. The north doorway, now concealed by a modern extension containing lavatories, has a plain chamfered two-centred arch. It seems likely that the western four bays of the aisle were all rebuilt at the same period and that any evidence of an earlier aisle or transept preceding it was removed at this time.

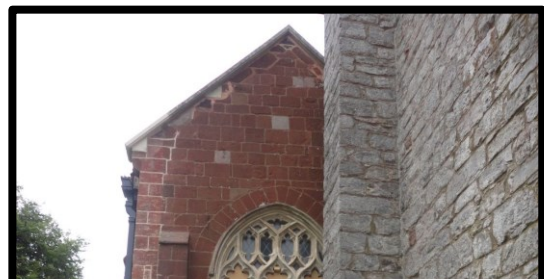
Fig. 7	View of the western elevation of the tower and north aisle prior to the works showing the modern boiler house and chimney shaft (left) and the aisle west window extending to its full original height.	6
Fig. 8	View of the west wall of the aisle during demolition works showing the shortening of the window and the removal of medieval fabric below to create the lavatory access.	6
Fig. 9	View of the underground boiler house showing the brick lining of the room and the concrete capping which may have preserved the height of post-medieval ground levels.	9
Fig. 10	View of the western elevation of the north aisle during the insertion of a concrete lintel for the new doorway and prior to the demolition of the medieval walling.	9
Fig. 11	View of the western wall of the aisle from the interior during demolition, showing the mixed rubble masonry bonded with very hard white lime mortar. Two reused red sandstone treads from a medieval newel stair in were recovered from this area.	9

The western façade of the church is dominated by the tower (Fig. 7). This is almost entirely constructed of grey limestone, apart from the dressings of the principal west window and doorway, which have granite mouldings and tracery and feature alternating limestone and red sandstone voussoirs giving a very festive polychromatic effect to the heads of the principal openings. The tower is in three stages, divided by sloping string courses and crowned with an embattled parapet with corner pinnacles decorated with crockets. The buttresses are offset from the corners on each face, including the east face, and the very modest belfry windows, each of two small lancet lights, have red stone dressings.

The boiler house at Kingsteignton (Figs 7, 8) occupied the angle between the west wall of the north aisle and the north wall of the tower, and was a low structure with walls of concrete blocks, only the upper parts of which projected above the ground. The roof of the boiler house was a low, shallow-pitched, almost flat roof sloping down to the west from a point just below the sill of the west window of the aisle, which lay at a height of approximately 2.2m above modern ground level. The great majority of the interior of the building lay beneath ground level in a deep brick-lined cellar which had been dug in the 20th century at a distance of about 0.9 m from the base of the north aisle wall and just over 2m from the base of the tower, no doubt in order to avoid possible disturbance to the footings of the church building. The boiler house was vented by a tall, brown-brick chimney built against the aisle of the church alongside a projecting buttress at its north-western corner. This chimney and the entire upper part of the boiler house were entirely demolished to ground level for the construction of the new building exposing the fabric of the lower part of the west wall of the aisle and the lower part of the north wall of the tower.

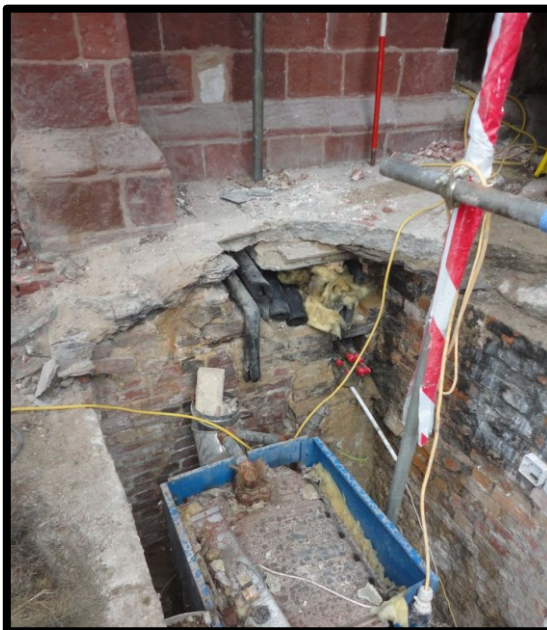
Fig. 9 View of the underground boiler house showing the brick lining of the room and the concrete capping which may have preserved the height of post-medieval ground levels.

The brick lining of the lower part of the boiler chamber was not removed during the current works, neither were the footings of the aisle or tower disturbed, so the possibilities for archaeological observations in these areas were limited; however, part of the overbuild against the church wall, above ground level but beneath the roof of the boiler house was dug away. This rose to a height of approximately 0.6m above the level of the church floor internally and was capped by 20th-century concrete (Fig 9) at a level about 1m below the roof of the boiler house. This upstanding baulk of material masked the plinth of the tower and its buttresses but rose just below the plinth of the aisle, and sloped down to the north away from the tower. This may conceivably have represented the level of build-up of the ground around the church prior to modern levelling of the churchyard in the 19th- or 20th century. Unfortunately this deposit was much disturbed by modern pipework and brickwork for the walling of the boiler house and no evidence of archaeological stratigraphy or other features were observed on its removal. The remains of a reused 19th-century slate tombstone were recovered from the walling of the boiler house close to the base of the tower buttress. This was much damaged, but retained the remains of a triangular head with a delicately incised border and bore the inscription as follows (restored):

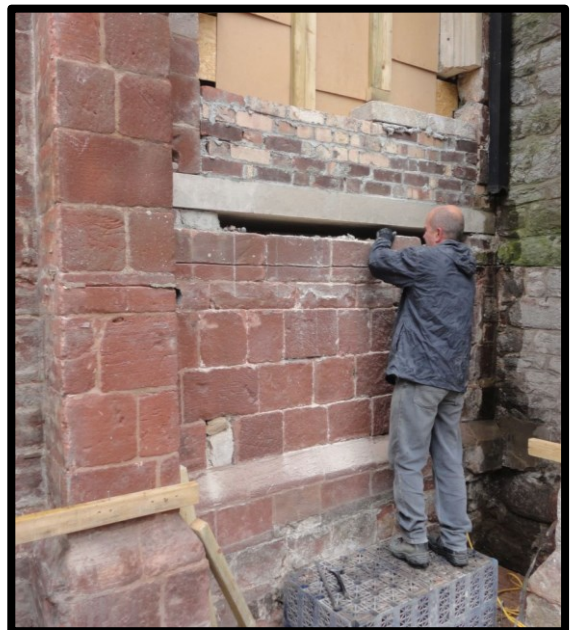
Fig. 10 View of the western elevation of the north aisle during the insertion of a concrete lintel for the new doorway and prior to the demolition of the medieval walling.

Following the removal of the concrete and brickwork the lower part of the wall of the aisle was exposed (Fig. 10). This revealed four courses of red sandstone blockwork beneath the level of the chamfered plinth and five courses above it, below the sill of the aisle west window. The blockwork was of very high quality, tightly coursed and bonded with white lime mortar. It was clearly meant to be displayed and must have been visible above the medieval ground level, which may be assumed to be more-or-less level with the present internal floors of the aisle. The footings of the church were also partially visible, consisting of small, unsquared blocks of red sandstone and fragments of volcanic trap rubble bonded with a very hard and very high-quality white lime mortar.

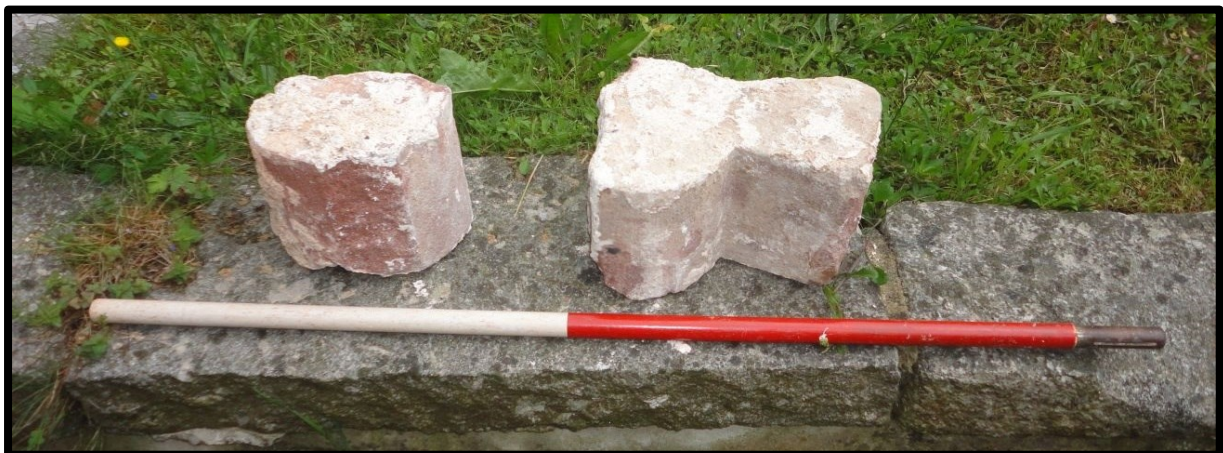
Fig. 14 Two shaped blocks recovered during the demolition of the west wall of the aisle, showing the characteristic 'keyhole' shape of the treads of a newel stair or vice.

The only finds recovered from the walling, apart from a few pieces of slate which had been used for levelling near the base of the wall, were the two worked blocks which had been built into the internal face of the wall. These blocks were clearly derived from a medieval vice or newel stair. One of the blocks (Fig. 14) retained the characteristic 'keyhole' form of the central sub-cylindrical newel and the flaring shape of the tread adjoining. The second block retained only the newel, the tread having been broken off before being reused within the wall. It is likely that the blocks were derived from a stair turret which was demolished at the construction of the present north aisle. This may have served as a rood stair within the north wall of the nave or chancel or, just possibly, the stair of an earlier tower, either at the west end or over the crossing of the early-medieval church building.

The tower of the present church is clearly a later addition, indeed, possibly a very late addition, and the reused blocks from an earlier newel stair, found within the west wall of the aisle raise the possibility that the present tower replaces an earlier tower or turret. If this is the case, then the admittedly very slight hints in the surviving fabric of a cruciform church with transepts may raise the possibility that the church at Kingsteignton was originally crowned with a central tower like the examples formerly at east Teignmouth and Bishopsteignton. If such a tower existed, it must also have been demolished during late-medieval alterations to the church and has left very little trace. The total disappearance, as late as 1815-16, of the central tower at Bishopsteignton (which has also left barely a trace in the visible fabric, but is well known from 18th-century illustrations) provides a valuable demonstration of the need for caution in

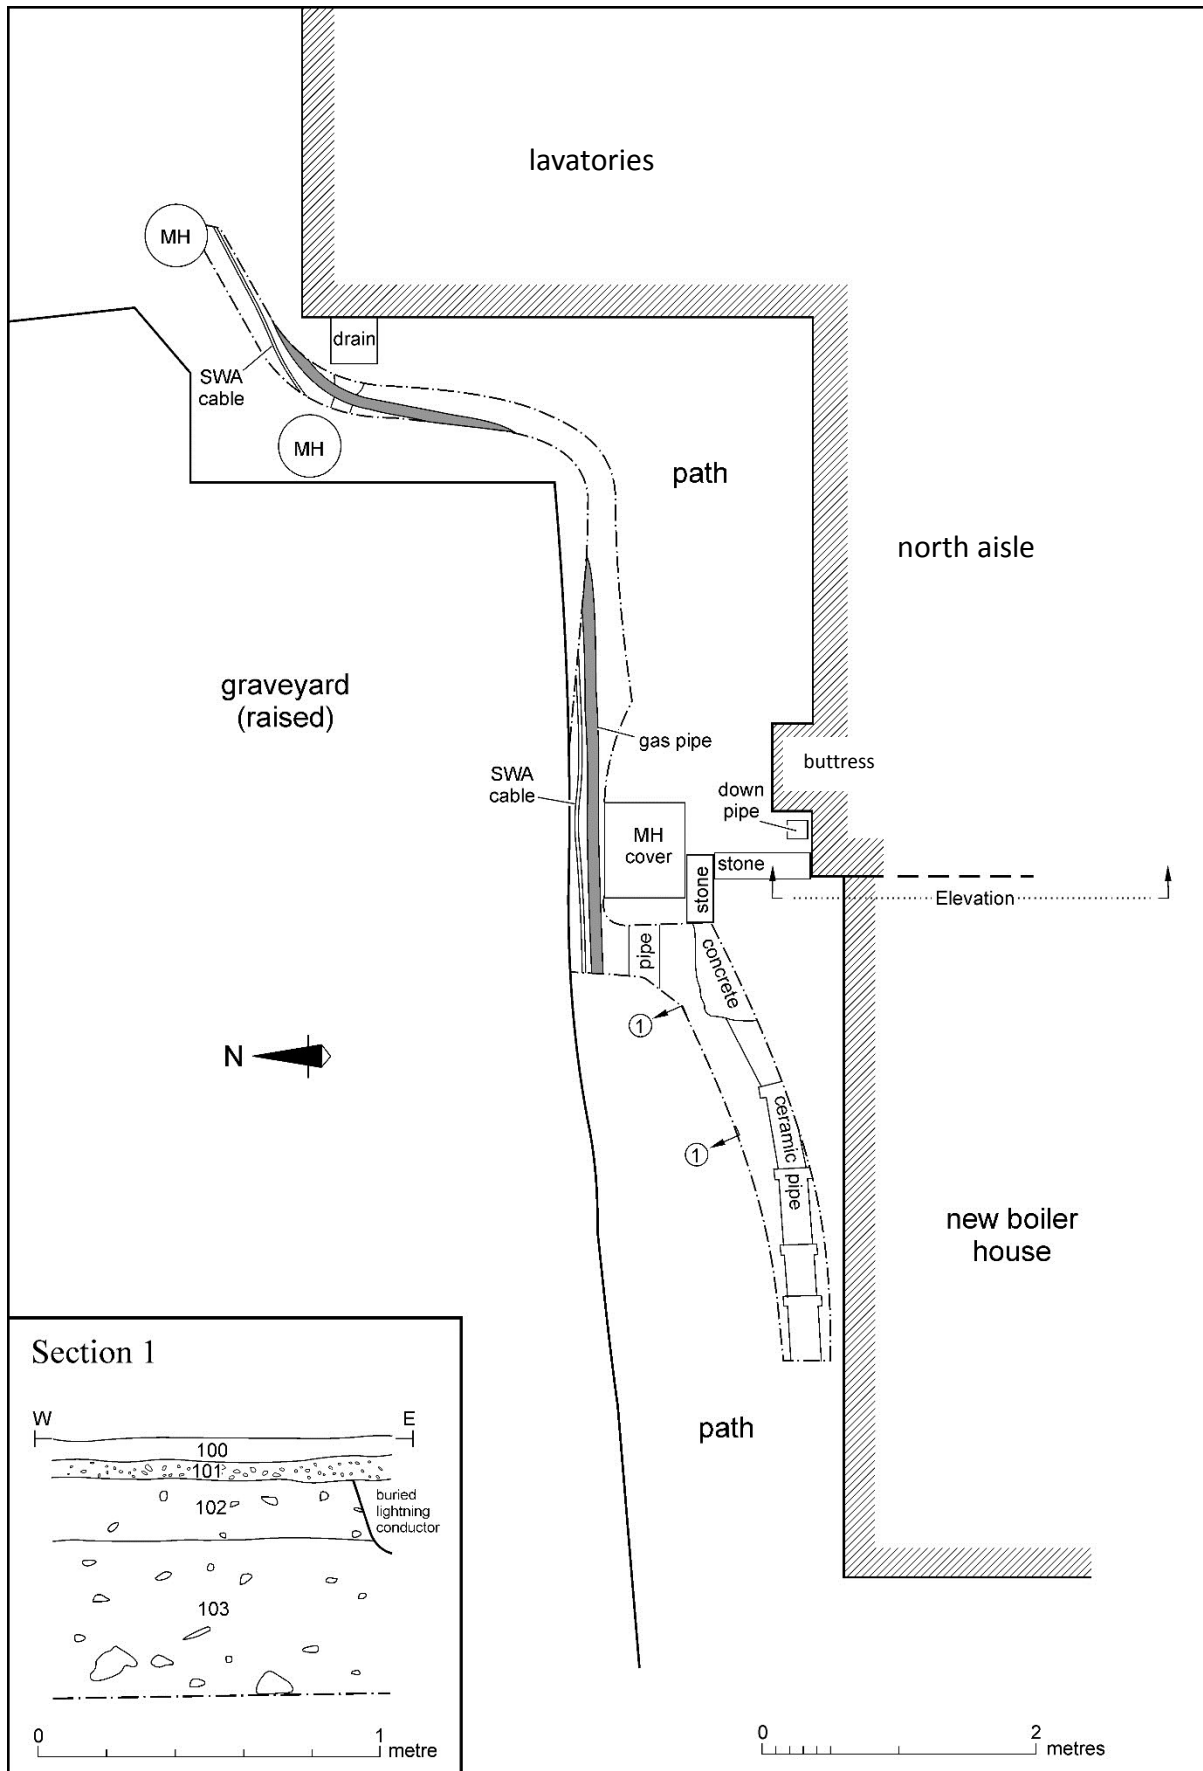
Fig. 15 Plan and section of the excavations for service trenches on the north side of the church.

During the trenching, owing to the potential archaeological sensitivity of the site, a watching brief was carried out on the groundworks. This work was carried out on behalf of Richard Parker Historic Building Recording and Interpretation by archaeologists from AC Archaeology (Devon). The site was visited twice, on the 2nd and the 9th of September 2013. The excavation of the trenching by the contractors was observed and the trenching was then planned at a scale of 1:50. A small section of stratigraphy undisturbed by the earlier service trenches was exposed and this was therefore recorded in section at a scale of 1:20. The results of the recording are shown in Fig 15, Section 1.

The uppermost layer of the exposed section (Context 100) consisted of modern turf, to a depth of 0.06m. This overlay a layer of fine, dark grey gravel (Context 101) to a similar depth, which was interpreted as the make up for a path. This overlay a very mixed and loose deposit of dark grey/brown coarse sandy clay (Context 102). This was interpreted as levelling following the excavation of the earlier pipe trenches, perhaps after some reduction in the level of the churchyard close to the walling of the church in the 19th or 20th century. Beneath this was a layer of soft, moist dark grey/brown sandy clay with occasional angular stones (Context 103). The layer was relatively homogenous and well consolidated and contained fragments of disarticulated human bone. This was interpreted as a burial soil, likely to have been dug and re-dug to a substantial depth by the excavation of successive graves over a long period. The bottom of this layer was not seen, the trench at this point being less than a metre deep. The remains recovered from the trenching included a total of 106 fragments of disarticulated Human bone comprising:

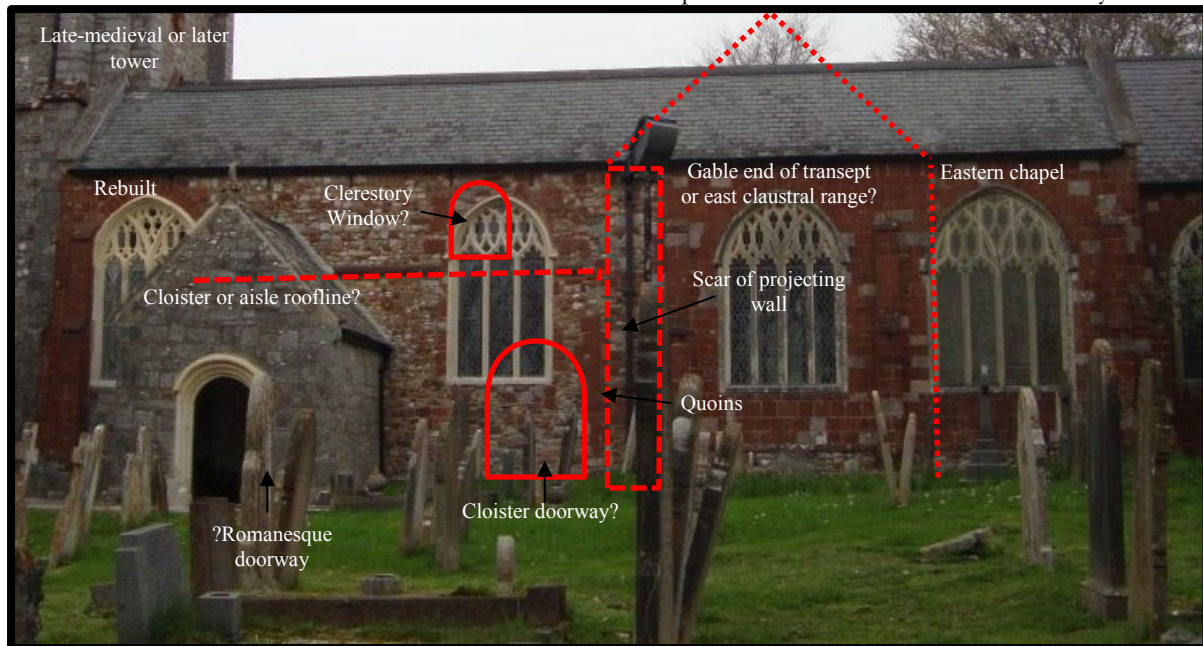
Fig. 16 Interpretation of the fabric of the south aisle at Kingsteignton showing the possible remains of a cloister roof, cloister east doorway, possible transept/east claustral range and the remains of a possible clerestory window above the cloister roof.

If this interpretation were applied at Kingsteignton (Fig 16), the blocked doorway to the east of the porch might be interpreted as the doorway to the east walk of a cloister, and the remains of the returning wall alongside it as the west wall of a demolished eastern claustral range, perhaps continuing the line of an early transept southwards. If the present south doorway of the church is also an early opening, perhaps altered in the 15th or 16th century by cutting away and re-carving a solid tympanum, then this might conceivably be interpreted as another cloister door, perhaps opening either into the north walk, or possibly into the junction of the north and west walks, from the western part of the church. Alternatively this doorway might have been created, or reset here in the late medieval period, when the present porch with its characteristically 16th-century spiral mouldings was erected and any earlier structures to the south were cleared away. Rebuilding of the western end of the aisle has obscured any evidence of a wall scar to the west, for the projection of the western claustral range, supposing one ever existed.

If these features do provide evidence for a cloister, it would certainly have been a very small one, with sides only 30ft (9.15m) at least, or at most 40ft feet (12.2m) long. Small or irregularly-shaped cloisters are not unknown and the size of the cloister would have depended on the size of the community as well

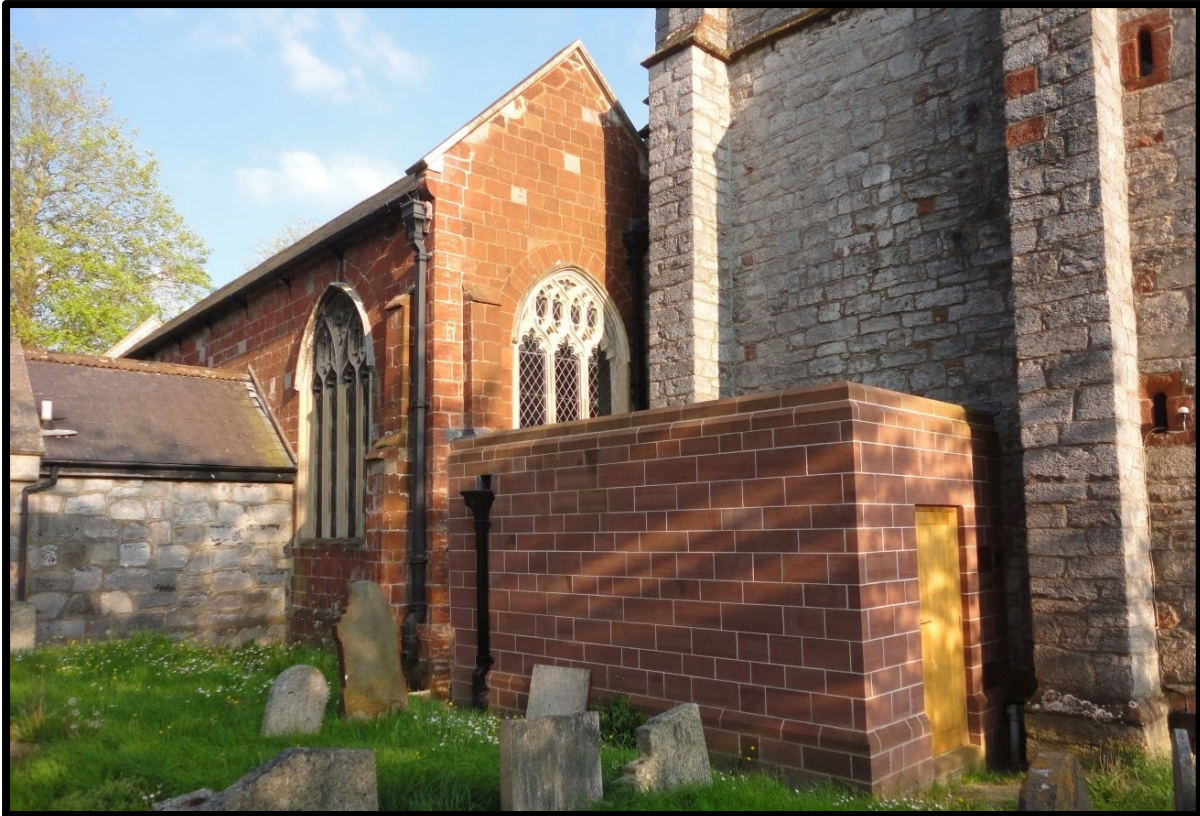
Fig. 18 View of the new boiler house and toilets after completion.
