The site of the Botanic Gardens, Leith Walk

34 Haddington Place, Edinburgh

Archaeological Evaluation and Excavation

Data Structure Report

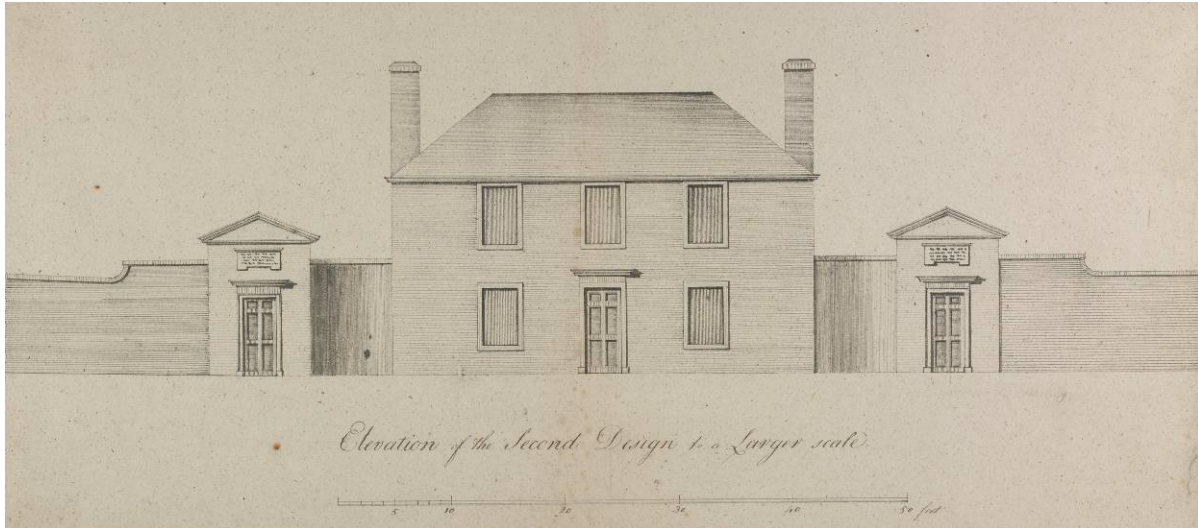
Figure 3 Proposed elevation of Botanic Cottage (Royal Botanic Garden Edinburgh)

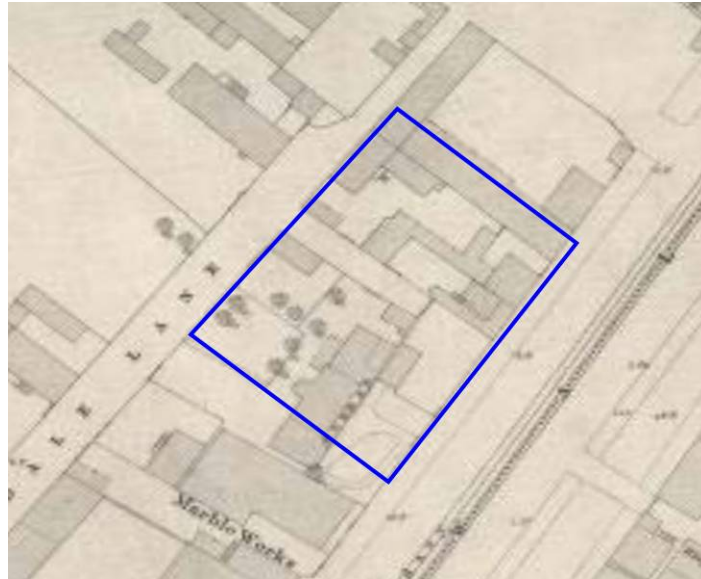
Figure 6 Detail of the wider site area in blue as set against the site as it appeared in the Ordnance Survey map of 1876. The area around Botanic Cottage has become extensively settled with a collection of small buildings.
Addyman Archaeology after NLS

By 1876 the entire area has changed significantly and the site has been subsumed within the urban expansion of Edinburgh. The area to the rear of the cottage still seems to contain an area of gardens, but the north eastern half of the site is now developed, housing a range of irregular buildings. These survive, with some alteration until the 1950s, by which time the garage has been built on the site.

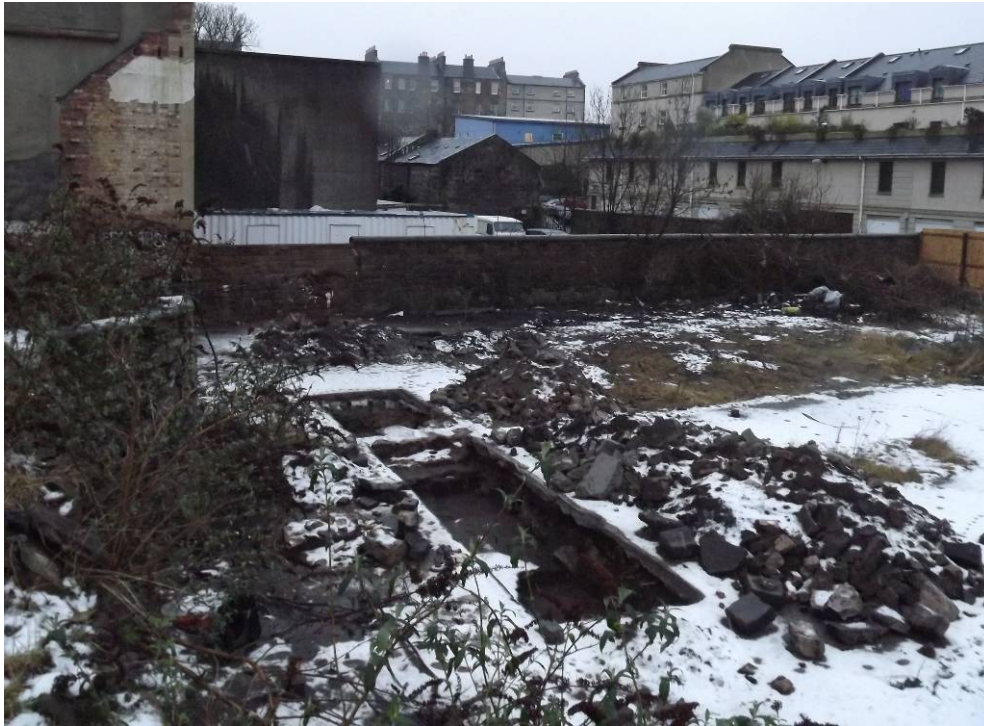
*Plate 1 General location shot of Trench 01 and Trench 02 in the background and foreground respectively.
(Photograph 102)*

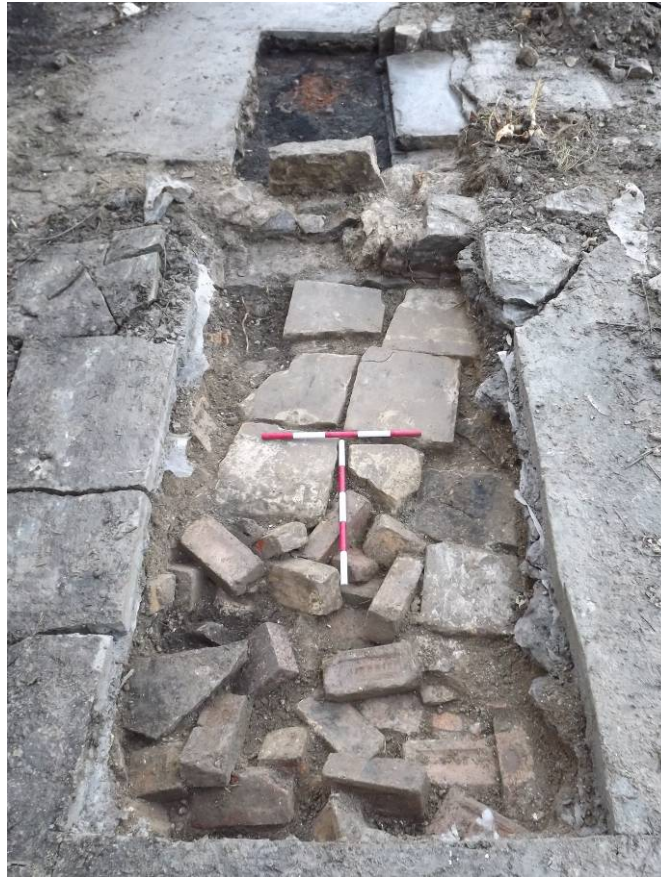
Plate 2 Mid-excavation view of Trench 1(2013) showing (0104) (Photograph 020)

The modern concrete floor surface {0101} was broken and removed by a mechanical excavator. This revealed a mixed deposit dominated by a series of large, cut sandstone blocks and bricks lain flat within a matrix of lime mortar – (0104) (Plate 2). These were initially thought to be the remnants of a disrupted flag surface, but as excavation proceeded it became clear the deposit was more modern. All the blocks were tooled square, with neat diagonal tooling. These were spray painted with graffiti on the underside and were interpreted as relating to widening of the rear windows in the 1990s. During this work it is thought that the now redundant and removed dressing stones were buried beneath the floor.

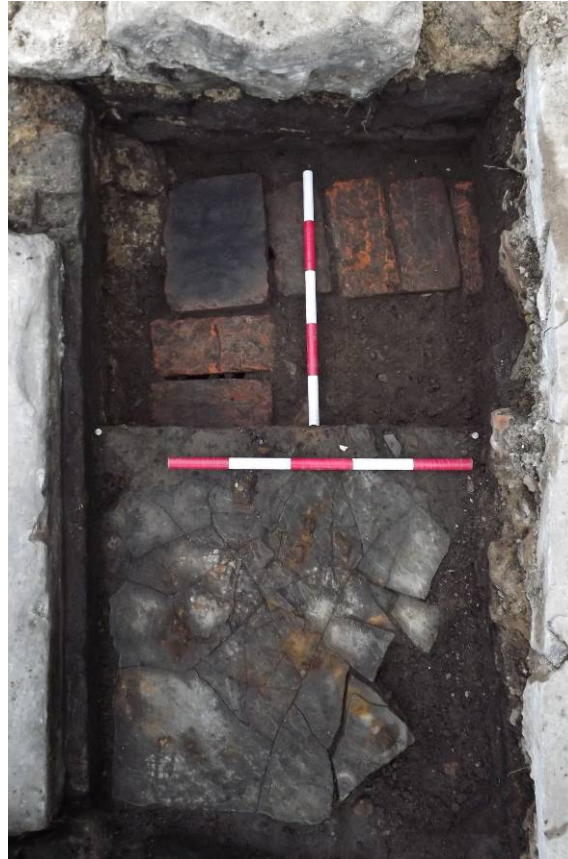
Plate 3 Vertical view facing west of flagstone (0110) and drain {0111} (Photograph 069)

Below (0108), what was interpreted as a heavily fragmented flagstone sat in front of the door. This was recorded as (0110) and interpreted as a strengthening of a worn area in front of the door. This worn area had developed in (0109), a deposit of gravelly and silty and gritty mid brown sandy soil, with a depth of 0.15-0.20m. This deposit directly overlay a brick culvert drain {0111}.

The drain is constructed from hand made bricks of possible 18th/19th century date placed length ways, side by side. These are lime mortar bonded, with individual dimensions of c.0.23m by 0.11m by 0.06m. This runs N-S along the west wall of the cottage, before returning to the west along the stair tower foundation. The drain clearly respects, and post-dates the construction of the cottage stair tower.

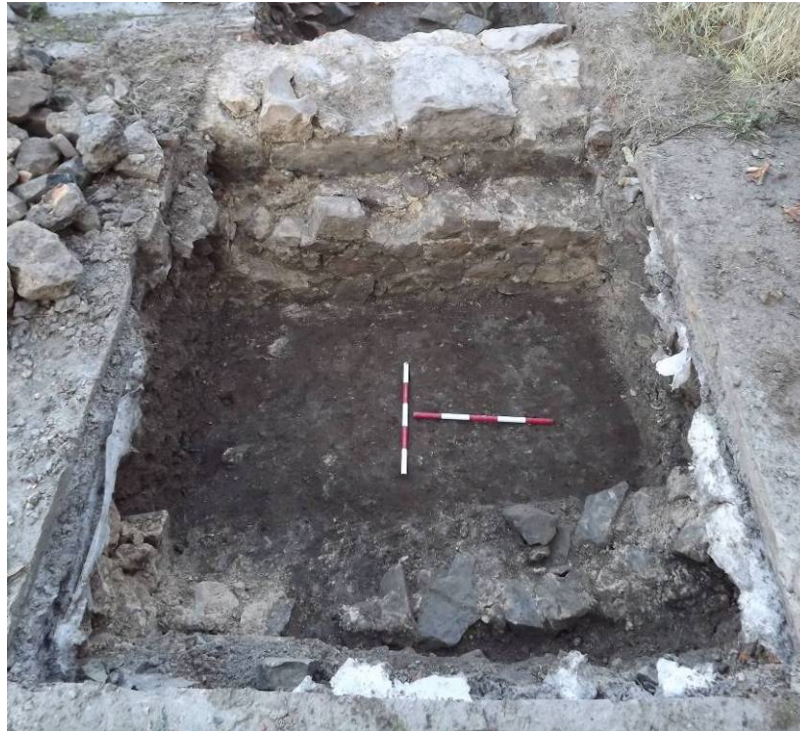
Plate 4 Post-excavation view of Trench 02(2013) looking north (Photograph 025)

The infilled material (0205/0206/0209) had a depth of around 0.50m, packed around the sleeper wall {0210} and main north wall of the cottage {0202}. Both the deposits and the walls sat directly on top of a beaten earth floor surface (0207). This comprised moderately compact dark brown silty sand. Excavation of a sondage through (0207) showed the underlying (0208) to be similar, but with a more orange hue. In the restricted sondage, this was interpreted as the natural subsoil, with some evidence for disturbance through burrowing.

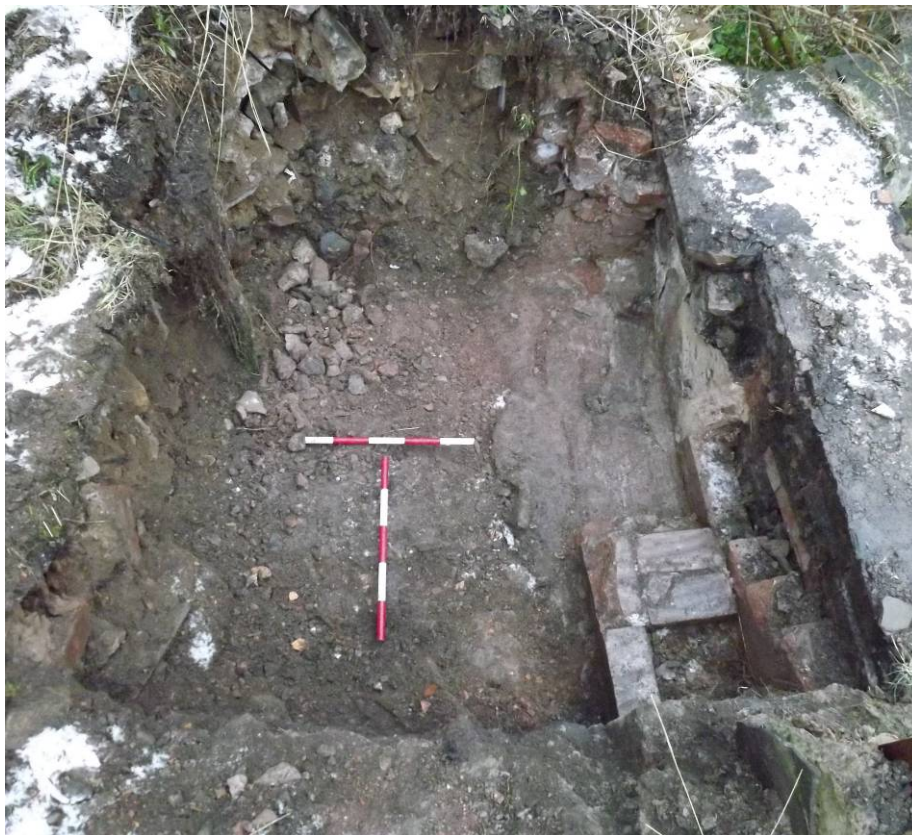
Plate 5 Post-excavation view of Trench 03 facing south (Photograph 108)

Trench 3 was abandoned at a depth of c. 1m. Although the conclusions gained from such a limited and constricted excavation can only be tentative at best, the upper parts of the entrance on the street facing side were revealed. These were seen to be unambiguously plain, with a simple angle rather than a more elaborately moulded surround.

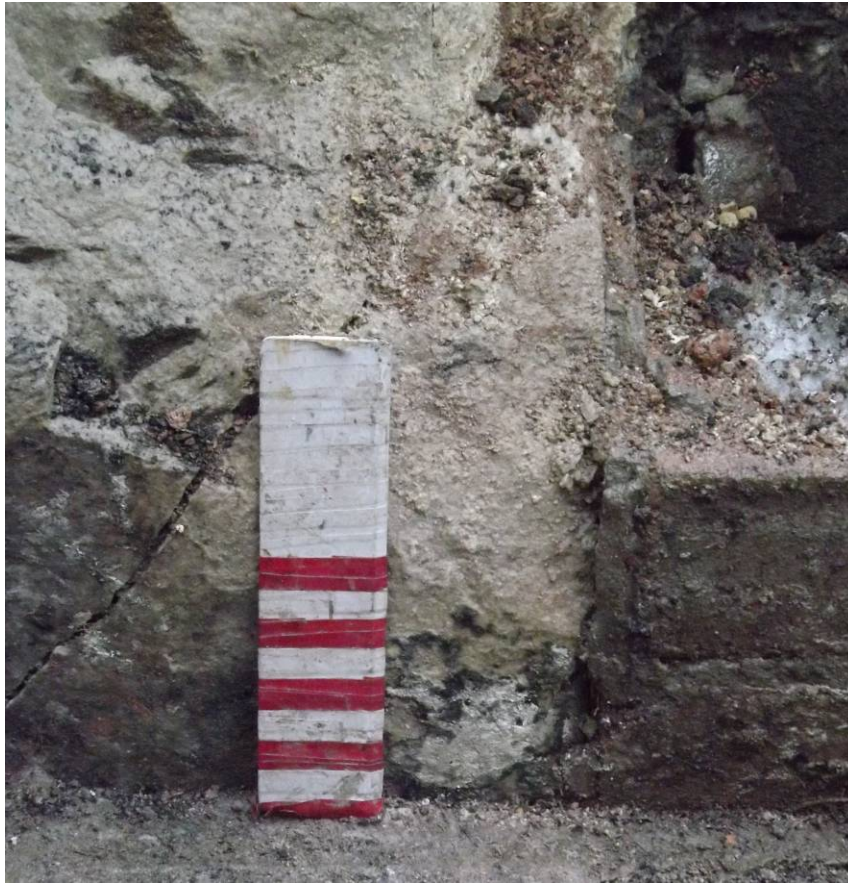
Plate 6 Detailed view of the quoins within Trench 03 (Photograph 112)

It would seem from the results of Trench 03 that the more elaborate design shown in the 1780s drawings was never fully executed (*Plate 6*). The existence of the Williamson tablet (unless it originated from another feature entirely) does suggest that part of the work was carried out – perhaps just the tablet and pediment, omitting the more elaborate architrave.

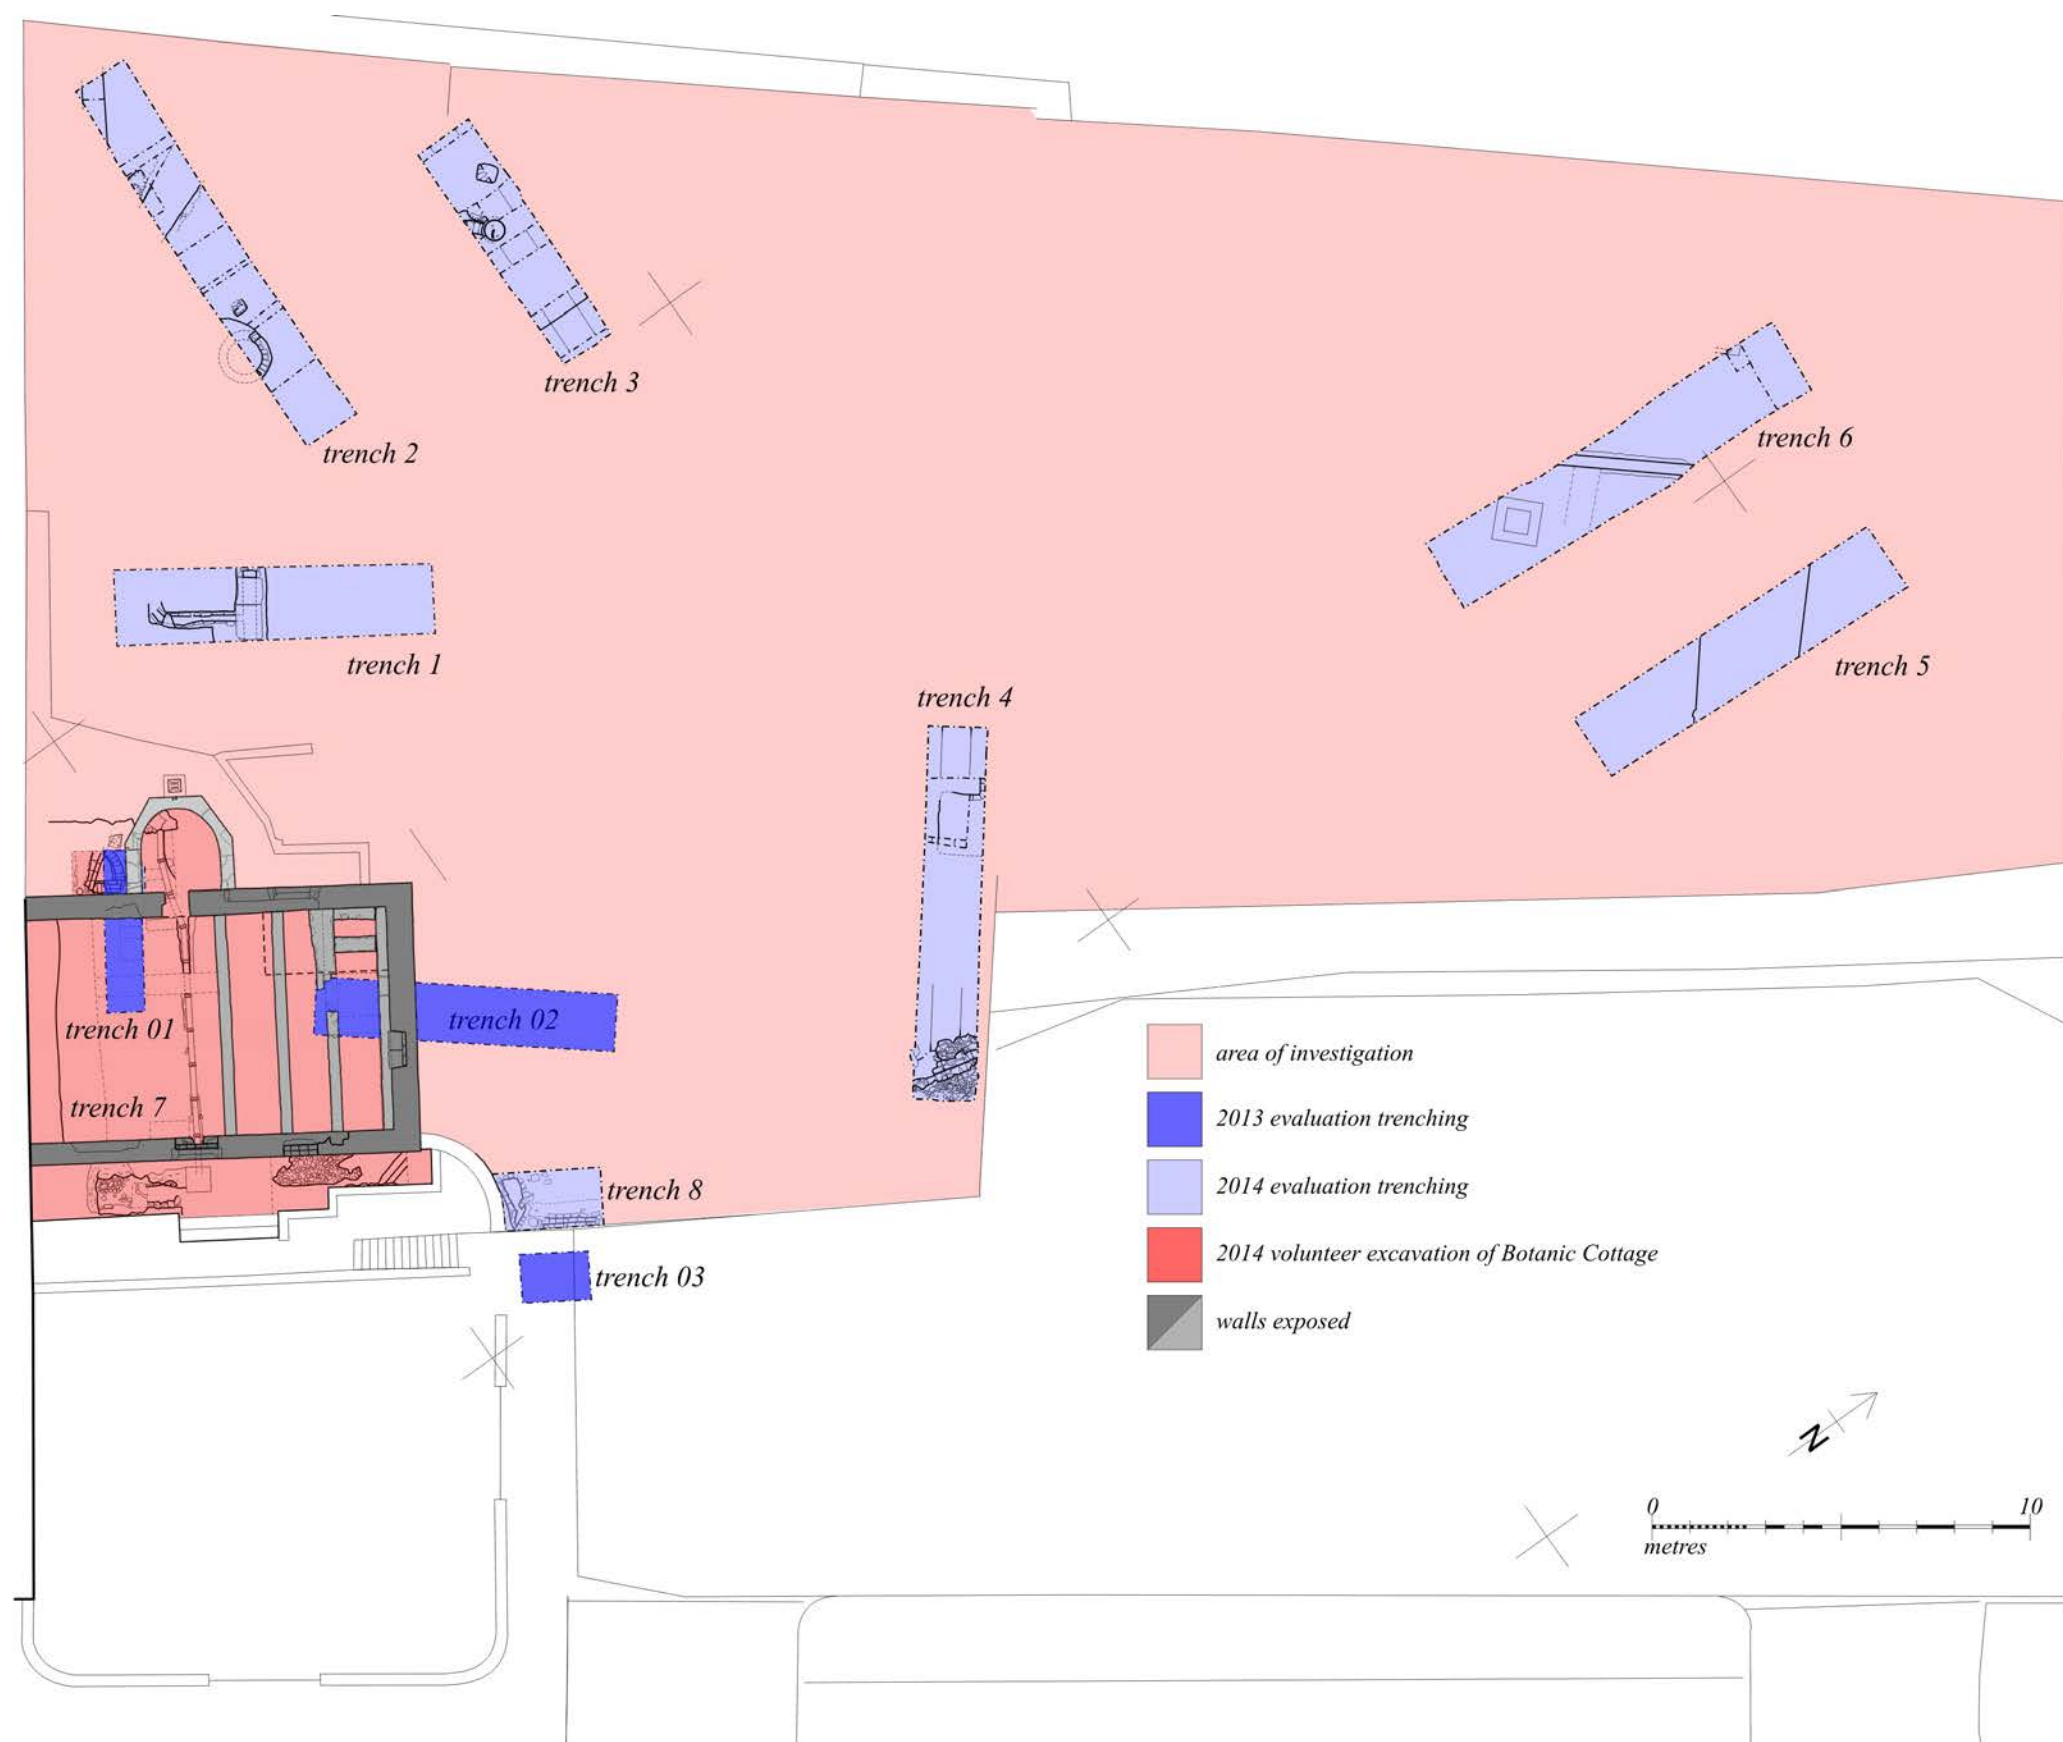
Figure 9 Trench location plan

Trench 2 (*Figure 9*) was excavated from south west to north east, and was begun in the south west corner of the site. The map regression had indicated that this area was never built upon and it was anticipated this area had survived in use as a garden. However the upper deposits proved to be a mix of modern levelling material, hardcore and iron (*Fe*) industrial waste fused together (201) most likely representing a base for a hardstanding or carpark.

Trench 3 (*Figure 9*) ran parallel to Trench 2 and had a length of around 7.25m. This trench was predominantly located beneath the footprint of the 20th century garage building as indicated by the concrete slab which was broken prior to excavation commencing.

Trench 4 (*Figure 9*) measured c.10m and was aligned west to east across the northern limit of the concrete pad that had previously made up the floor of the modern garage. The map regression had indicated that the area of, and specifically just north of, Trench 4 may have survived free of subsequent development prior to the construction of the garage. The logistics of excavating on a constrained site with undulating ground made the placement of Trench 4 just south of the ideal location a necessity.

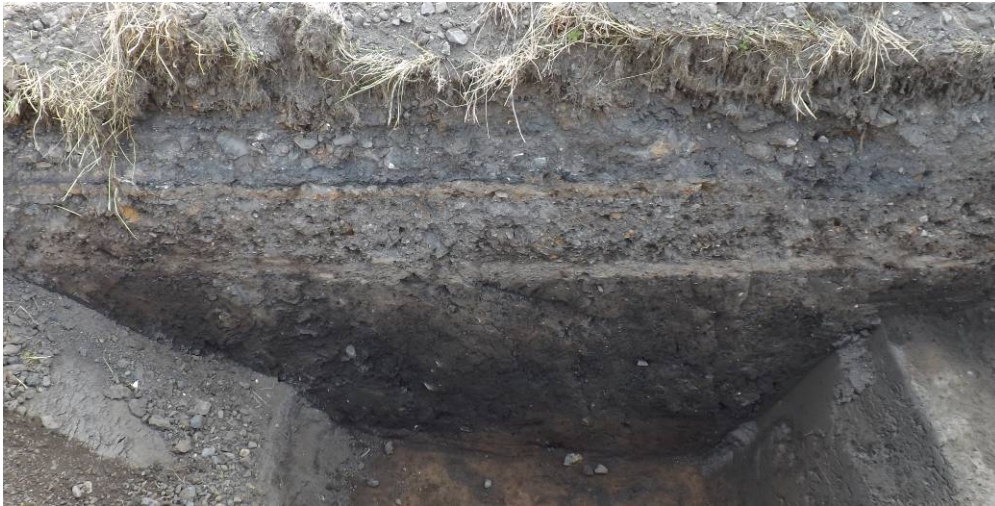
Plate 7 West facing section of Trench 1 showing the clear stratigraphy (Photograph 444)

The stratigraphy in Trench 1 was very clear (*Plate 7*). A layer of turf (*101*) directly overlay a levelling deposit of c.0.30m depth. Consisting of grey silty soil rich in cinders and frequent medium rounded stones, these upper deposits were of 20th century date and likely related to a landscaping of the wider site.

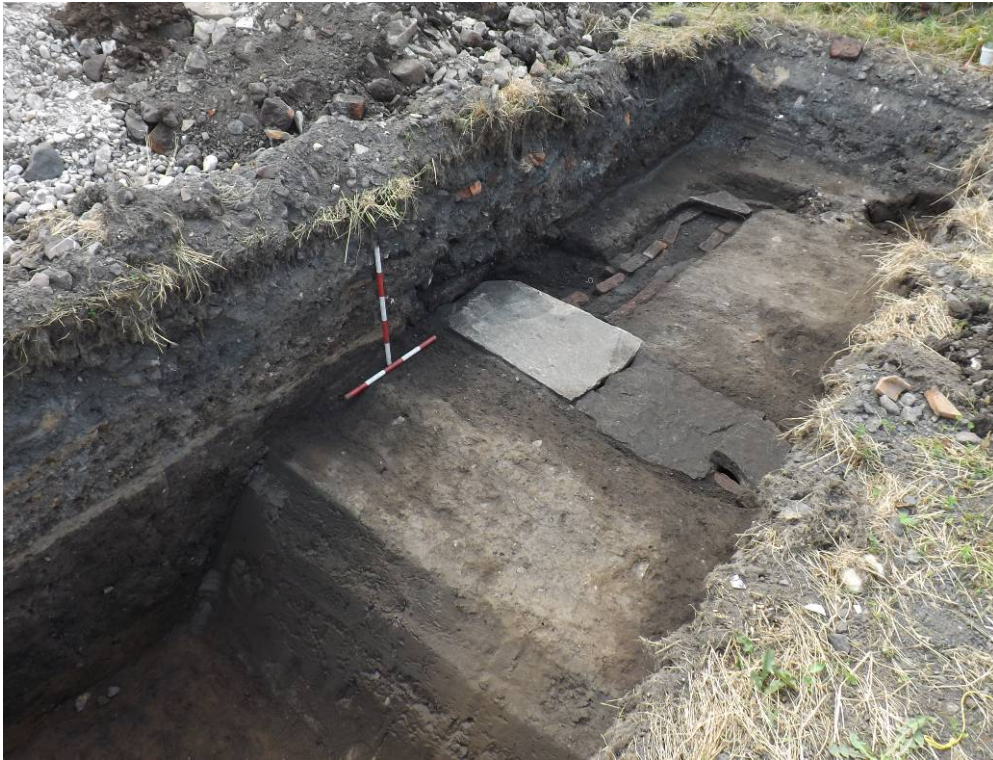
Plate 8 Mid-excavation view of Trench 1 looking NW (Photograph 450)

The upper levelling deposits peeled back to reveal (*104*), the garden soil of the Botanic Gardens noted elsewhere across the site. Here, as elsewhere, this comprised a fine grain, slightly gritty mid to dark brown silty loam c.0.70m deep. Whilst the natural subsoil (*106*) was revealed at the northern end of the trench, machine excavation of <0.10m of (*104*) across the middle of the trench revealed a number of features set into this that required further investigation (*Plate 8*). These features proved to be drains.

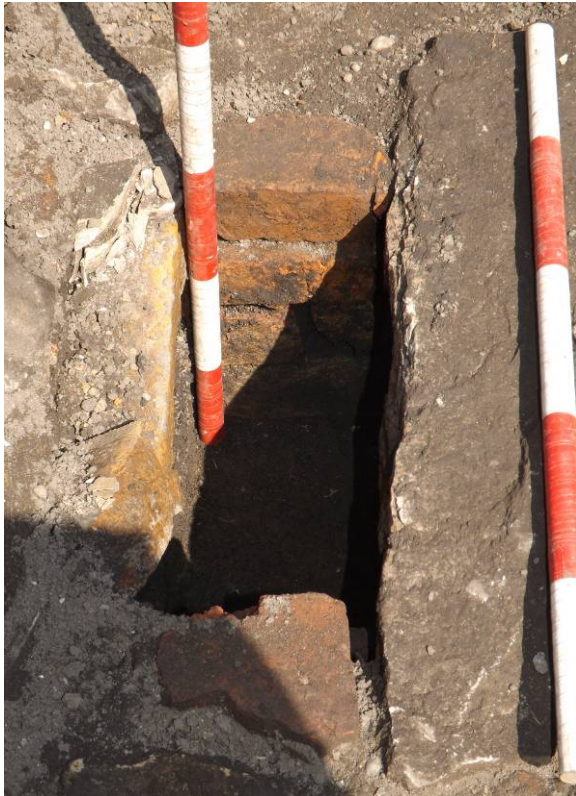
*Plate 9 Post-excavation view of {108}
(Photograph 481)*

These drains were cut into the garden soil (104) the cuts for which were clear and vertical sided. Two large and one slightly smaller sandstone flagstones were revealed, these aligned east to west across the trench; further flags were noted continuing into both west and east sections. Removal of the smaller sandstone flagstone against the southern baulk revealed a brick-lined drain (Plate 9). The structural elements of the drain were recorded as {108}. The interior of the drain was filled with a concentration of mottled fine grained silt – (112). The bricks that made up the sides were of early hand-made variety, sitting three bricks high on top of a stone base. The structure of {108} had been constructed within a cut [107]. This was 0.65m wide and <0.35m deep. The smaller flagstone that was lifted was obviously a capping for an inspection hole to the drain as the brick drain sides beneath rose up flush with the general capping stone and this flag would have sat at a higher level than them presumably near or at ground level.

To the south of the main drain {108}, another smaller brick lined drain ran in a northerly direction into the main drain. Recorded as {110}, this smaller tributary curved to the south west at the southern end of the trench, where a modern feature (apparently a recent borehole test feature) caused a disruption. Only one small sandstone cap stone survived in situ on {110}, allowing the brick sides of the drain to be clearly seen. This comprised two courses of edge set early handmade bricks built up from a flagstone base. As with {108}, the interior was blocked with fine grain silt, here recorded as (111). The cut for {110} was around 0.30m wide with the final depth unrealised. The area between the cut and the brick sides of the drain was filled with backfilled garden soil (114). The sides of the drain without their capping have been pushed inwards a bit perhaps relating to heavy traffic during later use of the site.

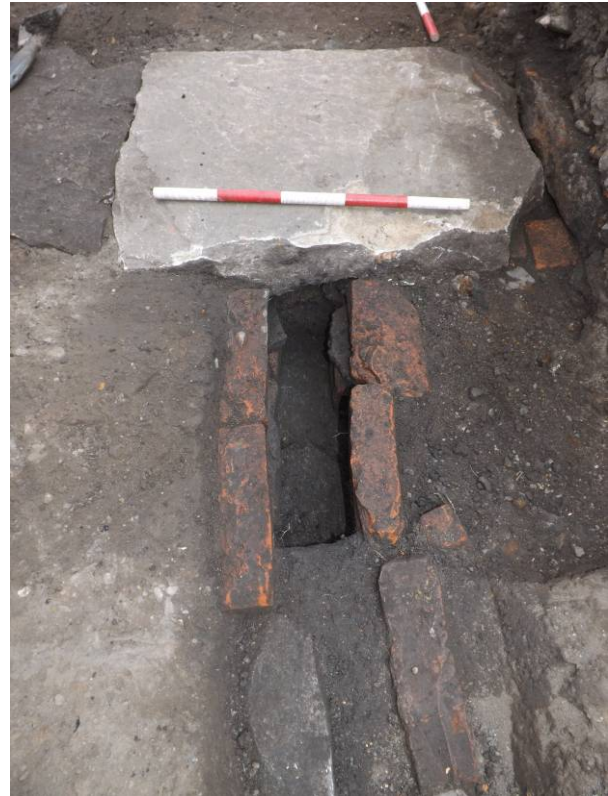
*Plate 10 Post-excavation view of feature {110}
(Photograph 454)*

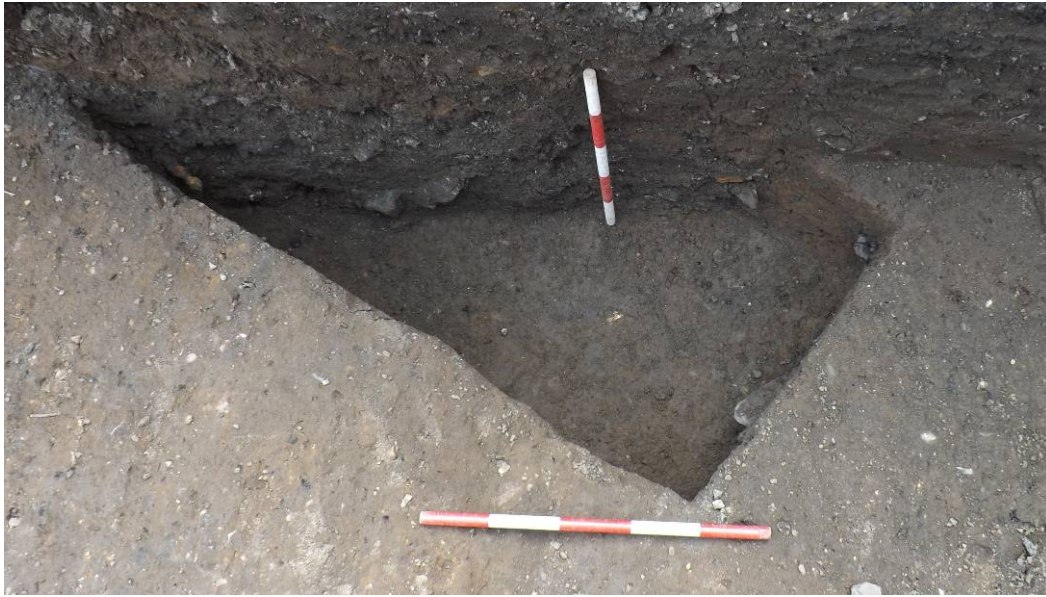
At the south west end of Trench 2, a linear cut was noted after removal of (204), running west to east. 0.60m wide, the cut [210] was visible in the section from the surface of the Botanic garden soil (204). This gave the feature an overall depth of c.1.20m, with vertical sides and a flat base (*Plate 4*)

Plate 11 Post-excavation view of linear feature [210/211] (Photograph 404)

The function of this linear is unclear. The fill (211) was a bit mixed, with the lower fill dominated by cinders, and the upper fill characterised by re-deposited loam from (204). These were recorded as one context as there was no clear distinction, with the two merging together. The feature must be garden related, but the date and function cannot be ascertained.

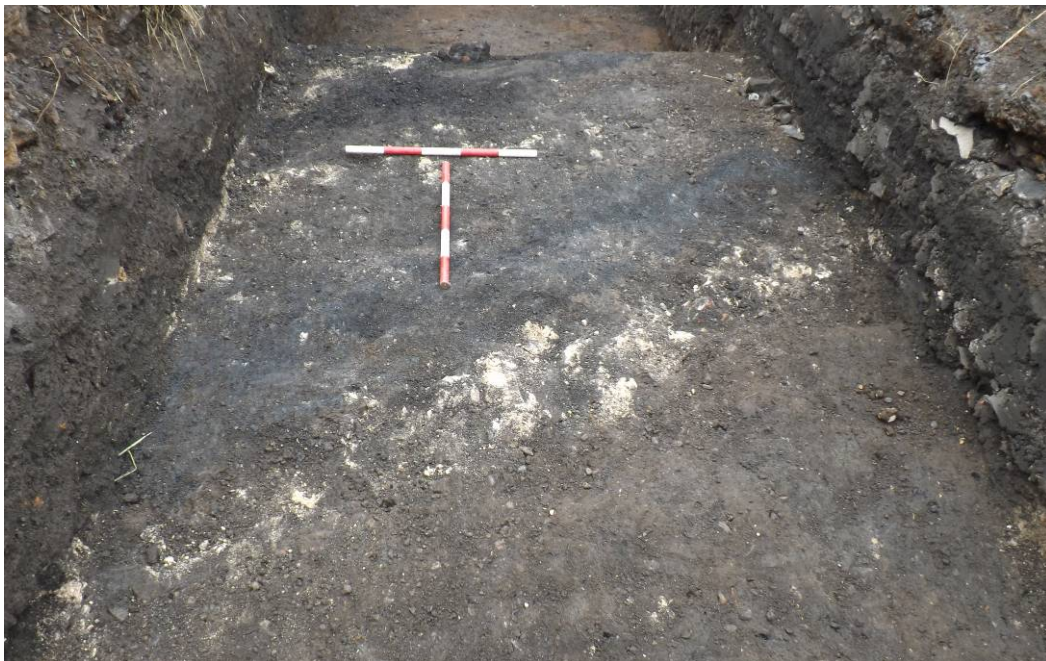
Immediately north of [210/211], another linear feature [208/209) was recorded, this time running NNW-SSE obliquely across the trench. [208/209) was noted during the mechanical excavation and this area was left 'high' at the horizon of (204). (209) proved to be very firmly compact gravel and cinder, set within a shallow cut 1.1m wide and 0.30m deep. Along the edges of the linear, fragmentary remnants of lime mortar perhaps indicated the existence of robbed walling or edging.

Plate 12 Path [208/209) looking SW. Note the lime mortar strips edging the feature. (Photograph 350)

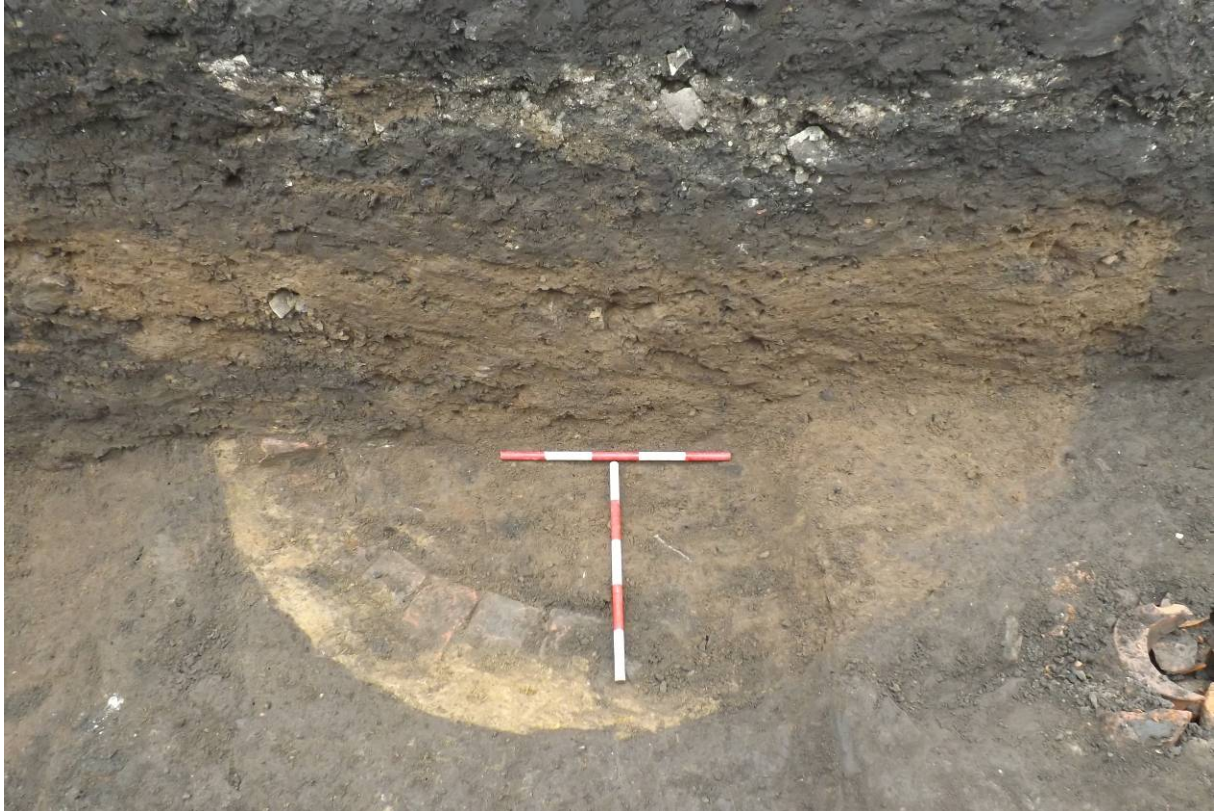
However, removal of <0.80m of (207) revealed a line of bricks {206} which were clearly structural. A short distance to the south west, a further feature [212/213] was also revealed at this level (*Plate 13*).

Plate 13 Pre-excavation view of the well [205] showing (207) visible in the north west facing section and the brick lining of the well {206}. Note the sub-rectangular feature [212/213] to the right of the picture (Photograph 351)

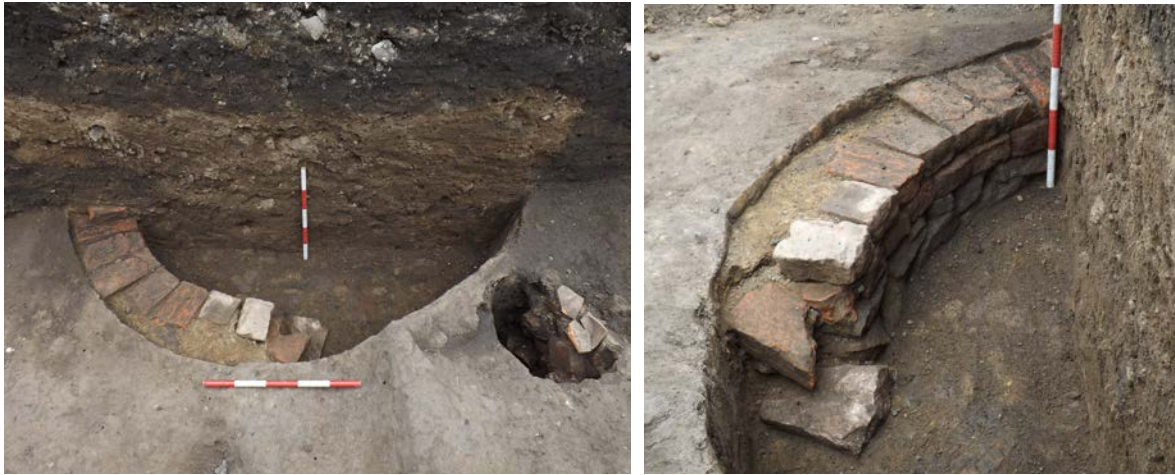
The area around {206} was cleaned, revealing an arrangement of around eight bricks splayed lengthways around the northern side of the well cut [205] (*Plate 14*). These were handmade clay bricks, and can be tentatively dated to the 18th century. Removal of c.0.35m of the fill (207) did not reveal the base of the feature, but did reveal two courses of bricks set atop a rubblestone continuation of the sides (*Plate 15*), this indicated that the general construction of the well was of rubble stone with only the upper more visible part constructed from brick.

Plate 14 Post-excavation view of the well [205/206/207] and pit [212/213] looking SE (Photograph 425)

This feature is clearly a well, subsequently largely robbed and infilled. Those robbing the bricks and stones had successfully removed more of these from the southern side, but had given up removing those along the northern edge. The well was subsequently filled with gritty sand, likely from building operations elsewhere on site.

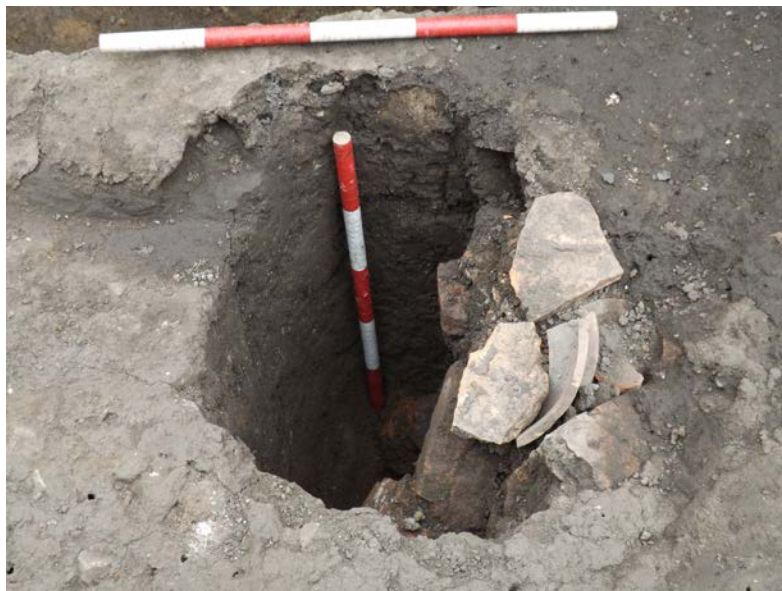
Plate 16 Post-half sectioned view of [212/213]. Note the volume of brick and ceramic fragments in (213) (Photograph 429)

Pit [212] proved to be 0.60m deep as excavated, but was likely around 1.10m deep if cut from the same depth as the well. Measuring 0.35m by 0.35m, the sides were vertically cut and the cuts made by a spade could be seen in the sides during excavation.

The fill (213) essentially comprised a compact concentration of broken brick and red ceramic sherds from flower pots. This feature was interpreted as a post-hole, with the ceramic and brick fragments forming packing around a now removed timber. The close proximity of the post-hole to the well makes it likely the two are related. A timber inserted so close to the well would almost certainly have had a role in removing buckets of water from within via some form of pulley or crane system.

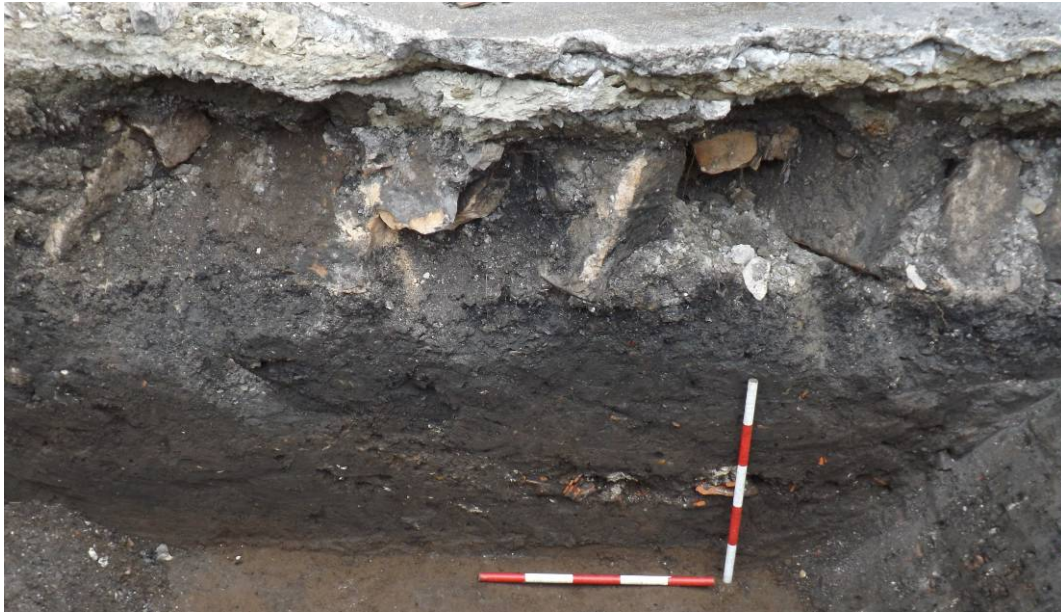
After the concrete (301) was removed, the upper deposits in Trench 3 were seen to be a large quantity of building rubble, including dressed stones and quoins ((302) - *Plate 18*). The angle at which these lay suggested they had either collapsed into this position, or been deposited here while still loosely bonded.

Plate 18 NW facing section of Trench 3 showing dressed stone and rubble deposit (302) (Photograph 326)

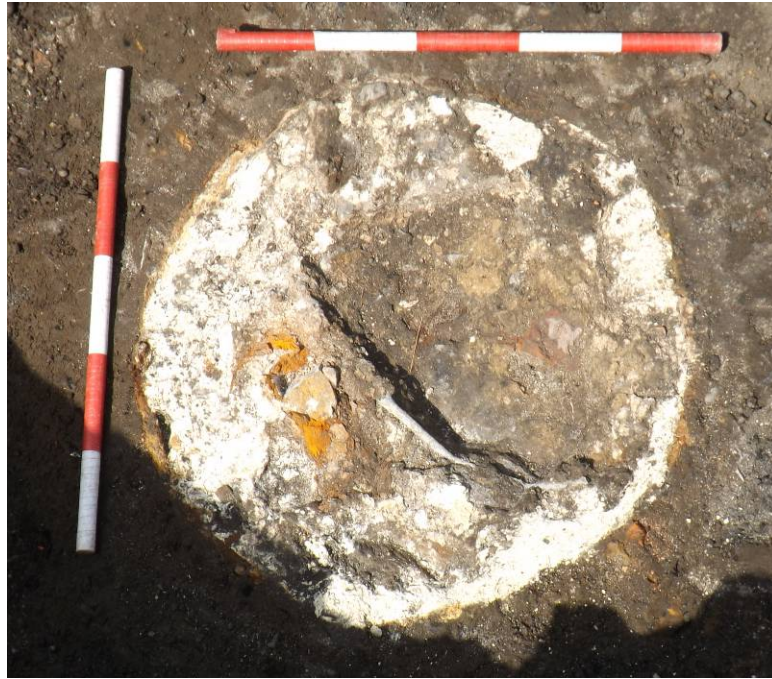
Two features were recorded cut into the surface of the garden soil (304). The most obvious was a circular deposit of white lime, mottled with occasional areas of stone and slightly grubby (*Plate 19*). A general clean around the feature revealed that the lime was located within a degraded timber barrel of 0.54m diameter (312), placed within a pit [311]. The area between the barrel and the sides of the cut had been packed with a stony mixture of soil (313). The cut was around 0.10m wider than the barrel on all sides.

Plate 19 Pre-excavation view of [311/312/313] (Photograph 308)

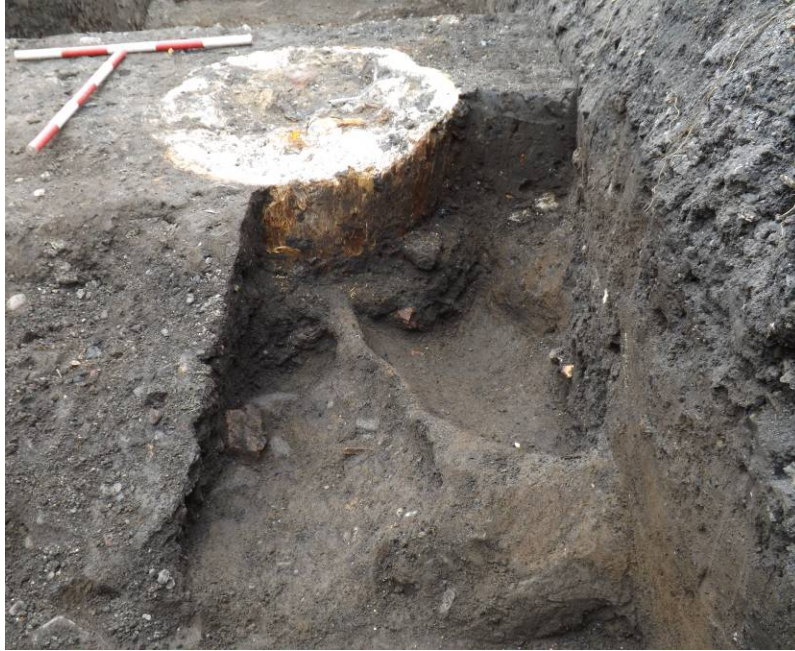
A sondage was excavated down the southern side of the feature in order to see the sides of the barrel and reveal the cut in section. The barrel survived to a remarkable degree, with each timber stave still visible and viable enough to remain in position as excavation continued (*Plate 20*).

Working in this sondage to uncover the barrel also revealed two linear features directly adjacent (*Plate 20*). Both [306/305) and [307/308) are overlain by the barrel, although no direct relationship is visible between the two linears themselves. Both have gently sloping sides with a roughly flat base and were filled by a cinder rich deposit. It seems clear that both of these linears represent garden features, perhaps planting beds.

*Plate 20 Post-excavation view of [311/312/313] with [306/305) and [307/308) visible in the foreground
(Photograph 325)*

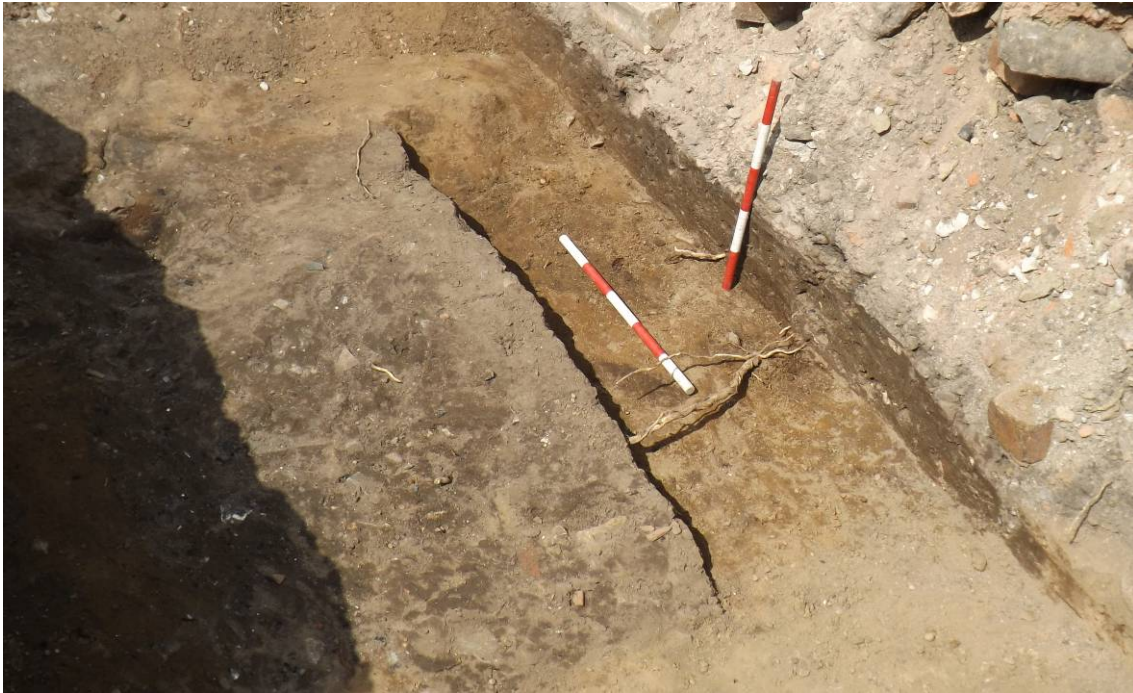
Plate 22 Post-excavation view of [506/507/508) looking N (Photograph 298)

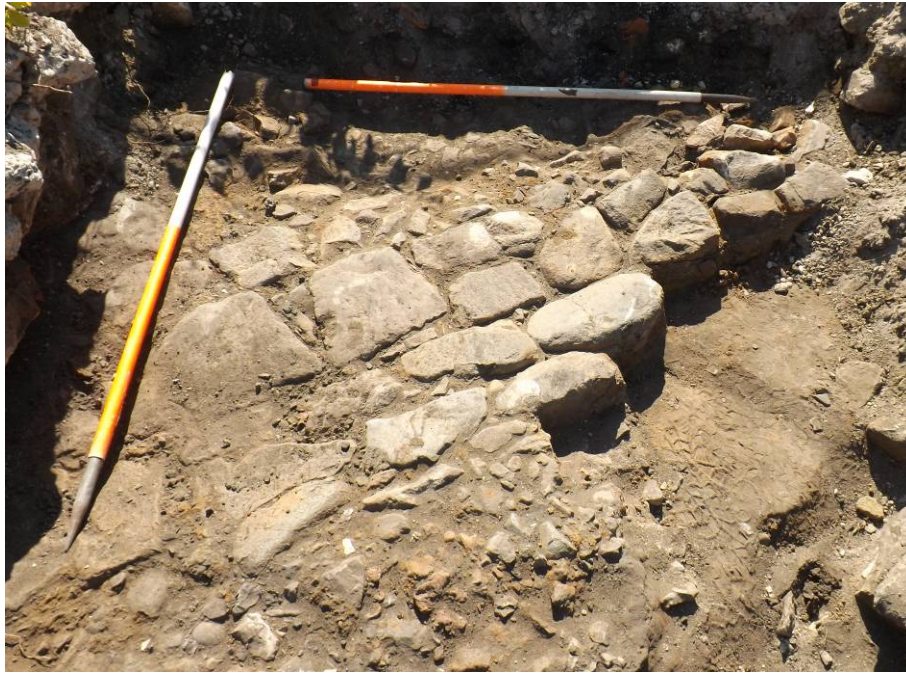
At a higher level at the east end of Trench 4, the fragmentary remnants of a cobbled/metalled surface were recorded. This deposit (408) seemed to directly overlie the natural subsoil. Truncated to the west, and possibly even the east where the metalling meets the edge of Trench 4, (409) seems to represent a fragment of a wider surface that survived the grubbing out in this part of the site. The surface is composed of a series of small rounded and angular stones, firmly compacted around a number of larger, flat, smooth, irregular cobbles. These larger cobbles have the appearance of perhaps being a small drainage channel aligned roughly NNW-SSE. Removal of firmly compact material (409) from on top of the cobbles revealed a number of 19th century ceramic fragments.

Plate 23 Post-excavation view of the cobbled/metalled surface (408) looking E (Photograph 526)

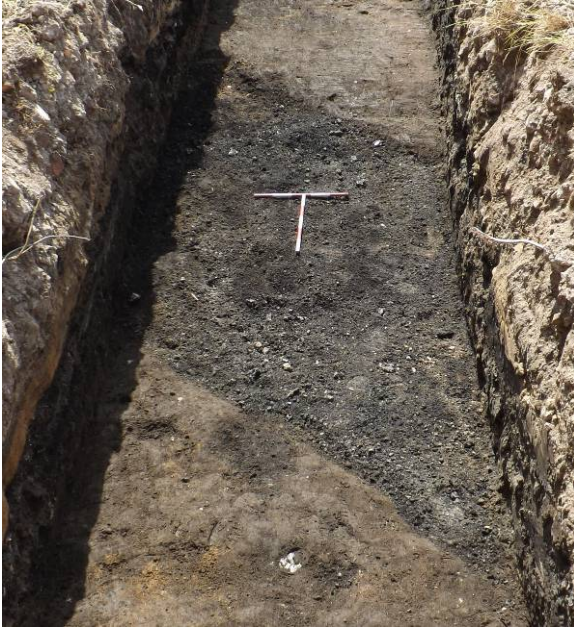
The cinder linear feature was shown during excavation to comprise a moderate to firmly compact dark black to grey deposit of cinders. Recorded as (507), excavation showed this deposit to be c.0.15m deep and sitting within a deep cut [506]. (507) was the secondary fill of the linear. Below the cinders a moderate to firmly compact dark brown gritty silt (508) comprised the primary fill. With a depth of c.0.45m this showed [506] to have a depth of 0.60m with vertical sides and a flat base. [506] was cut into (509), the garden soil of the Botanic Gardens. (509) may have been truncated above.

Plate 24 General view of [506/507] within Trench 5 looking SE (Photograph 244)

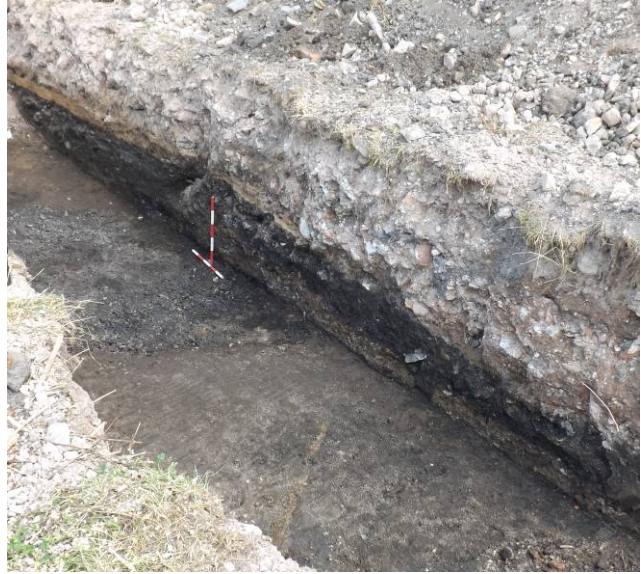
Plate 25 The NE facing section of Trench 5 (Photograph 252)
