The site of the Botanic Gardens, Leith Walk

34 Haddington Place, Edinburgh

Archaeological Evaluation and Excavation

Data Structure Report

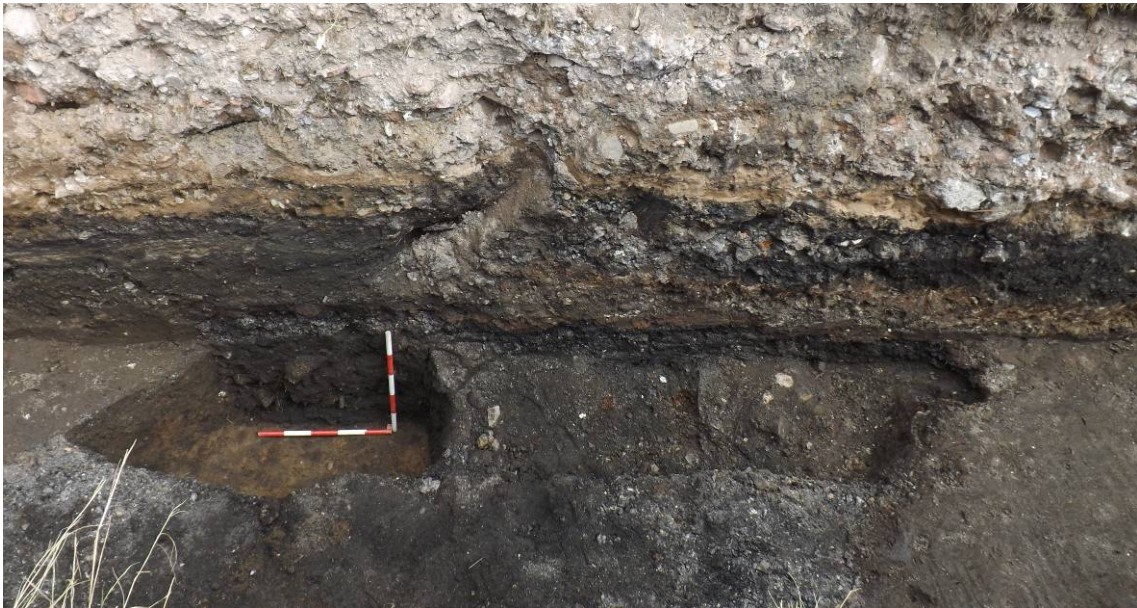
Plate 26 Post-excavation view of [506/507/508] while facing south west (Photograph 254)

The function of the large linear feature [506] is unclear. When this was initially recorded with a dense concentration of cinders (507) on top, it was thought the feature may have been part of the path network around the gardens. However, the depth of the cut is curious, as is the lower fill of dark brown gritty silt (508). It may be that the feature was initially utilised as a bed for plants and was subsequently re-used as a path, with cinders spread atop. It is also possible that the spreading of cinders in the bed may have been a later addition, or in some way related to the different horticultural and planting activities in the feature. In the 18th century these may have been experimental in nature.

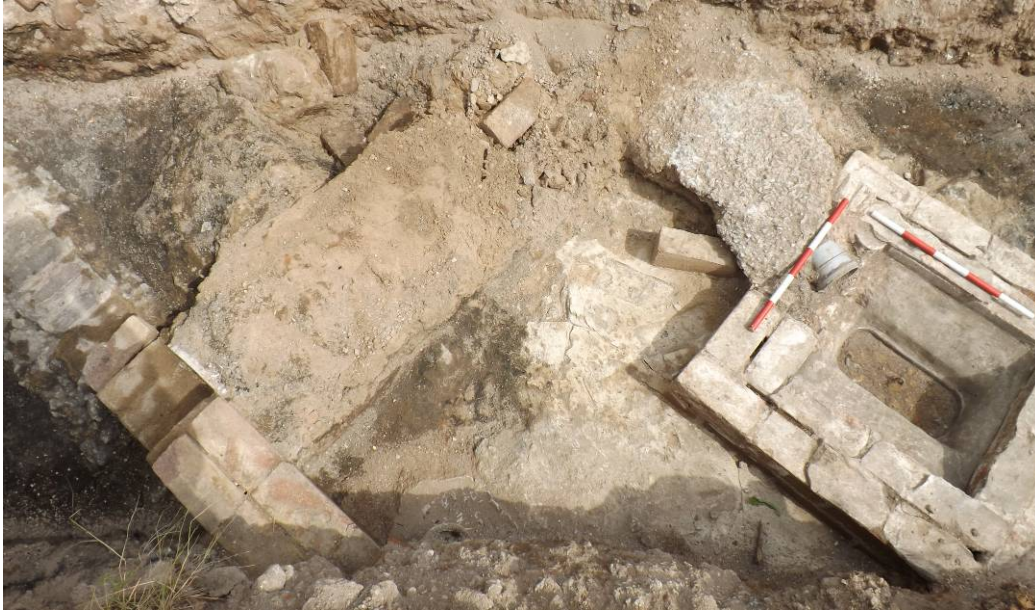
Below this the remnants of 19th and 20th century structures were recorded. Aligned NNE-SSW a wall two bricks wide set into a concrete foundation {603} survived beside a square, brick built sump or rodding eye {604} - *Plate 27* and *Plate 28* this takes water from 2 ceramic downpipes to the NW and NE. All of the contexts recorded around these features relate to the 19th and 20th century usage of the site and are of limited archaeological interest.

Plate 27 Structural remains within Trench 6 facing NE (Photograph 210)

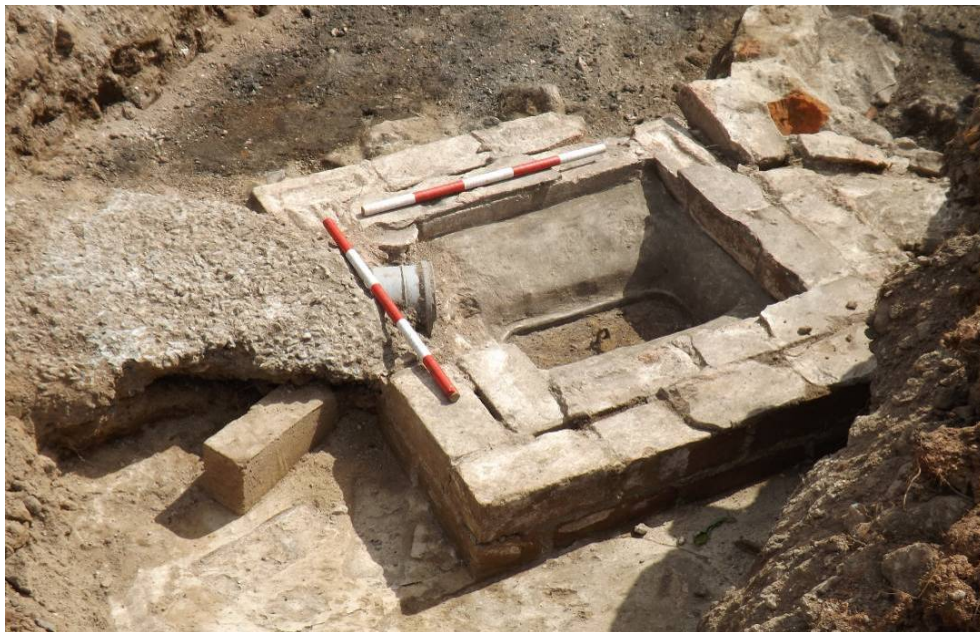
Plate 28 Detailed view of {604} (Photograph 213)

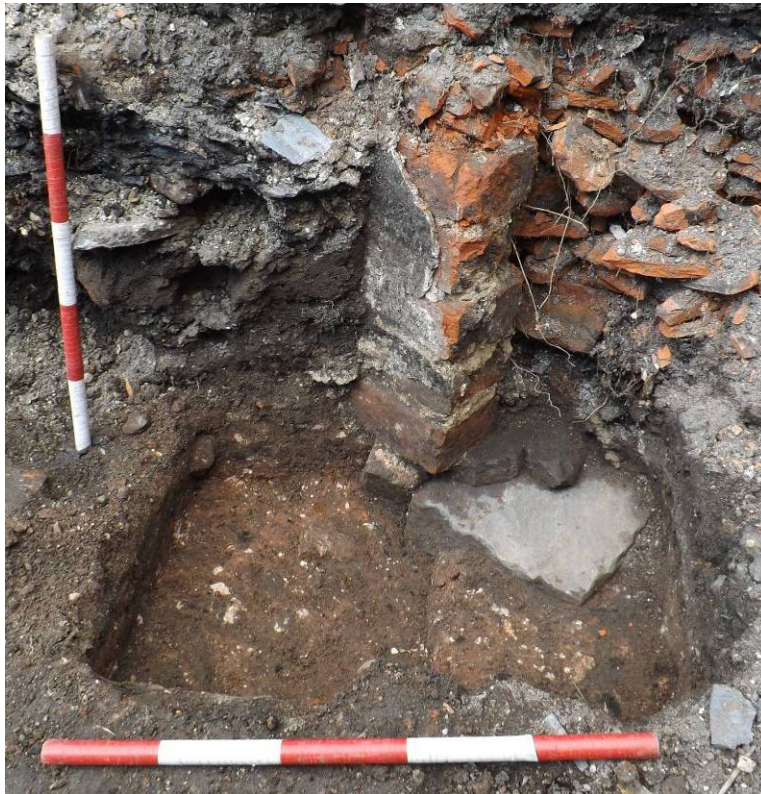
The stub of a wall {611} was noted at the extreme North West end of Trench 6, slightly protruding into the trench from the north east facing section (*Plate 29*). Aligned north to south, the wall was constructed from five courses of what appeared to be 18th century handmade bricks bonded by creamy lime mortar, only one brick wide. The eastern face of the wall as plastered in lime, perhaps indicating that this was an external face. To the west and north of {611} a large concentration of pan tiles (616) may be the roof of the structure, collapsed inwards and held in position by the remains of {611}.

The wall protruded only slightly into the trench and sat directly atop a large grey stone {612}. This had the appearance of a degraded threshold stone, but it was not possible to say this with certainty due to the constraints of the trench.

Plate 29 {611/612} in the NE facing section of Trench 6 (Photograph 232)

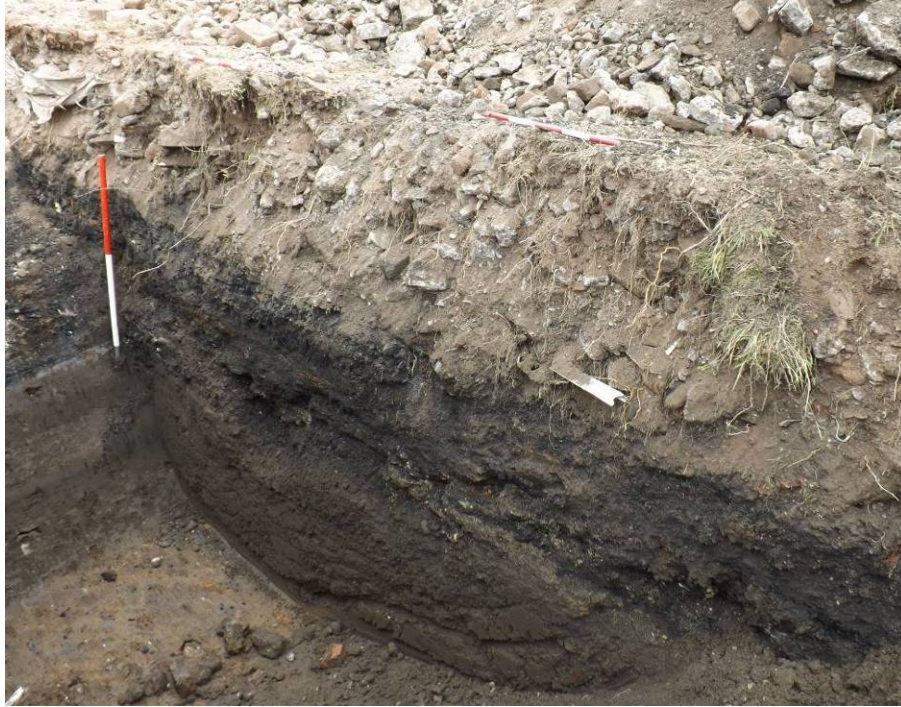
Plate 30 Garden soil (619) within Trench 6 (Photograph 196)

The southern end of the trench was excavated to a final depth of 2.40m and revealed garden soil (619) surviving at a depth of 1.60m (*Plate 30*). The depth and stability of the trench here made it impossible for the archaeologists to safely enter and the trench was partially backfilled.

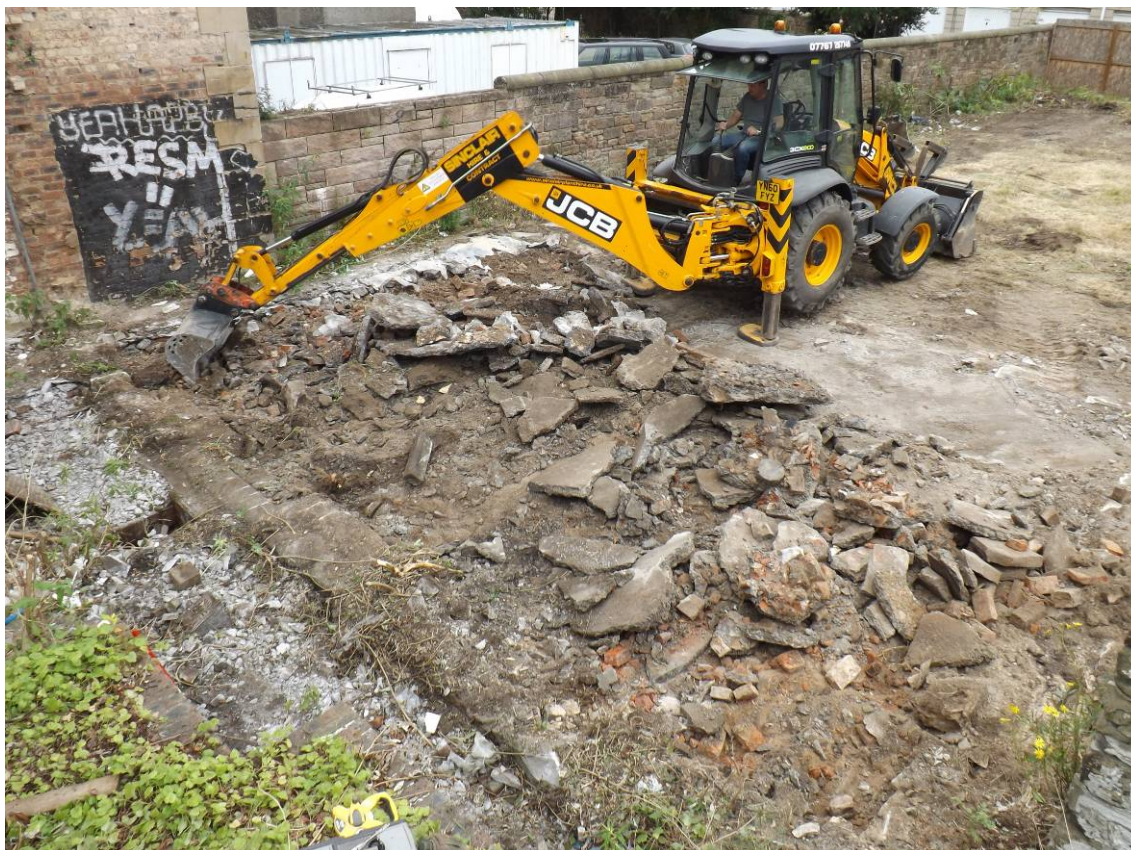
Plate 31 Removing the upper deposits from the footprint of Botanic Cottage (Photograph 168)

As indicated during the 2013 evaluation, the upper deposits in Trench 7 comprised two layers of 20th century concrete flooring {701/702} set into a wider levelling deposit (703). This levelling deposit comprised a mixture of mixed and mottled gritty silt abundant in small to medium angular stones and fragments of brick. In addition a large number of ornamentally carved blocks of granite and quartz were visible, many adhering to the blocks of removed concrete.

Blocks such as these were also located in the 2013 evaluation and originated in the use of the site as a workshop for a monumental mason in the 20th century.

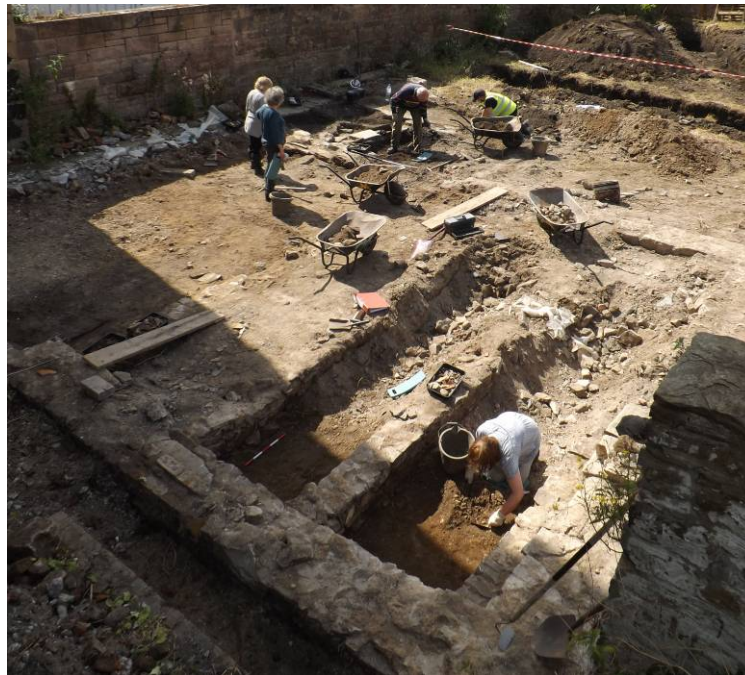
*Plate 32 Working shot showing (704) being removed from the northern half of the cottage
(Photograph 221)*

As the evaluation had previously indicated the nature of the deposits in the northern end of the cottage, it was appropriate to remove the bulk of these by mechanical excavator. The four sleeper walls in this area (with the first {706} abutting hard against, and running parallel to the main footing {705}) formed three roughly matching compartments. The mechanical excavator was used to remove

much of deposit (704) from within the northernmost of these two compartments, with a north to south running baulk left as a control at the western end. The southernmost (formed by enclosing walls {709} and {708}) was left *in situ*, acting as both a control and an access point to work being undertaken elsewhere in and around the cottage.

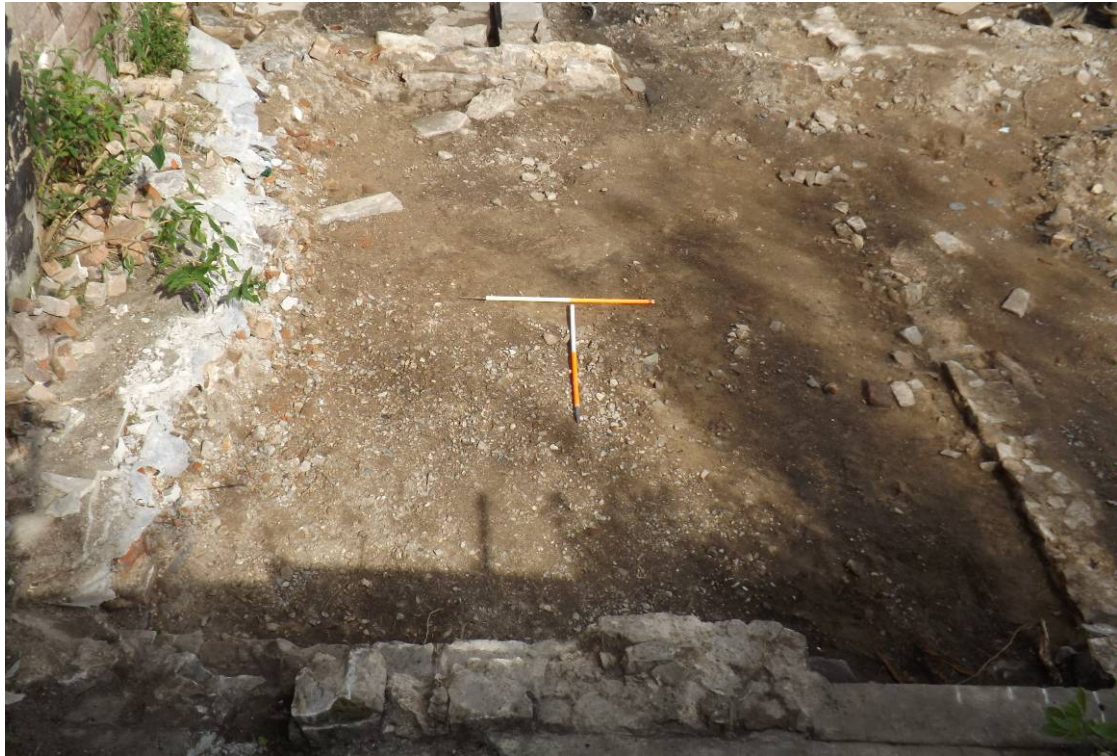
Plate 33 Pre-excavation view of Botanic Cottage south of {709} (visible to the right) looking west (Photograph 228)

South of sleeper wall {709} no features could be readily discerned. This area was rigorously cleaned, with the fill shown to be notably different from (704) to the north. Here this was much looser, with a larger concentration of sand, areas of small rounded stones, grit and beach pebbles – (714). The sleeper walls meant that no direct relationship could be discerned between (704) and (714), but the purpose of the two deposits is the same. Both were deliberately placed in the foundations of the cottage to bring the floor level up. It is not clear if both were deposited simultaneously.

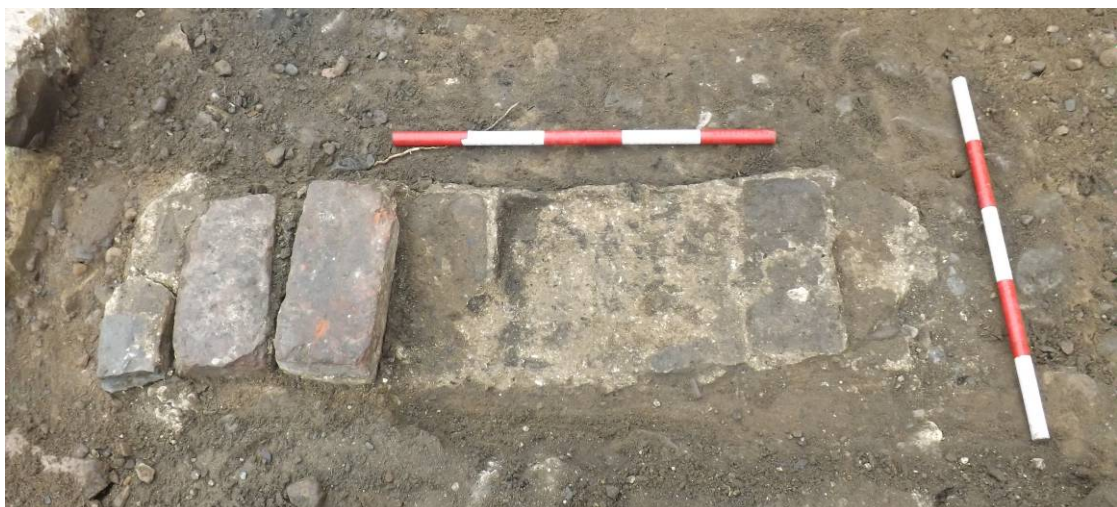
Plate 34 Fragmentary internal partition {759} lying atop (714) (Photograph 340)

Aligned north to south immediately west of the main entrance to the cottage, three fragmentary bricks survived from an internal partition, set into a bed of lime mortar. The imprint of further bricks survived in the lime mortar, giving the feature a final length of c.1.05m (*Plate 34*).

{759} sat atop, and clearly post-dated the infilled deposit (714). While the construction of {759} with early 19th century handmade bricks indicated this may have been an internal partition in use when the Botanic Gardens were on site, subsequent cleaning of the area revealed that the wall overlaid and post-dated a late 19th century or early 20th century salt glazed ceramic drain (*Plate 35*).

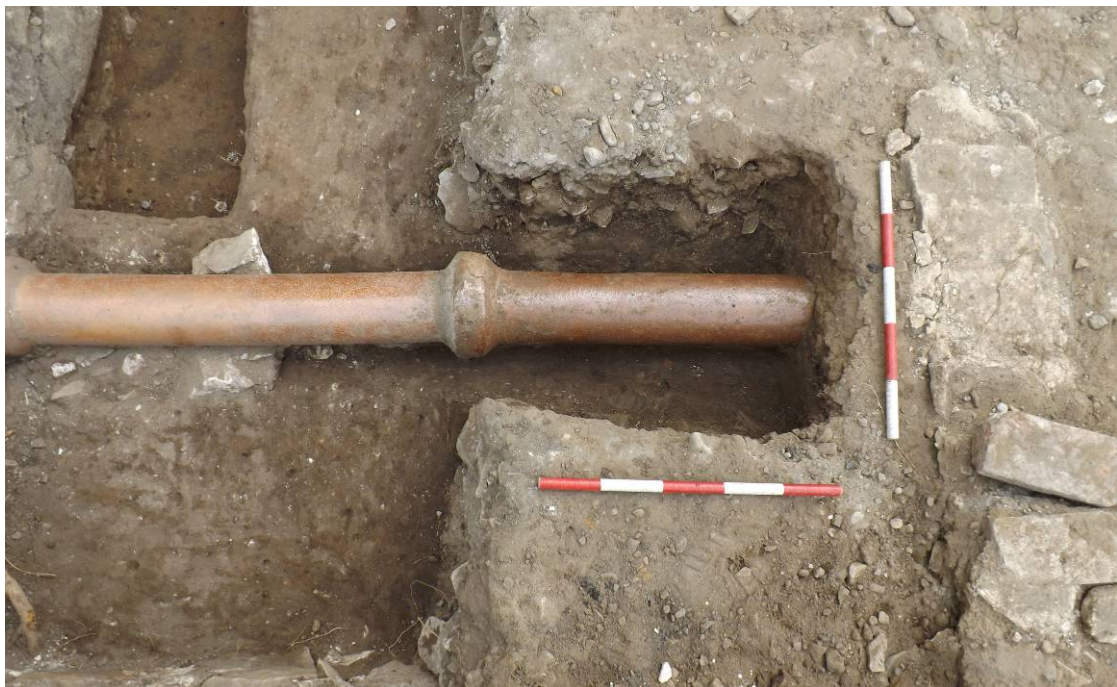
Plate 35 View of [712/711]. Note {759} overlying the drainage cut to the right of the picture (Photograph 379)

One large salt-glazed drain (713) (*Plate 35*) ran across the centre of the cottage from west to east. This is typically of late 19th or 20th century date and connected with an existing manhole immediately east of the cottage's entrance and a drain located at the rear of the cottage to the west.

The drain was cut through the wider deposit (714) from the surface, although only barely cutting into underlying (721). In places (*Plate 35*) the pipe had been propped on larger stones placed in the bottom of the cut, clearly to steady the pipe during installation and ensure the correct gradient for the internal flow.

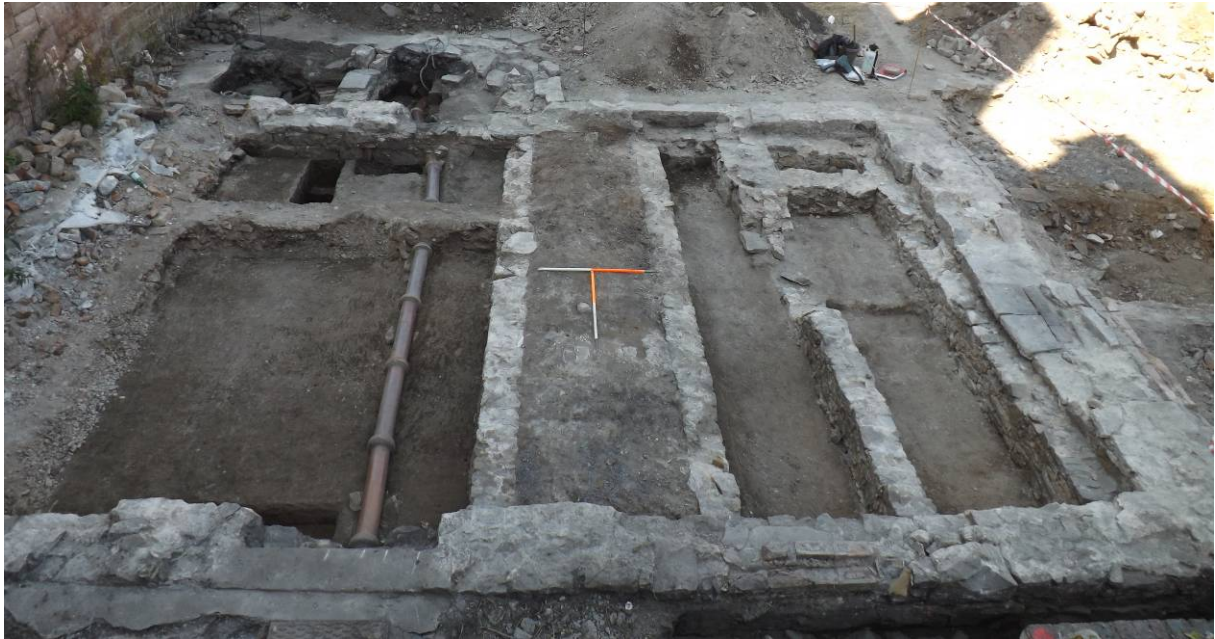
Plate 36 Post-excavation view of the cottage footings looking west (Photograph 570)

Removal of (704) from the north of the cottage and (714) from the south of the cottage revealed the foundations of the cottage (with the exception of the central area between {708} and {709}). These sat directly atop the beaten earth original ground surface (721).

The northern half of the cottage had clearly contained a timber floor, as had been indicated by the 2013 evaluation. The four sleeper walls were built to a height upon which north to south aligned timber joists would have been laid. Floorboards would then be placed atop the joists, running west to east across this part of the cottage. All four sleeper walls were built as secondary works to the construction of the main cottage walls, abutting against them. Whether these sleeper walls were built at the time, shortly after the initial construction of the cottage, or as later additions is unclear. The construction of the sleeper walls is the same as the general foundations, using similar masonry and lime mortar, perhaps indicating that they are contemporary.

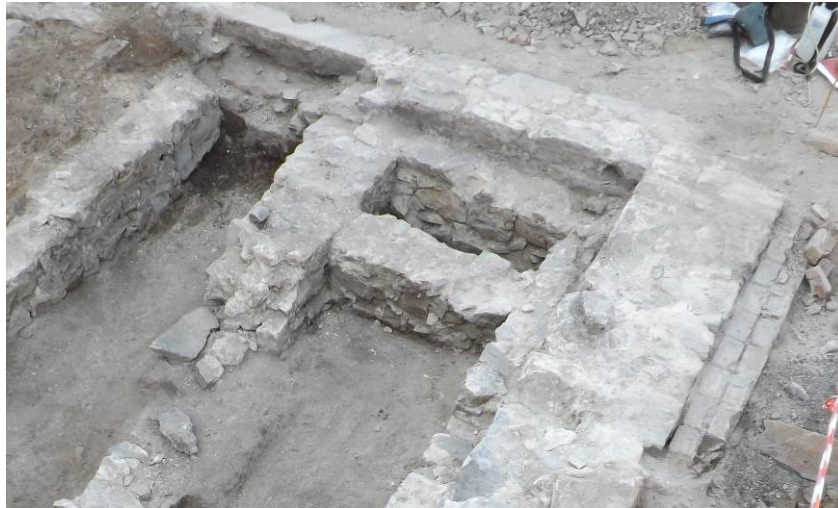
Plate 37 General view looking south west from above showing the strengthened foundations {724}, {725} & {762} in the north west corner of the cottage (Photograph 576)

Only in the north west corner of the cottage were architectural details uncovered which posed questions and revealed subsequent phasing (*Plate 37*).

Two small additional sleeper, or cross-walls had been built aligned north to south in the space between the sleeper walls {706} and {707}. Placed only 0.44m apart, these walls abutted {706} to the north and {707} to the south. The area between was filled by the same material found nearby – (704).

Taken together {724}, {725} and {762} create a major secondary strengthening of the cottage foundations. As with the sleeper walls {706 - 709}, it is possible that these additional foundations were constructed at around the same time as the main cottage building. However, this explanation would be difficult for {762}, which is more roughly constructed and abutting against {707}. If the two were built at the time of the initial cottage construction, it would be difficult to explain why the sleeper wall {707} was not initially built in larger form and why it was required to abut {762}.

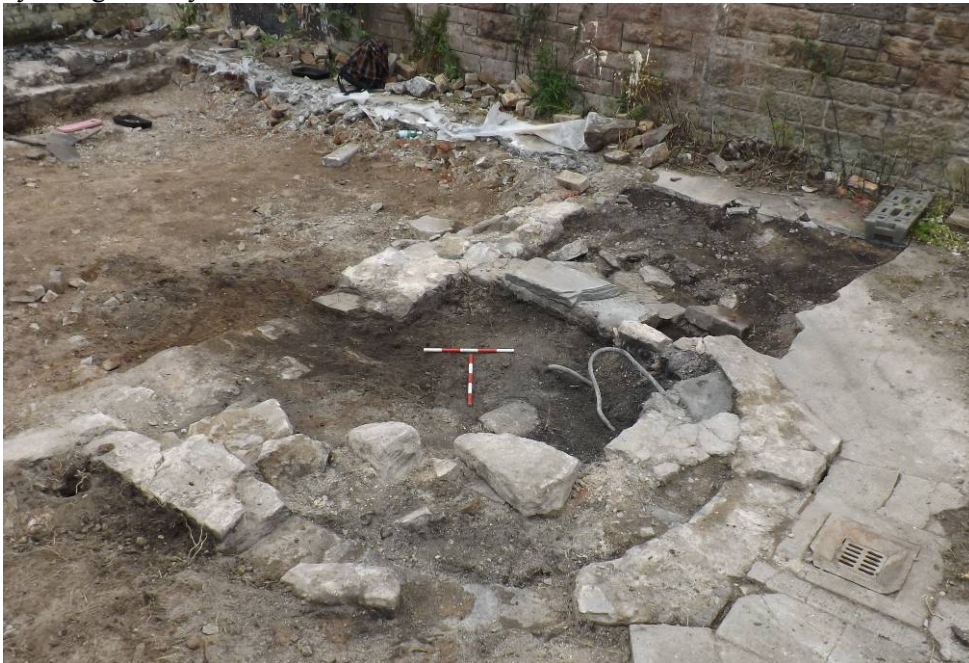
Plate 38 Pre-excavation view of external stair tower {715} (Photograph 236)

Initial cleaning revealed the upper deposit to comprise a very loose matrix of friable fractured coal and cinder (716) - *Plate 38*. (716) ran up to, and abutted the walls of the tower, but in the south west

corner, lay below fragmentary remnants of a floor surface (758/757}. (716) was likely a levelling deposit, utilising nearby industrial cinders to prepare the floor for the flagstones {757}. Like elsewhere across the footprint of Botanic Cottage, these flagstones were subsequently removed, leaving only a fragmentary indication in the corner of the stair tower.

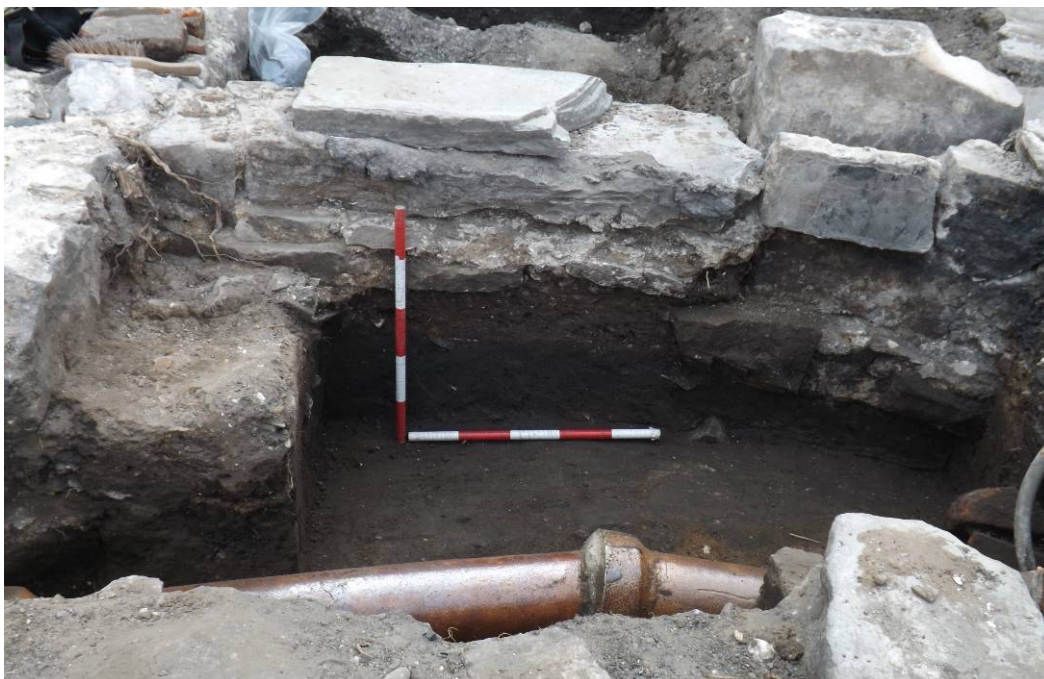
Plate 39 North facing section of the stair tower showing (720) underlying {735} and abutting {715}. Note the 'kink' in the ceramic drain (713) in the foreground (Photograph 487)

Below the levelling material (716), (720) was an old ground surface, underlying {735} the secondary threshold stone set into the south wall and acting as the external entrance of the tower. This abutted the walls of the stair tower (*Plate 39*).

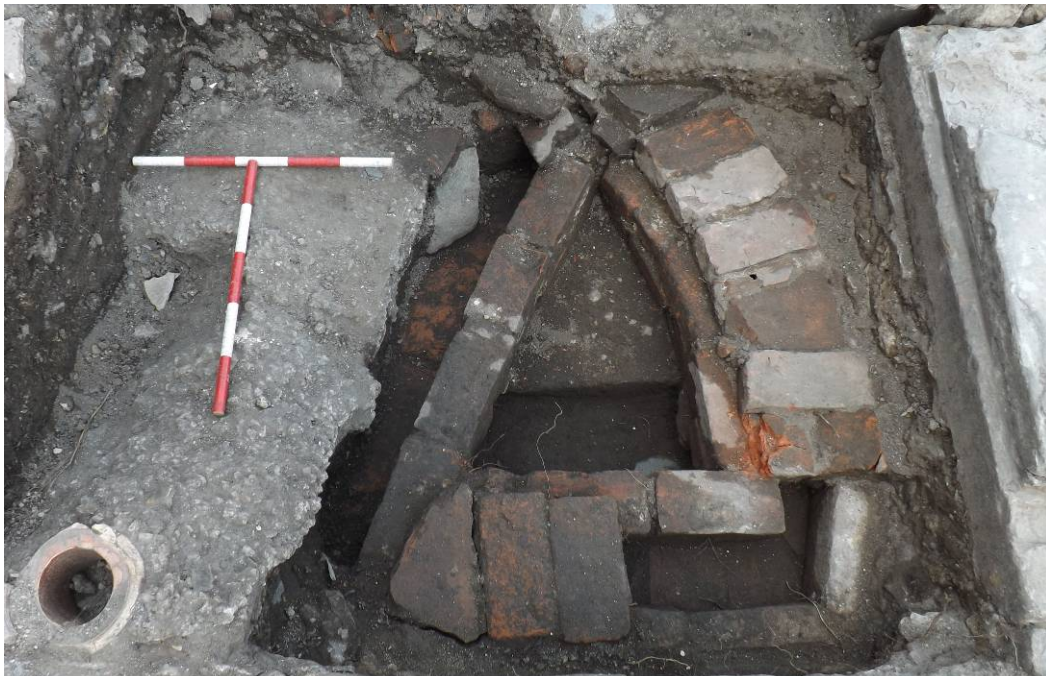
Plate 40 Post-excavation view of {753} (left) cutting {751} (right) (Photograph 565)

The fact the drain respects both the wall of Botanic Cottage {705} and the later stair tower {715} indicates that the drain is later than the construction of the stair tower (*Plate 40*).

The sharp angle in the drain is curious. To the south both arms of this drain were cut by a very similar, but clearly later, brick lined drain {753}. This example was aligned NW-SE, and may be a repair to the {751} drainage network, perhaps bridging the troublesome sharp angle in that drain which would easily become clogged with silt and debris.

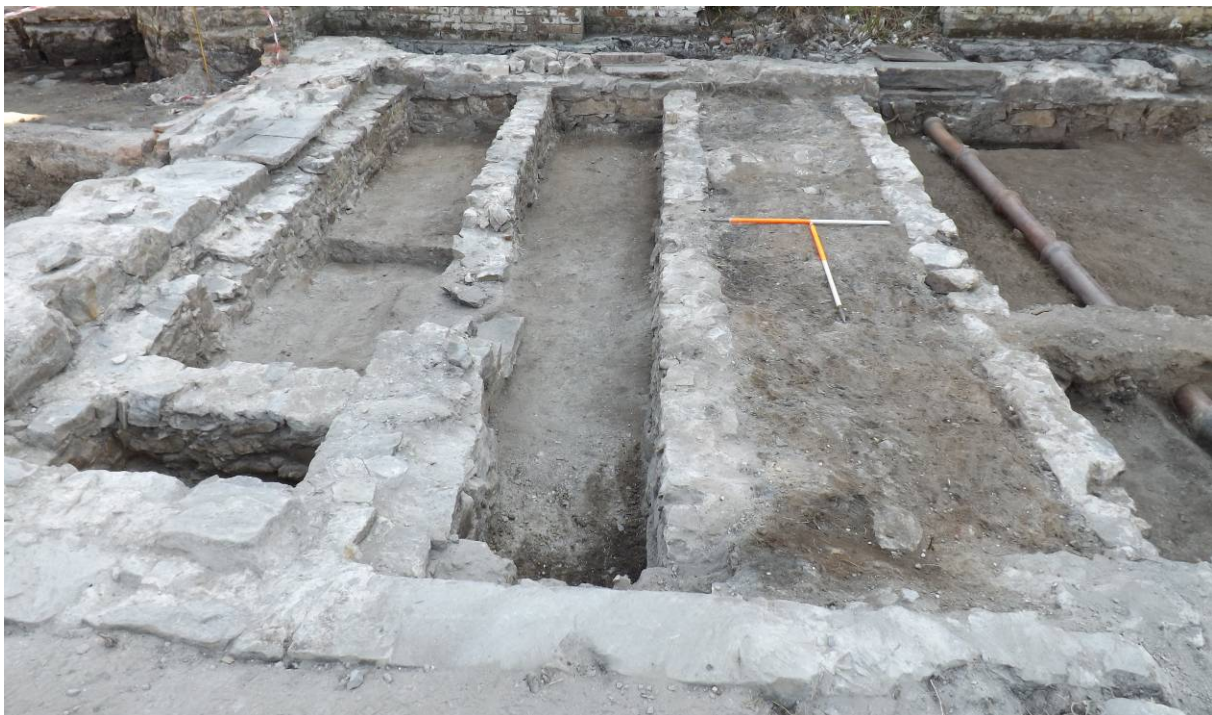
Plate 41 Post-excavation view of Botanic Cottage from the west. Note the sill {764} in the immediate foreground (Photograph 578)

On the west wall {764} comprised a large threshold or sill stone set into {705} (Plate 38). Placed at this level, it was clear that {764} had formed the threshold of a doorway. However, the detail of the stone indicated that this stone had initially been a window sill. The chamfer sloped downwards in a manner that would not be seen on a threshold stone. On site it was thought that a window in this location may have been converted to a doorway, with a lowering of the sill, perhaps when the external stair tower was constructed alternatively the threshold stone was replaced due to wear with a reused window sill.

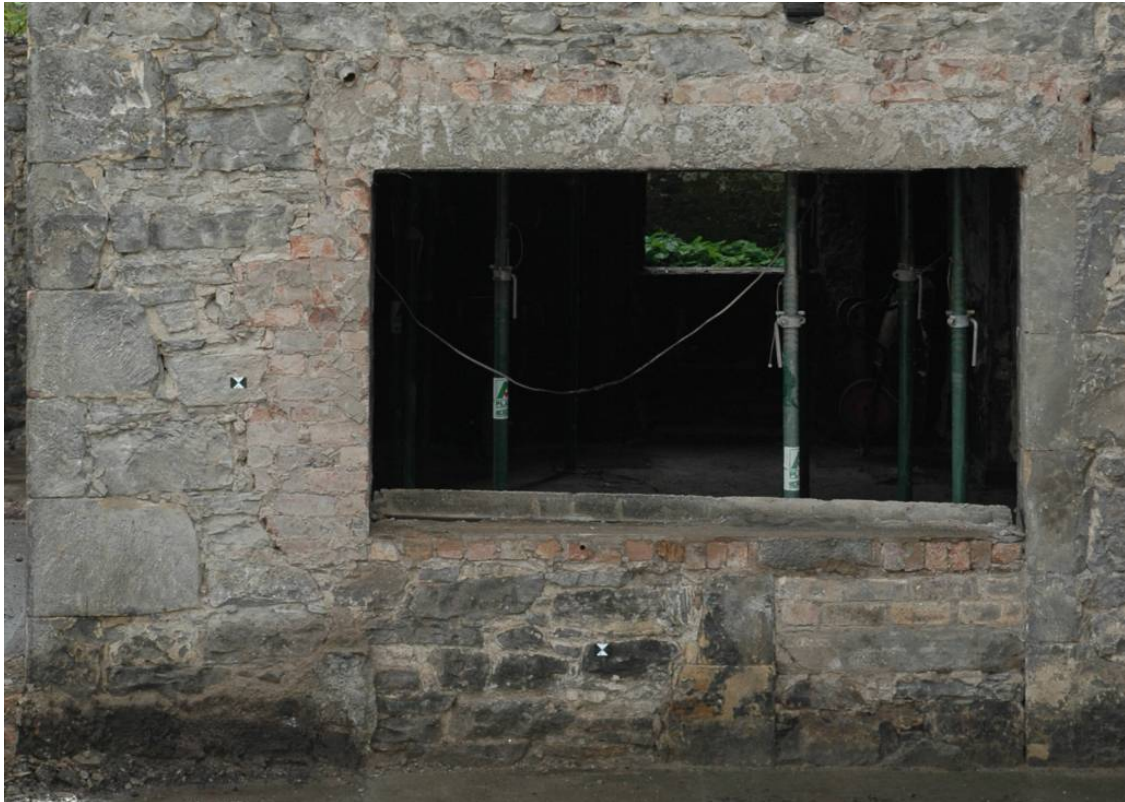
Plate 42 View of the west facing external elevation of Botanic Cottage. Note the blocking of the opening below and to the left of the window opening. Taken from the GUARD photo archive.

Assessment of the photographic archive from the original building recording completed by GUARD revealed alterations and phasing in this location (*Plate 39*). Clearly there had been a door here, with the lower half subsequently blocked and a larger window opening created at a higher level. It is felt this door was original and serviced the stairs to the lecture rooms above the sill {764} was probably latterly replaced. After the construction of the external stair, the doorway was blocked up, and the door part blocked into a window, latterly made much larger than before.

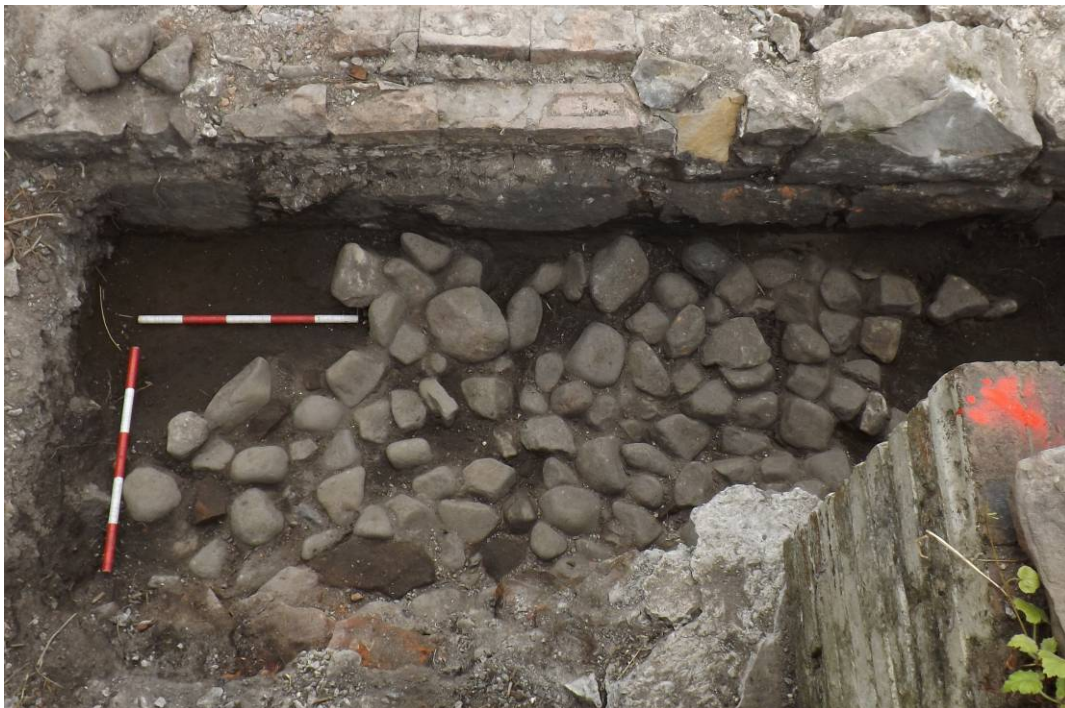
Plate 43 Cobbled surface (726) to the front of Botanic Cottage, located north of the main entrance (Photograph 376)

In both sondages the concrete was bedded on a very mixed deposit of mid brown silt abundant in fragments of red brick. This bedding material had a depth of <0.40m and was removed to reveal a disturbed cobbled surface. To the north of the manhole, off the north east corner of the cottage, the cobbled surface (726) was composed by a range of rounded stones bedded into underlying soil. One layer deep, this surface respects the wall of the cottage, but is clearly truncated and disturbed to the south and east. To the north, the cobbles are also cut by a salt-glazed drain [729/728].

These cobbles are at a good level to be considered the original ground surface associated with the construction of Botanic Cottage. A sondage excavated through the bedding material where the cobbles (726) were already disturbed by the salt-glazed drain revealed a compact surface of dark to black brown sandy silt acting as bedding. Recorded as (731), this material likely represents a working surface and is akin to (721) within the cottage itself. Underlying material (732) was very similar and is essentially the original topsoil.

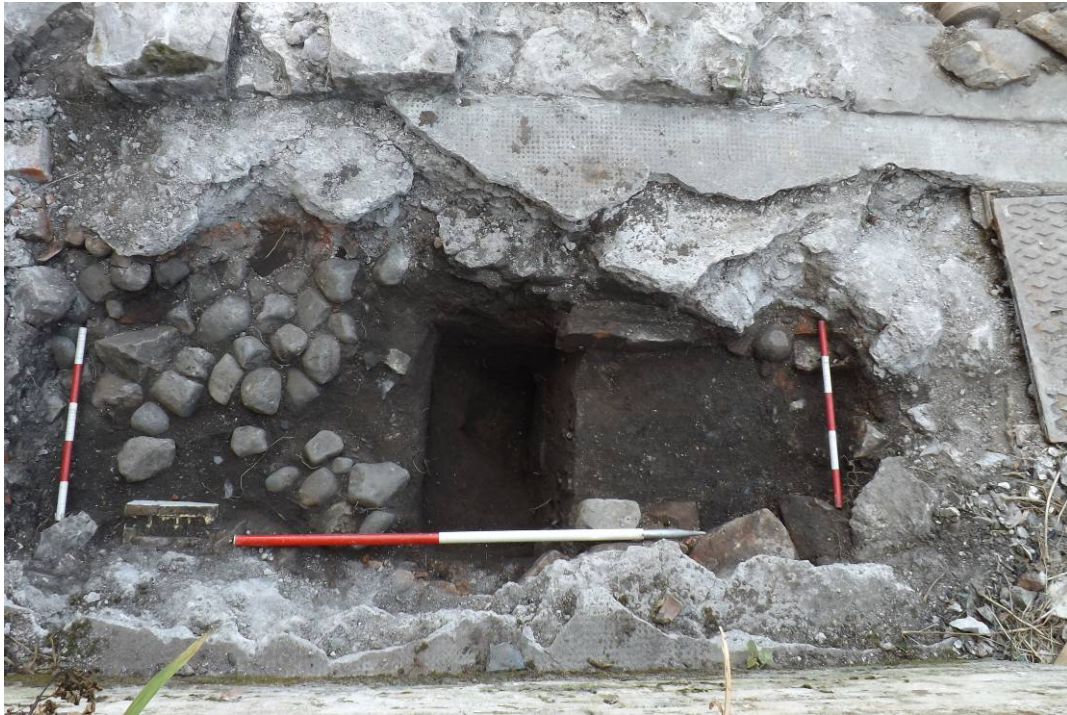
Plate 44 Post-excavation view (facing west) of the external sondage to the south of the main entrance to the cottage. Note the manhole and threshold stone to the right of the picture (Photograph 506)

South of the manhole the cobbles (740) were so disrupted as to no longer form a recognisable surface. A sondage through the mid brown silty sand revealed a possible feature or pit [743/744] cut into the underlying topsoil (742), but no artefacts were located and the fill was very similar to the topsoil itself.

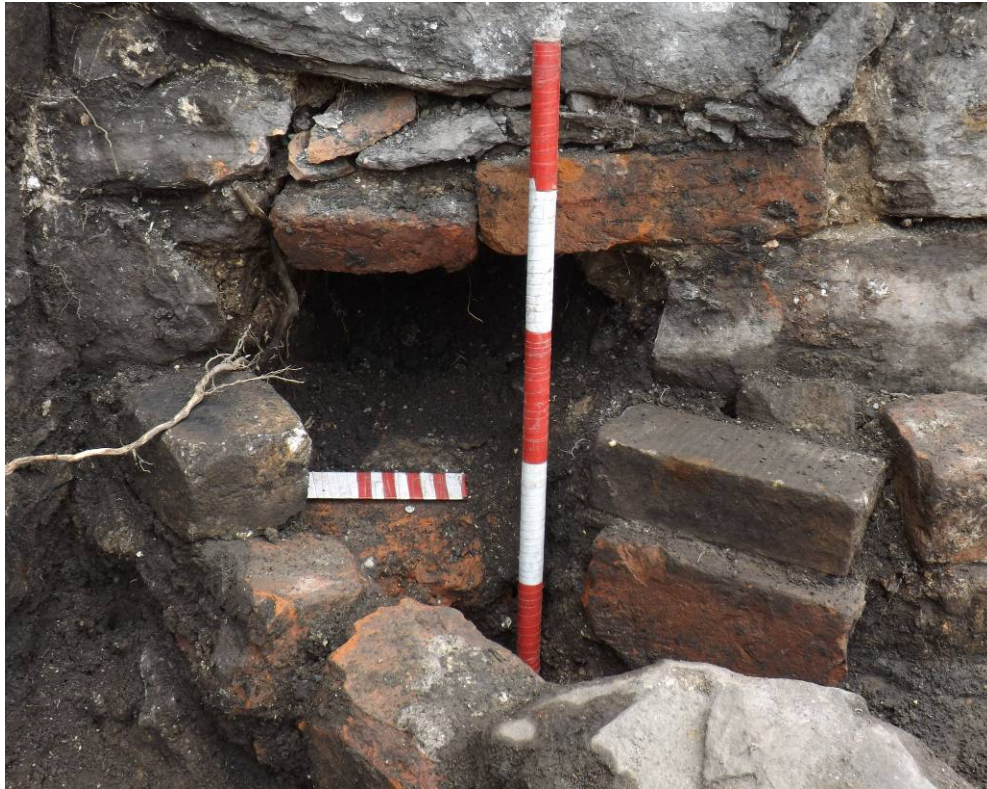
Plate 45 View of the opening in the upstanding 18th century wall. Note the dressed stone lining the drain {805} to the right of the opening, likely originating in the monumental mason's workshop of the mid 20th century (Photograph 516)

As the levels were lowered, an opening was revealed in the upstanding 18th century wall (*Plate 42*). This measured around 0.3m by 0.2m, set into the curved flanking wall of the cottage in the re-entrant where this met the main boundary wall. The opening faced the north, but the brick lined feature {805} which ran from it turned sharply westwards (*Plate 44*), curving around the face of the flanking wall. This feature {805} had all the appearance of a brick lined drain, composed of handmade red/orange bricks with occasional later irregular or dressed stones. These dressed stones were an unusual addition which seemed to have originated in the monumental masons of the 20th century. One curious aspect of {805} is that it widened towards the west, and seemed to be blocked by a series of broken handmade bricks at the western end. It may be that there was an outflow from the drain at a (now truncated) higher level.

As expected from a drain, {805} was filled by a soft to moderately compact mixed and mottled deposit of fine grain silt with occasional flecks of charcoal; lime mortar; and rare small stones – (806). The surprising element of this deposit was the large quantity of ash within.

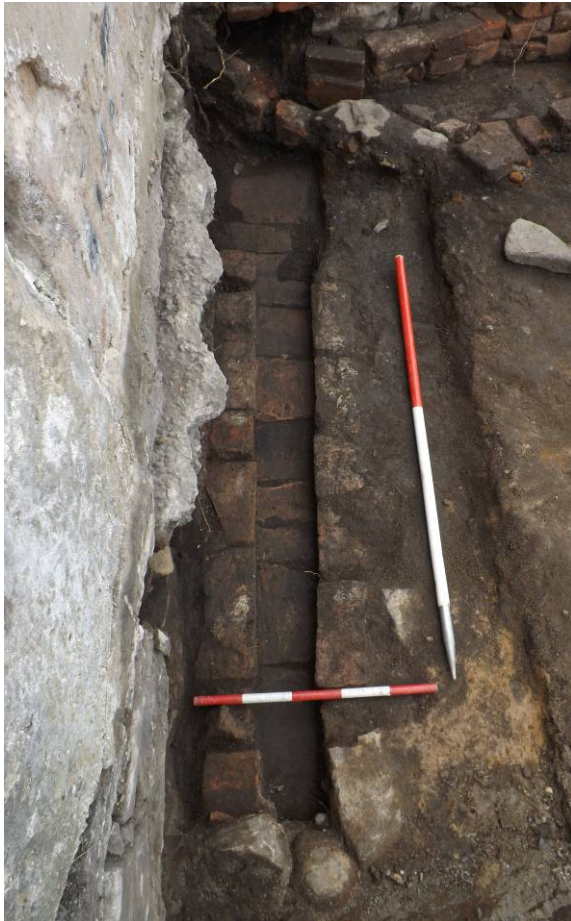
Plate 46 Post-excavation view of {804} looking south (Photograph 512)

The curvilinear nature of {805} was explained as excavation became deeper. {805} directly overlay, but also truncated an earlier brick lined drain {804}, which ran N-S along the foot of the upstanding boundary wall. {804} was comprised of similar red/orange handmade bricks of 18th century style, with one course set atop a series of large red tiles. This drain lines up with the opening visible in the re-entrant of the flanking wall, but was subsequently truncated by a later drain. The brick lined drain {804} was filled with a moderately compact mid brown sandy silt, speckled with flecks of black silt.

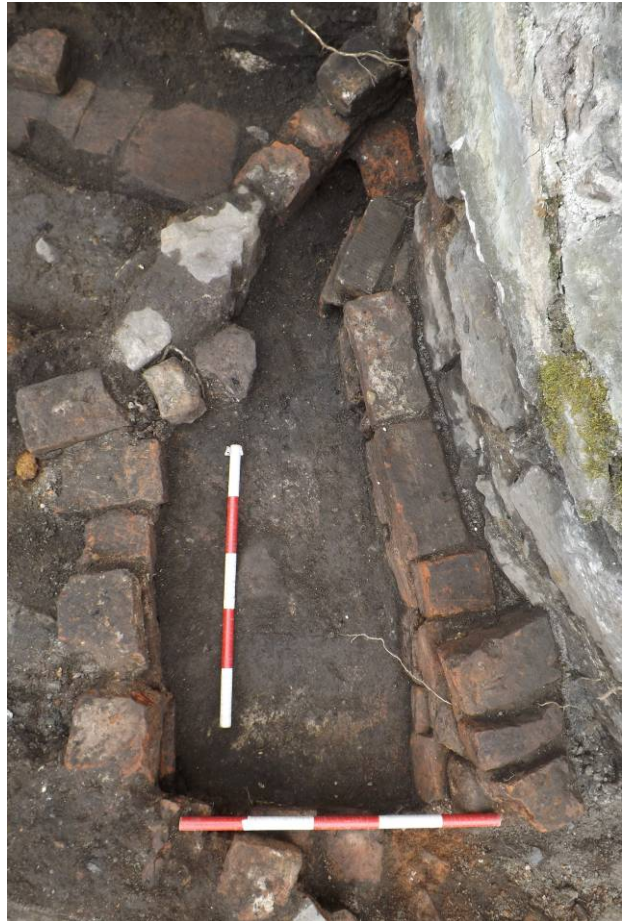
Plate 47 Post-excavation view of {805} facing east (Photograph 513)

{805} sat atop a rough surface of mottled and mixed deposit of gritty sand (807). This was interpreted as a working surface.

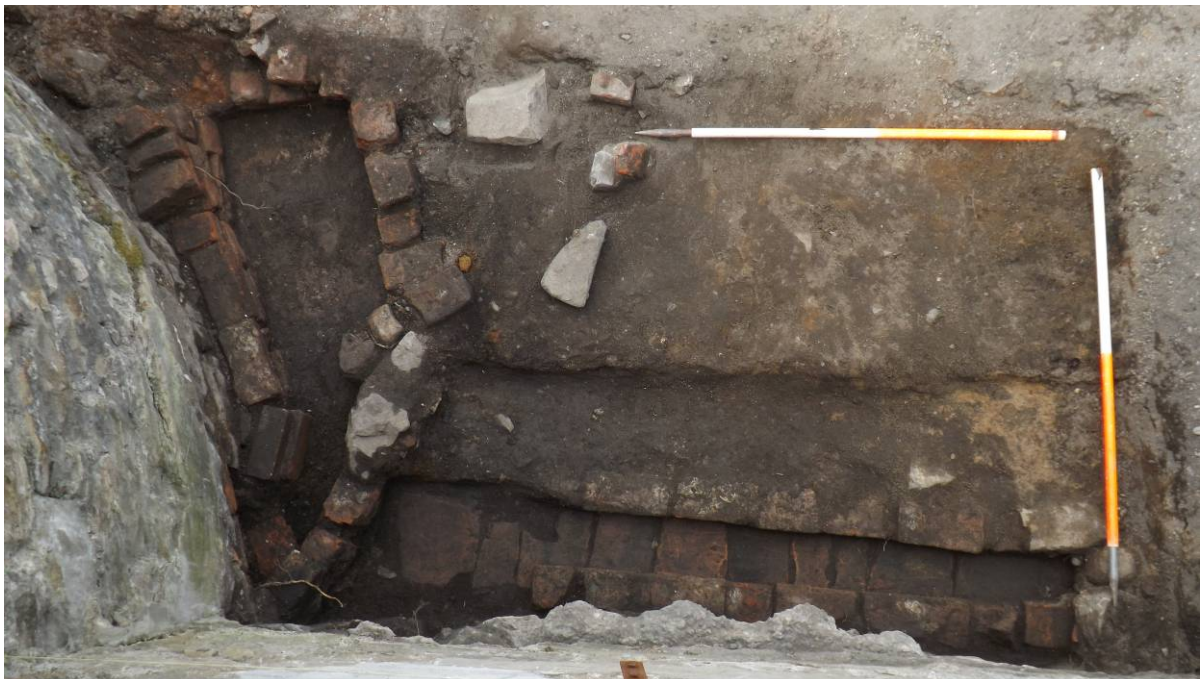
Plate 48 Vertical view facing east and showing the limits of Trench 8 (Photograph 520)
