Myrton Castle

Monreith, by Port William, Wigtownshire

Archaeological Evaluation : August 2015

Addyman Archaeology
Building Historians & Archaeologists
A division of Simpson & Brown Architects

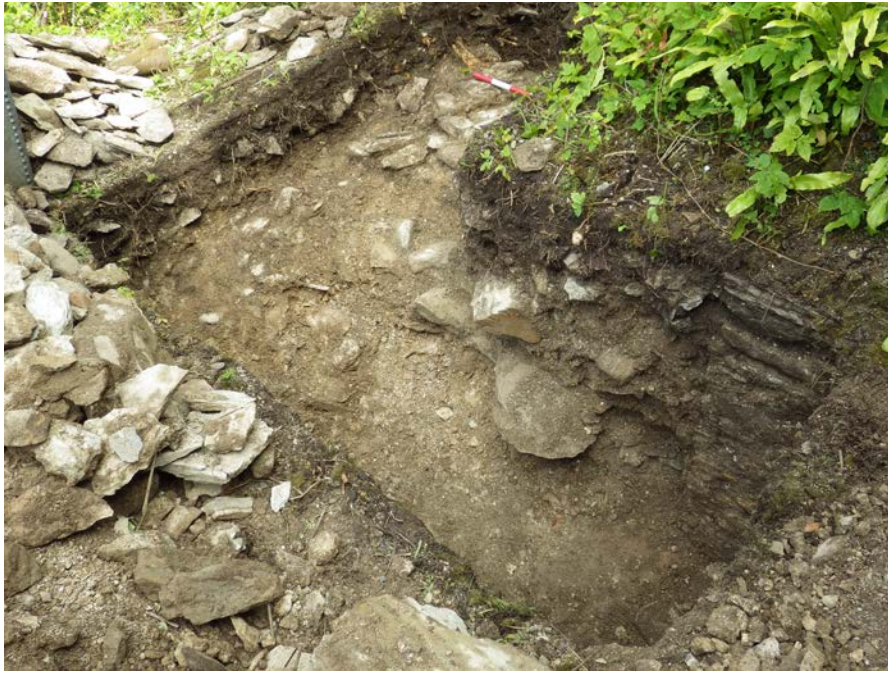
Plate 5 Deposit [105] in Trench 1, in north-west corner, looking north-east

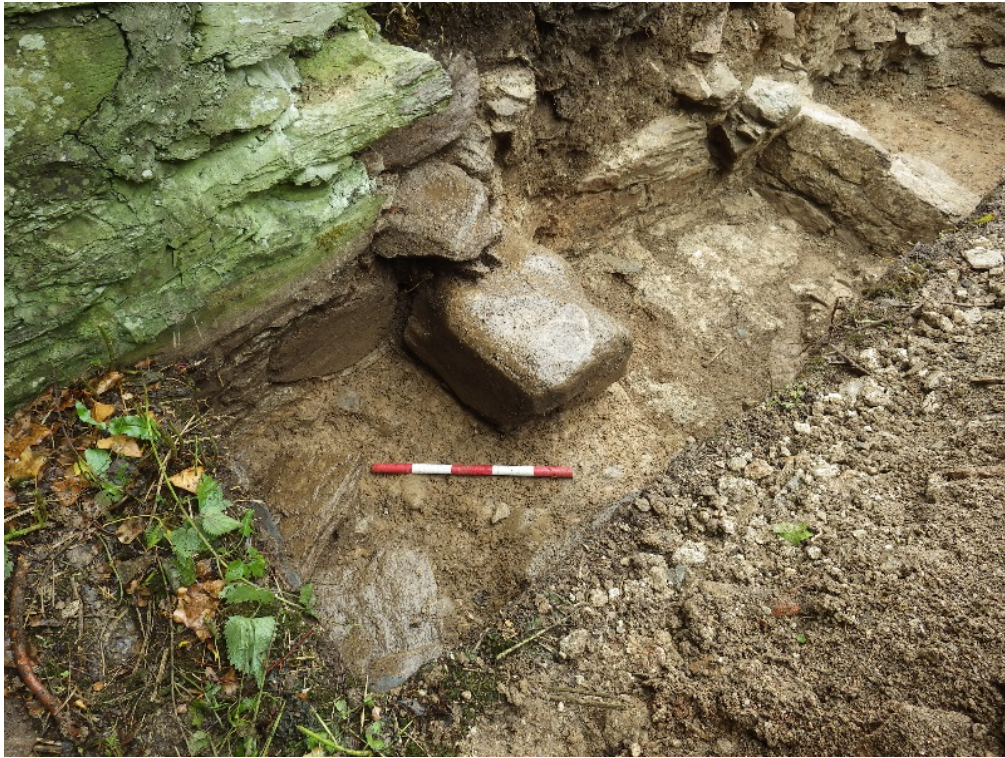
Plate 7 The projecting stub of wall [208] as initially revealed; the distorted section of walling at top right [211] lies on the line of the north exterior wall face of the early tower; looking northwest

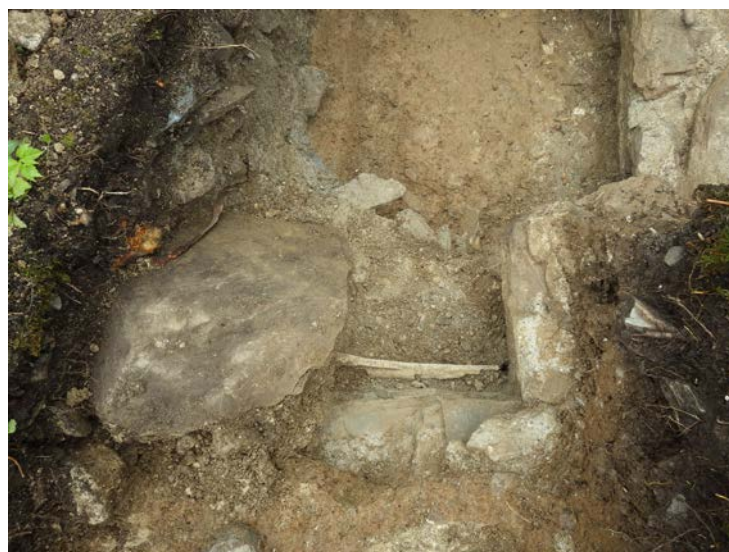
Plate 8 Window recess [213] with internal partition wall [211] to right, looking east

Other secondary interventions to the later range were indicated by a secondary lath and plaster lining [214] within the window [213]; the timber of this had rotted away leaving the plaster upstanding. This plaster was quite hard, thick and very well preserved allowing it to stand unsupported (*plate 8*).

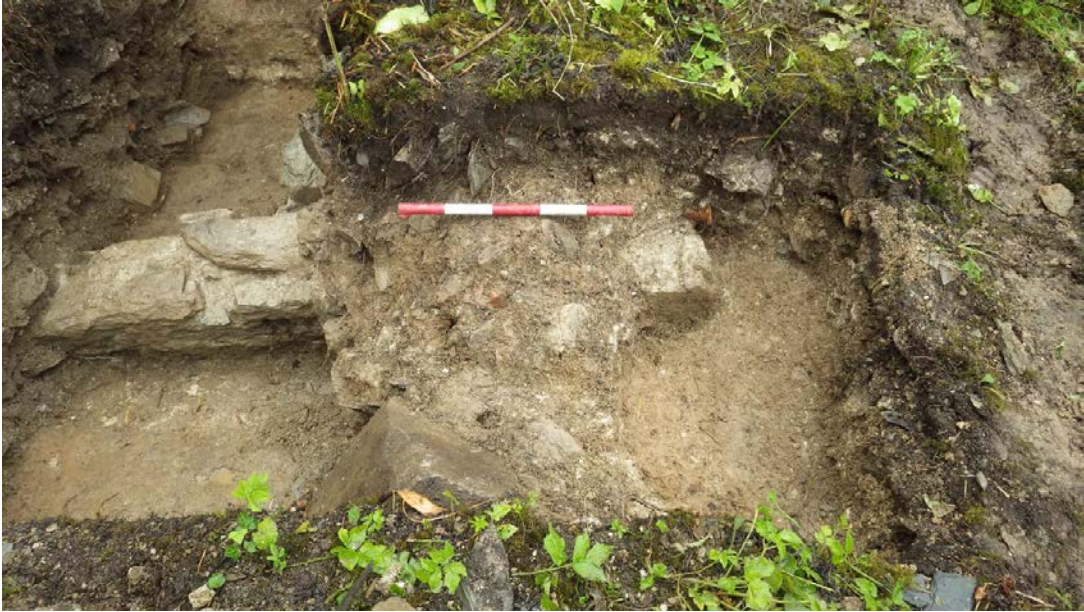
Plate 10 clay capping [207] enhancing ruined castle walls (50 cm scale)

Following the initial demolition and robbing of the masonry to below ground level a linear mound of rubble-rich clayey material [207] was formed running along the line of the demolished west wall. This was initially considered to be the wall core of a clay-bonded wall with the facing stones robbed. However continuing excavation showed the surviving masonry beneath to be lime-bonded. This was interpreted as a deliberate attempt to delineate and make visible the walls of the castle that had been robbed to beneath ground level, as part of landscaping works to enhance the appearance of the ruined castle.

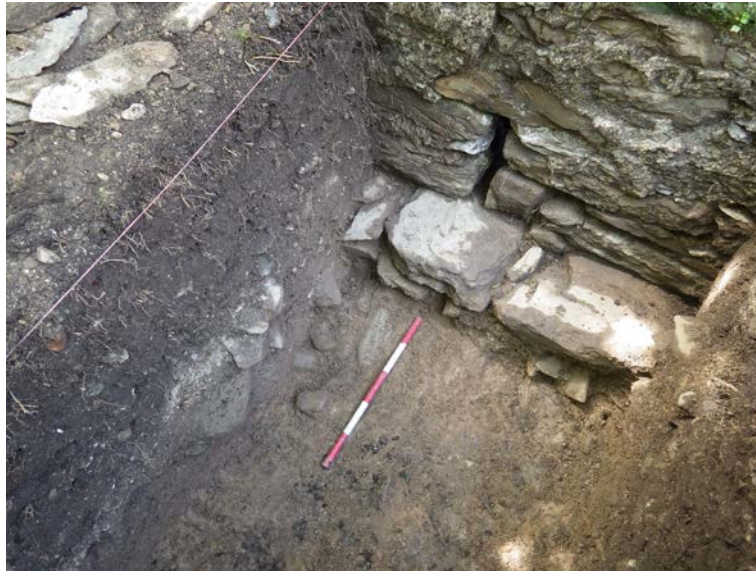
Plate 12 Trench 3 showing post hole [313] pre-excitation between scale and section; looking south-west

Post-hole [313] was cut into the clay of the motte (*figure 9*). It was 0.26m wide and 0.16m deep; but only half was exposed against the south-facing section of the trench (*plate 12*). It was filled with a rounded pebble post packing [314] within a matrix of grey-brown silty clay [315]. The sides slope inwards at a near 45° angle and terminate at a base set with a flat stone. While there is a possibility that it may relate to early structures occupying the motte summit, the feature was perhaps more likely contemporaneous with either the construction of, or the earliest phases of, the later medieval castle.

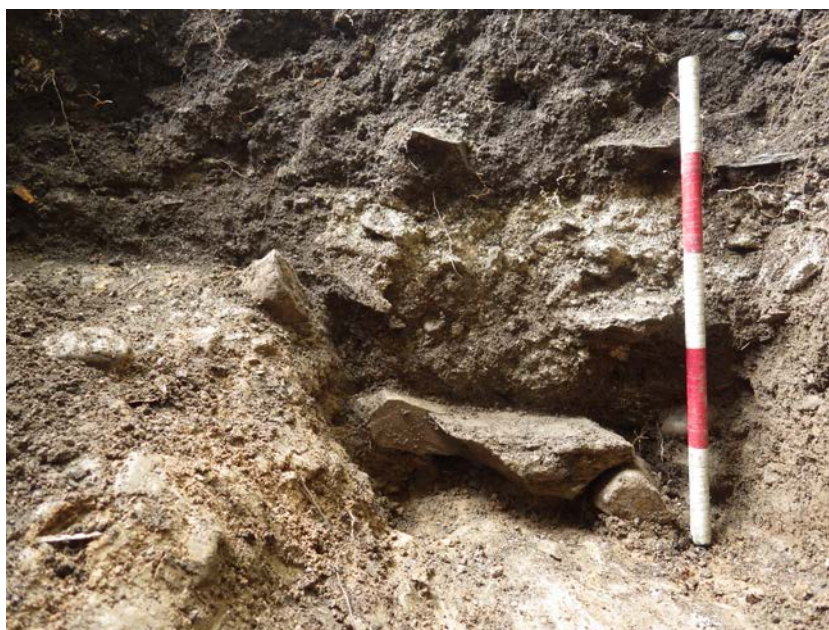
Plate 14 Trench 3 showing motte surface and west-facing drain section; looking east

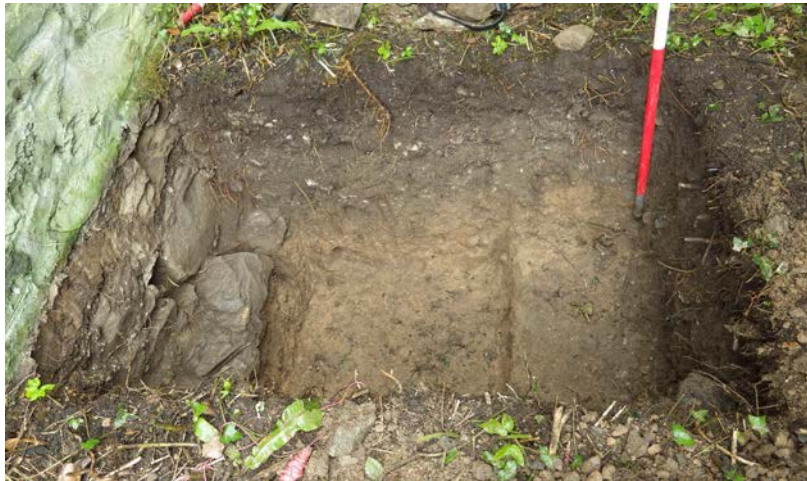
Plate 16 East section of Trench 4 at limit of excavation, looking east

The wall of the tower [403] was built above the foundation course. There was some possible suggestion of a shallow footing trench [407] cut into the top of the motte; however this was poorly defined and mainly suggested in the east section – see *plate 16* below. The gun loop [405] within the wall was low and narrow and had been simply formed by rubble stone, without dressings (*plate 17*).

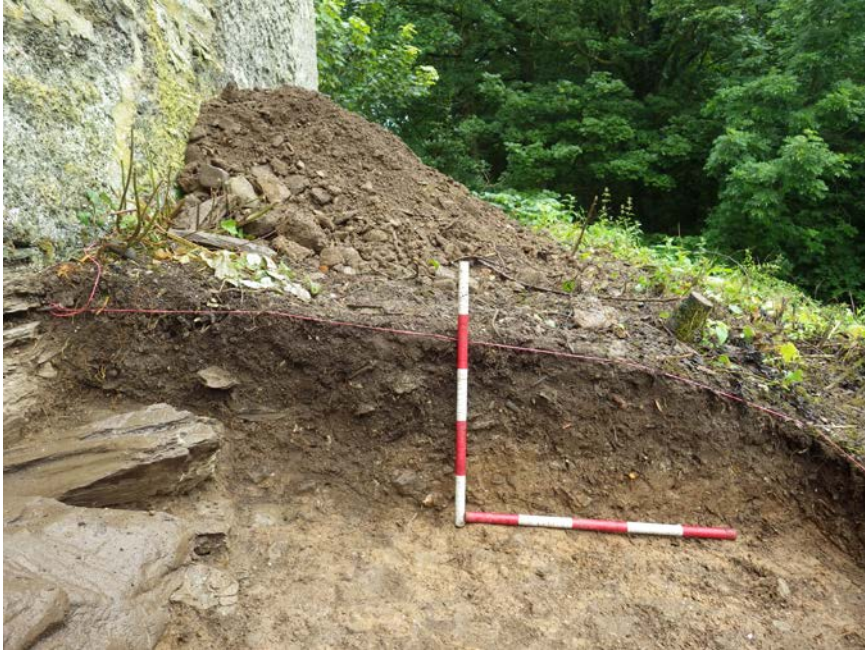
Plate 19 Post-excitation south section of Trench 5, showing cut [506] and fill (507)

The castle foundation trench [506] was a north-south orientated linear cut with a 45° sloping side and flat base cut into the clay motte surface. The foundation trench was filled by mid to grey brown gritty silty clay [507] with mortar flecks and angular stone and pebble inclusions, surviving to a depth of 0.15m. The foundation trench and fill are most visible in the north facing section (*plate 19*), and it is within this fill [507] that the castle foundations [503] are set.

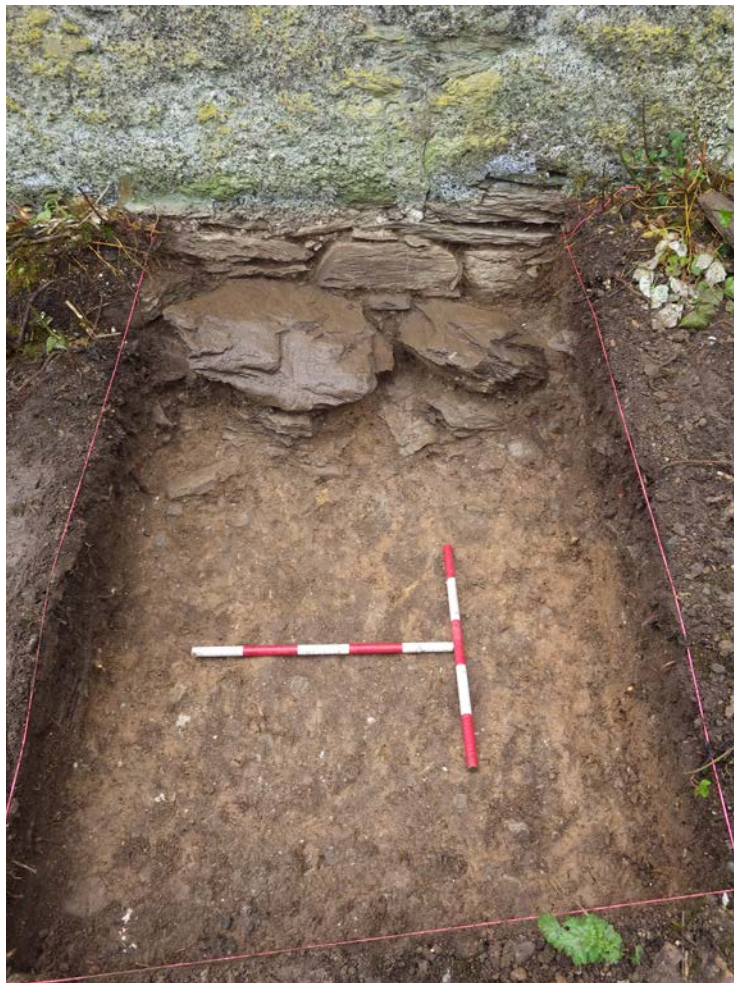
Plate 20 Post-excitation of Trench 5, looking east

The castle foundations [503] are made up of a single course of large linear stone slabs measuring 0.50m in width and approximately 0.20m in thickness. Protruding 0.40m from the castle's western face, the foundation stones are aligned east-west and arranged in a north-south arrangement (*plate 20*). The foundation stones appear to be un-bonded, though are mortared to the overlying wall with a yellow to light brown shell rich mortar [504] seen in the southeast corner of the trench.

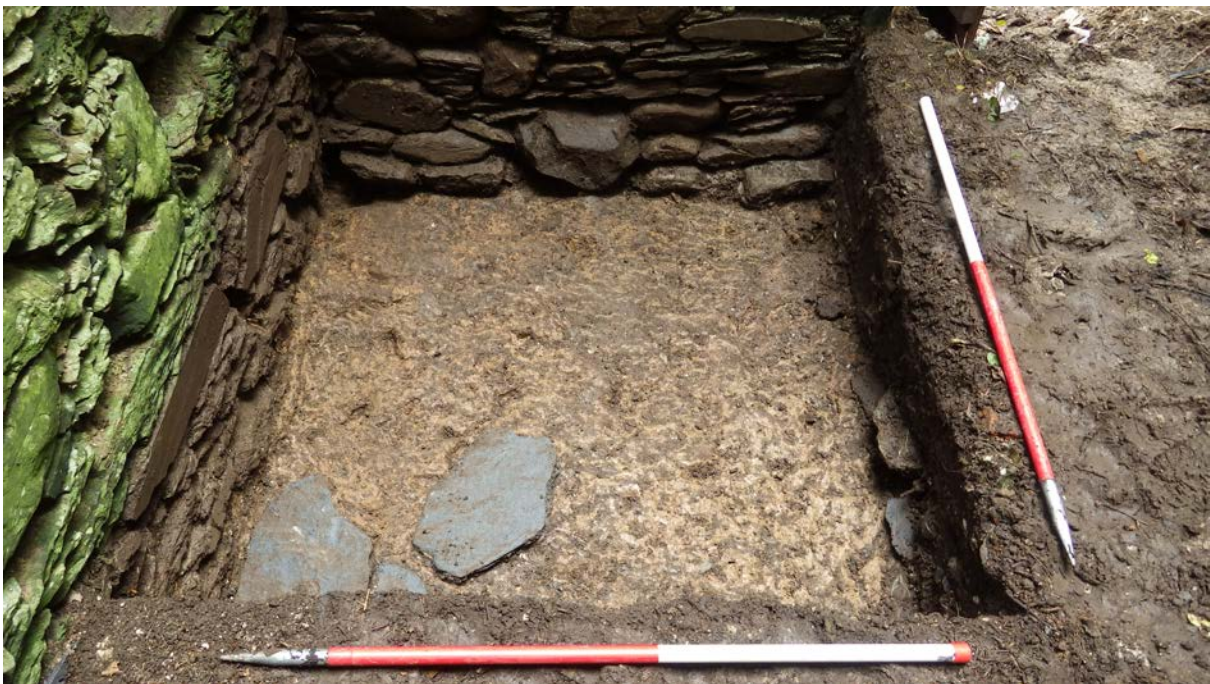
Plate 22 Post-excavation view of Trench 6 with (602) in the SE corner and the motte top (604) across the bottom of the trench, looking north (014)

The base of the original tower wall [605] was constructed on the surface of [604], within a foundation cut, which was not seen. The northern doocot wall [606] appeared to have been constructed directly upon the levelled surface of the motte (*plate 22*). Both walls were of rubble construction with lime and mortar bonding.

Overlying this deposit was a concentration of slate and rubble [602], although this did not cover the whole surface of the motte. The deposit of slate and rubble is likely to be the result of the abandonment and destruction phase of the upper floors and roof of the tower. It was 0.10m – 0.20m in depth. Within this deposit were frequent roof slates, brick (matching the bricks employed for the nesting boxes – hand-made low-fired orange-red terracotta of narrow thickness), mortar and rubble stone. Such material had been observed throughout the overlying topsoil but was present in a greater concentration in [602].

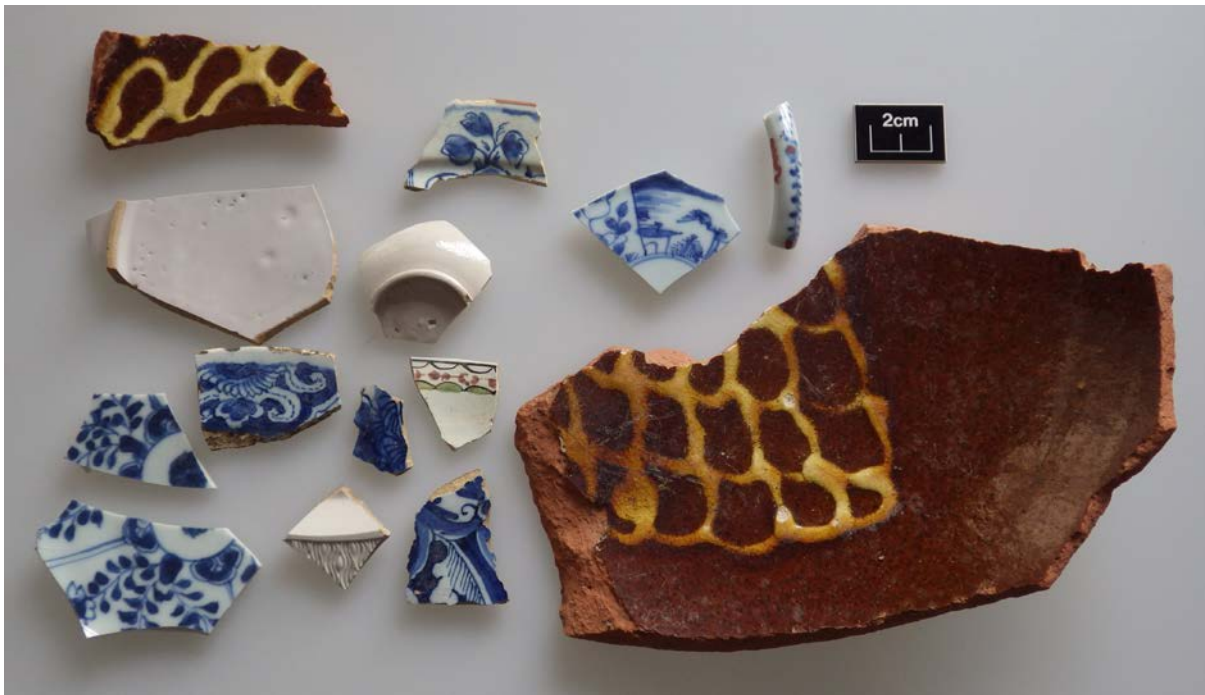
Plate 23 The range of ceramics recovered from the excavations, all of mid- and later-18th century in date

The ceramic assemblage is made up of 93 sherds, mostly recovered from the demolition debris of Trenches 1 and 2, and clearly relate to the later domestic occupation of the castle. These sherds mostly comprise late-17th to mid-18th century tin-glazed ceramics, mid-18th century salt-glazed and creamware ceramics, as well as porcelain, pearlware, and Scottish redware. Some of the finds from Trench 1 included numerous fragments of a chamber pot with residue, and fragments of what is likely an 18th century slipware loaf dish (SF002). Unsurprisingly the finds from Trench 2 were similar to those recovered from Trench 1, with numerous chamber pot fragments, delftware, creamware, and porcelain having been recovered amongst others. Trench 3 also produced a number of ceramic sherds, with a number of tin-glazed, creamware, and porcelain fragments coming from the demolition debris below the castle's eastern face.

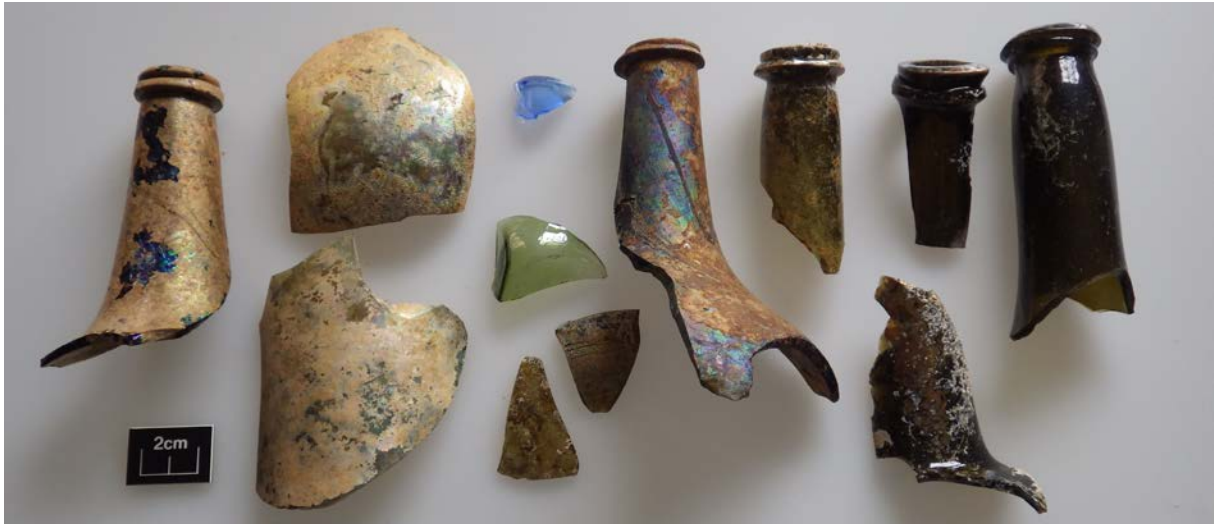
Plate 24 Selection of bottle glass, mostly later 18th century

In total 194 shards of glass were recovered, these mainly green bottle glass that had been incorporated into the mortar uncovered within Trenches 1 and 2. The majority of the green bottle glass is datable to the mid to late 18th century, with one shard possibly dating to the late 17th century (SF005). Four base shards from a particularly large case gin bottle (SF003) were also recovered from the demolition debris within Trench 1; this displayed a pontil scar and likely dates to the final quarter of the 18th century.

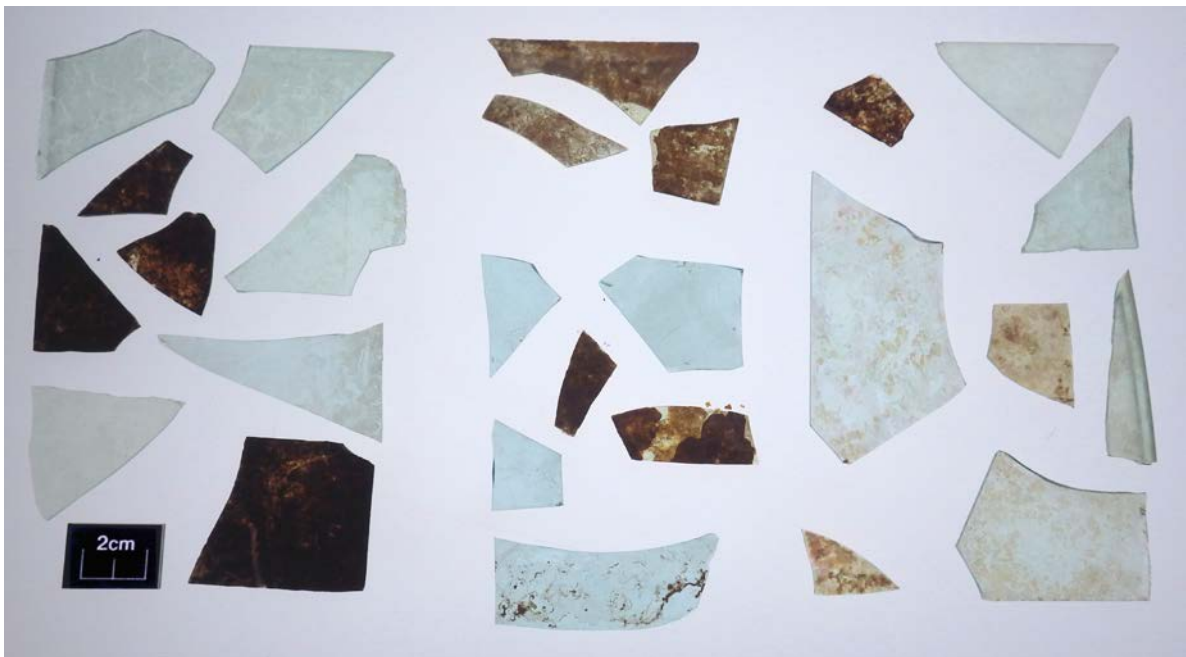
Plate 25 Selection of window glass

Numerous shards of window glass are also present within the assemblage, recovered from Trenches 1, 2, 3, 4, and 6. Many of these shards are clear / aqua glass and likely date to the 18th century; some of the shards recovered are a darker-iridescent glass and are likely somewhat earlier in date. In addition to the glass pane shards, a section of Lead window came (SF001) was also recovered from the demolition debris within Trench 1.

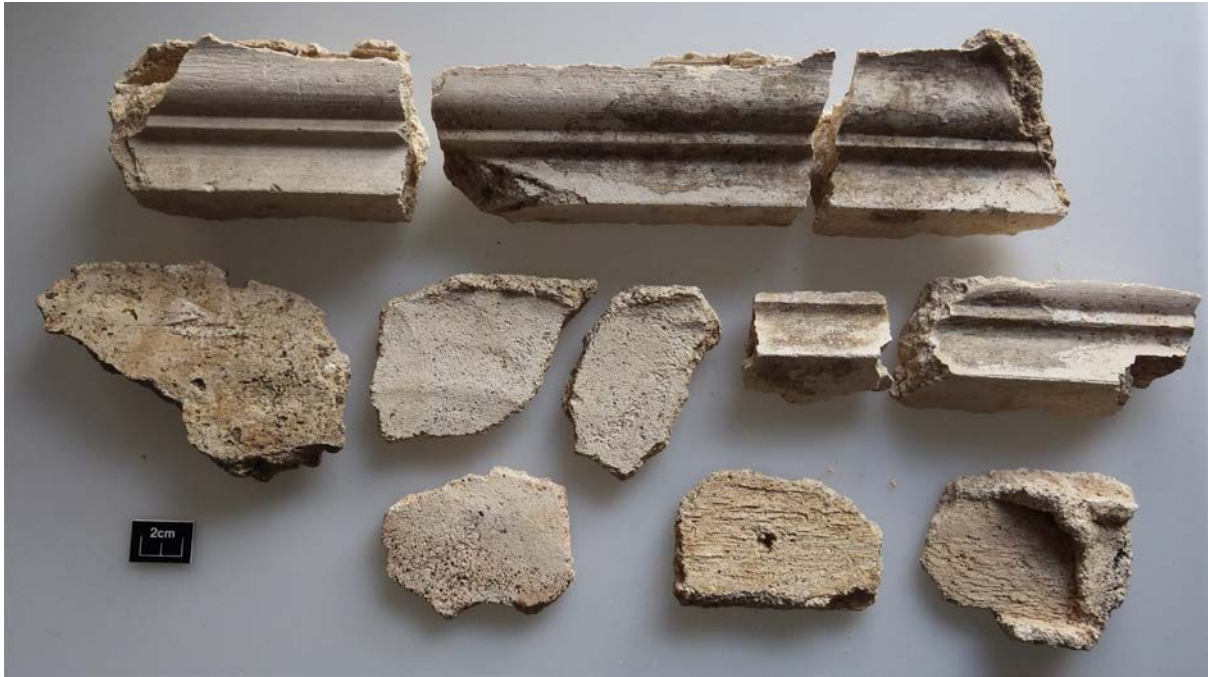
Plate 27 Selection of plaster from trenches 1 and 2 including run cornice sections of classical profile

The plaster and mortar assemblage consists of 64 fragments, including 52 plaster fragments and 12 lumps of mortar. All of the plaster was recovered from Trenches 1 and 2, while the mortar comes from trenches 2 and 3. Both wall plaster and ceiling plaster are present, some with the remnants of paint and brush hairs adhering (SF011). 5 fragments of moulded architectural plaster (SF017) were recovered from the context associated with ceiling collapse within Trench 1, some of these are conjoining, and show lath imprints and traces of paint remaining – sections of a robustly detailed run classical cornice. The mortar (in addition to what is adhered to the glass assemblage) was recovered from Trenches 2 and 3. The mortar from Trench 2 is likely 17th-18th century in date, and is associated with the demolition rubble deposits. The mortar from Trench 3 is much earlier in date, shell-rich, and is likely the result of debris / collapse from the late medieval tower.
