LIGHTNING CONDUCTOR TRENCH
HADDO HOUSE
TARVES
ABERDEENSHIRE

Archaeological Evaluation

Report No: MAS 2012-4

HADDO HOUSE ABERDEENSHIRE LIGHTNING CONDUCTOR REPLACEMENT -Archaeological Evaluation-

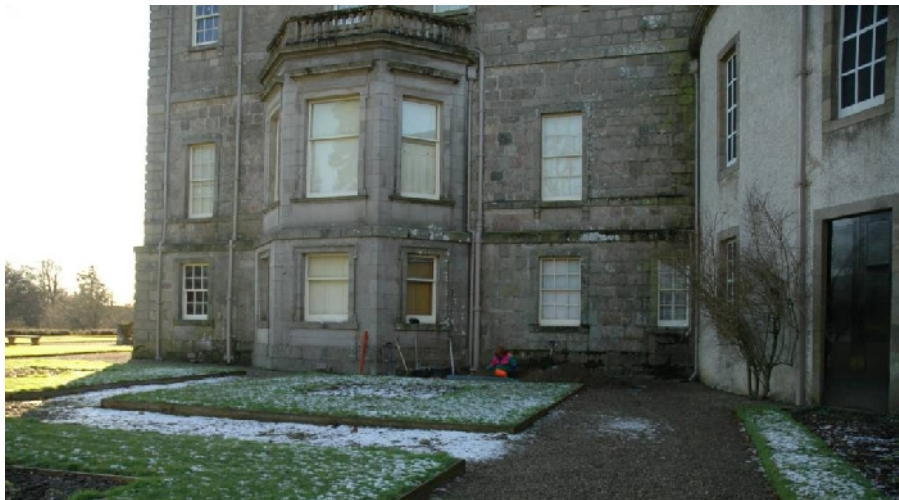
Illus 2 Location of trench LC2. Person standing in trench.

Between 1.3m and 2.3m from the outer N wall of the main central block of Haddo House and W of the W side of the bay window. 1m square and 500-700mm deep.

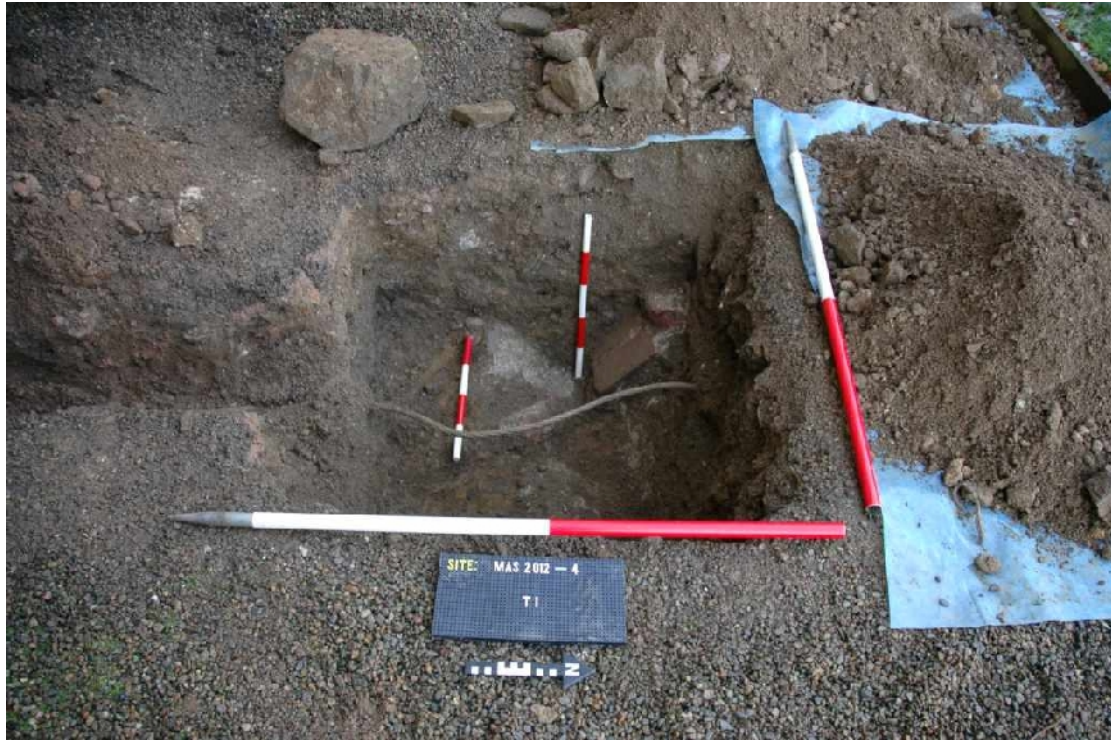
Illus 6 Drain in W section of LC2, looking W

A gully ran WSW/ENE across the base of the LC2 trench; it was partially cut into the natural and was c.400mm in width and V-shaped in section with a maximum internal height of 280mm. This was the remains of a V-sectioned brick-lined drain (5); bricks only survived on the N side at the W end. Elsewhere the bricks had been removed (probably when the lightning conductor cable was inserted) and only the bedding mortar remained.

The V-section brick-lined drain is identical to the brick-lined drains excavated at Castle Fraser, Aberdeenshire (Murray and Murray 2008, 28-29, illus 15, 16) which were thought to date to the end of the 18th or early 19th century. It was considered that they were perhaps unlikely to date to after the 1830s/40s when the manufacture and

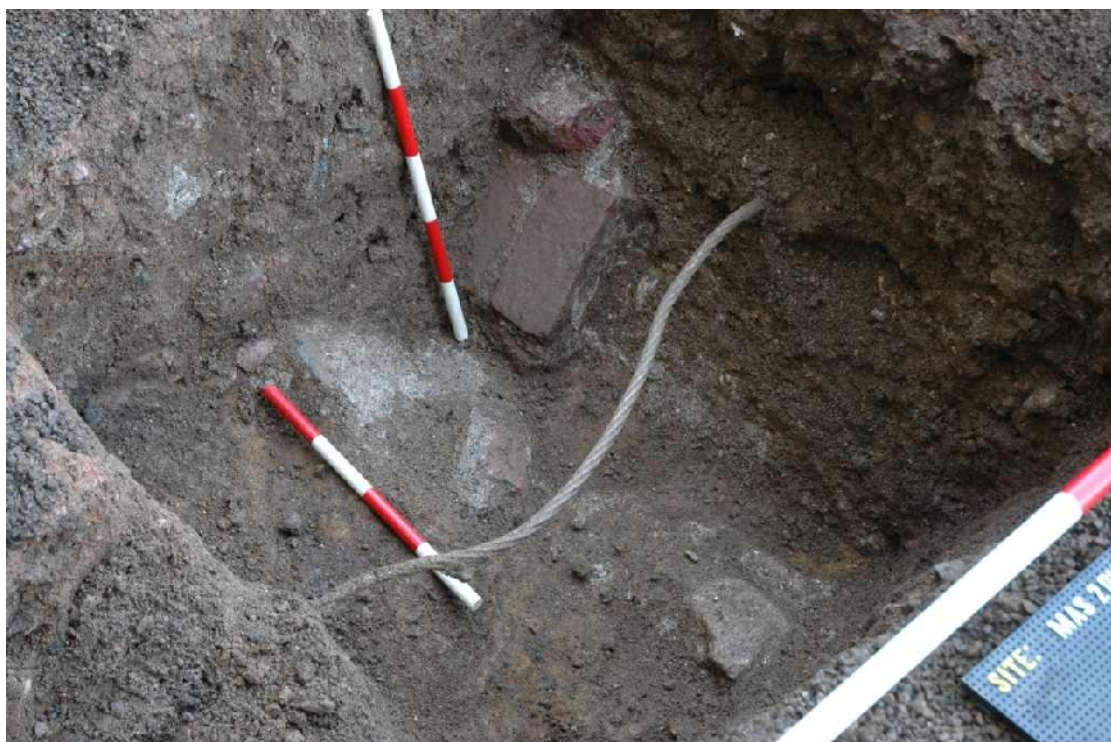
Illus 7 Drain across the base of the trench, looking NW
