HADDO HOUSE ABERDEENSHIRE STAFF CAR PARK MAINS WATER LEAK

**- Archaeological Watching Brief -
Carried out 17th July 2013
by
Murray Archaeological Services Ltd**

**Report No: MAS 2013-22
by
H K Murray**

**HADDO HOUSE STAFF CAR PARK
ABERDEENSHIRE
MAINS WATER LEAK
-Archaeological Watching Brief-**

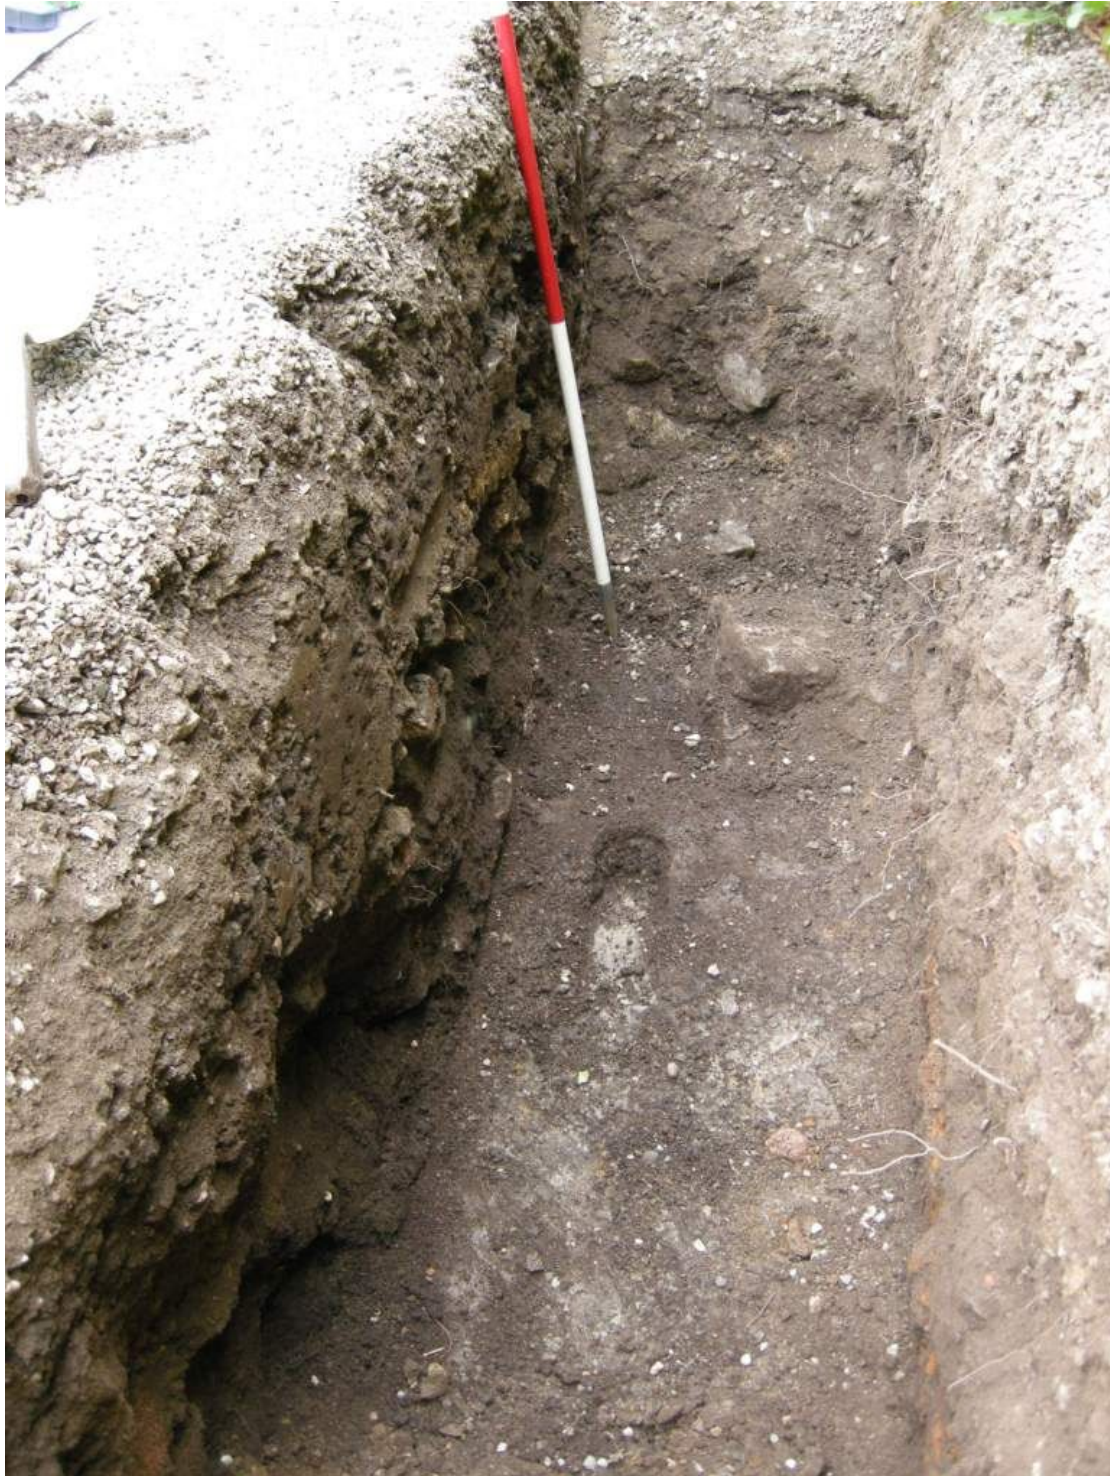
Illus 4 Trench 1 looking N. In E (RHS) section brown line is the exposed iron water main. In the W section (LHS) the undisturbed stratigraphy is visible.

In the S part, the E side of the trench was cut by the trench for the cast iron water main; this was backfilled with a mixture of small rubble, soil and clay. The top of the main is c. 900mm below the surface of the car park. The W side of the trench and the W section showed the following stratigraphy:

1. c 200mm gravel and yard make-up
2. 400-600mm made up ground including some stone, fragments of mortar and occasional fragments of slate.
3. c 300mm crumbly brown humic soil
4. c 40mm small pieces of stone and some sandy mortar
5. 80-100mm black compact peaty soil, probably natural
6. natural clay

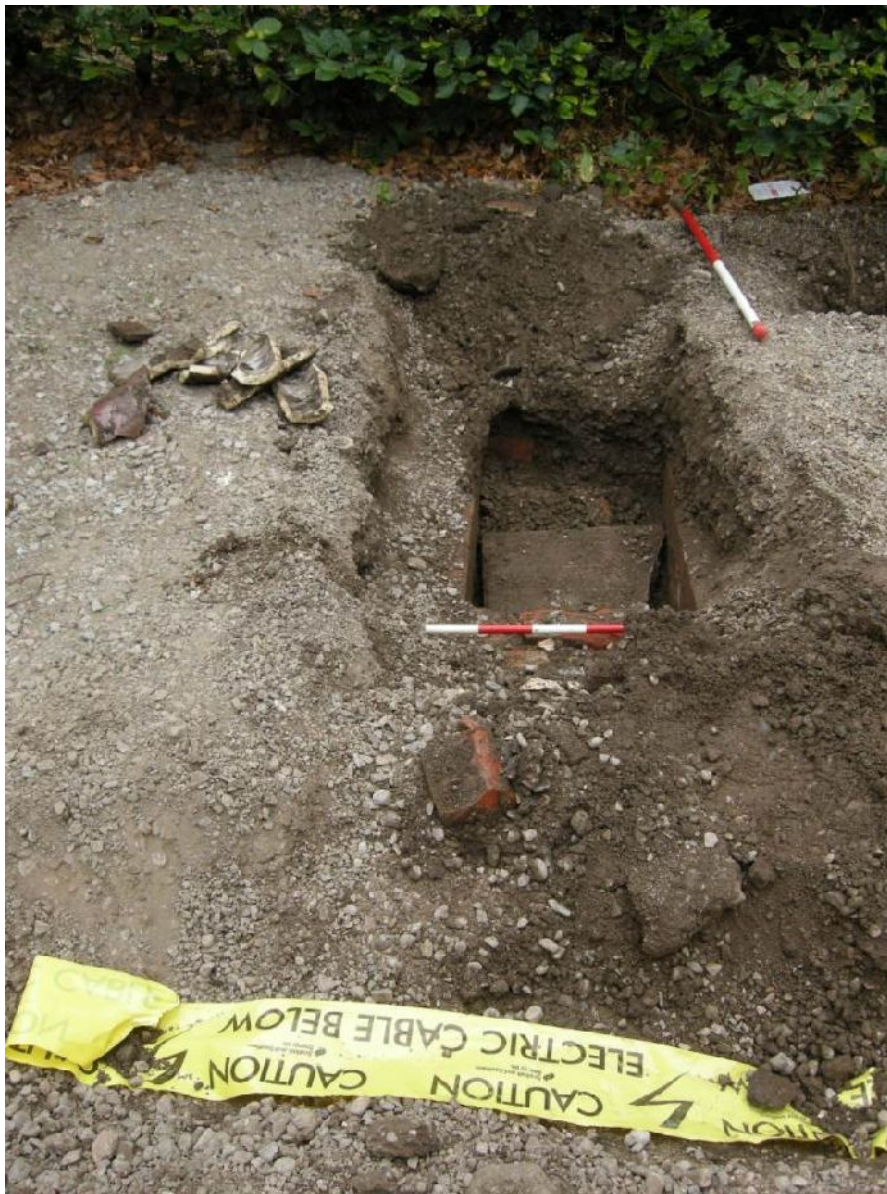
Illus 5 Looking E along trench 2. Electric cable in foreground with brick inspection pit behind.

Trench 2 revealed a brick built inspection pit 460mm x 970mm (18" x 3' 6"); this had been backfilled with its broken cover and with soil and broken drain pipe fragments.

A live electricity cable in a metal pipe was revealed running NE/SW between the Haddo House S wing and Haddo House Hall. This was only just below the car park make-up at 200-300mm. Where exposed it was covered with hazard tape and backfilled.
