FIRE MAIN TRENCH
LEITH HALL
ABERDEENSHIRE

Archaeological Watching Brief
Carried out between October 2013 and April 2015
by
Murray Archaeological Services Ltd

Report No: MAS 2015-16
by
H K Murray and J C Murray

-Archaeological watching brief-

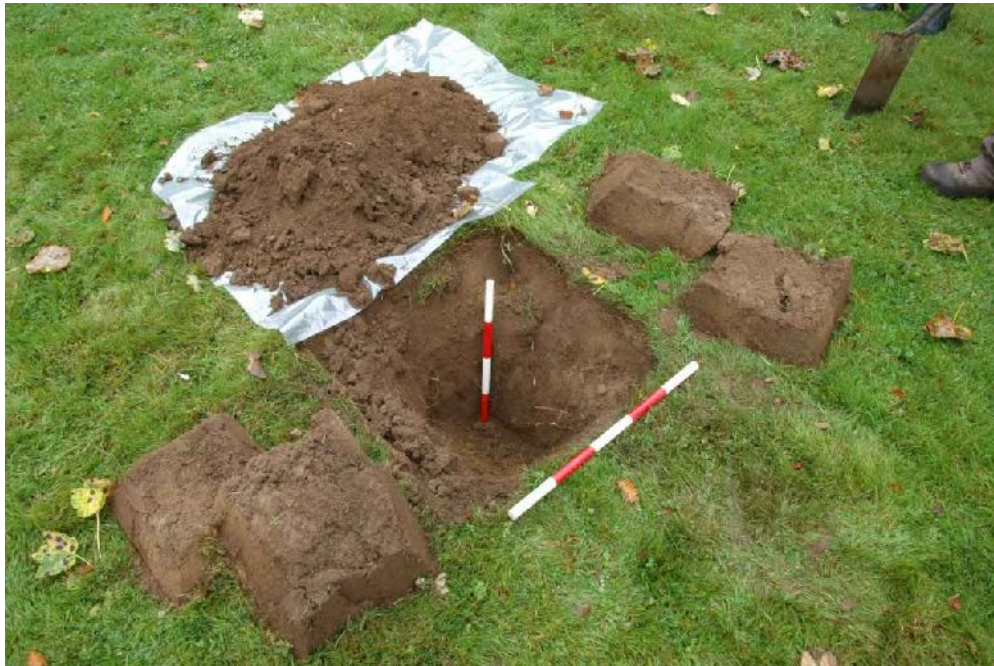
Illus 5 Detail of Test pit 2013

In October 2013 a test pit 500mm square was dug by hand under archaeological supervision in the N lawn at GPS: 354047,829842. It was dug to a total depth of 400mm, which comprised 200mm of topsoil over 150mm of slightly stony subsoil over yellow sandy natural.

No archaeological finds or features were observed.

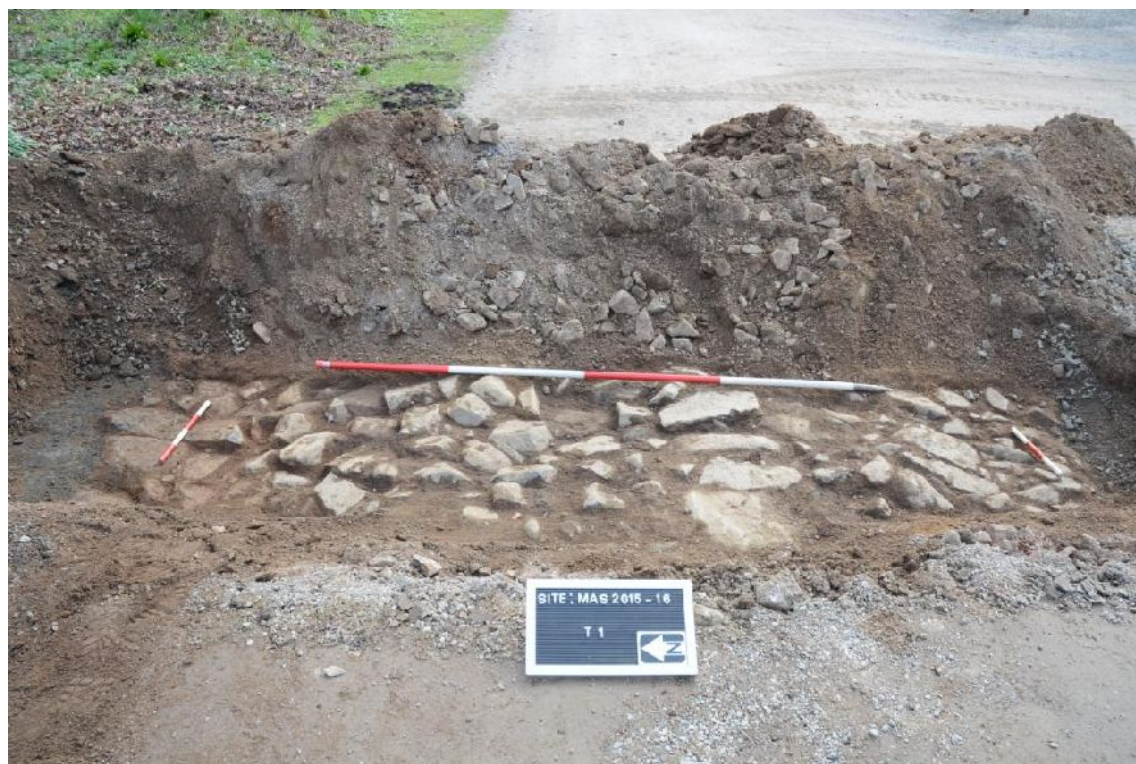
Illus 7 Detail of stone surface in trench 1

This trench, just W of the opening into the car park, revealed an earlier stone road surface below 350mm of current road material comprising quarry dust and sub-base. The earlier road surface was made up of irregularly-sized, flattish stones varying in size from very small (60 x 100mm) to large (290 x 300mm, 60 x 300mm). On the S side the edge had been cut by a telecomm installation and the stones were much smaller. On the N side bigger stones (250x600mm) formed the N edge. This was bordered by a possible ditch with a mid grey fill of soft, silty, water-deposited material.

6.1 Driveway Of the five trenches along the course of the drive, only trench 1 showed any evidence of an earlier road surface. This could not be dated and appears to be a relatively restricted area, possibly a stone surface used to build up a wet or worn area of the roadway near the junction of a number of routes. It does suggest it would be useful to observe any service trenches in the road between this point and the entrance to the Hall to identify the extent of this feature.

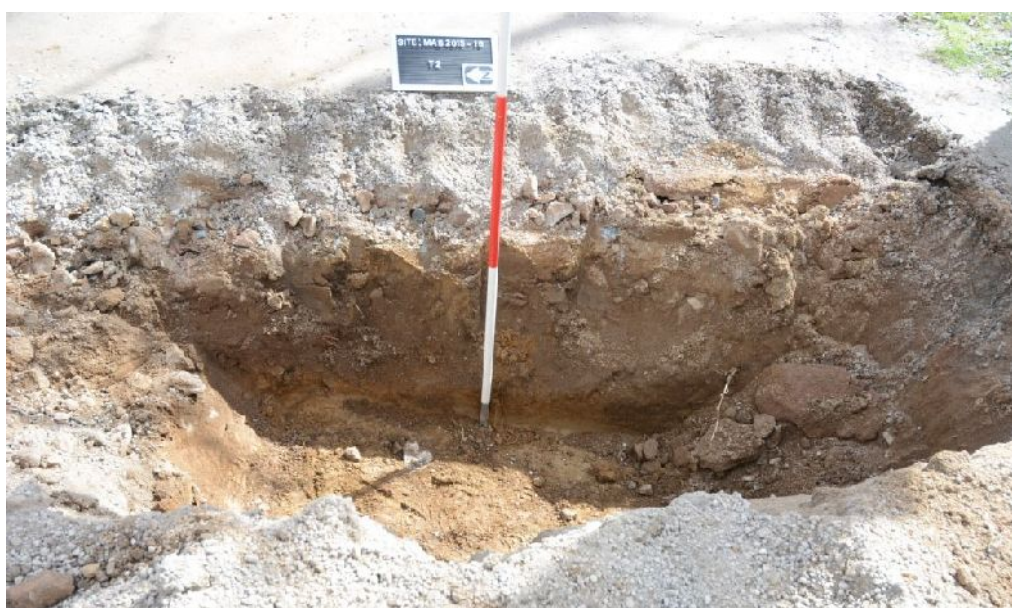
Illus 9 Detail of trench 2

The present road surface comprised c. 400mm of pea gravel and granite dust which lay directly on soft, beige, sandy and slightly silty natural.

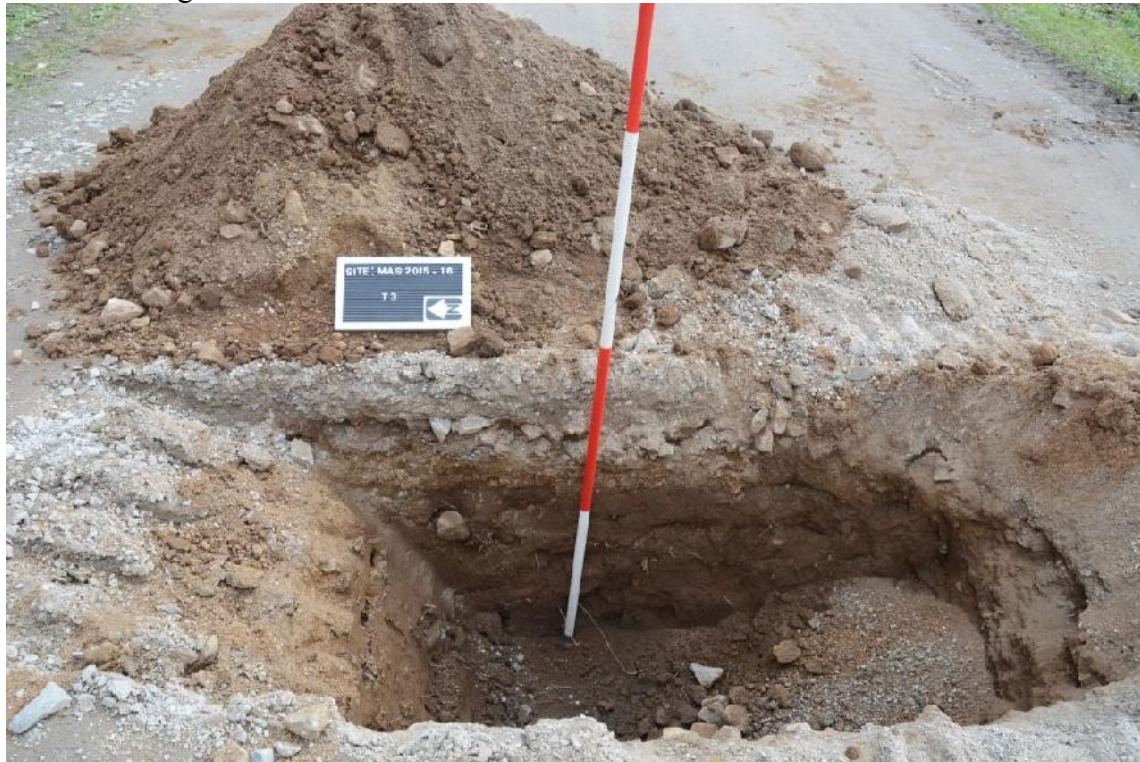
Illus 10 Detail of trench 3

The present road surface comprised c. 300mm of small stone and granite dust which lay directly on soft, beige, sandy and slightly silty natural.

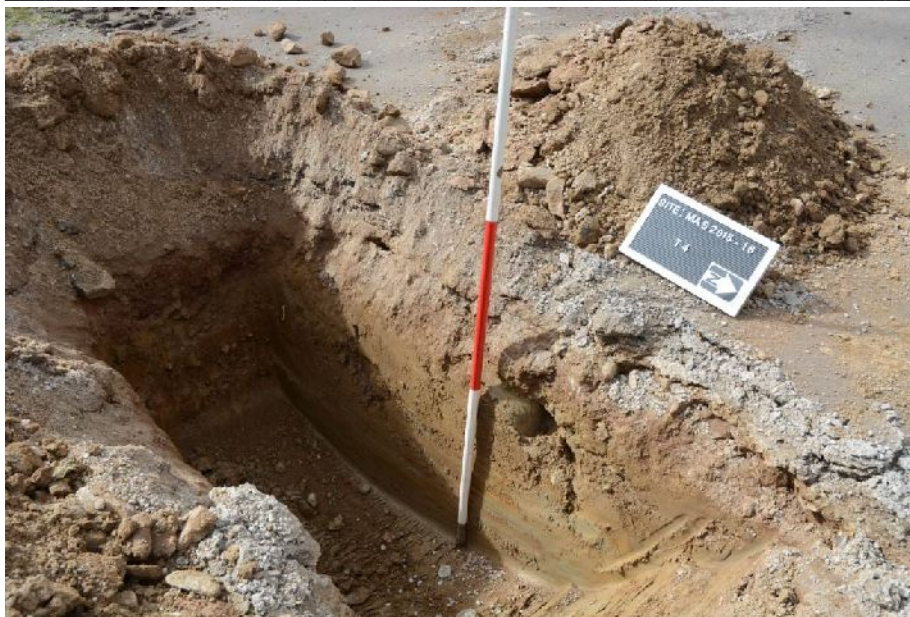
Illus 11 Detail of trench 4

As trenches 2-3. The present road surface comprised c. 300mm of small stone and granite dust which lay directly on soft, beige, sandy and slightly silty natural.

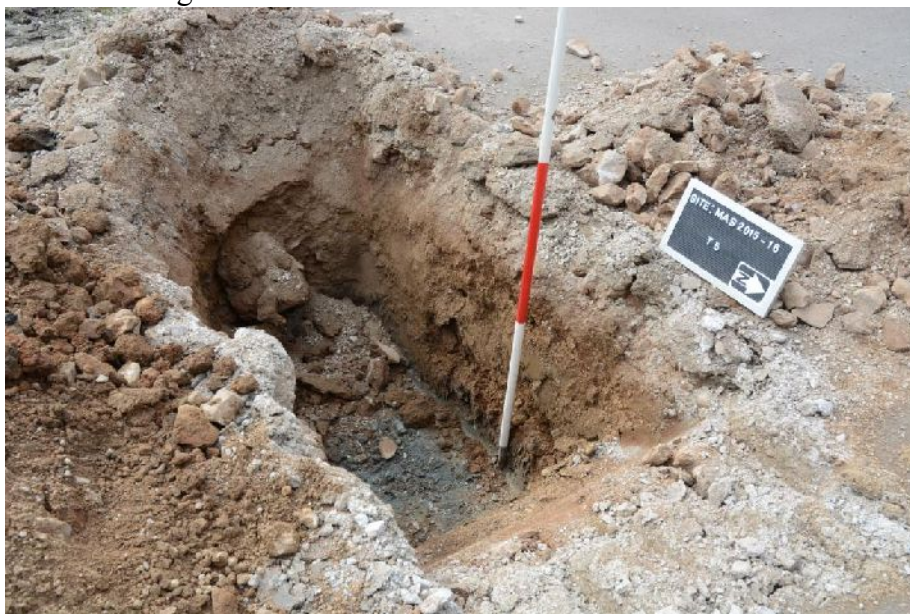
Illus 12 Detail of trench 5

As trenches 2-4. The present road surface comprised c. 300mm of small stones and granite dust which lay directly on soft, beige, sandy and slightly silty natural. Below the beige sandy natural there was a hard, grey, slightly silty natural.

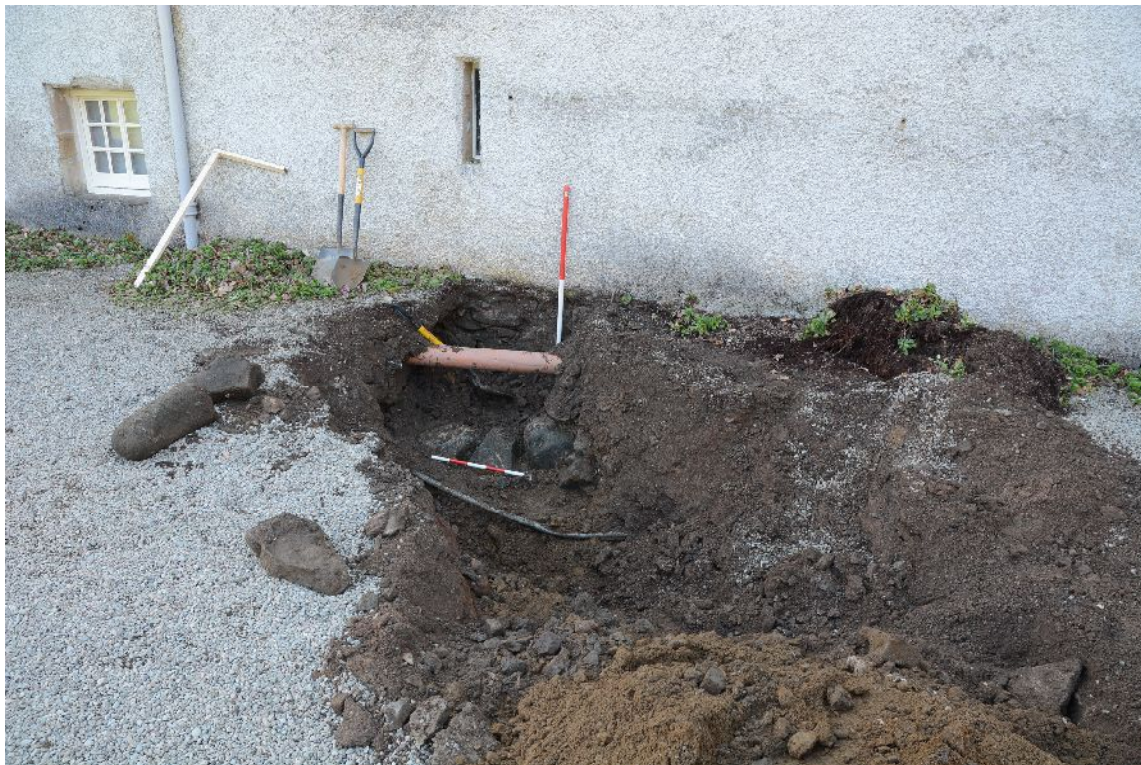
Illus 13 Excavated portion of trench dug in error. The main trench began at the downpipe to LHS.

The wrong line was taken at first (Illus 13; Illus 15. Blue dotted line); this line was de-turfed but not dug except beside the castle wall where drainage pipes and a lead pipe were revealed. Below the pipes at c. 354082,829802, three stones (200x300mm to 250x300mm) were exposed running E/W parallel to the wall of the building. They appeared to have some clay-bonding but did not appear convincing as a structure. They were undisturbed and this 'mistaken' part of the trench (c 1.5m W of the proper trench) was backfilled.

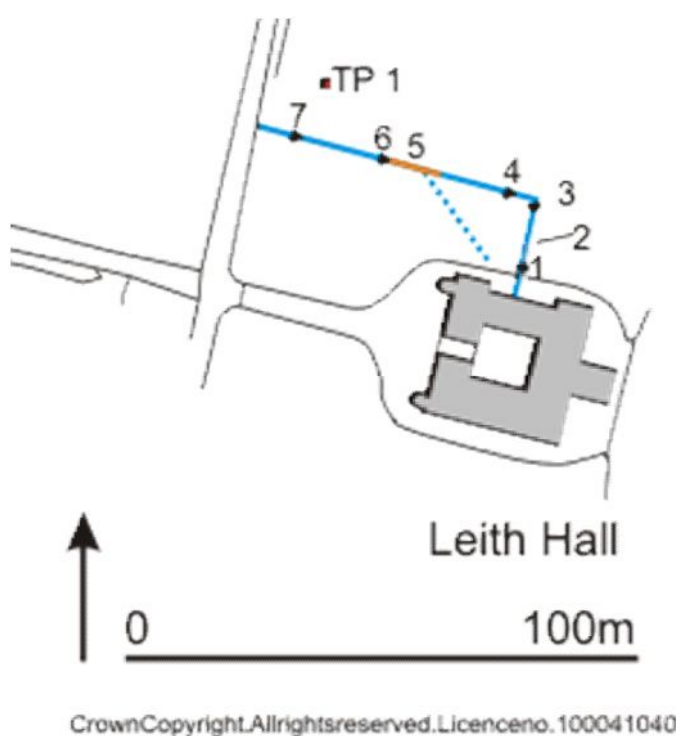
Illus 15 Detail of lawn area indicating water main trench (blue) and features. Dotted blue line indicates a line that was de-turfed (but not excavated) in error.

The Water Main trench was 1m wide and extended in an L-shape, extending c 19m NNE from the N wall of the Hall at 354083,829803 to 354086,829821, and then turning to run NNW for c 56m to the edge of the lawn at 354031,829835. It was dug to a depth of 1.10m.

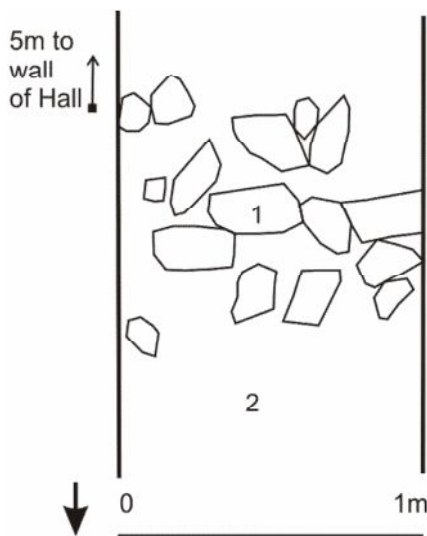
Illus 16 Plan of context 1

An E/W linear band of stones, c 800-850mm wide, extended across the trench c. 5m N of the wall of the Hall. Most of the stones lay 200-250mm below the grass with a few almost to the surface. It was sealed by c. 50mm pink/orange gritty sand and c 10mm hard black gritty below 180mm topsoil. Although well packed together there was no obvious bonding between the stones and they may be the remnant of a low dry-built feature such as an edging, rather than a wall of any height.

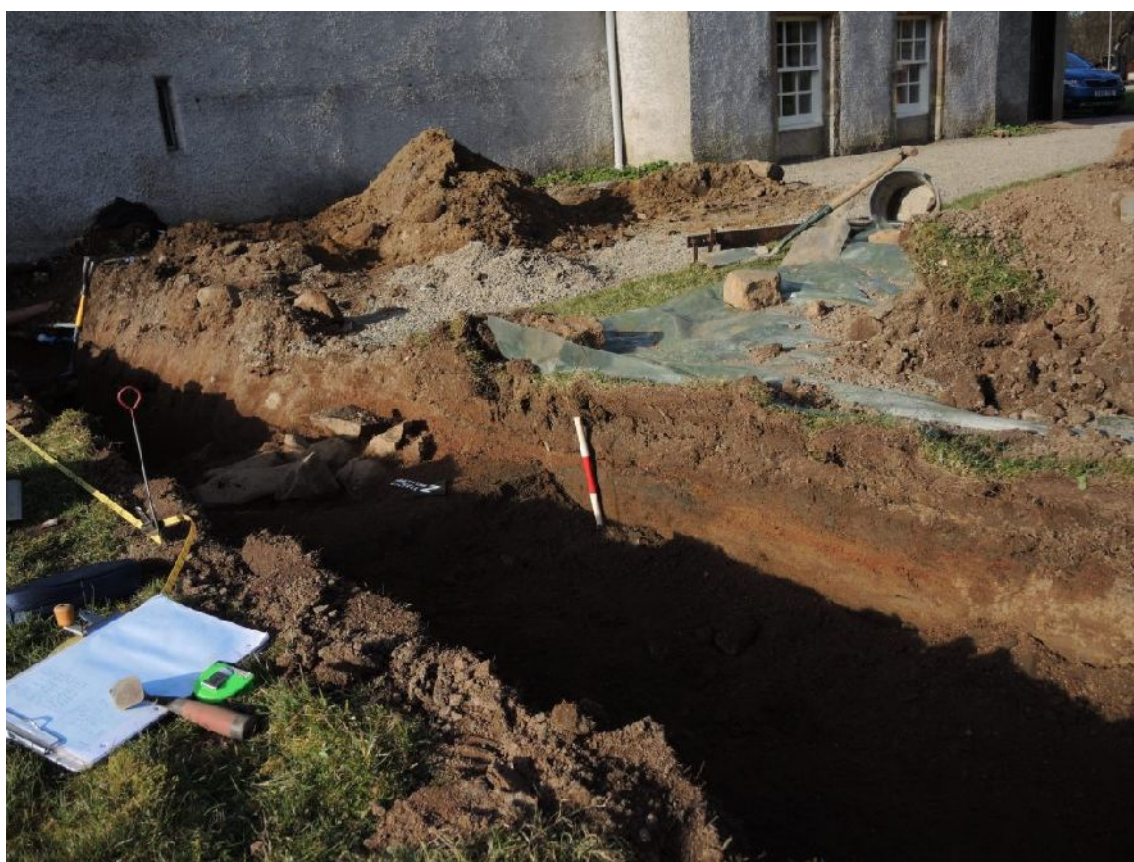
Illus 4 Surface 2 in section in relation to Hall and to wall/border context 1

A very hard, compact, gritty surface extended from c 3m from wall of Hall N to c 11m from the wall of Hall. In most places it appeared to be pinkish in colour but in some areas it was grey; this may indicate areas of patching of a surface.

Context 2 was clearly a hard surface and can be identified with some confidence as the wide pathway around the building. This is first shown on the 1797 plan (Illus 23), although on this plan there is also a path running NW to the stable, which was probably never implemented as the N/S path to the stable still exists. More clearly, the 1858 Estate map and the 1866 and 1899 OS maps (Illus 24-26) show a wide area of hard surface/path encircling the Hall, with what may have been garden beds or grass between this surface and the wall of the Hall on the N and S sides.

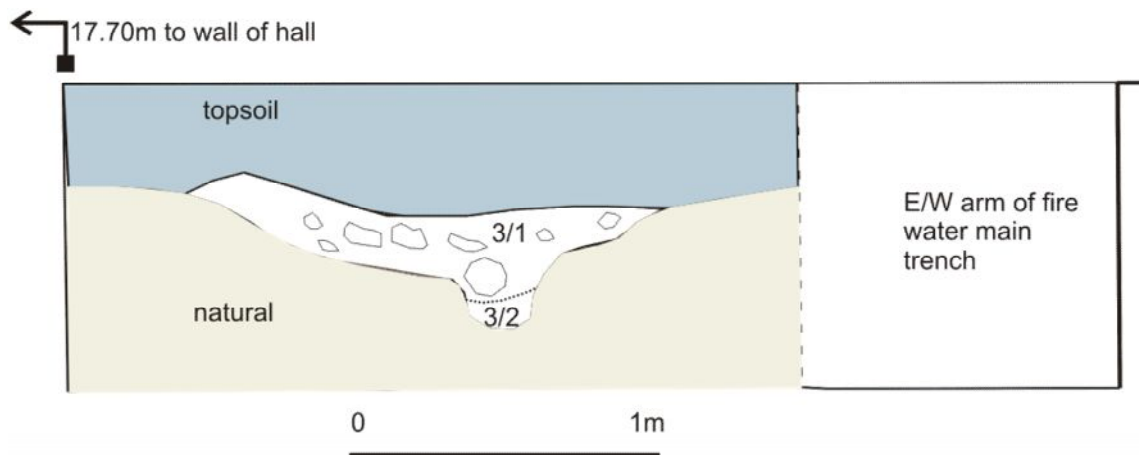
Illus 19 W section of fire main trench from c 17.7m N of wall of Hall, showing section through pit/trench context 3.

The fire main trench cut across a pit or trench, context 3, between 18.1m and 19.6m N of N wall of Hall, and extending at least the width of the trench (1m). In the E section it was 1.5m wide at the top with a shallow bowl-shaped profile cut c. 300mm deep into the natural yellow sand with a grey silt/sand fill with frequent unstructured stones (3/1). The base of the cut had a hard layer of iron pan over the natural suggesting that water had lain in the cut at some stage. It was sealed by 350-400mm of topsoil. The W section

(Illus 19, 20) was similar but with a further cut, 200-250mm wide and 200mm deep in the centre of the base (3/2); this seemed to be a limited feature as it disappeared when the section was cleaned back- possibly a root/planting hole or possibly a rodent hole.

Feature 3, some 18m N of the wall of the Hall, does not appear to coincide with any hard features shown on any of the maps from 1797 onwards. It may have been a relatively small pit made by the removal of a shrub but it may also have been a section across a shallow trench running E/W parallel with the N wall of the Hall. This could be proved or disproved at some point in the future by section across the same line further to the W. If this had been a trench then it is possible that it marked the central division of the gardens shown on the 1758 Estate plan (Illus 28). It could have been a bedding trench for a hedge.

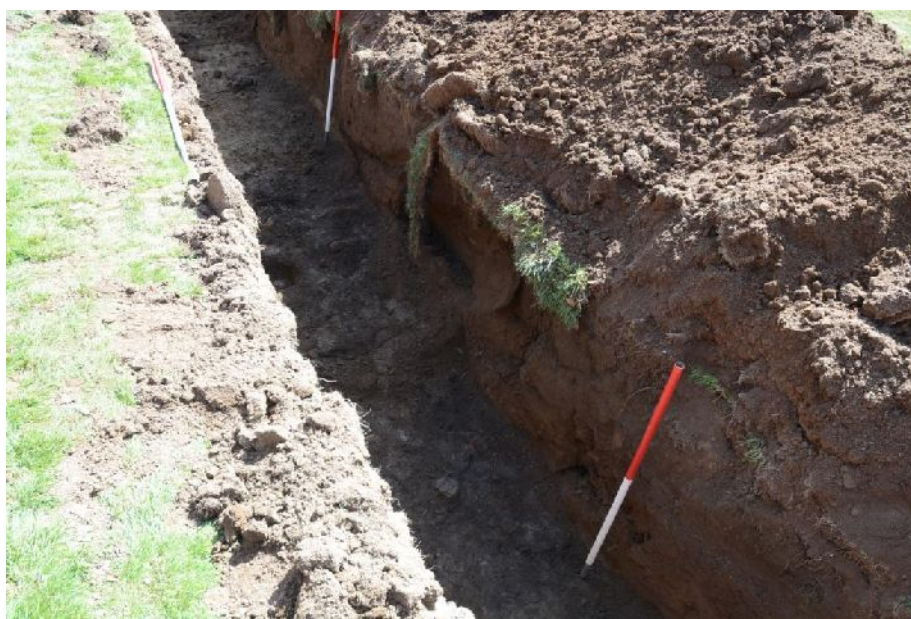
Illus 5 Gully context 5

From GPS: 354056,829829 to 354068, 829826. Appears to be a natural gully c. 11.5m long (E/W) and extending N and S beyond the trench. The natural clean sand which is c. 300mm below surface on either side of the gully appears to slope down gently into it;

there is no obvious appearance of a cut. In the centre the gully base is 0.80-1.0m below the present surface. The lower fill is of dark grey silt with some small random stones at the base. The higher fill, possibly imported leveling material, includes redeposited natural below the topsoil. This corresponds to the N edge of a magnetic anomaly indicated by the gradiometer survey (Illus 22: C) which is marked on the map as 'buried foundation' (GSB, 2003, 2 and fig 3.). It is possible a natural hollow was leveled.

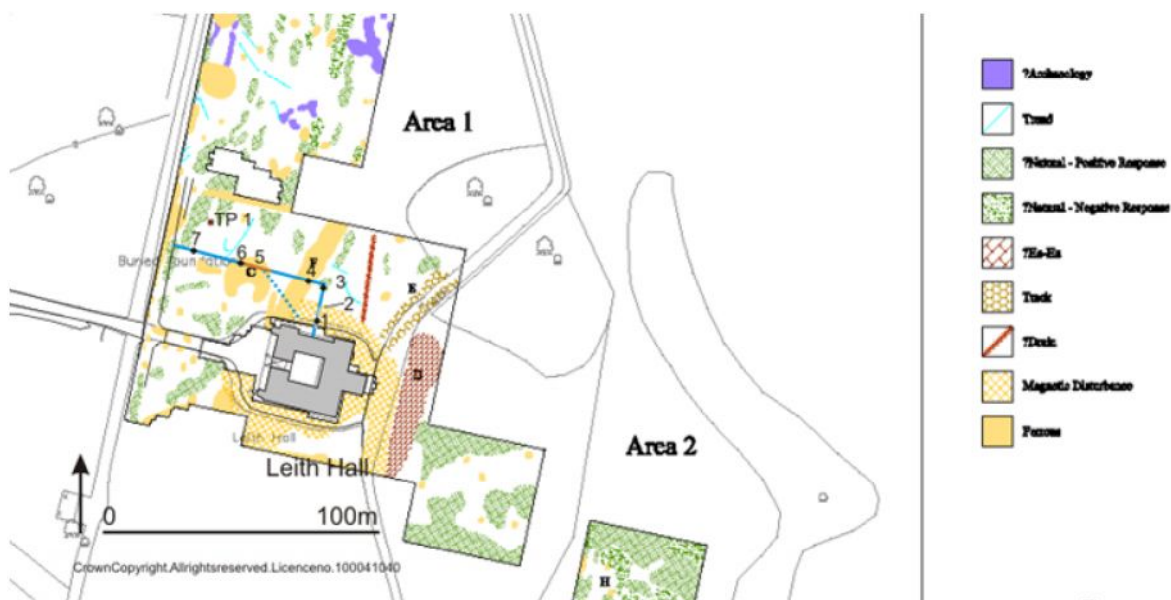
Illus 22 2013 plan overlaid on 2003 gradiometer survey (GPS 2003 fig 3).

This corresponds to a wide band of magnetic response around the Hall indicated by the gradiometer survey (Illus 22) (GSB, 2003 and fig 3.).

GPS: 354081,829822. Cast iron water pipe NNE/SSW at 600mm below surface. This pipe runs to NW corner of the Hall (Murray 2003, 5). It corresponds to a magnetic anomaly indicated by the gradiometer survey (Illus 22: F) (GSB, 2003, 2 and fig 3).
