Cloister 1 Sections 49 & 51

Glastonbury 1957

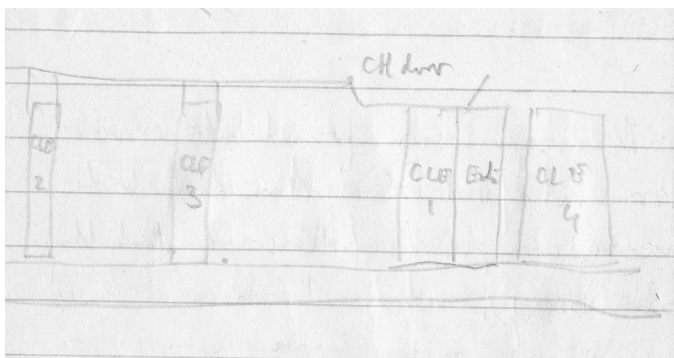
Sketch of cloister trenches.

CLE 3 – trench badly disturbed and no foundations visible. On south side modern trench following E wall extends 1'6" into trench.

Lias foundations of cloister wall [C:4088] and buttresses [C:4087] visible.

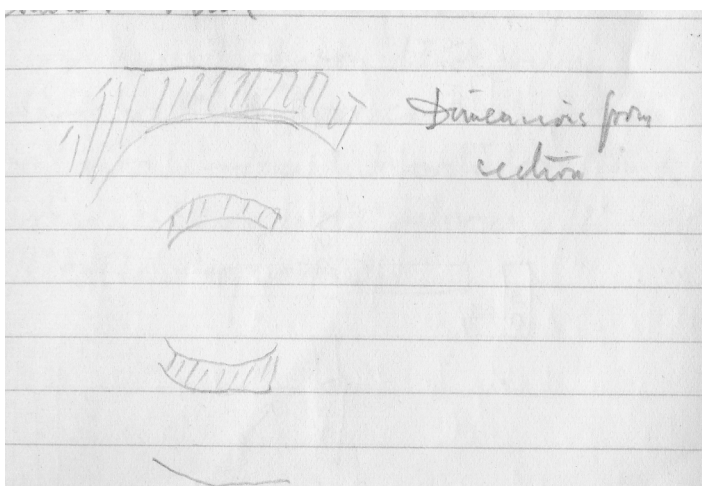
Much tumbled remains of 12th century refectory wall [C:5621] cloister paving [C:5620] and cloister wall [C:5622] at S End. Cloister walk 6' wide and some slabs [C:5620] undisturbed in-situ. This is cut into clay [C:5611] stained and disturbed to a great depth. Beyond this partially explored remains of lavatory [C:5618] [C:5619] much disturbed. Apparently polygonal outside and with circular wall (see sketch).

Sketch of polygonal lavatory in CLS 2.

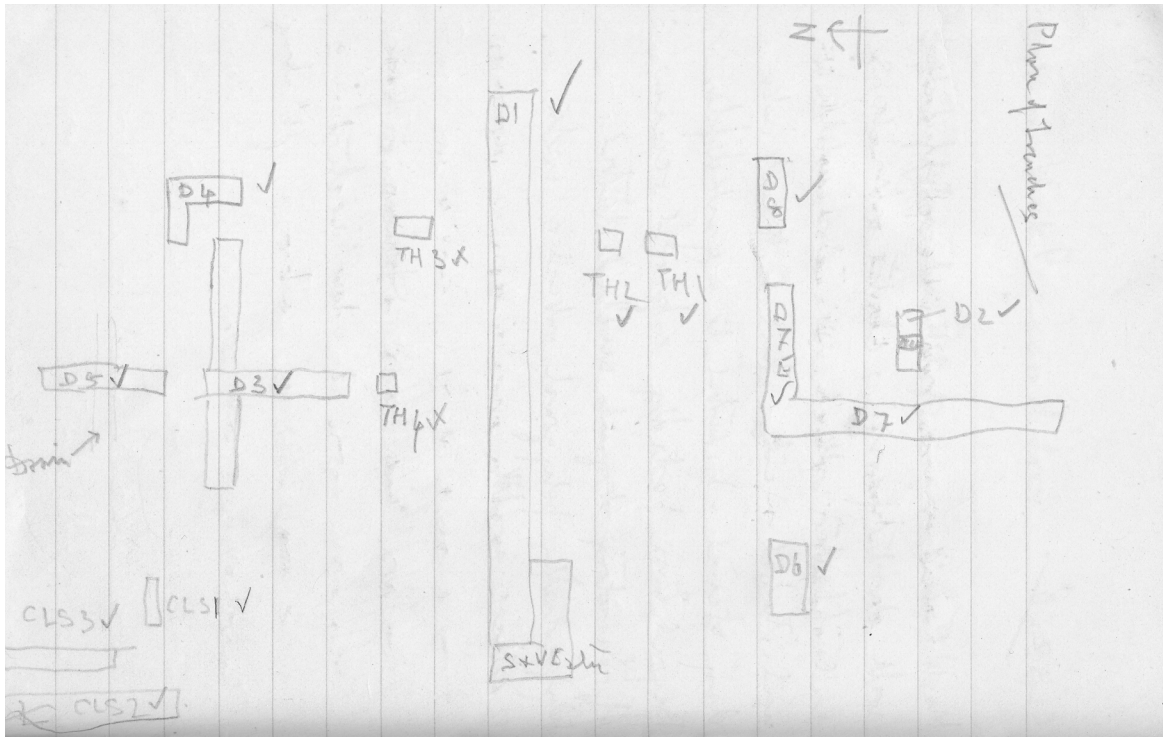
Sketch of trench plan showing D1-D8, TH1-4, CLS1-3 and S & W Extn.

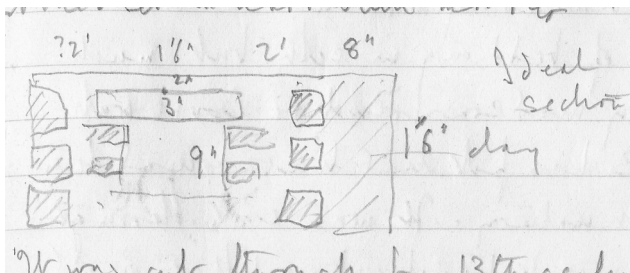
It had sunk badly over clay [C:5006] but lined up with top of substantial stone built water channel [C:5018] running obliquely across main trench. This was of irregular stones set in hard white mortar. (Sketch of 'ideal section')

Sketch of drain section in D7.

It was cut through by 13th century south wall of range [C:5020]. Piece of 12th century wall [C:5021] with characteristic yellow mortar as D1 found outside. It represented inner face cut through longitudinally by 13th century reredorter. Whole of area (except drain) covered by 6" burnt debris [C:5016] levelled by a 0.5" band of clay [C:5015] above which was 13th century bedding [C:5001]. This was to fill sag. Inter-beddings gone.

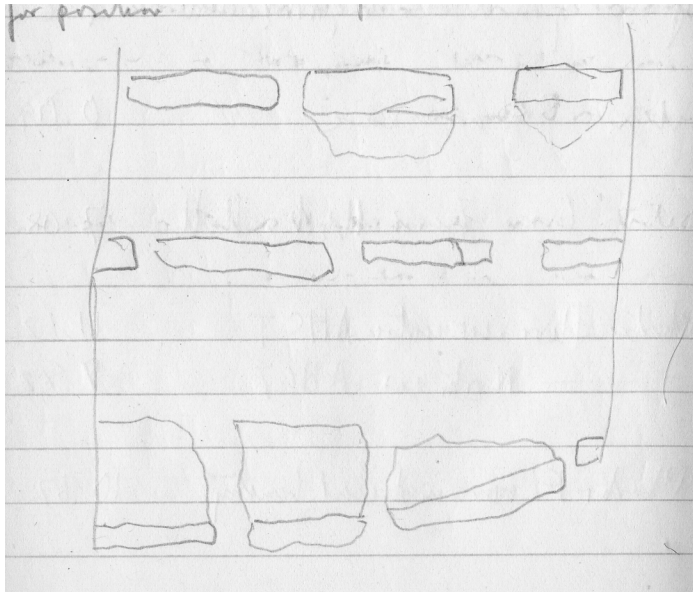
Cists c. 25' from Chapel (see section for position).

Sketch section in trench south of Lady Chapel. Plan of cists in trench c. 7.62m S of Lady Chapel. North arrow at top of drawing.

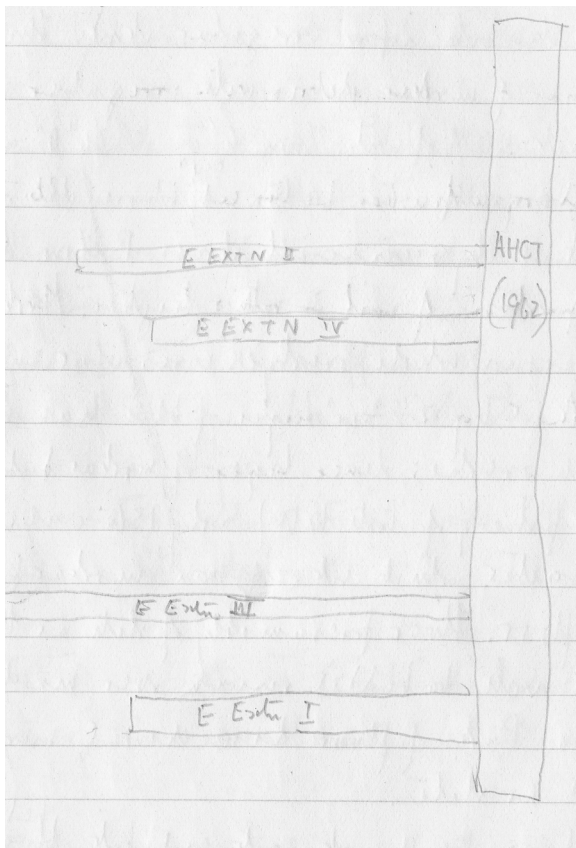
Datum AHCT (1962) E Extension ii (2) 9.51

Sketch showing plan of Abbot's Hall Cross Trench (1962) and four eastern extensions.
