# Newport Medieval Ship Project

## Specialist Report:

# LEATHER

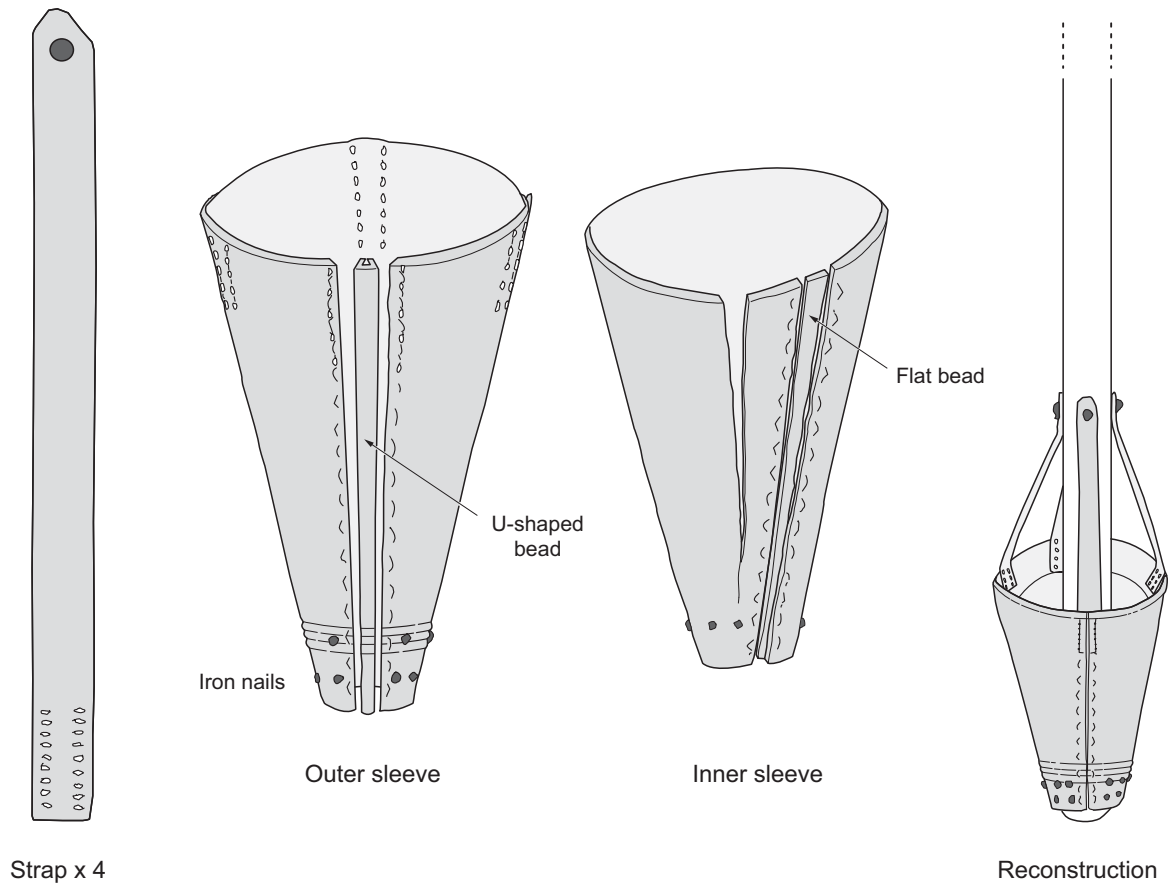
MSG 879

Figure Leather 1: schematic diagram of construction of burr valve  
MSG879 from the Newport ship

A complete upper valve of leather (**1 MSG879\* photo**) still attached to the wooden spear (pump rod) of common ash wood (*Fraxinus excelsior* L.), the central rod-like handle by which the valve was moved up and down, was found in just aft of Frame 15\_2 above plank S12\_3 in context 130: unfortunately it was not closely associated with any of the lower valve (foot valve) parts recovered though a valve claque, from a lower valve (**5 MSG012\***) was recovered from the same context (130) between F33-38 on the starboard side. This complete upper valve (**1 MSG879\***) is an important find confirming that the burr pump mechanism was in use in the fifteenth century as suspected by Oertling (1996:16) and being potentially a hundred years earlier than other examples known to date. While the mechanism of the burr pump and the components have been fully described elsewhere (Oertling 1996: 16-21 and figure 3) in view of the importance of the find the complete burr valve is

mouth (top) of the outer sleeve, the stitches sunk into a stitching channel on the grain side of the sleeve only. Four straps, now torn into several joining parts, have a straight ends with clipped corners producing slightly rounded ends. Each has an iron nail c. 25mm from one end to attach to the wooden spear and a double row of grain/flesh stitching with thread impression on the flesh side only at the other by which they were attached to the inner face of the mouth of the outer sleeve. Outer sleeve length 210mm, max width at the mouth 210mm, min width around the spear 35mm. Leather worn cattle hide. In addition, two small rectangular pieces of strap 35x30x5.35mm; 17x27x4.42mm) with cut ends and two rows of grain/flesh stitching. Their width does not match the four straps from this valve nor do the four straps have any impressions or other indication that they were originally sewn to them suggesting that they come from another valve. Leather cattle hide 4.86mm thick, inner sleeve cattle hide delaminating, straps cattle hide 4.29-5.57mm thick. **MSG879 SF116 (130)** [seen wet]

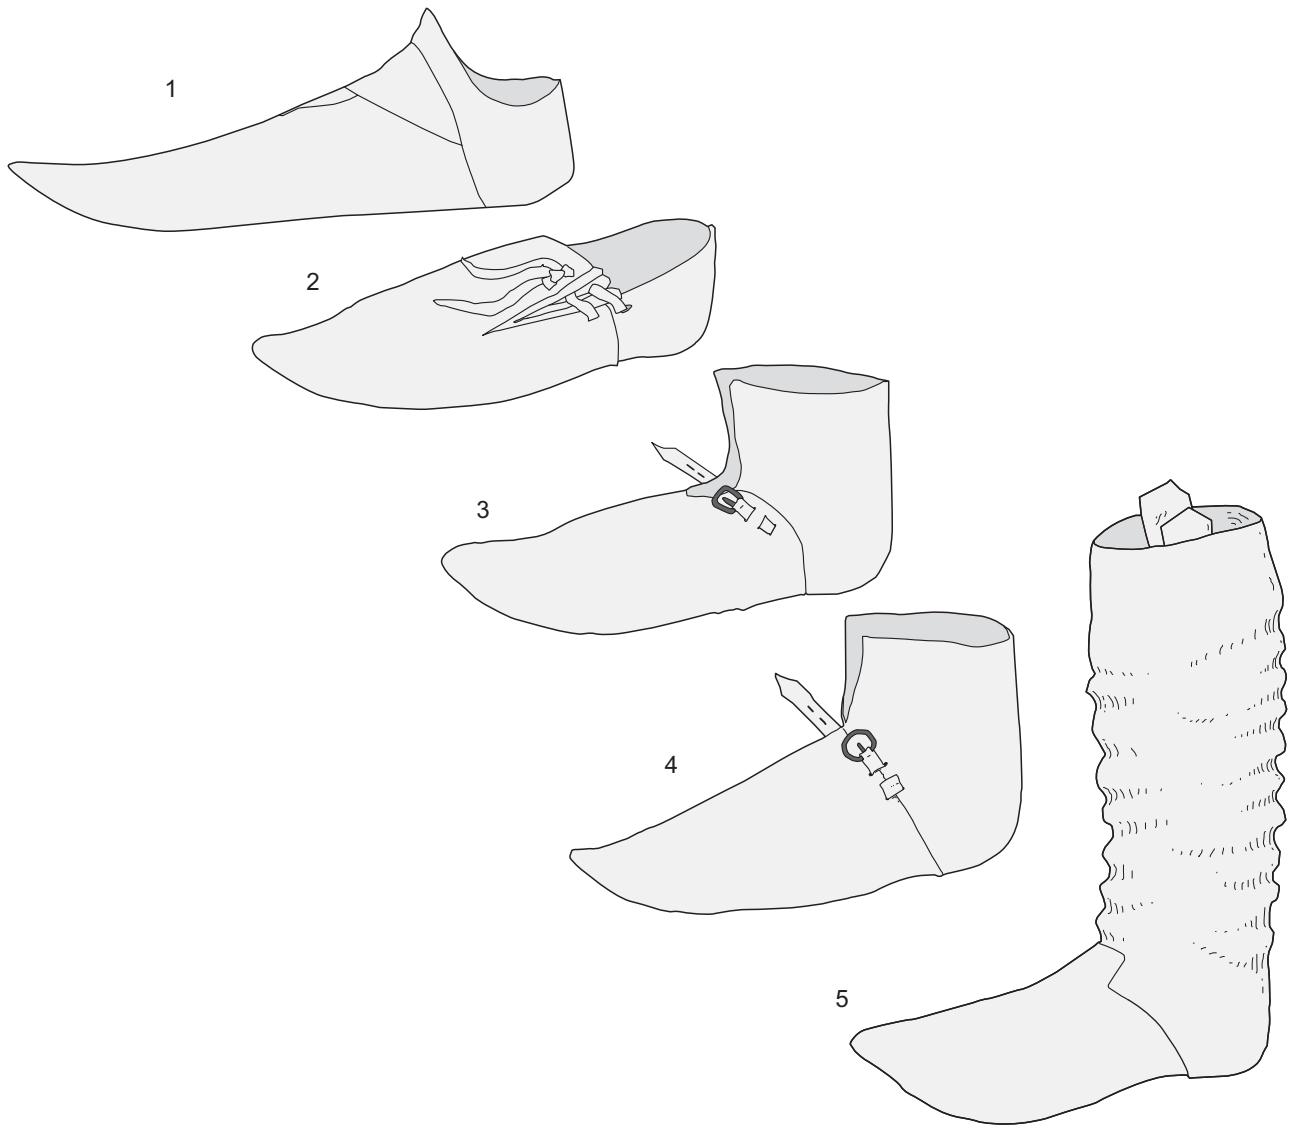
Figure Leather 2: Footwear styles present on the Newport ship  
(no. 4 after Goubitz 2001: 181 figure 20), no. 5 after Mould  
forthcoming).

Figure Leather 2: Footwear styles present on the Newport ship (no. 4 after Goubitz 2001: 181 figure 20), no. 5 after Mould forthcoming).

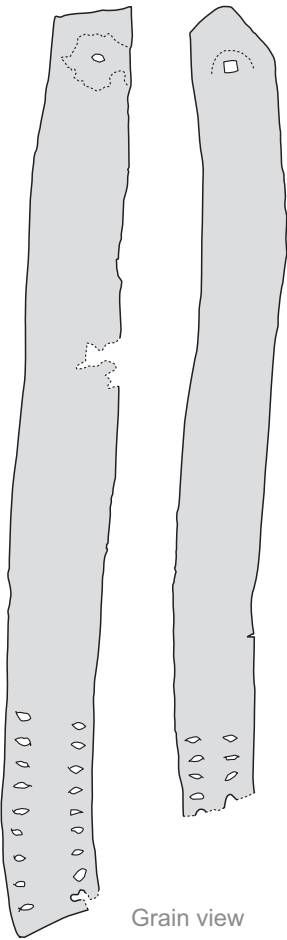
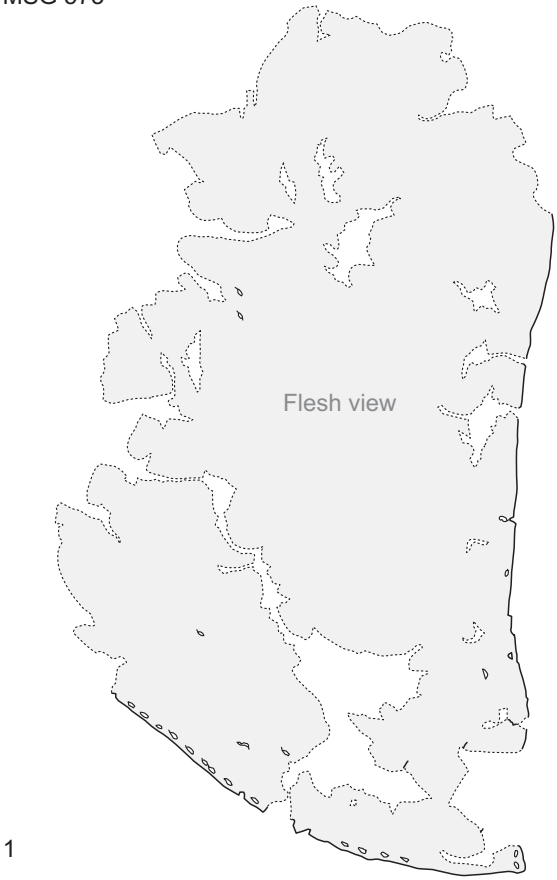
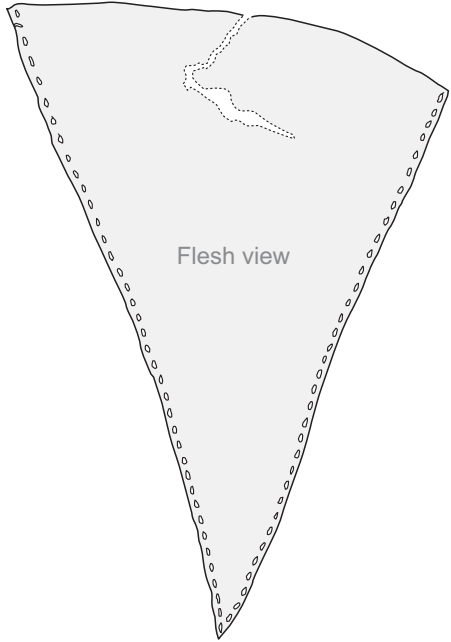
Leather Catalogue 2  
MSG 1287

Flesh view

Grain view

The remains of a second burr valve (**2 MSG1287\***) were found within pump 1682 and associated with pump base 3114, located at frame station 58. The fragmentary burr valve comprised pieces of nailed panel that had been broken from the outer sleeve, pieces broken from the outer or inner sleeve, along with a flat bead from within the seam and broken straps of characteristic type nailed at one end and stitched at the other. The straps had the impression made by wound thick thread or cord at their nailed ends indicating that the nailing attaching them to the central wooden spear had been further strengthened by tightly wrapping cord around it; a feature noted on later examples (Oertling 1996:17 figure 3). Though highly fragmentary this burr valve appears to have differed slightly from the complete example (**1 MSG879\***) described previously. The sleeves and straps were

Broken panel fragment (150x115x0.91mm) with three nail holes with impressions of round heads 12mm in diameter, spaced 25-30mm (1-1 ¼ inch) apart and a torn, vertical seam. A fragment (92x70x1.90mm) with nail holes and a small length of a torn butted seam. A fragment (86x80x1.52mm) with the remains of a torn grain/flesh seam with saddle stitching, stitch length 7-8mm and a pair of grain/flesh stitch holes. A fragment (95x40x1.32mm) with a cut curved edge surviving. A U-shaped grain/flesh seam, stitch length 5-6mm, broken from the base of the inner sleeve? with a butted edge/flesh seam, stitch length 3mm surviving to each side for a height of c. 12mm (illustrated). Small fragments with broken seams or nail holes and other fragments with all edges torn (largest 116x56x1.81mm). Length of flat rand 8mm wide with grain/flesh stitching, stitch length 8-9mm, from within the vertical seam of the sleeve. Two near complete straps (illustrated) each with straight and pointed ends with nail hole at one end and two rows of grain/flesh stitching to attach to the sleeves at the other. A series of seven horizontal cord impressions run across the nailed ends c. 20mm from the terminal. Five other similar strap fragments and a narrower strap (35x14x2.22mm) broken at each end with four widely spaced grain/flesh stitches, stitch length 8-9mm along one end and cord impressions. Leather calfskin, some delaminated, the straps c. 2mm thick. **MSG1287 (120) pump 1682**

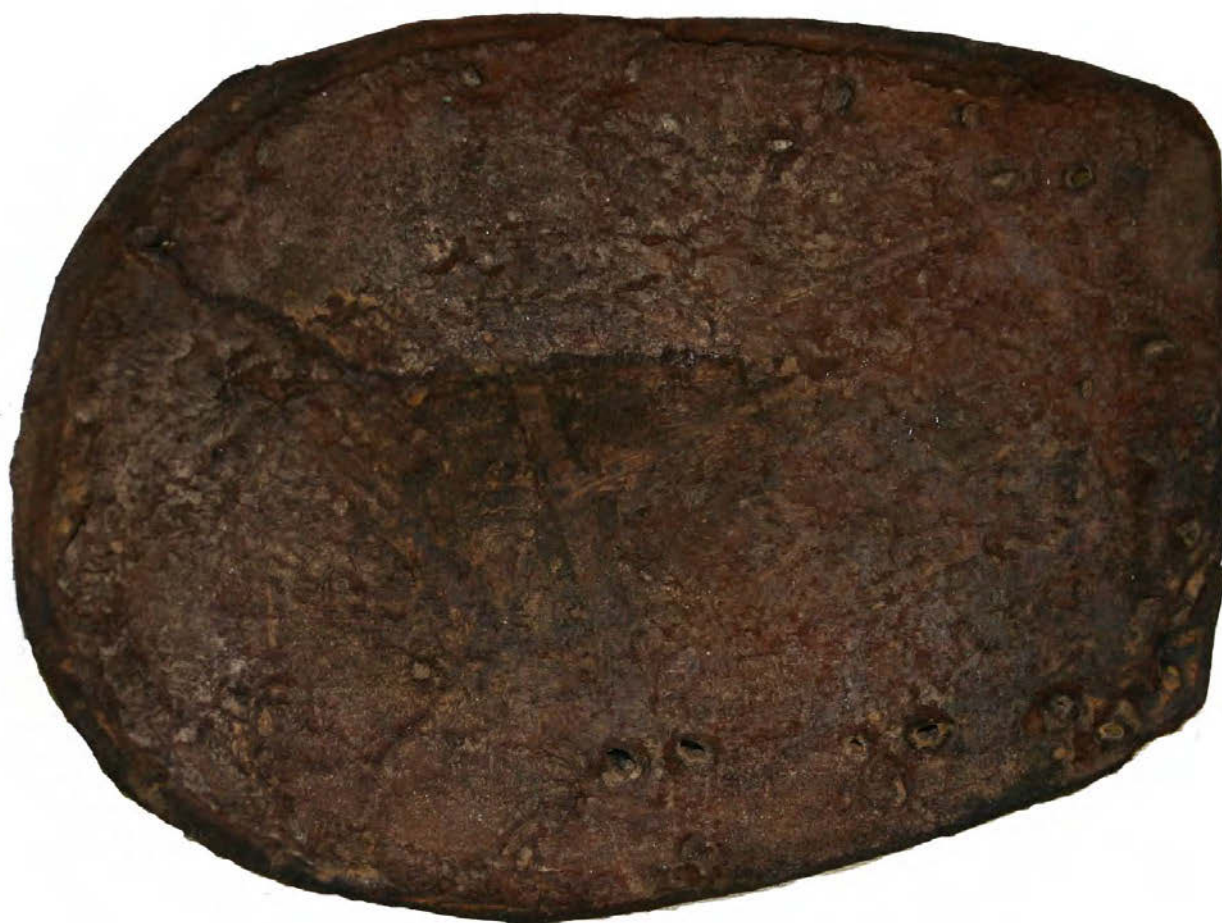
**MSG 114**

Function: Shoe heel repair - clump.

Dimensions: 105mm x 82mm x 5.2mm

Description: Adult size right foot, large seat repair. Stitch or nail holes around outer edge, unevenly spaced. One end, is rounded, the opposite end is straight. One large rip from the heel end is 65mm in length. 4 of the 5 sides are stitched. One eyelet is present, tear drop in shape. The stitching along the longest edge perforates through the leather. The rest of the stitching is only visible on the flesh side.

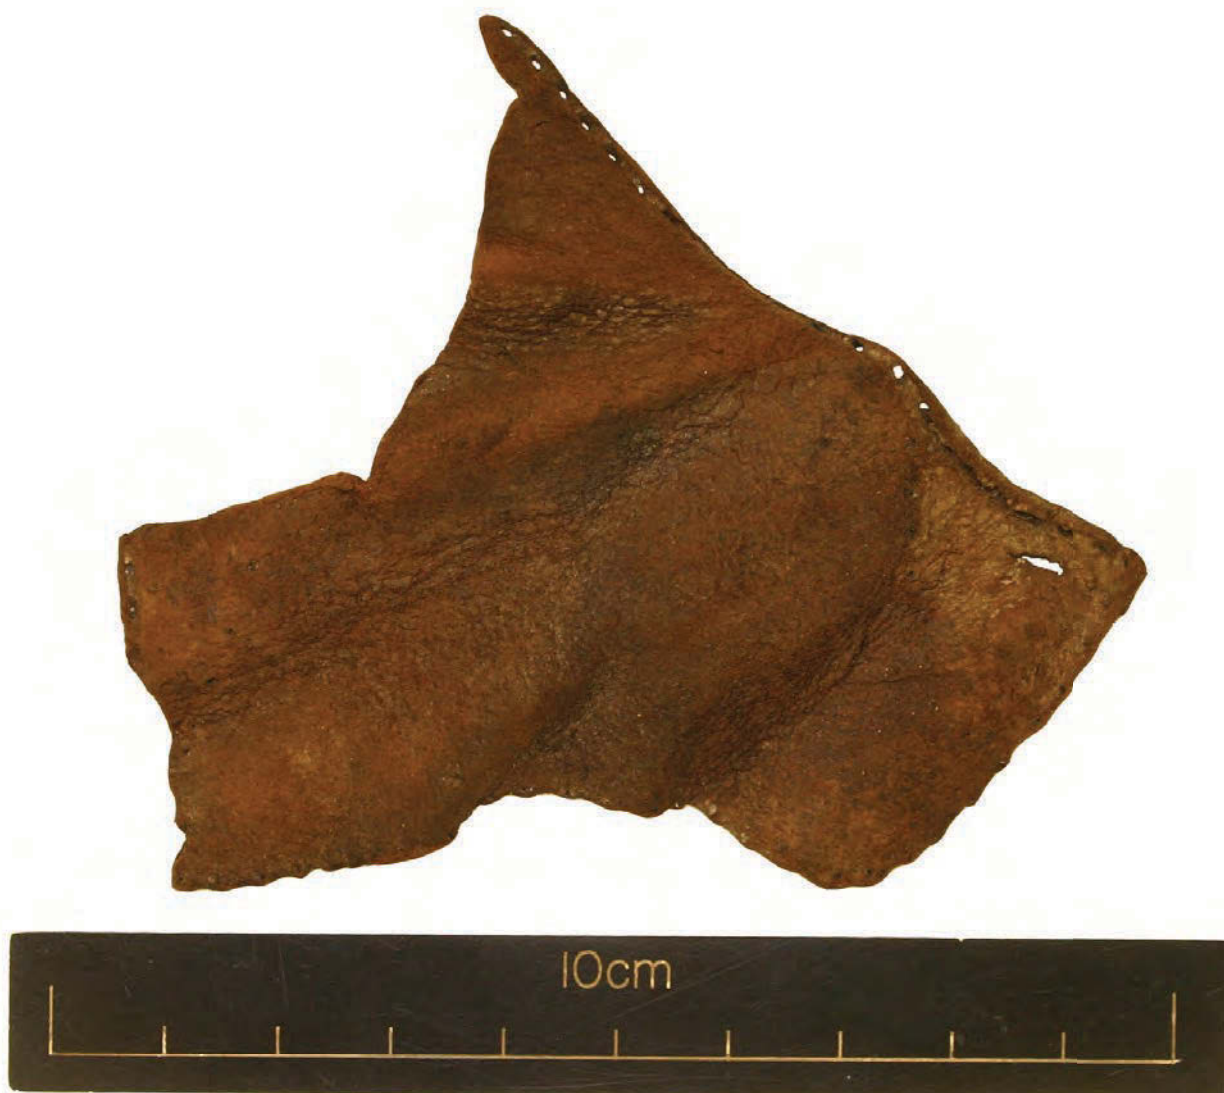
**MSG 115**

Dimensions: 89.4mmx81mmx2.2mm.

Description: 4 of the 5 edges are stitched. One eyelet is present, tear drop in shape. The stitching along the longest edge perforates through the leather. The rest of the stitching is only visible on the flesh side. Tear-drop shaped fastening hole at the junction of the front seam and leg opening.

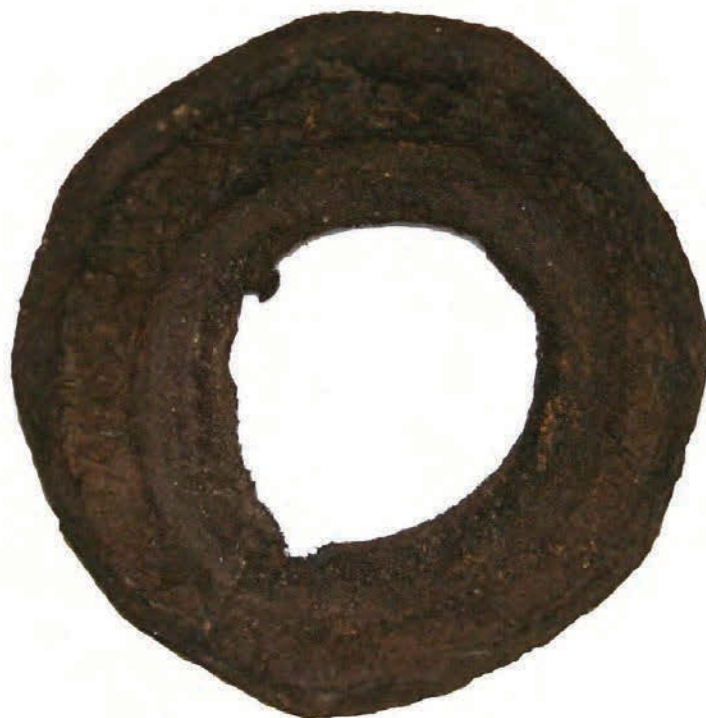
**MSG 131**

Dimensions: Outer diam is 53mm, inner diam is 24mm.  
3.1mm thick.

Description: Octagonal in plan with roughly circular hole through the centre with a circular compression mark which has a diameter of 26mm. Small amount of damage around inner hole-possibly original.

Four leather washers were found: three complete and one (MSG 143) broken. All were of cattle hide c. 5-5.5mm thick, one (MSG144) was heavily worn and now significantly thinner. One (**6 MSG131\***) was found on the starboard side of the inter-frame space F30-31 in the basal dark brown/black organic layer (context 152) thought to contain residues accumulated in the bilges or washed in shortly after the ship was sunk. As such one might infer that the washer came from a bilge pump but a second item (MSG147, see Table Leather 5 below) found in the same context, however, clearly was unrelated to pumping equipment. This washer (**6 MSG131\***) differs from the rest in being distinctly dished with a clear circular impression c 38mm in diameter around the central hole producing a stepped inner profile suggesting it was originally seated within a cylinder possibly a lower valve. The other washers were flat. Three sizes were apparent a smaller at 44mm, medium at 54mm and a larger at 80mm. The largest example (MSG568) had been cut from leather salvaged from another item as unrelated stitch holes and slits were present. All four washers had been cut 'freehand', none had been cut from a compass drawn template suggesting that they may have been replacement parts made by the crew as and when needed.

Circular washer with an irregular central hole, 27mm in diameter, and a dished profile. The central area has a clear circular impression, 38mm in diameter, around the hole on the flesh side producing a stepped inner profile. The outer face, the grain surface, is curved, smooth and heavily worn. Leather cattle hide 5mm thick. Diameter 54mm, estimated height of curve c. 10mm. **MSG131 (152)**

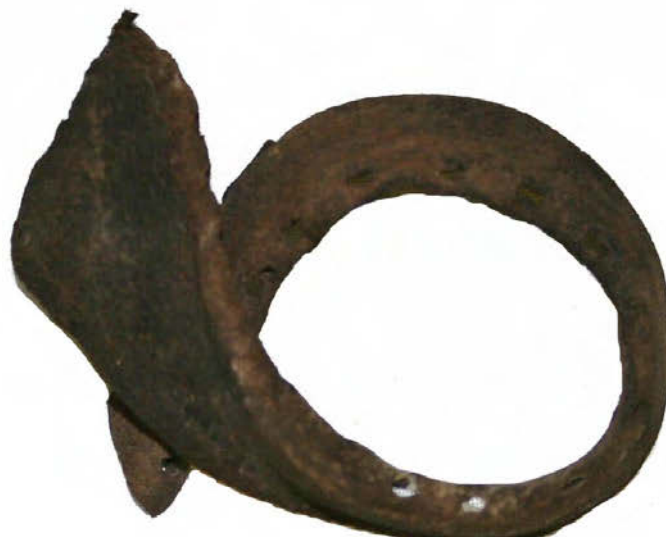
**MSG 132**

Dimensions: 160mm x 11.4mm x 1.8mm.

Description: Large stitch holes along one edge, evenly spaced 5.2mm apart. Heel stiffener of adult size cut away c. 13mm above the lasting margin when removing the shoe upper from the sole.

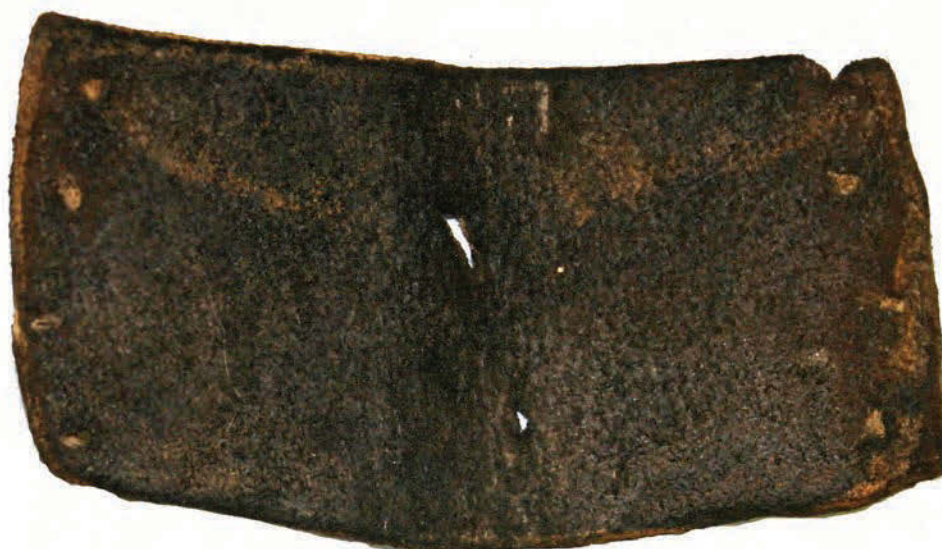
**MSG 133**

Dimensions: 70.7mm x 37.3mm x 2.2mm

Description: Rectangular in plan with stitch holes along both parallel short edges. Larger puncture holes in the centre. Worn.

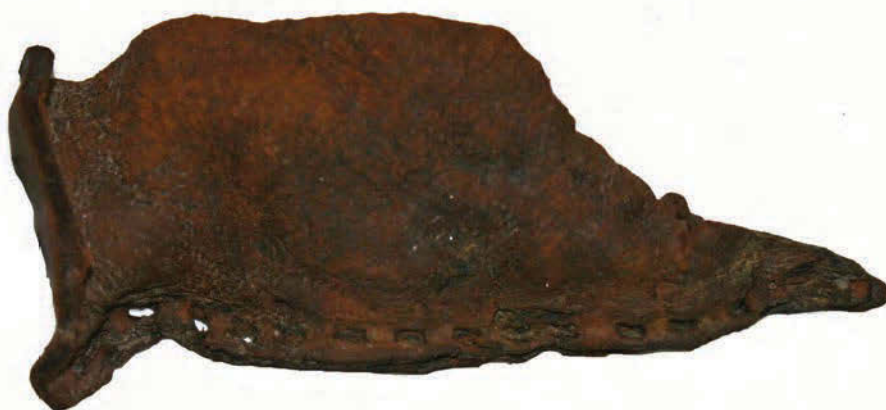
Description: 4 fragments . Two of the edges are doubled over and stitched. The other three are strips with stitch holes. One is 'V' shaped in plan with double rows of stitching and 2mm thick. Turn-welted sole, rand, upper lasting margin fragments. Left foot.

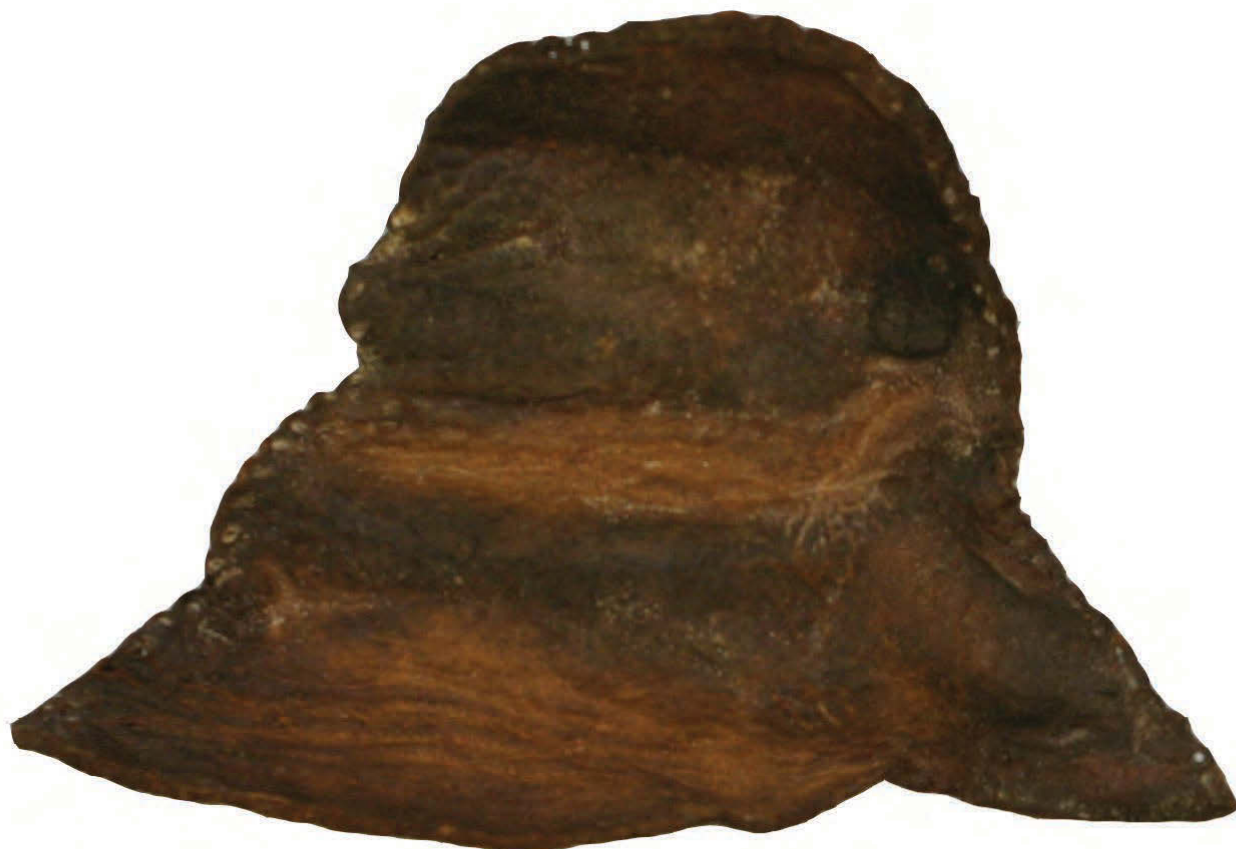
**MSG 135**

Description: Two original edges, both with stitch holes. A grain/flesh closed seam. Some cracking on grain surface. Potentially from clothing.

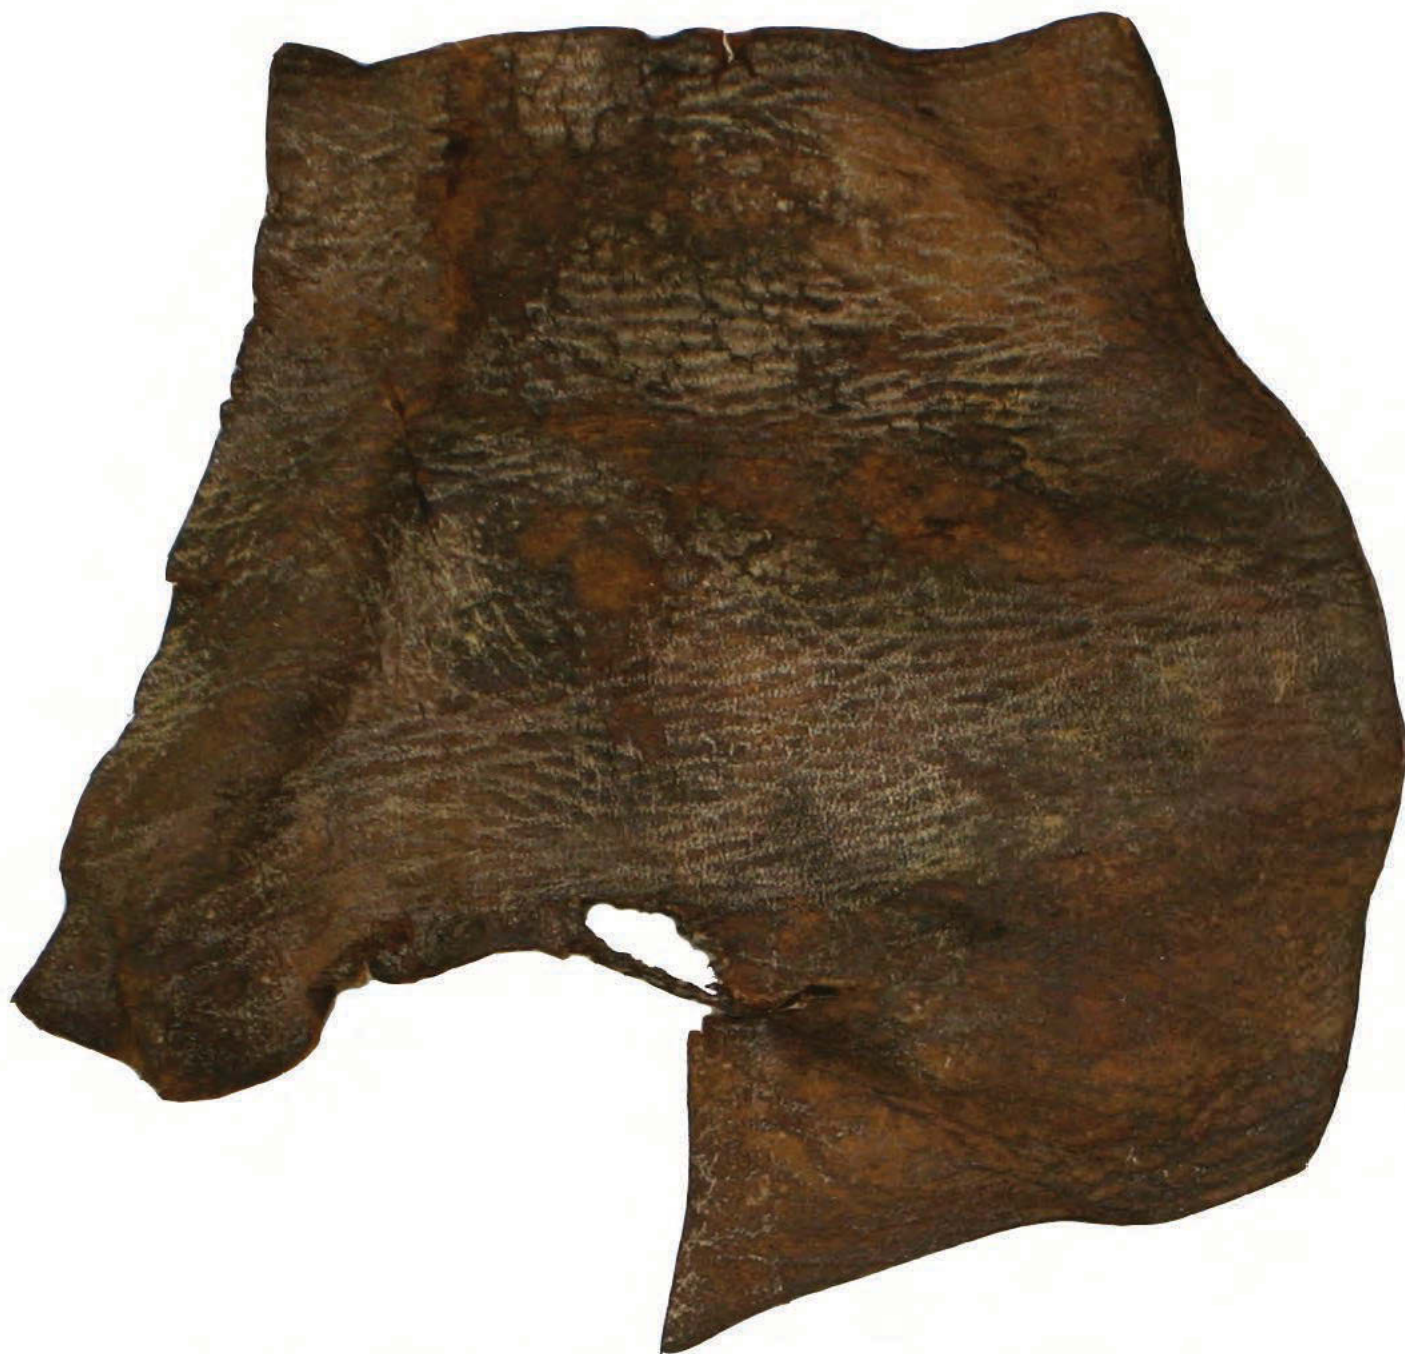
**MSG 137**

Description: Worn. Roughly rectangular in plan. Evidence of stitching along both long edges. Bind stitching was used only in one corner - suggested by the small area of scalloped edge. Right of two part quarters worn away along the lower edge so that the lasting margin is missing.

Context	MSG No	SF No	Material	Name	Type	Part	Description
130	MSG137	0	Leather	Shoe	Ankleboot	Quarters	right of two part quarters worn away along the lower edge so that the lasting margin is missing. Butted edge/flesh back seam, stitch length 3mm, and front seam. The upper part of the back seam has been cut away. The top edge is gently convex curving with a cropped front corner, this may be original
130	MSG139	0	Leather	Waste	Secondary	Trimming	narrow trimming with skived (bevelled) edge
130	MSG139	0	Leather	Waste	Secondary	Trimming	narrow trimming with skived (bevelled) edge
130	MSG142	0	Leather	Shoe	Sole	welted sole	waist and seat area of welted sole, probably worn on the right foot, adult size. Broken away at the lower tread and edge of the seat. Sole has a waist (50mm) and seat of medium width. Grain/flesh seam stitch length 5-7mm. Worn stitching at the lower tread from a repair
130	MSG146	0	Leather	Waste	Secondary		elongated triangular shaped piece

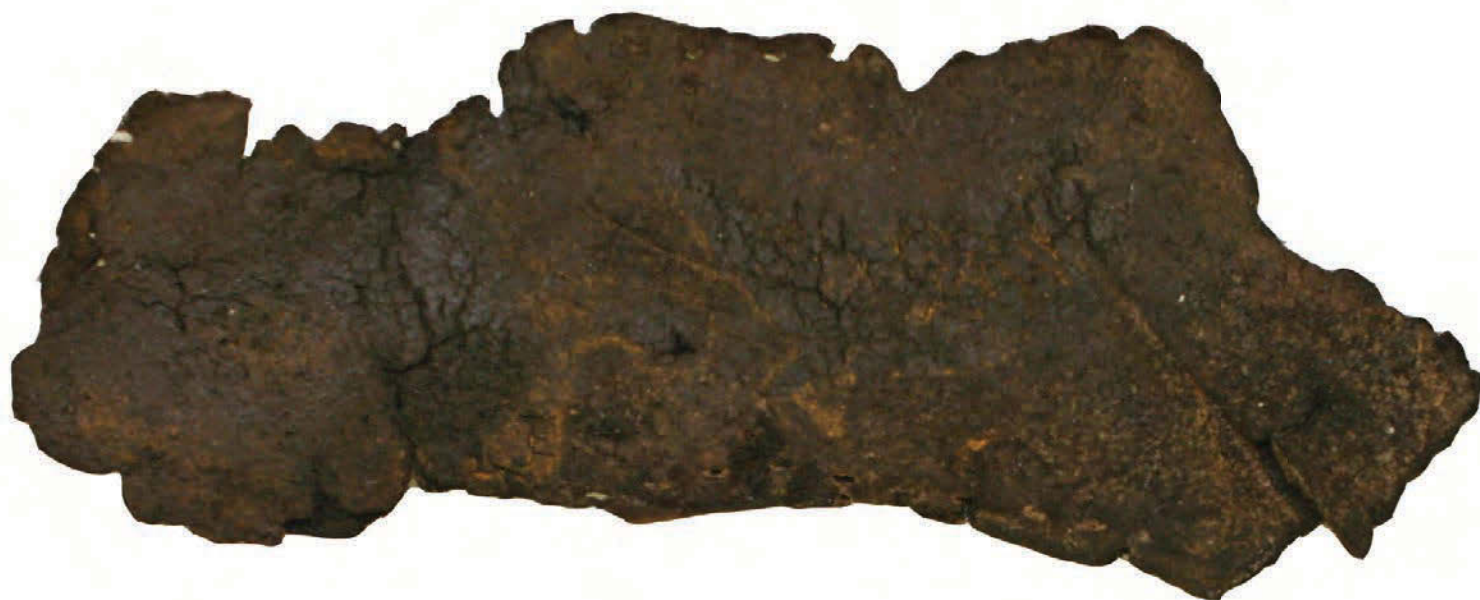
**MSG 141**

Description: Stitching along one side. Stitch holes are 1mm in diameter and uniformly 2.4mm apart. Second set of stitching, visible only on the flesh side, are of varying distance apart. Possibly part of MSG115.

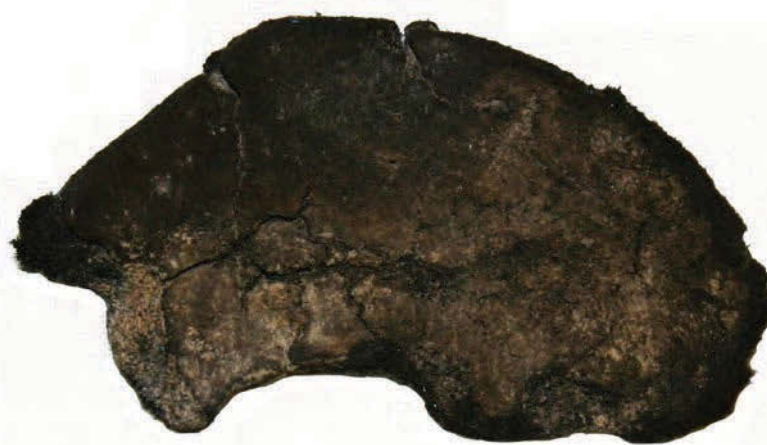
**MSG 142**

Description: Waist and seat area of welted sole. Varies in thickness. Stitch holes visible along the long edges. Probably right foot. Adult size. Worn stitching at the lower tread from a repair.

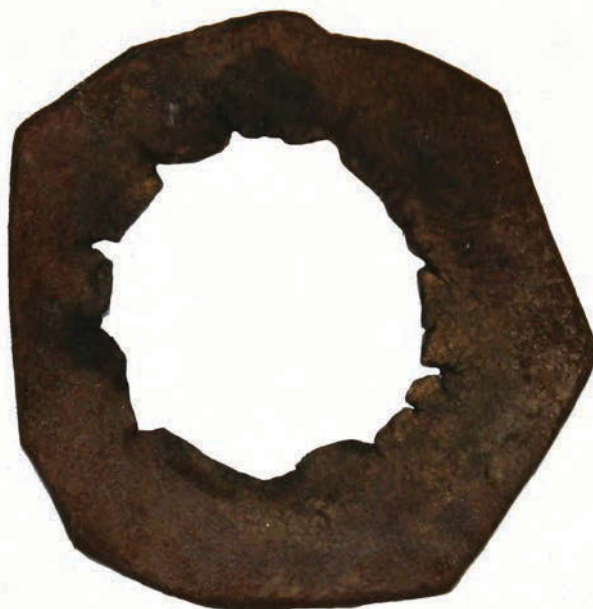
Description: Broken washer: crescent-shaped piece with a hand cut, curved outer edge and a less clearly cut inner edge, other ends broken.

149	MSG143		Leather	Washer			Broken washer: crescent-shaped piece with a hand cut, curved outer edge and a less clearly cut inner edge, other ends broken
152	MSG131		Leather	Washer			circular washer with central hole, diam 27mm, and dished outer profile. Centre of flesh side has circular impression around the hole and a stepped inner profile
152	MSG147		Leather	Shoe	Upper	heel stiffener	fragmentary remains (8+ pieces) of heel stiffener, lasting margin broken off. Adult size
172	MSG155	SF185	Leather	Shoe	High-throated slip on shoe	Turnshoe sole, rand, vamp, vamp throat extension forming wrap around one-piece quarters, heel stiffener	complete shoe for left foot, adult size with long pointed toe with c 80mm extension and narrow waist 36mm wide. High-throated vamp with extension at the instep wrapping around to form a one-piece quarters with a butted back seam. Secondary vertical slashes at the ankle on each side, that also cuts through one side of the heel stiffener

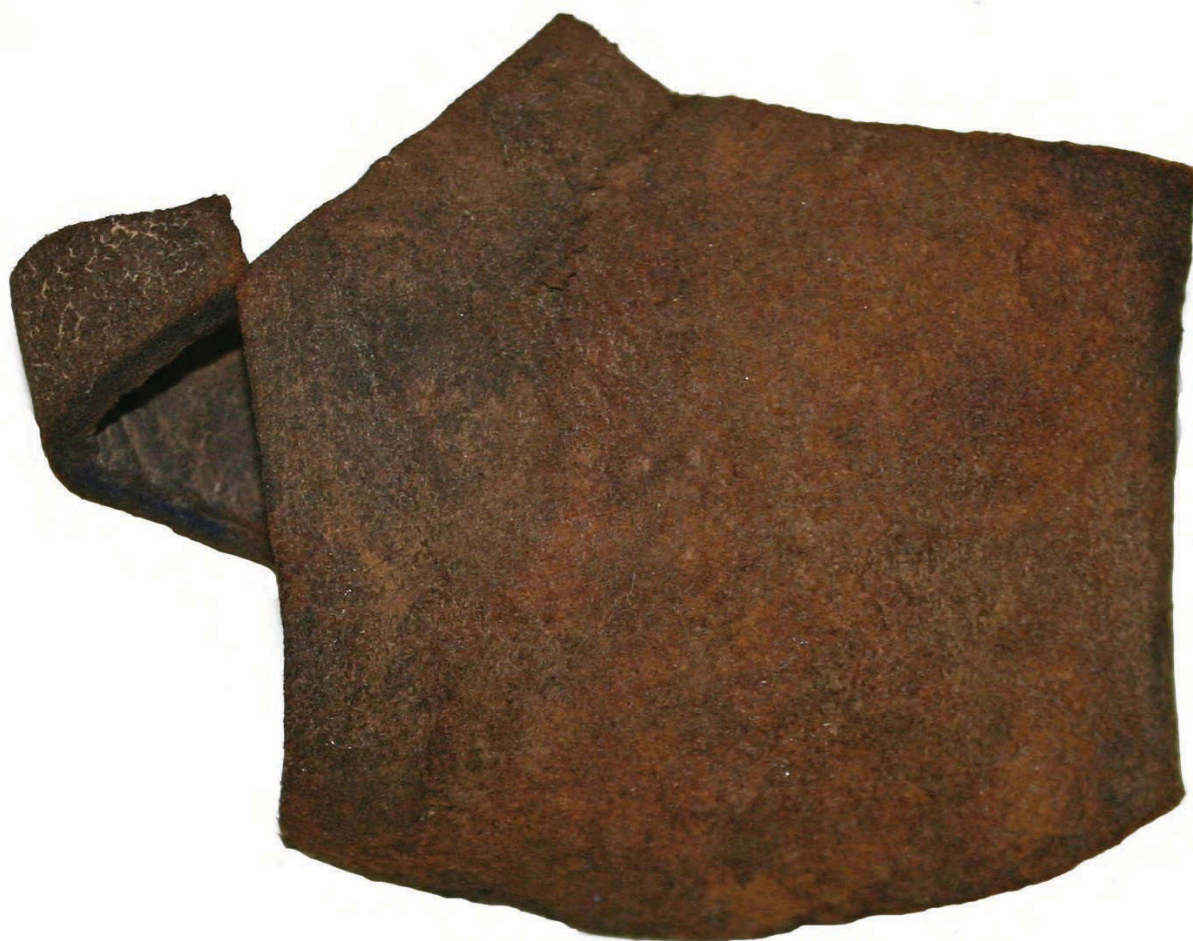
**MSG 145**

Description: Triangular in plan, the points of which are damaged. Comprised of one piece of leather folded in two. The outer surface of the folded piece appears to be suede like. Some dried sediment is present on outer surface. Possibly from a shoe upper.

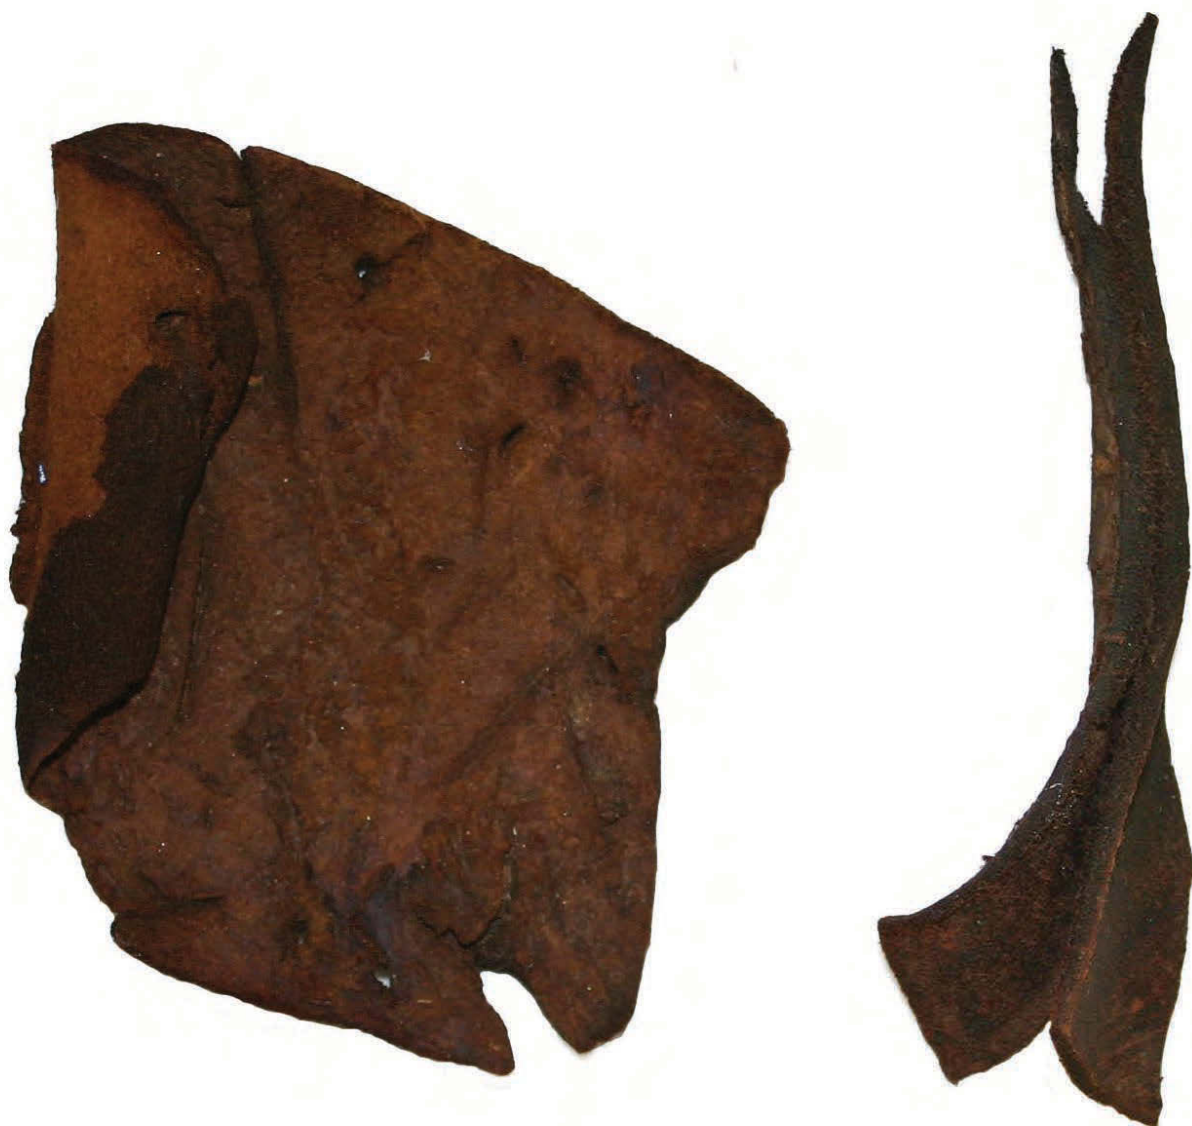
**MSG 147**

Description: 11 Leather fragments. The largest has possible binding stitch. Three other fragments also have stitching, one of which is binding. Adult size.

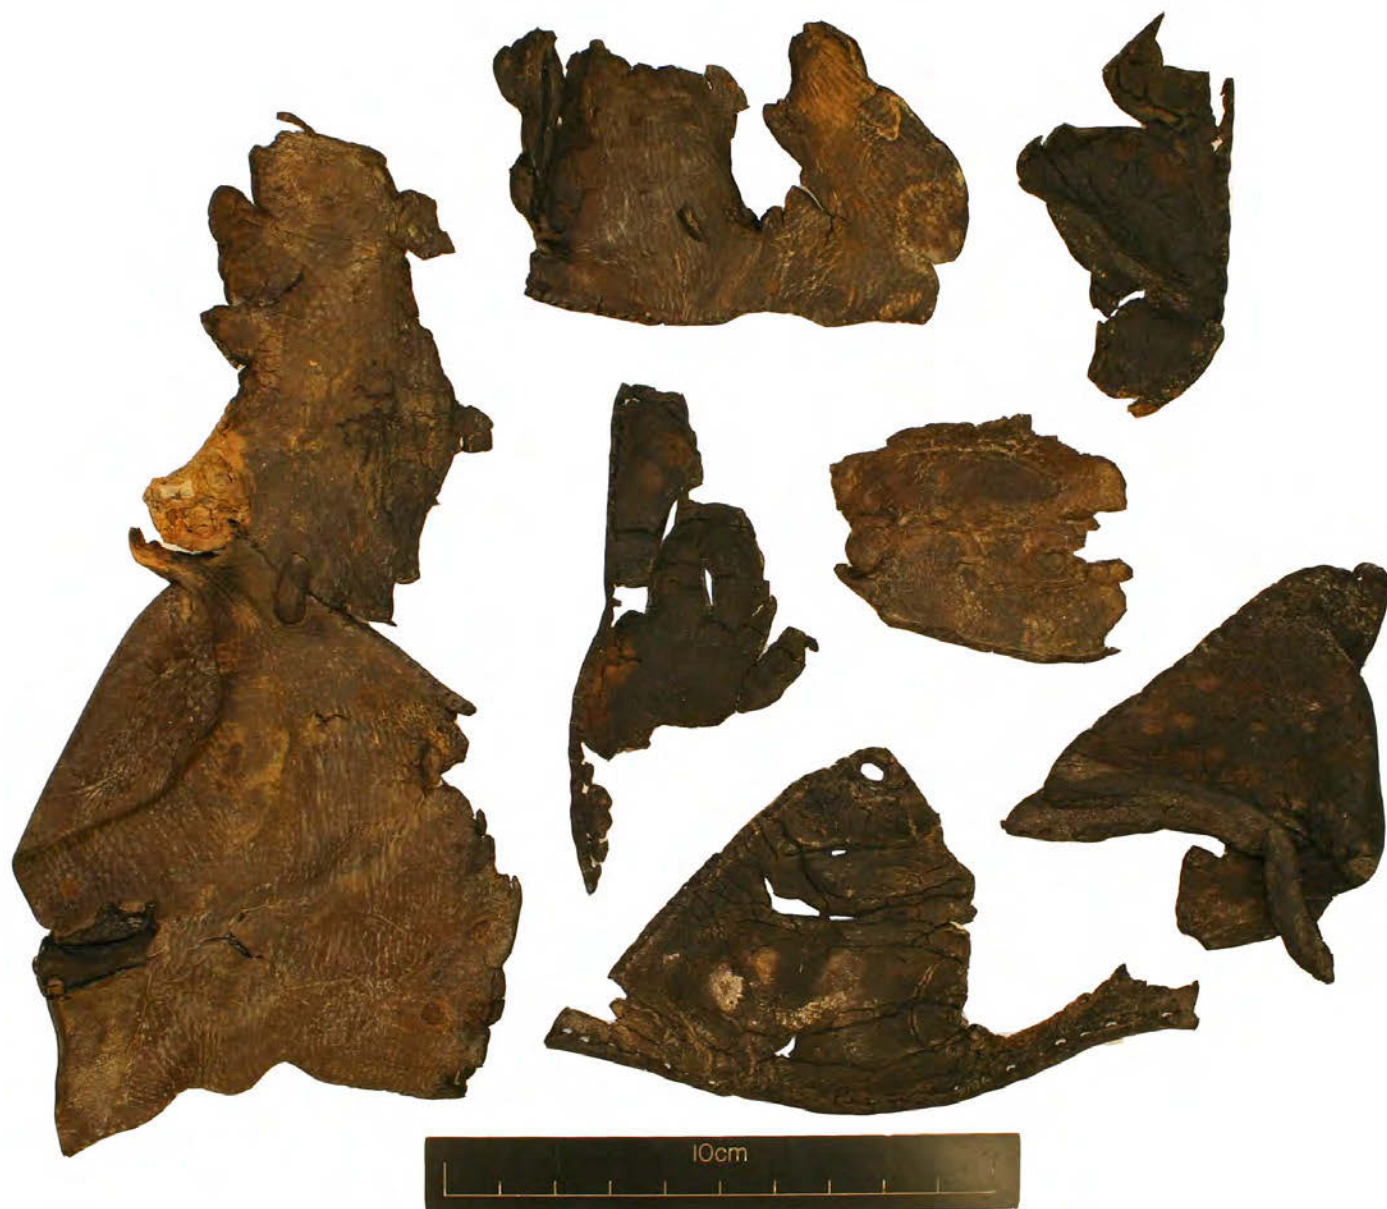
MSG 545

Description: 12 parts & several fragments. Sole has stitch holes around the edges, except at the heel. 28 teardrop shaped holes are punctured through the sole in the arch area of the foot, the function of these are unclear. Toe is slightly poulaine in style & is 45mm in length. 4 fragments of rand - all with stitching. One triangular piece, folded in half, has binding stitch along one edge. Two other pieces, or possibly three have tear drop holes.

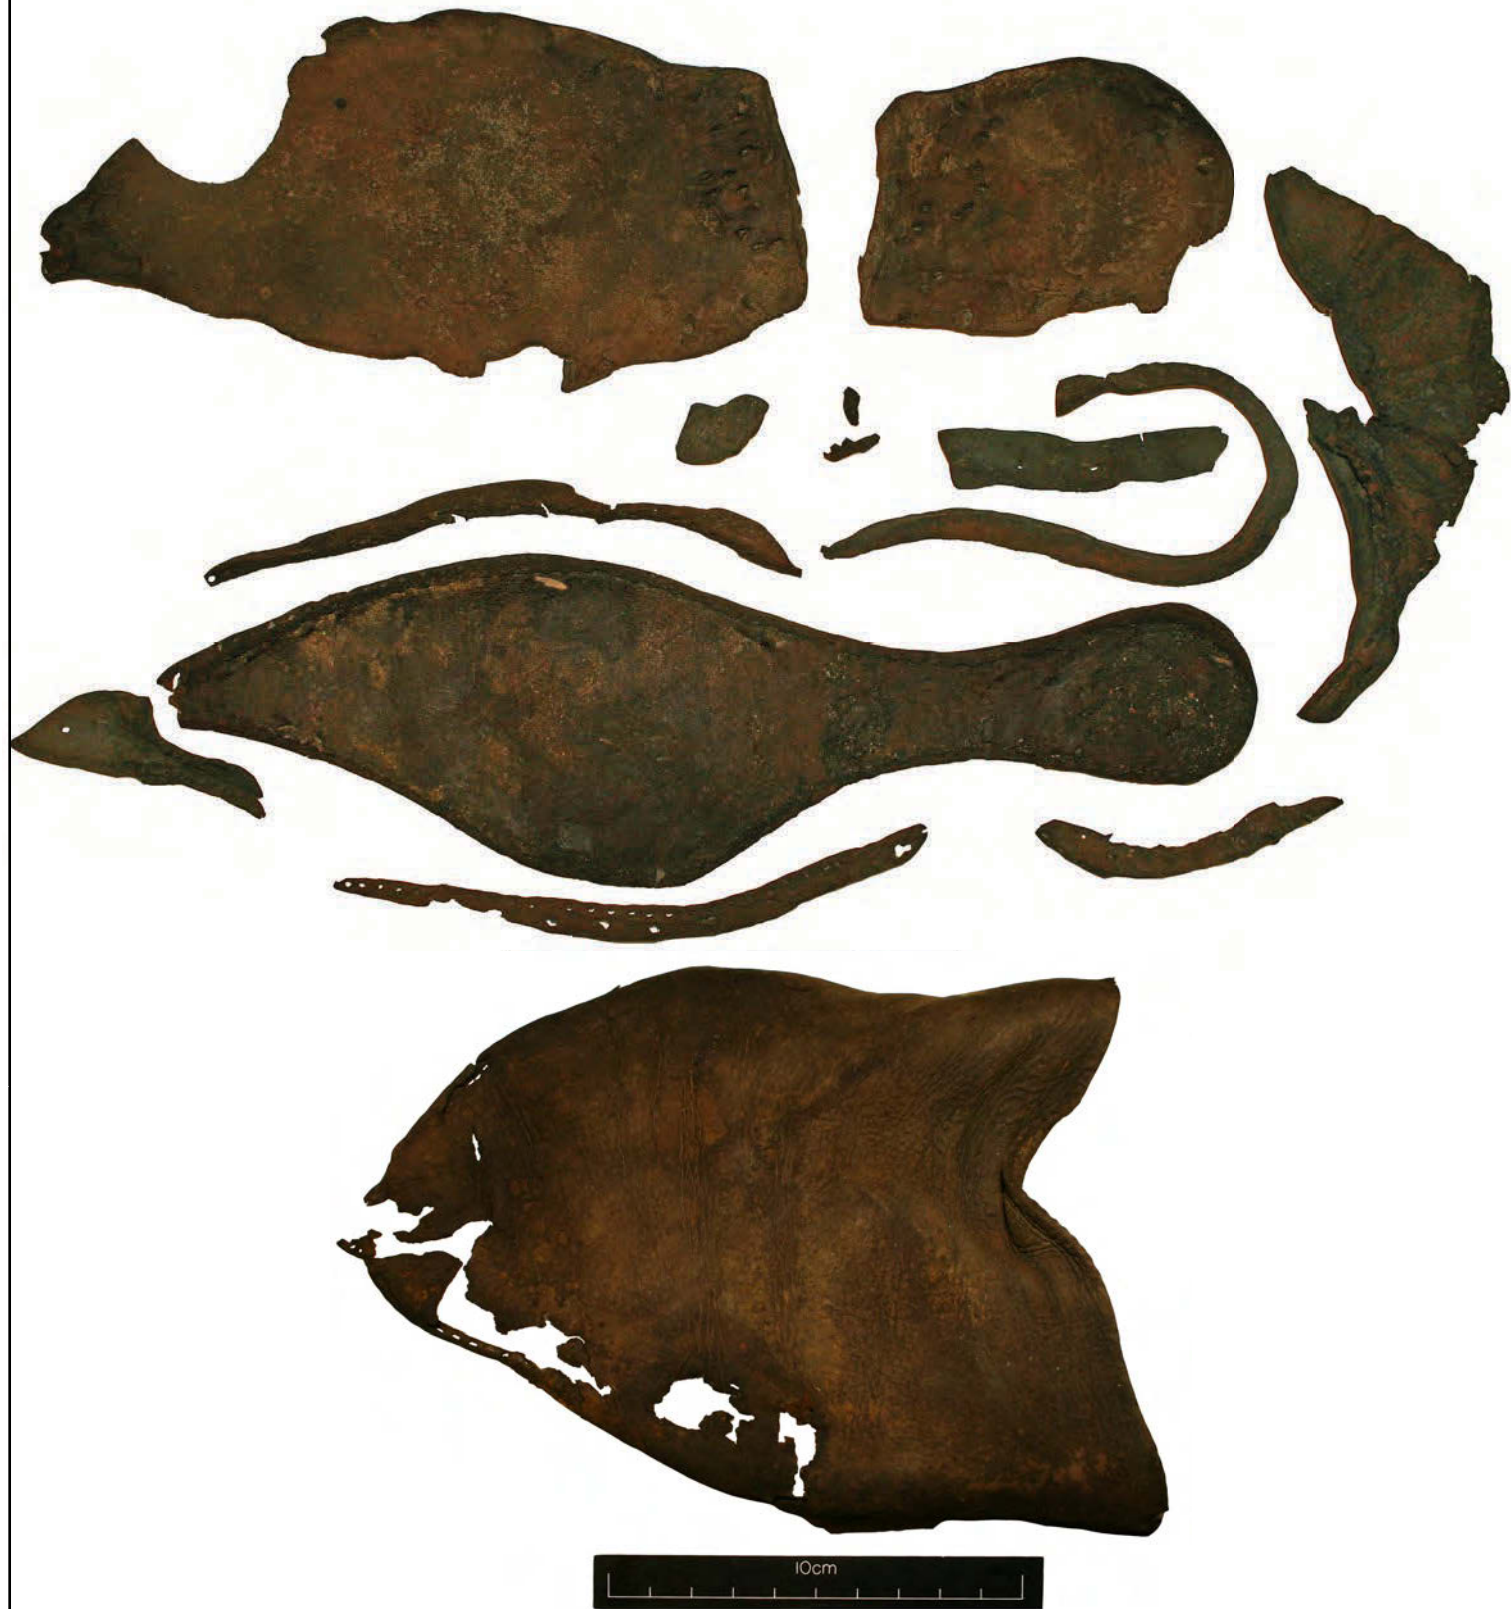
Description: Ankle boot fragments. 8 pieces. Largest piece consists of 2 pieces connected by a leather stitch 12mm in length and 5mm wide. On the reverse side the stitch is knotted twice with two single loops. Adjacent to the is a stitch is a piece of concretion, in a brittle state. Small stitch holes exist along at least one edge. 2 of the other 7 pieces also have stitch holes. Adult size.

1002	MSG543	SF305	Leather	Shoe	Upper fragments	?vamp area	one larger and numerous small fragments, the larger with small area of grain/flesh lasting margin, stitch length 6mm. Surface much cracked and with much soil still adhering
