# Newport Medieval Ship Project

## Specialist Report:

# LEATHER

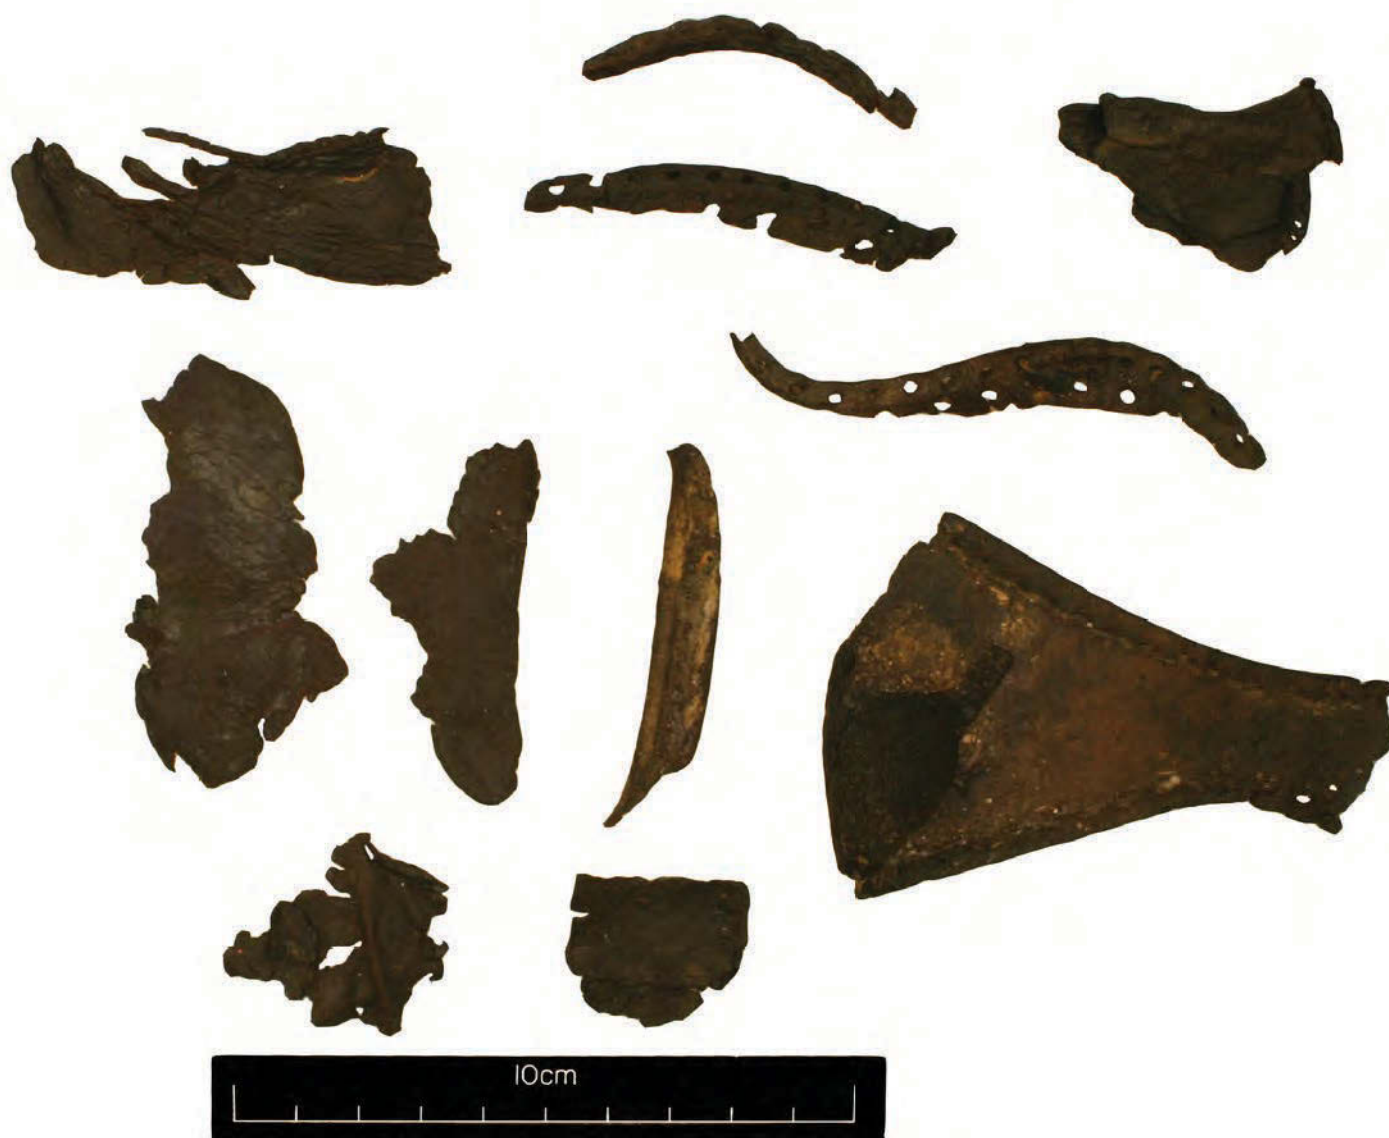
MSG 554

Material: Leather - cattle hide.	Sole with long pointed toe with 45mm extension and narrow waist 25mm wide and matching forepart clump repair. Toe area of vamp, fragment broken from the left side of vamp, right vamp wing. Left of two part quarters and matching heel stiffener. Sole heavily stitched across waist from repair, upper lasting margin also has repair stitching and a strip with similar stitching appears to be from an internal upper repair.
Context: 128	
Function: Shoe fragments.	
Dimensions: (Sole) 260mm x 71mm x 1.36mm.	
Description: Turnshoe of uncertain style for right foot, adult size.

MSG554	258 (sole)	80	1.58	cattle hide, worn	conserved	8273 (no used twice)	0	6	F4-5 PORT BOW

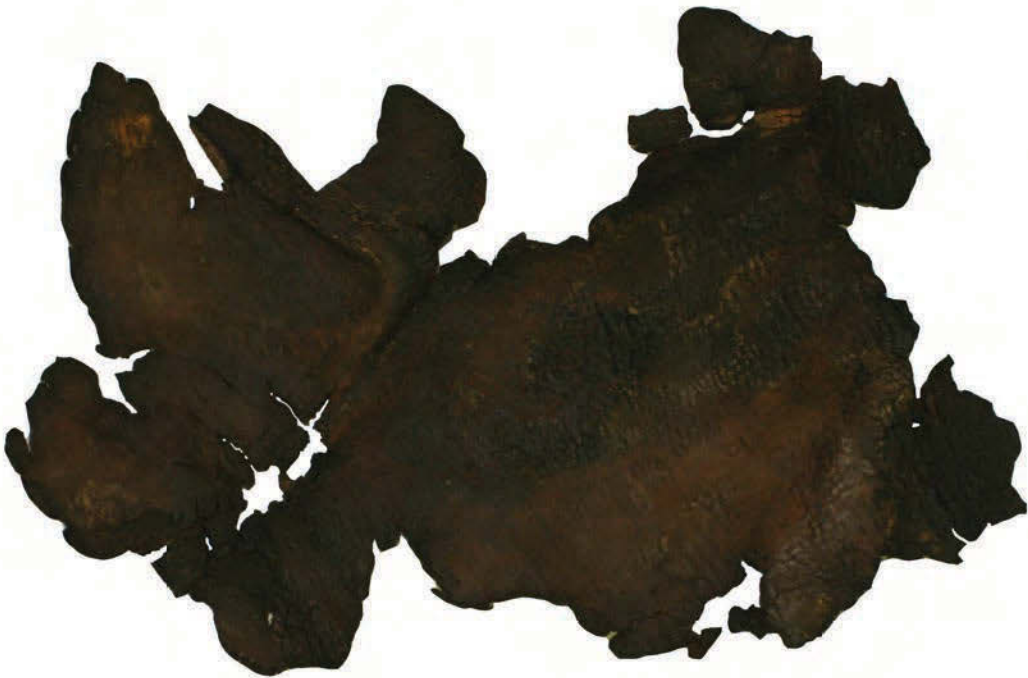
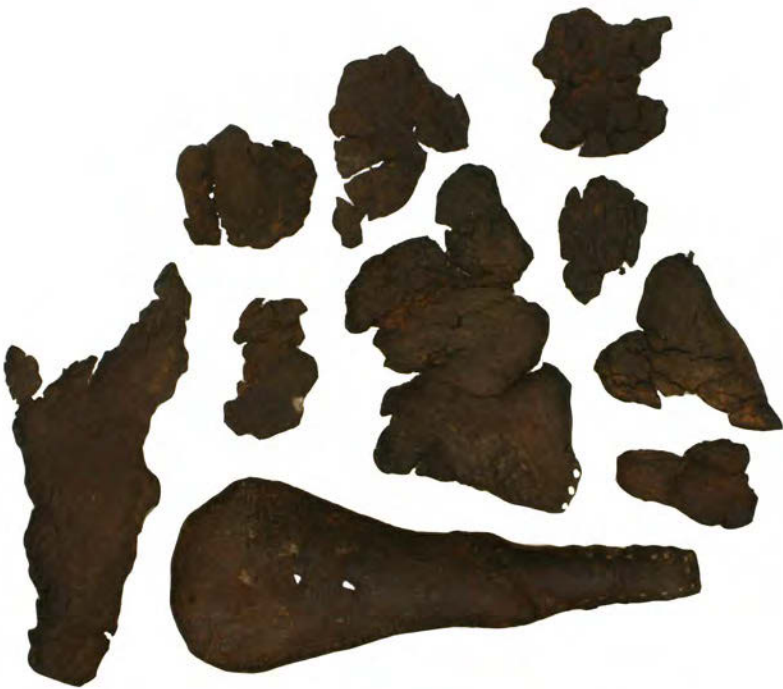
MSG 556

Description: sole with narrow waist 23mm wide, broken away across lower tread and upper seat. 6 fragments of rand 11mm wide including 3 with stitching to attach a repair. 8 small fragments of upper including 1 with fine whip stitching that may be from a tongue and 1 apparently from a heel stiffener.

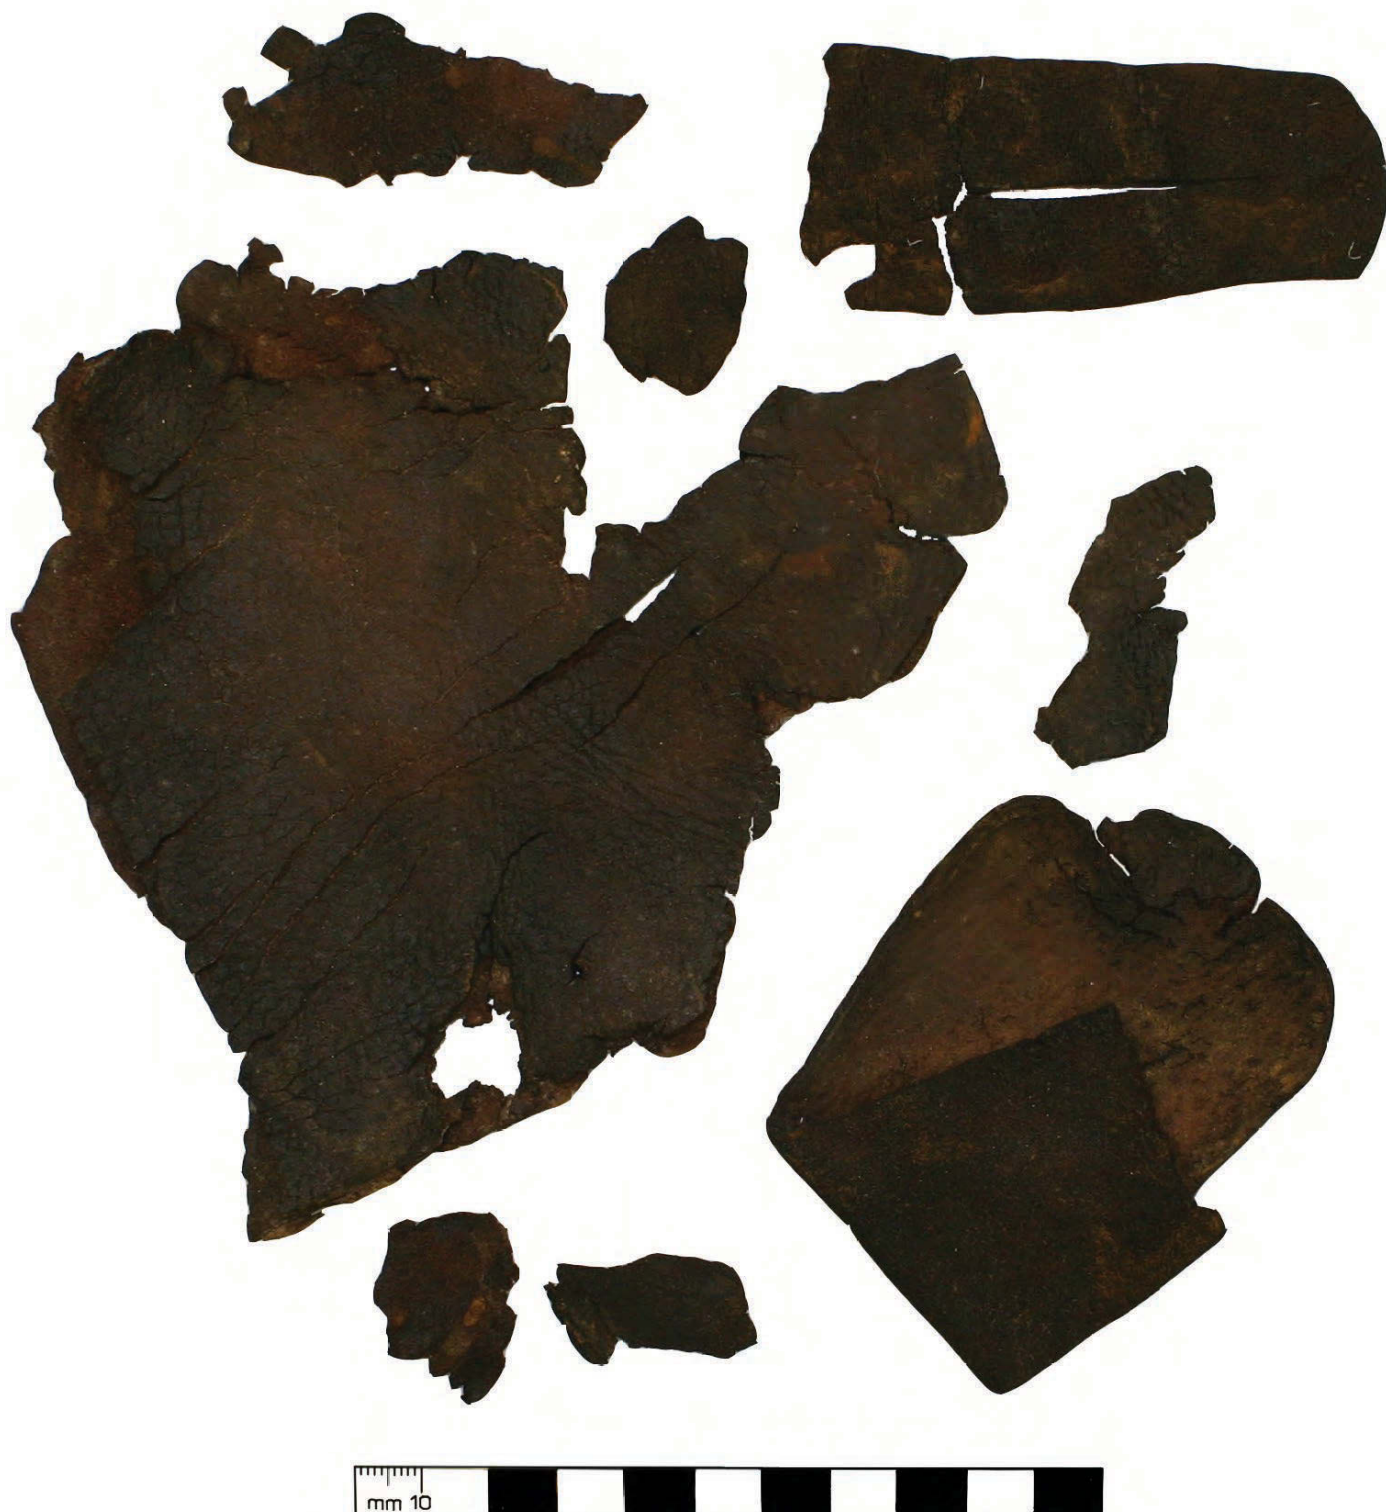
MSG 557

Material: Leather - calfskin.	Piece (107x42x1.16mm) broken from it with small area of original edge surviving. Smaller fragment (84x51x1.34mm) with 3 stitches from a butted whip stitched edge/flesh seam, stitch length 4mm. 7+ small fragments broken from them. Tongue-shaped boot strap with a wide rounded terminal tapering to a narrow strap with a straight end with a seam of grain/flesh stitching, stitch length 5mm, around the edge. 3 pairs of irregular nail or stitch holes aligned 10mm apart running slightly off centre down the wider end. Length 130mm, width max 50mm, min 11mm.
Context: Bow NE	
Function: Shoe fragments.	
Dimensions: largest piece,225mm x 200mm x 1.9mm.	
Description: leathrepanel originally folded with few distinguishing features but 4 stitches from a whip stitched lapped seam on the grain side along a small area of edge.

U/S	MSG557	SF113	Leather	Shoe?	Boot?	leg?, upper fragments, boot strap	panel originally folded with few distinguishing features but 4 stitches from a whip stitched lapped seam on the grain side along a small area of edge. Piece (107x42x1.16mm) broken from it with small area of original edge surviving. Smaller fragment (84x51x1.34mm) with 3 stitches from a butted whip stiched edge/flesh seam, stitch length 4mm. 7+ small fragments broken from them. Tongue-shaped boot strap with a wide rounded terminal tapering to a narrow strap with a straight end with a seam of grain/flesh stitching, stitch length 5mm, around the edge. 3 pairs of irregular nail or stitch holes aligned 10mm apart running slightly off centre down the wider end. Length 130mm, width max 50mm, min 11mm.

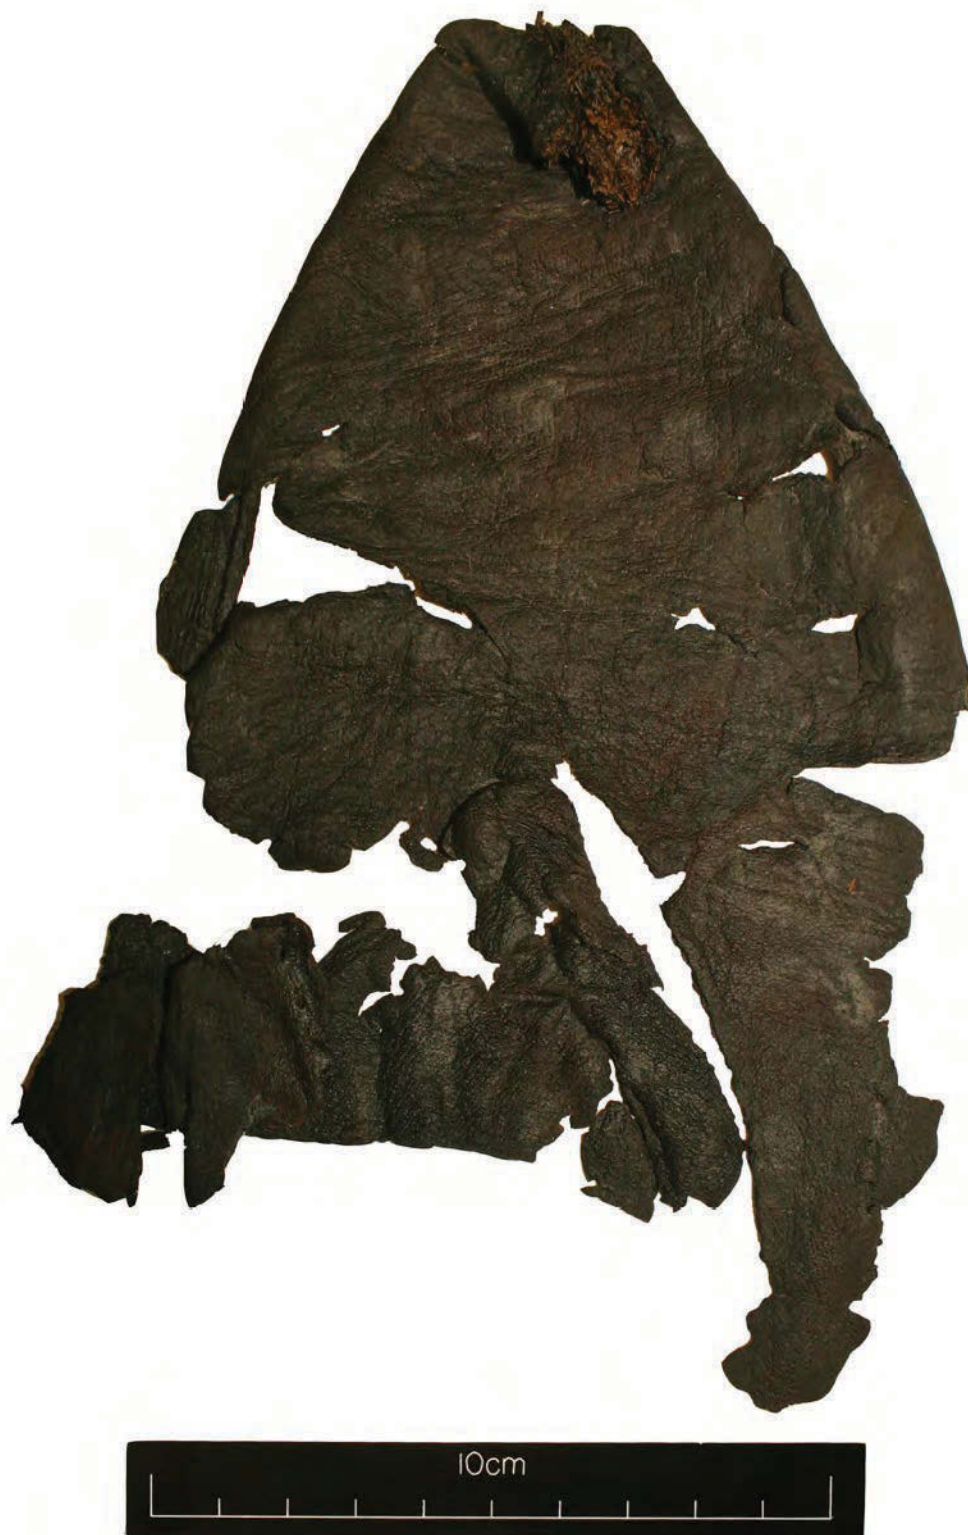
MSG 558

Description: Leather fragments. The largest is fragmented around the edges and in a delicate state, no stitching. The remaining fragments have no stitching however one piece does have a slit cut horizontally along the length. It is 87mmx39mmx1.69mm.

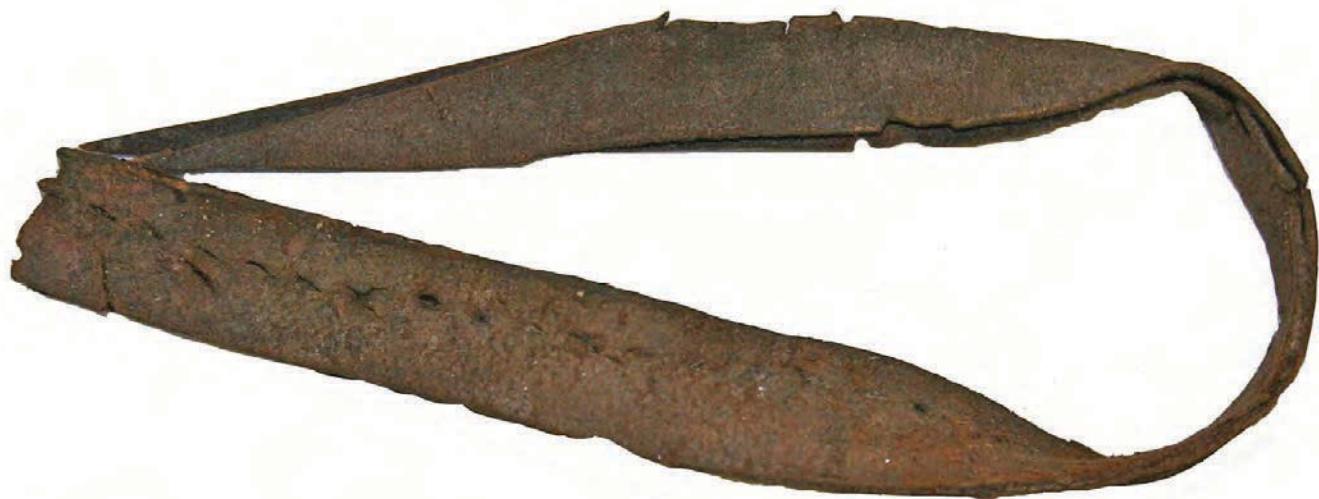
Description: Upper fragments. Quite brittle. Some possible stitching. One end has some hair like fibre attached- yellowish in colour. Much of the leather is redish in colour.

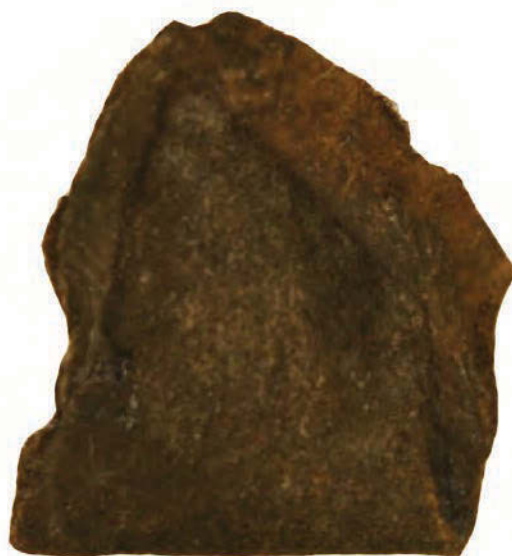
Function: Clump seat repair.

Dimensions: 70mm x 69mm x 2.48mm.

Description: Descriptionclump seat, left foot, adult size with some wear. In addition to the tunnel stitching around the edge on the flesh side is a line of 3 nail/peg holes across the lower edge and 2 running vertically up the centre.
