**Forth and Clyde Canal
Lock 17, Underwood
By-Wash Culvert**

Archaeological Watching Brief
January-March 2009

Site: Lock 17 on the Forth and Clyde Canal at Underwood

Description: Archaeological Watching Brief during the excavation of three chambers and a pipe track for the installation of a by-wash culvert on the South side of Lock 17

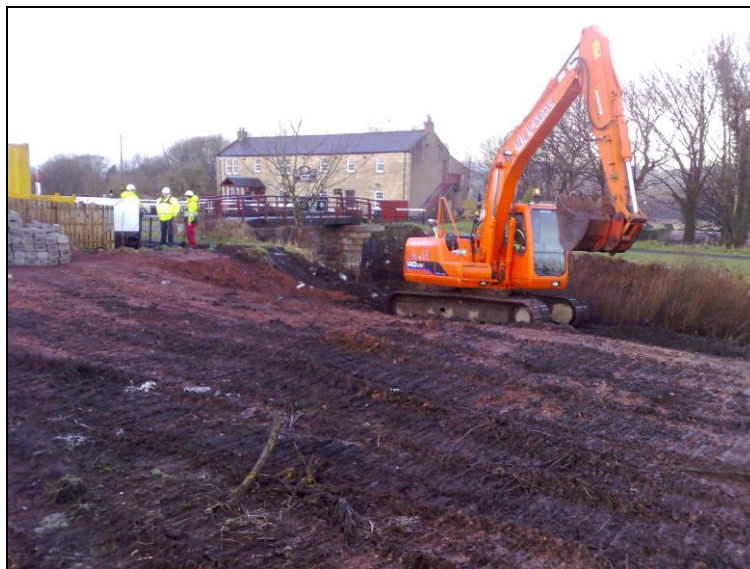
Figure 3: Remains of the Blaze Dam looking NW

The excavation began to the E of the Lock Chamber. The area of land here was heavily vegetated and this was stripped prior to the excavation of the E Outlet Chamber. On removal of the vegetation, a large amount of red blaze was revealed below the topsoil. This contained red bricks and lots of modern rubbish such as plastic cups. This turned out to be the dredged out remains of a blaze dam that had been placed in the canal c.2002 during work on the lock gates.

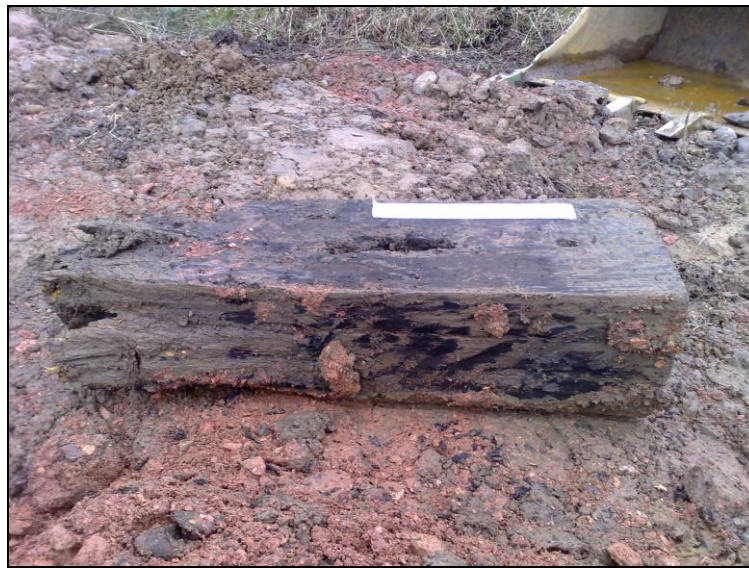
Figure 4: The End of a Balance Beam found within the Blaze Dam

The dam collapsed and had to be dredged out and as a result a piece of lock furniture, probably the end of a balance beam, was dredged out at the same time. The section was composed of a loose dark brown silty topsoil **F101** 120mm deep covering the dumped remains of the red blaze dam **F102**, an undulating layer up to 500mm deep. Below this was a buried dark brown silty topsoil **F103** 100mm deep (the previous ground surface) overlying a 250mm deep compact subsoil layer of greyish-brown silty clay containing numerous oval pebbles <110mm **F104**. Below this was a compact layer of heavy greyish-brown boulder clay

Photo No.	Description	From	Date
34	End of a balance beam from an old lock gate found within dumped blaze	-	15/01/2009
35	End of a balance beam from an old lock gate found within dumped blaze	-	15/01/2009
36	Broken timber found within dumped blaze	SW	15/01/2009
37	Access steps at E Outlet Chamber	SW	15/01/2009
38	Pumping water from inundated E Outlet Chamber	SW	19/01/2009
39	Looking NNE at E Outlet Chamber with pump	SSW	20/01/2009
40	E Outlet Chamber emptied with poured stone base	SW	20/01/2009
41	E Outlet Chamber with poured concrete base	SW	21/01/2009
42	Shot showing dumped blaze dam in section	NW	21/01/2009
43	E Outlet Chamber with poured concrete base	SW	21/01/2009
44	Demolition of rubble boundary wall at W Inlet Chamber	SE	21/01/2009
45	Section of rubble boundary wall at W Inlet Chamber	NE	21/01/2009
46	N Facing section of rubble boundary wall at W Inlet Chamber	N	21/01/2009
47	Beginning excavation for W Inlet Chamber	N	21/01/2009

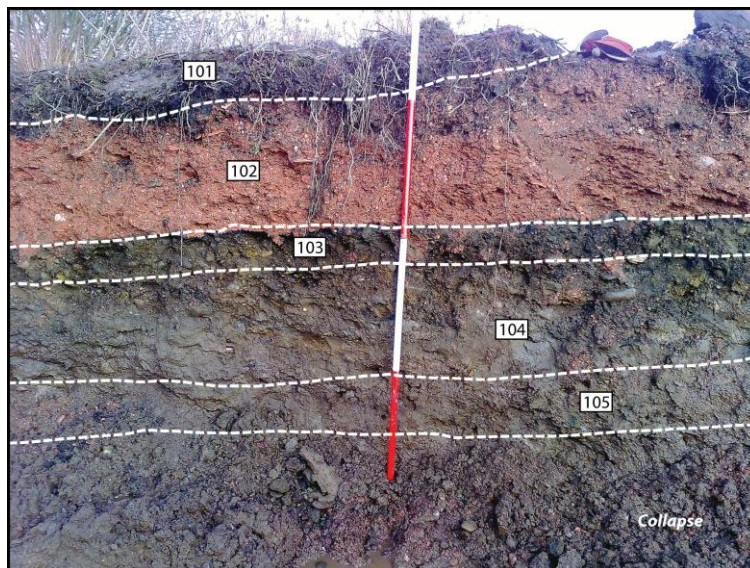
Figure 5: W-Facing Section S of the E Outlet Chamber

natural containing moderate inclusions of large sub-rounded boulders up to 800mm across F105. This layer was not fully exposed but reached a depth of at least 1.5m.

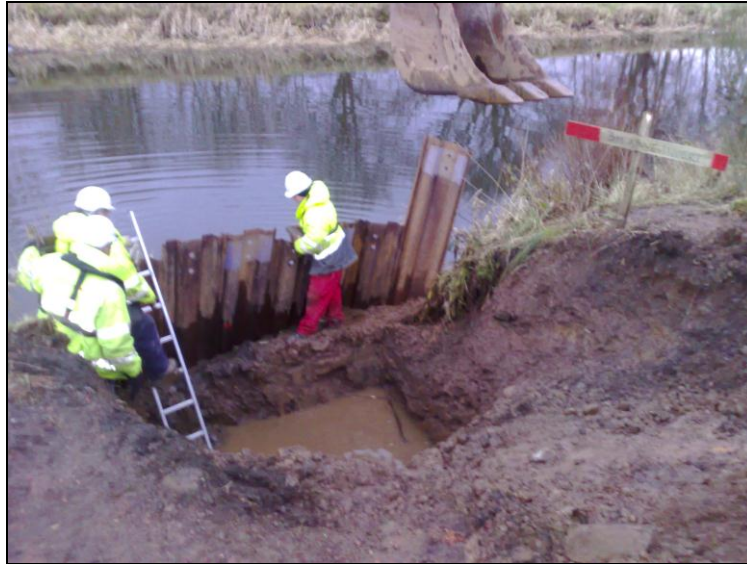
Figure 6: Trench 1 and the Cofferd Dam looking NNE

As the E Outlet Chamber was situated at the foot of the slope next to the canal edge, a sheet piled coffer dam had to be constructed to keep the water out of the excavation. An area approximately 4m x 4m was excavated to a depth of 800mm and then stepped down by a further 800mm to allow safe access to the excavation. The coffer dam was allowing water through so the excavation had to be pumped out before the concrete base of the chamber

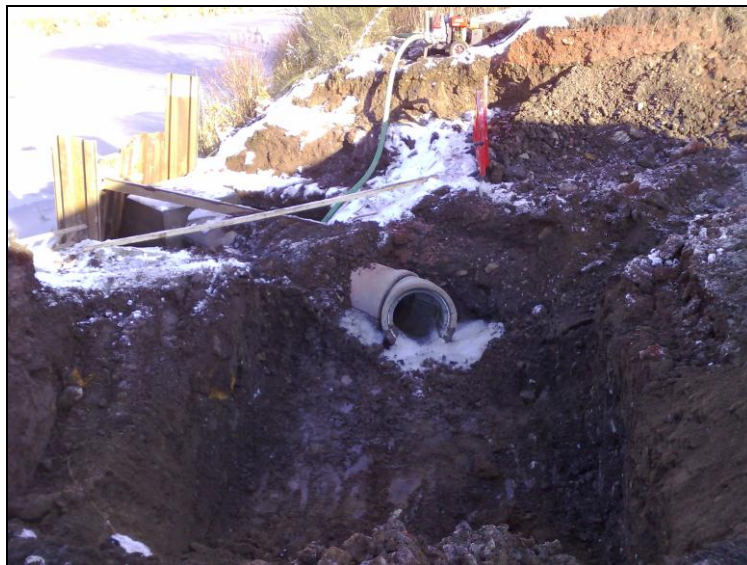
Figure 7: Looking NE at the completed E Outlet Chamber with fitted Pipe

could be laid. The chamber was then constructed and a dogleg of concrete pipe was fitted to connect later to the E Baffle Chamber. The pipe was bedded on a 150mm deep bed of pea gravel and backfilled with unsorted Type 1 stone and finings.

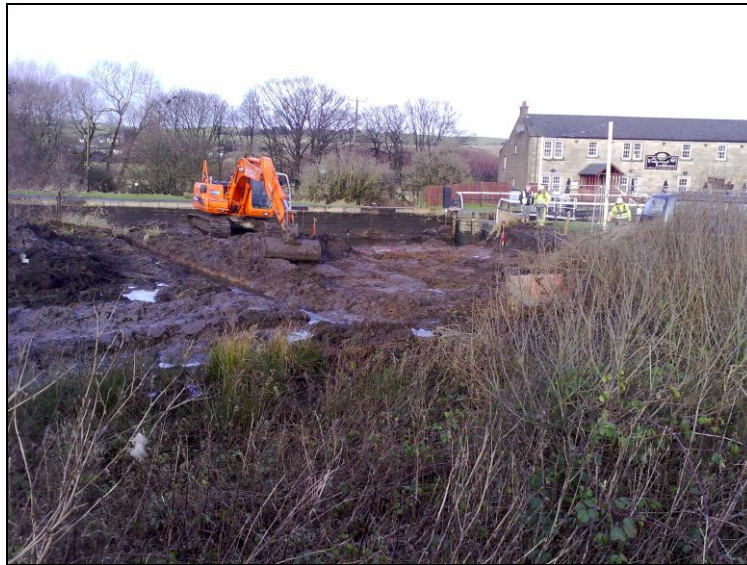
Figure 8: Looking NNE at the re-routed water course (running SE-NW)

channel 900mm deep was cut from the SE corner of the field and headed NW to the canal and the old water course was filled in. The channel was constantly inundating and it was only possible to take quick photographs of the section – these showed a loose dark brown silty topsoil overlying a pebble-rich greyish brown silty clay subsoil bedded on a compact layer of heavy yellowish-brown natural clay.

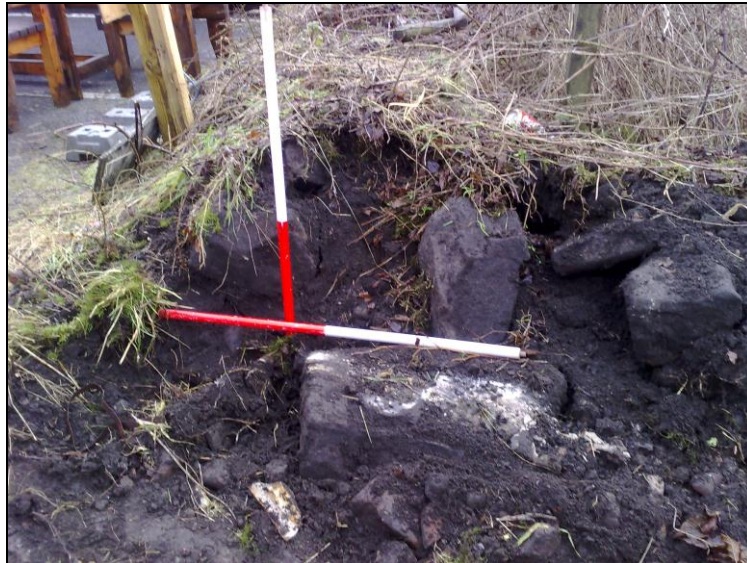
Figure 9: Looking SE at a Section through the breached wall

A loose rubble and silt boundary (more of a bund than a wall) had to be breached at the NW corner of the car park in order to allow access for the digger and dumper truck. Much of the masonry was re-used dressed yellow sandstone and this was bonded in a matrix of dark brown silt, the whole lying on a bed of sandstone rubble.

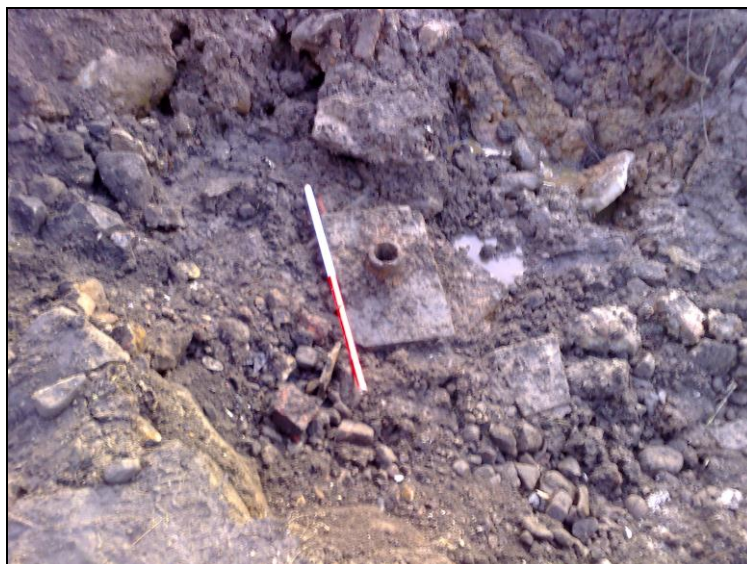
Figure 10: Looking SSW at the Cast Iron Cover and Red Brick Trap

Once the area had been graded flat, the excavation for the W Inlet Chamber started. It became clear that the ground here had been disturbed previously. There were several cast iron pipes running from S-N at variable depths of 500mm-1m and a cast iron cover with a brick trap were uncovered 1m W of the breached wall, although it was not necessary to remove this as it was out-with the area of the main excavation. This is likely to have been a septic tank, possibly related to the building shown to the SE of the car park on 19th century OS maps.

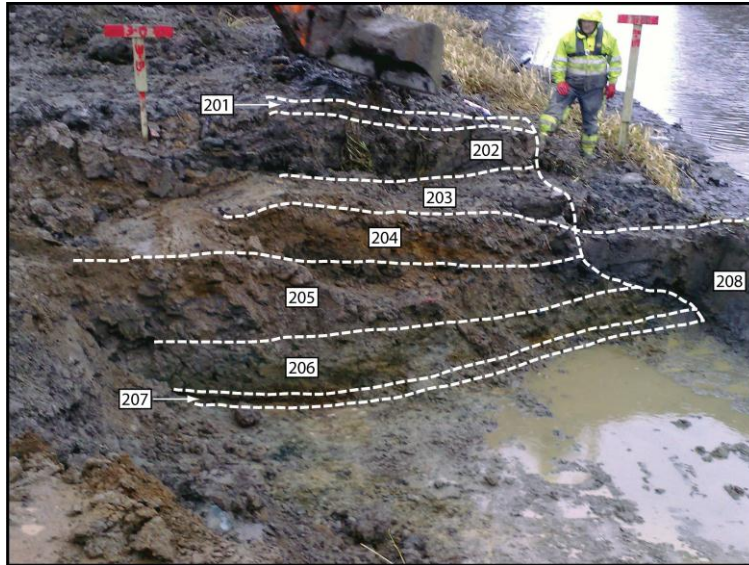
Figure 11: The E-Facing Section of Trench 2 – Note the dredged material to the right

An area approximately 8m x 8m was excavated on the sloped ground falling towards the canal – the N portion of the excavation was therefore much shallower than the S side which had a depth of c.2m a step was cut in to allow safe access to the excavation. The E facing section showed that the original cut for the canal was approximately 1.5m back from the current N edge of the S canal bank.

The section was composed of several layers, the uppermost of which was a waterlogged dark brown silty topsoil **F201** 120mm deep. Below this was a 300mm deep layer of compact grey brown sandy clay **F202** with numerous oval pebble inclusions <120mm. This sat on a compact clean layer of heavy mid greyish brown clay **F203** 300mm deep overlying a compact band of orange brown sandy gravel **F204** 250mm deep. Below this was a 400mm deep layer of compact pinkish grey Sandy Clay **F205** with numerous small pebble inclusions <80mm overlying a compact band of heavy greyish brown boulder clay **F206** 250mm thick. A further compact band of orange brown sandy gravel **F207** 250mm deep lay below **F206**. The bank to the N was composed of material dredged up from the canal bed. The material was a waterlogged layer of mid-grey silt and clay **F208** containing numerous pieces of timber and a further piece of lock gate furniture, showing that the N portion of the bank had been graded up, possibly when the lock was being restored in 1982 or 2002.

The regular layout and integrity of F201-F207 showed that these were layers of naturally formed strata- there was no indication of re-deposition that would have been consistent with the structure of the anterior mound of the Antonine Wall.

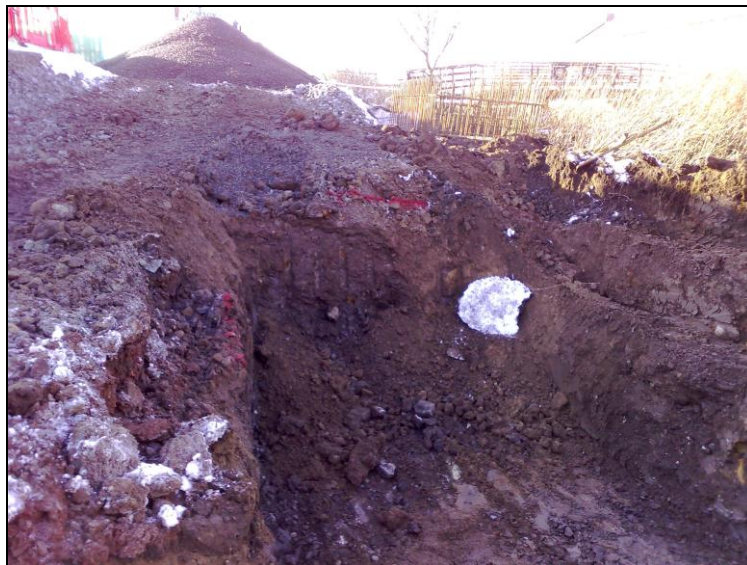
Figure 14: Looking E at Trench 3 for the E Baffle Chamber

The trench was approximately 3.5m E-W x 2.5m N-S and reached a depth of 2.5m (the area had been previously stripped and graded). The N-Facing section was composed of a loose dark brown silty topsoil F301 120mm deep covering the dumped remains of the red blaze dam F302, an undulating layer up to 500mm deep. Below this was a buried dark brown silty

topsoil F303 100mm deep (the previous ground surface) overlying a 250mm deep compact subsoil layer of greyish-brown silty clay containing numerous oval pebbles <110mm F304. Below this was a compact layer of heavy greyish-brown boulder clay natural containing moderate inclusions of large sub-rounded boulders up to 800mm across F305. This layer was not fully exposed. Nothing of archaeological interest was revealed.

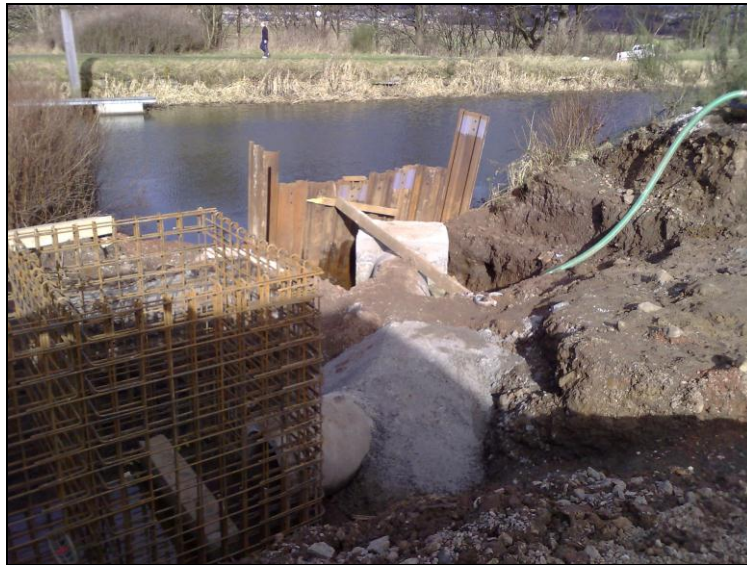
Figure 15: The connection between the E Baffle Chamber and E Outlet Chamber

The excavation was dressed and the concrete chamber emplaced and connected by a 5m run of concrete pipe to the E Outlet Chamber.

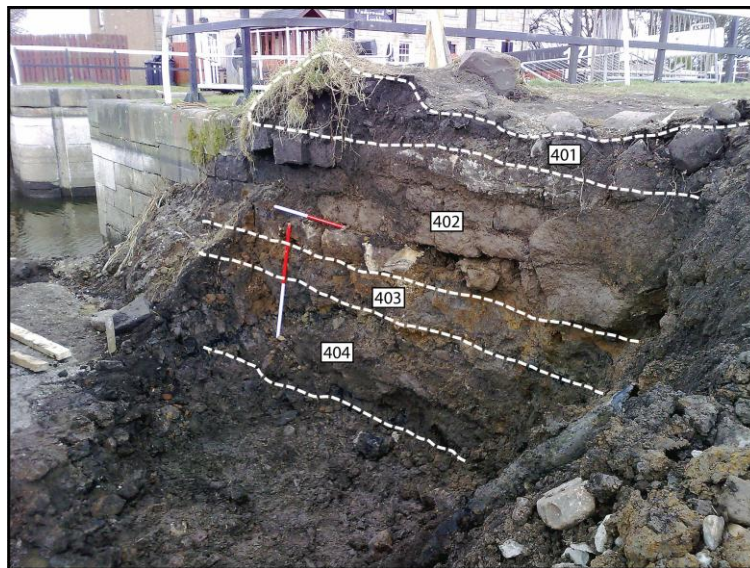
Figure 16: Looking NW at the section of un-jointed revetment wall

The excavation of Trench 2 had required the breaching of the bund **F401** forming the W boundary of the car park, this was composed of re-used dressed yellow sandstone blocks bonded in a matrix of dark brown silt 1.25m E-W x 750mm high, the whole lying on a bed of sandstone rubble 100mm deep. Below this, the section of wall **F402** was exposed. It was composed of 3 courses of un-jointed rectangular yellow sandstone blocks with stippled dressing 600mm high sitting on a protruding base course of un-jointed rectangular yellow sandstone blocks with stippled dressing 200mm high and protruding at the base by 50mm. The wall sat on a bed of yellowish brown sand and sandstone rubble **F403** 100mm deep, this in turn sat on a layer of very compact heavy mid-grey puddle clay **F404**, exposed to a depth of 750mm. This section of wall was keyed into the SW wall of the lock chamber so it seems

likely, especially given that the wall has puddle clay running below, that this was an original part of the 18th century design. It was likely to have been a revetment bridging the sloping section of ground from the S side of the Lock Wall to the made up ground forming the flat area to the S of the Lock. Unfortunately a matter of minutes after it was exposed, it started to collapse.

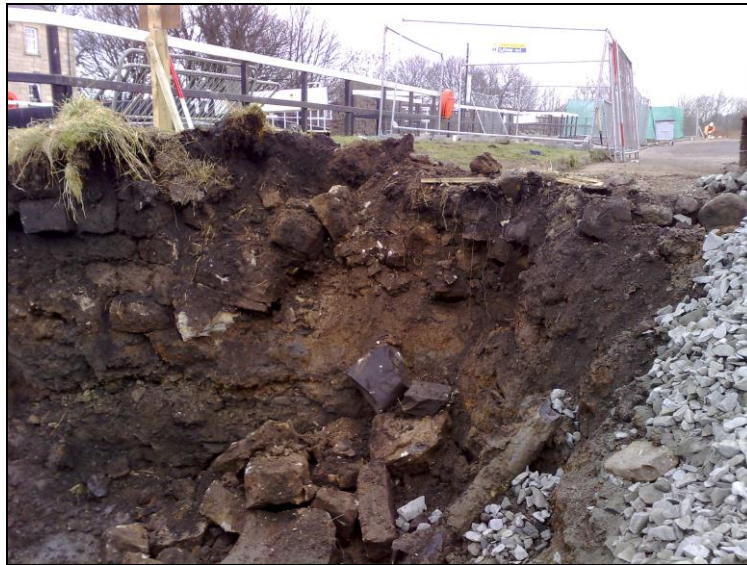
Figure 17: The revetment wall after it collapsed

As the wall had become dangerous, overhanging the excavation, it was agreed with HS that it could be breached. The S portion was kept largely intact and the cut for the pipe trench continued. As the wall collapsed it exposed the section which showed that the wall was 500mm wide and was backed with a layer of compact grey clay 250mm thick F405.

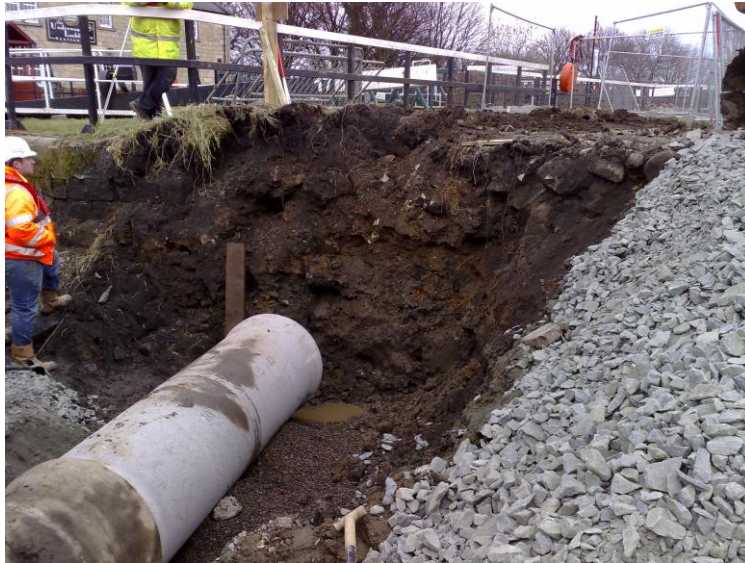
Figure 18: The dog legged pipe from the W Inlet Chamber looking NE

The initial dog legged pipe was laid and this allowed the excavation to continue in a straight line from W-E.

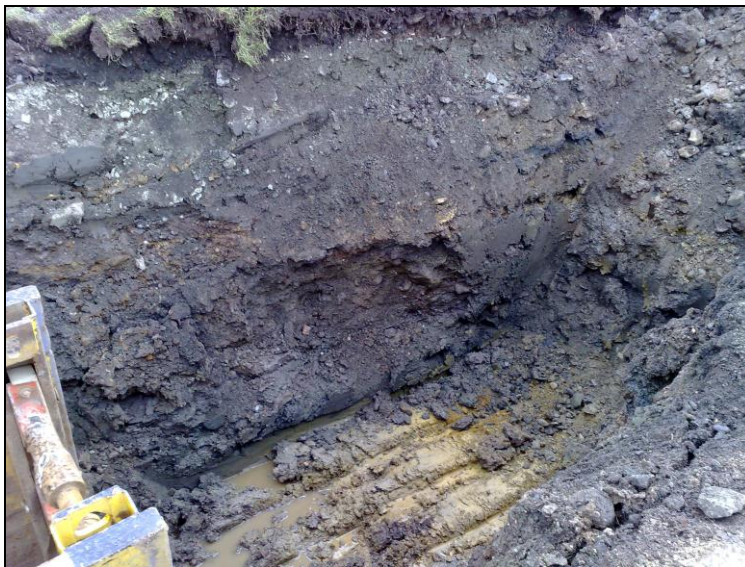
Figure 19: A typical section of the W portion of the pipe track

The pipe track was initially excavated from W to E. There were variations within the section to suggest that parts of the upper surface had been disturbed.

As part of the restoration of the Lock, new posts had been dug in and it was clear that the upper 300mm was made up at this time - it was composed of **F406**, a layer of Type 1 stone. It also contained a remnant of the previous lock gate. The base of the excavation showed that the puddle clay sealing the lock chamber sat on a compact layer of heavy yellowish-brown natural clay **F407**.

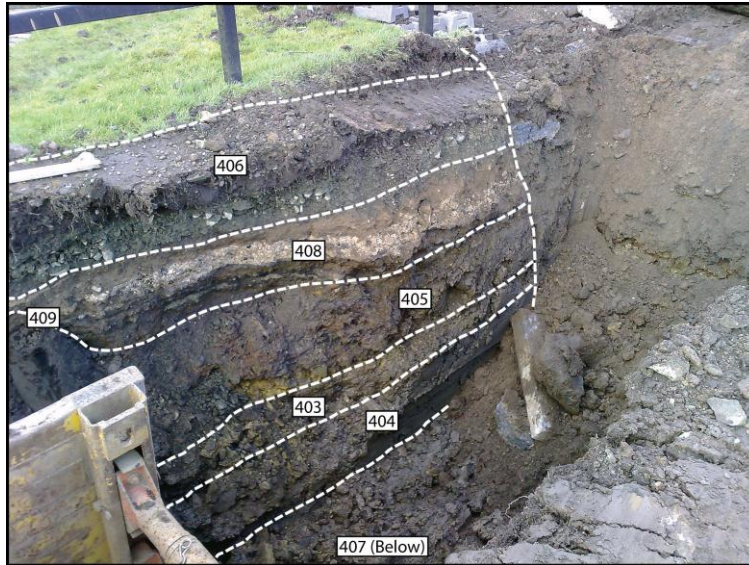
Figure 22: Demolition layers showing the position of the outhouse looking NE

8m into the pipe track excavation there were several layers of demolition debris **F408** composed of red bricks, mortar and sand sitting within a sloping cut **F409** up to 500mm deep. These were likely to represent the remains of a brick outhouse photographed in the 1970s.

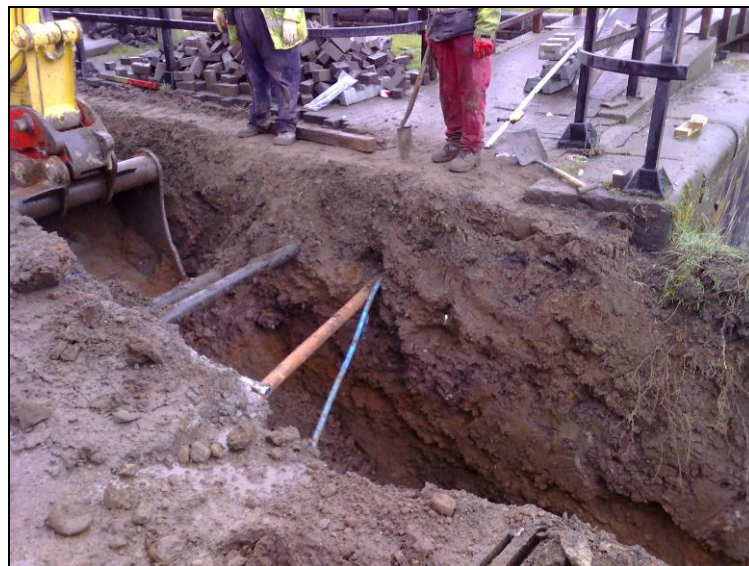
Figure 23: Location of services at the foot bridge looking NNW

Thereafter the section was disturbed in several places. To the E, the make-up of the car park and drainage systems had truncated a large part of the upper section while at the footbridge, 4 different services comprising Gas, Waste, Water and British Telecom had to be located. These were hand dug and recorded photographically in relation to the bridge.

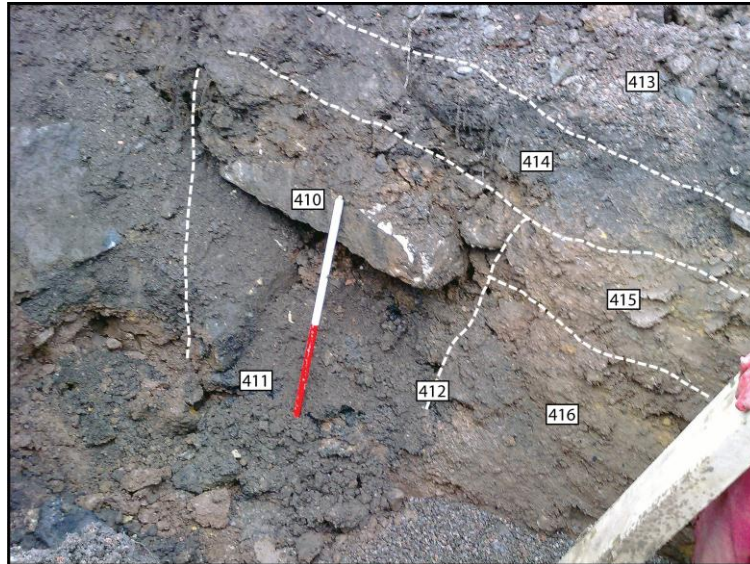
In the E portion of the Pipe Trench, one feature was uncovered 10m E of the SE wall of the Lock. A slabbed field drain **F410** composed of coursed sandstone side walls with large sandstone caps was breached while cutting the track. Its base coincided with the depth of the

base of the track and it contained a mid grey silty fill **F411**, 60mm deep. The aperture of the drain was 750mm high x 500mm wide. No water inundated the trench, indicating that the drain was no longer in use.

*Figure 24: Trench 4 (E end) showing drain **F410***

To the E of the lock chamber, the section reverted back to that seen in Trenches 1 and 3. The field drain **F410** was cut (via **F412**) through sub-layers **F415** and **F416** and was covered by the buried topsoil **F414** below the remains of the blaze dam **F413**.
