British Waterways
Minor Archaeological Works 2010

Forth and Clyde Canal

Lock 17 Spoil Removal

Project Code: BW-FC17-2010-01

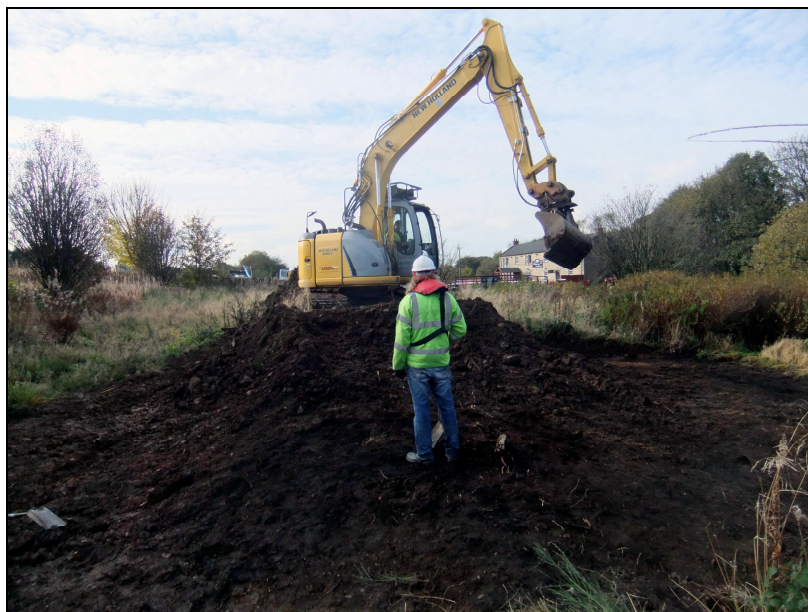
Plate 1: The spoil being removed.

In consultation with Morrison Construction, it was decided that the most appropriate method of removing the spoil was to dig from the E and cast back to form a spoil heap to the W. In this way the overburden and the spoil heap would be cast back as the dig progressed from E to W. This meant that there was no need for an additional vehicle to run the spoil to the W end of the site, something that would minimise additional impact on the monument.

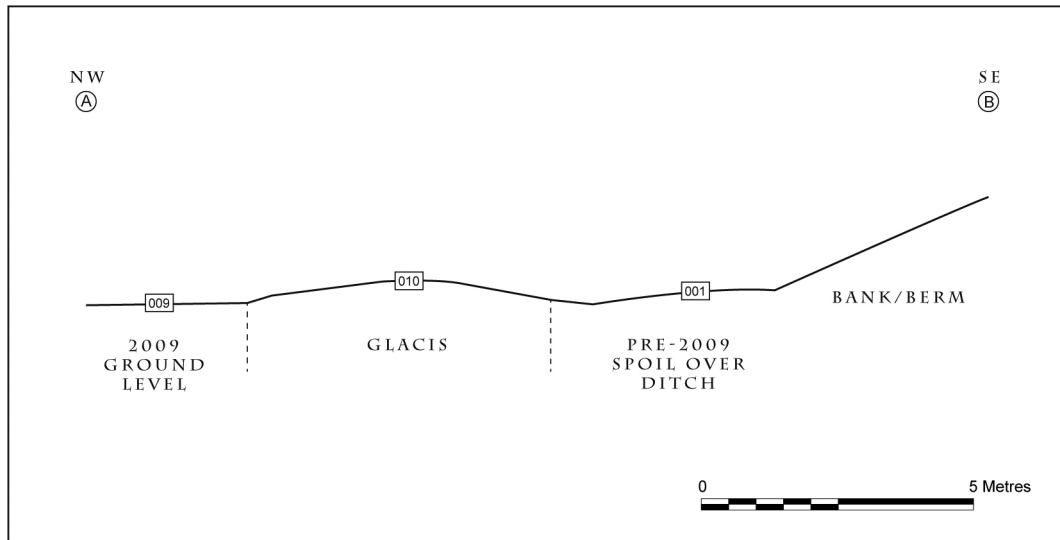
Figure 3: Section A-B across the E area showing general profile of Roman remains after clearance work.

The overburden (001) consisted of a re-deposited mixture of pale brown silt and clay, rich in red blaise and stone inclusions of varying shapes and sizes including Type 1 aggregate, pea gravel and large chunks of sandstone (see Figures 2 and 3). Within the layer were pieces of wooden fence posts, reinforcing mesh, glass and modern detritus such as plastic cups and paper waste. At the E end, the spoil was up to 1m deep, while to the W it was at least 150mm deep. The overburden peeled off onto a flattened, blackened turf line (009) – a moderately compact dark brown to black coloured silt with roots and flattened vegetation throughout, covered in thick leaf mulch, especially on the N side of the *glacis*. This layer represented the original
