**St MARY MAGDALEN CHAPEL, RIPON**

**ARCHAEOLOGICAL WATCHING BRIEF**

**The Trustees of St Mary and St John Hospital Charity**

February 2013

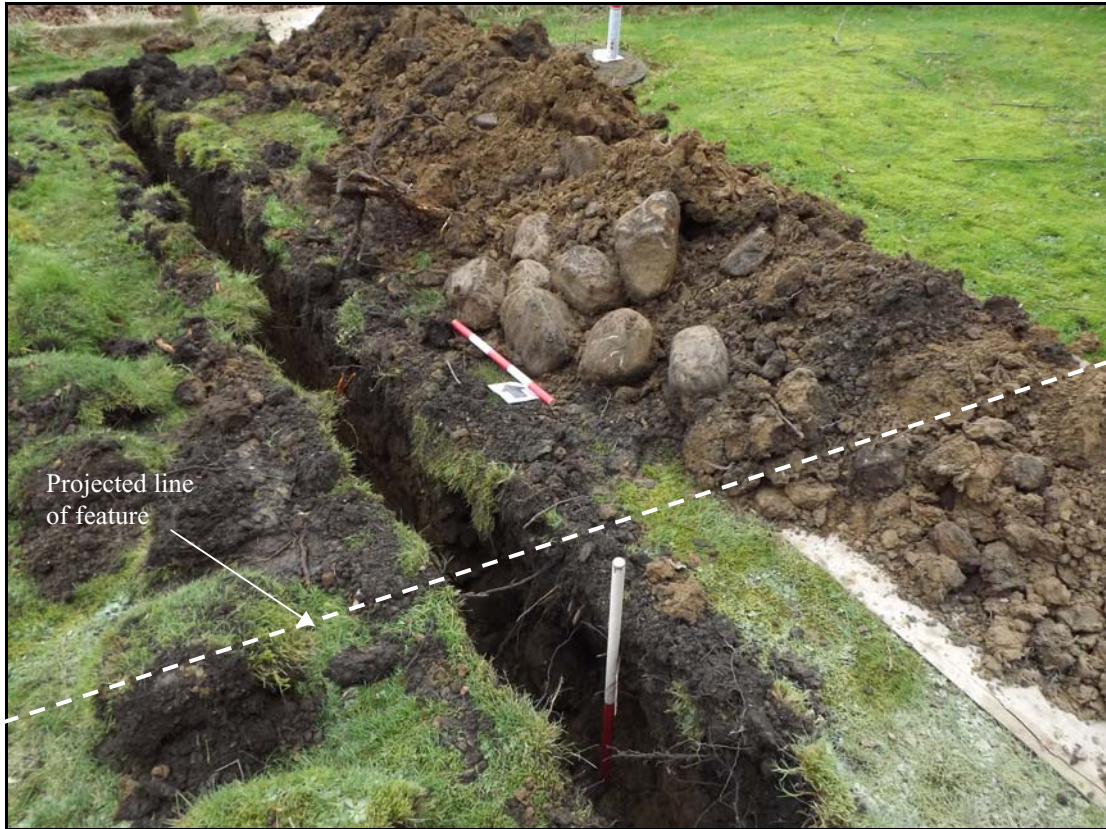
Plate 1. Remains of cobble built feature, the upright scale marks its location within the trench, looking north, scales 0.5&1m

Plate 1. Remains of cobble built feature, the upright scale marks its location within the trench, looking north, scales 0.5&1m

- 5.2 In addition to the human bone a single feature was identified along the line of the new service trench. This was a feature encountered 2.8m to the north of the north wall of the chapel (Plates 1 & 2). The feature was built without mortar from medium sized (*c.*0.1-0.3m<sup>3</sup>) water rolled cobbles in a narrow construction trench. The remains were 0.5m wide (north to south) and extended from just below the base of the topsoil (0.2m below ground level) to beyond the base of the service trench (0.8m below ground level, *c.*24mOD). The feature did not contain any mortar or other bonding material and did not appear to be of a ‘dry-stone wall’ type construction – the water rounded cobbles would have slipped off each other without mortar to hold them in position. The cobbles appear to have been tightly packed in a random pattern into a narrow trench in order to form the feature.

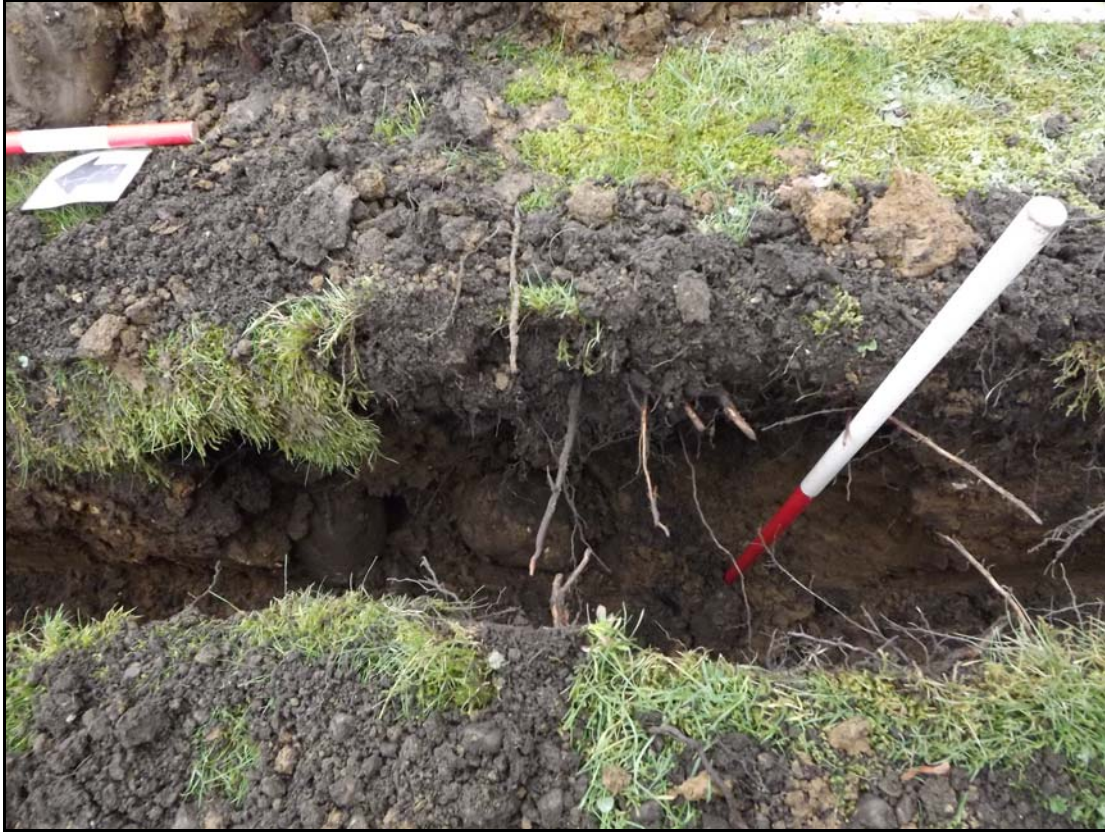
Plate 2. Remains of cobble built feature, the upright scale is at the southern end of the feature, looking east, scales 0.5&1m

Plate 2. Remains of cobble built feature, the upright scale is at the southern end of the feature, looking east, scales 0.5&1m

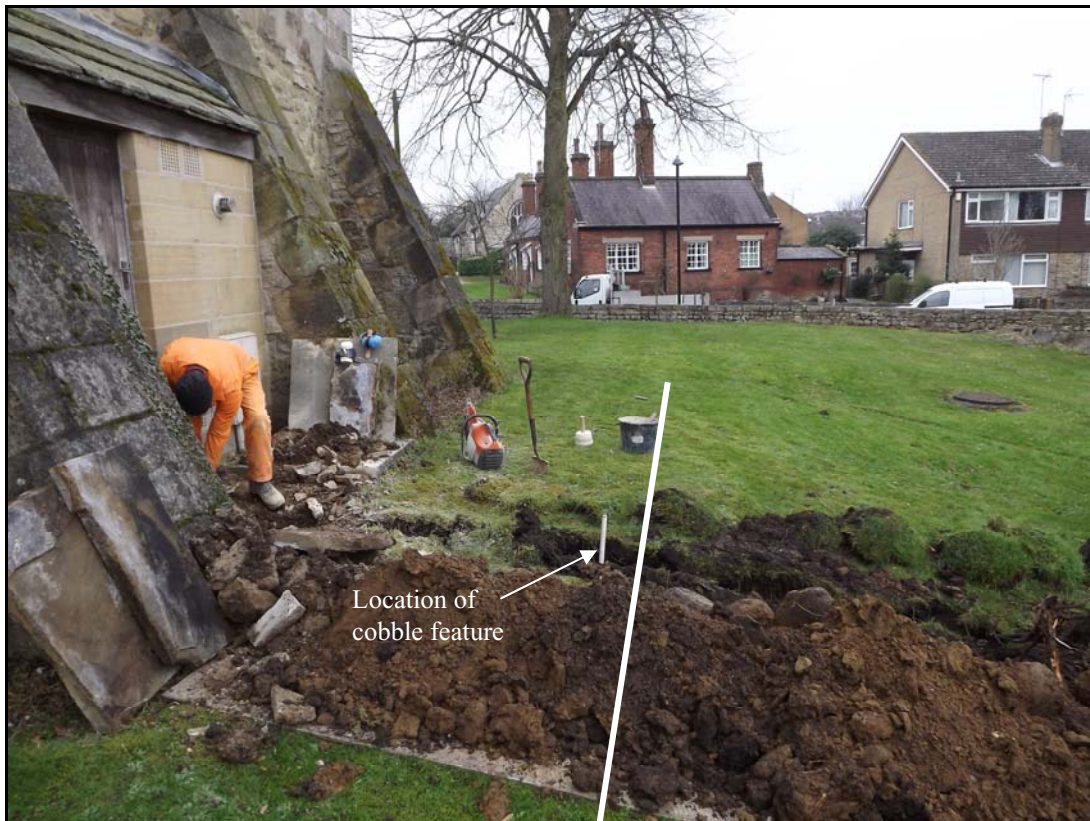
Plate 3. General view west showing break of slope associated with cobble feature

Plate 3. General view west showing break of slope associated with cobble feature

- 5.3 From what could be seen of the feature in the narrow service trench it was orientated east-west and to run parallel to the northern wall of the chapel. This alignment appears to coincide with a break in slope with an increase in the angle of slope to the north of this line. No artefactual material was associated with the feature and as such it is not possible to date it. During the excavation a single sherd of 19<sup>th</sup> century pottery was noted in the topsoil. No other finds or features were encountered.
