AN ARCHAEOLOGICAL ASSESSMENT

TANFIELD BRIDGE, WEST TANFIELD, NORTH YORKSHIRE

by Rhona Finlayson

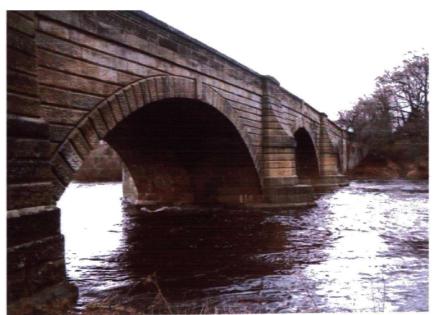
Plate 1, The east, downstream side of Tanfield Bridge, from the south bank of the River Ure

There is documentary evidence from the North Riding Quarter Sessions that in October 1609 a sum of £30 was allowed for the 'erecting of a new stone bridge at West Tanfield' (Jervoise 1931, 79). A bridge raised on three arches is described in 1725 and is reported to be in some decay in 1733 and it was rebuilt in 1737 after further damage caused by flooding (VCH 1914, 384). The money allocated for this re-build was recorded by the North Riding Quarter Sessions in April 1734 as £250 (Jervoise 1931, 79). The current ashlar bridge, possessing three segmental arches with voussoirs and hoodmoulds to throw off the rain, dates from this rebuild, but has been the subject of some later alteration. Jervoise describes the bridge at West Tanfield as 'an 18th century bridge with three segmental arches, which has been widened downstream to give a width of nearly 20 feet' (1931, 79). The 'seam' where the added build of the widening joins with the earlier part of the bridge can be seen clearly beneath the arches (see Plate 1). One of the two very heavily weathered inscriptions on the western face of the bridge reads:

There are differences between the tooling of the stone work on each side of the bridge reflecting the two stages of construction represented. On the western side the blocks are rougher but plain-faced where as on the eastern side the blocks have patterned tool work (see Plates 1 and 3). There are also differences in stonework between the parts of the bridge constructed on the north and the south bank reflecting the fact that when the bridge was constructed the River Ure formed

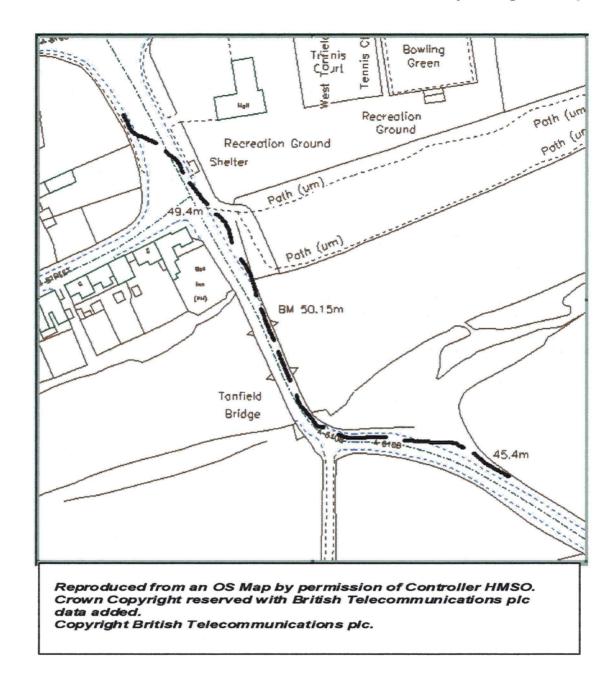
Fig 2, Location of proposed new ductwork across Tanfield Bridge

In December 2003 to January 2004 the York Archaeological Trust undertook an archaeological desk top assessment of the bridge over the River Ure at West Tanfield (National Grid Reference SE 27007870). This work was carried out on behalf of British Telecommunications plc for the purpose of meeting a condition set by English Heritage in relation to work involved by taking a proposed route over the bridge for telecommunication ductwork between North Stainley, south of the river and West Tanfield on the north bank of the river. The scope of the proposed work is for a plastic duct 100mm in diameter, containing a fibre optic cable, to be laid crossing Tanfield Bridge, placed within the tarmac road surface and covered with a concrete protection (see method statement, Appendix 1).

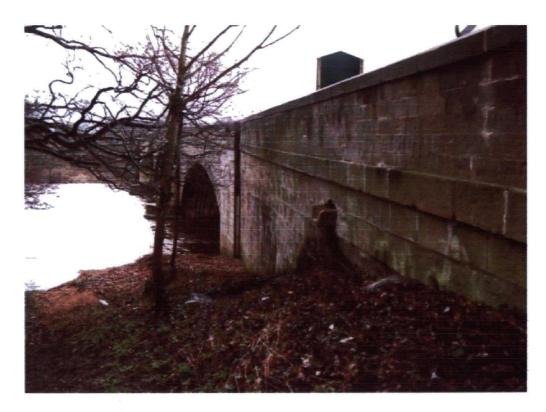
Plate 2, The east side of Tanfield Bridge, from the north bank of the River Ure, showing the drain carrying run-off water

There are a number of 20th century alterations. At some stage a drainage pipe to remove run-off has been inserted. The outflow appears from a pipe in the bridge on the north bank, downstream side (see Plate 2). In recent years four ducts carrying communication services for a company other than BT have been installed and have been buried to a presumed depth of 600mm in the road crossing the bridge (Ratcliffe *pers comm.*). This ducting is thought to have been placed along the eastern side of the bridge and the route of the proposed BT ducting is also proposed for the eastern side of the bridge (see Fig. 1). There are a number of road signs which have been erected on the southern side of the bridge, all of which have been placed in trenches with concrete around their bases. There is also a manhole inspection cover on the south bank side of the bridge. The inner faces of the bridge show evidence of repeated scrapes from vehicles driving too close to the stone work as they cross the bridge. There is a portion of masonry on the south side of the bridge lying on the ground which has evidently been knocked off, presumably by a close encounter with a vehicle.

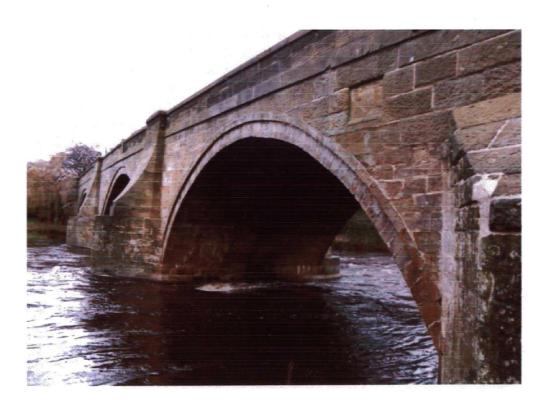
Plate 3, The west, upstream side of Tanfield Bridge from the south bank of the River Ure

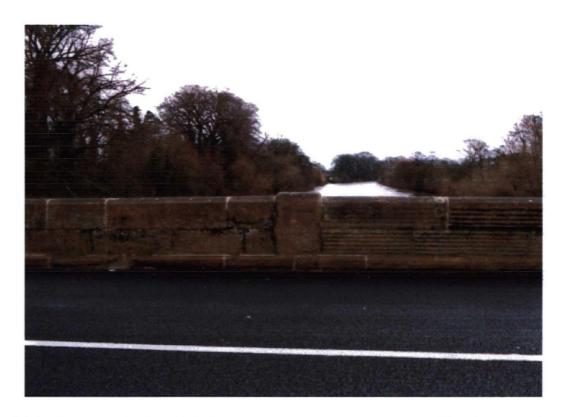
Plate 4, The inner, west side of Tanfield Bridge from showing the division between the North and West Ridings

the boundary between the North and West Ridings of Yorkshire. On the south side of the river (the West Riding) the blocks in the parapets are horizontally tooled whereas on the north bank (the North Riding) the parapets are constructed from plain-faced blocks. The boundary at the centre of the bridge is marked by an inscription on the inner face of each side of the bridge. The stone on the upstream side reads Division of the W. and N. Riding and the stone on the downstream side reads Division of the N. and W. Riding (see Plates 4 and 5).

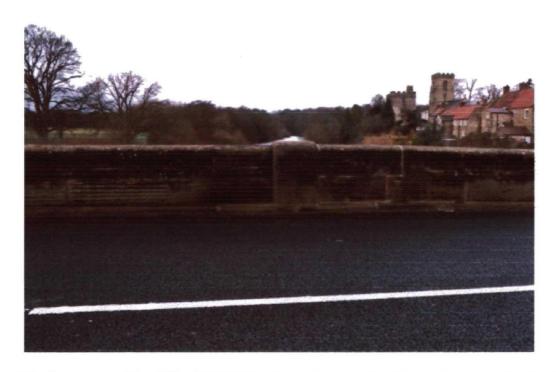
Plate 5, The inner, east side of Tanfield Bridge from showing the division between the North and West Ridings

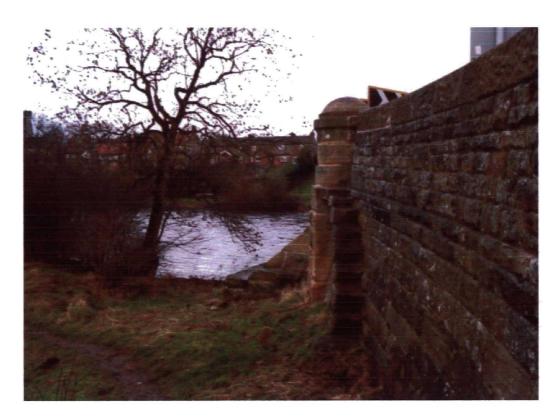
Plate 6, The west side of Tanfield Bridge, south bank showing the steps which lead up to the roadway

On the south bank, west side of the bridge, a narrow set of steps leads to the road from the base of the bridge (see Plate 6). These may have been part of the original design, or added later.
