# HISTORIC SCOTLAND PROPERTIES IN CARE MINOR ARCHAEOLOGICAL WORKS 2012

# Crichton Castle • Watching Brief • November 2012

SITE:	Crichton Castle	
N.G.R.:	NT 3803 6113	
DESCRIPTION:	Watching Brief during the excavation of trenches related to the installation of a new gate	
PROJECT CODE:	HSCO-90084-2012-02	
CONTENTS:	Introduction	1
	Description	2
	Conclusions	3
	List of Contexts	4
	List of Digital Photographs	5

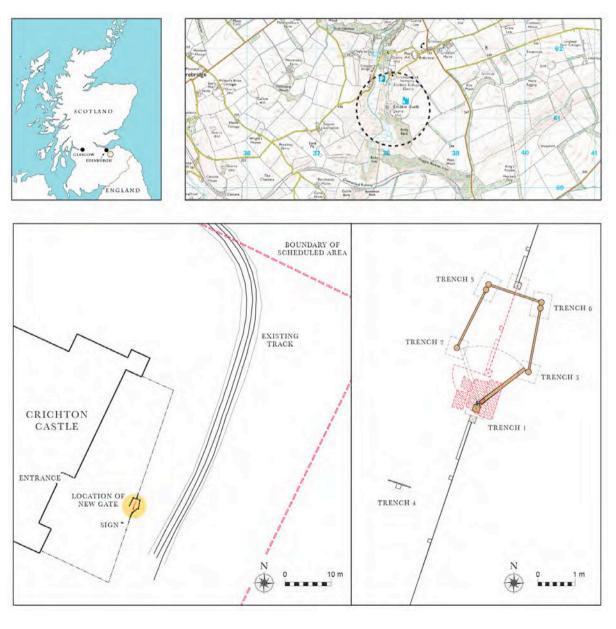
Figure 1: Plan showing the location of Crichton Castle, and the site of the present works

Under the terms of its PIC Call-Off contract with Historic Scotland, Kirkdale Archaeology was asked to monitor the excavation of six small trenches just outside Crichton Castle (Fig.1). The Castle is a dramatic ruin situated at the top of a steep glen carrying the Tyne Water, in Midlothian. The site is a suite of buildings of varying ages; with a tower in its NE corner of late fourteenth century date and later ranges built up around this.
