SCPP Archaeological Works 2008

# Stirling Castle Palace West Range French Drain Extension to Trench 24

Project. SCPP-2008-06

Archaeological monitoring June & July 2008

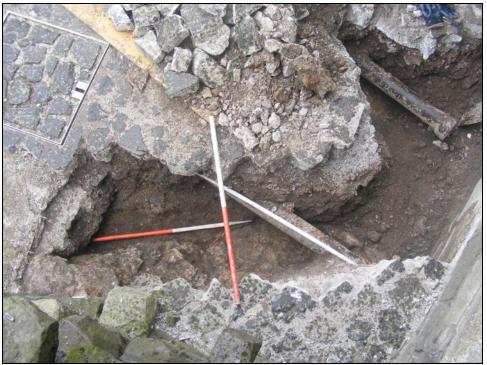
Figure 1: Photograph of the extension to Trench 24 (N to top)

1	Introduction	
2	Excavations	3
3	Conclusions	5
A1.	Appendix 1 : List of Contexts	6
A2.	Appendix 2: List of Drawings	
A3.	Appendix 3: List of Photographs	
A4.	Appendix 4: Illustrations	
г.	4 Di	-
Figure	1: Photograph of the extension to Trench 24 (N to top)	/
Figure :	2: Plan of the extension to Trench 24.	7

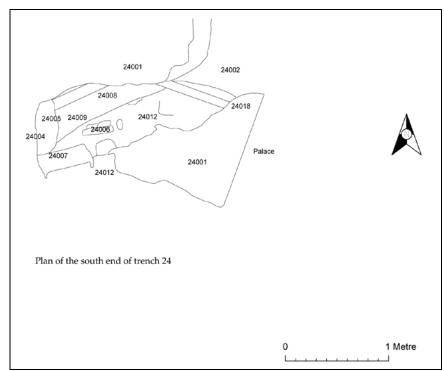
Figure 2: Plan of the extension to Trench 24

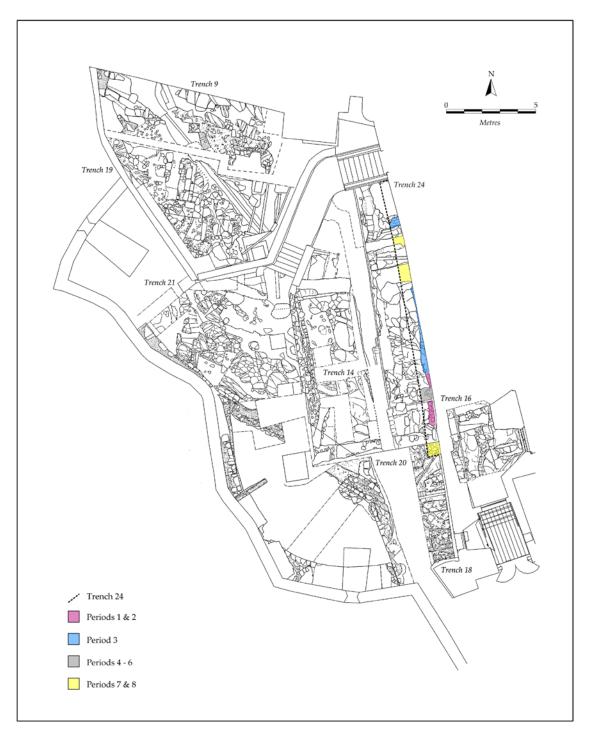
Figure 1 - Phased Plan of Walls in Trench 24

At the N end the proposed depth of the trench is 1.4m deep, however bedrock is around 0.7m deep at this point. Several walls cross and reduce the width of the trench in the re-excavated section of Trench 14, these range from early pre-palace Period 1 and 2 structures to 18th century and 19th century Period 7 and Period 8 ablution house walls (Figure 1).

The proposed route of trench 24 through Trench 18 will encounter further such walls. It would also cut across a previously unexcavated section of the ladies lookout. Cutting such a narrow trench across this area is inadvisable and a larger excavation across this area may be more
