37 Park Avenue, Seaburn, Sunderland

Photographic Recording of WWII Air Raid Shelter in rear garden

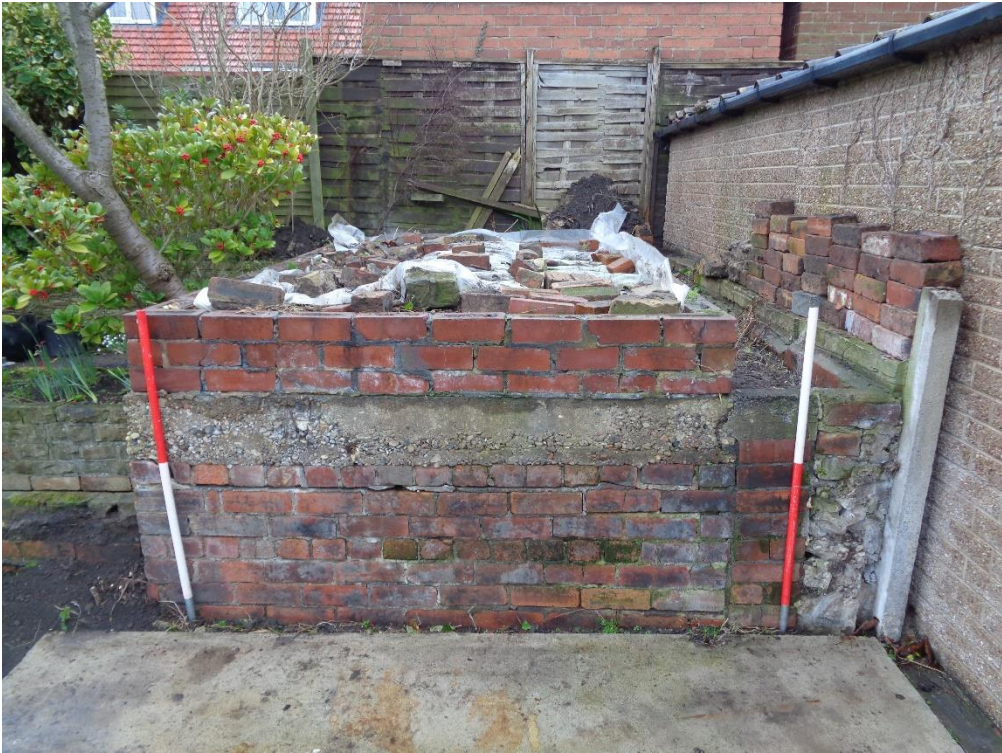
Shot Number	Direction of View	Scale	Description	Taken by:
1	W	2x1m	East Elevation	CS
2	NW	2x1m	South and East Elevation	CS
3	N	1x1m	South Elevation	CS
4	N	2x1m	Stairway	CS
5	S	1x1m	Stairway	CS
6	NW	1x1m	North Wall	CS
7	NE	1x1m	East Wall	CS
8	SW	1x1m	South Wall	CS
9	W	1x1m	West Wall	CS
10	W	1x1m	Detail of Escape	CS
11	W	none	Detail of Escape	CS
12	NE	1x1m	Detail of Drain	CS
13	E	none	Detail of Light Fitting	CS
14	NW	none	General View	CS
