**OBSERVATION & RECORDING REPORT:
ST MARY MAGDALENE CHURCH
GREAT HAMPDEN
BUCKINGHAMSHIRE**

on behalf of Great Hampden Parochial Church Council

August 2014

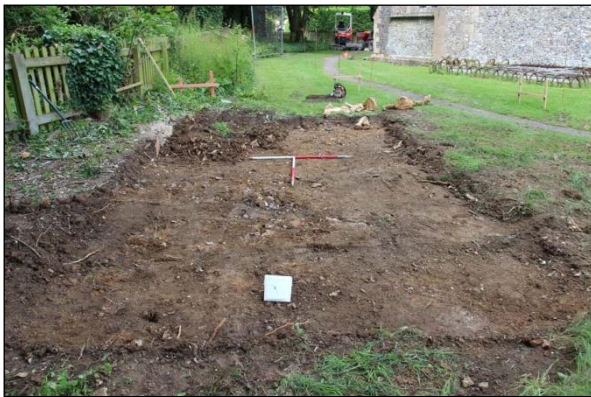
Plate 1: WC block and store room: initial ground reduction, view north

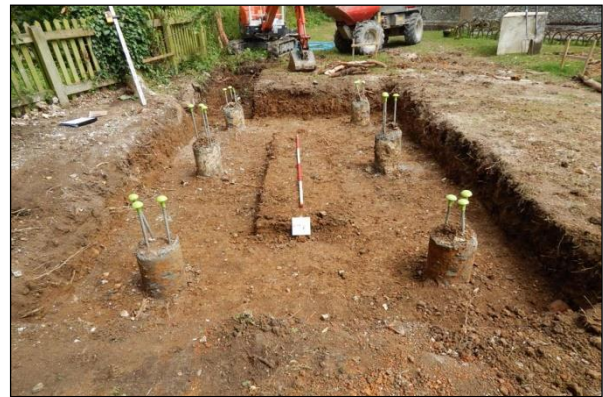
Plate 2: WC block and store room: full ground reduction with piles, view north

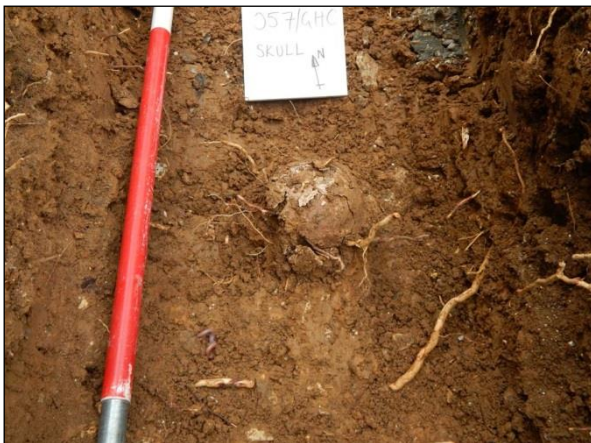
Plate 3: WC block and store room: partial skull, view north

The ground that made up the WC block was very mixed, with occasional fragments of tile and brick. A couple of fragments of human bone were found as was a skull fragment by the central pile to the east. The skull was at a depth of 0.76m BGL, and had probably been disturbed during previous groundworks as it was found in isolation.

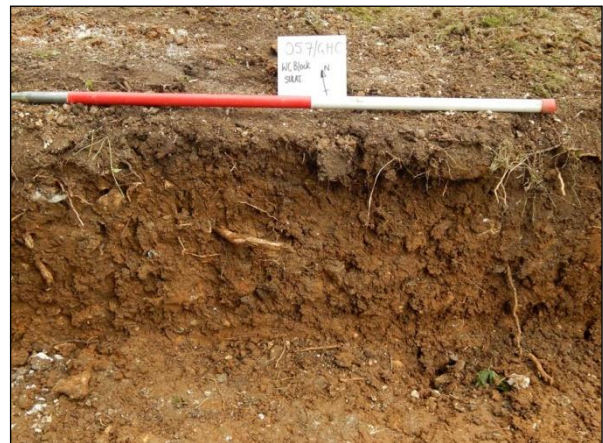
Plate 4: WC block and store room: stratigraphy of ground reduction

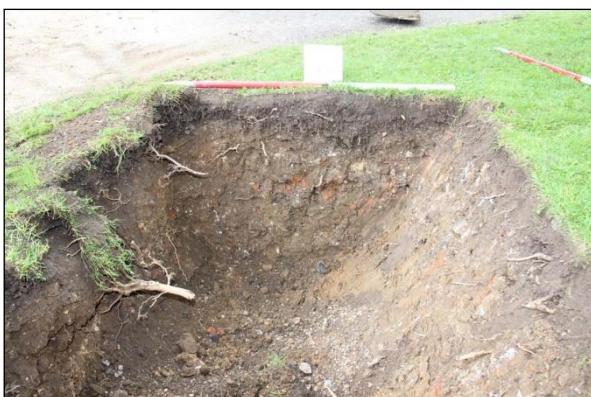
Plate 5: Pit 1, view east

A 0.75m square pit (Pit 1) was excavated to the north of the church to allow a moling machine to pass under the driveway to Pit 2. This was machined to a depth of 0.7m and comprised c.0.12m of topsoil over c.0.42m of made-ground consisting of a mixture of subsoil, some re-deposited natural and frequent modern building debris. The natural was reached c.0.54m BGL and no archaeological features or finds were observed.

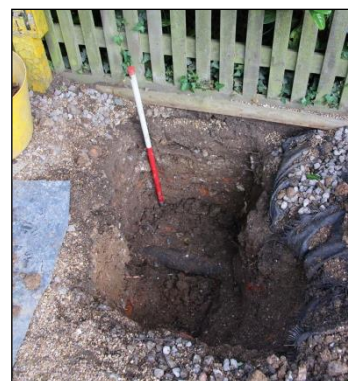
Plate 6: Pit 2, view northeast

Pit 2, which measured 1.0m x 1.5m, was excavated to the east of a water hydrant on the northern edge of the driveway. It was positioned between the church and the manor house, but just beyond the churchyard boundary. The topsoil was 0.15m deep, and the underlying made ground contained brick, mortar, tile, large flints and chalk inclusions as well as some rooting. The water hydrant pipe was found 1.0m BGL, which appeared to be sitting on more solid clay, possibly the natural geology. There were no archaeological features or finds.

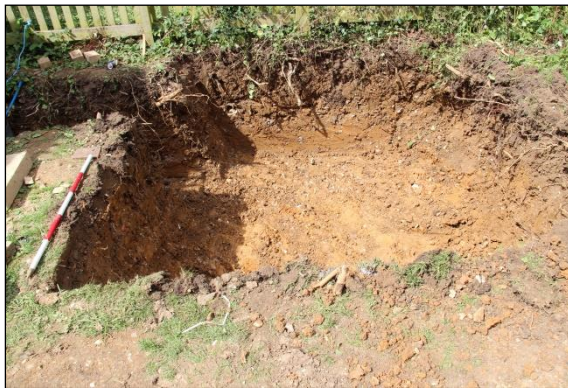
Plate 7: Pit 3, view west

A cess pit (Pit 3) was excavated to the west of the church and north of the new measuring 2.60m square. The topsoil was c.0.12m deep, over c.0.50m of subsoil of mid brown sandy clay with flint and a small amount of CBM. At 1.20m the natural orange clay with gravel had been breached by c.0.30m without revealing any cuts or features, though three fragments of disarticulated human remains were recovered. No further finds or archaeological features were observed.

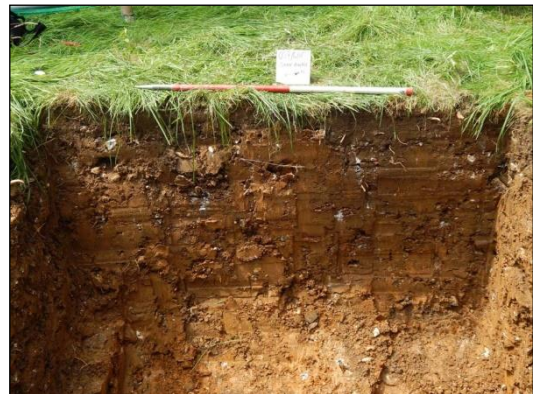
Plate 8: Pit 4 stratigraphy, view west

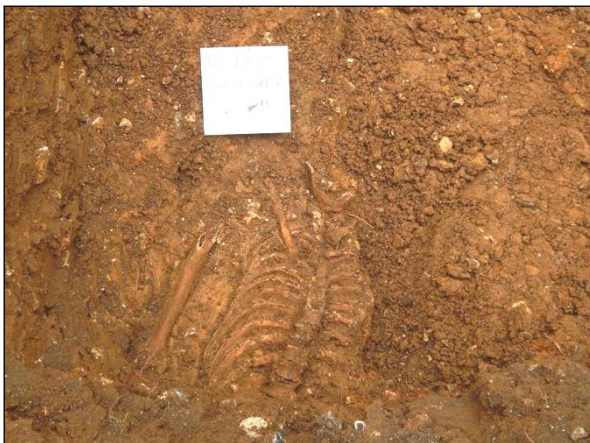
Plate 9: Pit 4: skeleton 2, view west

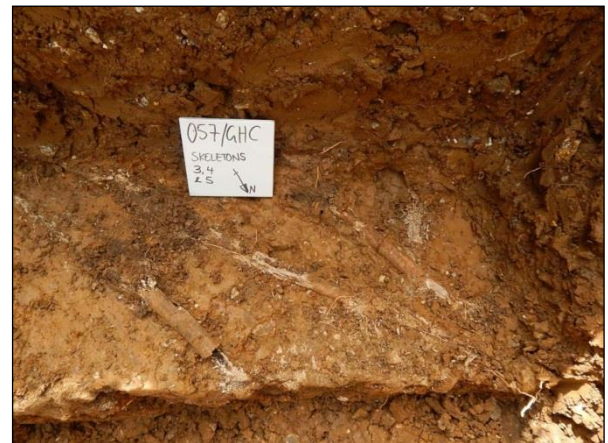
Plate 10: Pit 4: skeletons 3, 4 & 5, view southeast

To the north of Skeletons 3, 4, and 5 was an area c.0.54 x 0.18m of bone fragments of no discernible shape and in such poor condition it was impossible to discern what the bones had been. It could possibly have been the remains of foot or hip bones associated with the legs.

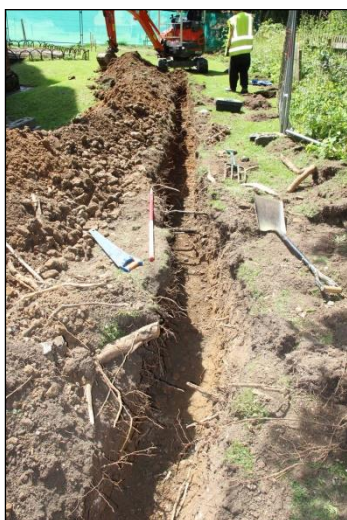
Plate 11: Trench 1, view southwest

Trench 1, which was aligned northeast – southwest, measured 0.5m in width and 0.7m in depth. It was excavated to the west of the western path. The stratigraphy comprised c.0.12m of topsoil over c.0.42m of made-ground, which consisted of mixed subsoil, some re-deposited natural and frequent modern building debris. The area had been considerably disturbed by the presence of two electric cables and a sewage pipe at a depth of c.0.70m. Two small fragments of human bone were found in the trench and it is probable they had been mixed in with the made ground after being disturbed at an earlier point.

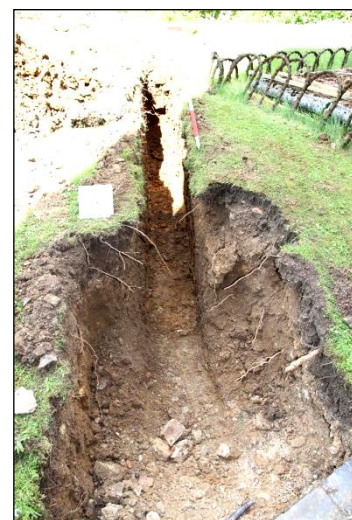
Plate 12: Trench 3 from church, view northwest

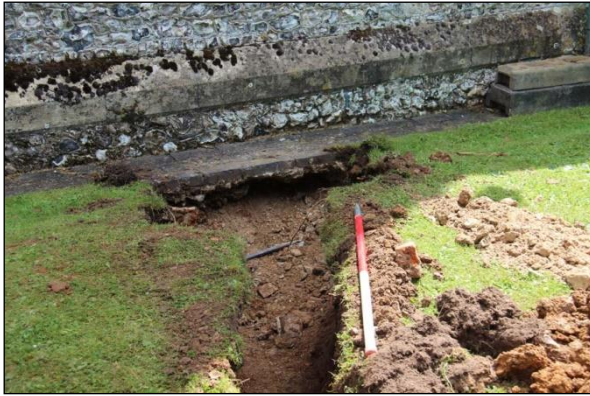
Plate 13: Trench 3 at west wall of church, view southeast

At the face of the west wall of the church was a gully which had to be breached to gain access to the foundations for the coring machine. The gully was made of blue bricks three courses wide and 0.05m deep. Under this was a layer of cement c.0.14m deep over made ground, largely consisting of rubble, at least 0.44m deep. The made ground by the wall was mixed and loose, perhaps to serve as a French drain. The natural geology was not reached and there were no archaeological features found.

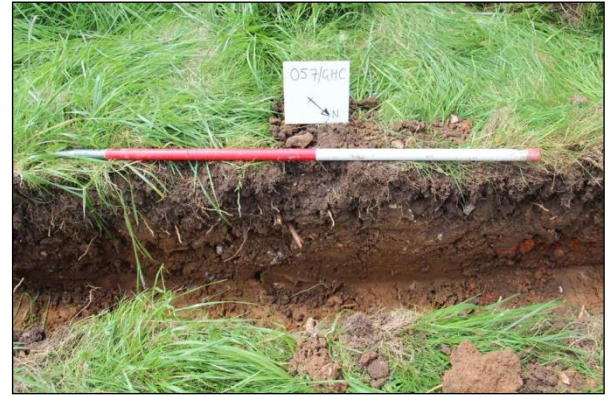
Plate 14: Trench 4 stratigraphy, view southwest

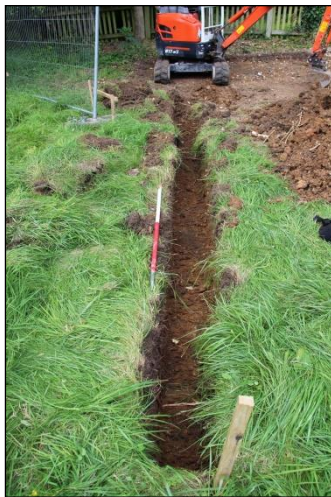
Plate 15: Trench 4, view northwest

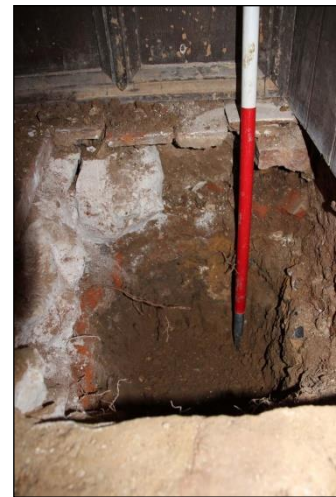
Plate 16: Church interior: pit in bell tower, view west

Church interior (Plate 16)
