KDK ARCHAEOLOGY LTD

Historic Building Recording and Archaeological Watching Brief

Wellwick House
Ellesborough Road
Butlers Cross
Buckinghamshire

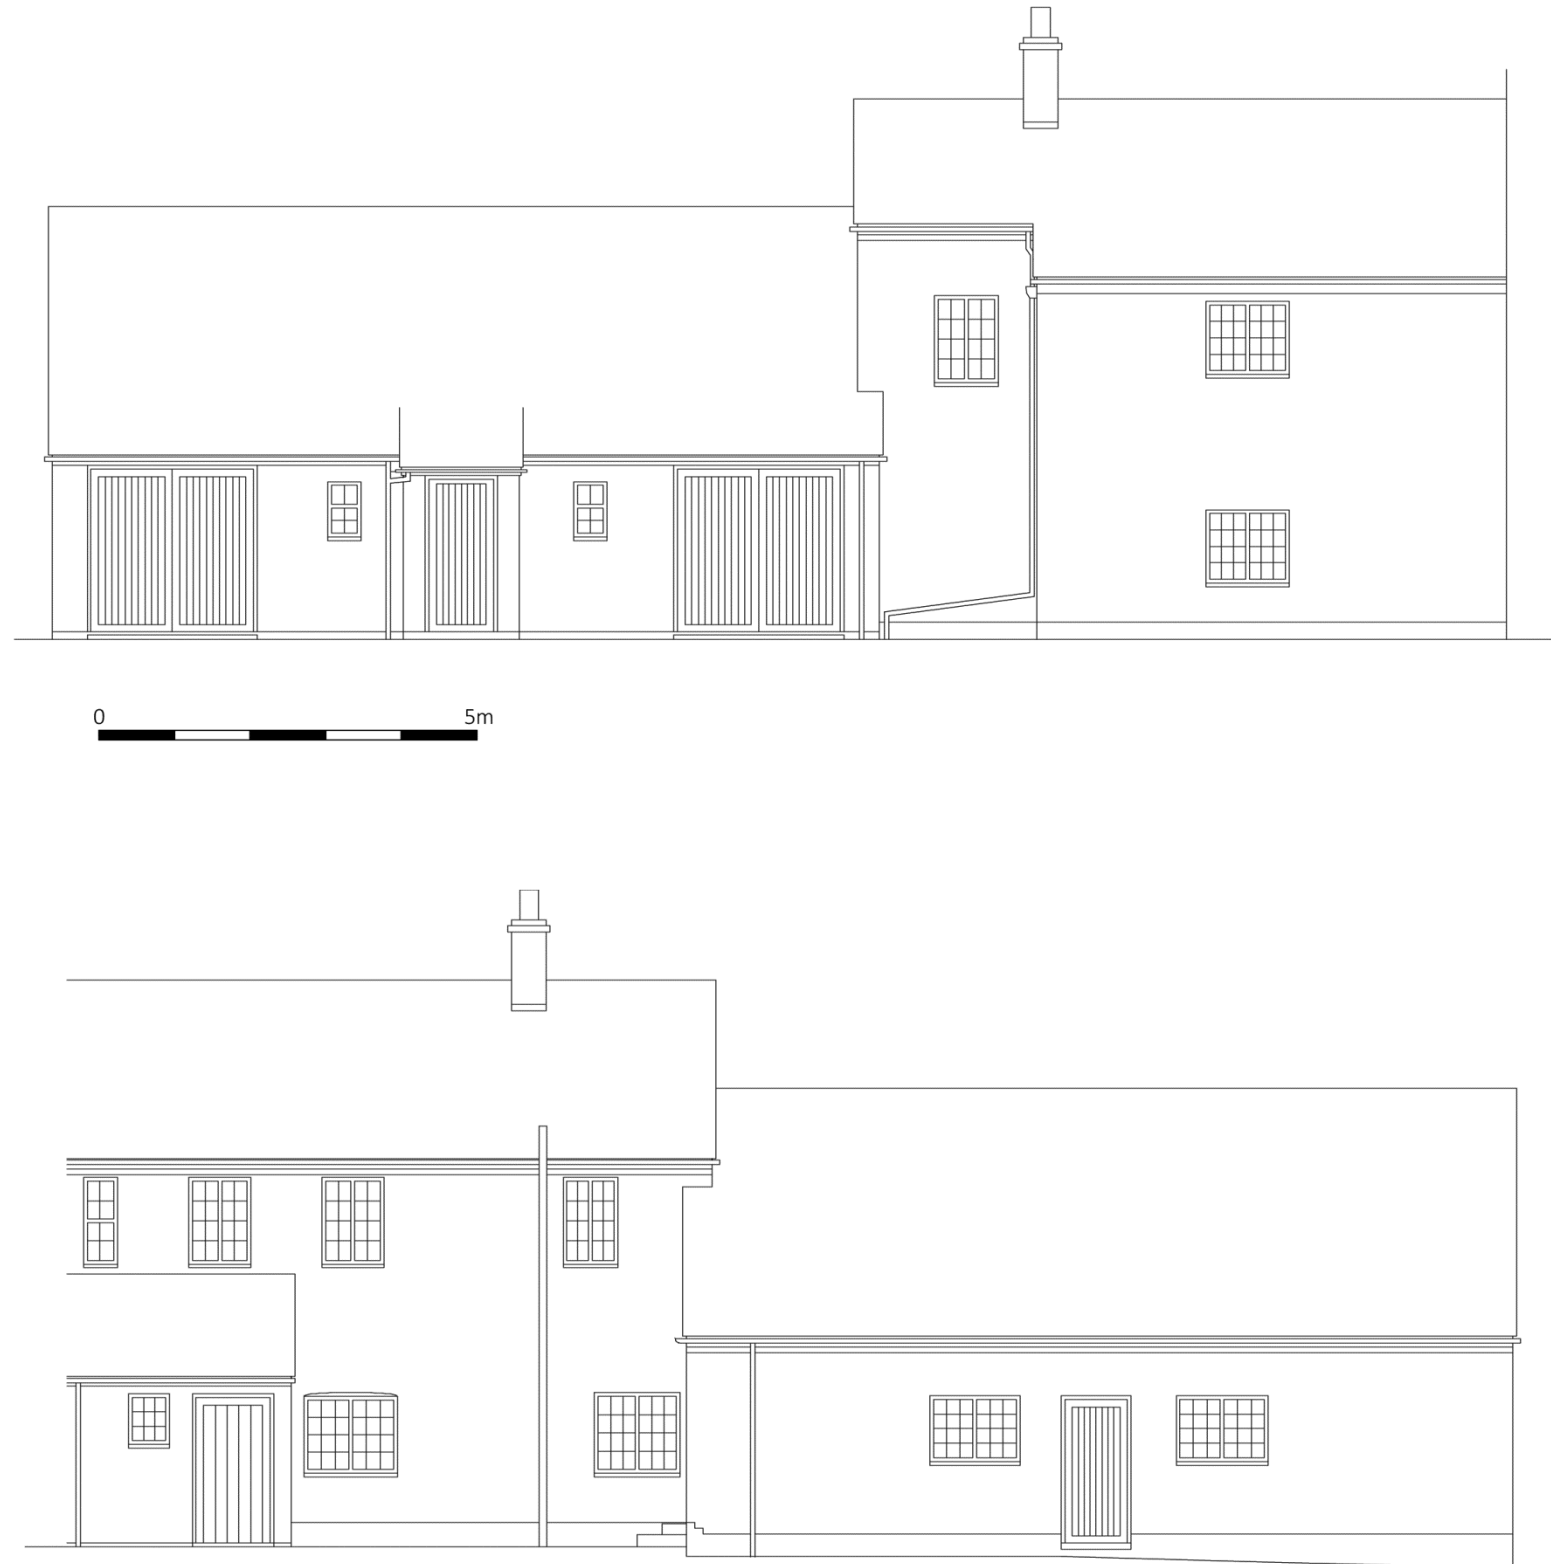
Figure 11: Front and rear elevation of the north wing (scale 1:100)

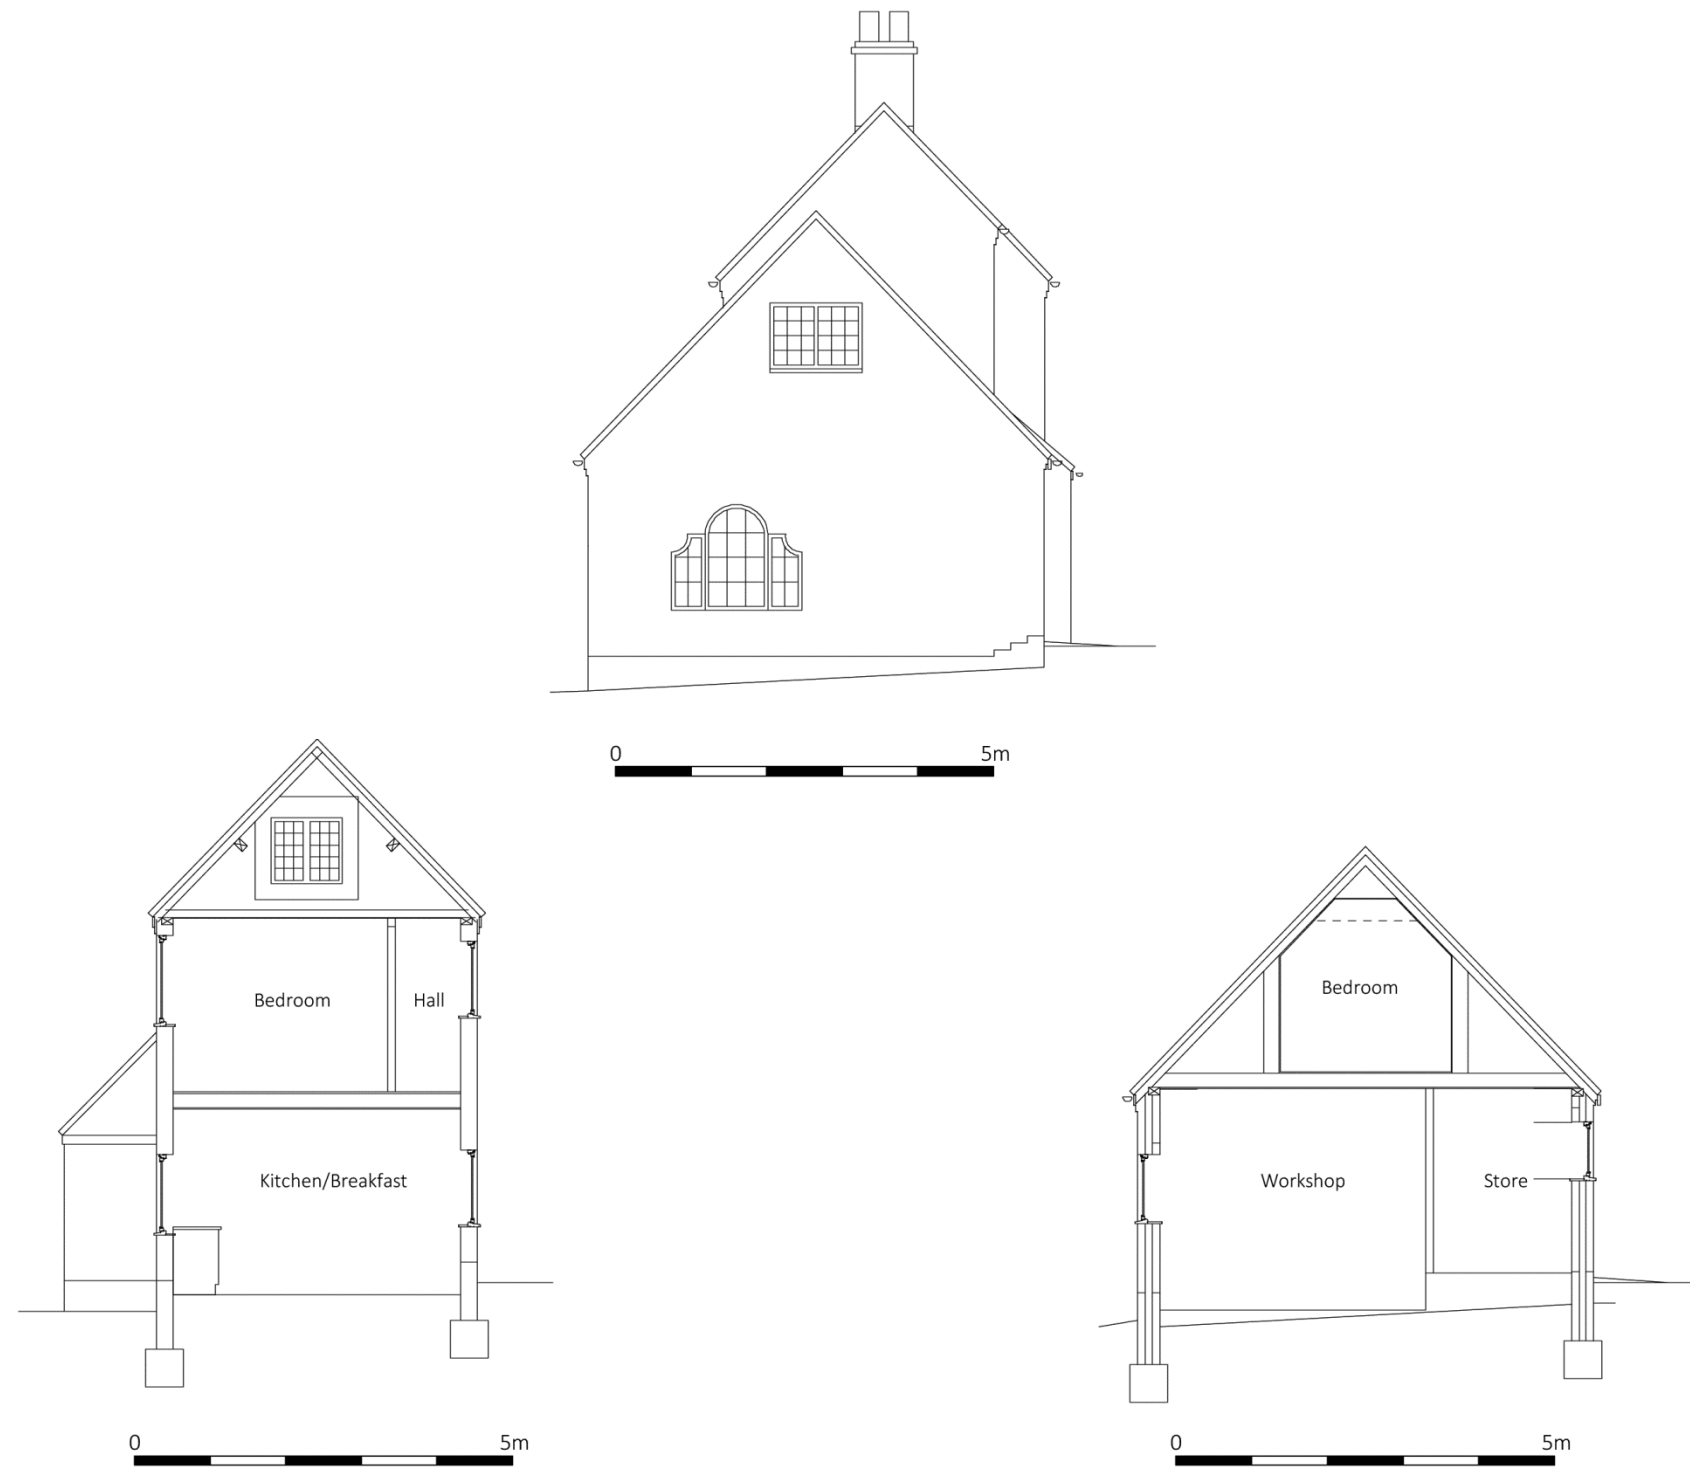
Figure 12: Gable end and sections of the north wing (scale 1:100)

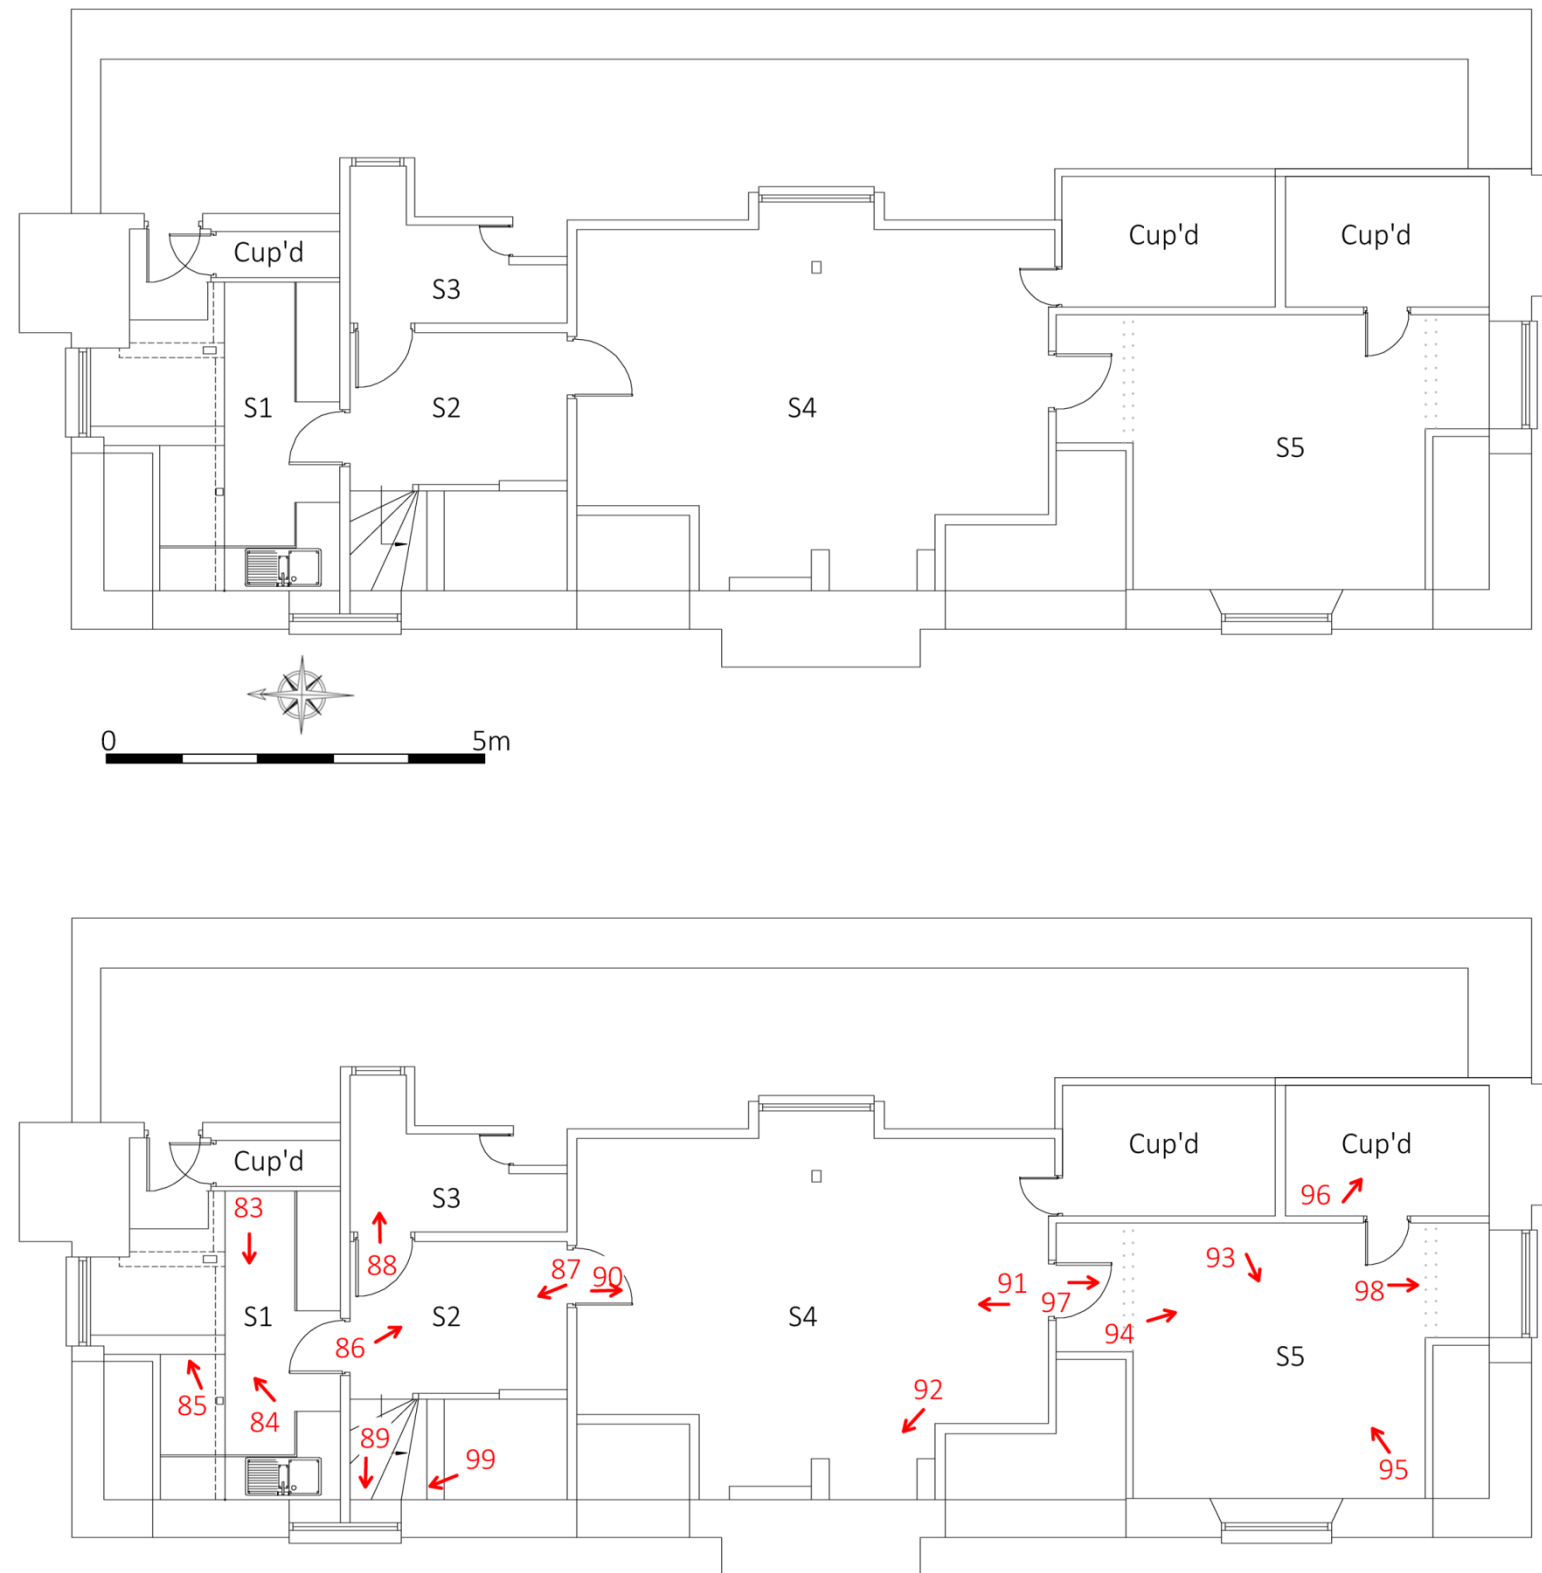
Figure 17: Floor and photo plans of the second floor; numbers are shot numbers and relate to survey sheets in Appendix 1 (scale 1:100)

4.6 **Second Floor** (Fig. 17, Plates 103-118)

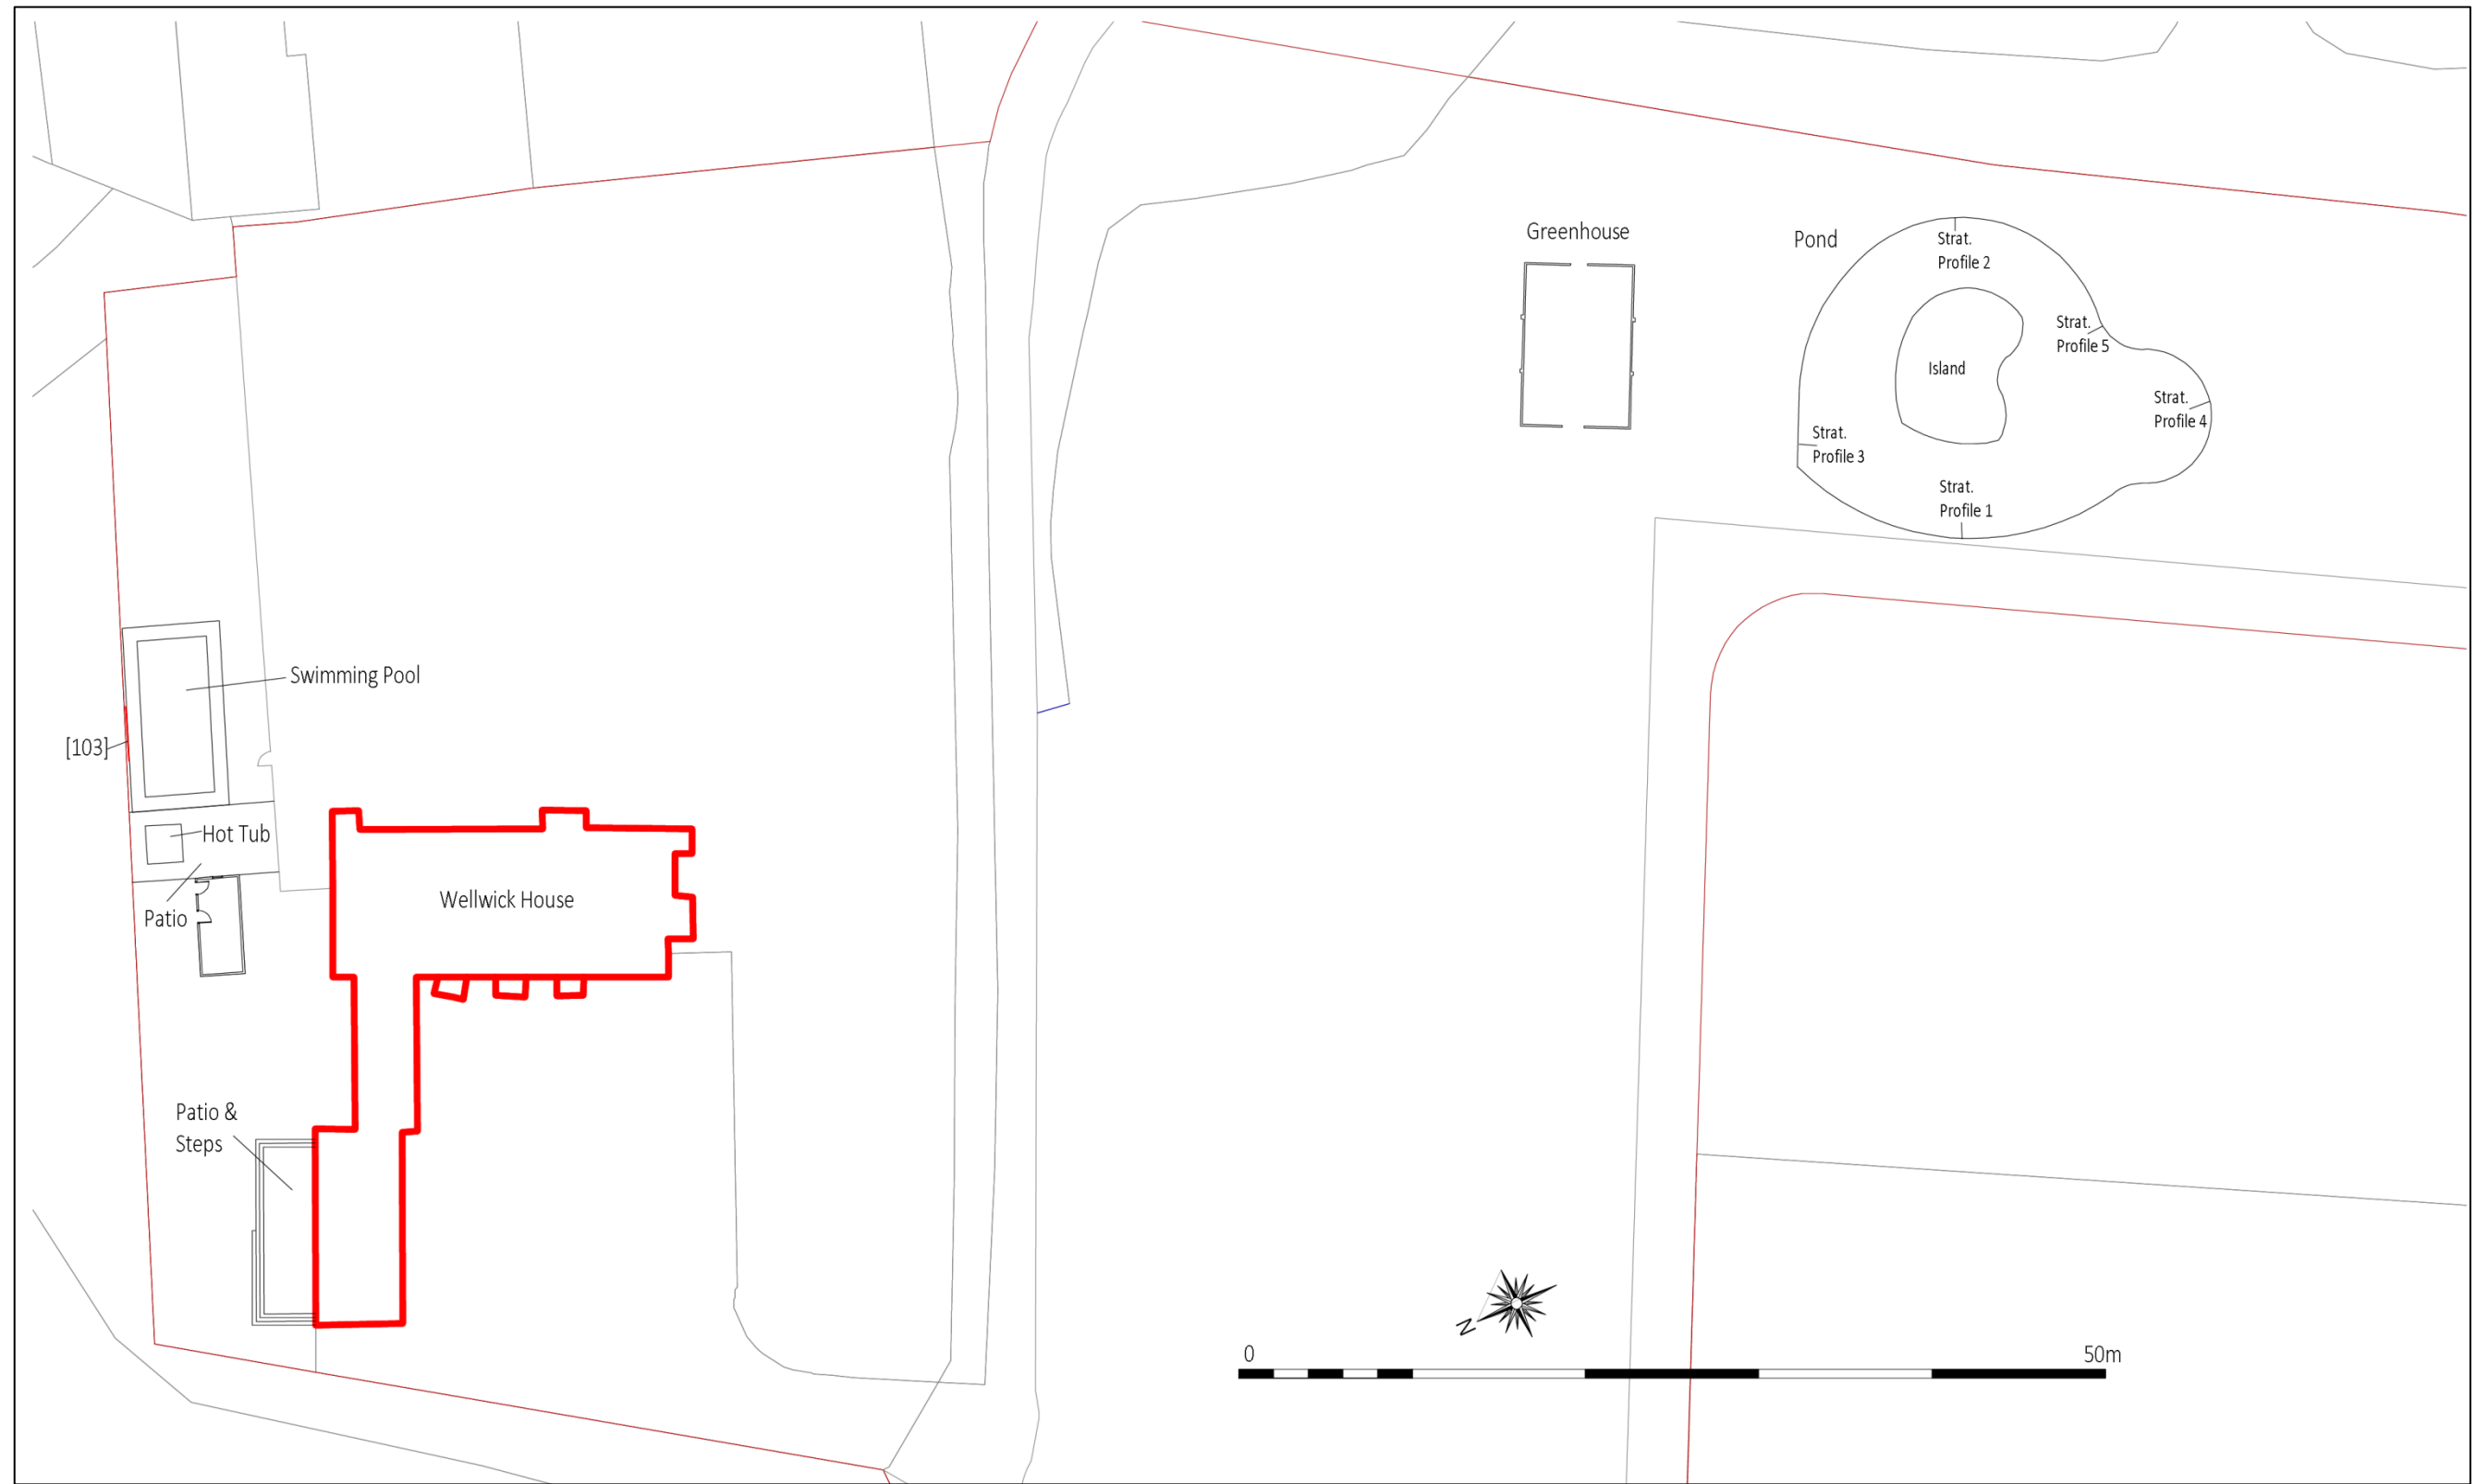
Figure 18: Wellwick House: location of the swimming pool and pond (scale 1:400)

In May and July 2019 KDK Archaeology Ltd undertook a programme of Archaeological Observation and Recording of excavations for the construction of a swimming pool, and a large pond within the grounds of the development site (Fig. 18).

The excavation for the pond, situated c. 70m southeast of Wellwick House (Figs. 18 & 20; Plates 8-14), was archaeologically monitored over the course of three days. The area excavated was 34.5m long x 18m wide and between 0.08m and 1m deep. A 7 tonne excavator with a 1m toothless bucket was used to excavate the pond.

The overgrown remains of a former green/glass house were situated c. 10m northeast of the pond (Fig. 18; Plate 15). The remains consist of a 9.4m x 6.2m rectangular structure, and a standing 0.8m high brick wall (equivalent to 10 courses). The bricks measured 225mm (L) x 110mm (W) x 65mm (D), with a shallow frog and were bonded with concrete mortar. As part of the development this green/glass house will be renovated back to its original use, though this did not involve any excavation.

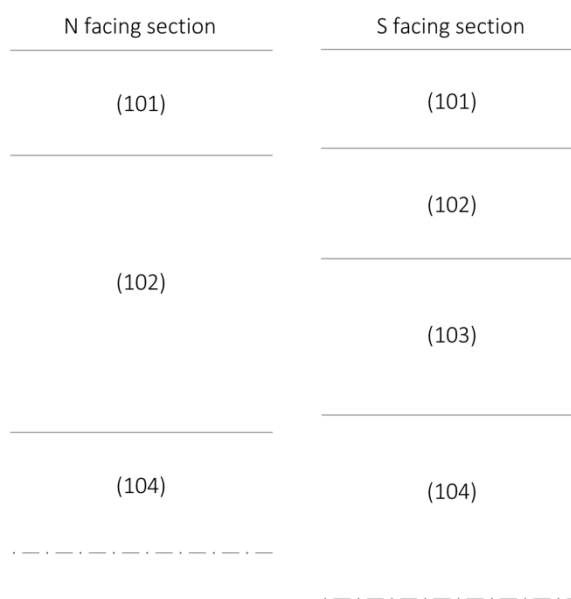
Figure 19: Schematic stratigraphy of the swimming pool (north & south facing sections)

- Topsoil (101): 0.19 - 0.20m deep
- Subsoil (102): 0.21 - 0.53m deep, grey clay with flint inclusions.
- Natural (104): 0.23 - 0.35m deep (exposed), mid brownish clay.

A CBM deposit (103) with a grey clayey matrix, 2.70 long x between 0.25 and 0.30m deep, was observed 0.40m BGL on the north section, 4.5m from the northeast corner of the excavation, where it stratigraphically overlies the natural. The fragmentary bricks within the deposit were well puddled (i.e. the process of mixing water in with, and settling or consolidating the brick fabric) with spanish, which suggests these bricks were manufactured no earlier than the late 18th century. It is likely that these bricks represent the remains of a wall. A water-main pipe was revealed at the southern side of the excavation. No other archaeological materials/features were found within the footprint of the swimming pool excavation.

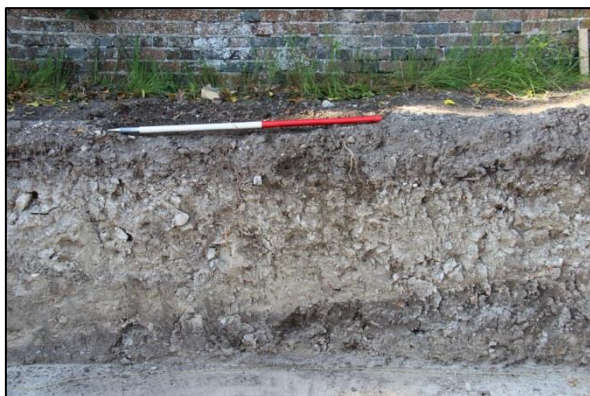
Plate 5: Swimming pool - north facing section

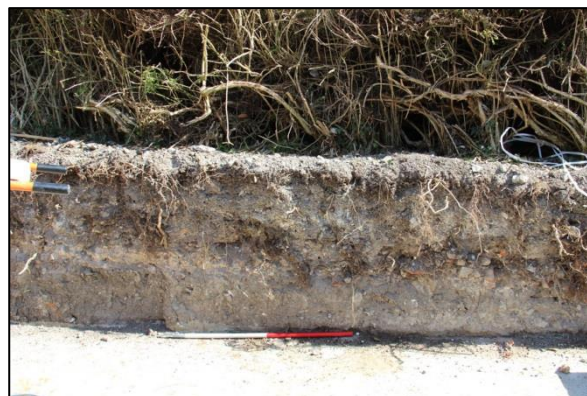
Plate 6: Swimming pool - CBM deposit (103), south facing section

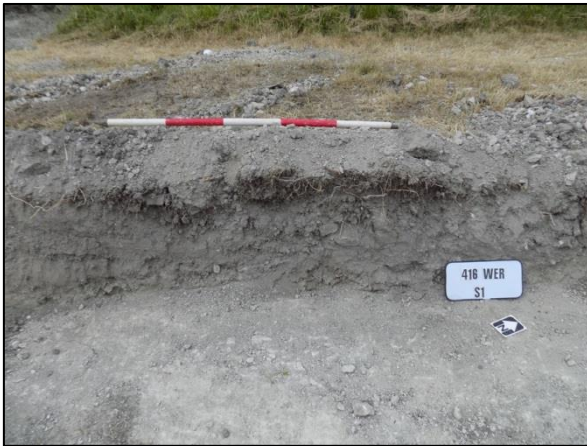
Plate 10: Pond, stratigraphic profile 1

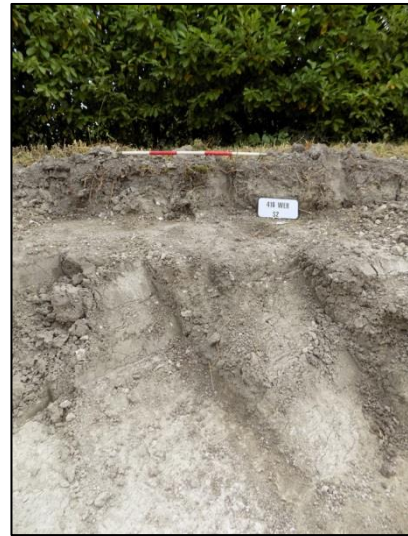
Plate 11: Pond, stratigraphic profile 2

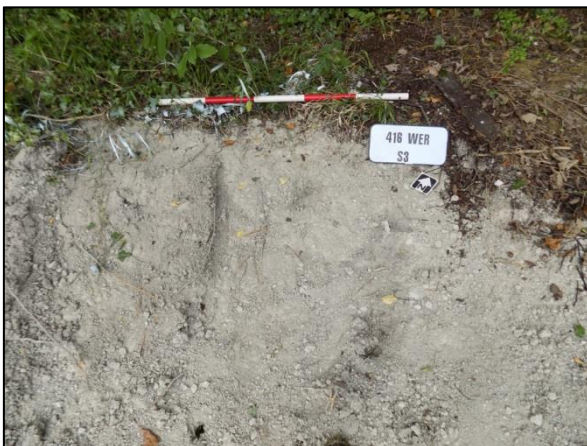
Plate 12: Pond, stratigraphic profile 3

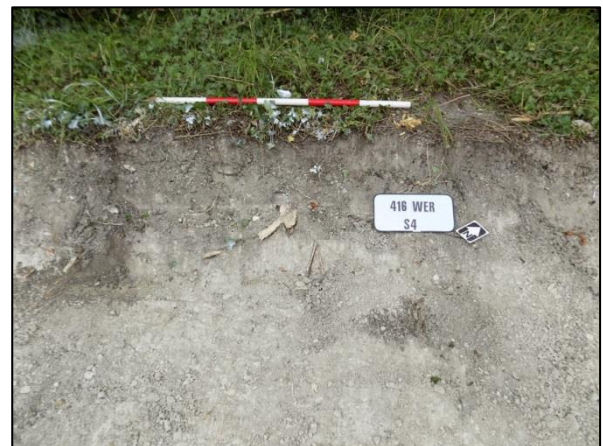
Plate 13: Pond, stratigraphic profile 4

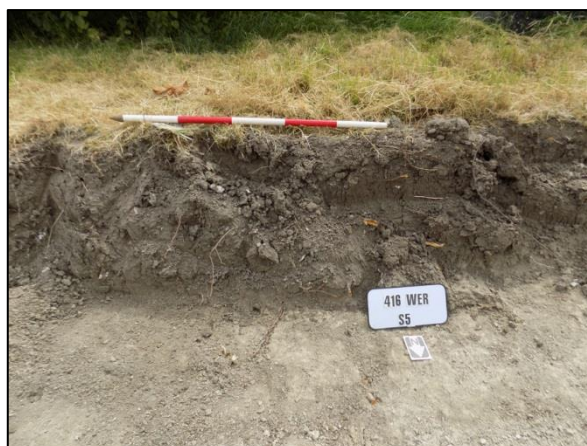
Plate 14: Pond, stratigraphic profile 5

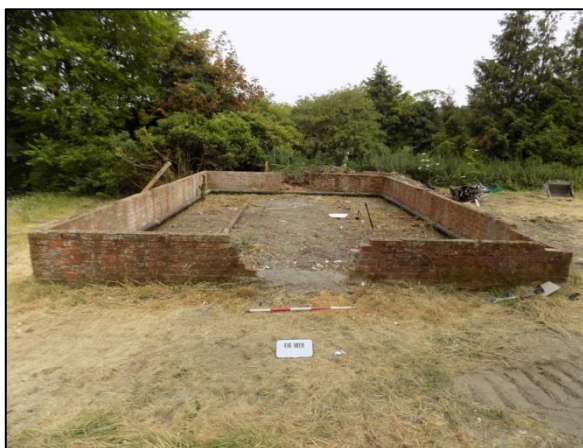
Plate 15: The 'Greenhouse', facing southeast

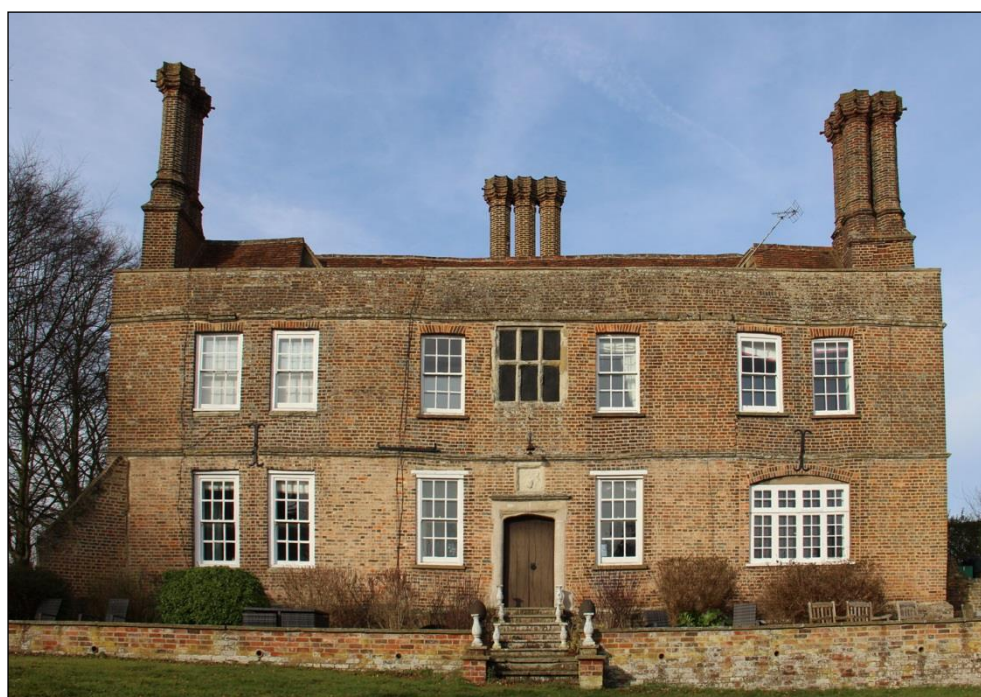
Plate 16: East elevation (1)

The main elevation (Plate 16) is brick built with a substantial buttress to the southeast corner. The brickwork is predominantly in English Bond with some English Garden Bond and has been repointed. There is a string course above each of the floors with a plain parapet above the upper string course. The door frame is clunch built and has a four centred arch, spandrels and a hood mould. The door itself is oak. The clunch made coat of arms above the hood mould has eroded to the extent that it is no longer distinguishable. The Royal Commission of Historic Monument written in 1912 details it as *a chevron between three hats of estate, over the shield a helm and mantle with crest, now broken, apparently an arm holding an arrow* (RCHME 1912). Above the doorway is a stone mullioned window, also of clunch and considerably eroded. To the left of the door are three 6 over 6 timber sash windows on both floors. The first floor fenestration continues the theme at first floor level, but the ground floor has a single 6 over 6 timber sash immediately adjacent to the door and a 4-light timber casement under a segmental arch at the northern end. None of the other ground floor windows have brick arches, but all on the first floor have a relieving arch albeit of haphazard construction. The brickwork as a whole can be seen to have been the result of various building and/or repair programmes; this is clear in the different forms of brick used and in the irregular survival of queen closers on either side of the windows. Structural problems in the building are also clear in that the wall is bowed in more than one location and iron ties as well as a large brick built buttress have been deployed to stabilise the wall. Nonetheless, a number of fissures are apparent on the brickwork and the string courses. The size and fabric of the bricks suggest that the earliest are from the 17th century.

Project code: 416/WER	Project: Wellwick House	Building No/Elevation: 1 East elevation
Doors: Timber door set within a clunch built a doorcase with a coat of arms above		
Windows GF: Three 6/6 timber sash windows to the south of the door; one similar to the north of the door and a 4-light casement under a segmental relieving arch to the north.		
Windows FF: Centrally located clunch built mullion and transom window is flanked by three 6/6 timber sash windows on either side. The two southernmost have stone sills whereas the others are tiled or cement. Soldier course of brickwork above each window.		
Walling material: Brickwork with a stone string course above the ground and first floor windows. Bricks c. 22x10x5cm (8½x4x2") Various episodes of brick construction including historic repairs. Diagonal brick buttress at the southern end. A structural fault has resulted in a recess in the brickwork at the northern end of the wall.

Other Architectural Features: Brick parapet behind which is a small roof at either end of the elevation in front of the main roof. All are clay tiled. Chimney stack at the northern end has 6 shafts and the initials E.B and 1616 on recessed bricks. Eight brick and stone steps lead up to the front door.		
Recorder: KK	Survey Date: 11.12.2018

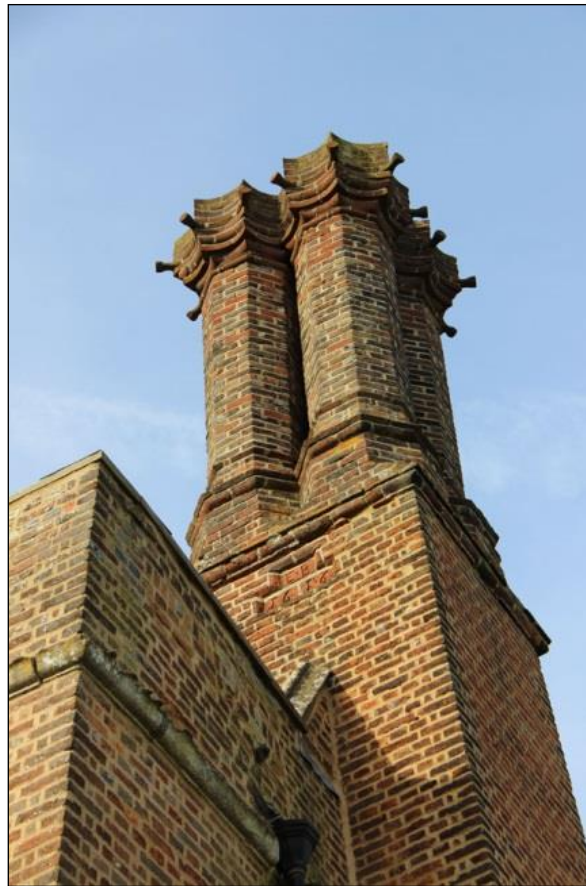
Plate 17: East elevation: chimney detail (4)

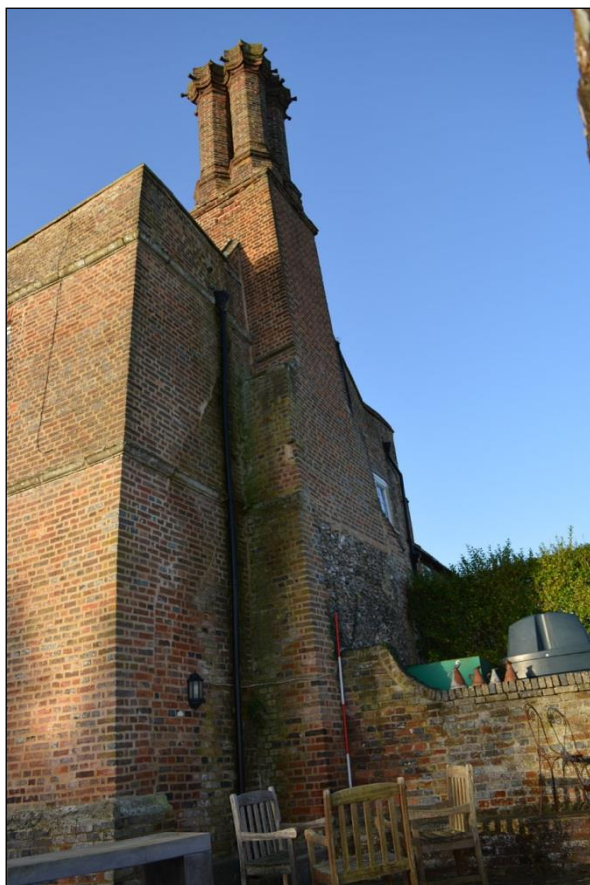
Project code: 416/WER	Project: Wellwick House	Building No/Elevation: 1 North elevation
Doors:		
Windows GF: 2-light casement with leaded glass		
Windows FF: 3-light leaded timber casement set under brick relieving arch		
Windows SF: 3-light stone mullioned window		
Walling material: Predominantly brick with some flint walling at first floor level. Ground floor brickwork is recent, but that above the first floor window is 17 th century. Extensive repairs evident in NW corner. String course beneath the parapet extends as far as the chimney stack.		
Other Architectural Features: End stack is predominantly brick built with a section of flint walling at ground floor level. It has a square base with 6 octagonal shafts and elaborately moulded heads.		
Recorder: KK	Survey Date: 11.12.2018

Plate 18: Main house: north elevation, eastern end (2)

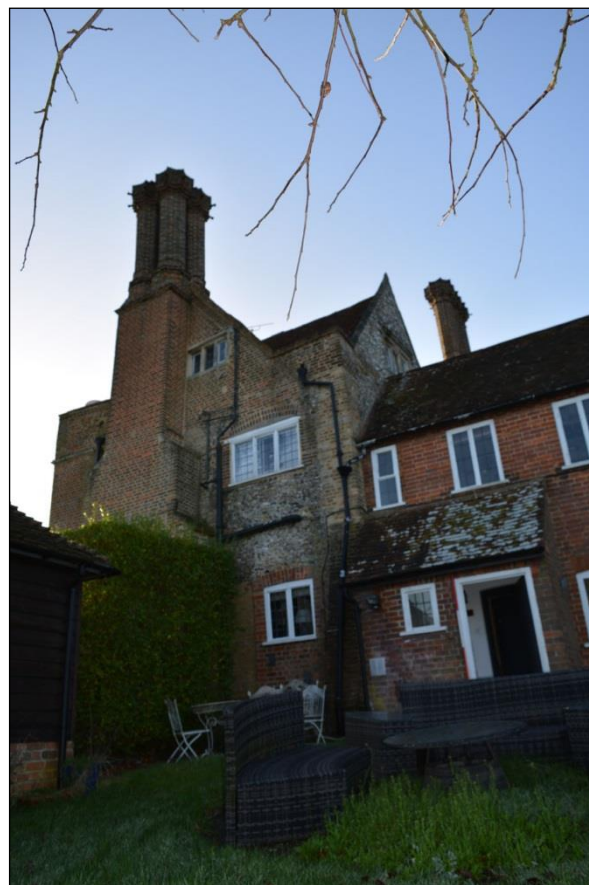
Plate 19: Main house: north elevation (3)

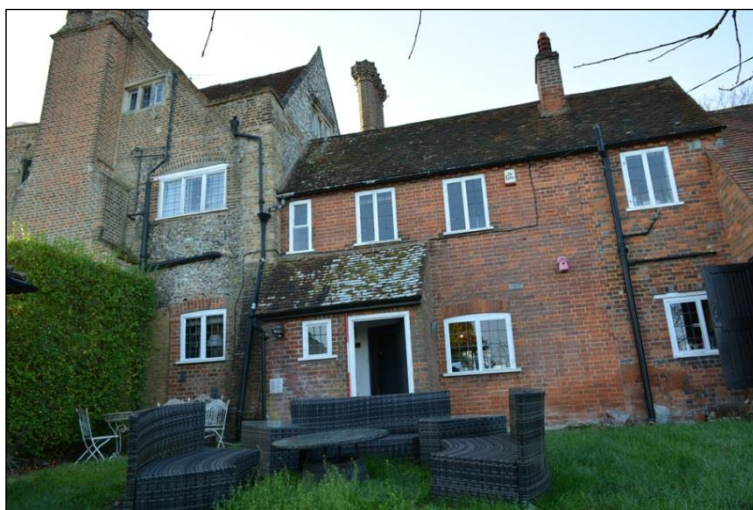
Project code: 416/WER	Project: Wellwick House	Building No/Elevation: 2 North wing, north
Doors: Timber door in lean-to porch		
Windows GF: Fixed light window to east of door and 2-light casement under brick segmental arch to the west. Both have timber sills. Queen closers to the western window. A further 2-light timber casement at the western end of the 2-storey section under brick soldier course. No queen closers.		
Windows FF: Three 2-light timber casements directly under the eaves with queen closers to either side. Single light window to the east.		
Walling material: 19 th century brickwork in Flemish bond with dentilled eaves. The walling to the east of the downpipe appears to be later than that to the west. A clear line of queen closers indicates the eastern end to be earlier.		
Other Architectural Features: Lean-to brick porch under clay tiled roof added later.		
Recorder: KK	Survey Date: 11.12.2018

Plate 20: Building 2: north elevation (5)

The 2-storey extension to the north of the main range was constructed in two phases as is clear in the brickwork (Plates 20 & 21). The western end of the south elevation is slightly recessed and it is clear from this and the brickwork on the north elevation that this was added to the kitchen some decades later. Both the recessed part of the north range and the earlier kitchen section have 2-light timber windows on the first floor, and the kitchen has the same at ground floor level. Of interest is the different use of brickwork on this, in essence the front elevation of the building. Whereas the rear wall of the kitchen has an irregular variation of English Bond in stoney mortar, this elevation is of Flemish Garden Wall Bond. The north elevation of the western end is built in Flemish bond using recycled bricks in cement mortar. The porch, like the garage is in Stretcher Bond and is probably of a similar, mid-late 20th century, date. This entire range of buildings has dentilated eaves.

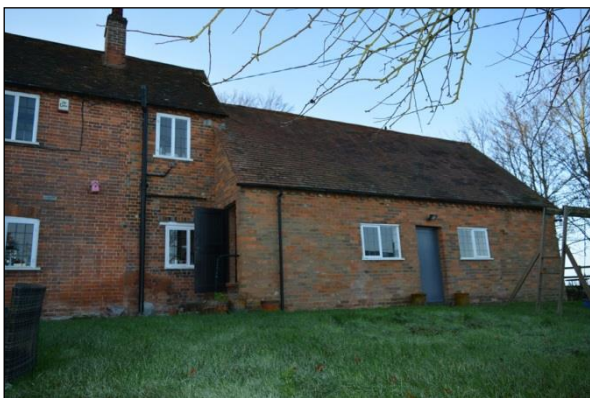
Project code: 416/WER	Project: Wellwick House	Building No/Elevation: 3 North, east and west els
Doors: Timber door in north and east elevations		
Windows GF: 2-light casement on either side of the door		
Windows FF: 2-light timber casement in the west elevation		
Walling material: 20 th century brickwork in Stretcher bond with dentilled eaves.		
Other Architectural Features: Clay tiled roof		
Recorder: KK	Survey Date: 11.12.2018

Plate 21: Building 3: north and east elevations (6)

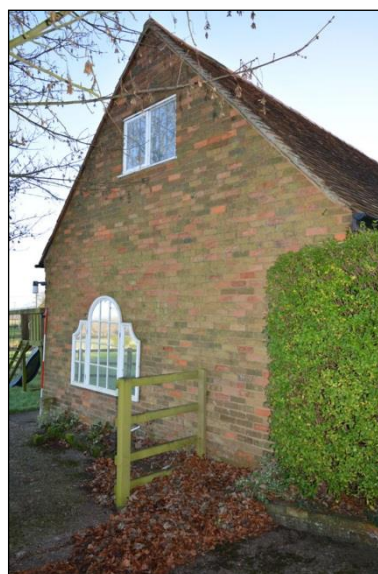
Plate 22: Building 3: west elevation (7)

The west elevation of the garage is plain other than a 2-light timber casement under the eaves, whilst 2-light windows on either side of a timber door grace the north elevation (Plate 22). The south elevation of the garage has a central door flanked by a single window beyond which are double garage doors on either side (Plate 23).

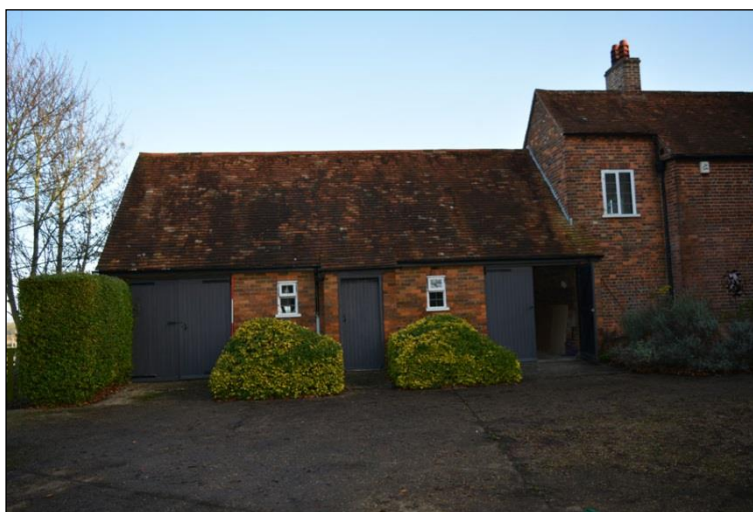
Project code: 416/WER	Project: Wellwick House	Building No/Elevation: 3 South elevation
Doors: Two modern double timber doors with a single door in slight projection in the centre of the elevation.		
Windows GF: 2-light top hung window on either side of the single door		
Walling material: Brickwork in Stretcher Bond		
Other Architectural Features:		
Recorder: KK	Survey Date: 11.12.2018

Plate 23: Building 3: south elevation (8)

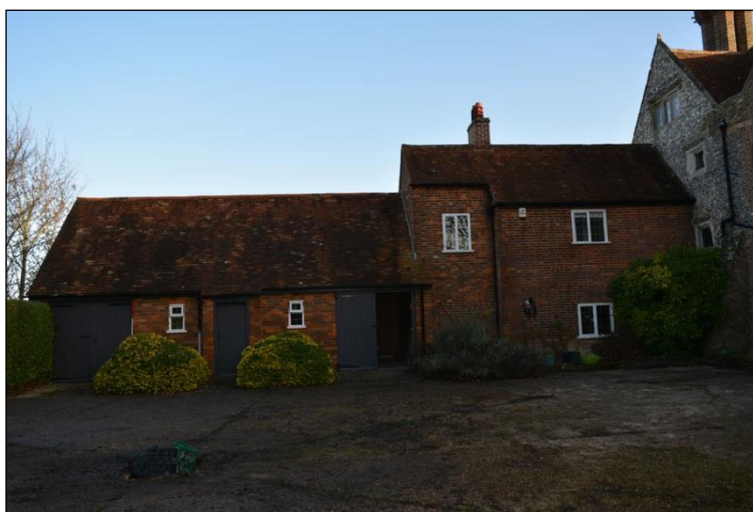
Project code: 416/WER	Project: Wellwick House	Building No/Elevation: 2 South elevation
Doors: None		
Windows GF: 2-light timber window under brick soldier course. Timber sill		
Windows FF: 2-light timber window with timber sill directly below the eaves		
Walling material: 19 th century brickwork in Flemish bond. No queen closers		
Other Architectural Features:		
Recorder: KK	Survey Date: 11.12.2018

Plate 24: Buildings 2 & 3: south elevation (9)

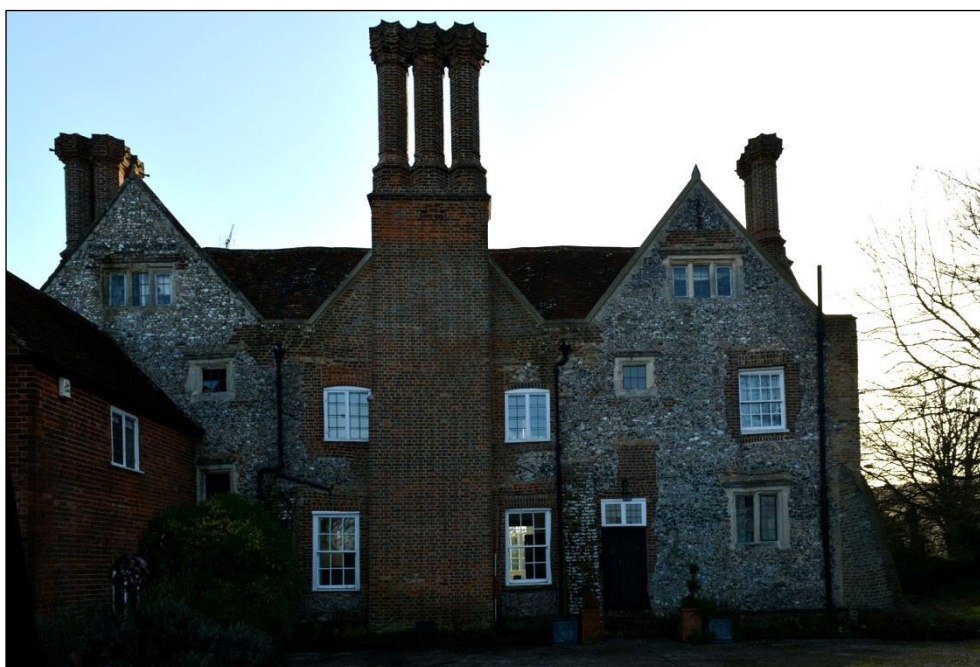
Project code: 416/WER	Project: Wellwick House	Building No/Elevation: 1 West elevation
Doors: Timber door in southernmost section		
Windows GF: Two 6/6 timber sash in central section; 2-light stone mullioned window in southern section. Stone window in northernmost section half way between ground and first floors that lit staircase		
Windows FF: Two 2-light timber casements under relieving arches in central section; single light stone window and 8/8 timber sash in southern section; single light stone window in northern section. Stone window in southern section brick upped		
Windows SF: 3-light stone mullioned window in northern section. All stone windows have stone (not clunch) moulded string course serving as hoodmould		
Walling material: Predominantly flint built, the central section has a large brick chimney stack with brick surrounding the windows		
Other Architectural Features: Chimney has 3 octagonal shafts on rectangular base. AW 1616 inscribed in recessed bricks at the top of the base

Plate 25: Building 1: west elevation (10)

The rear elevation is predominantly of flint and field stones (Plate 25). The brickwork is largely confined to the central section, where there is a large chimney stack, as well as brickwork around the windows and in the gable. There are further, smaller areas of brickwork to the south of this, most significantly the edge of the wall and the diagonal buttress supporting it. The fenestration is more varied in this elevation, with several stone windows surviving in the northern and southern gables, with the central gable sporting 6 over 6 timber sash windows at ground floor level and 2-light timber casements above. In addition to the mullioned stone windows in the southern gable, there is also an 8 over 8 timber sash in the first floor and a rectangular 2-light window above the back door, which replaces a stone window that was noted by RCHME in 1912. The plank and batten door to the rear has three brick steps leading up to it.

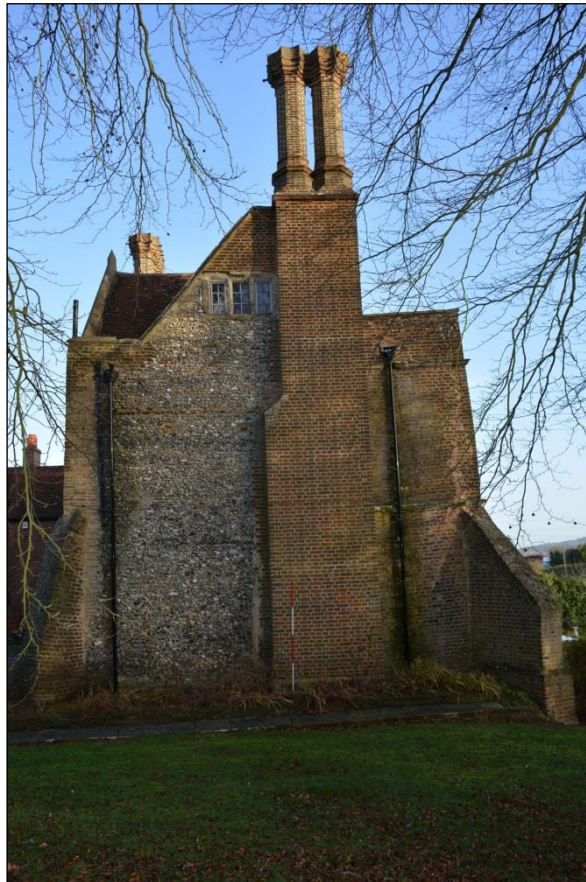
Project code: 416/WER	Project: Wellwick House	Building No/Elevation: 1 South elevation
Windows SF: 3-light clunch mullioned window		
Walling material: Flint to the west of the chimney stack and brickwork to the right and above the second floor window. Structural repairs evident to east of chimney. Stone string course from front elevation extends as far as the chimney in this elevation.		
Other Architectural Features: Two octagonal shafts on chimney stack the same style as the north and west elevations. Chimney appears to have been rebuilt, or heavily restored as the coursing is very regular and queen closers are present. The diagonal buttress is a later addition and is not keyed into the building.		
Recorder: KK	Survey Date: 11.12.2018

Plate 26: Building 1: south elevation (11)

The south wall of the main range has only a 3-light stone mullioned window at attic level (Plate 26). The remainder of the wall is devoid of openings, but is of different building materials. With the exception of the wall above the window, flint and fieldstone make up most of the wall to the west of the brick built chimney stack and the wall to the east as well as the western edge of the elevation and the buttresses on both corners are of brick. Whereas the chimney stack has carefully laid bricks in English Bond with queen closers defining the edges on both sides, the brickwork in the wall to the east of the stack is less well laid, although also in English Bond. It would appear that the stack has seen some remedial work, which the adjacent wall is lacking. An interesting survival is the brick defined put log holes that can be seen at three levels in the flint walling.
