KDK ARCHAEOLOGY LTD

Historic Building Recording and Archaeological Watching Brief

Wellwick House
Ellesborough Road
Butlers Cross
Buckinghamshire

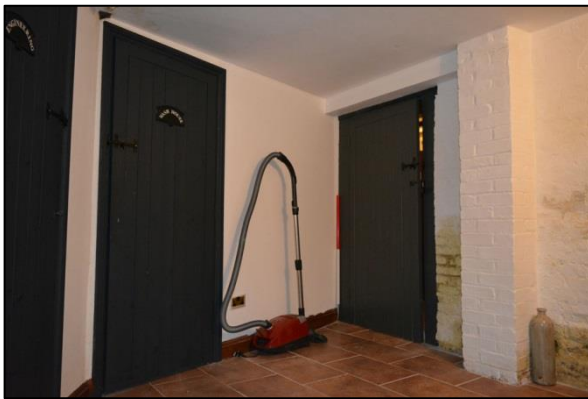
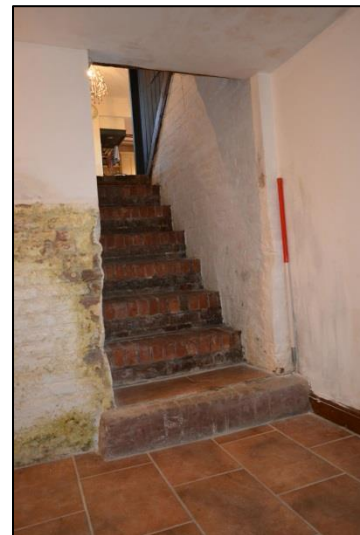
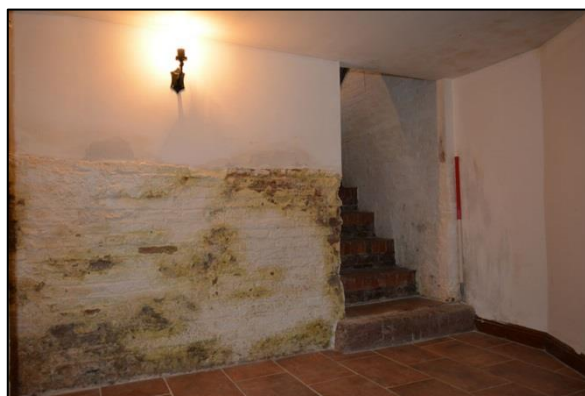
Project code: 416/WER	Project: Wellwick House	Room no: B1
Location: W end		Function: Lobby
Wall form & decor: South and west walls largely brick built, but modern stud partitions make up the rest. Earlier brickwork in east wall, 1.23m high. Bricks measure 20-22cm.		
Ceiling / roof structure: Modern painted plasterboard		
Doors: Four modern ledger doors		
Floor: Modern stone effect tiles		
Staircase: Brick built stairs of 8 treads in NW corner		
Recorder: KK		Survey Date: 11.12.2018

Plate 29: Room B1: northwest corner (14)

Plate 30: Room B1: southeast corner (15)

Plate 31: Room B1: east wall (16)

The basement underlies the main range and is accessed by a brick staircase from the kitchen. The stairs lead to a recently subdivided cellar with a 'lobby' area (B1; Plates 29-31) leading to a boiler room (B7; Plates 45-46), a laundry (B5; Plates 42-43) and two older cellars, B2 (Plate 32) and B3 (Plates 33-38). The laundry is further subdivided with a small WC in the southeast corner.

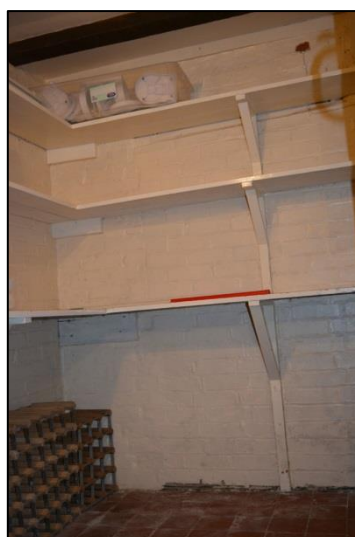
Project code: 416/WER	Project: Wellwick House	Room no: B2
Location: S of B1		Function: Pantry
Wall form & decor: Painted brick. North wall has queen closers at w end of wall. East wall is modern and built in stretcher bond. South wall has a bricked up doorway. West wall was breached in 20th century to install window		
Ceiling / roof structure: Three exposed joists aligned, c.13 cm wide on 40cm centring east -west		
Windows: Modern installation to west		
Doors: Modern door to north		
Floor: Quarry tiles		
Fireplace:		
Staircase:		
Other architectural details: South and east walls are shelf lined		
Recorder: KK	Survey Date: 11.12.2018

Plate 32: Room B2: view to northwest (17)

A further blocked opening is evident in the wall between cellars B2 and B3, where the lintel of an earlier door survives behind the larder shelves of B2. A blocked opening in a different form is present in the west wall of Room B3, where a deep cupboard has been created out of a former window recess. Whereas this recess is probably the original that was noted by RCHME to be blocked in 1912, the window opening in B2 is a later, possibly 19th century installation, and that in the west wall of B4 is modern.

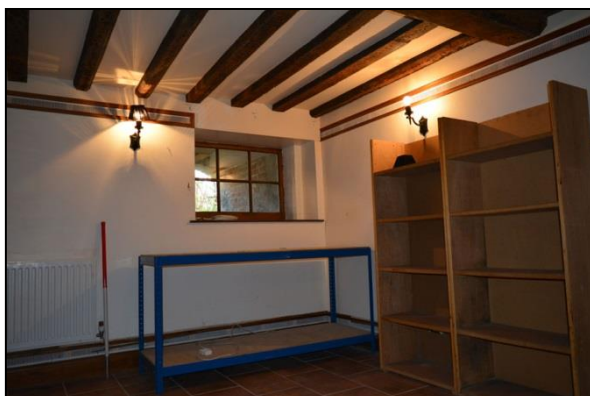
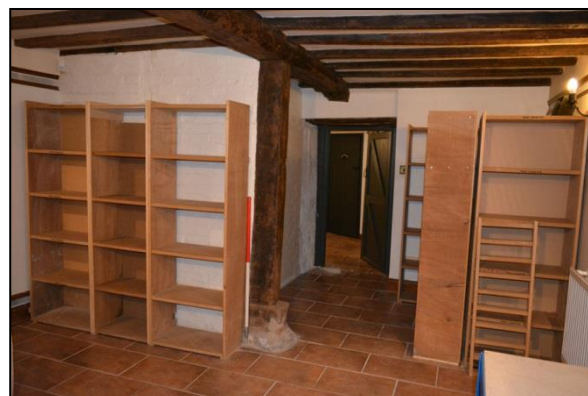
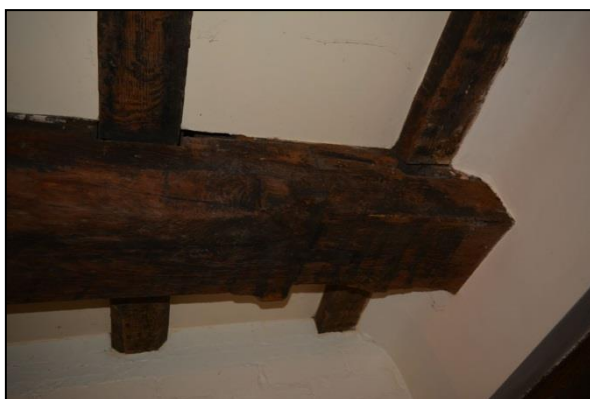
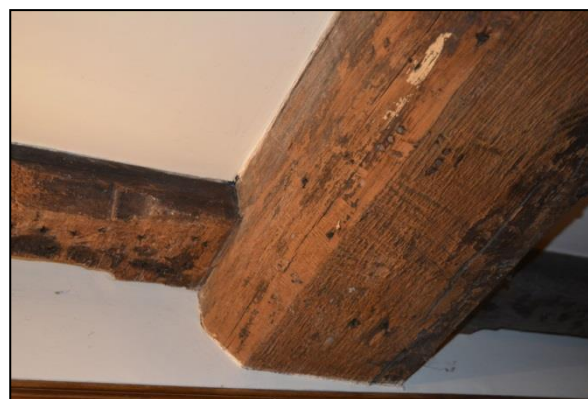
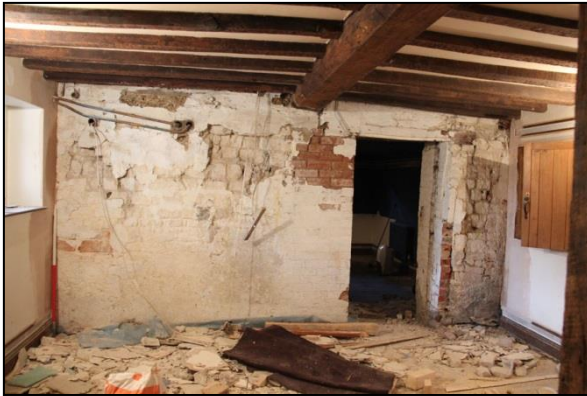
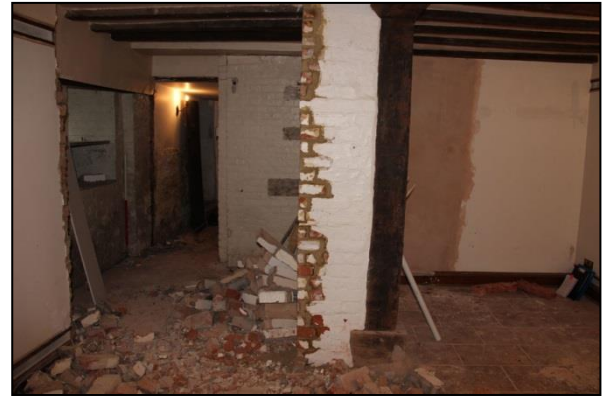
Project code: 416/WER	Project: Wellwick House	Room no: B3
Location: Centre of basement		Function:
Wall form & decor: Painted modern brick partition walls to B2. Other walls are painted plaster		
Ceiling / roof structure: North-south aligned beam, c28cm wide, with lamb's tongue chamfer stop (LTCS) to north. A bridle butted scarf joint at northern end of beam extends beam northwards beam. Chamfer is 8cm deep. Joists, c.2 cm wide on 44cm centring. Some have seven replaced in antiquity and have no chamfers, others also have LTCS.		
Windows: Modern installation to east		
Doors: Modern door to north and another to B4. Double cupboard doors to west		
Floor: Modern stone effect tiles		
Fireplace:		
Staircase:		
Other architectural details: Deep cupboard to SW		
Recorder: KK		Survey Date: 11.12.2018

Plate 33: Room B3: view to northwest (18)

Plate 34: Room B3: view to south (19)

Plate 35: Room B3: timber detail (23)

Plate 36: Room B3: timber detail (24)

Plate 37: Room B3: north wall fabric exposed

Plate 38: Room B3: view to south during works

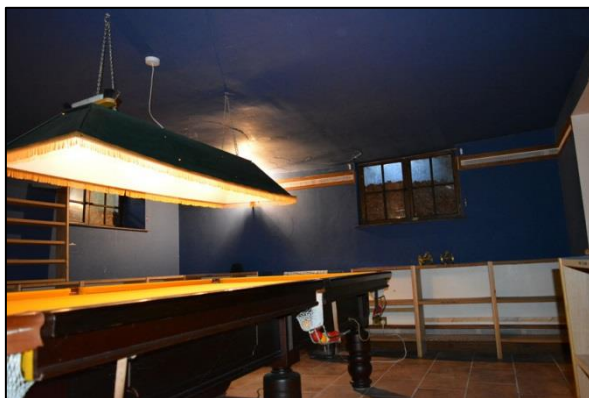
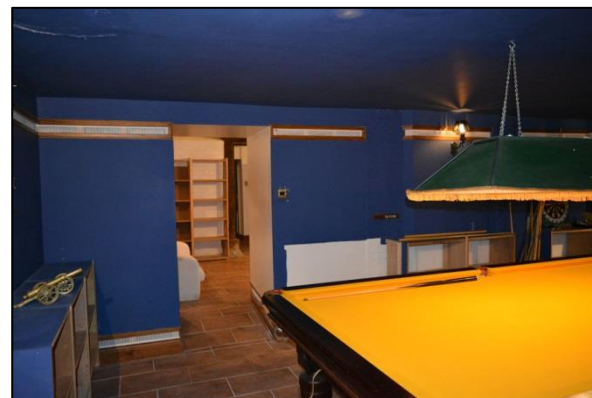
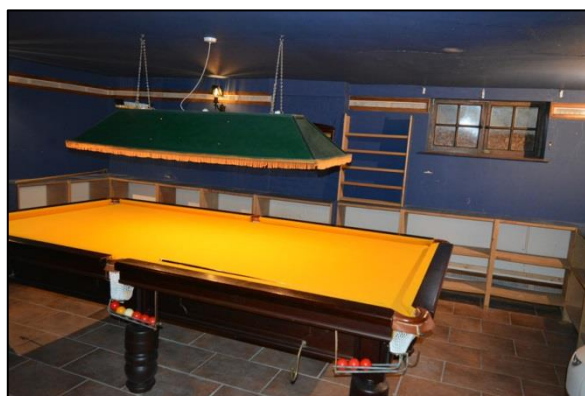
Project code: 416/WER	Project: Wellwick House	Room no: B4
Location: Southern end of basement		Function: Billiards room
Wall form & decor: Plasterboard painted dark blue throughout apart from two brick piers to north and one brick section to east of southern window.		
Ceiling / roof structure: Painted plasterboard.		
Windows: 2-light timber window to south and west.		
Doors: None.		
Floor: Stone effect tiles same as in B1 and B3.		
Fireplace:		
Staircase:		
Other architectural details: Air vents set in all four walls as continuous feature.		
Recorder: KK		Survey Date: 11.12.2018

Plate 39: Room B4: view to northeast (20)

Plate 40: Room B4: view to south (21)

Plate 41: Room B4: view to northwest (22)

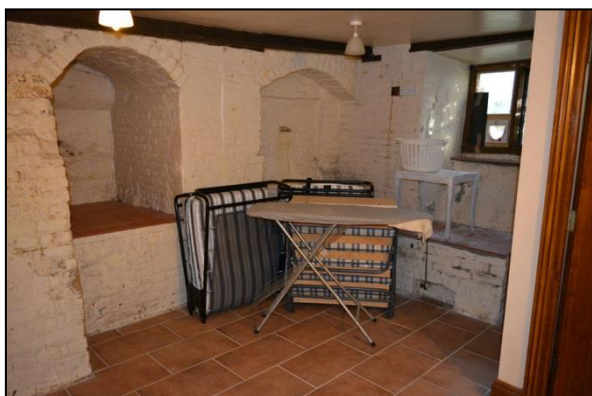
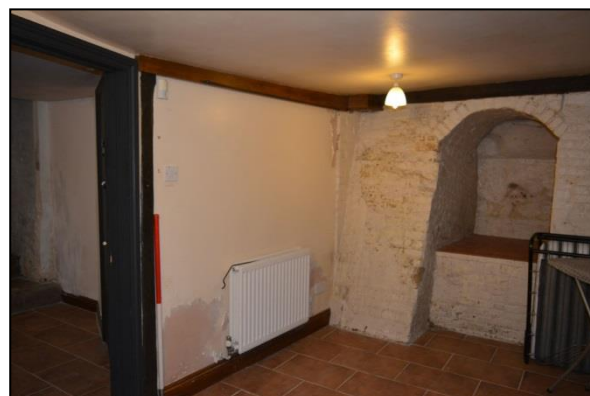
Project code: 416/WER	Project: Wellwick House	Room no: B5
Location: NE corner		Function: Wash house
Wall form & decor: North and east walls are painted brick. All others are modern plasterboard. Bricks are various sizes with evidence of later work, such as in the western recess where the east wall was rebuilt. The eastern recess has been bricked up.		
Ceiling / roof structure: Modern plasterboard		
Windows: 2-light timber window with historical furniture to east.		
Doors: Modern doors to west and east		
Floor: Modern stone effect tiles		
Fireplace:		
Staircase:		
Other architectural details: Large brick buttress in NW corner.		
Recorder: KK		Survey Date: 11.12.2018

Plate 42: Room B5: view to southwest (25)

Plate 43: Room B5: view to southeast (26)

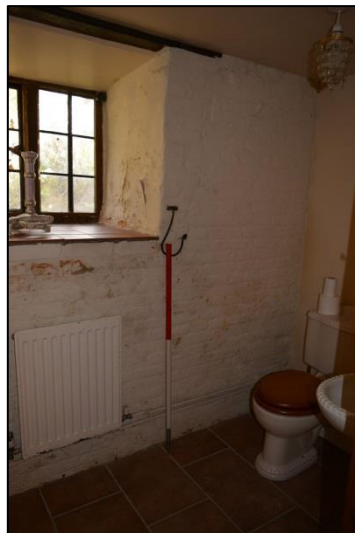
Project code: 416/WER	Project: Wellwick House	Room no: B6
Location: SE corner of B5		Function: WC
Wall form & decor: East wall brick otherwise modern stud partitions.		
Ceiling / roof structure: Painted plasterboard.		
Windows: 2-light timber million with modern rectangular cakes and early 17th window furniture.		
Doors:		
Floor: Modern stone effect tiles.		
Fireplace:		
Staircase:		
Other architectural details: Modern WC and basin to S and E respectively.		
Recorder: KK	Survey Date: 11.12.2018

Plate 44: Room B6: view to northwest (27)

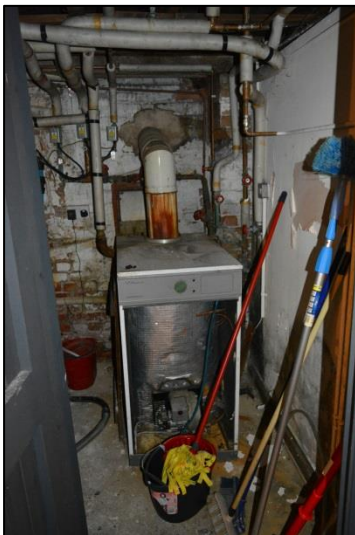
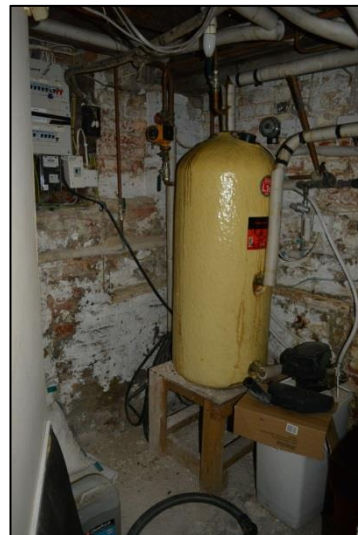
Project code: 416/WER	Project: Wellwick House	Room no: B7
Location: NW corner		Function: Boiler House
Wall form & decor: Brick to north and west		
Ceiling / roof structure:		
Windows:		
Doors: Modern door to south		
Floor: ? Concrete		
Fireplace:		
Staircase:		
Other architectural details:		
Recorder: KK		Survey Date: 11.12.2018

Plate 45: Room B7: view to south (28)

Plate 46: Room B7: southeast corner (29)

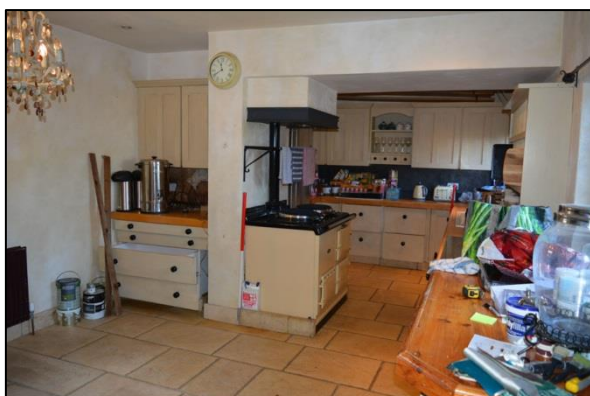
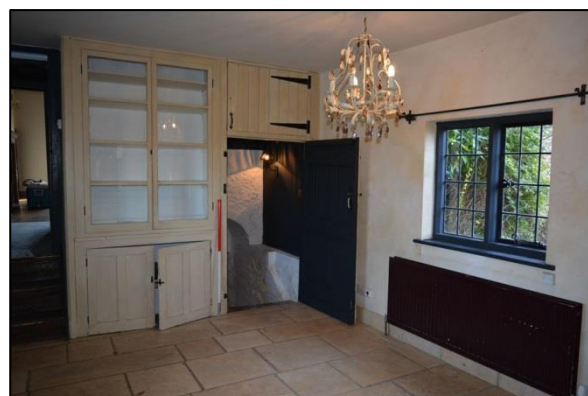
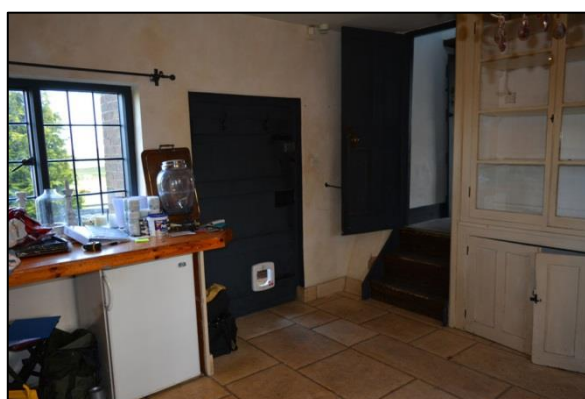
Project code: 416/WER	Project: Wellwick House, Wendover	Room no: G1
Location: East end of north wing		Function: Kitchen
Wall form & decor: Painted		
Ceiling / roof structure: Painted plasterboard		
Windows: Two timber mullioned casements to north, one of the same to the south		
Doors: Plank and batten door to external lobby to N and cellars to SE. 4-panelled door to main house to east		
Floor: Stone effect tiles		
Fireplace: Aga to south		
Staircase: Stairs up to main house and brick built staircase to cellars		
Other architectural details: The kitchen is in two main sections to either side of a return wall at the northern end of which is the AGA		
Recorder: KK		Survey Date: 11.12.2018

Plate 47: Room G1: view to southwest (30)

Plate 48: Room G1: view to southeast (31)

Plate 49: Room G1: view to northeast (32)

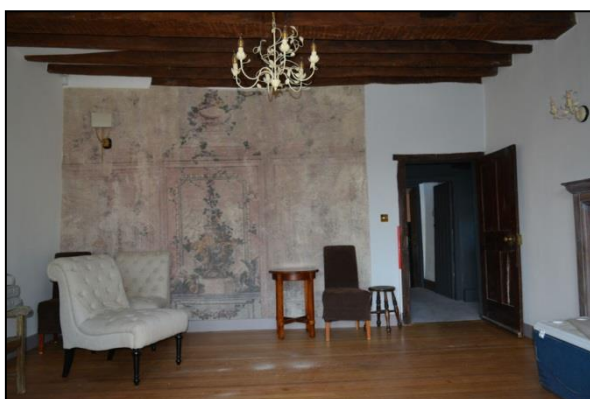
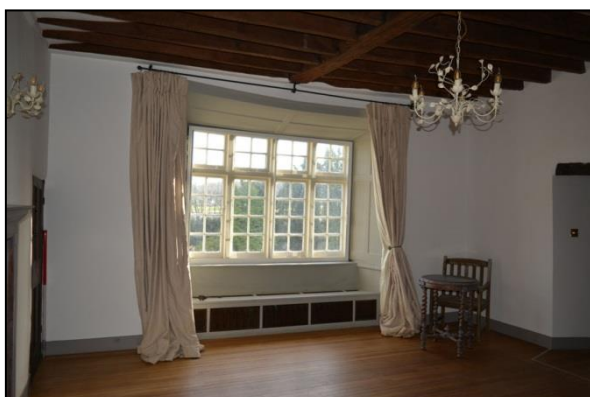
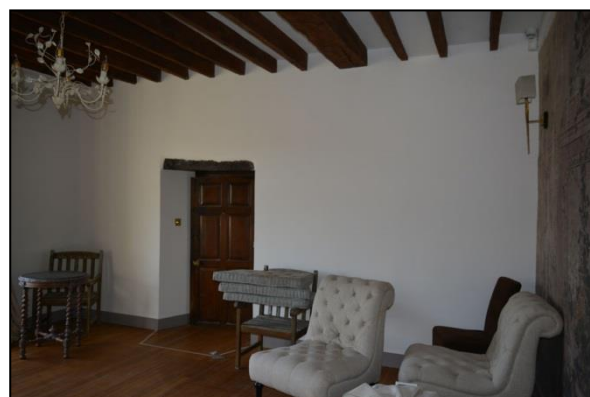
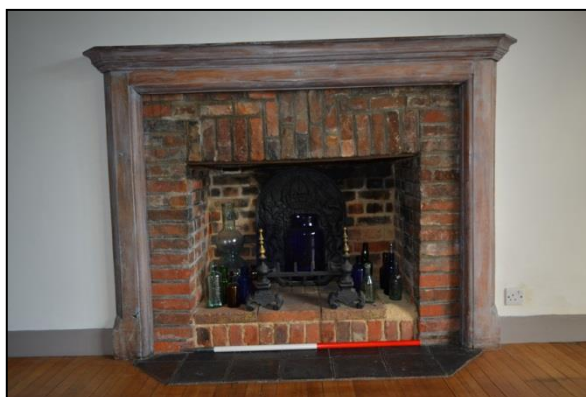
Project code: 416/WER	Project: Wellwick House	Room no: G2
Location: North end of main house (Building 1)		Function: Living room
Wall form & decor: Painted other than north wall which has wallpaper		
Ceiling / roof structure: Axial beam aligned east west then north south. Joists are thin section. No chamfers		
Windows: 4-light casement with secondary glazing to east		
Doors: 4 panelled door to west and 6 panelled to south (G3)		
Floor: Modern timber		
Fireplace: Brick built with brick base, tiled hearth and timber surround. Probably 20 th century		
Staircase:		
Other architectural details:		
Recorder: KK		Survey Date: 11.12.2018

Plate 50: Room G2: view to west (33)

Plate 51: Room G2: view to north (34)

Plate 52: Room G2: east wall (35)

Plate 53: Room G2: south wall (36)

Plate 54: Room G2: fireplace detail (37)

The ground floor windows in the main range are mainly 6/6 timber sash windows with the exception of the Room G2 which has 4-light casement with secondary glazing to the east, G6 which has a stone mullioned window to the west, and the 2-light timber window in the north wall of the range, which has replaced an earlier door.

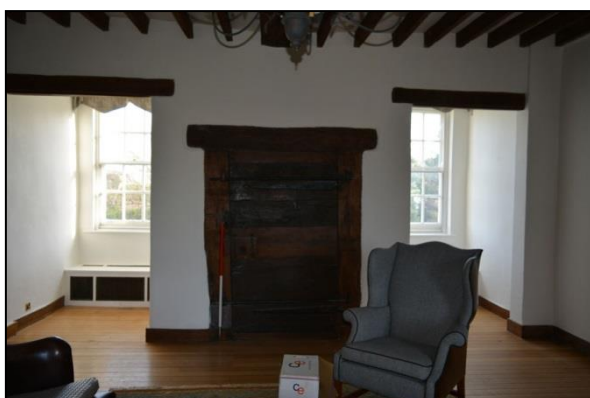
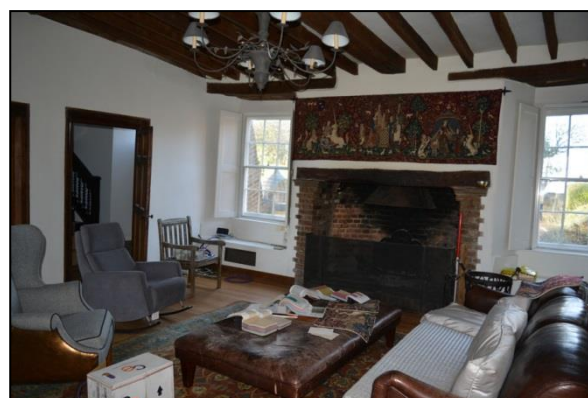
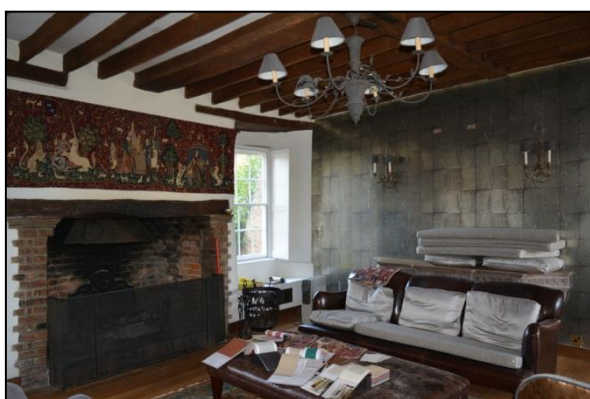
Project code: 416/WER	Project: Wellwick House	Room no: G3
Location: Central room in Building 1		Function: Main entrance
Wall form & decor: Modern skirting. Wallpaper to north painted elsewhere		
Ceiling / roof structure: Similar to G2, but aligned east-west		
Windows: 6/6 timber sash windows to east and west. Those in the east wall are set within deep recesses. Those to west are shuttered with window seats below.		
Doors: Original late med/early post-med door to east. Long strap hinges, iron security bars top and bottom as well as lock and key.		
Floor: Modern timber		
Fireplace: Semi circular brick built fireplace to west. Raised brick and tile hearth. Modern brick piers to front supporting lintel.		
Staircase:		
Other architectural details: Front door in recess flanked by 6/6 timber sash windows to either side		
Recorder: KK		Survey Date: 11.12.2018

Plate 55: Room G3: east wall (38)

Plate 56: Room G3: view to southwest (39)

Plate 57: Room G3: view to northwest (40)

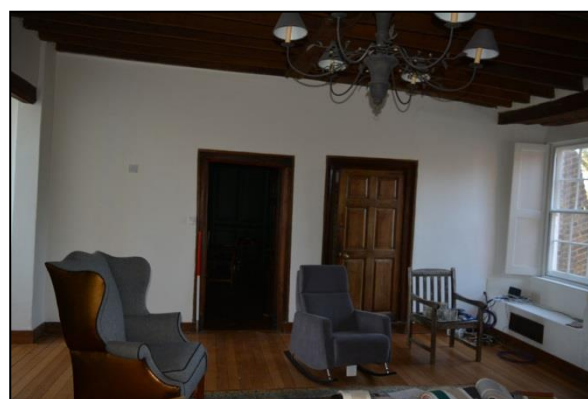
Plate 58: Room G3: view to south (41)

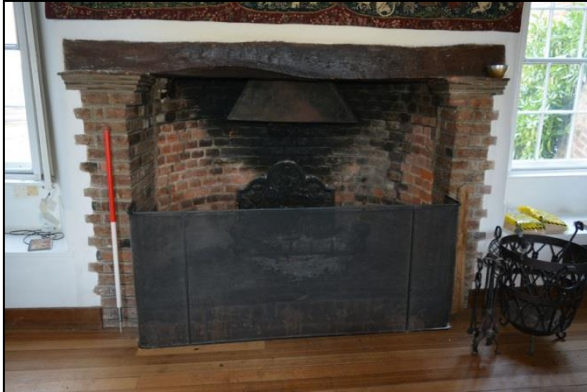
Plate 59: Room G3: fireplace detail (42)

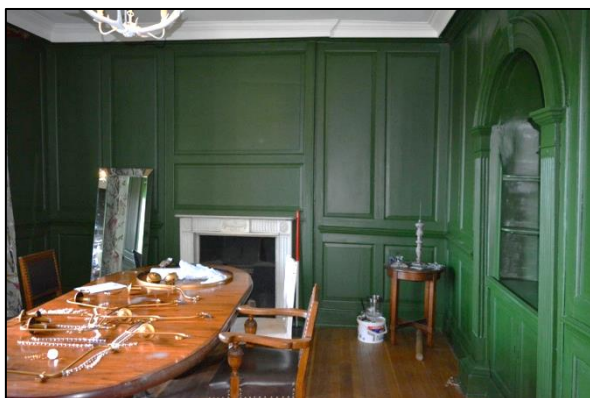
Project code: 416/WER	Project: Wellwick House, Wendover	Room no: G4
Location: Southern end of Building 1		Function: Dining room
Wall form & decor: Full height panelling painted green with cornice above		
Ceiling / roof structure: Painted plasterboard		
Windows: Two 6/6 timber sash windows to east with window seats and shutters		
Doors: 6-panelled Regency style door to north		
Floor: Modern timber boards aligned north-south		
Fireplace: Regency style fireplace to the south		
Staircase:		
Other architectural details: Recessed arch to west		
Recorder: KK	Survey Date: 11.12.2018

Plate 61: Room G4: south wall (43)

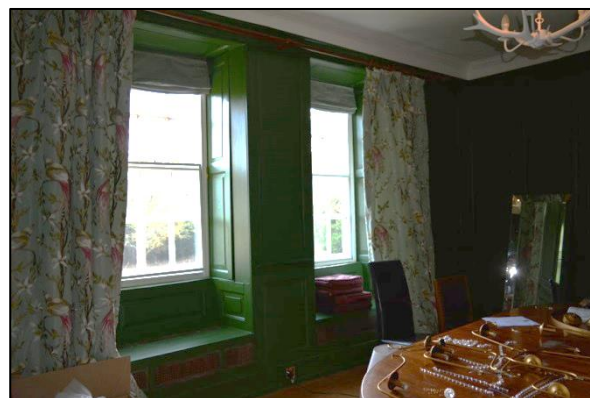
Plate 62: Room G4: east wall (44)

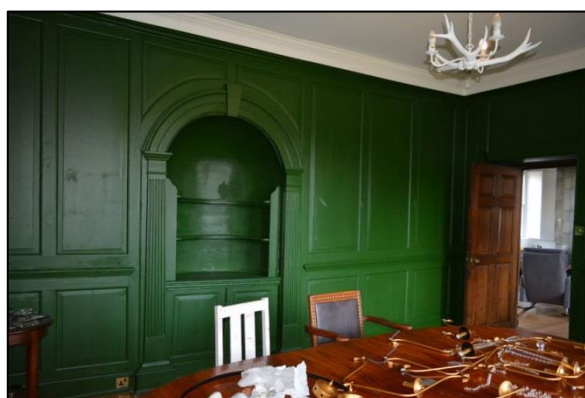
Plate 63: Room G4: west wall (45)

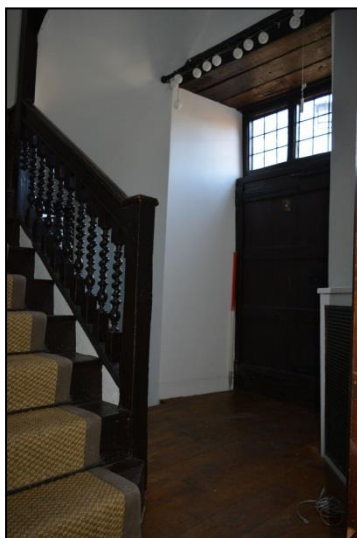
Project code: 416/WER	Project: Wellwick House	Room no: G5
Location: West of G5		Function: Back lobby
Wall form & decor: Painted plaster		
Ceiling / roof structure: Painted plasterboard		
Windows: Rectangular lights over the door		
Doors: Three late med plank and batten doors to rear, Room G6 and below stairs.		
Floor: Timber boards aligned east west. Not original.		
Fireplace:		
Staircase: Barley twist balusters to oak staircase. Closed string, winding stair.		
Other architectural details:		
Recorder: KK	Survey Date: 11.12.2018

Plate 64: Room G5: view to southwest (46)

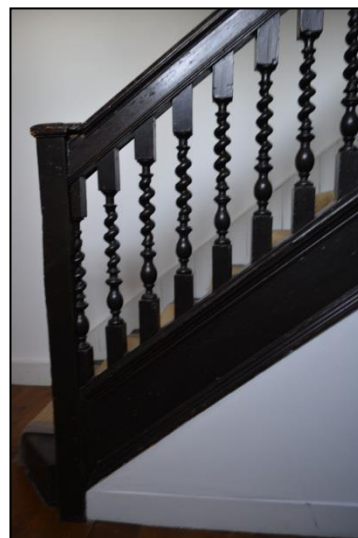
Plate 65: Room G5: stair detail (47)

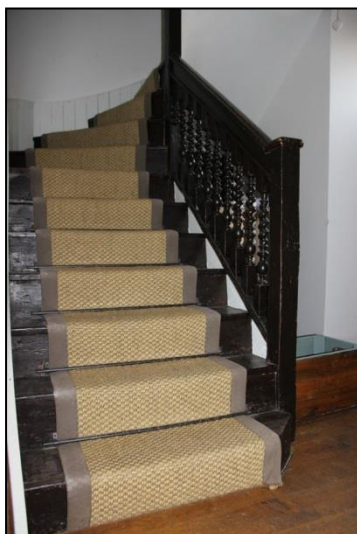
Plate 66: Room G5: view to south (48)

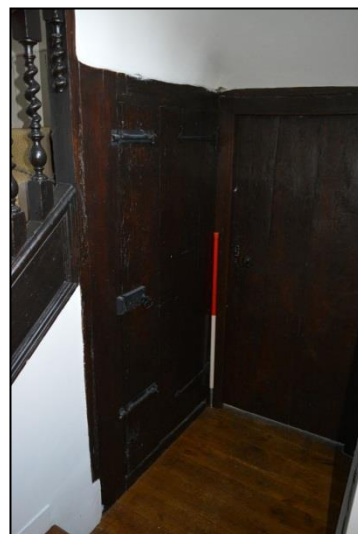
Plate 67: Room G5: southeast corner (49)

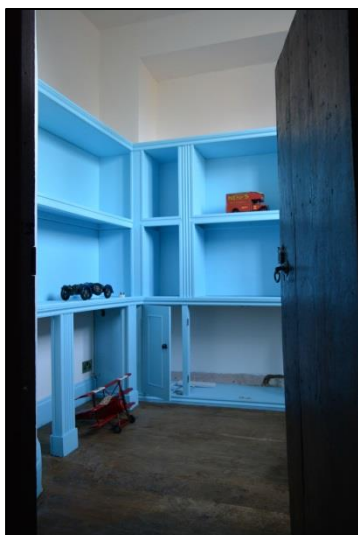
Project code: 416/WER	Project: Wellwick House, Wendover	Room no: G6
Location: Southwest corner of the main house		Function: Unknown
Wall form & decor: Painted and lined with shelves		
Ceiling / roof structure: Painted		
Windows: Stone mullioned window with rectangular comes to the west		
Doors: Plank and batten door to the north		
Floor: Timber boards aligned east-west		
Fireplace:		
Staircase:		
Other architectural details: Recesses to south wall partly obscured by shelving		
Recorder: KK	Survey Date: 11.12.2018

Plate 68: Room G6: view to south (50)

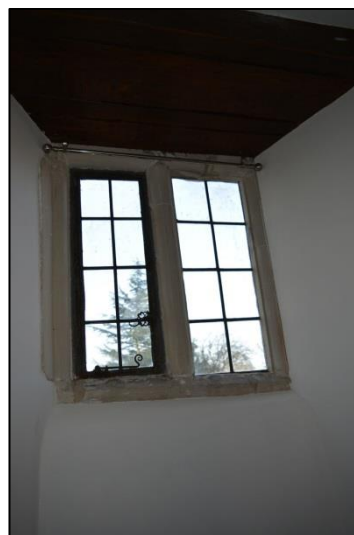
Plate 69: Room G6: window in west wall (51)

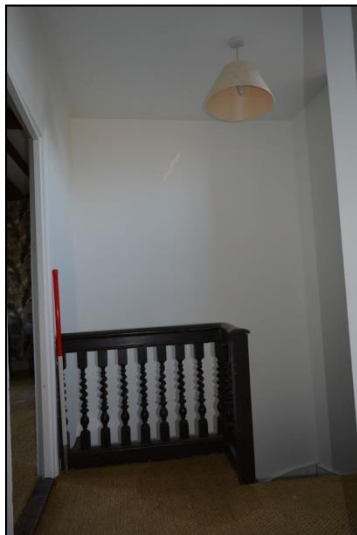
Project code: 416/WER	Project: Wellwick House	Room no: F1
Location: South end of Building 1		Function: Stairwell
Wall form & decor: Painted with plain skirting		
Ceiling / roof structure: Painted		
Windows: Stone window to West		
Doors: Oak plank and batten doors to north and east		
Floor: Carpet over tile		
Staircase: Barley twist balusters to oak staircase. Closed string, winding stair.		
Recorder: KK		Survey Date: 11.12.2018

Plate 70: Room F1: view to south (52)

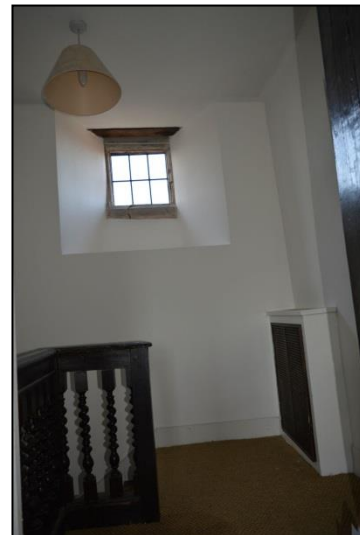
Plate 71: Room F1: view to west (53)

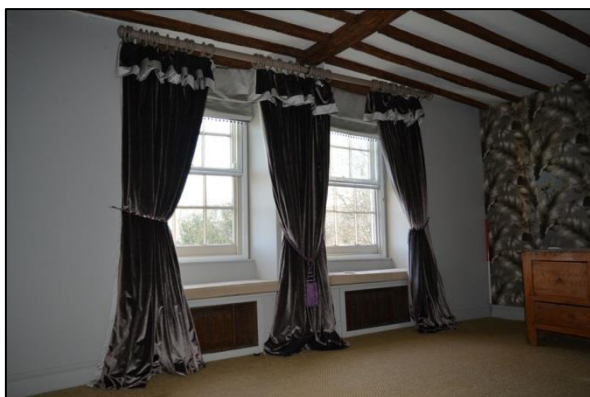
Project code: 416/WER	Project: Wellwick House	Room no: F2
Location: Southern end of Building 1		Function: Bedroom
Wall form & decor: Modern skirting		
Ceiling / roof structure: Axial beam north to south. Thin section joists. No chamfers.		
Windows: 6/6 timber to east		
Doors: Two plank and batten doors to west		
Floor: Carpe over boards		
Fireplace: Semicircular brick built fireplace with modern stone surround to south		
Staircase:		
Other architectural details:		
Recorder: KK	Survey Date: 11.12.2018

Plate 72: Room F2: east wall (54)

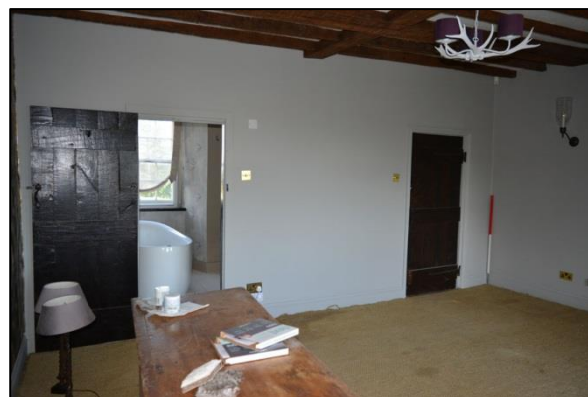
Plate 73: Room F2: west wall (55)

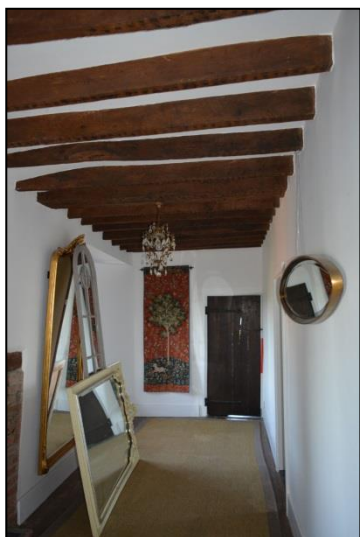
Project code: 416/WER	Project: Wellwick House	Room no: F3
Location: Between F1 and F11, Building 1		Function: Long gallery
Wall form & decor: Modern skirting		
Ceiling / roof structure: East west aligned thin section joists.		
Windows: Two timber mullioned to west.		
Doors: P&B to north and south.		
Floor: Wide oak planks, probably original.		
Fireplace: Rebuilt brick fireplace to west. Brick and tile hearth. Lozenge design in brick back.		
Staircase:		
Other architectural details:		
Recorder: KK	Survey Date: 11.12.2018

Plate 75: Room F3: view to north (57)

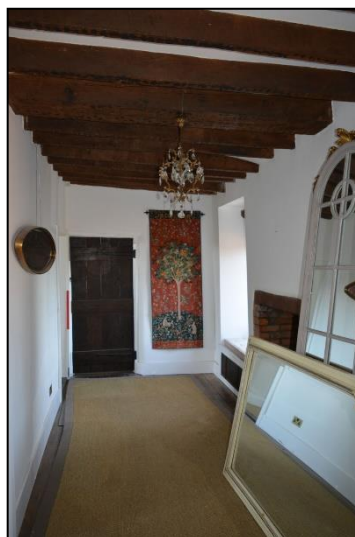
Plate 76: Room F3: view to south (58)

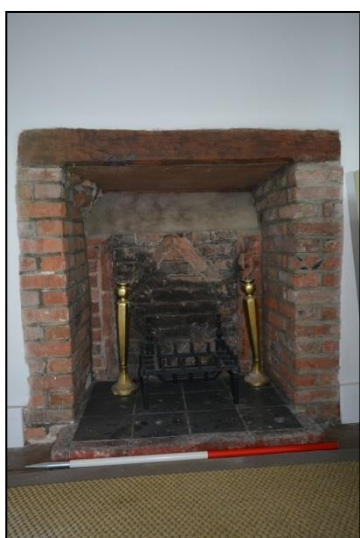
Plate 77: Room F3: fireplace detail (59)

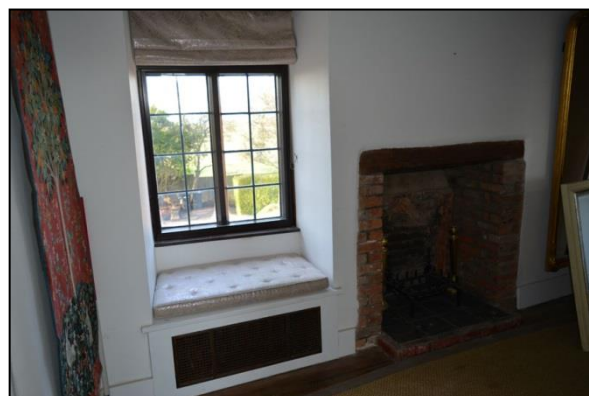
Plate 78: Room F3: window detail (60)

The windows in the east elevation are consistently 6 over 6 timber sash windows. Those in Rooms F2 and F6 have window seats. The fenestration in the west elevation is mixed, with timber mullioned windows in Room F3, and stone mullioned windows in F1 and F7. That in F7 is now blocked by the kitchen extension, but the rectangular frames and 17th century window furniture remains intact. It is uncertain whether the window furniture is original, but the fact that the exact same style of handle can be found in many of the later windows suggests not. Some hand blown glass was noted, as in Room F5.

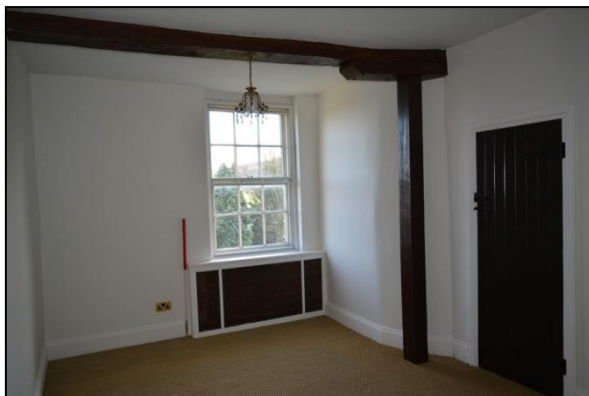
Project code: 416/WER	Project: Wellwick House	Room no: F4
Location: North of F4, Building 1		Function: Bedroom
Wall form & decor: plastered and painted. modern skirting		
Ceiling / roof structure: Painted plasterboard. Beam aligned north south at eastern end of room, with vertical post next to southern wall. Extends into F5.		
Windows: 6/6 timber sash to east		
Doors: O&B to west weigh long strap hinges		
Floor: Carpet over boards		
Fireplace:		
Staircase:		
Other architectural details: Wall curves in SE corner. Originally part of F5		
Recorder: KK	Survey Date: 11.12.2018

Plate 79 Room F4: east wall (61)

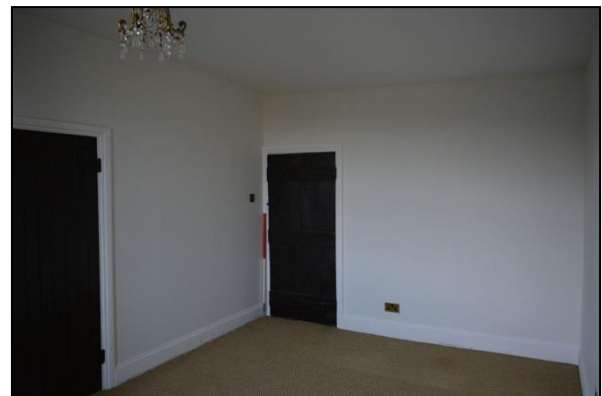
Plate 80: Room F4: view to southwest (62)

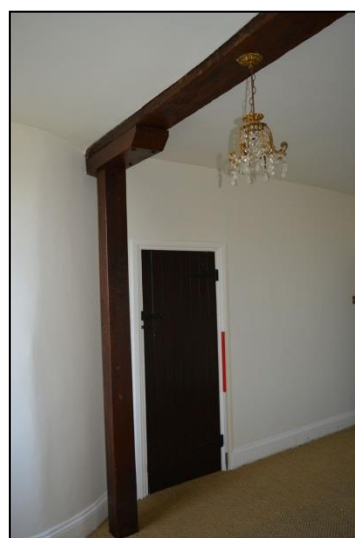
Plate 81: Room F4: timber detail (63)

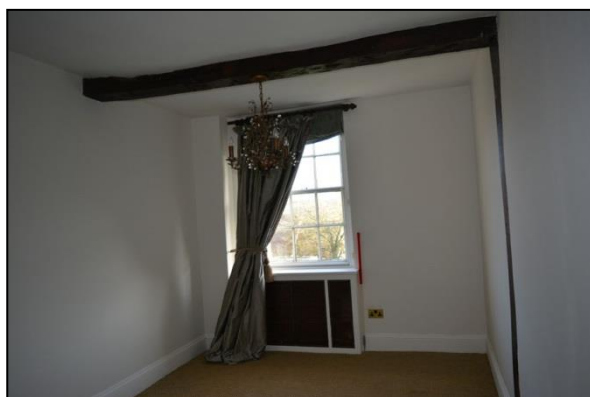
Project code: 416/WER	Project: Wellwick House	Room no: F5
Location: North of F4		Function: Bedroom
Wall form & decor: Plastered and painted. modern skirting		
Ceiling / roof structure: Painted plasterboard. Beam aligned north south at eastern end of room, with vertical post in southern wall. Beam jointed and tied with metalwork two thirds along.		
Windows: 6/6 timber sash to east with some handblown glass		
Doors: Plank and batten door to west with long strap hinges		
Floor: Carpet over boards		
Fireplace:		
Staircase:		
Other architectural details: Originally part of F4		
Recorder: KK	Survey Date: 11.12.2018

Plate 82: Room F5: east wall (64)

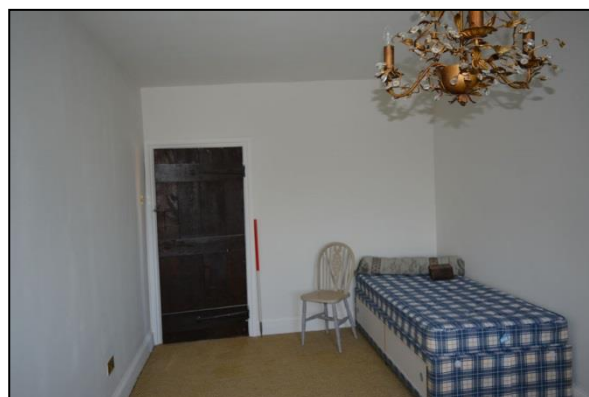
Plate 83: Room F5: west wall (65)

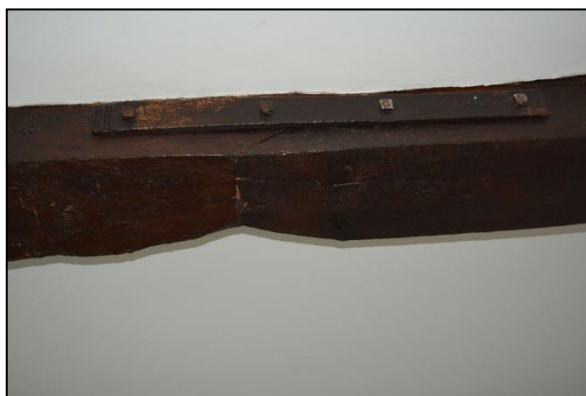
Plate 84: Room F5: timber detail (66)

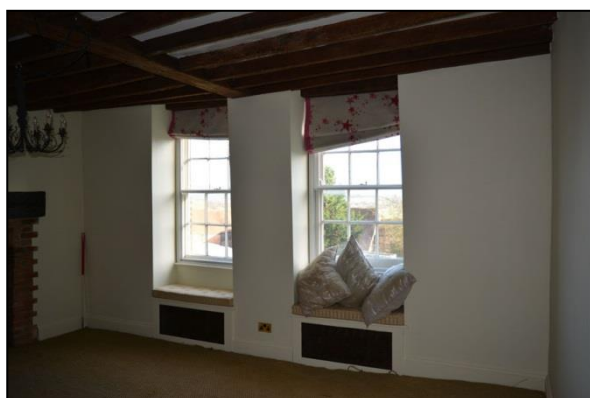
Project code: 416/WER	Project: Wellwick House	Room no: F6
Location: North end of Building 1		Function: Bedroom
Wall form & decor: Timbers around the door to west. Otherwise painted. Modern skirting		
Ceiling / roof structure: Axial beam east-west, thin section joists. No chamfers.		
Windows: 6/6 timber sash to east x2. Window seats.		
Doors: P&B to west. Not necessarily original		
Floor: Carpet over boards		
Fireplace: Brick built fireplace to north. Frontage modern, but earlier brickworks survives at the back and on rear of return walls stone base. Timber lintel		
Staircase:		
Other architectural details:		
Recorder: KK		Survey Date: 11.12.2018

Plate 85: Room F6: east wall (67)

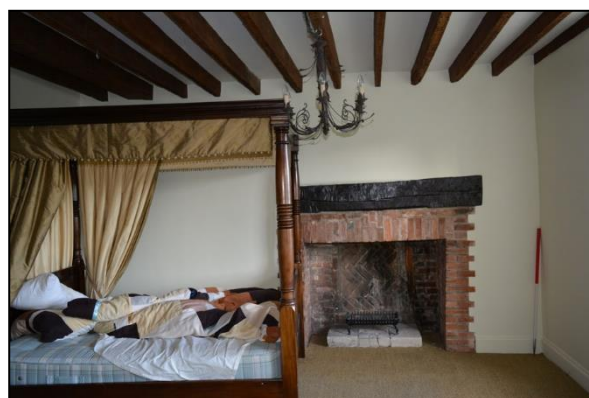
Plate 86: Room F6: north wall (68)

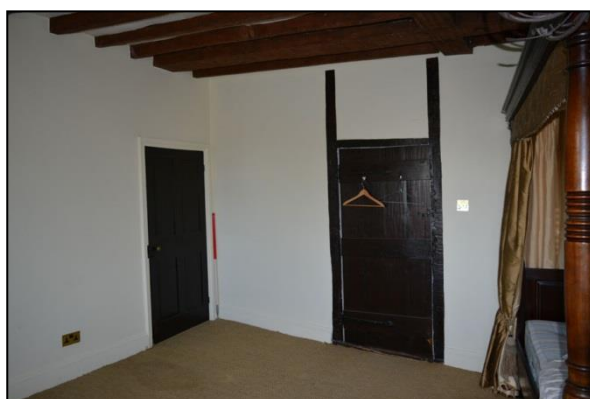
Plate 87: Room F6: west wall (69)

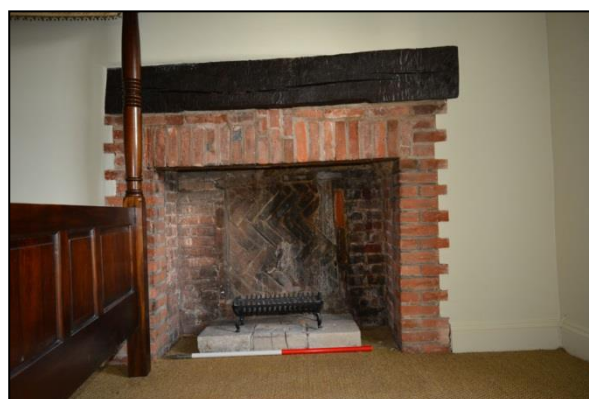
Plate 88: Room F6: fireplace detail (70)

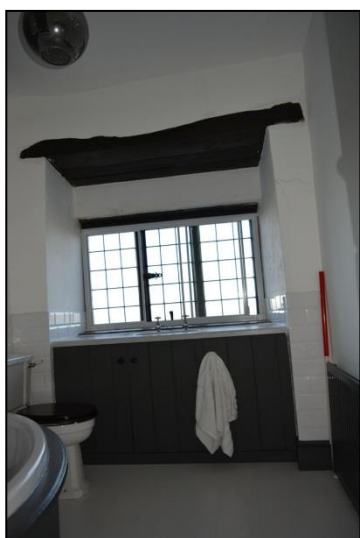
Project code: 416/WER	Project: Wellwick House	Room no: F7
Location: Northwest corner of Building 1		Function: Bathroom
Wall form & decor: Part-tiled, painted paper, modern skirting		
Ceiling / roof structure: Painted		
Windows: 3-light timber mullion to north. 2-light Stone million to west		
Doors: Modern plank and batten to south		
Floor: Tiled		
Fireplace:		
Staircase:		
Other architectural details:		
Recorder: KK	Survey Date: 11.12.2018

Plate 89: Room F7: view to north (71)

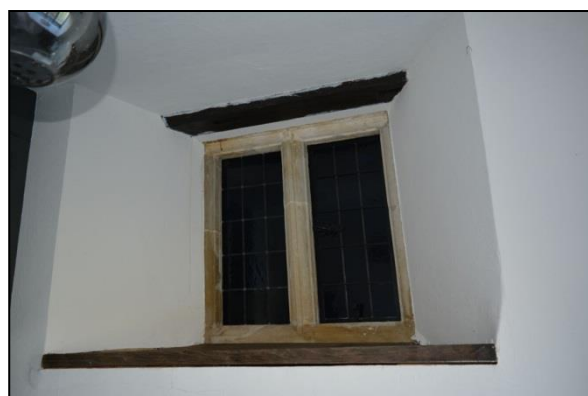
Plate 90: Room F7: window detail (72)

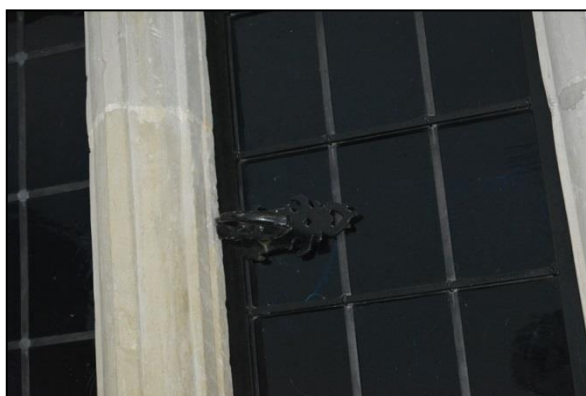
Plate 91: Room F7: window furniture detail (73)

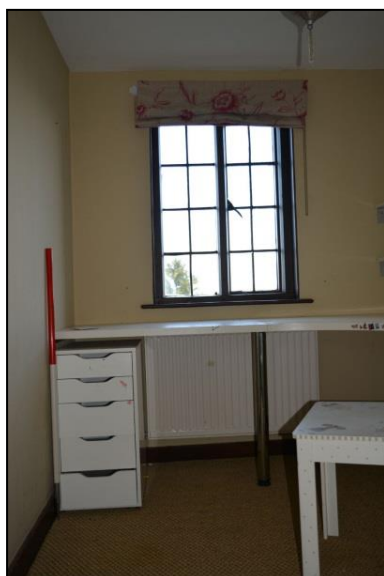
Project code: 416/WER	Project: Wellwick House	Room no: F8
Location: East end of Building 2		Function: Bedroom
Wall form & decor: Papered, modern skirting		
Ceiling / roof structure: Painted		
Windows: 2-light timber casement to north		
Doors: 4-panelled to south		
Floor: Carpet over boards.		
Fireplace:		
Staircase:		
Other architectural details: Stone mullioned window in F7 exposed during building works		
Recorder: KK		Survey Date: 11.12.2018

Plate 92: Room F8: view to north (76)

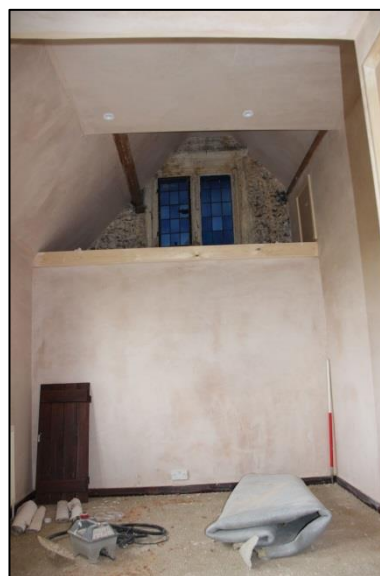
Plate 93: Room F8: view to east during renovation

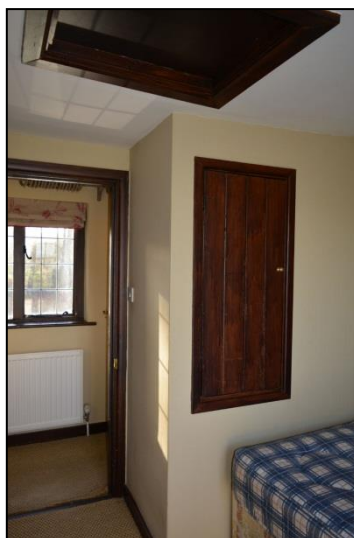
Project code: 416/WER	Project: Wellwick House	Room no: F9
Location: West of F8, Building 2		Function: Bedroom
Wall form & decor: Paper over modern skirting		
Ceiling / roof structure: Painted plasterboard. Hatch to roofspace		
Windows: 2-light timber casement to north		
Doors: 4-panelled door to south		
Floor: Carpet over boards		
Fireplace:		
Staircase:		
Other architectural details: Built in cupboards to east of door		
Recorder: KK	Survey Date: 11.12.2018

Plate 94: Room F9: view to southwest (77)

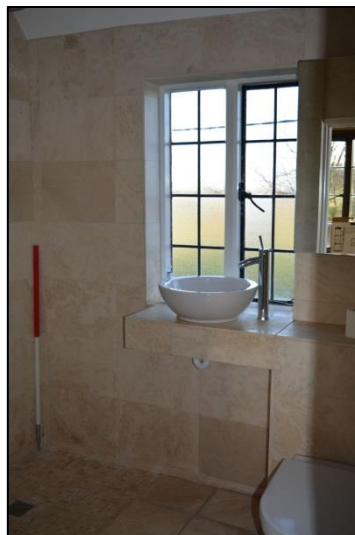
Project code: 416/WER	Project: Wellwick House	Room no: F10
Location: West of Room F9, Building 2		Function: Wet room
Wall form & decor: Fully tiled		
Ceiling / roof structure: Painted		
Windows: 2-light timber casement to north		
Doors: no door		
Floor: Tiled		
Fireplace:		
Staircase:		
Other architectural details:		
Recorder: KK		Survey Date: 11.12.2018

Plate 95: Room F10: view to northwest (78)

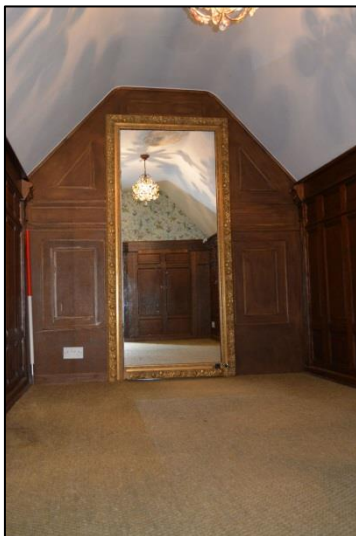
Project code: 416/WER	Project: Wellwick House	Room no: F11
Location: East end of Building 3		Function: Dressing room
Wall form & decor: Panelled		
Ceiling / roof structure: Hipped and painted		
Windows: None		
Doors: Mirror door to west		
Floor: Carpet over boards		
Fireplace:		
Staircase: Step down to east		
Other architectural details:		
Recorder: KK	Survey Date: 11.12.2018

Plate 96: Room F11: view to west (79)

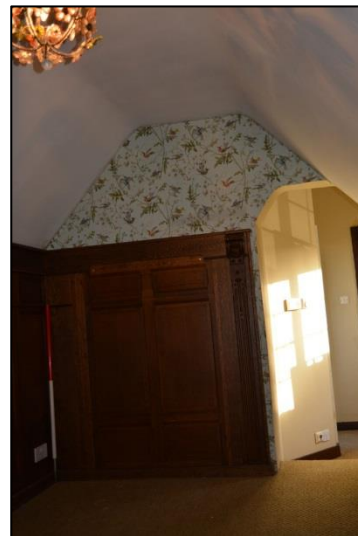
Plate 97: Room F11: view to east (80)

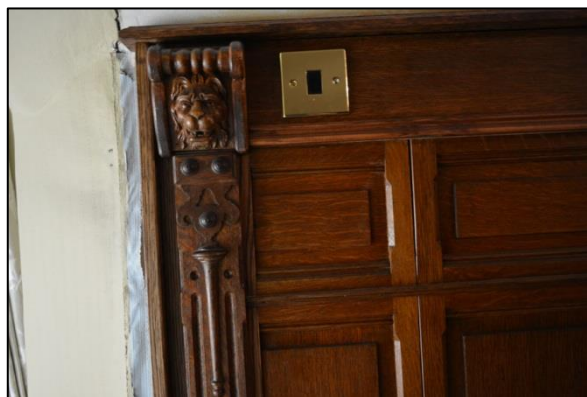
Plate 98: Room F11: panelling detail (82)

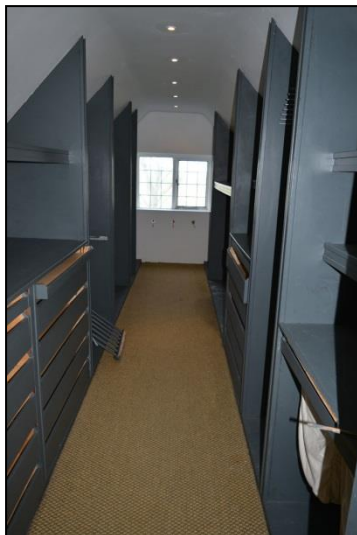
Plate 99: Room F12: view to west (81)

Project code: 416/WER	Project: Wellwick House	Room no: F12
Location: West end Building 3		Function: Dressing room
Wall form & decor: Fitted out		
Ceiling / roof structure: Hipped		
Windows: 2-light window to west		
Doors: Flush door to F11		
Floor: carpet over boards		
Fireplace:		
Staircase:		
Other architectural details:		
Recorder: KK	Survey Date: 11.12.2018

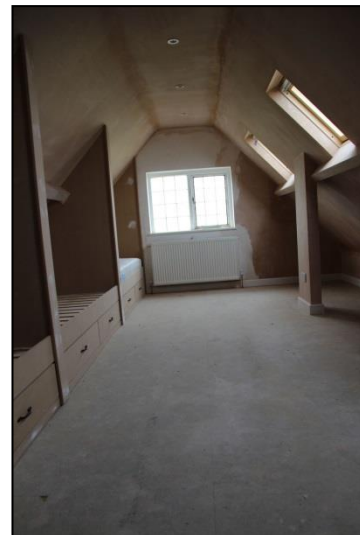
Plate 100: Room F12: view to west after restoration

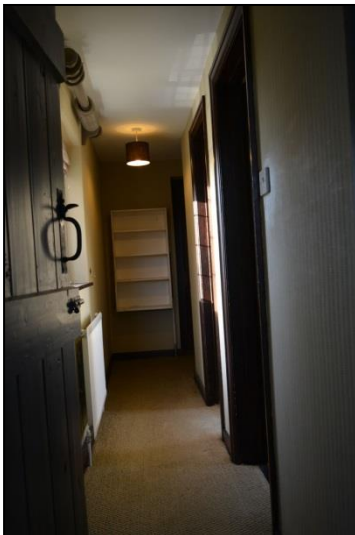
Plate 101: Room F13: view to west (74)

Project code: 416/WER	Project: Wellwick House	Room no: F13
Location: Building 2		Function: Passage
Wall form & decor: Painted		
Ceiling / roof structure: Painted		
Windows: Casement window to south		
Doors: Two 4-panelled door to north, one to east and one to west		
Floor: Carpet over boards		
Fireplace:		
Staircase: Steps up to Building 1 to east		
Other architectural details:		
Recorder: KK		Survey Date: 11.12.2018

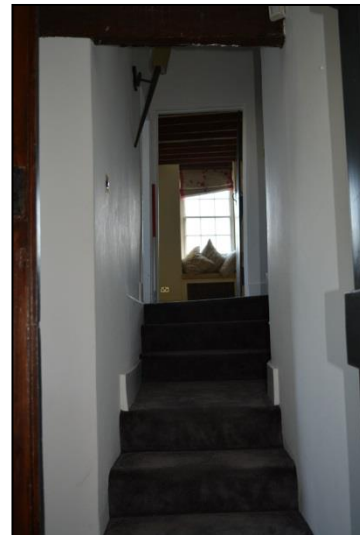
Plate102: Room F13: view to east (75)

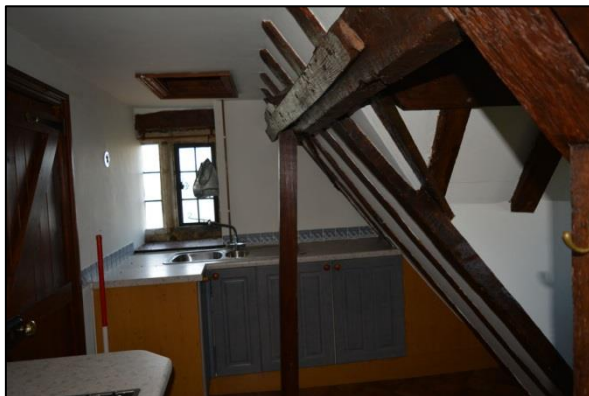
Plate 103: Room S1: view to west (83)

Project code: 416/WER	Project: Wellwick House	Room no: S1
Location: North end Building 1, second floor		Function: Kitchen
Wall form & decor: Painted. Moulded skirtings.		
Ceiling / roof structure: Purlin and rafters exposed running east-west along northern side of room		
Windows: 3-light stone mullioned window to the north with glazed lights and 17 th century window furniture. 3-light stone mullioned window to the west divided by partition wall between S1 and S2		
Doors: Modern timber ledge and braced door to south		
Floor: -		
Fireplace: -		
Staircase: -		
Other architectural details: Hatch to roofspace. Cupboard to east		
Recorder: KK	Survey Date: 11.12.2018

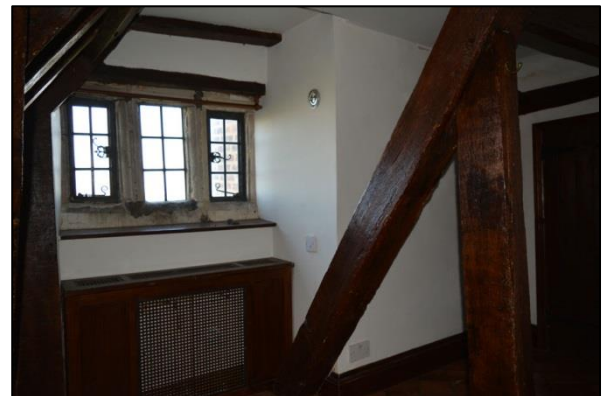
Plate 104: Room S1: view to northeast (84)

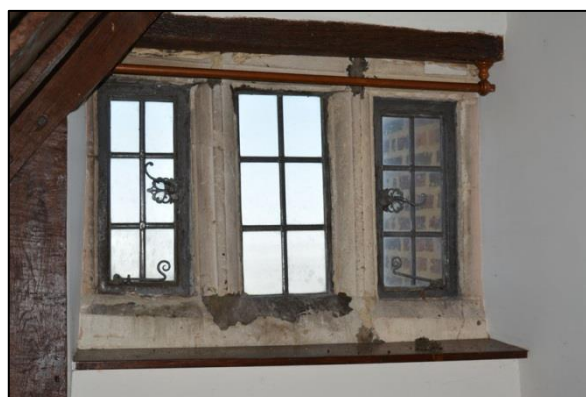
Plate 105: Room S1: north window detail (85)

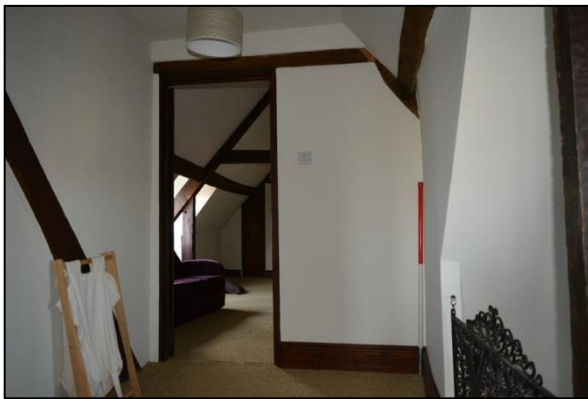
Plate 106: Room S2: view to south (86)

Project code: 416/WER	Project: Wellwick House	Room no: S2
Location: South of S1		Function: Landing
Wall form & decor: Painted. Moulded skirtings.		
Ceiling / roof structure: Painted with exposed timberwork		
Windows: 3-light stone mullioned window to the west divided by partition wall between S1 and S2		
Doors: Modern timber ledge and braced door to north, east and south		
Floor: Carpet over boards		
Fireplace:		
Staircase: Original oak stair along west wall with rope handrail and iron balustrade in S2		
Other architectural details:		
Recorder: KK	Survey Date: 11.12.2018

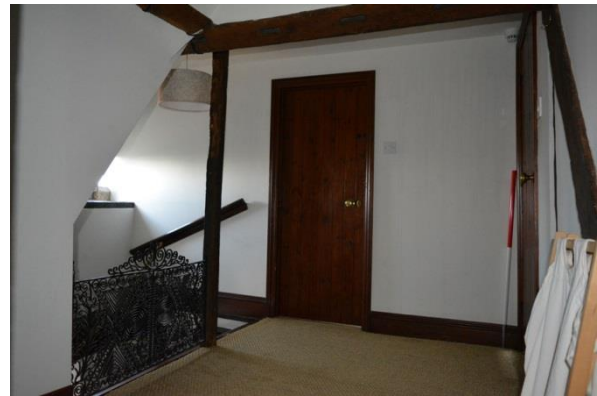
Plate 107: Room S2: view to north (87)

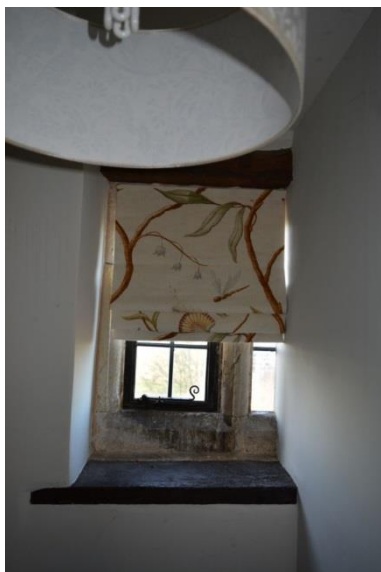
Plate 108: Room S2: window detail (89)
