KDK ARCHAEOLOGY LTD

Historic Building Recording and Archaeological Watching Brief

Wellwick House
Ellesborough Road
Butlers Cross
Buckinghamshire

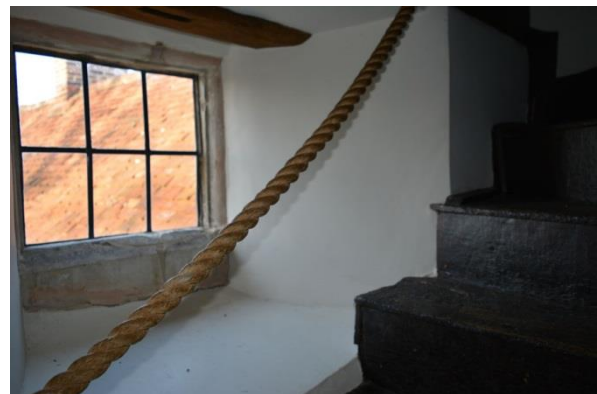
Plate 109: Room S2: stair detail (99)

Project code: 416/WER	Project: Wellwick House	Room no: S2
Location: South of S1		Function: Landing
Wall form & decor: Painted. Moulded skirtings.		
Ceiling / roof structure: Painted with exposed timberwork		
Windows: 3-light stone mullioned window to the west divided by partition wall between S1 and S2		
Doors: Modern timber ledge and braced door to north, east and south		
Floor: Carpet over boards		
Fireplace:		
Staircase: Original oak stair along west wall with rope handrail and iron balustrade in S2		
Other architectural details:		
Recorder: KK	Survey Date: 11.12.2018

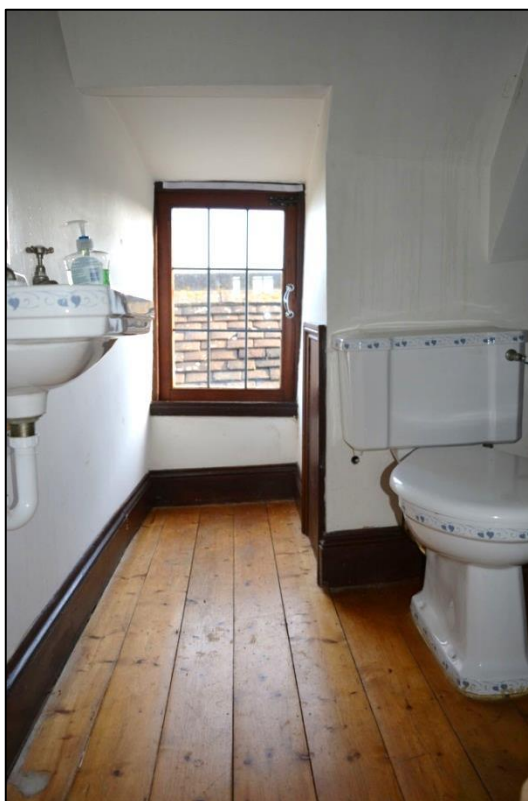
Plate 110: Room S3: view to east (88)

Project code: 416/WER	Project: Wellwick House	Room no: S3
Location: East of S2		Function: Bathroom
Wall form & decor: Painted with moulded skirtings		
Ceiling / roof structure: Painted		
Windows: Timber casement in deep recess to east		
Doors: Modern ledge and braced door to west		
Floor: Timber boards aligned east-west		
Fireplace:		
Staircase:		
Other architectural details: Door in south wall of recess		
Recorder: KK		Survey Date: 11.12.2018

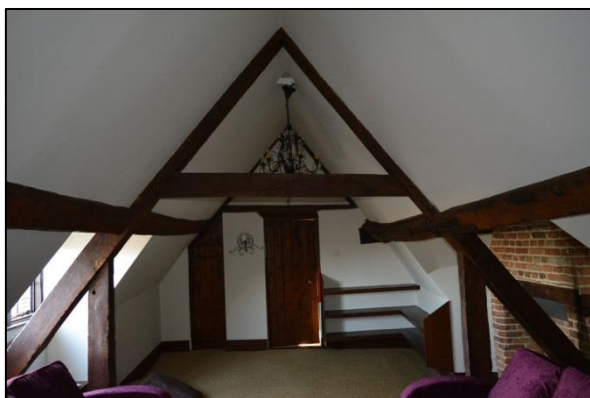
Plate 111: Room S4: view to south (90)

Project code: 416/WER	Project: Wellwick House	Room no: S4
Location: South of S2		Function: Living room
Wall form & decor: Painted. Moulded skirtings.		
Ceiling / roof structure: Painted with exposed trusses and purlins		
Windows: 3-light dormer window to east		
Doors: Modern timber ledge and braced door to north and south		
Floor: Carpet over boards		
Fireplace: Modern brick built fireplace to west		
Staircase:		
Other architectural details:		
Recorder: KK		Survey Date: 11.12.2018

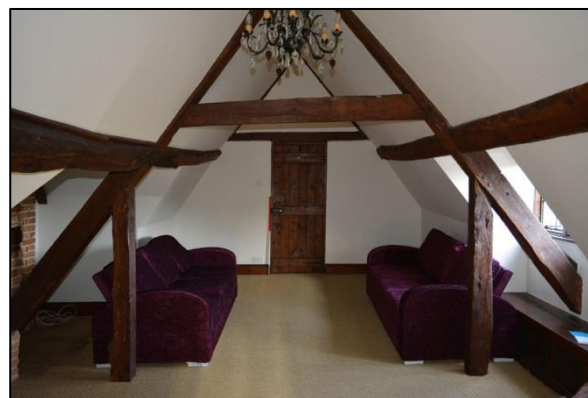
Plate 112: Room S4: view to north (91)

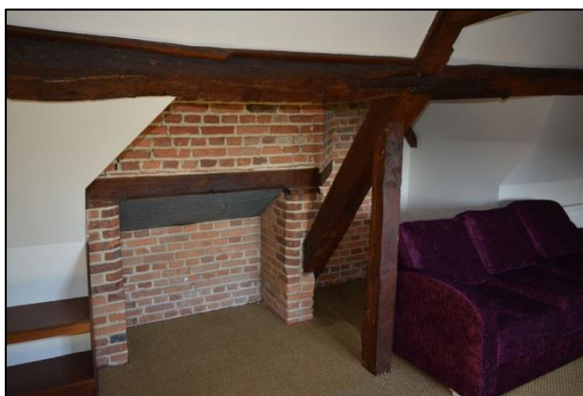
Plate 113: Room S4: fireplace detail (92)

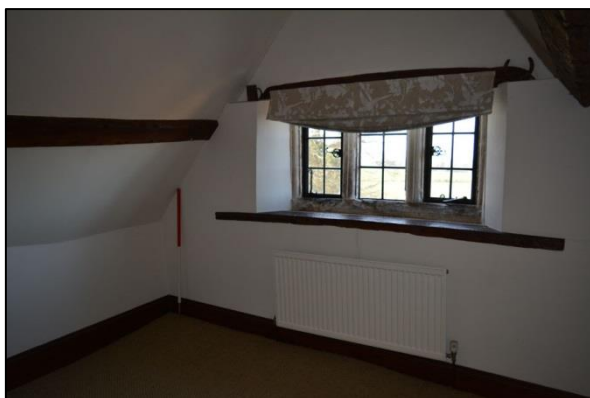
Plate 114: Room S5: southwest corner (93)

Project code: 416/WER	Project: Wellwick House	Room no: S5
Location: South of S4		Function: ?Bedroom
Wall form & decor: Painted. Moulded skirtings.		
Ceiling / roof structure: Painted with exposed trusses and (reused)purlins. Northern purlin has series of 3 adjoining stave holes at regular intervals. Southern purlin has redundant mortices and peg holes above		
Windows: 3-light mullioned clunch windows to south and west		
Doors: Modern timber ledge and braced door to north and east		
Floor: Carpet over boards		
Fireplace:		
Staircase:		
Other architectural details: Walk-in cupboard to east		
Recorder: KK	Survey Date: 11.12.2018

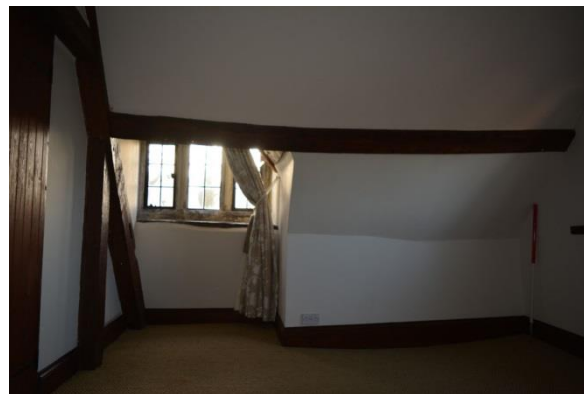
Plate 115: Room S5: south wall (94)

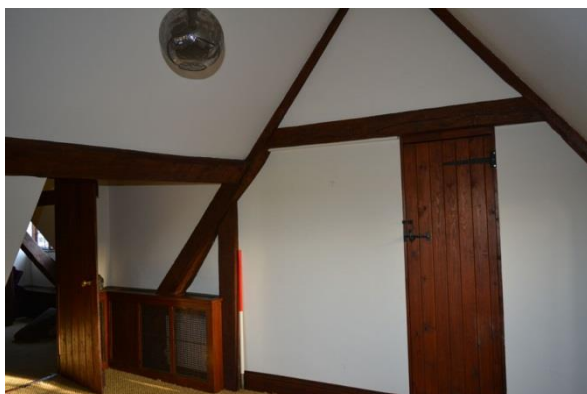
Plate 116: Room S5: west wall (95)

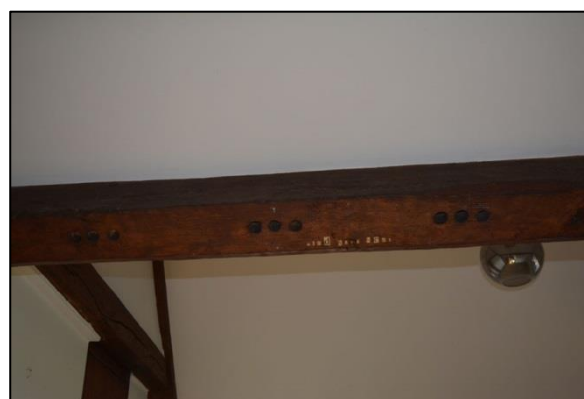
Plate 117: Room S5: stave holes in northern purlin (97)

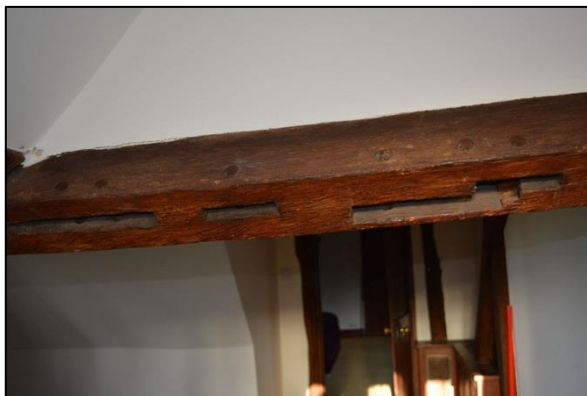
Plate 118: Room S5: redundant mortices in southern purlin (98)

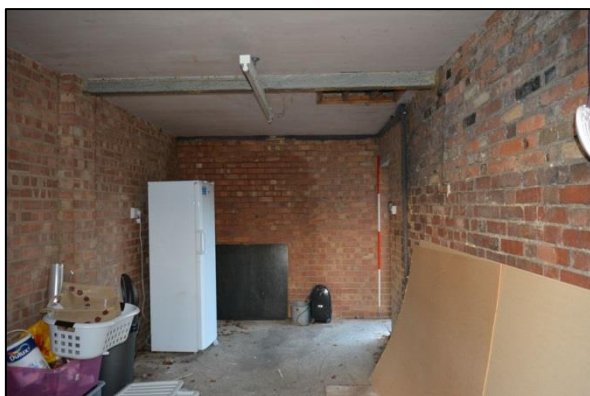
Plate 119: Outbuilding 1: view to north (100)

Project code: 416/WER	Project: Wellwick House, Wendover	Room no: OB1
Location: East end of garage block		Function: Garage
Wall form & decor: Unpainted Fletton brickwork to all walls other than the east wall, which is largely late 19 th /early 20 th century with a Fletton built addition to the north.		
Ceiling / roof structure: Plasterboard		
Windows:		
Doors: Double timber doors to the south, single timber door at the northern end of the east wall		
Floor: Concrete		
Fireplace:		
Staircase:		
Other architectural details:		
Recorder: KK	Survey Date: 11.12.2018

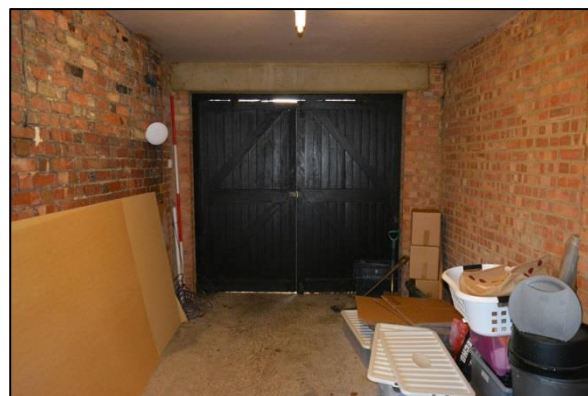
Plate 120: Outbuilding 1: view to south (101)

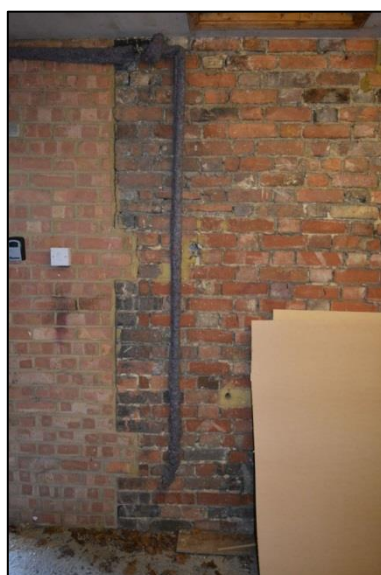
Plate 121: Outbuilding 1: junction of different brickwork in east wall (102)

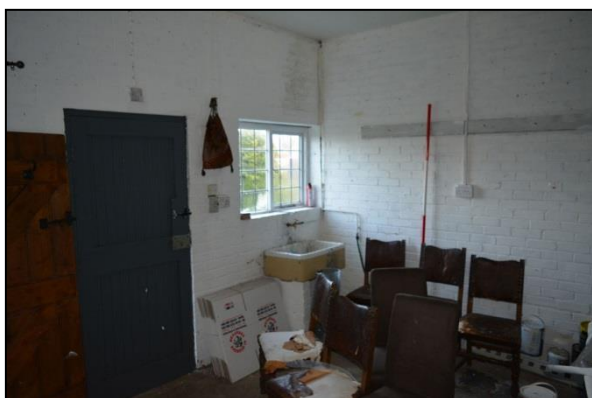
Plate 122: Outbuilding 2: view to northeast(103)

Project code: 416/WER	Project: Wellwick House, Wendover	Room no: OB2
Location: East end of garage block	Function: Garage	
Wall form & decor: Painted Fletton brickwork to all walls		
Ceiling / roof structure: Painted plasterboard		
Windows: Two 2-light timber casements with traditional fittings to the north, door to south		
Doors: Single timber door to north and		
Floor: Concrete		
Fireplace:		
Staircase: Two brick steps up toe southern door		
Other architectural details:		
Recorder: KK	Survey Date: 11.12.2018

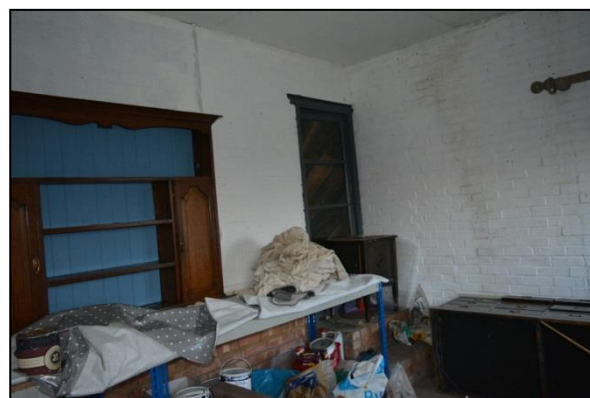
Plate 123: Outbuilding 2: view to southwest(104)

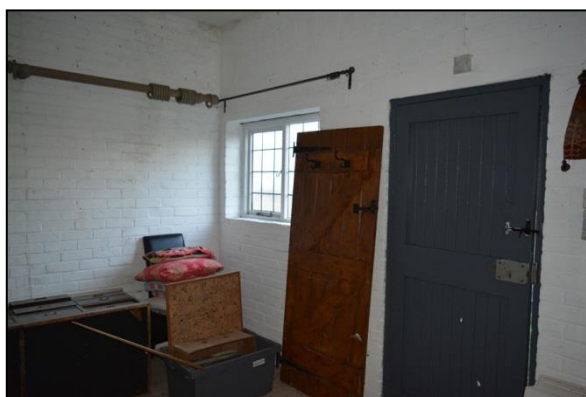
Plate 124: Outbuilding 2: view to northwest(105)

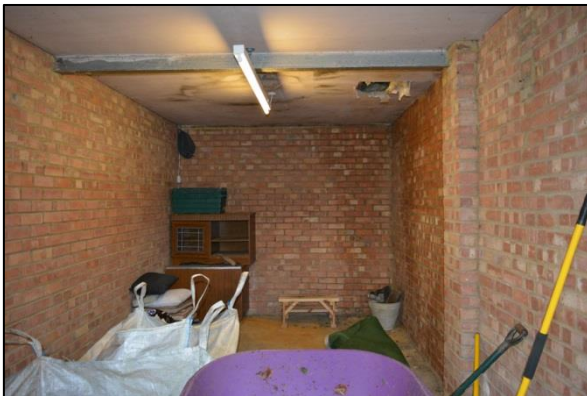
Plate 125: Outbuilding 3: view to north (106)

Project code: 416/WER	Project: Wellwick House, Wendover	Room no: OB3
Location: East end of garage block		Function: Garage
Wall form & decor: Unpainted Fletton brickwork set in stretcher bond with cement mortar		
Ceiling / roof structure: Plasterboard		
Windows:		
Doors: Double timber doors to the south		
Floor: Concrete		
Fireplace:		
Staircase:		
Other architectural details:		
Recorder: KK	Survey Date: 11.12.2018

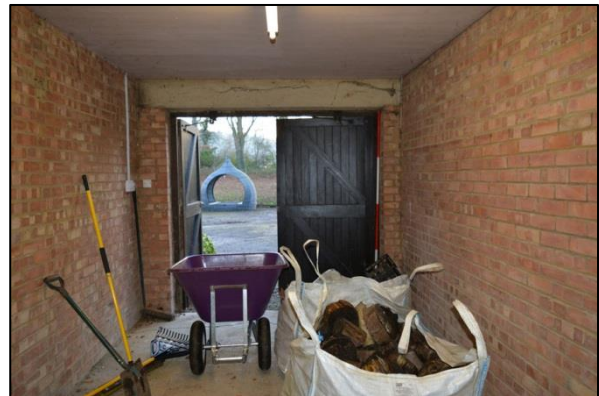
Plate 126: Outbuilding 3: view to south (107)
