**Historic building recording  
at Samuel Pepys Public House  
Slipton, Northamptonshire  
Level 2  
July 2022**

Report No. 22/75

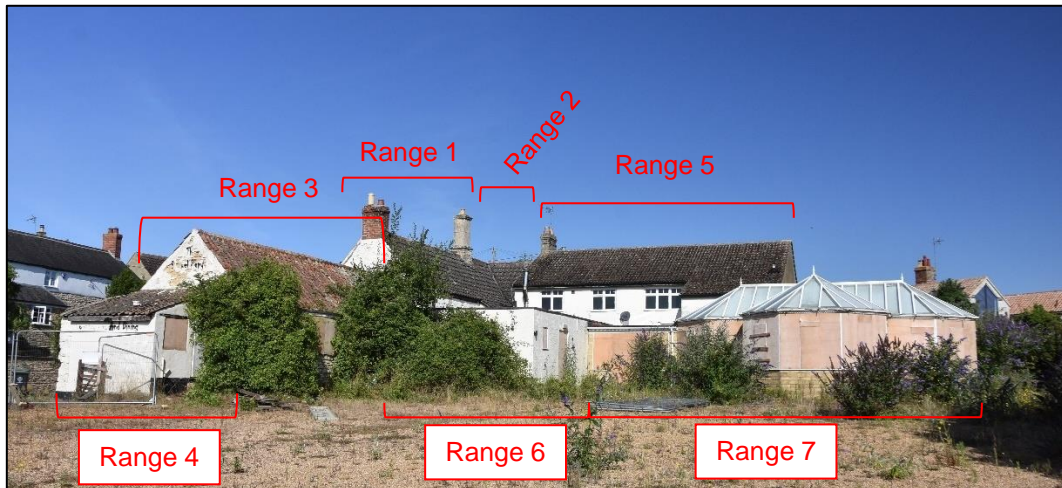
The building from the rear car park showing various ranges, looking south-west Fig 5

The site comprises the public house as described above (see Fig 105). The building comprises several distinctive ranges which for ease of reference are described in detail below and given numerical identifiers. Rather than elevation by elevation descriptions the exterior is described in these ranges. It is clear that the historic part of the public house lies adjacent to the road with subsequent later additions to the east and west, and more modern accretions to the rear. The rear of the property was overgrown and some elevations were obscured by vegetation.

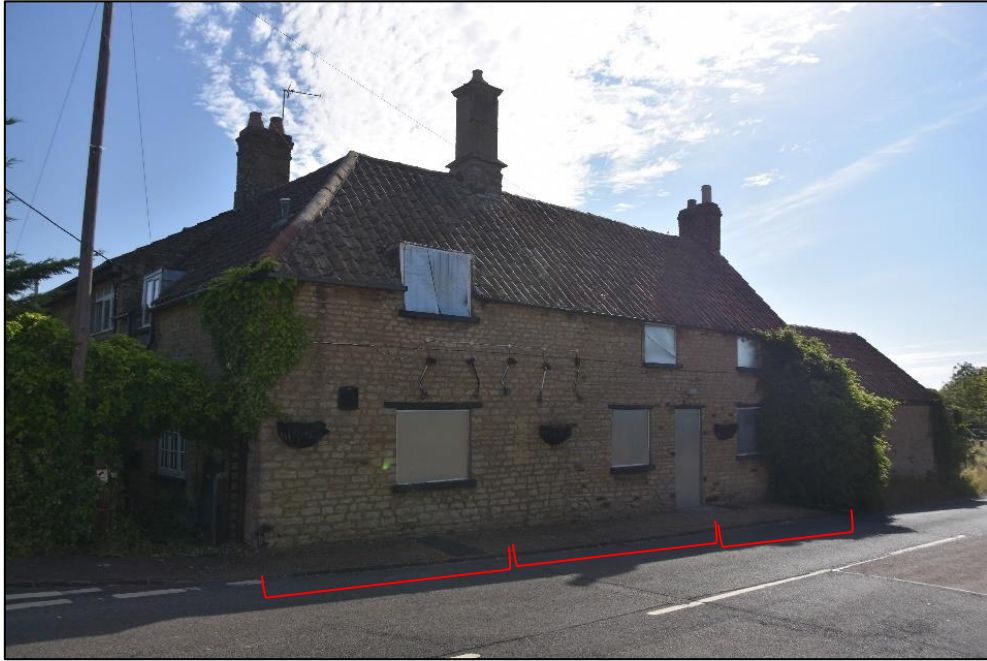
Street-facing south elevation showing Ranges 2, 1, and 3 (left, centre and right), looking east Fig 6

Fronting the road this range comprises the area of the building between the two chimney stacks (Fig 6). It is linear in form, comprised of two storeys with a double-pitched pan-tile roof. It is constructed of rubblestone with heavy cementitious render with buff coursed stone. There is the occasional darker orange stone similar to Northampton Sand. The windows and doors are boarded and are described in more detail below in the internal descriptions. They have slender timber lintels and sills and are painted black. The door has a flagstone to its threshold. The east gable end is painted but appears to be constructed of brick like the chimney above (Fig 7). The rear elevation is obscured by a later flat-roof range but is visible through a first floor window in an adjoining range. Heavily rendered and painted there is some evidence of it being stone construction with larger quoin blocks to the south-east corner (Fig 8). The elevation is plain but there may be evidence of a former roof line above the current flat-roof range. The two chimneys to the roof of Range 1 are of red brick to the east, with evidence of a former roof line just above the current pan-tiles. There is a fine ashlar example to the west with stone rubble base, string-course and moulded cornices.

This range lies to the immediate west of Range 1 and on first glance appears to be contemporary although it is of one-and-a-half storeys (see Fig 6). The range is fairly short extending west before returning to the north (Fig 9) and essentially comprising the corner between two other ranges. It is built of coursed buff rubblestone with no sign of the darker stone seen in Range 1. It too has been treated with heavy mortar which somewhat disguises the coursing. The windows to the south elevation are boarded and are described below in more detail but can be seen to retain timber painted sills and lintels though these are slender. The first floor windows protrude into the roof space with flat-roofs. The windows to the west elevation are not boarded and comprise timber multi-light casements.

Flanking Range 1 this single-storey range extends eastwards from the historic core in linear form with double-pitch pantile roof (see Fig 6). The construction is buff coursed rubblestone with the occasional darker stone similar to Range 1 (Fig 10). There is heavy cementitious render like Range 1 and 2. There are two windows to the south elevation of which one is boarded externally and the other is a multi-light timber casement. The east gable end abuts Range 4 but above has been painted with the name of the pub in lettering. Where the paint has failed buff stone is visible. The rear is largely obscured by vegetation but a bow window is visible projecting from the elevation with its own flat-roof (Fig 11). The stone base is rubblestone in squarer blocks then the adjoining ranges and without the heavy render treatment seen elsewhere.

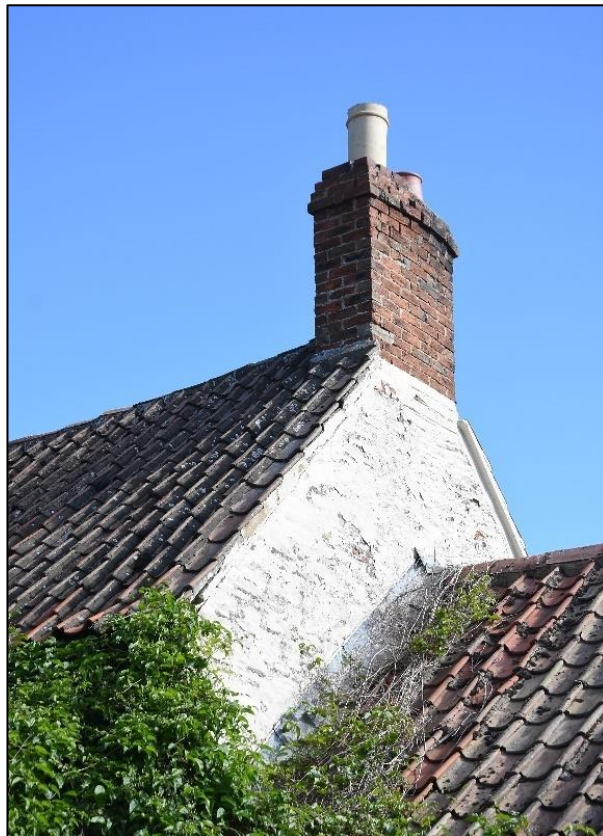
East gable end of Range 1, looking north-west Fig 7

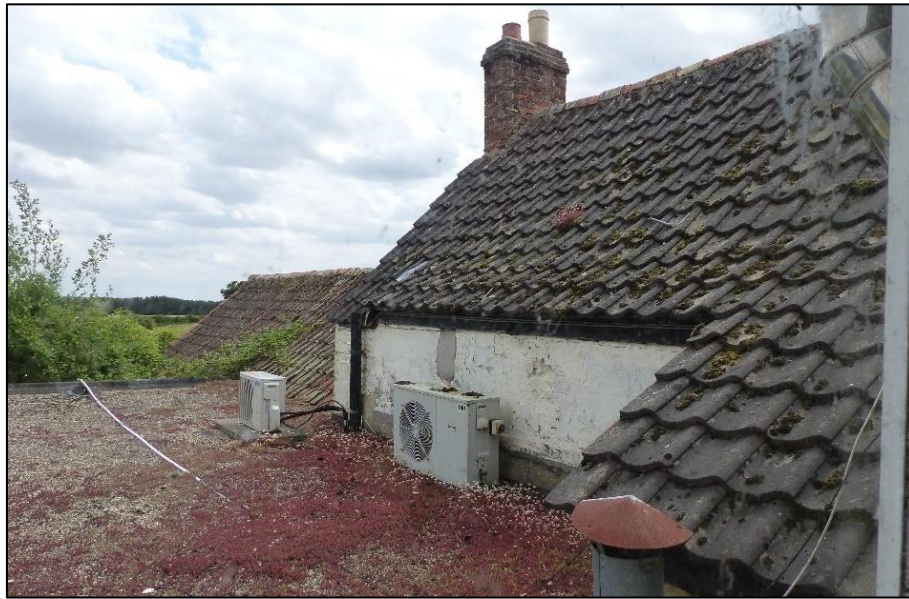
Rear of Range 1 seen from a first floor window, looking south Fig 8

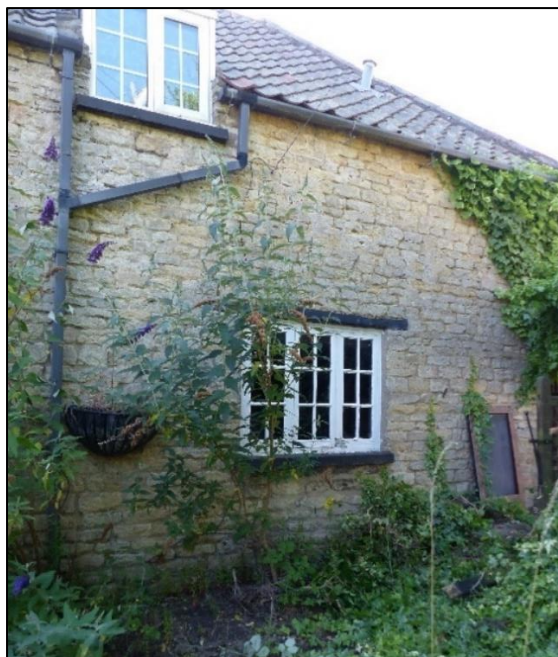
West elevation of Range 2, looking south Fig 9

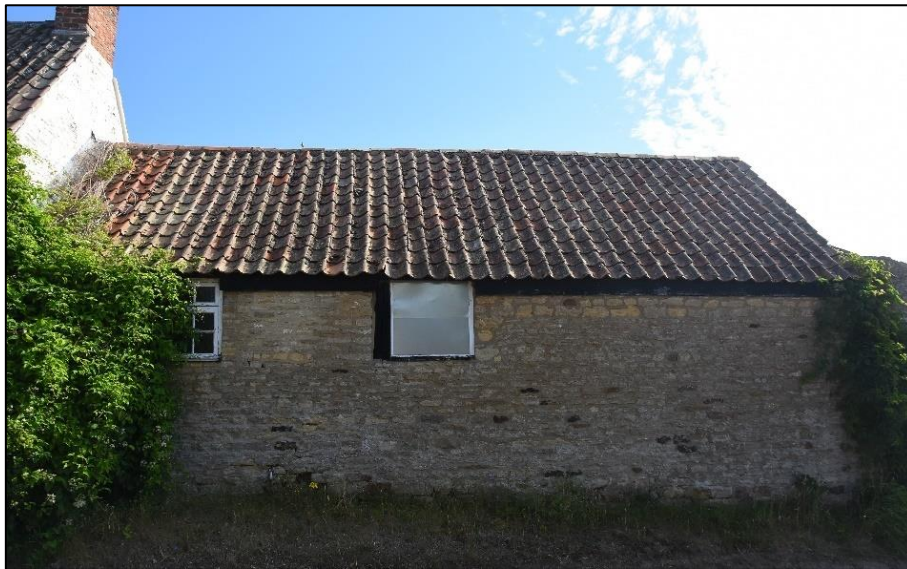
South elevation of Range 3, looking north-east Fig 10

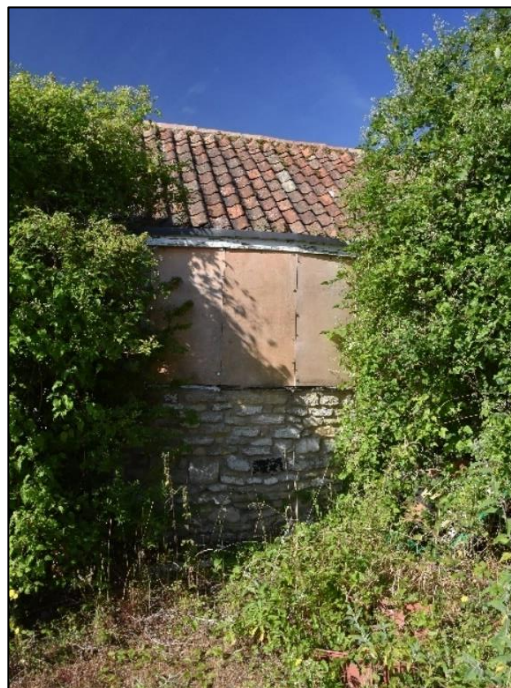
Bow window to the rear of Range 3, looking south-west Fig 11

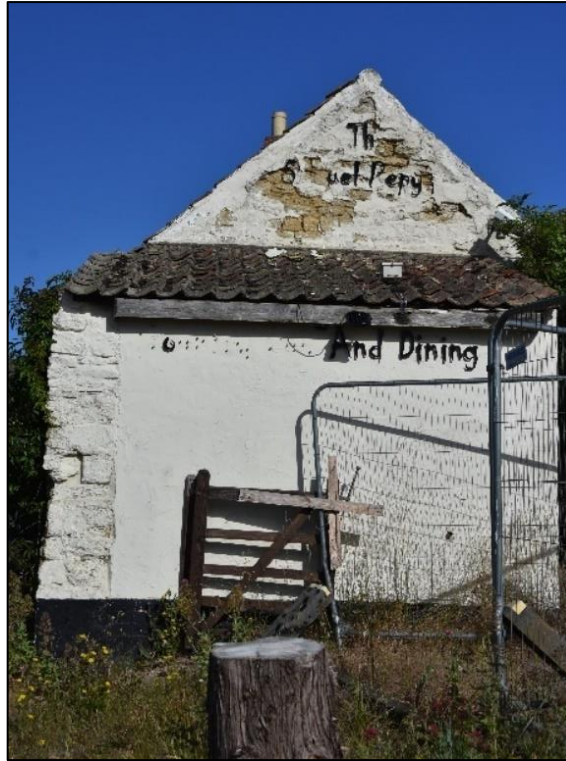
Range 4 abutting Range 3 to the west, looking north-west Fig 12

Abutting Range 3 this single-storey lean-to outshut has a rubblestone south elevation but its connection to Range 3 is obscured by vegetation. Its eastern and northern elevations are rendered and painted (Fig 12). There is a boarded window with timber slender lintel to the north, and a timber door accessed via concrete steps.

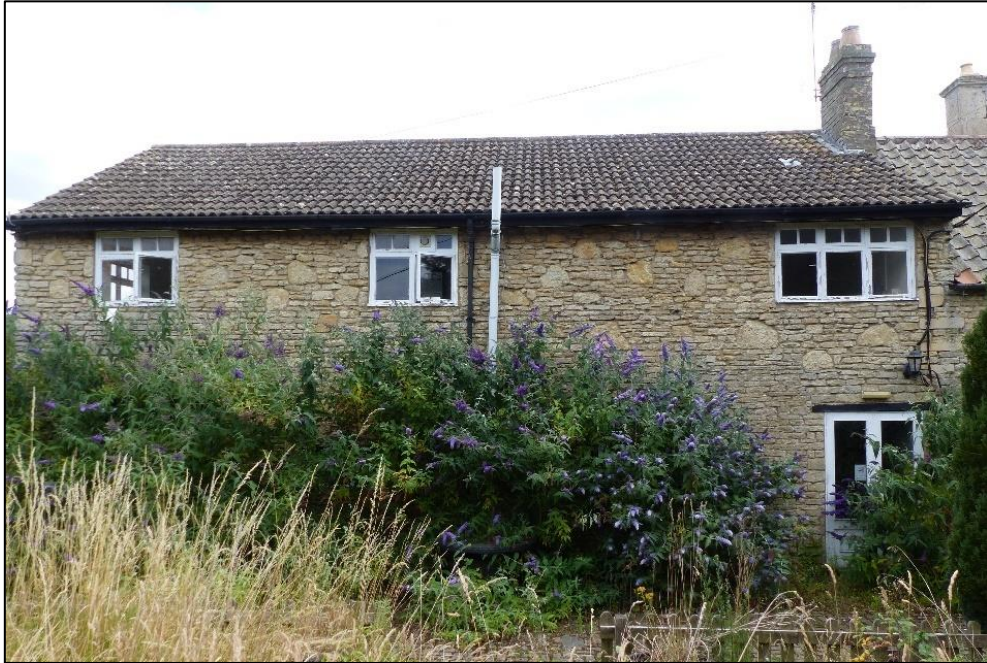
West elevation of Range 5, looking south-east Fig 13

Abutting Range 2 this large two-storey linear range with double-pitch roof creates the L-shape to the existing floor plan (Fig 13). It is constructed of rubblestone in coursing with large worked blocks used sporadically. The ground floor to the west is largely obscured by vegetation but a single timber door is visible to the south with slender timber lintel. There are three windows to the first floor; all timber modern casements. The north gable end visible above other extensions is rendered with pebble-dash and retains a single multi-light casement (Fig 14). The east elevation is obscured at ground floor level by a flat-roof range but retains three windows to the first floor and is rendered and painted (Fig 15). The roof is double-pitch laid with modern pantiles with a yellow brick chimney to the south junction with Range 2.

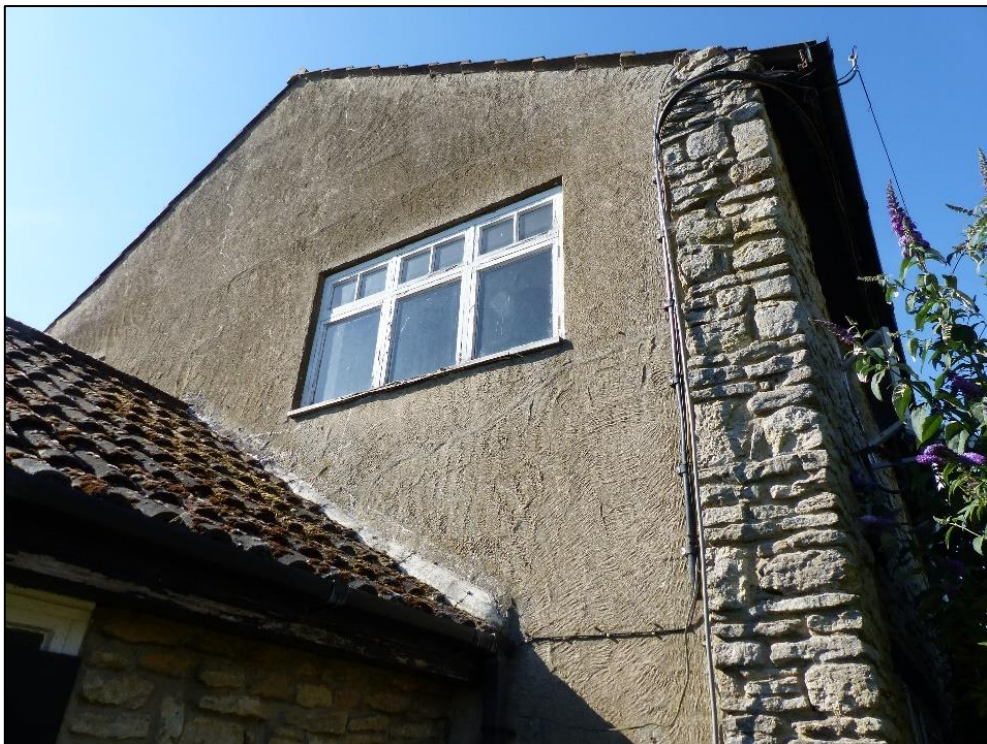
North gable end of Range 5, looking south-west Fig 14

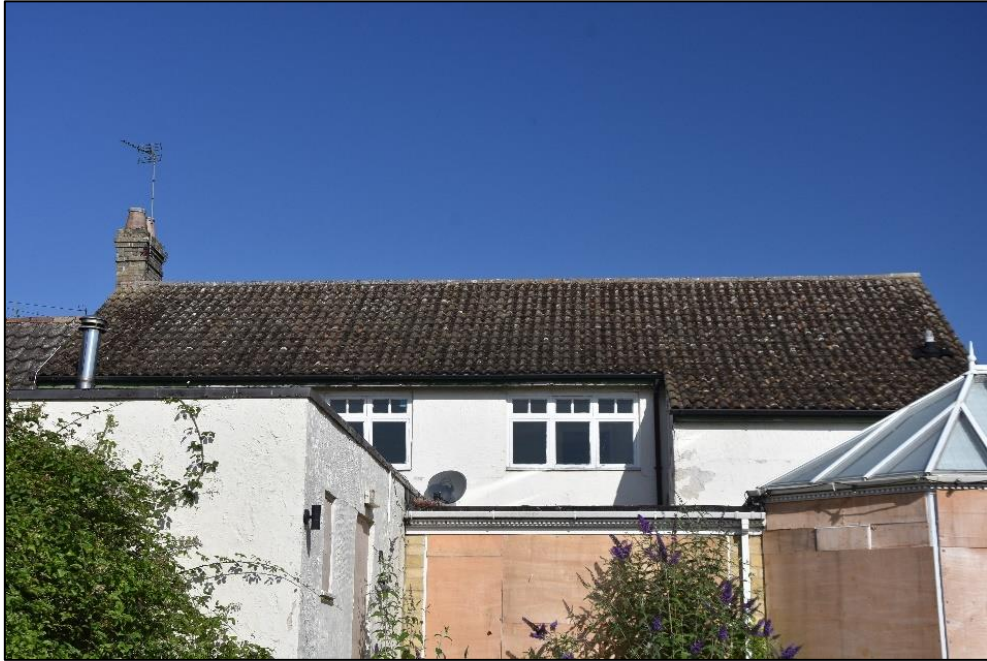
Range 5 to the rear, obscured by Range 6 at ground floor level, looking north-west  
Fig 15

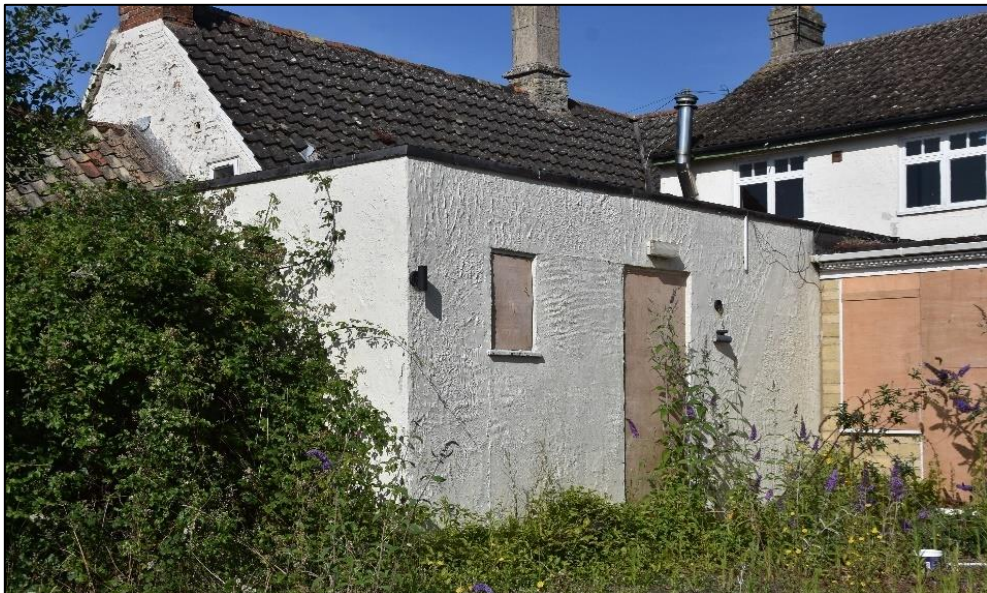
Range 6 visible to the rear yard, looking south-west Fig 16

A flat-roof range sitting within the return of Range 2 and obscuring Range 1 and 5. It is rendered and painted and the apertures are all boarded (Fig 16).

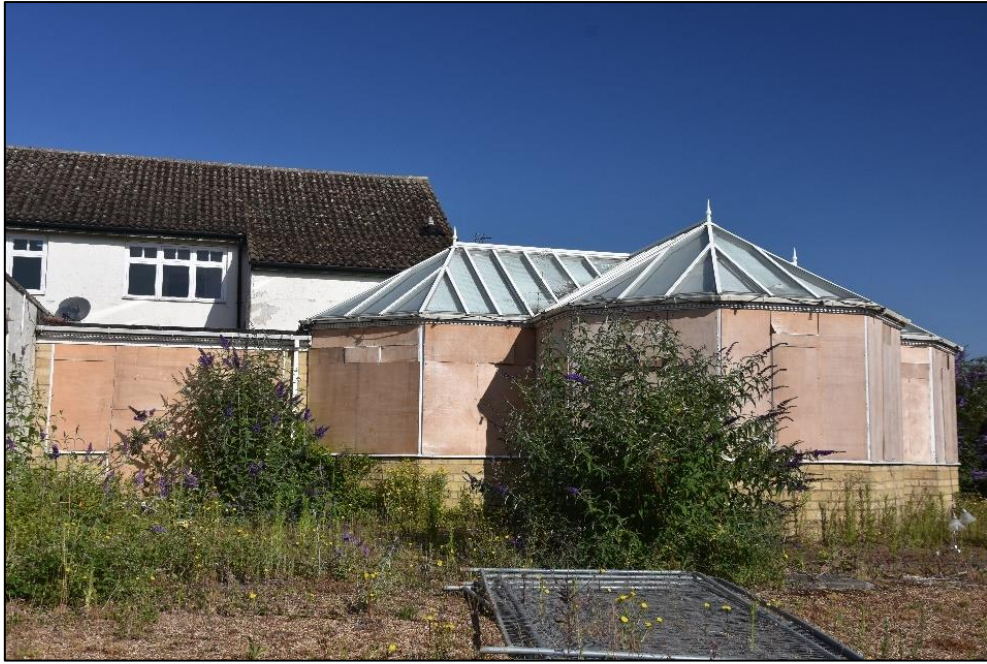
Conservatory range (Range 7), looking north-west Fig 17

A conservatory range providing restaurant space for the public house, with yellow ashlar blocks to the base and largely glazed elevations (Fig 17). There is a flat-roof element to the south and a T-shaped element to the north.

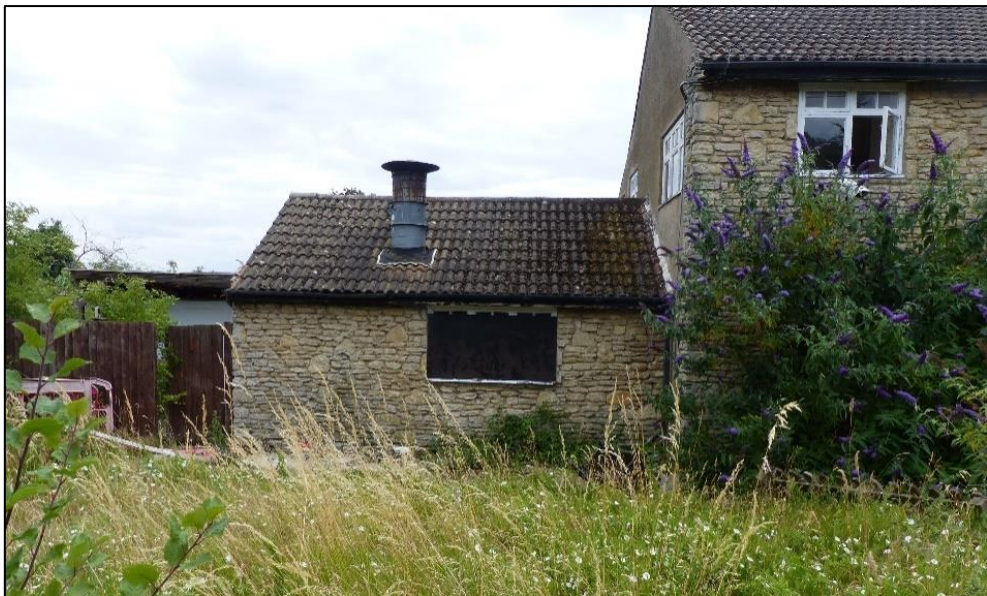
Fig 18

Range 8 abutting Range 5 to the south, looking south-east

A single-storey buff rubblestone structure to the north of Range 5 (Fig 18). It has a short linear floor plan with eastern projection and a double-pitch pantile roof (Fig 19). There are boarded windows and an industrial kitchen chimney to the roof.

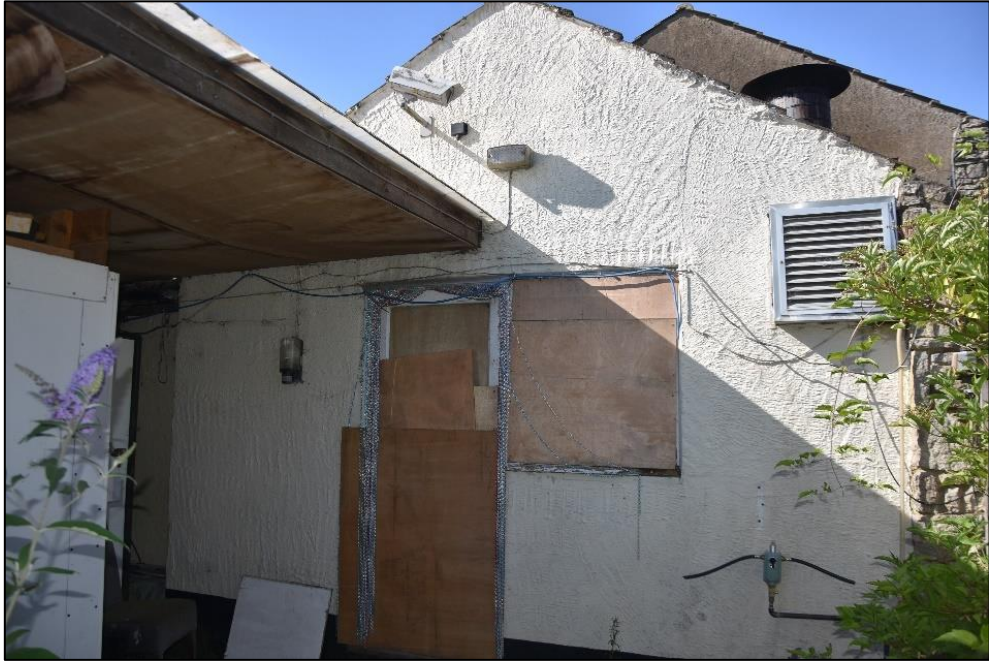
Fig 19

Rendered gable end of Range 8, looking south-west

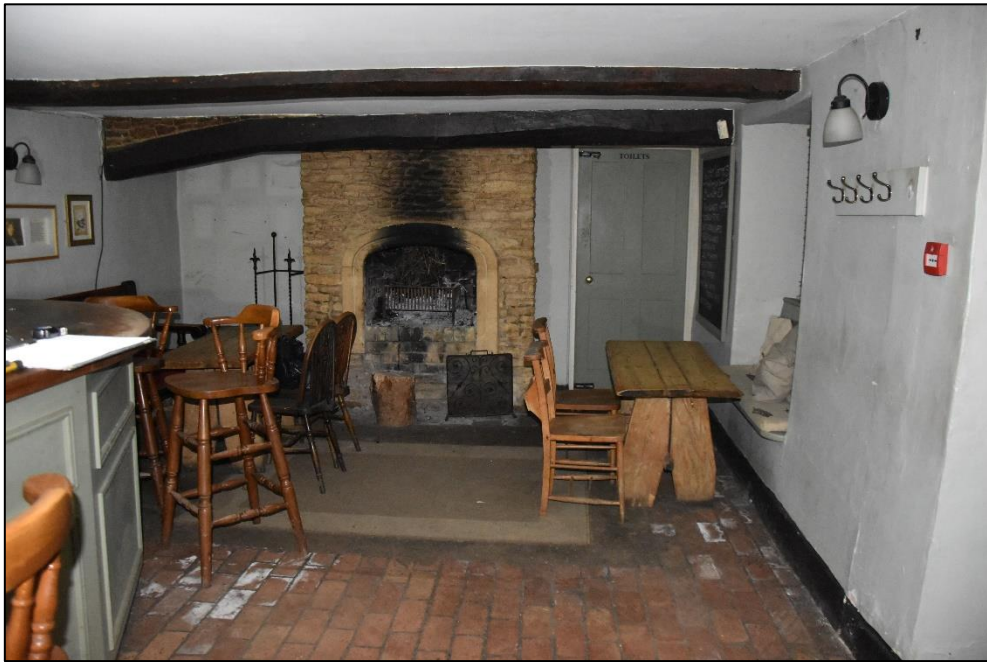
East end of the bar (GF01), looking south-east Fig 20

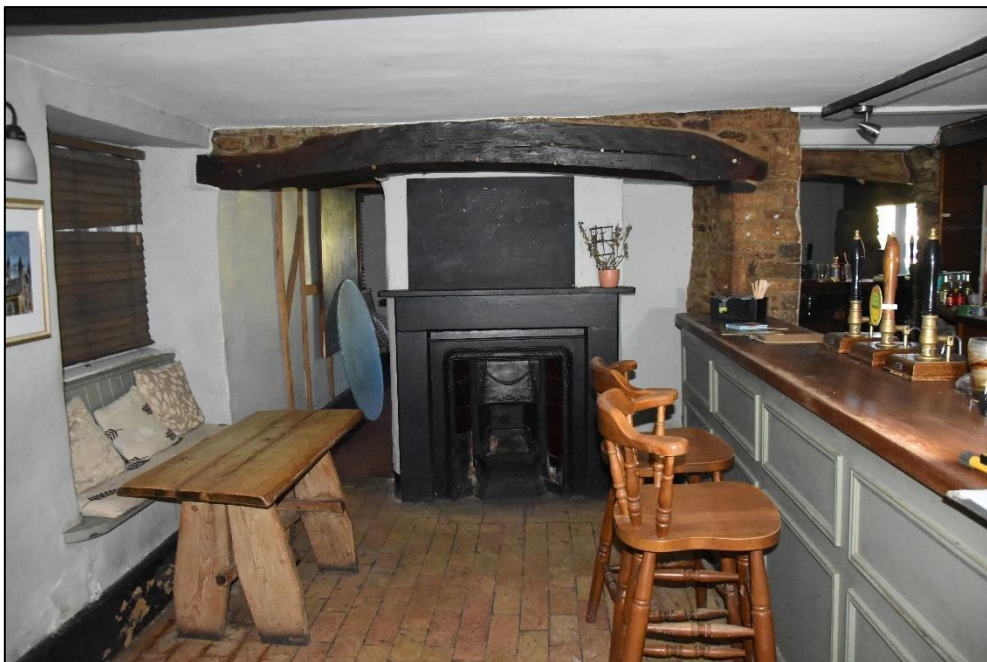
West end of the bar (GF01), looking north-west Fig 21

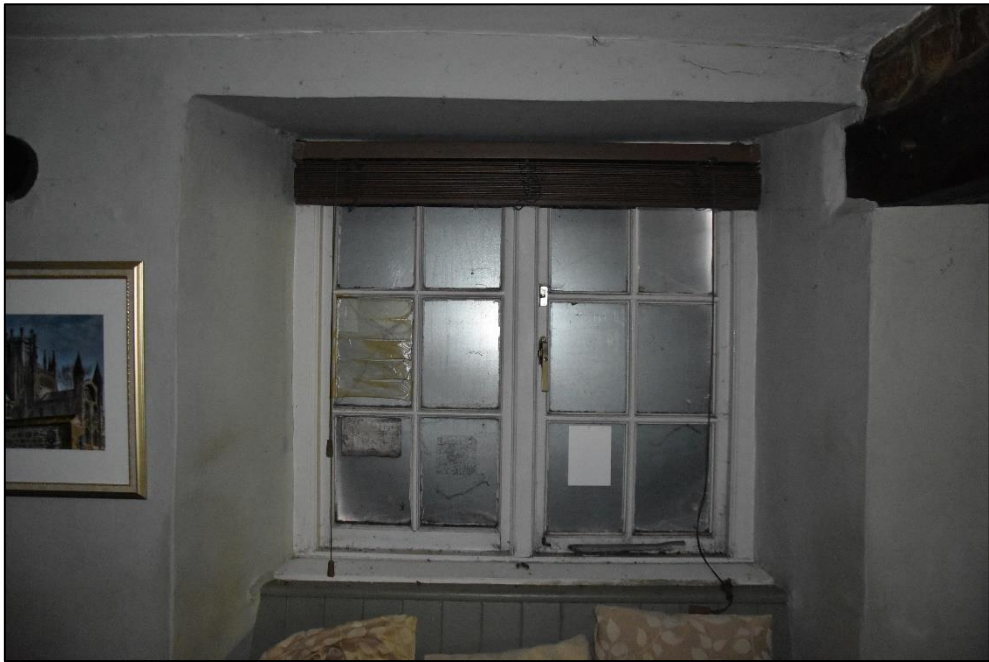
Fig 22

Casement within the bar (GF01), looking south-west

The floor is laid with brick tiles with some wear. There is a stone slab to the east around one of the two chimney stacks. The walls are rendered and painted and rise from a simple plinth. The two windows to the west wall are multi-pane two-light casements with thick glazing bars and modern brass catches (Fig 22). The door has two boarded panels with security bolts and an iron latch (Fig 23). The reveal it sits within exposes the thickness of this exterior wall.

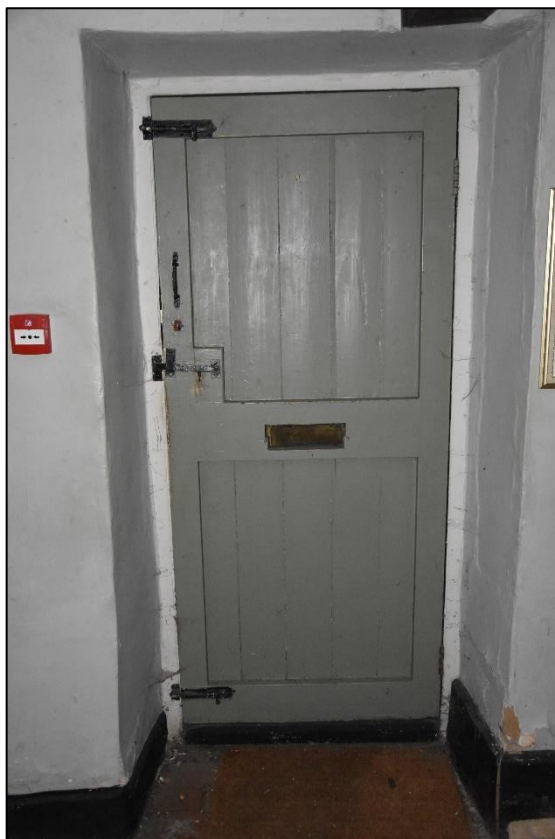
Fig 23

Exterior door within the bar (GF01), looking south-west

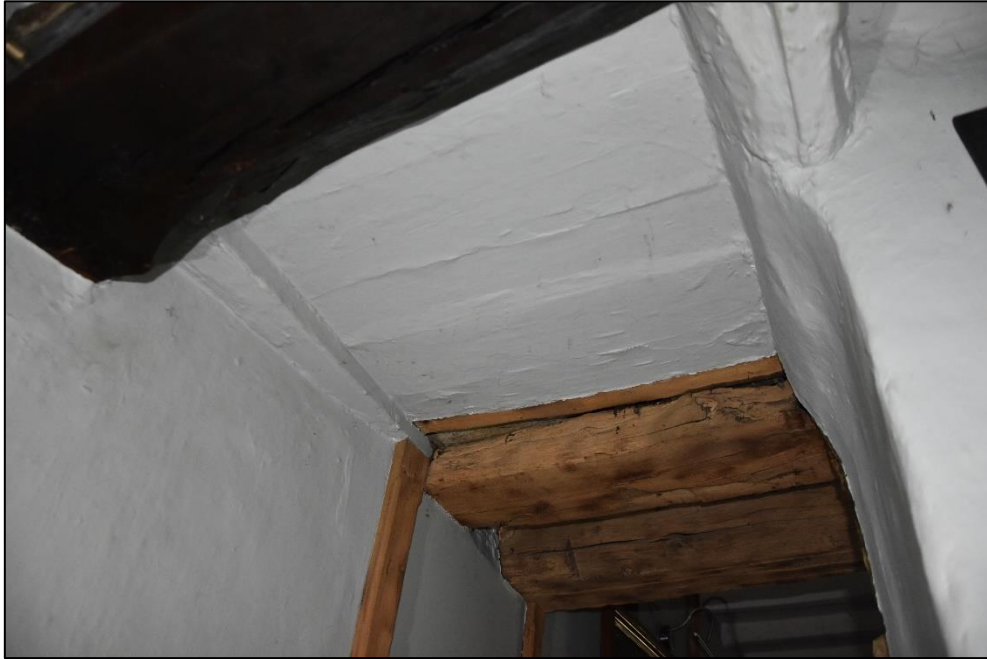
Space to the south of the fireplace marking the junction between Range 1 and 2, looking north Fig 24

At the opposite end of the room another chimney stack retains a simple timber surround with shelf, and a Victorian/Edwardian grate with dark red glazed tile slips. This sits the area between Range 1 and Range 2 and the wall to the west has been removed to provide access between the two areas (Fig 24). A stone projection to the east creates a large aperture with cranked timber bressummer above, this may well be part of a scheme to 'antique-ify' this space.

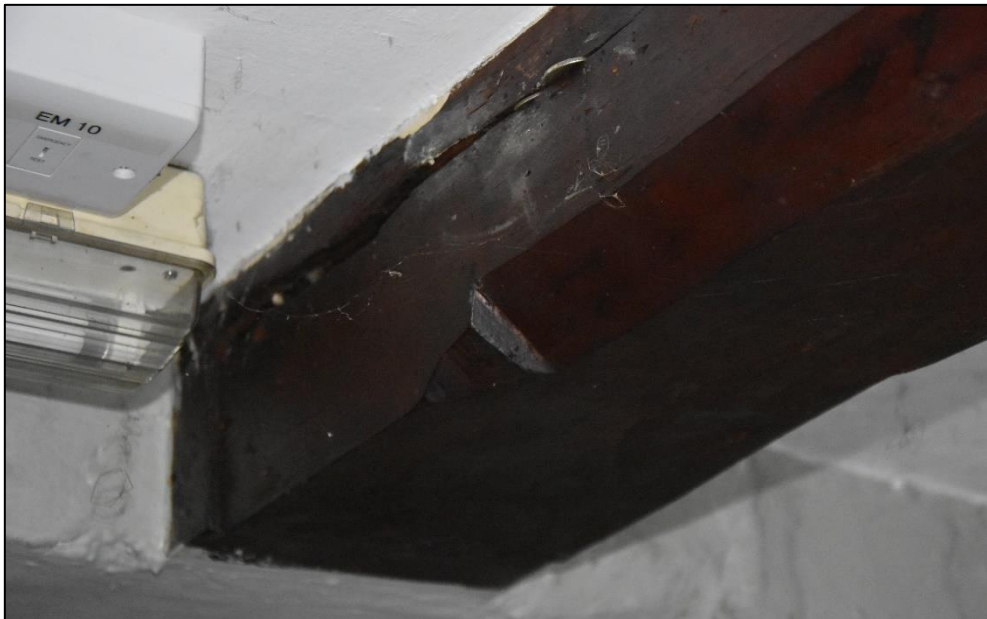
Chamfers and stops to the binding joist in the bar (GF01), looking north-east Fig 25

There are several three binding joists to the otherwise plain ceiling. The example nearest to the east fireplace is likely an insertion as it is cranked and has faux-chamfers. The other two examples both have chamfers and moulded stops of some age (Fig 25).

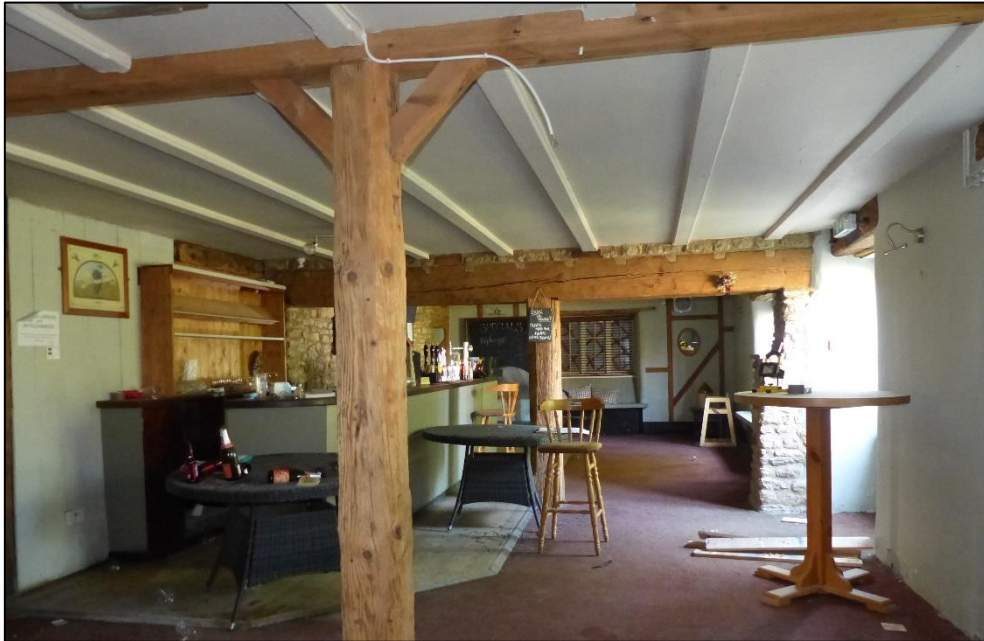
General view of the lounge (GF02), looking south Fig 26

This room is one of the largest on the ground floor and straddles the junction between Range 2 and Range 5. It is utilised as the public house's lounge with a bar along the east wall which is entirely modern (Fig 26). The area is divided into three bays, although it is not clear if these are bays in the true sense of the word: the descriptions will use this term loosely to describe these areas. As a whole, the room is carpeted with no skirting in some areas, and plain examples elsewhere which rise to plastered walls. There is some fictive timber-framing and joisting, which is described below and

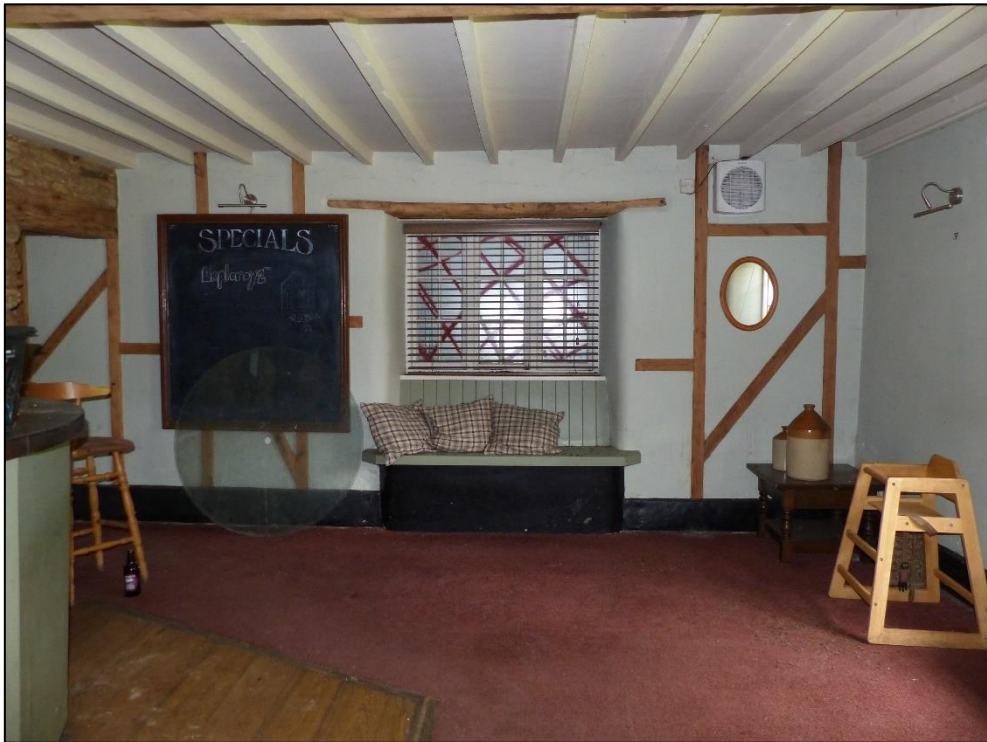
Fig 27

South wall of the lounge (GF02), looking south-west

The southernmost bay is housed entirely within Range 2. A plinth or simple skirting extends along the south and west walls, which are both plastered (Fig 27). The south wall has a series of fictive timber-framing comprising studs and raking struts, with ovolo-moulded chamfers and stops, and although it is pegged its form holds no structural purpose. There is a window to both the south and west walls with a timber window seat below. Both are of three-lights with multi-pane casements and modern brass catches and have slender timber lintels.

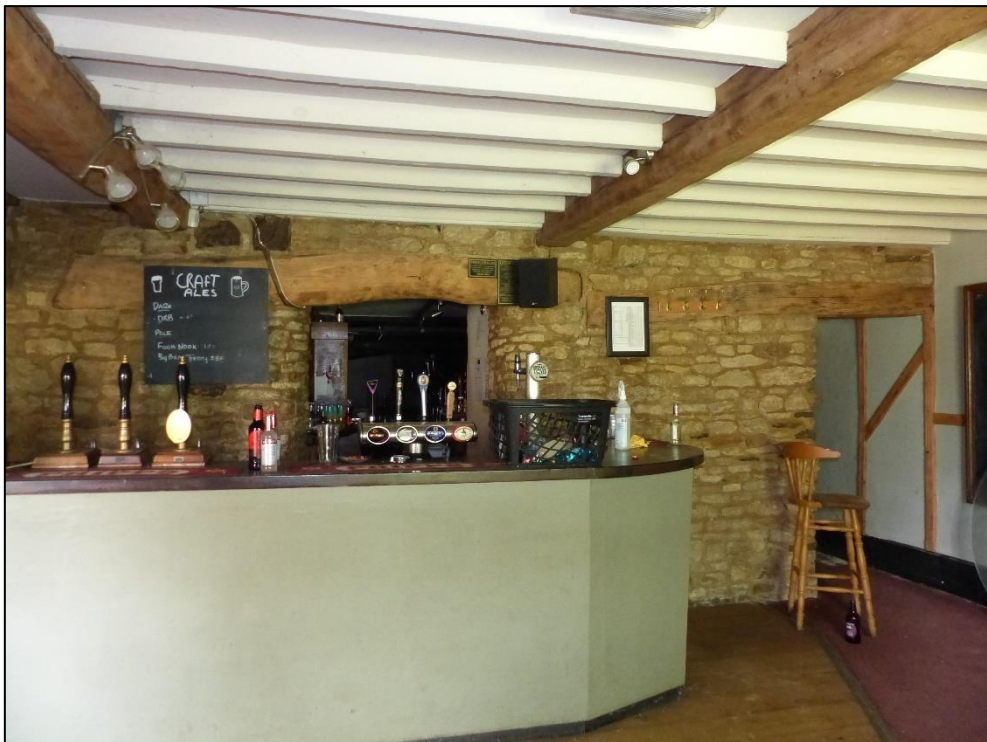
Fig 28

East wall of the southernmost bay in the lounge (GF02), looking south-east

The east wall abuts Range 1 to the east and is of stone construction; likely forming the outer wall of that range against which Range 2 has been constructed (Fig 28). Two apertures have been made through it. One to the south with long timber lintel forms the visitor entrance into the bar (GF01) next door and the other lies behind the bar and forms the staff access into the same space. This has a cranked robust lintel, which extends northwards, both are later additions.

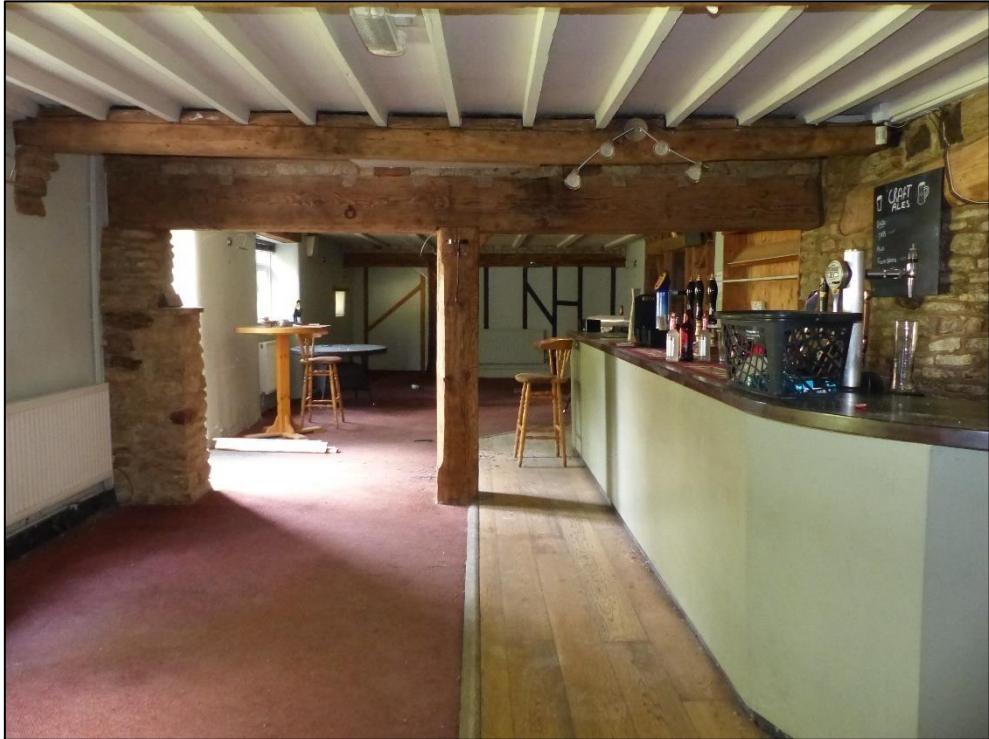
Area to the north of the south bay in the lounge (GF02), looking north-east Fig 29

The north wall is partially open to the adjoining bay and is formed of a stone pier to the west side made of rubblestone which supports a large binding joist which spans the entire breadth of the room and is set into the stone wall here (Fig 29). It measures 34cm by 33cm (13½" by 13") and has a central post with run-out chamfers. The post retains notches which would correlate to a different purpose in a different context, perhaps as wattle notches, or as a wall-plate with notches for common rafters and is heavily weathered (Fig 30). The binding joist above retains mortises for common joists to its edge but have been infilled with cement. Two courses of rubblestone sit above the binder.

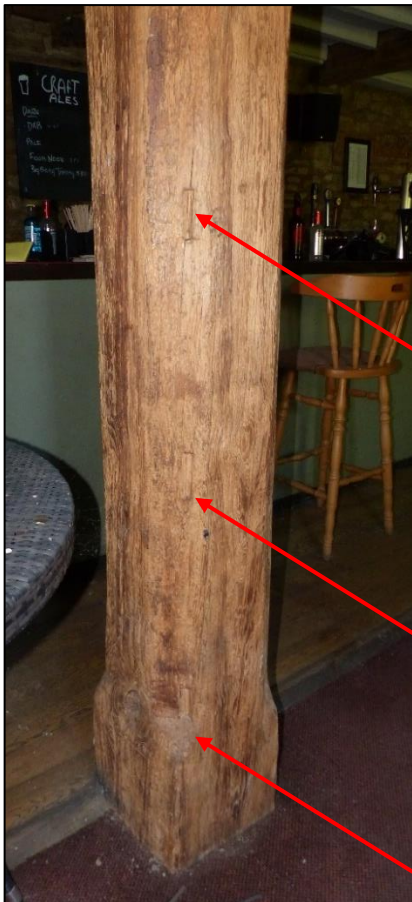
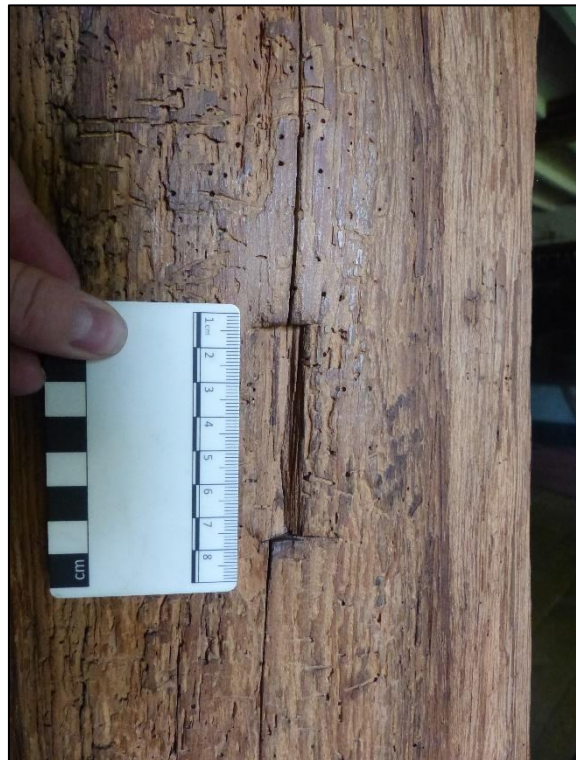
Notches to the post dividing the central and southern bay of the lounge (GF02), looking south-east Fig 30

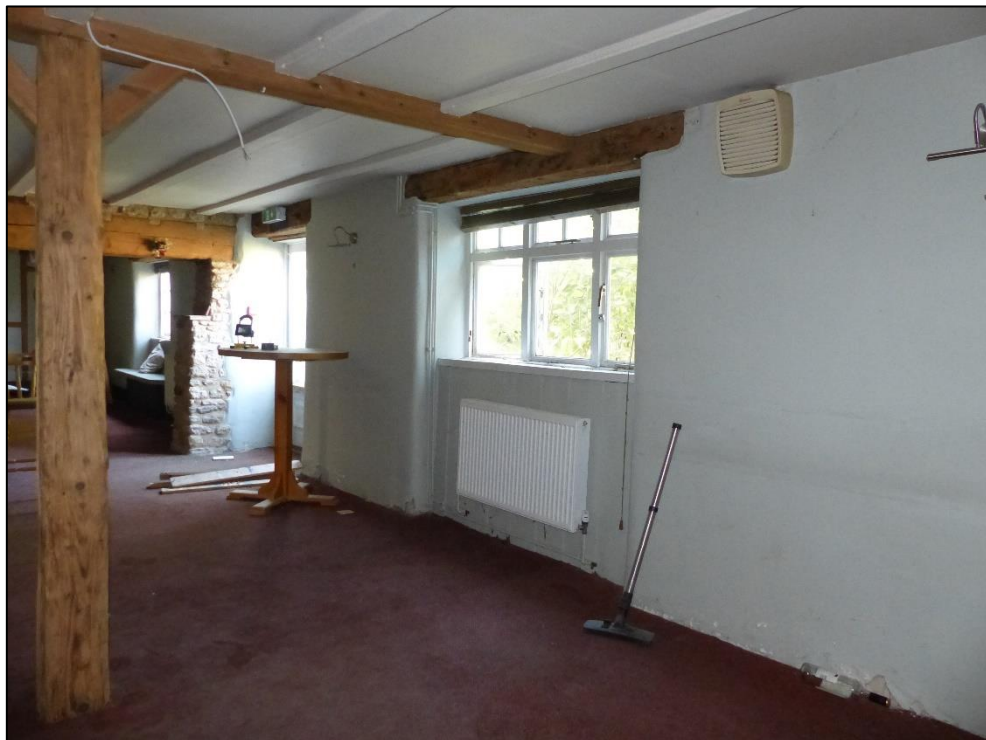
Fig 31

West wall of the lounge (GF02), looking south-west

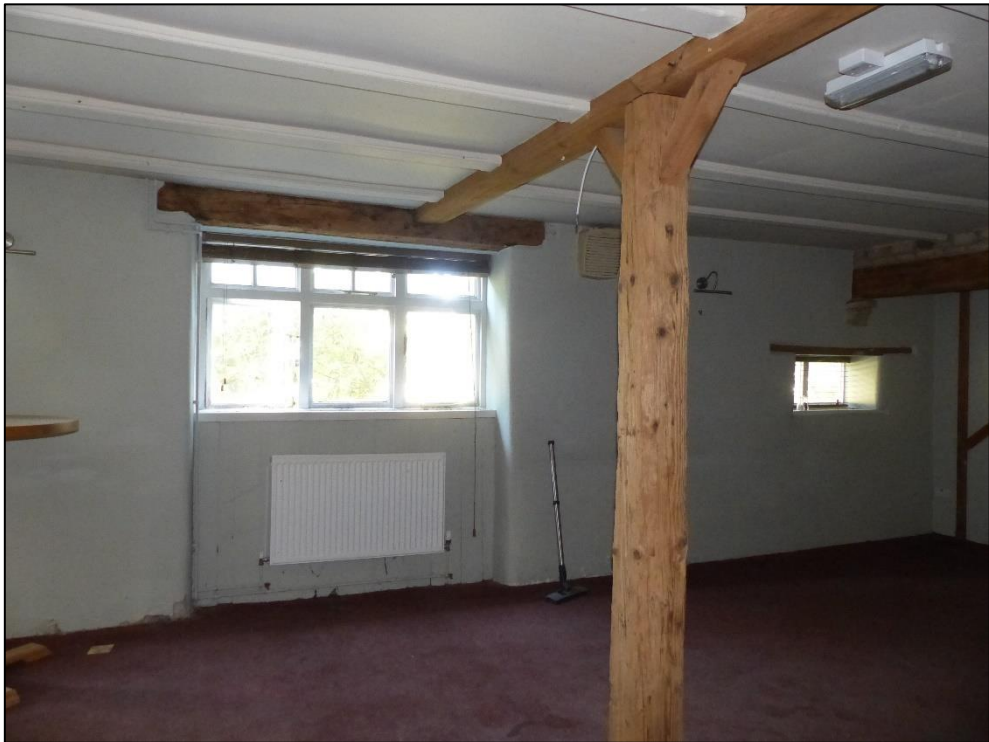
West wall of the lounge (GF02), looking north Fig 32

The ceiling in this area comprises a series of common joists all with the same moulded chamfers and stops seen to the fictive timber panels. They extend from the binding joists previously described and extend north-south to the binder which divides the bays. This binder has a central post with short straight braces with the same chamfers and stops as elsewhere (see Fig 32).

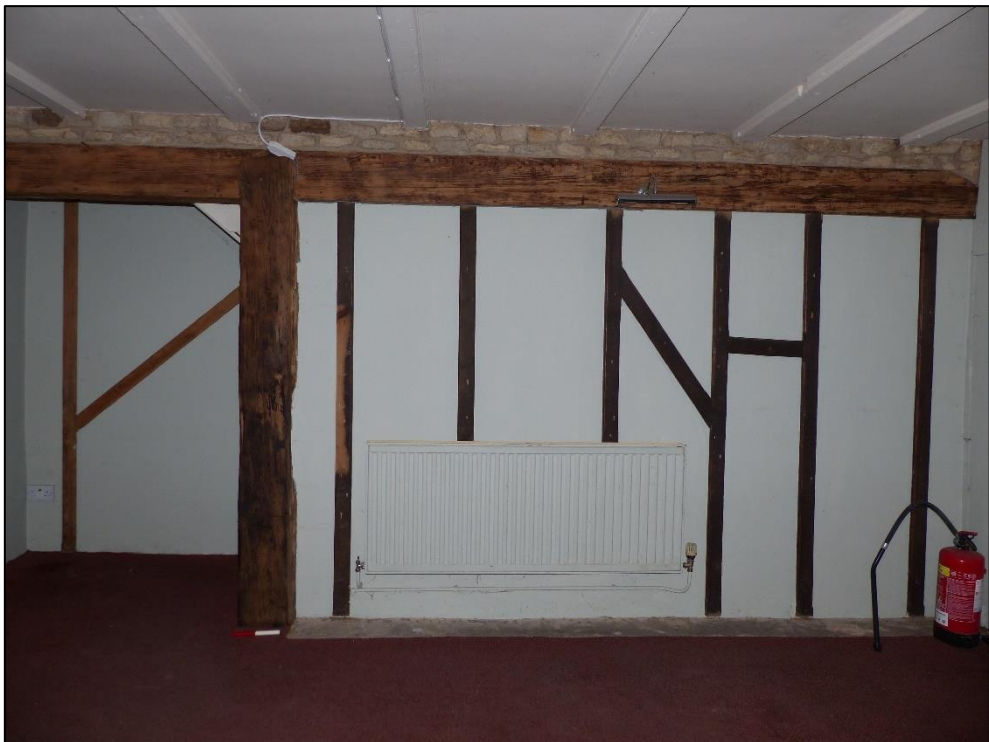
North wall of the lounge with fictive timber-framing, looking north-east Fig 33

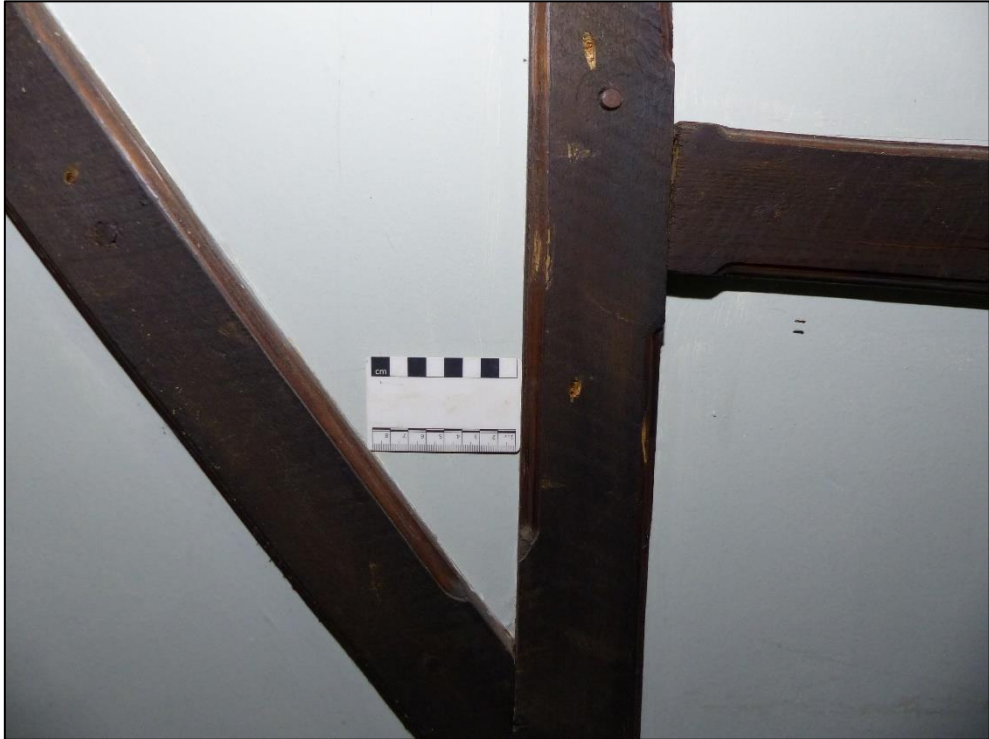
Detail of the fictive timber-framing seen in the lounge (GF02), with moulded chamfers, run-out stops, and pegging, looking north-east Fig 34

To the west straddling the two bays is a panel of timber-framing between two robust posts which remains open to the adjoining area of GF05 (Fig 35). The posts have chamfers with run-out stops supporting a large joist above with empty mortises for a series of common joists, this has been moved from another context. The series of studwork, braces and struts below all have the same moulded chamfers and run-out stops as seen elsewhere in the fictive timber elements of the bar area (see Fig 34).

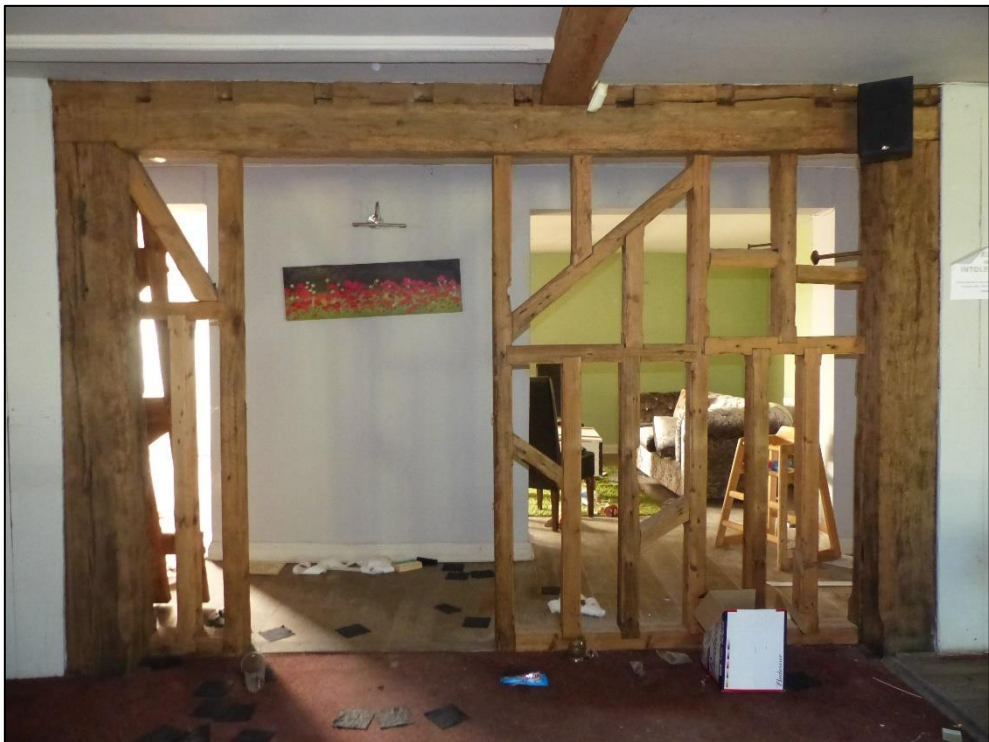
Fictive timber-framing to the east wall of the lounge (GF02), open to the adjoining space (GF05), looking east Fig 35
