**Historic building recording  
at Samuel Pepys Public House  
Slipton, Northamptonshire  
Level 2  
July 2022**

Report No. 22/75

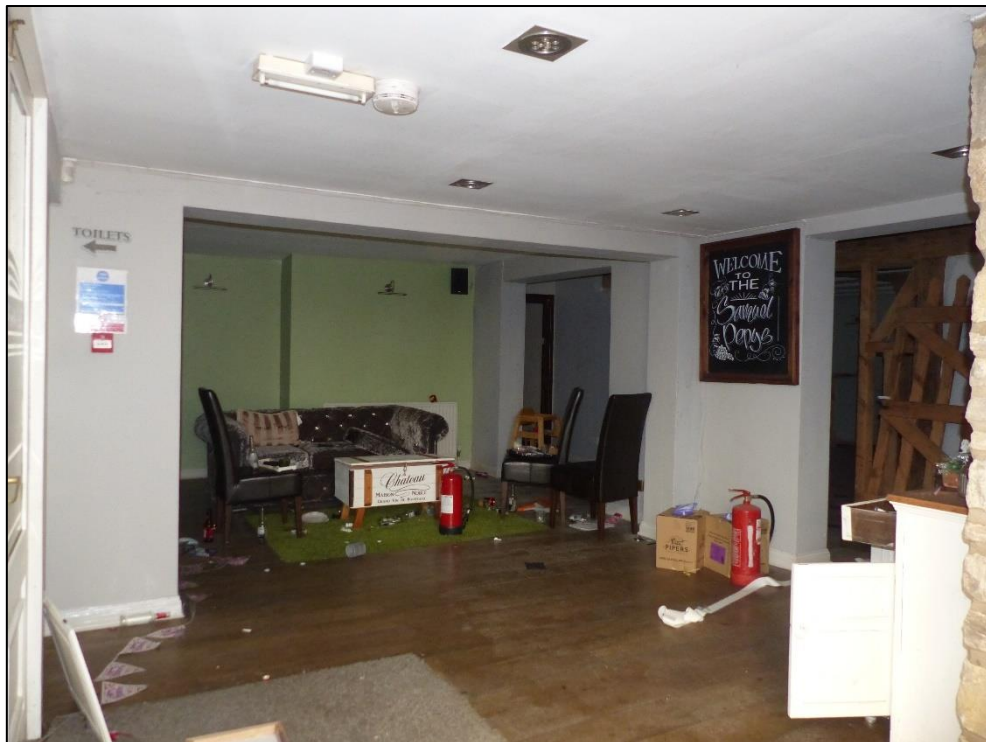
Waiting areas (GF03-04) adjacent to the restaurant, looking west Fig 36

Both areas have 20th century wooden flooring, a Type 1 skirting, plastered and painted walls and plain ceilings. To the north wall of GF04 the wall comprises exposed coursed stone but with heavy mortar.

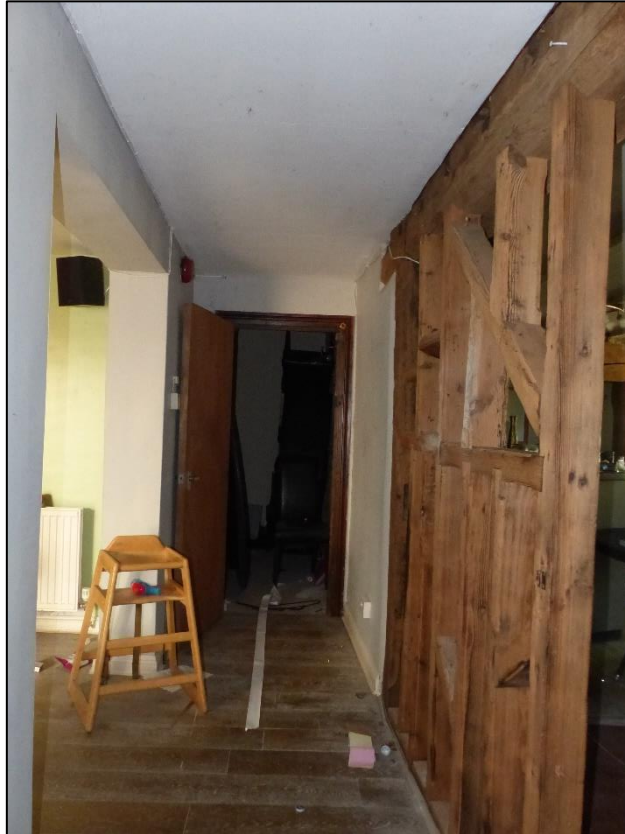
Access corridor (GF05) open to restaurant waiting areas to the east and the lounge to the west, looking north-east Fig 37

This corridor connects several of the public areas of the public house and lies within Range 5. To the north it gives access to several prep and service areas associated with the restaurant (GF06-09 and GF13a-b). To the east it is partially open to GF03 and GF04; restaurant waiting areas, and the lounge to the west (GF02), which comprises a faux timber-framing and is described in more detail below as part of the adjacent rooms descriptions (Fig 37).

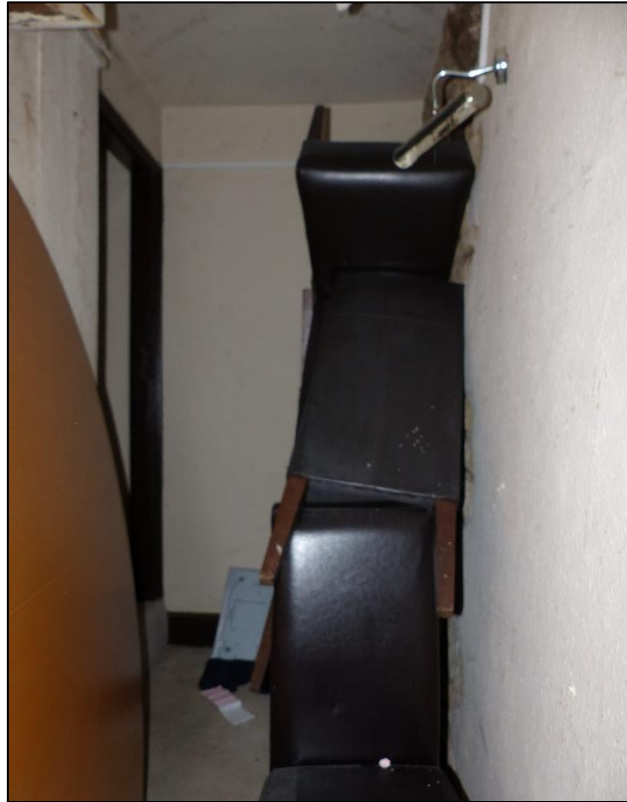
Small stair hall to the south of the main corridor (GF05), looking south-west Fig 38

To the south it has been subdivided to enclose a staircase accessing the first floor, which straddles the divide between Range 1 (Fig 38). Where the water damage has

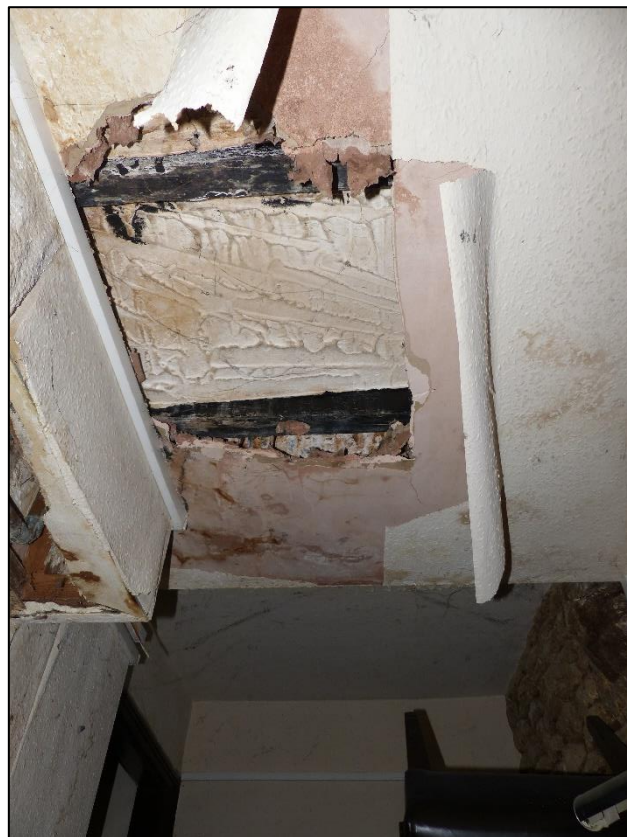
Exposed area of the ceiling within the small stair hall (GF05a), looking south-west Fig 39

occurred to the ceiling and wall paper has started to peel an Artex ceiling is exposed (Fig 39).

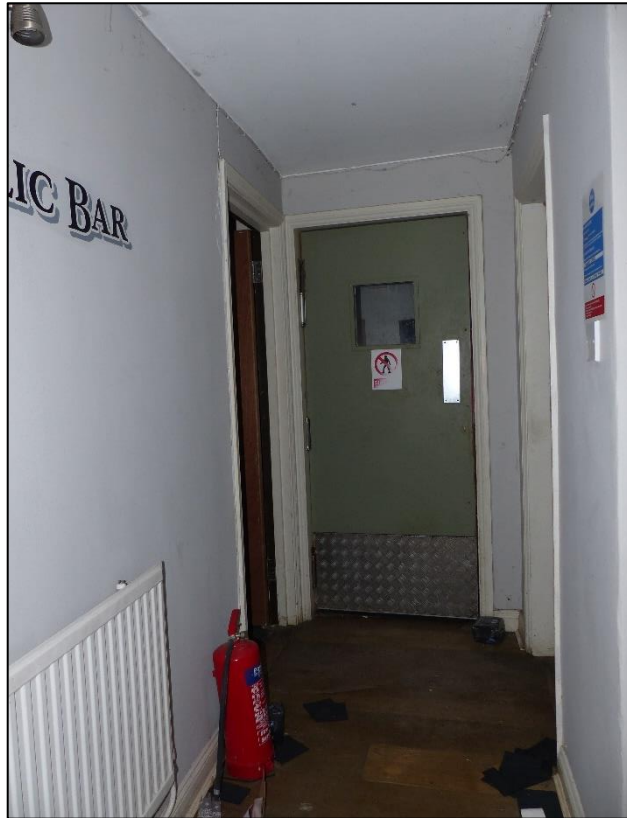
Access to various service areas to the north of GF05, looking north-east Fig 40

The area is laid with 20th century flooring and Type 1 skirting. This rises to plain walls and ceiling. There are multiple 20th century doors to the north, including a fire door with a moulded frame to GF05a, and simple frames to GF08, GF06 and GF13b (Fig 40).

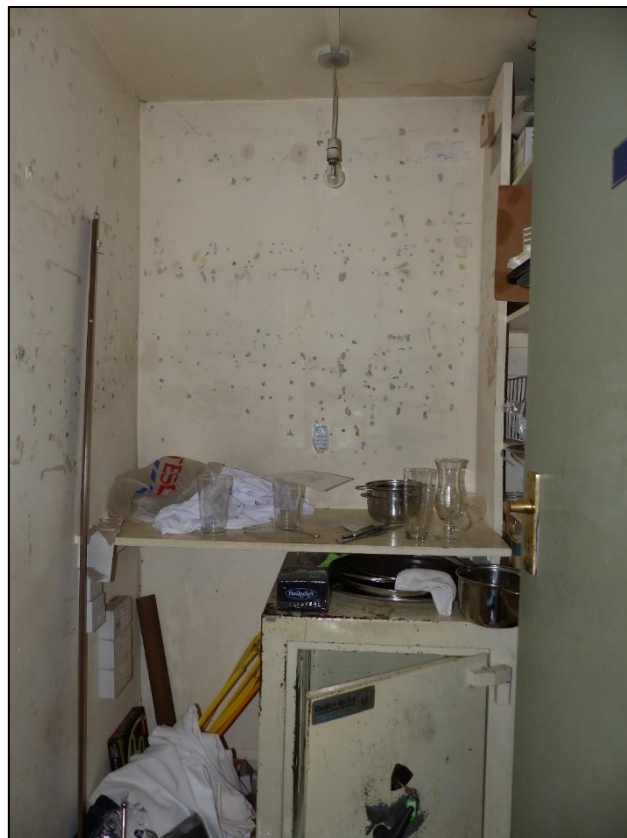
Interior of the safe room (GF05b), looking south-east Fig 41

Within GF05a there is a Dudley Safe, linoleum to the floor and Type 2 skirting (Fig 41).

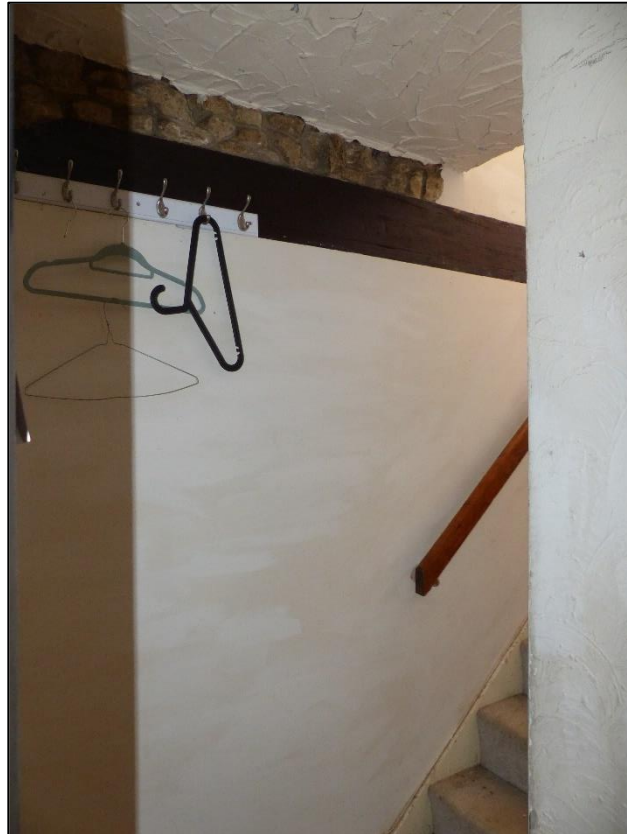
Stone and timber within stair hall (GF06), looking west Fig 44

GF06 has a linoleum floor over concrete and gives access to a staircase up to the first floor. The south wall retains some exposed stonework above a painted beam which extends towards the west (Fig 44).

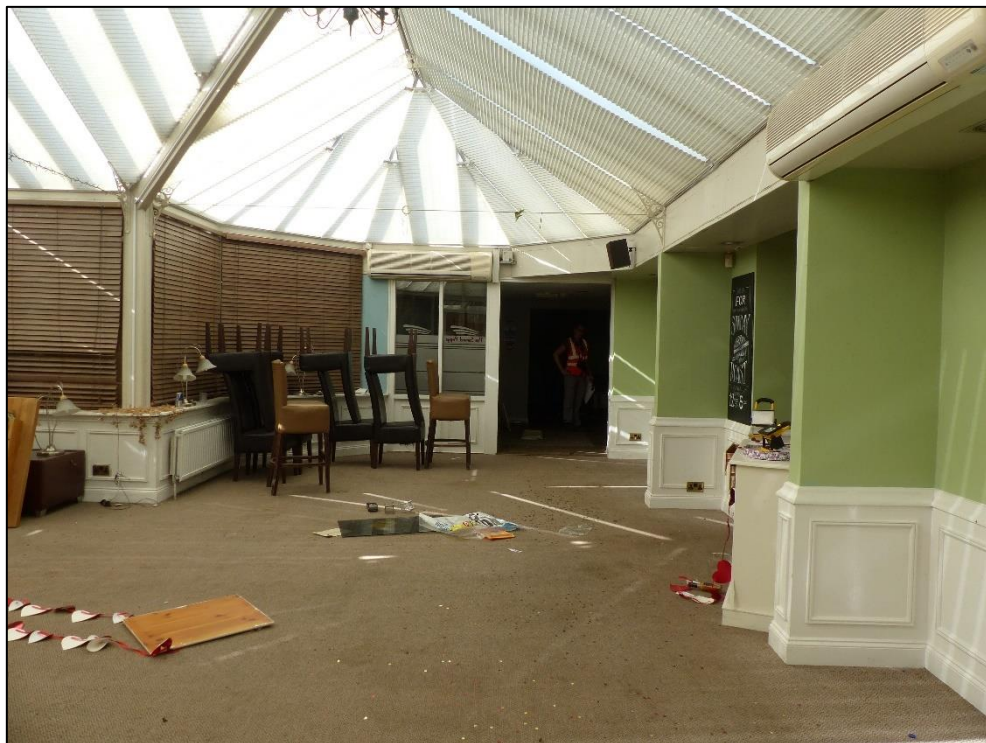
Conservatory restaurant (GF14), looking south-west Fig 50

The area is carpeted with Type 1 skirting rising to a dado and lower panelling with applied mouldings (Fig 50). Above the dado the north and east walls mostly comprise timber and glass partitions, to the west painted and plastered walls form the former exterior walls of Ranges 5 and 8 (Fig 51).

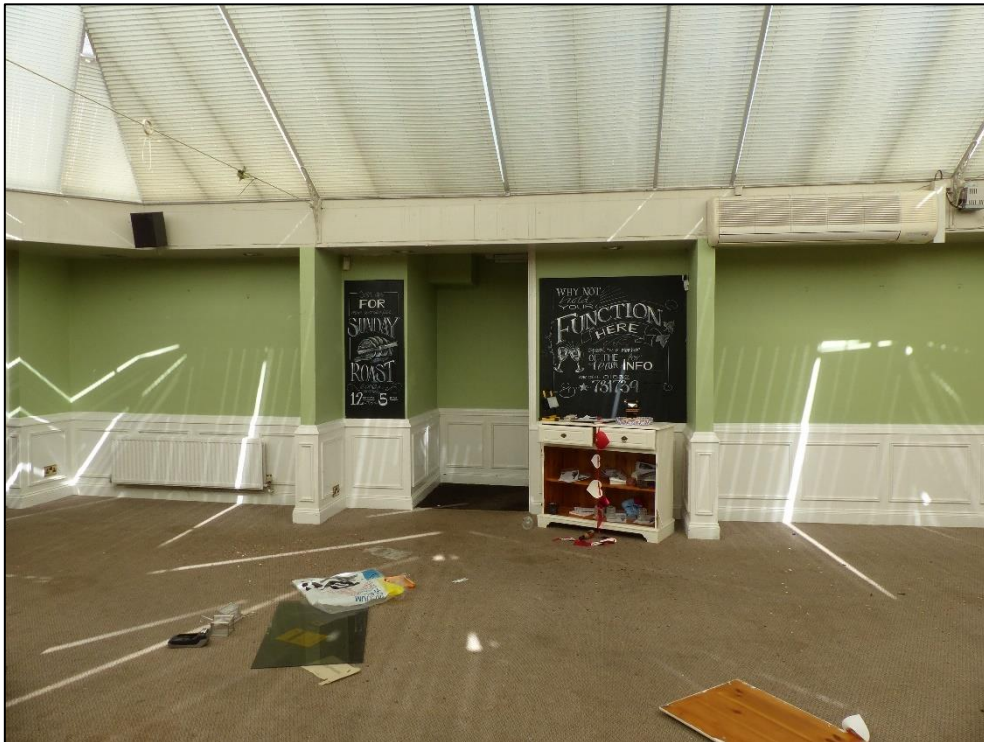
West wall of the restaurant (GF14), looking north-west Fig 51

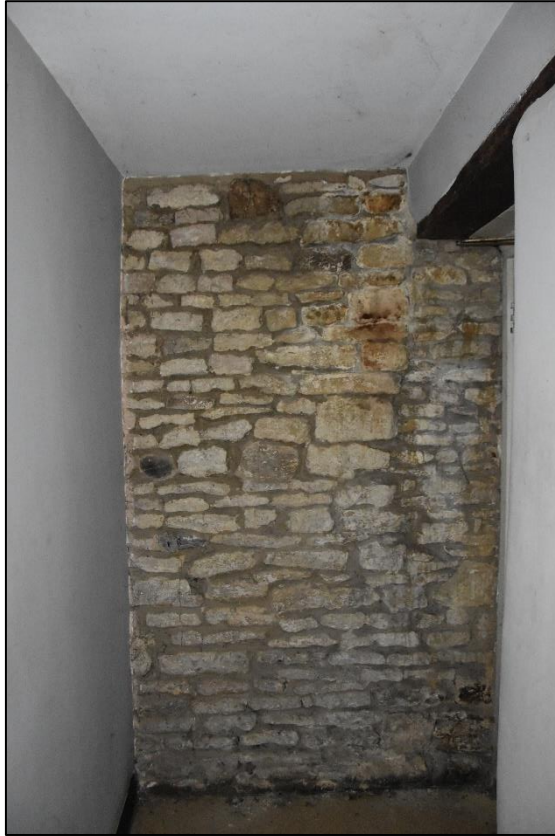
Exposed stone wall of the corridor (GF16), looking south-west Fig 54

GF16 extends through Range 6 and into Range 3 from north to south (Fig 53). It can be accessed externally at the north end and gives access to the bar cellar (GF24), and the bar area (GF01) along its west side. To the east doors to the customer WCs (GF17-18) and the manager's flat (GF19) are noted. The room has a linoleum floor with Type 1 skirting, plain walls and ceiling. The door to the Women's WC at the north end (GF17) is panelled, but likely all the doors are modern replacements. At the junction with Range 3 to the south end the floor level rises and overhead there is a boxed-in joist extending from east-west. Beyond this Range 3 has a simple skirting, and the southern end wall, comprising the external wall of the range, comprises exposed stone (Fig 54).

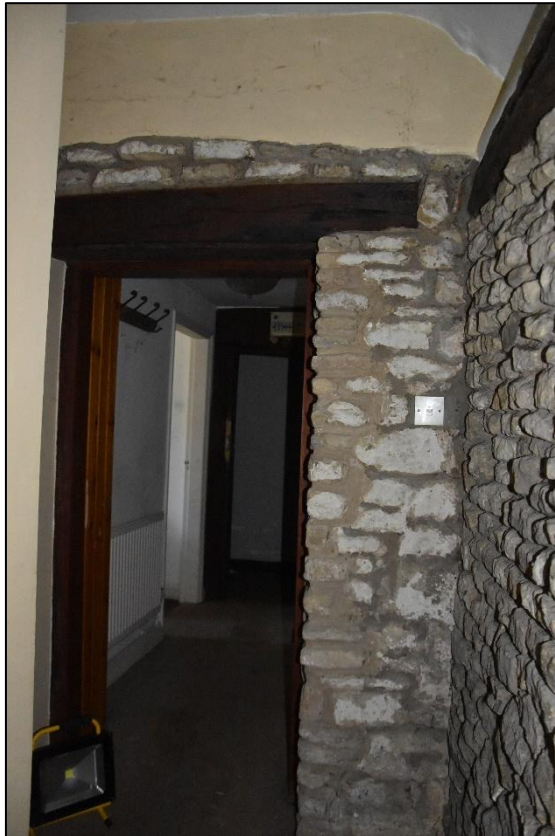
Entrance corridor division, looking west Fig 58

The entrance to the Manager’s flat is through GF16 at the south end. Once within the flat the corridor gives access into a bathroom (GF20), after which the corridor dog-legs to the north and returns to the east giving access to a bedroom (GF21) and a lounge (GF22). There is carpet to the floor with Type 1 skirting and the floor level rises slightly towards the eastern end of the room (Fig 57). There is an overhead joist within a stone partition and timber doorway, with no door, between the bathroom and bedroom (Fig 58).

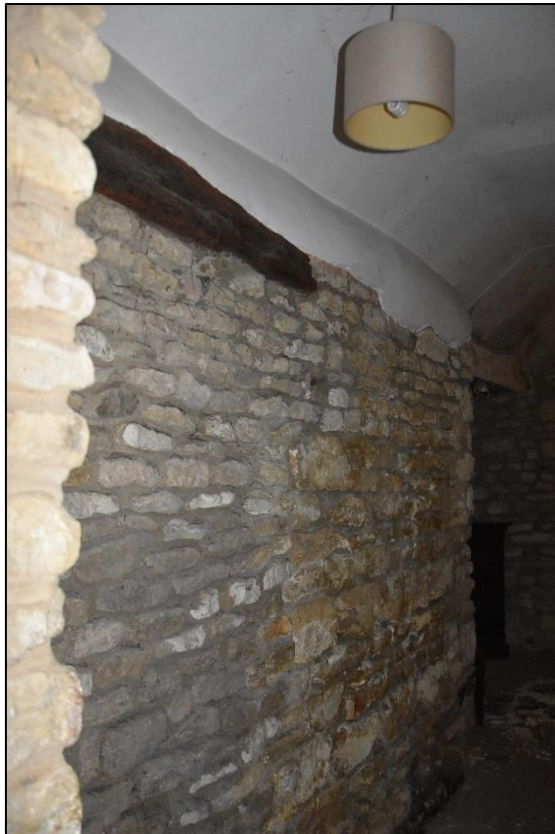
Exposed stone to the north wall of the entrance corridor, looking east Fig 59

The north wall at the east end is exposed stonework with a mixture of mortar types (Fig 59). There are a few straight joints suggesting some rebuilding but nothing consistent enough to postulate a cause.

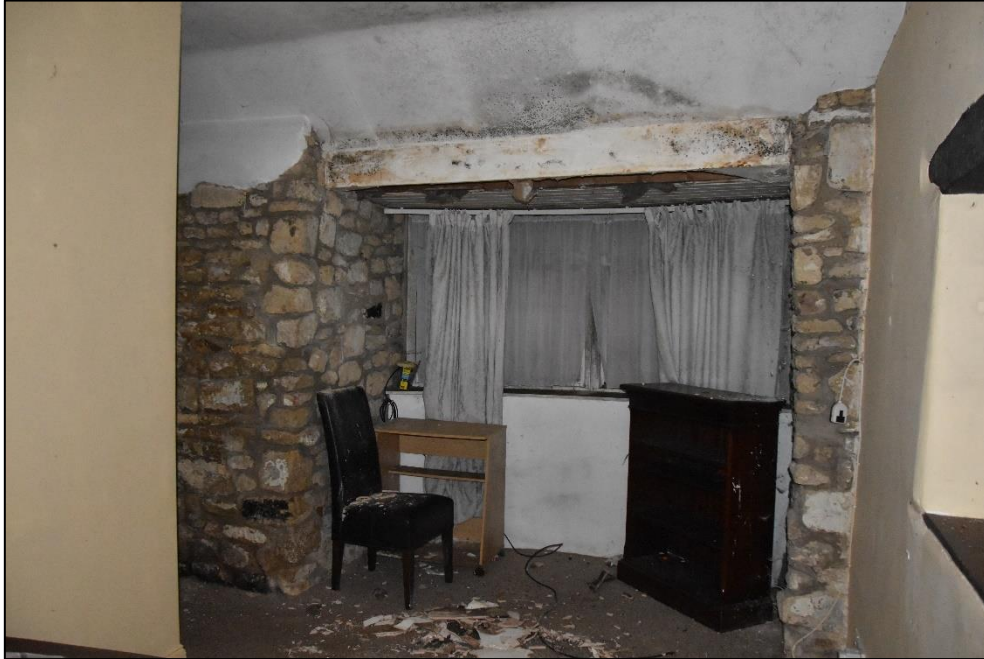
Manager’s flat lounge area (GF22), showing pushed-out bow window, looking north-east Fig 62

The living room lies at the east end of the access corridor and retains a carpet, Type 1 skirting, and plastered walls. There is a stone bay to the north wall which has been built outwards of the original exterior wall line (Fig 62). The ceiling of the bay retains concrete lintels.

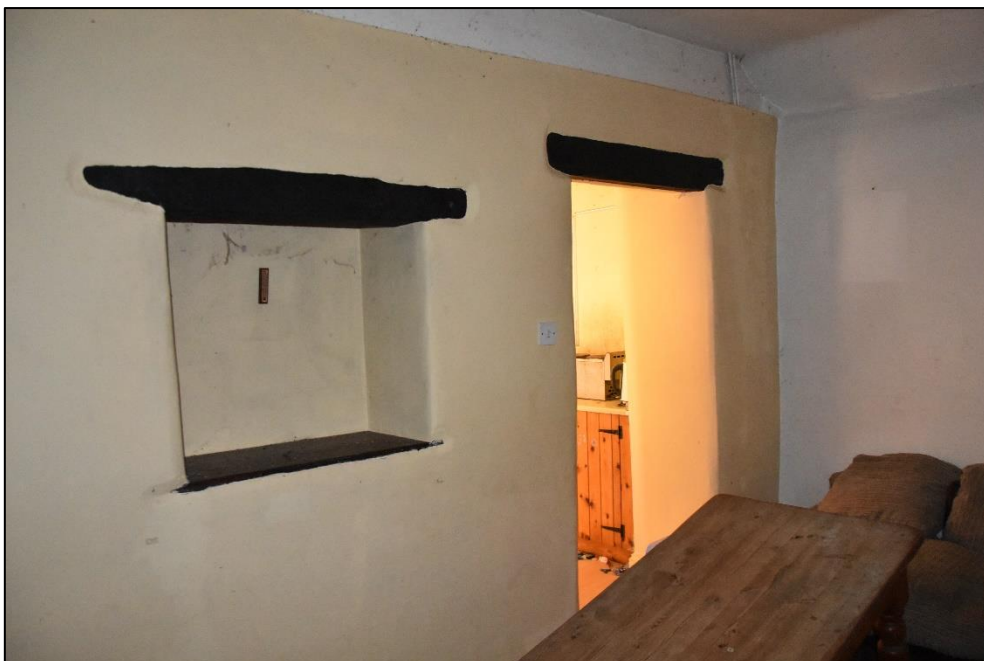
Blocked window and doorway within the Manager’s flat lounge (GF22), looking south Fig 63

To the east wall is a blocked window set within a deep reveal (Fig 63).

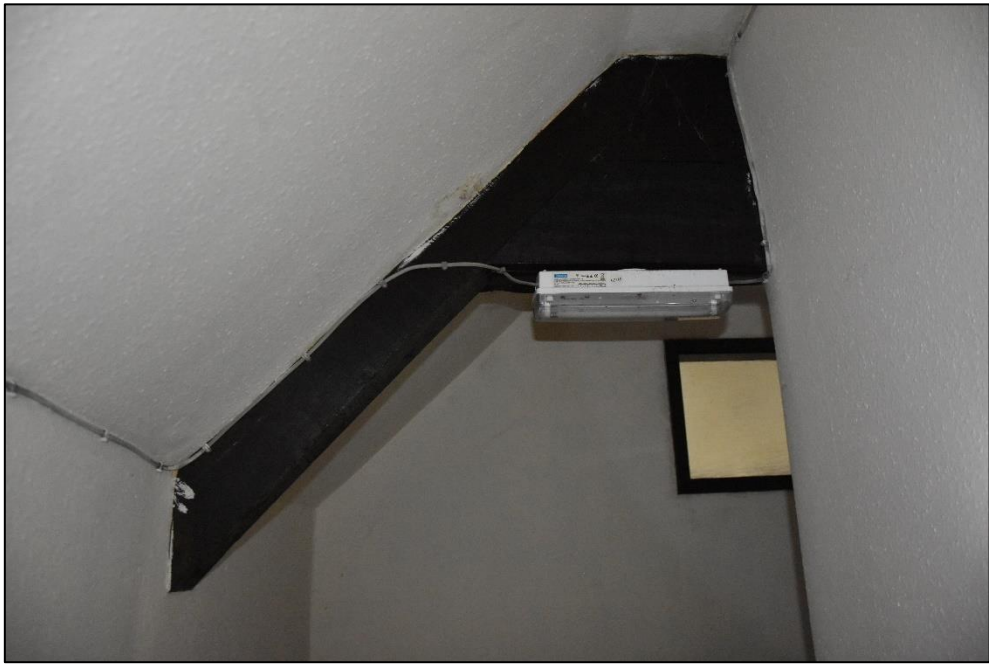
Exposed timber rafter within the first floor corridor (FF01), looking south-east Fig 68

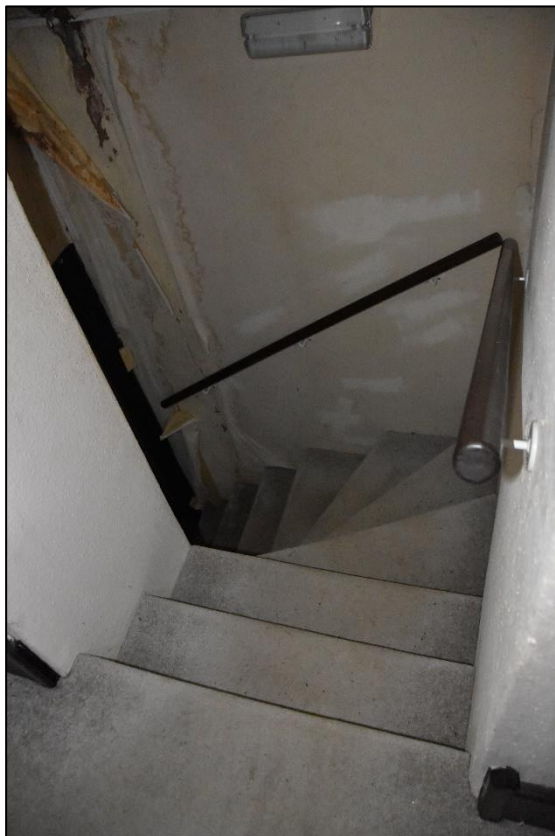
View of the staircase that rises within FF01, looking north Fig 69

The stairs rise as a winder with modern handrail (Fig 69). Water damage has caused the wallpaper to peel away from the walls.

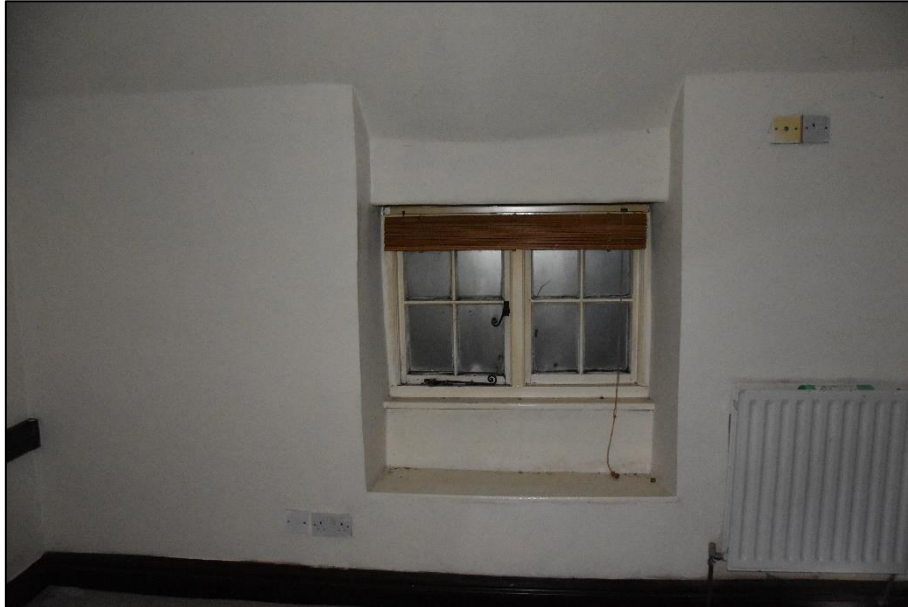
Window to the south wall of a first floor bedroom (FF02), looking south-west Fig 70

There is a two-light window set within a reveal to the south wall (Fig 70). Each light has four panes and there is a curled early-20th century catch. The east wall retains a series of fictive timber studs, braces, struts and rails (Fig 71). These are all of the same moulding and pegging as seen in the ground floors areas (see GF02).

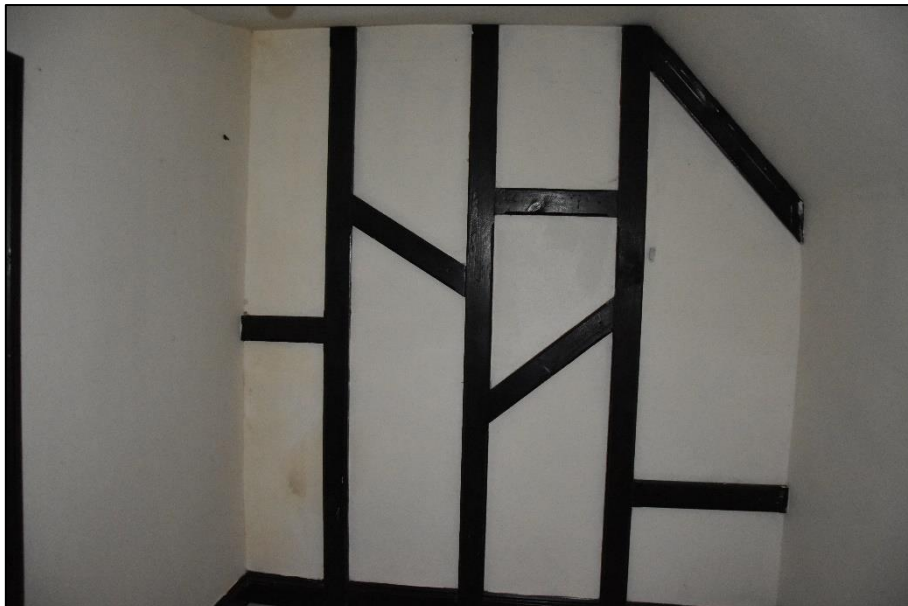
Fictive timber-framing in one of the first floor bedrooms (FF02), looking east Fig 71

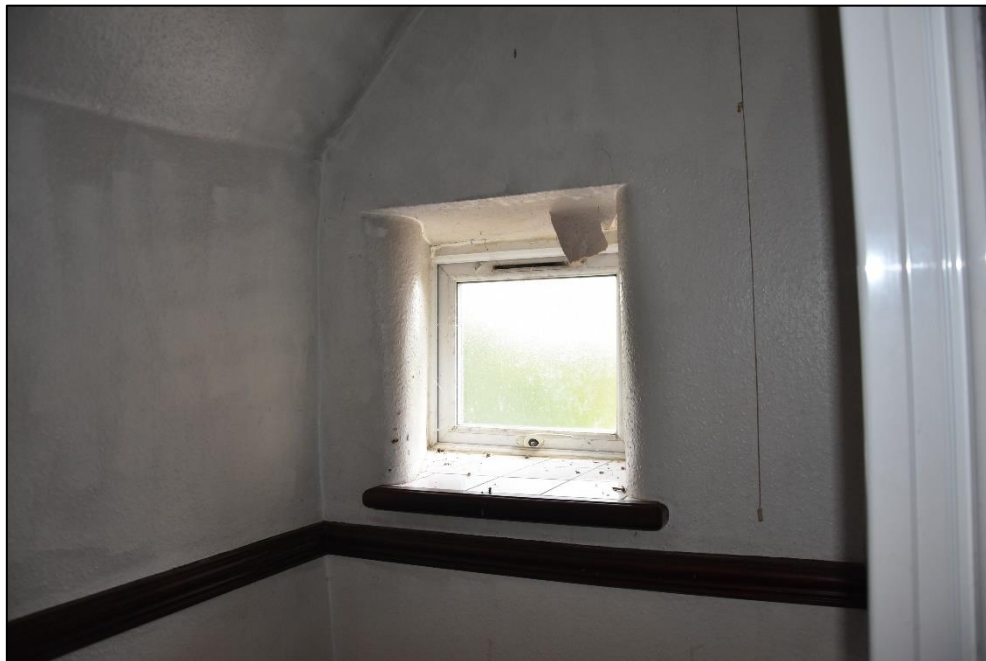
Window to the first floor bathroom (FF02a), looking north-east Fig 73

The adjoining ensuite retains little of historic interest. There is a timber dado rail to the tiled walls, and modern bathroom fixtures and fittings (Fig 72). The floor is laid in modern linoleum. A single light window lies to the east wall within a curved reveal (Fig 73). The window is modern with a timber sill and tiles.

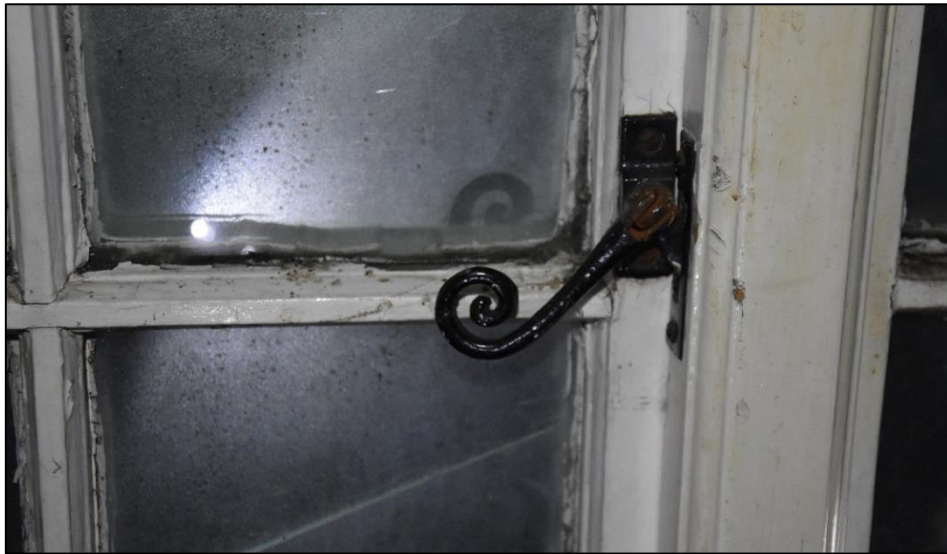
Curled catch and moulded glazing bar to the window in FF03, looking south Fig 74

This room is housed within the historic Range 1 and includes a large chimney stack to the west wall of some interest. There is a two-light window to the south wall of similar form to that seen in FF02 with slender glazing bars and curled window catch (Fig 74).

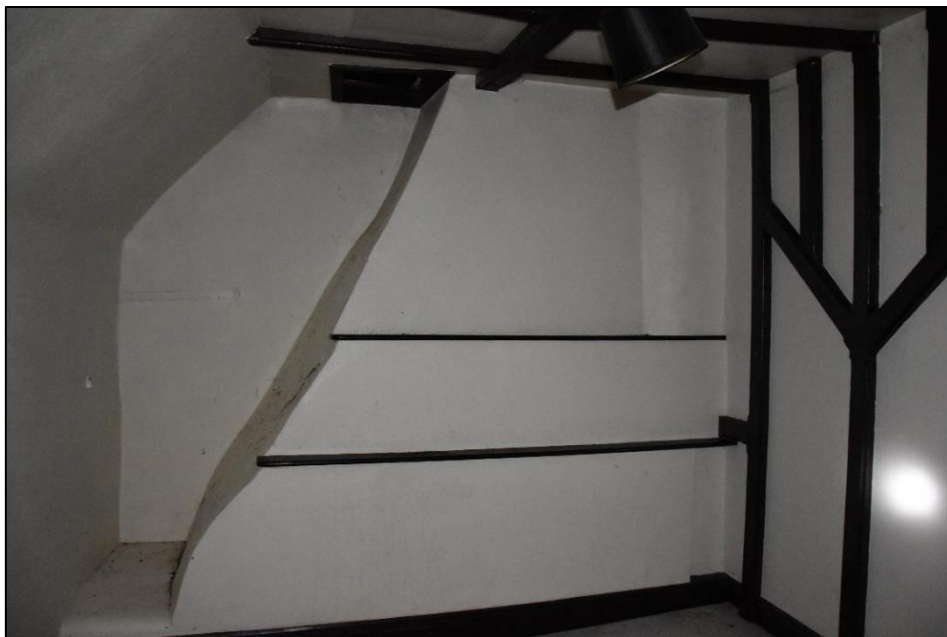
Large stack within one of the first floor bedrooms (FF03), looking north-west Fig 75

To the west wall a large stack rises through the space and is rendered and painted (Fig 75). Shelving has been fitted to its east side, but it almost fills the width of this room, being sloped on its south side so it tapers as it rises. There is an adjacent roof hatch, which gives access to the roof above Range 1 (see below).

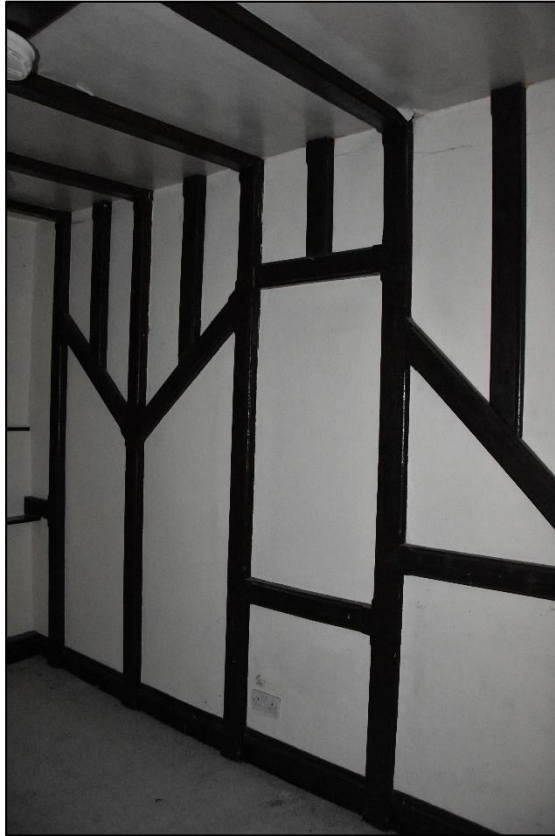
Fictive timber-framing in one of the first floor bedrooms (FF03), looking north Fig 76

The north wall retains the timber-framing seen elsewhere (Fig 76).

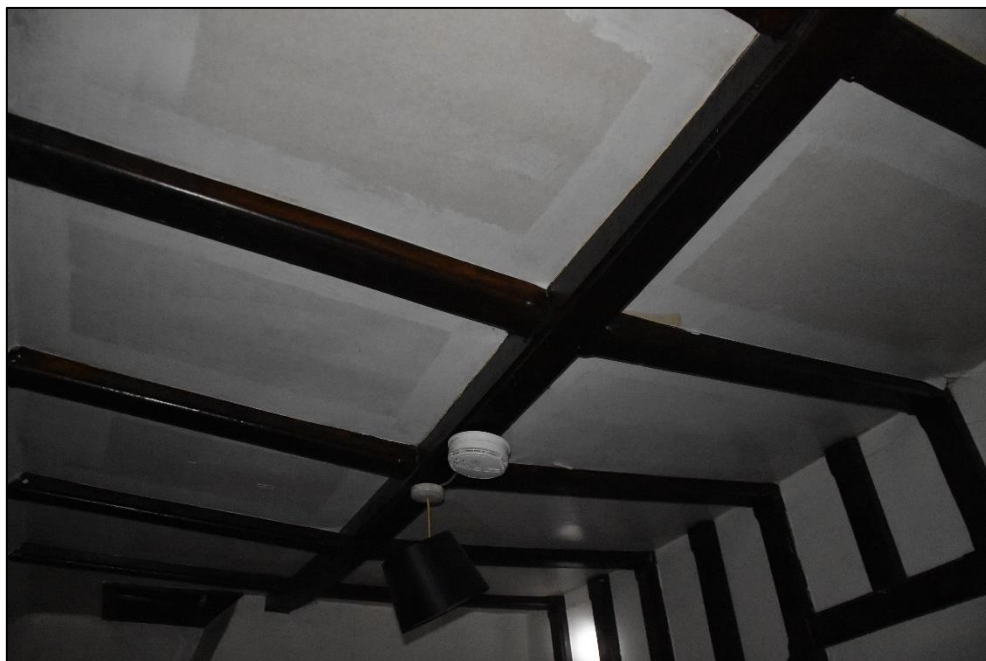
The ceiling also comprises a series of fictive joists and common joists in the manner of a historic arrangement, but clearly serves no structural purpose (Fig 77).

Ceiling joists in one of the first floor bedrooms (FF03), looking north-west Fig 77

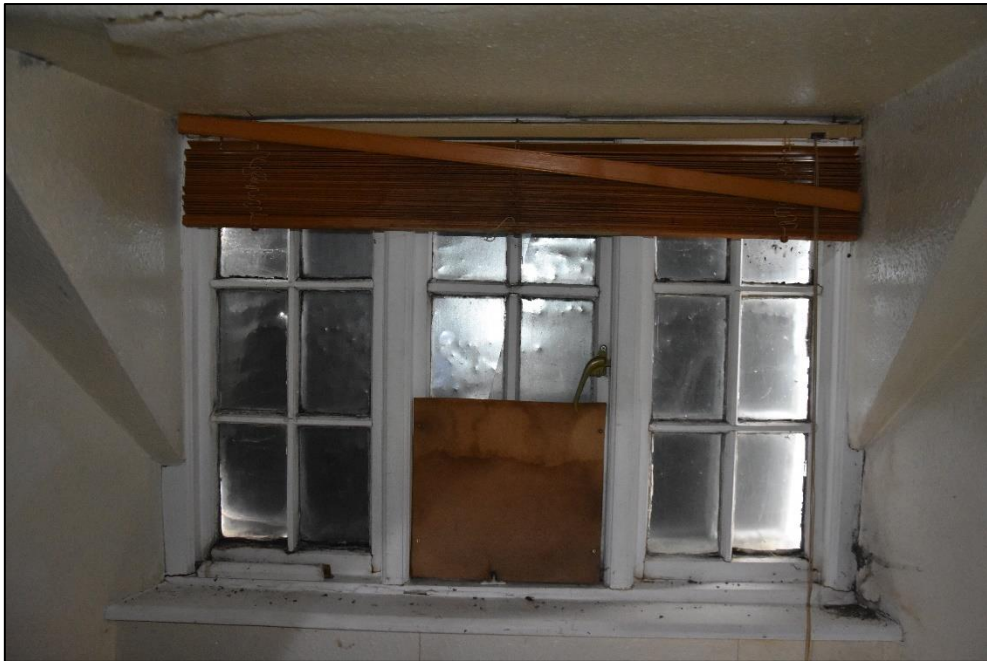
This bedroom lies at the west end of the main corridor (FF01) and is accessed through another of the bedrooms in this area (FF05), lying within Range 2. The door giving access is six-panelled with fielded panels and modern ironmongery. There is a window to the south wall set within a reveal with window seat or shelf (Fig 78). The window has three-lights with six panes to each light with modern catch but the same early-20th century glazing bars as seen elsewhere.

Window within one of the bedrooms to the first floor (FF04), looking south-west Fig 78

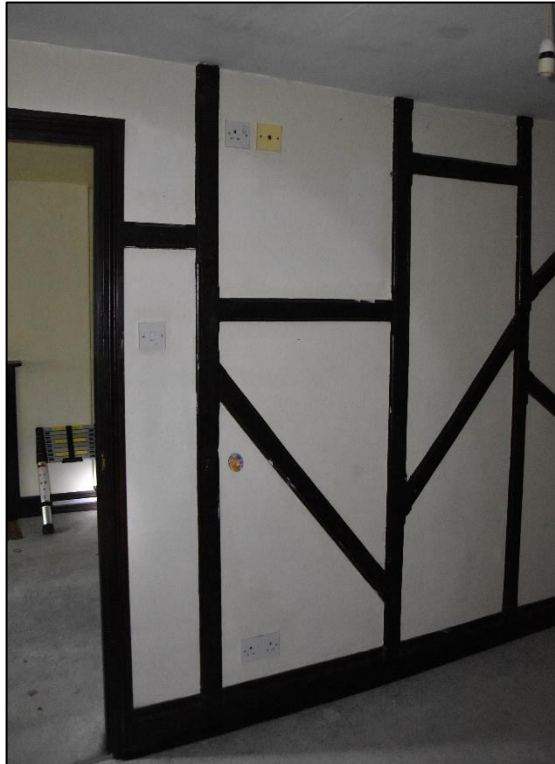
The north wall is partly covered in applied timber-framing, similar to other examples seen elsewhere (Fig 79).

Fictive timber-framing within a first floor bedroom (FF04), looking north-east Fig 79

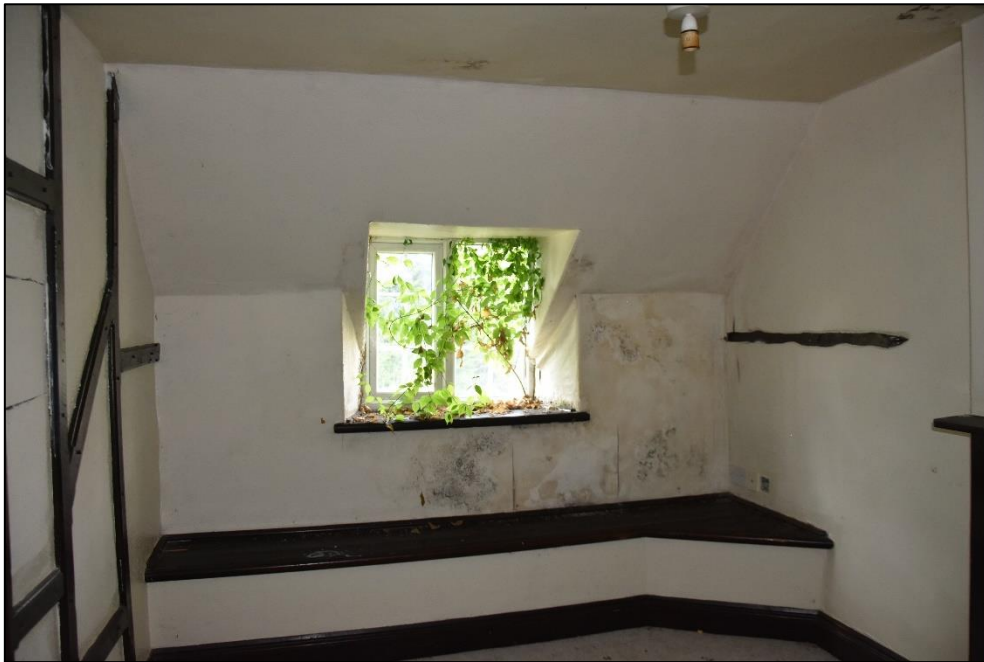
This room lies within Range 2 and is given access from the rear corridor (FF06) and gives access to another bedroom to the south (FF04), which is described above. There is a two-light window to the west wall partly within the sloping roof pitch (Fig 81). Below there is a long window seat. The window is uPVC of two-lights and vegetation has grown inside the building.

West wall of the first floor bedroom (FF04), looking north-west      Fig 81

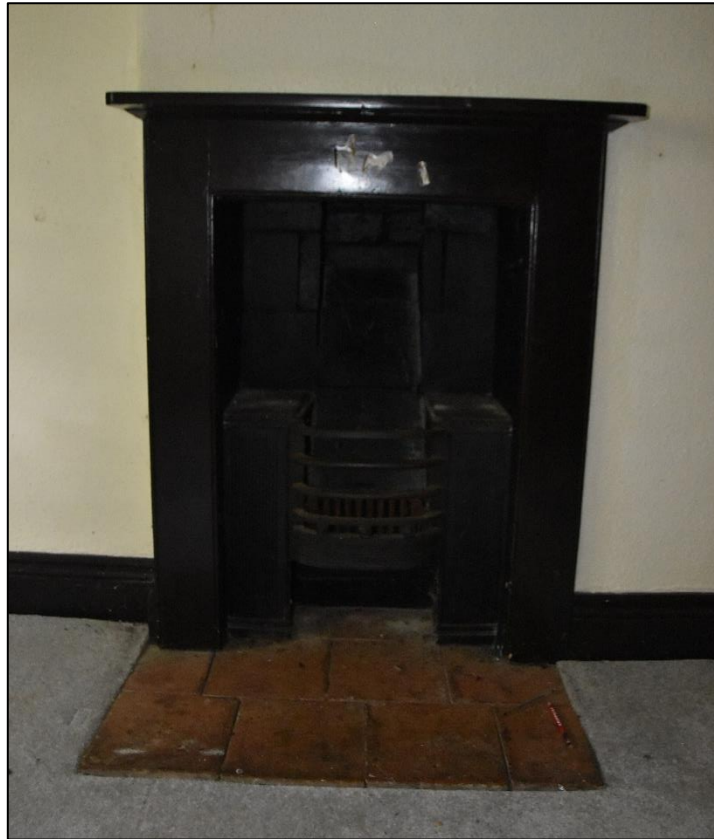
To the north wall is a fire surround and grate with tile hearth (Fig 82). The surround is timber and fairly simple with a shelf above. The grate is simple and 19th century in date. The north wall also retains a single timber bearer which lies to the west.

Fireplace in one of the first floor bedrooms (FF05), looking north Fig 82

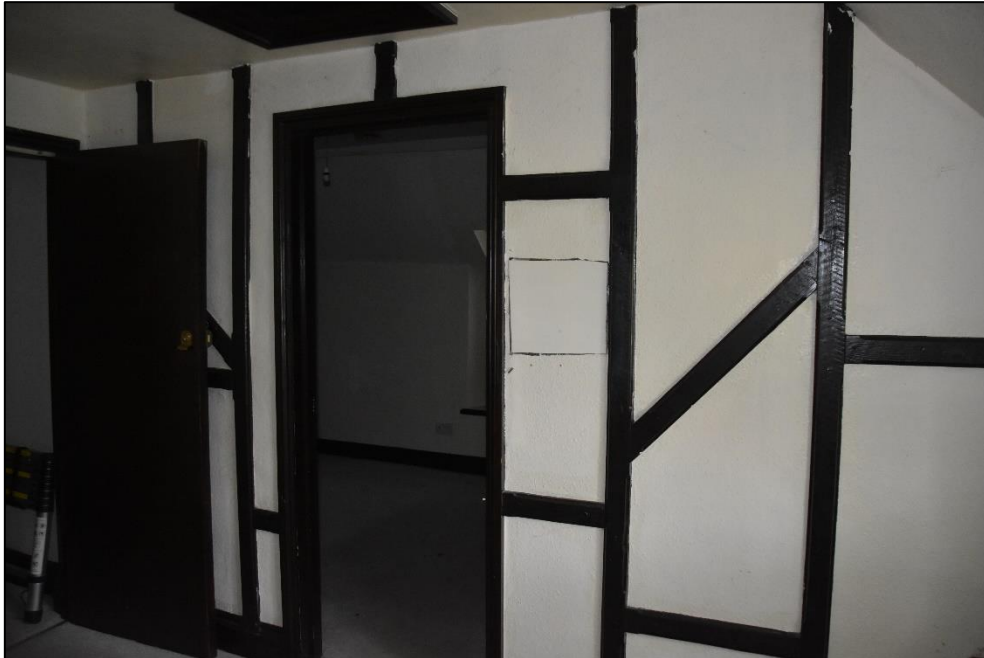
The south wall has fictive timber-framing and a door into the adjoining bedroom (FF04) (Fig 83).

Fictive timber-framing to the south wall of a first floor bedroom (FF05), looking south-west Fig 83

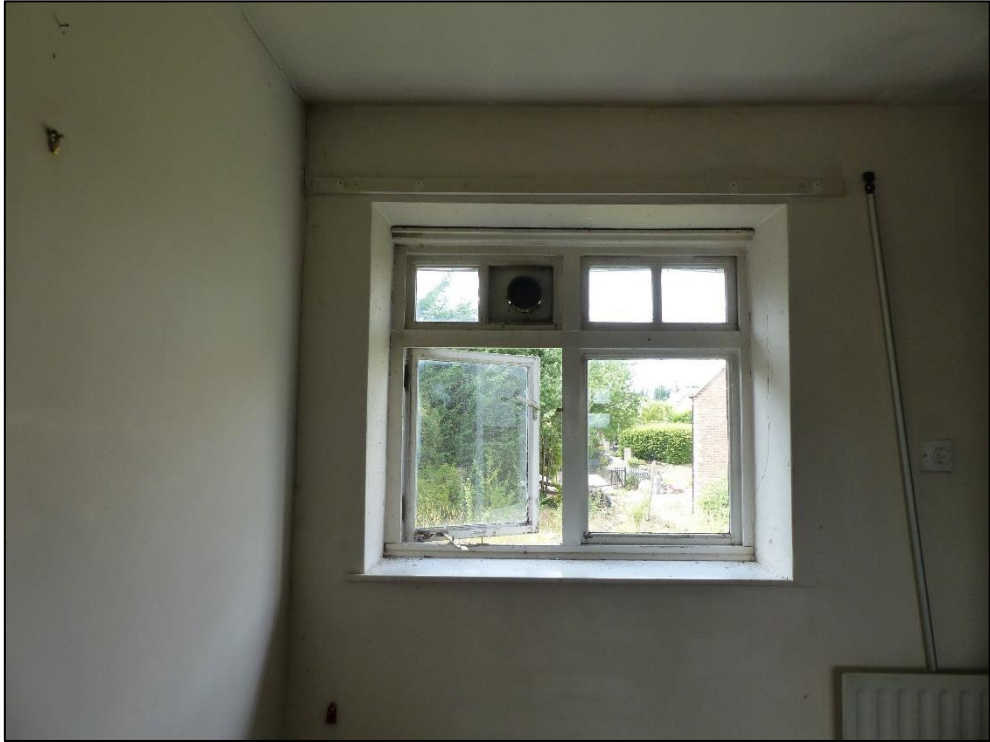
At the north end of the corridor the landing is lit by a four-light window with modern catch and stay bar, and heavy glazing bars (Fig 85). The staircase rises here in straight flight in painted timber with a simple balustrade of square-profile balusters (Fig 86). There is access into an office area and another bedroom (FF08 and FF10).

Window to the landing at the north end of the rear corridor (FF06), looking west Fig 85

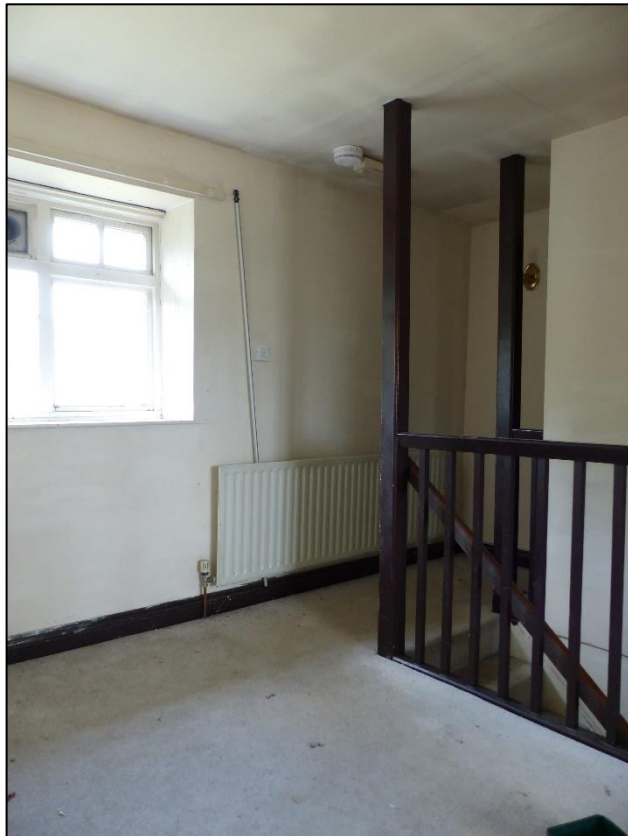
Landing area at the north end of the rear corridor (FF01), looking north-west Fig 86

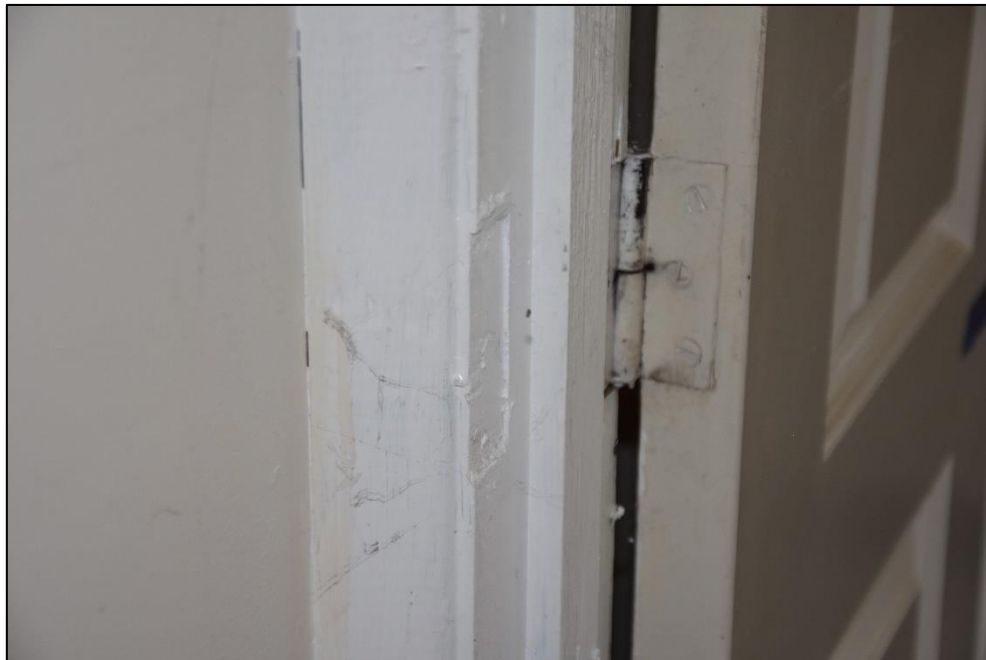
Notch for former door hinge, suggesting door has been re-orientated, or replaced, looking south-west Fig 91

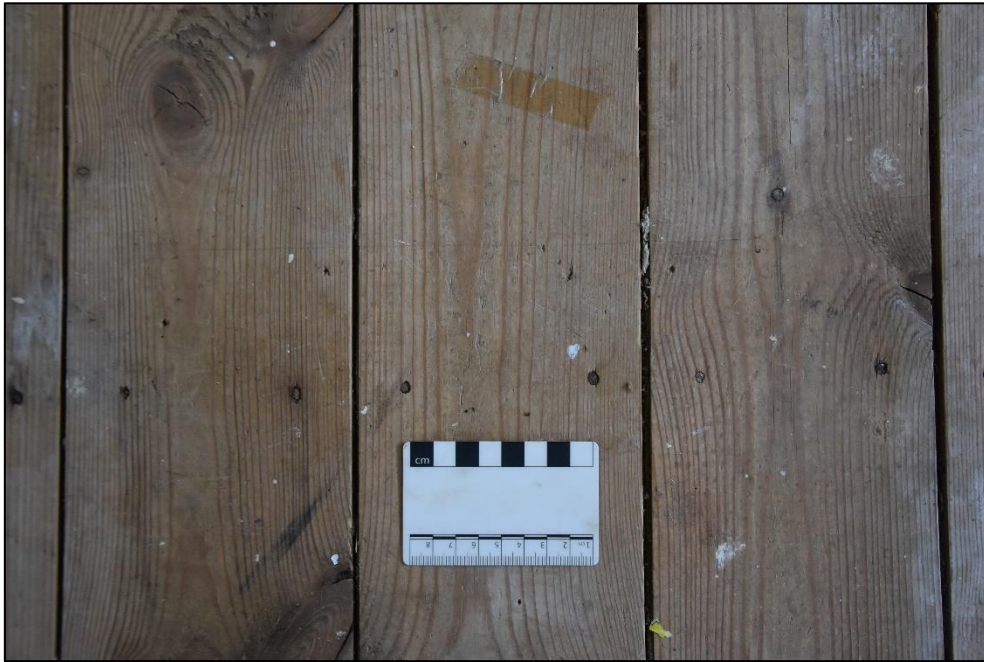
This bedroom lies to the east of the rear corridor and has lost its carpet. The exposed softwood floorboards are slender and extend north to south (Fig 94). There are two windows to the east wall, both of four-light form and of the same form as others in Range 5 (Fig 95). There is a door to the south giving access into the adjoining room (FF11), likely formerly a bathroom. Above there is a binding joist to the ceiling, which is likely fictive.

Exposed floorboards to a first floor bedroom (FF10), looking north-west Fig 94

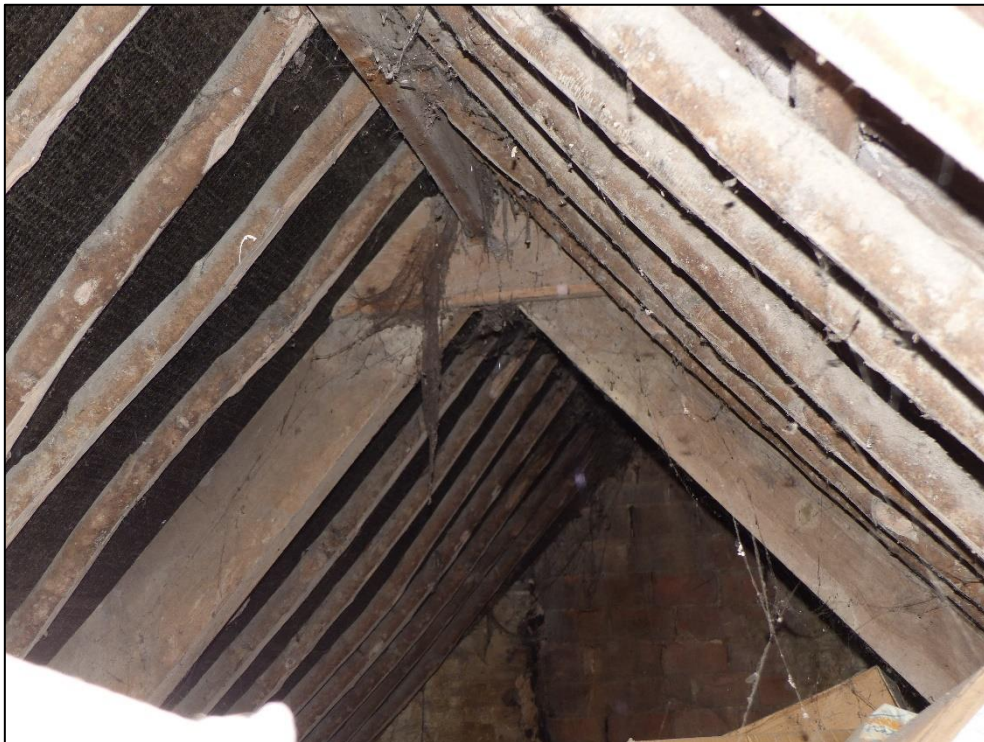
The stack rises in coursed rubblestone above the ceiling level with buff/yellow mortar. This material also forms the west gable end, which rises within this space. The east gable is also partially visible in coursed rubblestone to the outer edges with brick infill to the middle, likely infilling a former chimney stack either being inserted or removed (Fig 97).

The roof form itself is fairly simple with almost pole-like common rafters rising to a softwood ridgeboard. There only appears to be a single truss dividing the space into two bays. The principal rafters are slender but tall like boards with a yoke piece to the apex. There is no underlay to the south pitch which allows the battens to be viewed. There are pole-like purlins set into the stone gable end over which the rafters ride over the back (Fig 98).

View of the single truss and east gable end within the roof space above Range 1, looking south-east Fig 97
