**Historic building recording  
at Samuel Pepys Public House  
Slipton, Northamptonshire  
Level 2  
July 2022**

Report No. 22/75

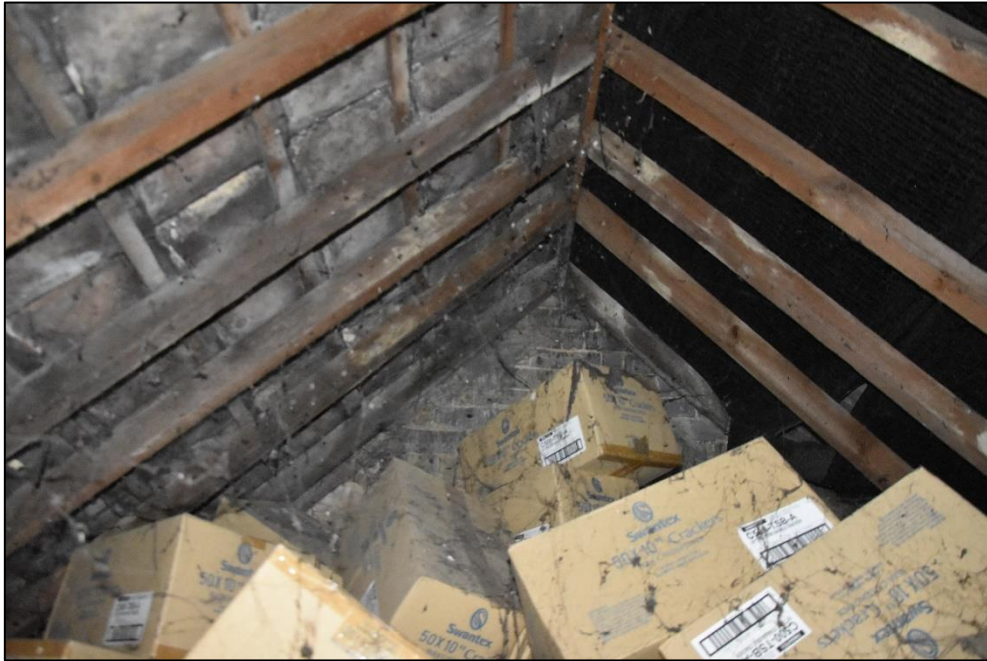
The north gable end is brick and is only partly visible from the hatch but appears to be laid in Flemish bond (Fig 98). The east gable end is constructed in rubblestone and the line of a former roof pitch is visible to its lower register (Fig 99).

North gable end of the roof over Range 2, looking north-east Fig 98

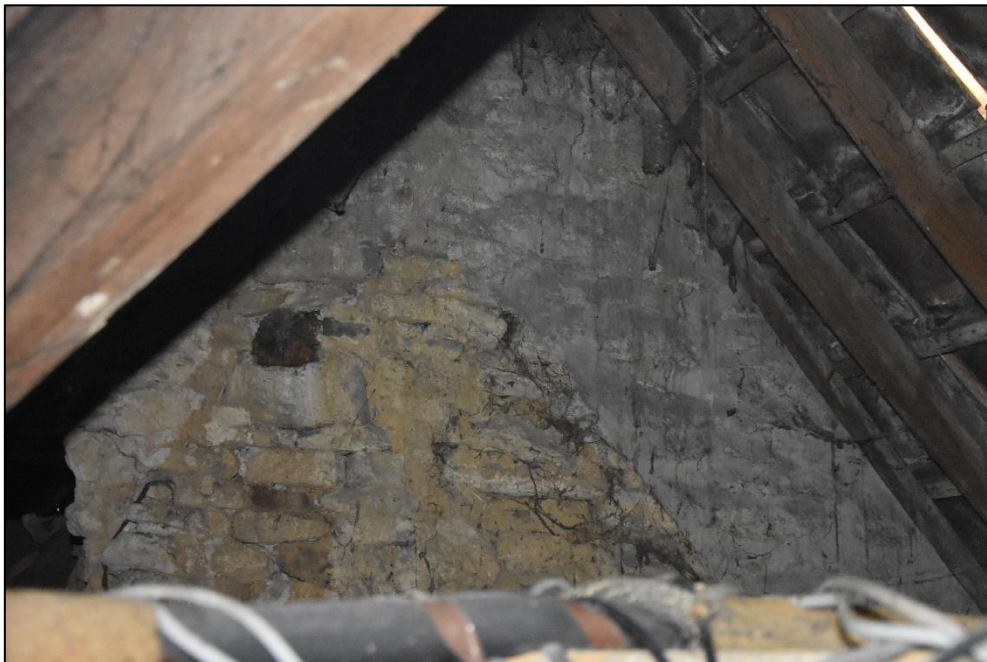
East gable end in the roof over Range 2, showing former roof line of a lower pitched roof, looking south-east Fig 99

The next two ranges could fall within the same constructional phase given they have no direct stratigraphic relationship in which to study. Range 2 has structural similarities with Range 3 and both are likely 18th or 19th century in date. Internal arrangements are difficult to ascertain given the level of alteration, but additional space and accommodation was clearly needed during this period. Range 2 is of further interest as it is possible this replaces a more historic structure with a lower roof line.

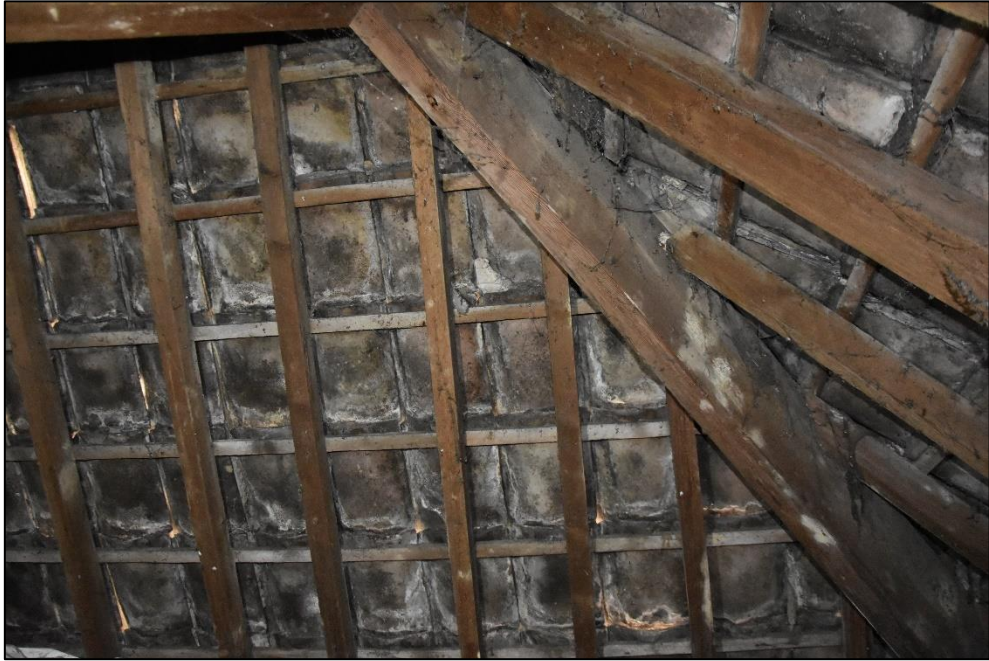
Otherwise, the roof structure is fairly regular constructed in softwood. From the hatch the hip and valley rafters are board-like being slender in width but not in height. The common rafters are square and rise evenly spaced to a ridgeboard, and then to the hip and valley rafters as the roof returns northwards (Fig 100). A series of battens lie over the backs of the common rafters and support the tiles. The west and south pitches have no underlay.

Roof structure above Range 2, looking south Fig 100

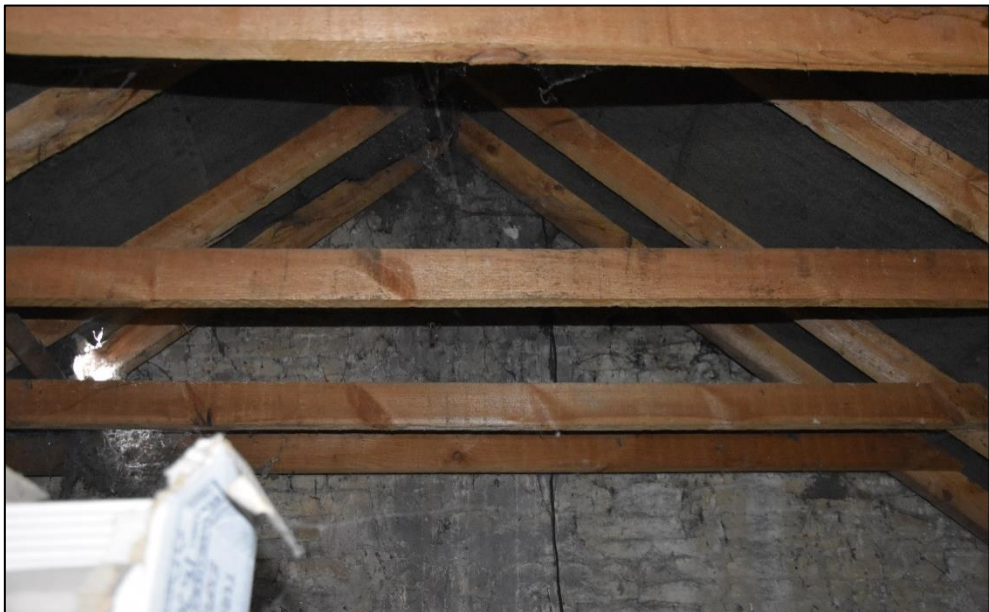
The roof over this range is accessible through a roof hatch within the Manager's flat in the bathroom (GF20). From this hatch the west gable end, or east gable end of Range 1, is visible constructed in rubblestone (Fig 101). In the opposite direction the dividing wall between Range 3 and 4 rises through the roof in rubblestone also, with a few darker sandstone examples, as was seen to the exterior in Range 3 to the exterior (Fig 102). The roof has been entirely replaced or is entirely modern with softwood machine-sawn timber. A series of rafters with collars are visible, rising to a slender ridgeboard. This bears similarities to the roof over Range 4, and Range 5 (see below).

The roof over Range 3, and the west gable end of Range 3, looking west Fig 101

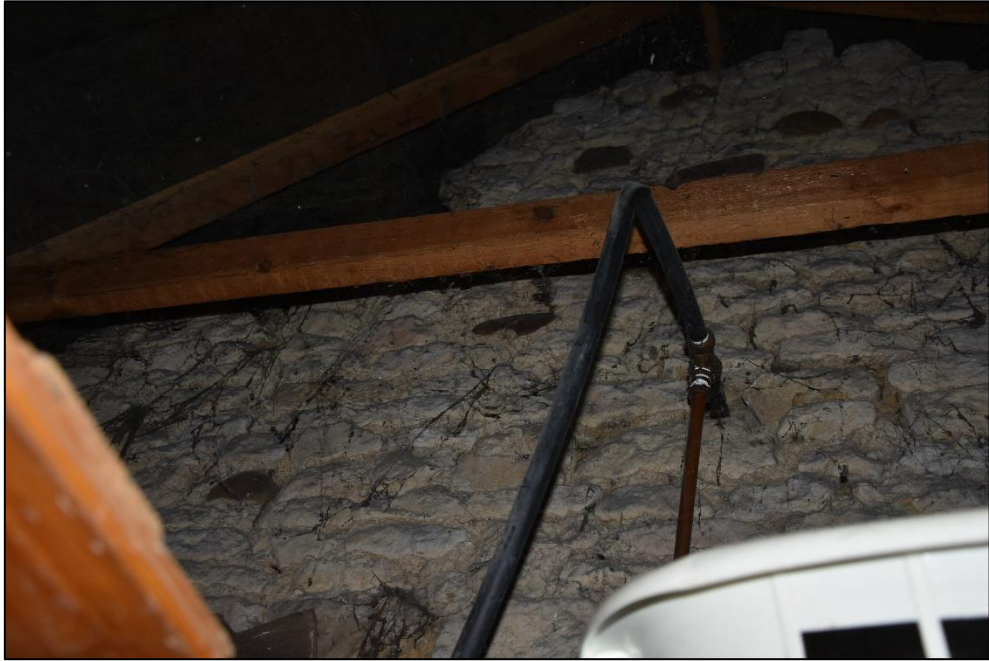
East gable end of Range 3, visible within the roof space, looking north-east Fig 102

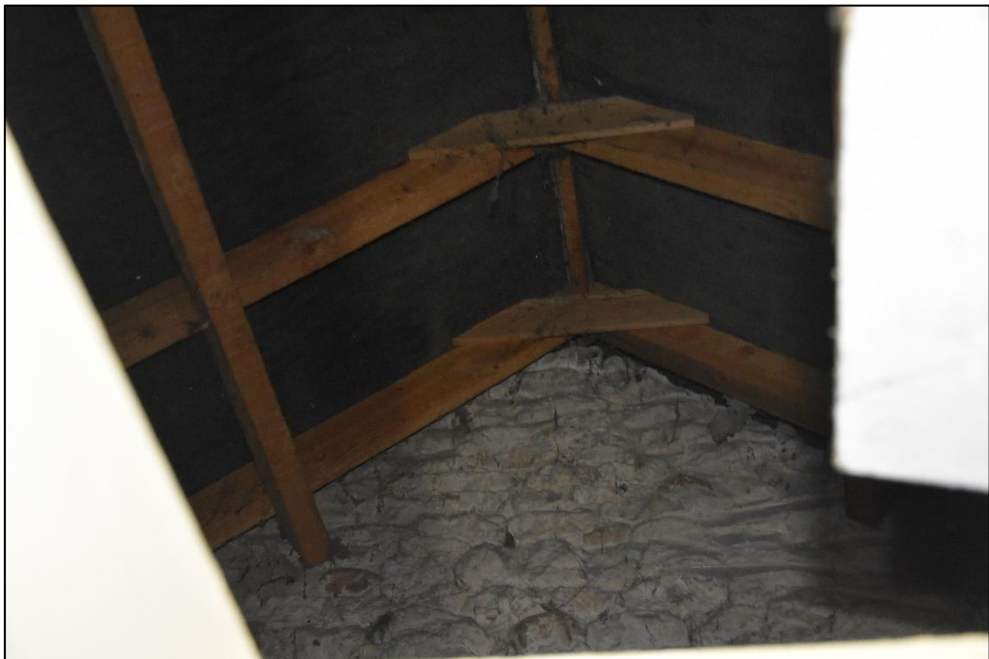
The roof over this range is visible through a hatch in the Manager's flat bedroom (GF21). The west gable end or dividing wall between Range 3 and 4 is visible in rubblestone (Fig 103). The roof is similar to that above Range 3 with modern softwood rafters rising to yoke pieces. There are one set of purlins visible.

Roof over Range 4 in modern softwood, looking west Fig 103

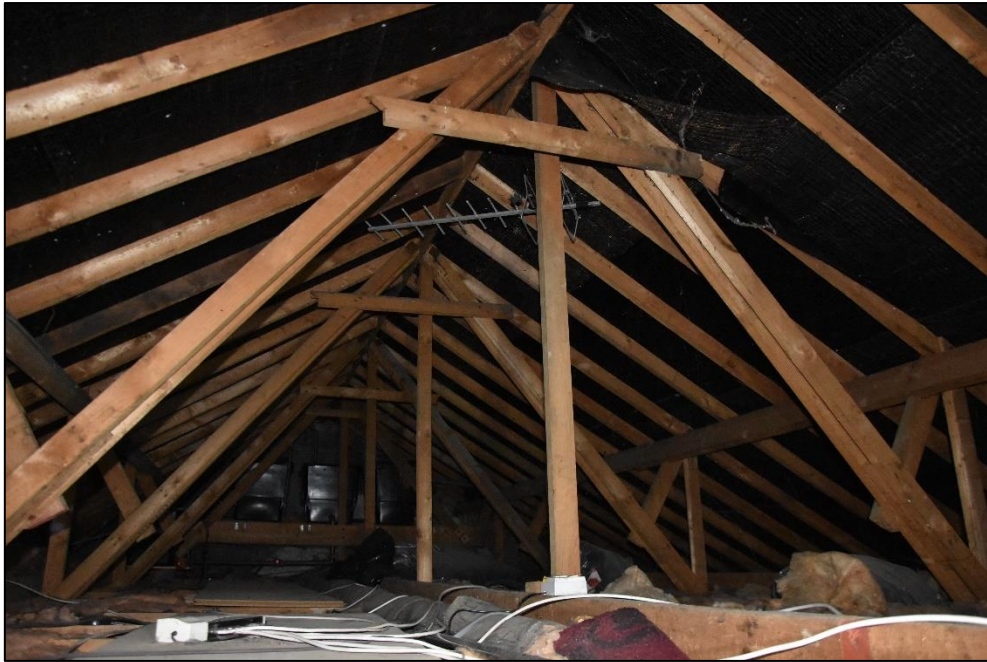
The roof over Range 5 is accessible through a roof hatch in a first floor office (FF09) and bears similarities in quality of timber to Ranges 3 and 4. However, the form is distinctly different and perhaps over-engineered (Fig 104). It is double-framed with a steeply pitched set of rafters and an upper shallowly pitched set of rafters bolted together at the ridgeboard. These are supported by a collar, nailed on and a central post rising from a long bridging joist. Other supports and struts are visible. The north gable end is constructed in breeze blocks.

Roof structure over Range 5 visible from a roof hatch at the north end, looking south-west Fig 104

Although there is a building present in the same position as Range 5 on historic maps, it's likely the current extension replaced a historic range here of smaller scale. The range added further lounge/bar space to the public house and gave additional bedrooms for the inn upstairs. The roof of this range suggests the current building is early to mid 20th century in date. Also, during this phase, a programme of applying faux timber-framing was carried out in order to decorate several of the internal spaces. Several of the doors also date from this period and the windows were replaced or inserted.

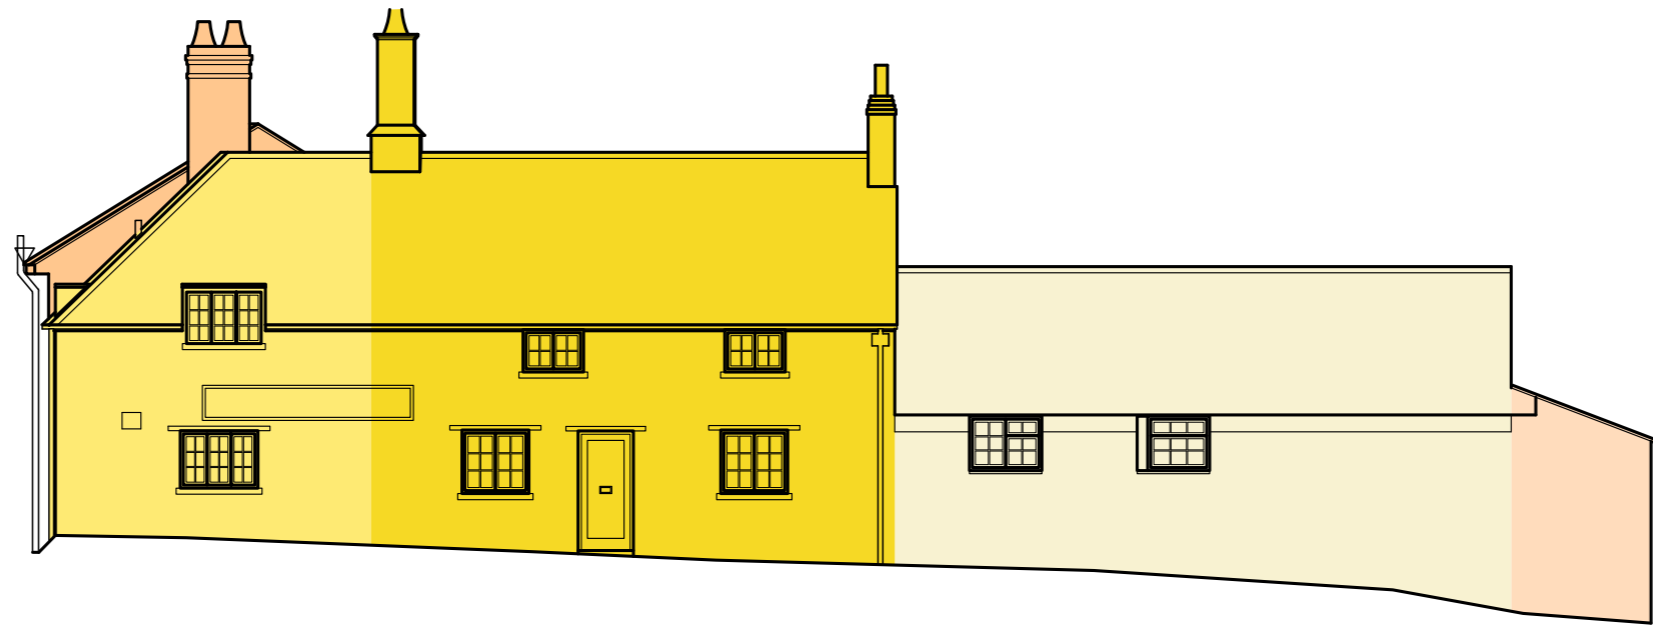
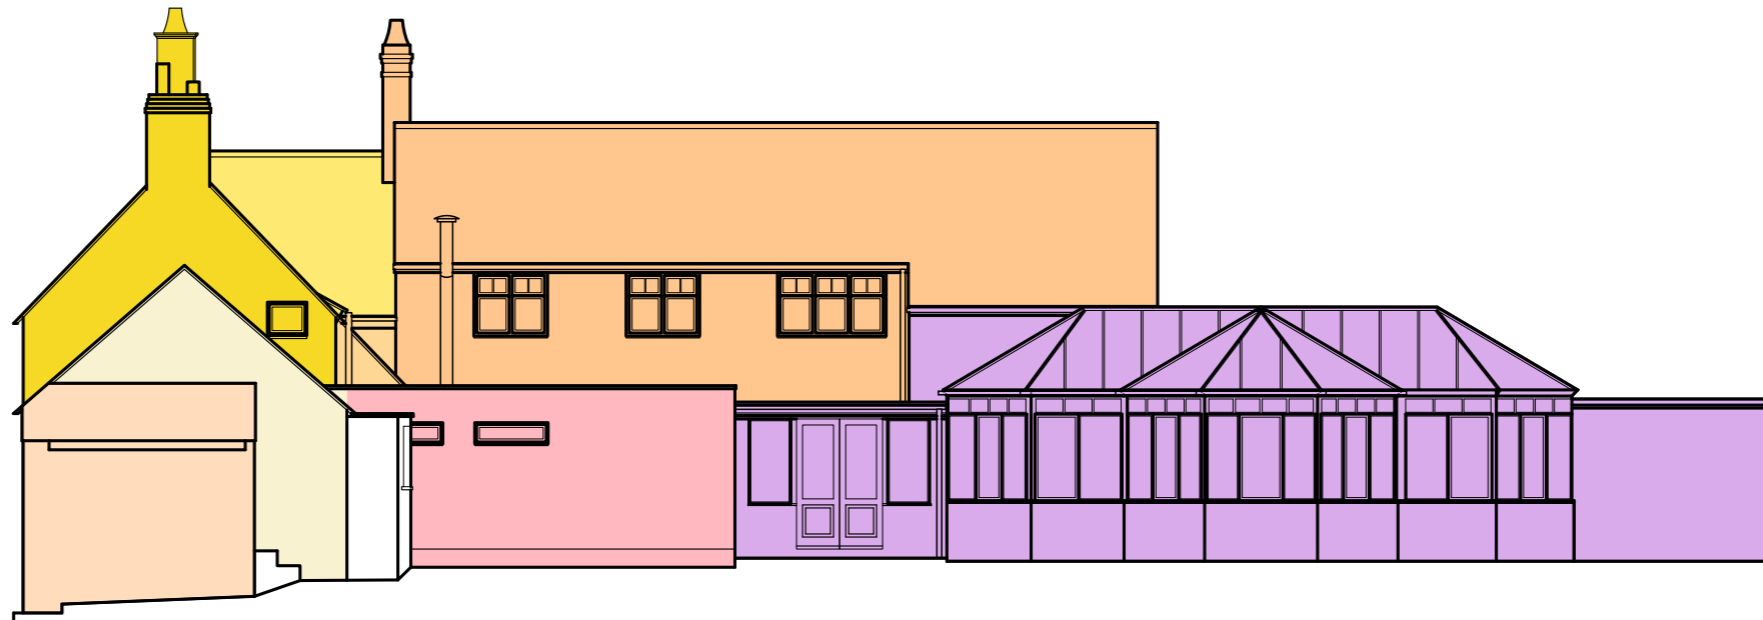
South-west elevation

South-east elevation

- Range 1
- Range 2
- Range 3
- Range 4
- Range 5
- Range 6
- Range 7
- Photographic location

The building can be easily divided into eight structural elements, which form the main phases of development to the site (Figs 105-107). It is clear that the use of the building as an inn and public house has stripped much of internal interest, which is typical of buildings of this type; particularly on the ground floor. Furthermore, a programme of roof repair may have further complicated the scrutinization of building fabric normally found in these areas.

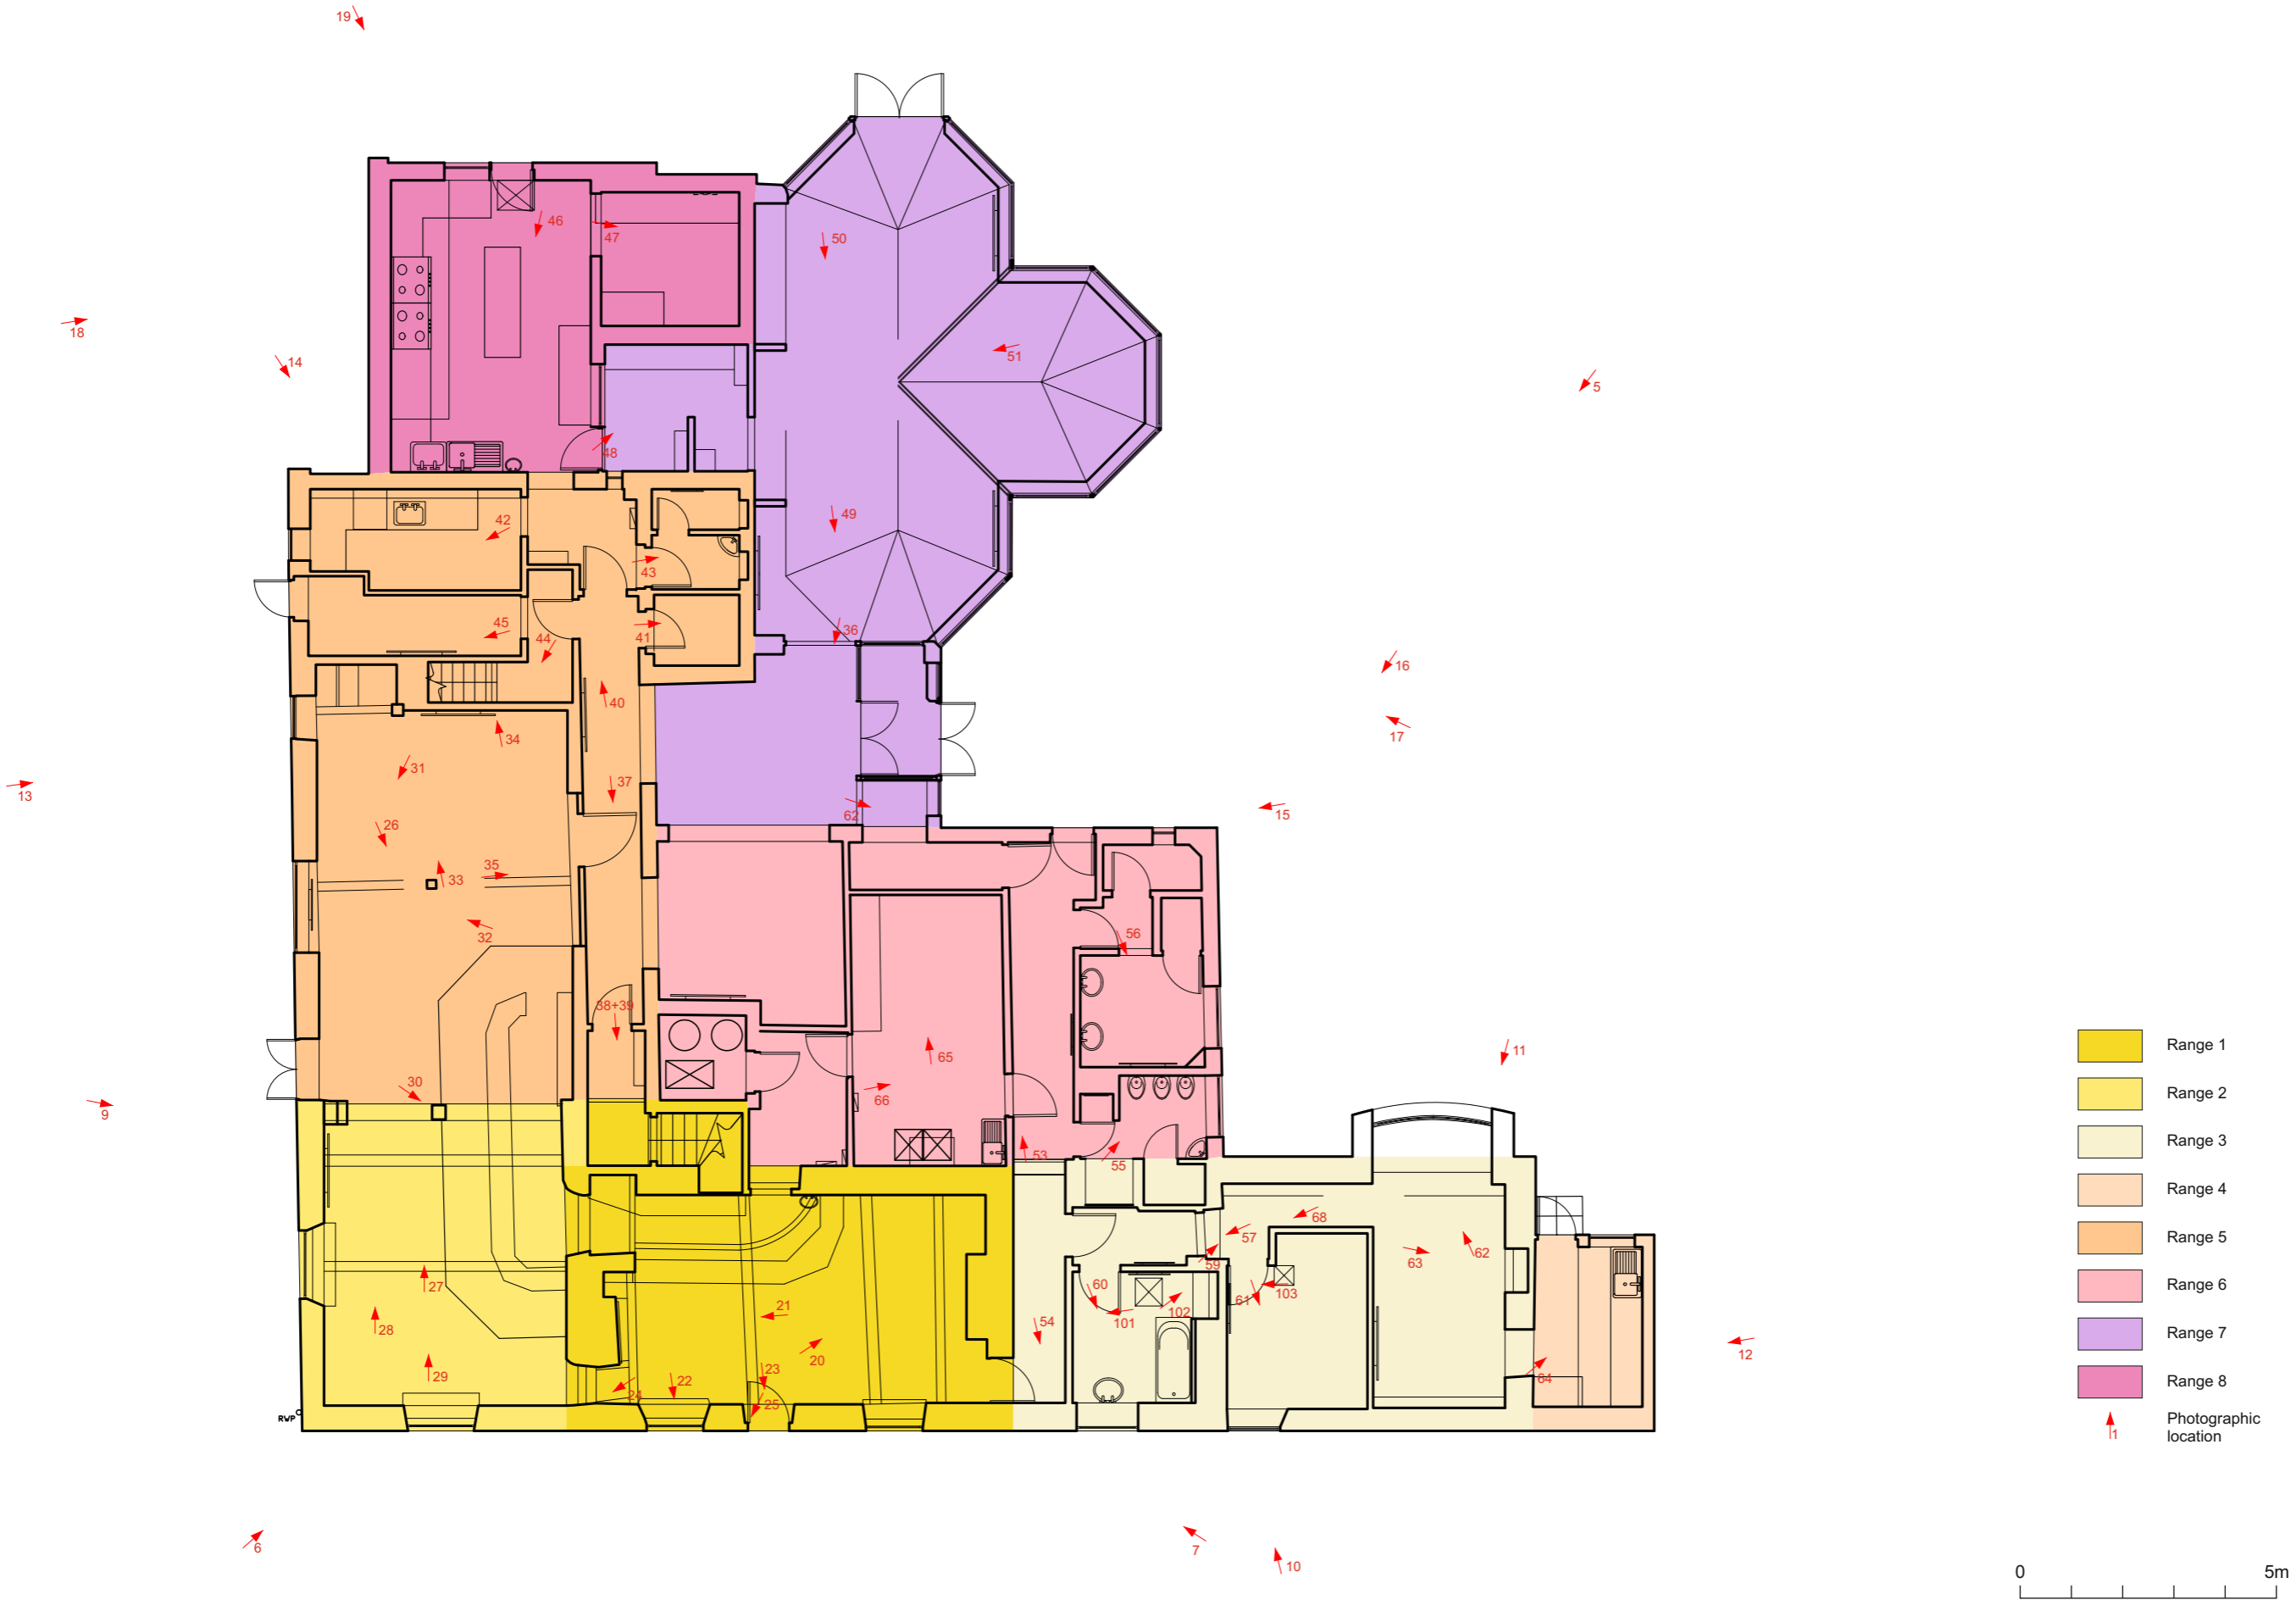
Ground floor plan with photo locations Fig 106

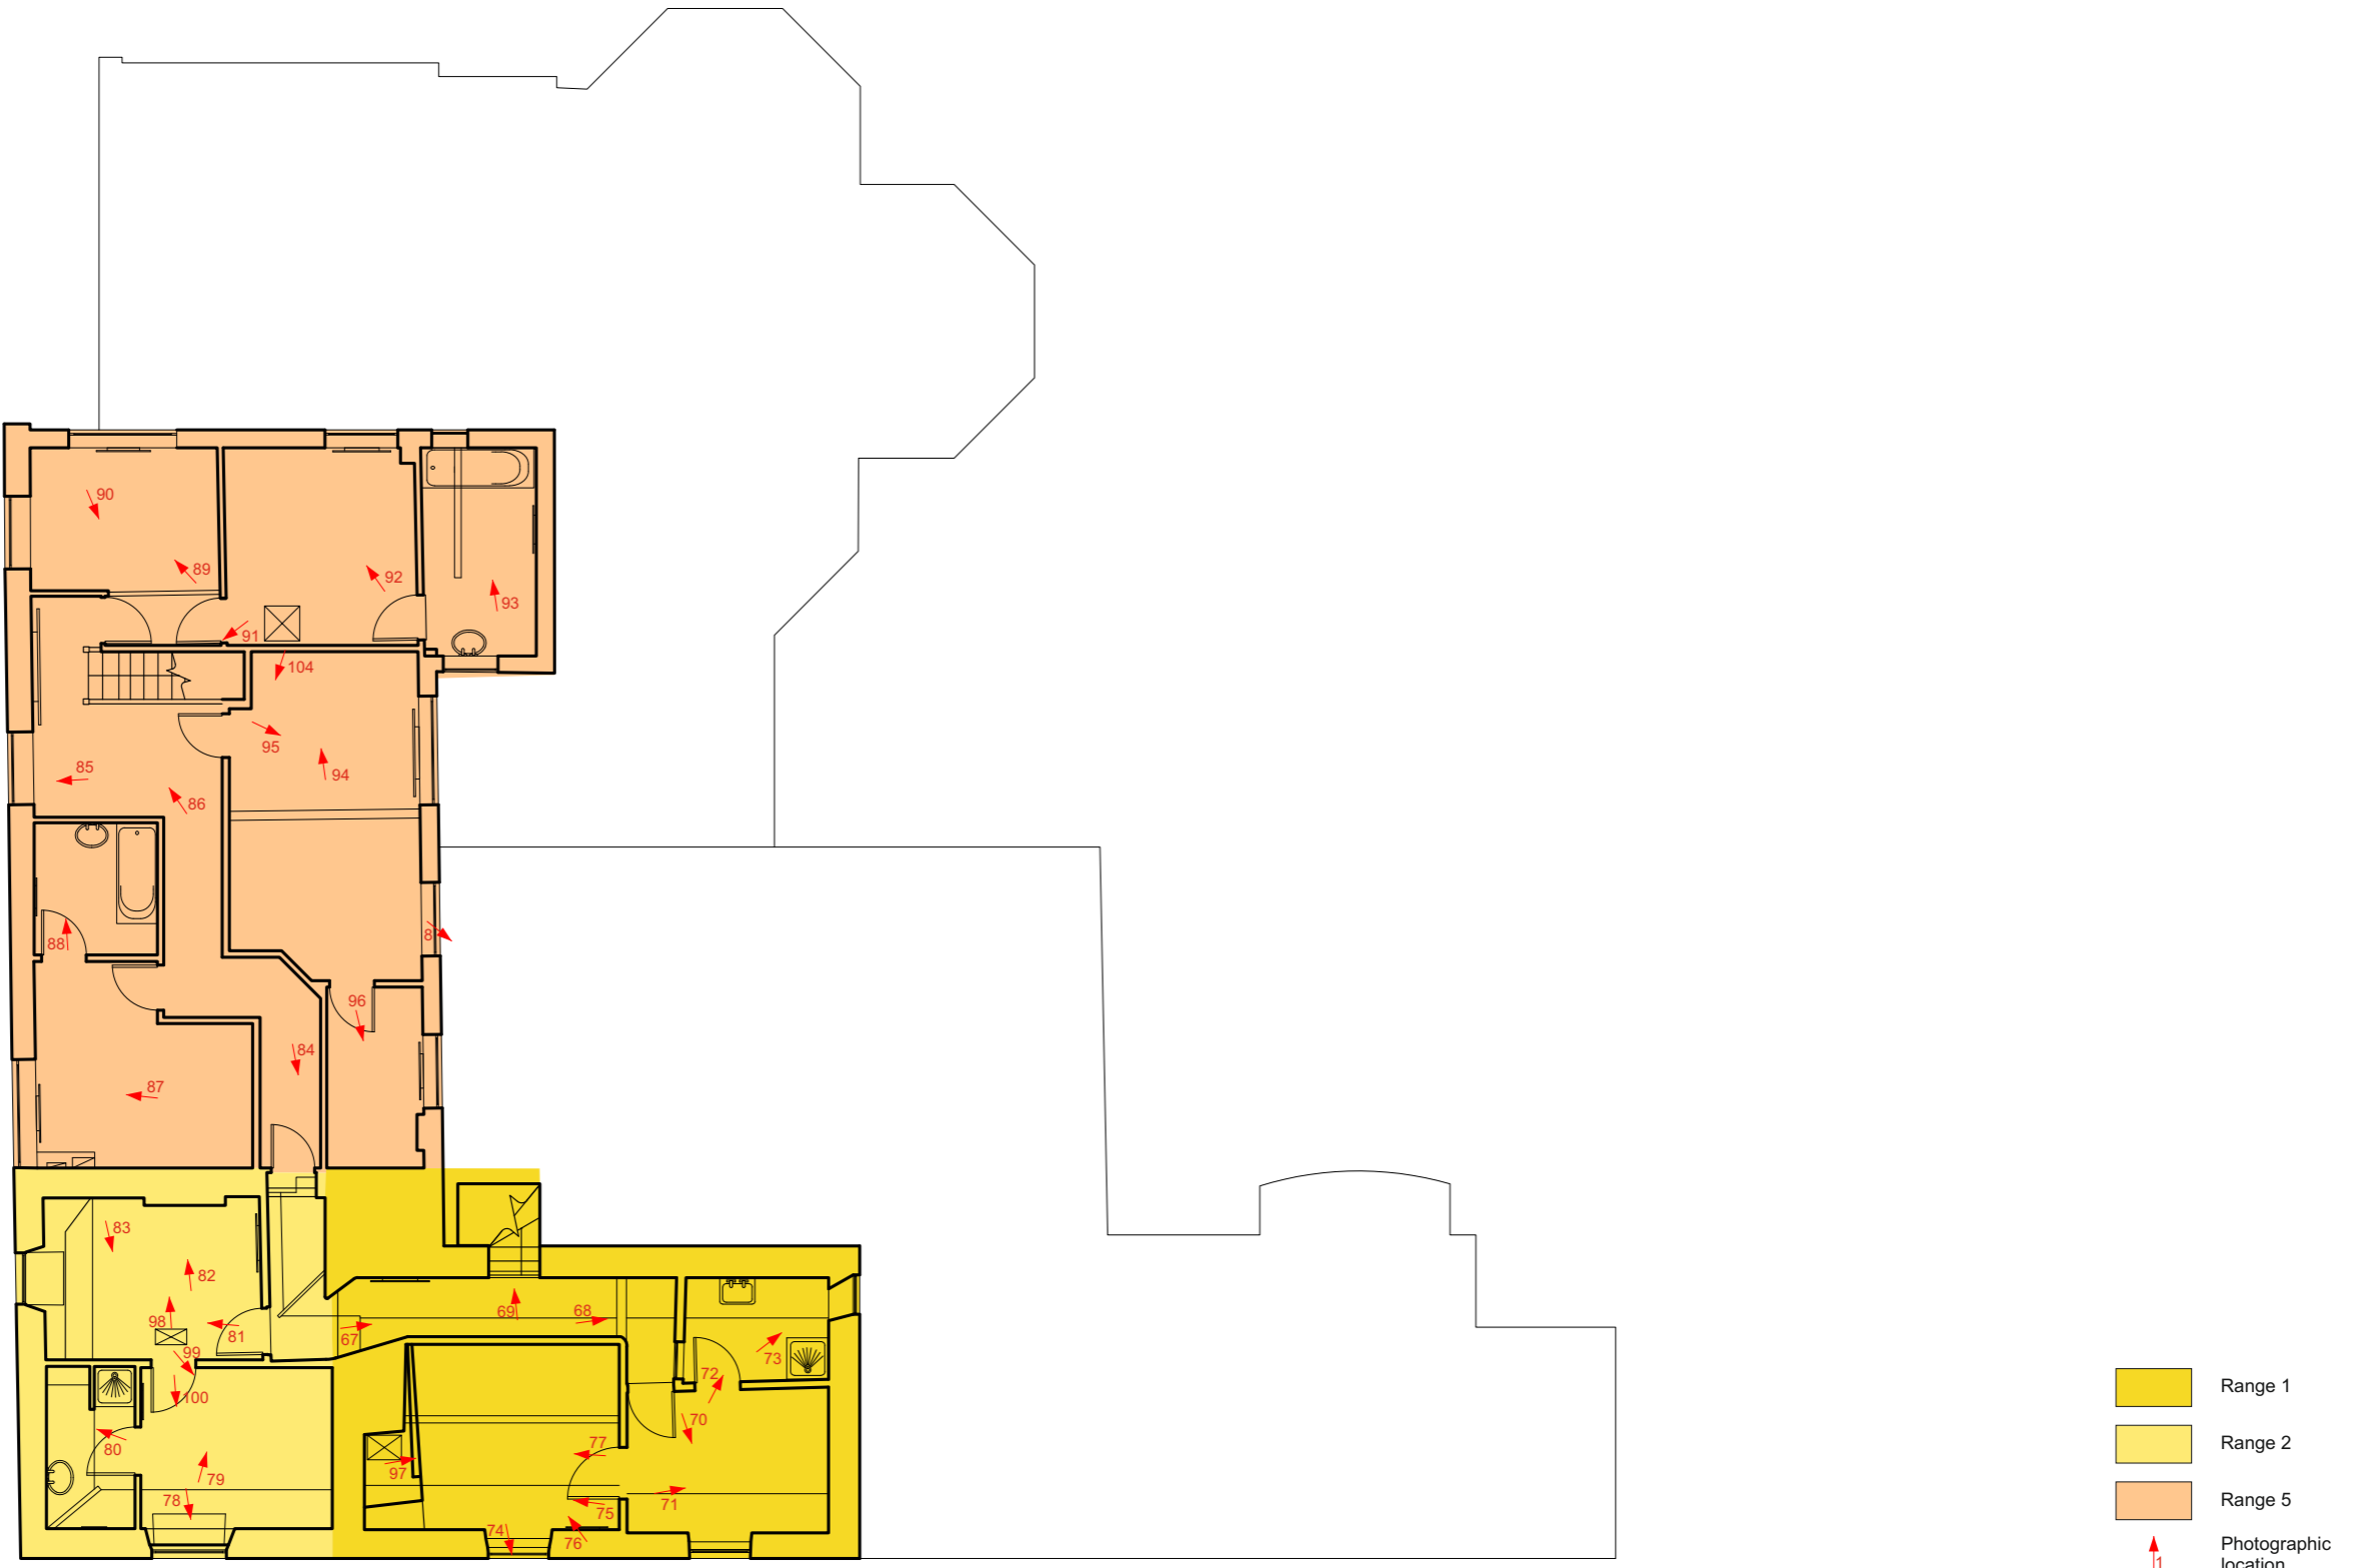
First floor plan with photo locations Fig 107

The first floor of the building only extends to Range 1, 2, and 5 as all other areas are single-storey (see Fig 106). Access is via two staircases rising from opposite ends of the central corridor (GF05). They give access to a corridor which dog-legs through the building (FF01 & FF06) and gives access to a series of bedrooms likely used when the public house became an inn. The bedrooms follow a similar decorative pattern in being carpeted with painted skirtings, plain plastered or wallpapered walls and plastered ceilings. The doors are all boarded on strap-hinges with ironmongery but retain little evidence of historic value.
