**Historic building recording
at Thornbrook House
Stoke Mandeville, Buckinghamshire
March 2021**

Report No. 21/039

Historic building recording at Thornbrook House Stoke Mandeville, Buckinghamshire March 2021

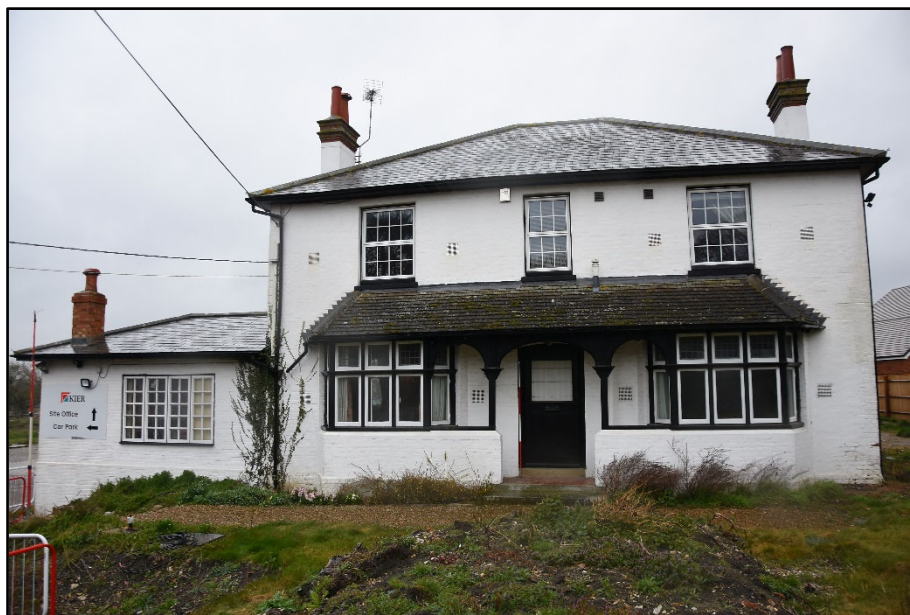
The east elevation comprising the main range, looking north-west Fig 5

This is the principal elevation facing a former lawn area to Risborough Road. The main range is symmetrical in its arrangement with central door and flanking windows (Fig 5). To the south this symmetry is interrupted by the extension of firebricks mentioned above.

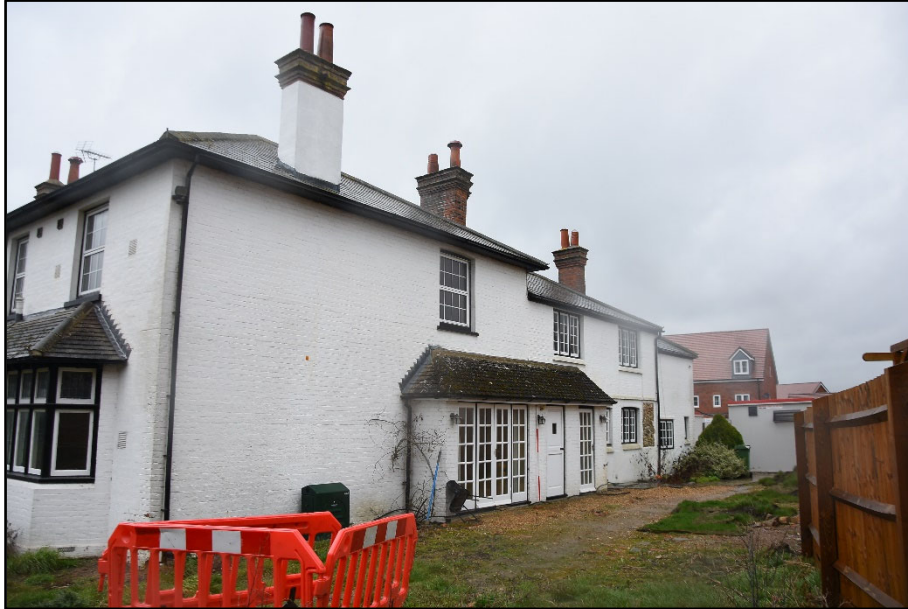
The long north elevation, looking west Fig 7

The north elevation currently faces the modern residential development and would have historically faced open land. It is formed of three two-storey components including the main range and two subsidiary rear ranges (Fig 7).

The main range is fairly plain with painted white brick face only being marked by a modern first floor window of eight-over-eight form and a small outshut which spans across to the adjoining rear range. The upper window sits in an aperture with cambered head and a black painted sill. Its timber frame has been painted black.

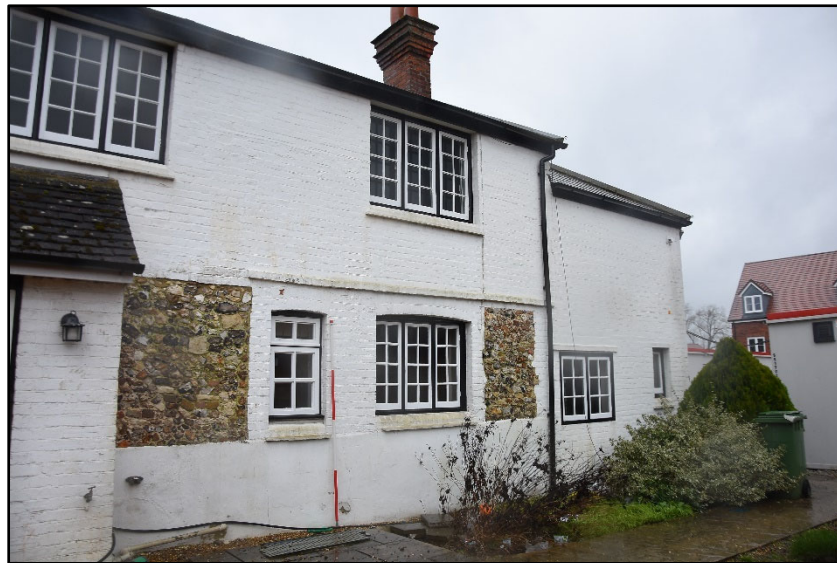
The rear ranges on the north elevation, looking south-west Fig 8

The ground floor is partially obscured by the outshut described above, but the rest of the façade is of some interest (Fig 8). The lower section has been rendered across in the manner of a dwarf wall. Above this are two apertures within cambered-arched heads, and two panels of exposed stone. The exposed stone panels are a mixture of pebbles, brick, and rubblestone. The two apertures are both in recessed reveals with sloped bricks and tile sills, with voussoirs above. The windows all have painted black timber frames. That to the east is a casement window with four-pane fixed, and two upper panes formed a top-hung casement. The second aperture to the west is a three-light window in black frame, each light has eight panes. Above this a partial line of

protruding bricks spans part way across this secondary range. To the first floor are two apertures set below the eaves. Both are three-light windows with each light of eight panes. The sills are sloped bricks with protruding tile sills.

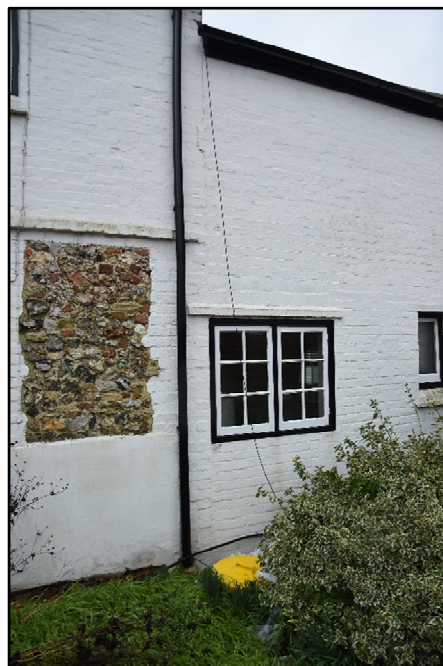
The join in the rear ranges between phases, looking south-west Fig 9

Further to the west again is the third part of this elevation. It is marked by a straight joint in the brickwork and a rainwater pipe to the secondary rear range (Fig 9). It is brick construction like its counterparts with a shallow slate roof. The façade is fairly plain only being marked on the ground floor by two apertures. That to the east is a timber window flush with the brickwork set below a small drip hood. It is a two-light casement. The other is a recessed fixed single light window with a sloped brick and protruding tile sill like the examples seen previously.

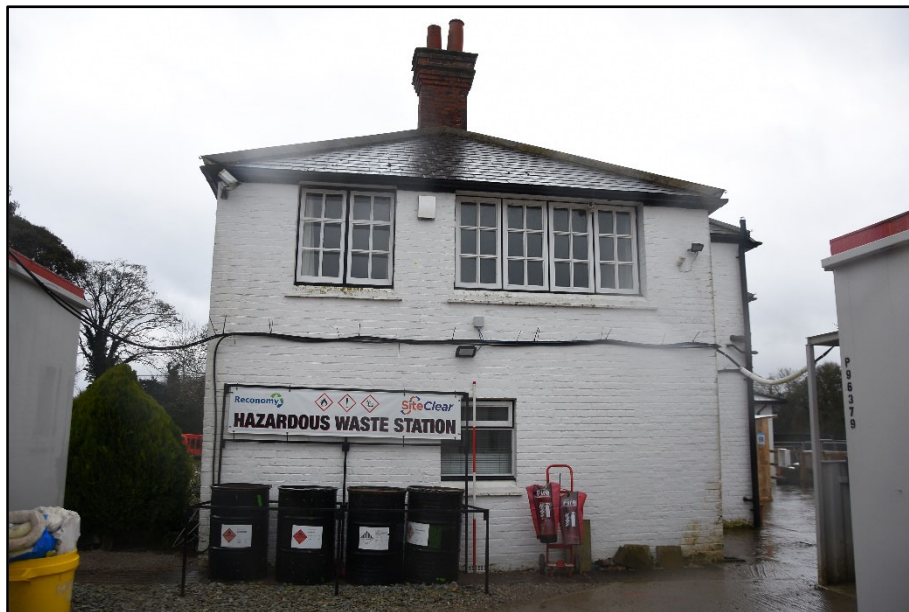
The west elevation, looking east Fig 11

The west elevation (Fig 11) is the shortest, although it continues to the south to the stepped rear ranges, these will be described below with the south elevation.

The ground floor aperture is a modern window with a fixed lower single pane and narrow top-hung casement. The aperture itself has a brick voussoir but the head is square. The sill has sloped bricks and a protruding tile course.

To the first floor the apertures have the same sills and sit below the eaves. That to the north is a two-light casement with six panes to each light. That to the south has four-lights. Although the sills are consistent their glazing bars differ in profile.

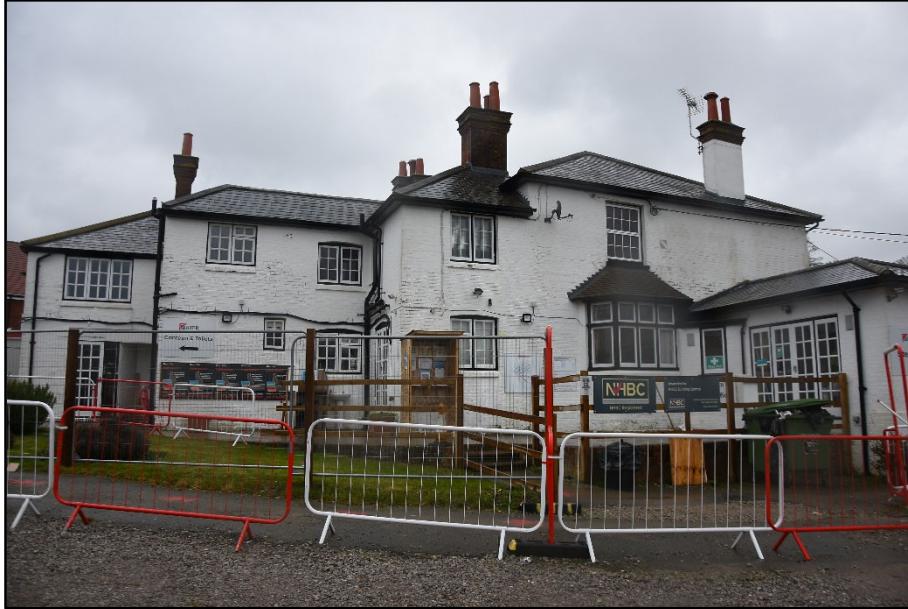
The south elevation, looking north-east Fig 13

The south elevation displays the most complexity and is a good indication of the various phases of this building. These comprise the two-storey main range and a short rear extension, and two longer two-storey rear ranges, as well as the southern single-storey projection described briefly above (Fig 13).

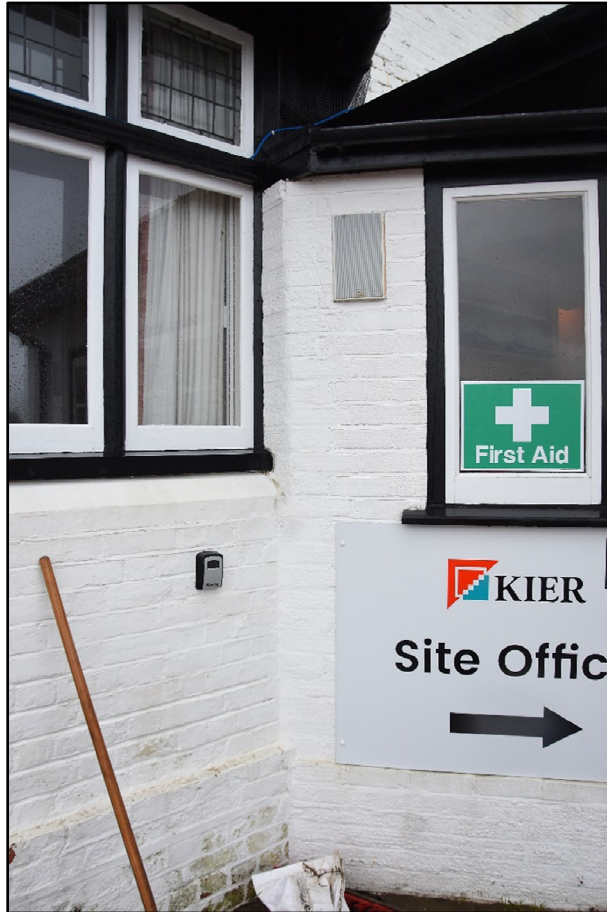
Canted section of wall between the bay window and southern extensions, looking north Fig 14

The southern single-storey projection has a hipped slate roof of shallow pitch. The south elevation has a single window of the same form and style as the east elevation. The west elevation returns to the main range with a canted wall (Fig 14). The elevation retains a set of French double doors with side lights in the same moulding and style as seen elsewhere and attributed to the early/mid-20th century. The chamfer return has a single fixed light window in black frame with a small sill. The roof arrangement here is awkward as the chamfer has a flat-roof.

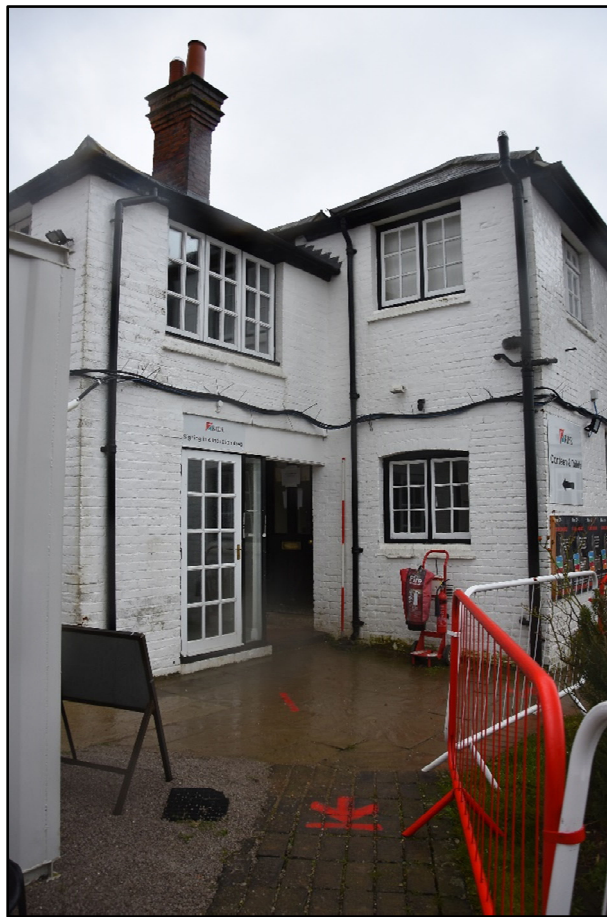
Junction of rear ranges along the south elevation, looking east Fig 15

Lastly along this elevation the south elevation of the western rear range is evident (Fig 15). On the ground floor tucked into the return is a short wind lobby open to the outdoors but creating a short passage with step up to a tiled floor and entrance into the service areas of the house. The door here is four-panelled with two glazed upper panels, a brass letterbox and brass doorknob. The concrete step into the house retains the paw prints of a small mammal, created when set. Adjacent to this entrance is a timber and glass door of fifteen panes of early/mid-20th century date, with single fixed side light. To the first floor above is a three-light fixed window with chunky glazing, each light has six panes, and the aperture has a sloped sill with protruding tile shelf.

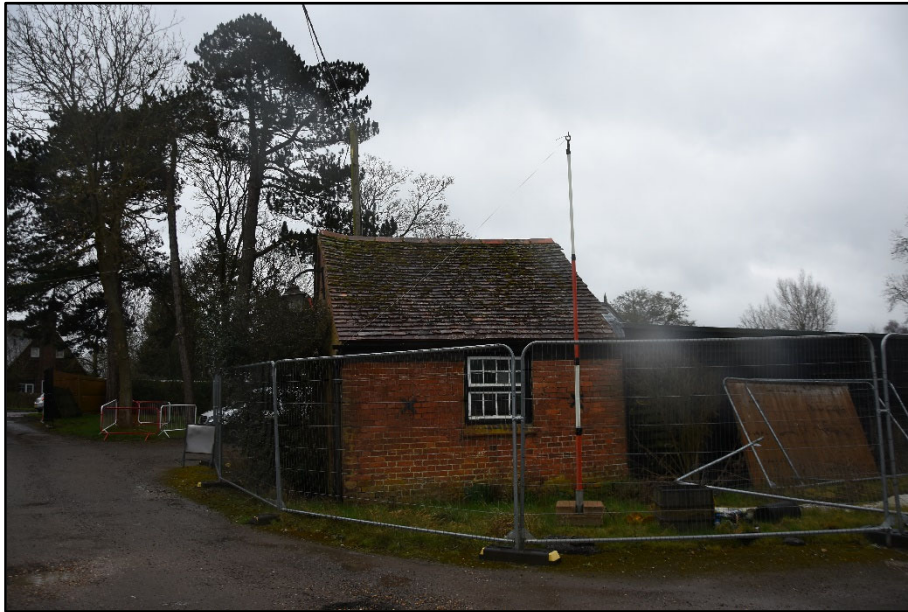
Outbuildings to the south-east of the house, looking south-east Fig 17

To the south-east of the main building is a series of outbuildings, not covered by the remit of this survey but photographed during the site visit for context (Figs 17-18). They comprised a single-storey red brick barn with pitch peg tile roof. This had several windows in the same manner as the house and a large lantern to its gable end, as well as two tie-plates to the west elevation. There was a timber garage with pitch roof and large double doors to its north gable end. In between the garage and the barn was a series of flat-roof ranges which spanned the gap between them. These were weather-boarded to the sites.

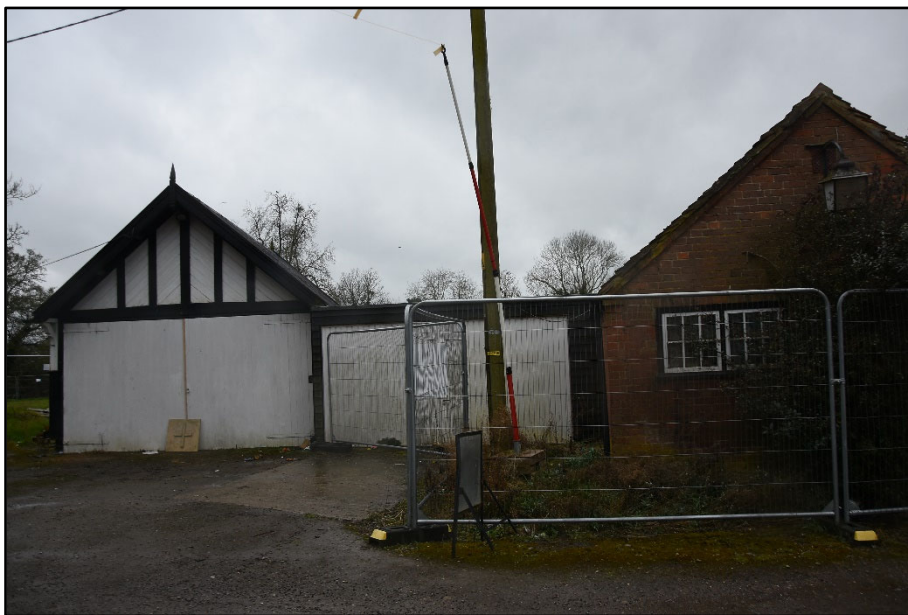
Outbuildings to the south-east of the house, looking south-west Fig 18

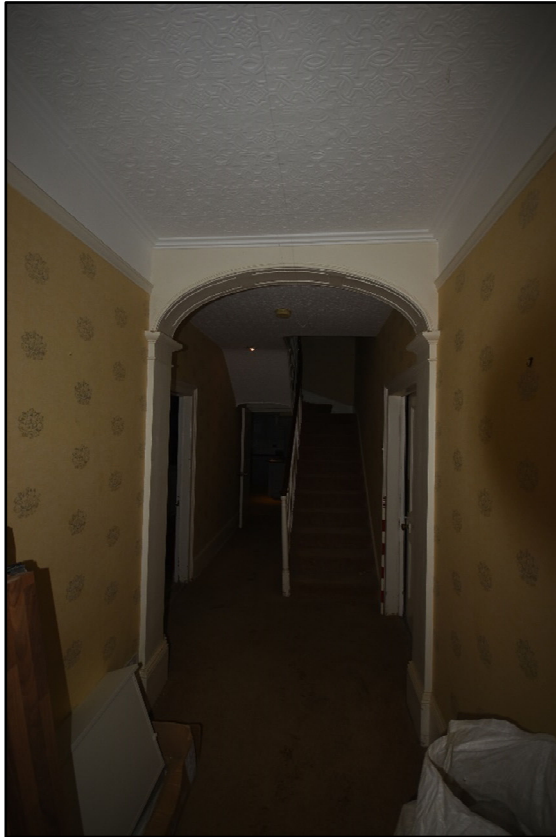
General view of GF01, looking north-west Fig 19

Entered from the east, the entrance hall stretches the length of the main range and gives access to the reception rooms within the main range, the first floor and the service ranges to the rear (Fig 19). It is finished with decorative features with a high moulded skirting rising to wallpapered walls with a high picture rails. Midway along the hall, and marking the division of reception rooms to the north and south, is a decorative archway. This rises from shallow pilasters with moulded short capitals to an elliptical arch. The spandrels are plain, but the soffit has three panels carved. Above this a moulded cornice sits below a textured wallpaper to the ceiling. The ceiling retains a ceiling rose with decorative foliage plaster finish. Some staining is evident to suggest heat/smoke damage. Beyond the archway to the rear of the hall the decorative finishes are less evident. There is no picture rail, no cornice, and the area has no evidence of being lit.

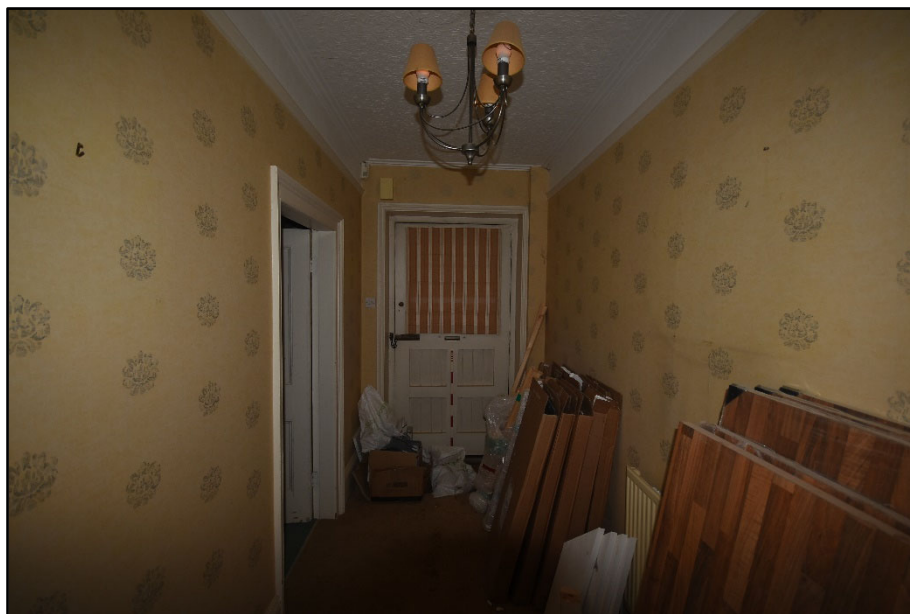
Entrance door into GF01 from the exterior, looking south-east Fig 20

The door from the exterior sits in a moulded frame and rests on barrel hinges to the east (Fig 20). The door has a large upper glazed panel, and four lower recessed panels. Above this the picture rail does not extend across this wall.

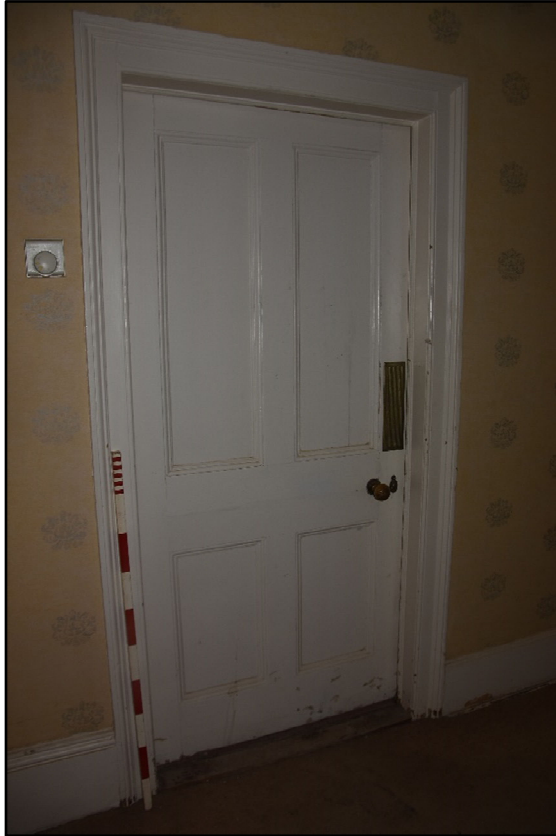
Typical door type seen in the main range, looking south-east Fig 21

There are three doors within this space that lead to the various reception rooms. A fourth would have been present along the south wall originally. However, this was likely blocked when the two southern reception rooms were amalgamated. The remaining follow a type which is continued throughout the main range (Fig 21). The door frames are moulded and the doors themselves are four-panelled, the upper panels being larger than the lower. The panels are all moulded and recessed. There is a brass doorknob present, a brass keyhole and a reeded brass finger plate. The doorknob to GF03 is simpler in design and may be a replacement.

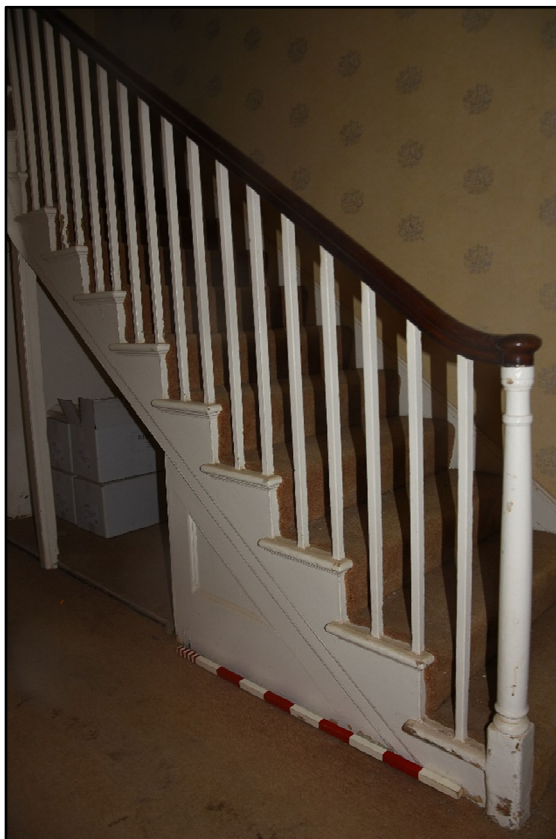
Staircase in GF01 giving access to the first floor, looking north Fig 22

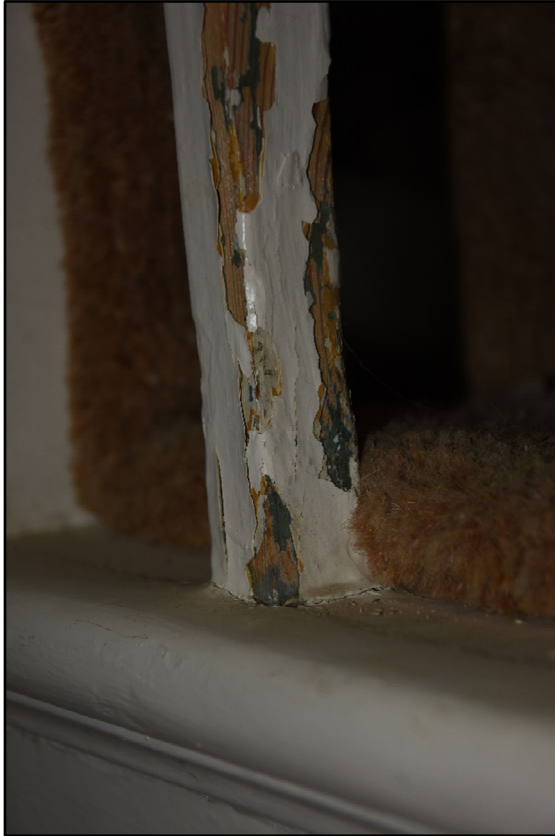
Evidence of paint on the stair balusters in GF01, looking north Fig 23

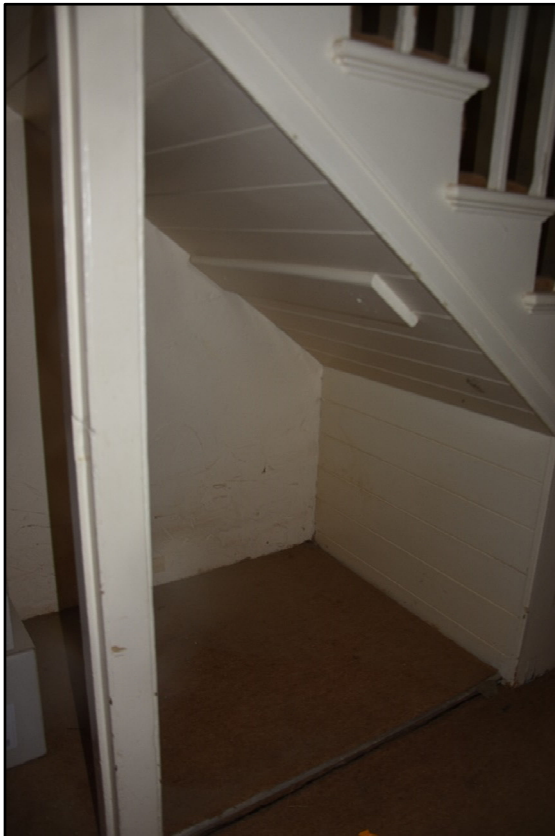
Area beneath the stairs in GF01, looking east Fig 24

The area beneath the stairs is open to the hall and the underside of the stairs are boarded. A single post supports the rise of the stairs as the string turns to accommodate the winder above (Fig 24). As the 1879 lists the house as having a cellar this may have been the entrance, the underside of the stairs being boarded from the outset is a good indication. Above a small arch in the ceiling bridges this gap between the southern wall and marks the change in sloping underside of the stair to flat ceiling again. Both retain the textured wallpaper seen elsewhere.

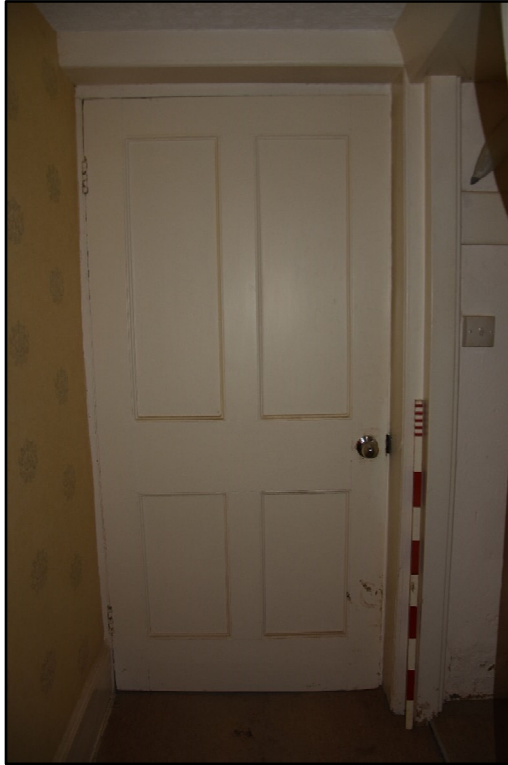
Door from GF01 giving access into the rear ranges, looking north Fig 25

To the western wall a single door gives access into the service ranges to the rear of the building. This door is of simpler form than elsewhere but is still of four panels all moulded and recessed with a single doorknob (Fig 25).

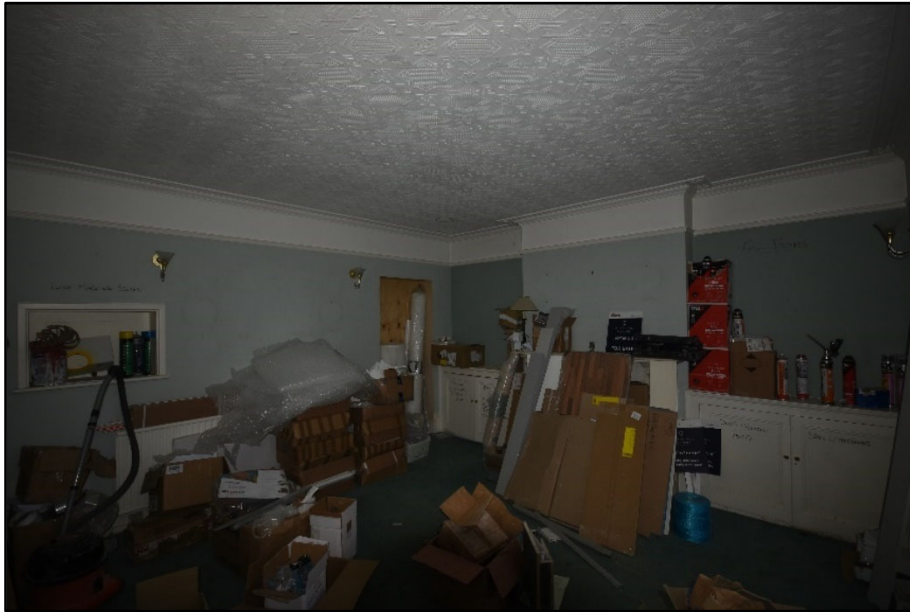
General view of GF02, looking north Fig 26

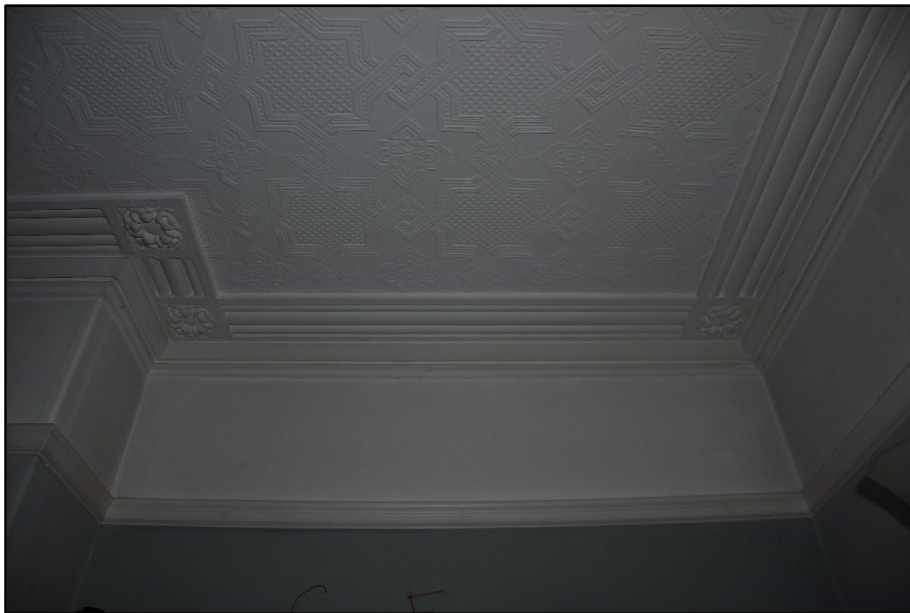
Detail of the cornice in GF02, looking north-east Fig 27

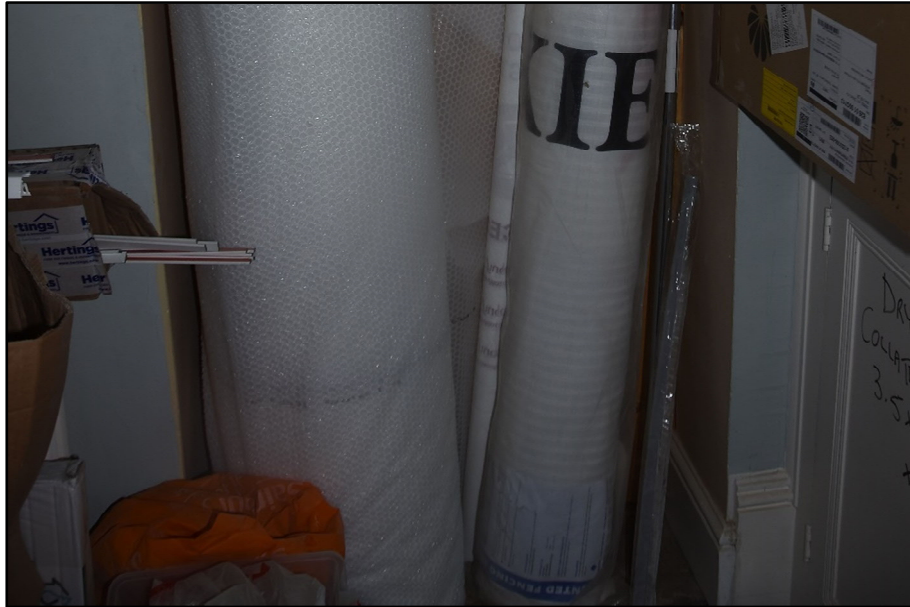
Detail of the skirting to the blocked aperture in GF02, looking north-west Fig 28

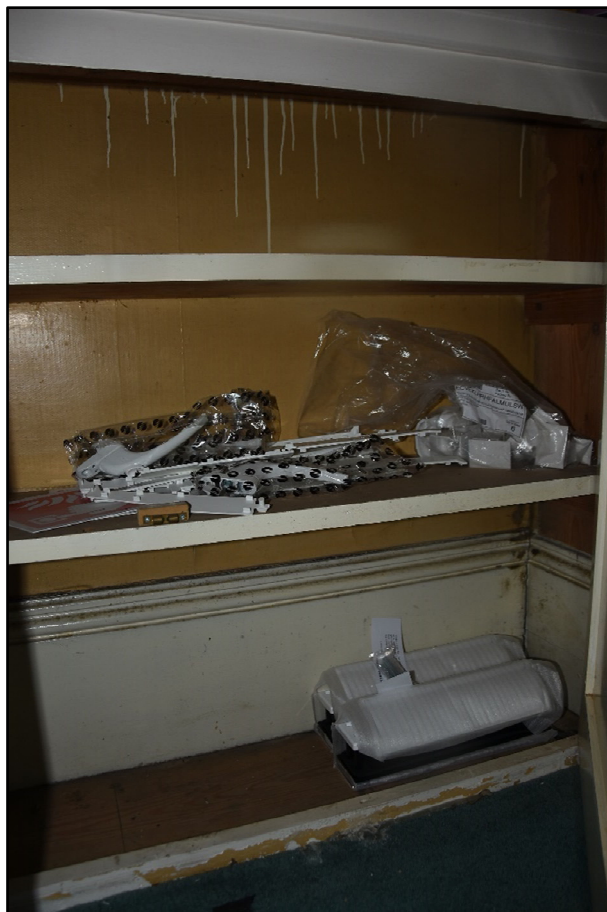
Interior of the cupboards in GF02, looking north-east Fig 29

To the north a central fireplace and stack is flanked by two low double-doored cabinets. The picture rail and cornice accommodate the stack which has a decorative marble fire surround. The fireplace has blue glazed slips with a cast-iron grate. The cabinets have finely moulded frames and single-panelled doors. The skirting continues into these cabinets where wooden floorboards are revealed (Fig 29), and a mustard yellow wallpaper.

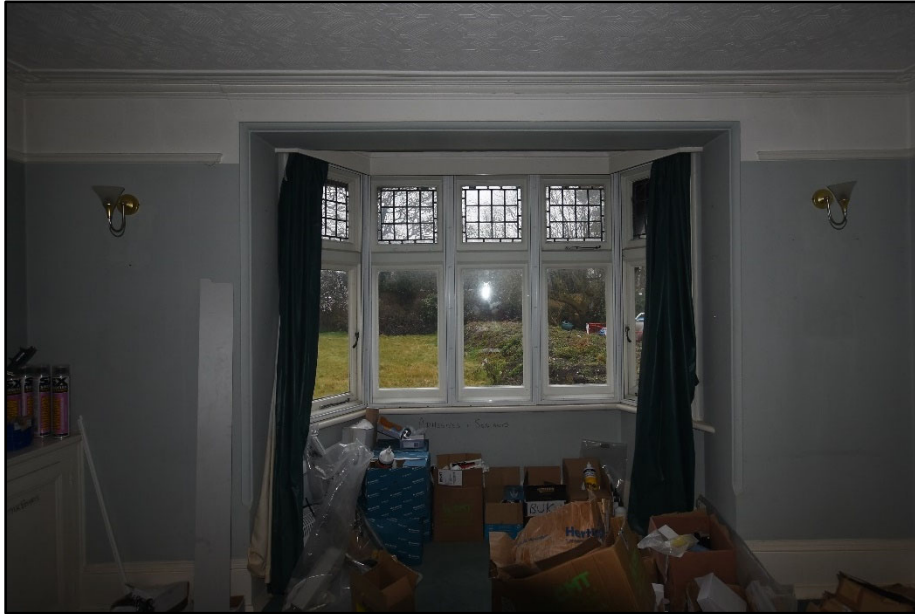
Bay window in GF02, looking south-east Fig 30

The east wall retains the bay window seen externally (Fig 30). The aperture into the bay has chamfered edges with an ovolo moulding running to plain stops part way to the skirting (Fig 31). The arrangement is somewhat obscured by a modern curtain rail and secondary glazing. The texture wallpaper to the ceiling in the main part of the room also exists in the ceiling of the bay. The canted lights of the window have casements to the lower sections. They retain a curved handle and a stay bar (Fig 32-33). The two

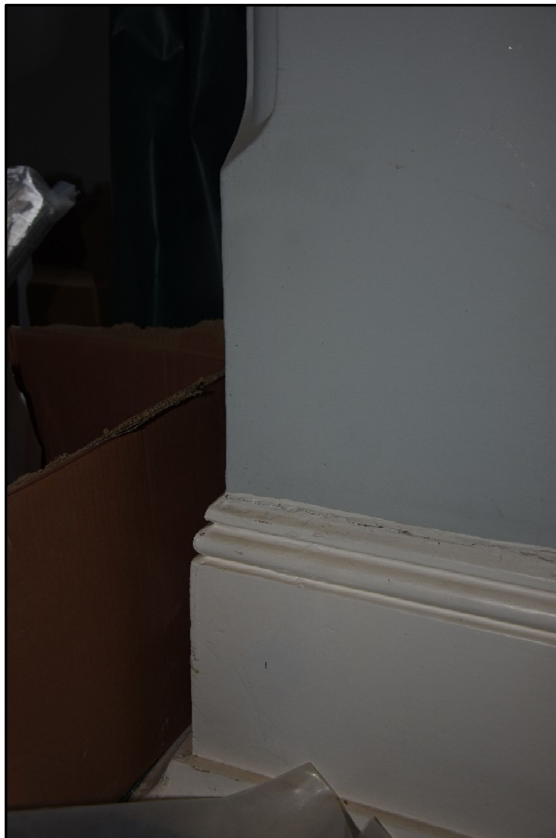
Chamfered and stopped corner to the bay window aperture, looking east Fig 31

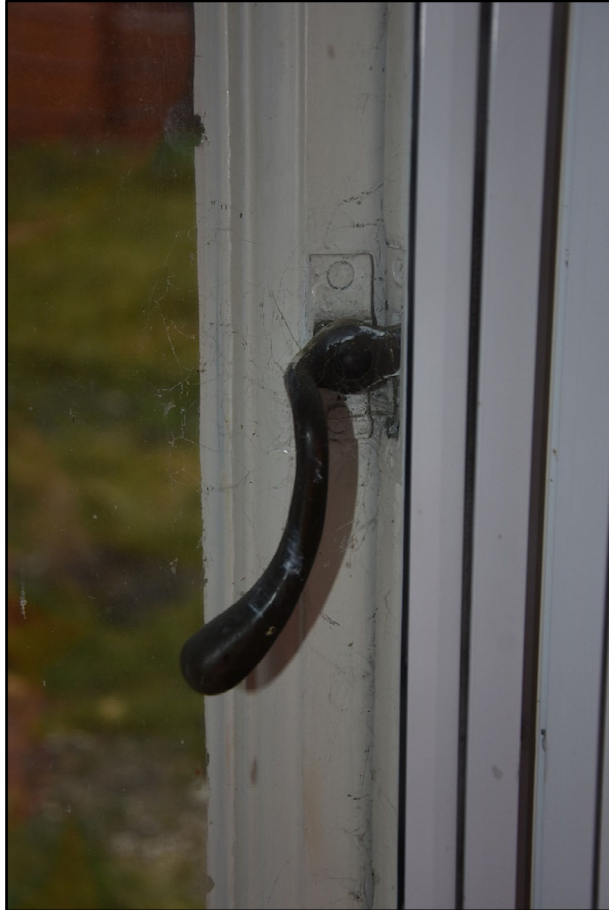
Window catch in GF02, looking south-east Fig 32

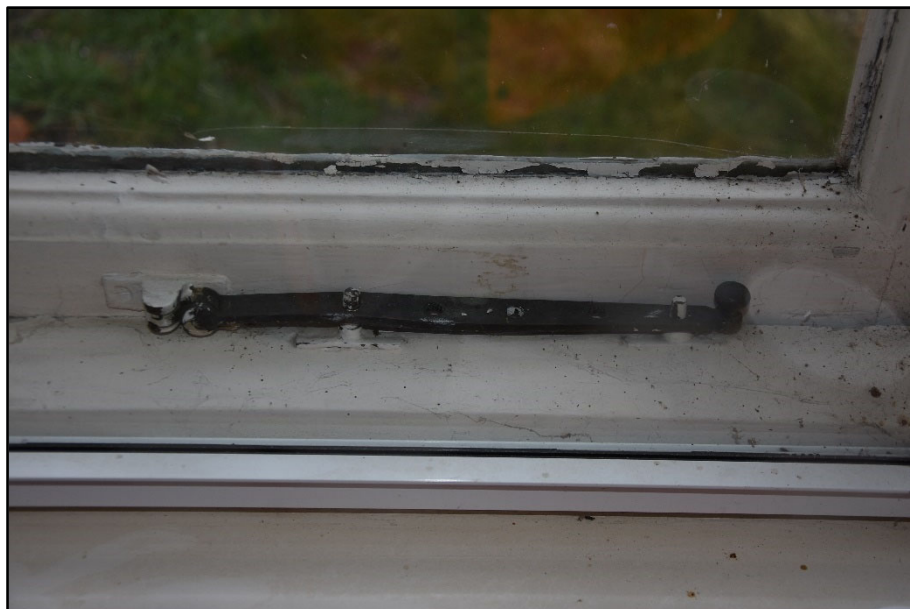
Window stay bar in GF02, looking south-east Fig 33

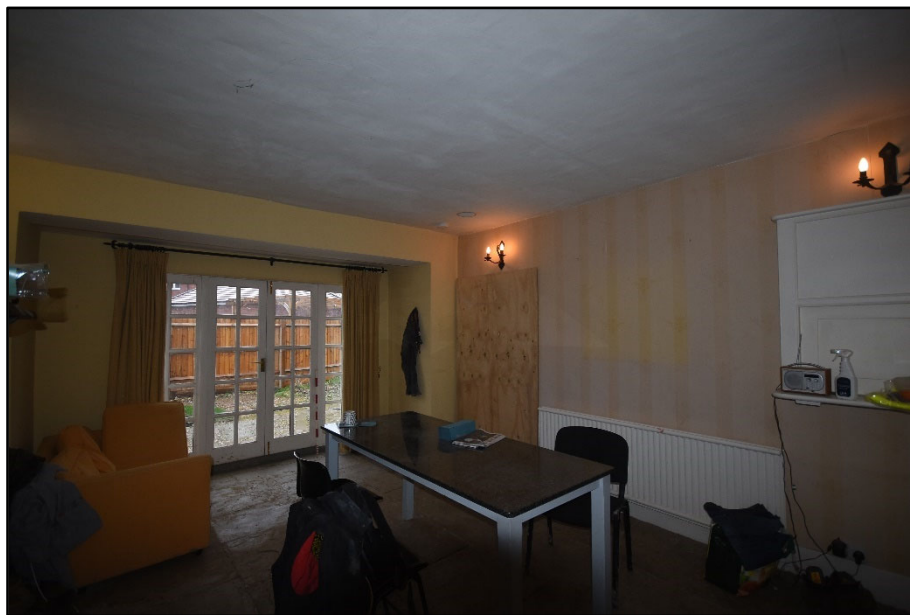
General view of GF03, looking north-east Fig 34

This room is accessed from the entrance hall and formerly from the reception room to the east, and from the service ranges to the west. Presumably the former kitchen or parlour this room has large flagstones to the floor and a simpler decorative finishes than the other reception rooms. A plain skirting rises to wallpaper and plaster walls with no cornice and a plaster ceiling. The room has been pushed out to the north as seen from the north elevation and houses French doors with modern fixtures (Fig 34).

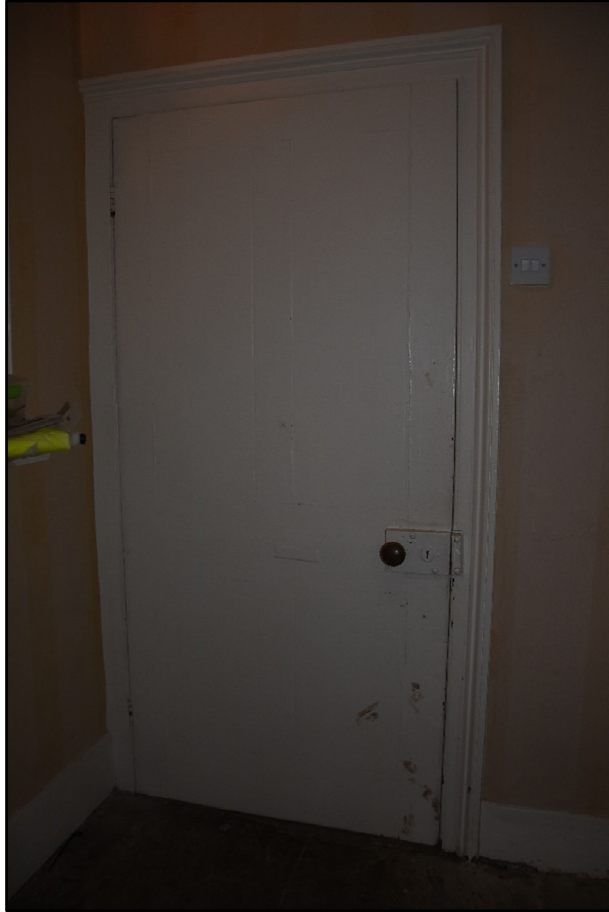
Door from GF01 in GF03, looking west Fig 35

The door from the entrance hall lies on the south wall and sits on barrel hinges. The four panels are much simplified and retain no mouldings. There is a lock case and plain doorknob (Fig 35). It appears the skirting has been removed along this wall.

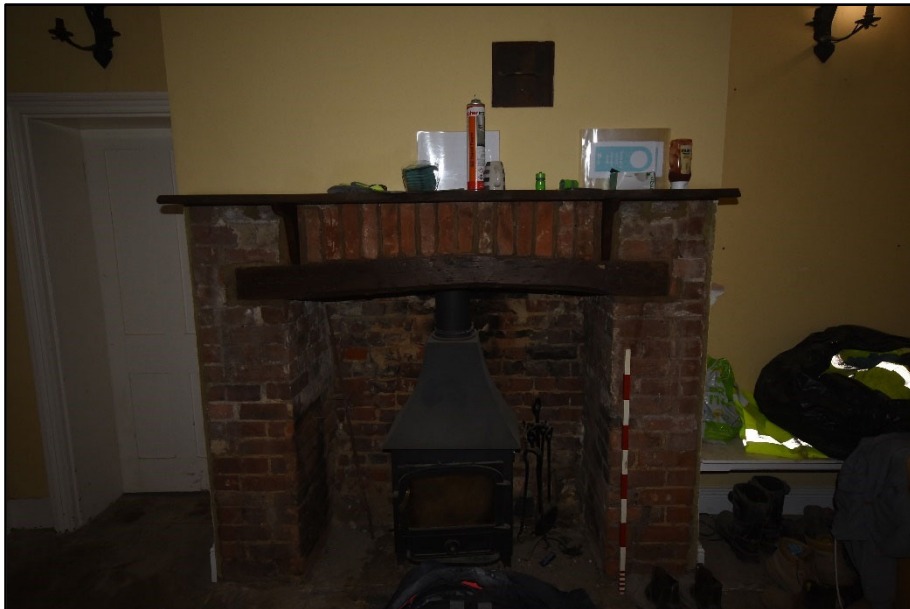
Fireplace in GF03, looking north-east Fig 36

To the west a central chimney stack has an exposed brick surround with large aperture to a wood-burning stove (Fig 36). The aperture has a cambered timber lintel. It appears the plaster has been removed from the surround to expose the underlying brick. A low bench lies to the north. To the south is the door through to the service ranges within a moulded frame. The moulding differs from those seen in the entrance hall. The door sits in a deep reveal and is of plain four-panel form, each panel is recessed. There is a plain doorknob and a key plate.

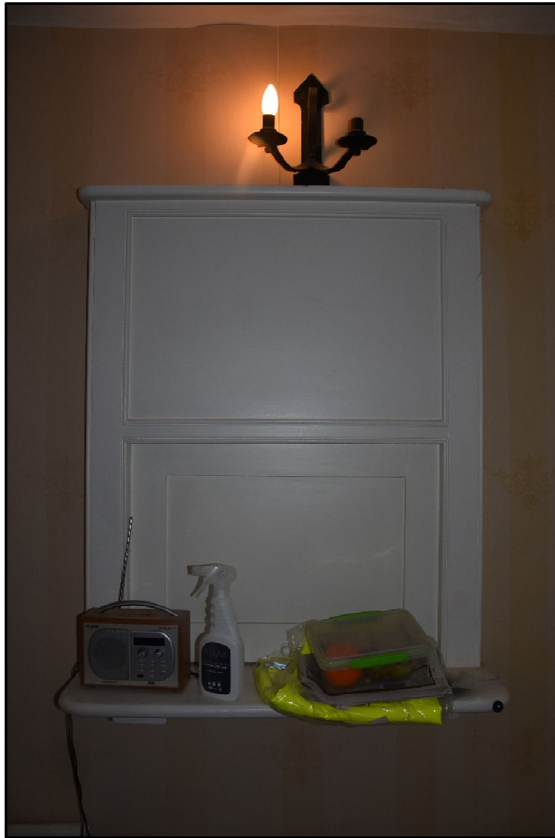
Service hatch through to GF02, looking south Fig 37

The door from the adjoining reception room (GF02) is boarded from this side. To the south the other side of the service hatch is visible. It is simple in design to fit its utilitarian purpose, but mouldings to the upper and lower panels suggest some elegance in design (Fig 37). It sits below a wall sconce that are also present to the east and west walls.

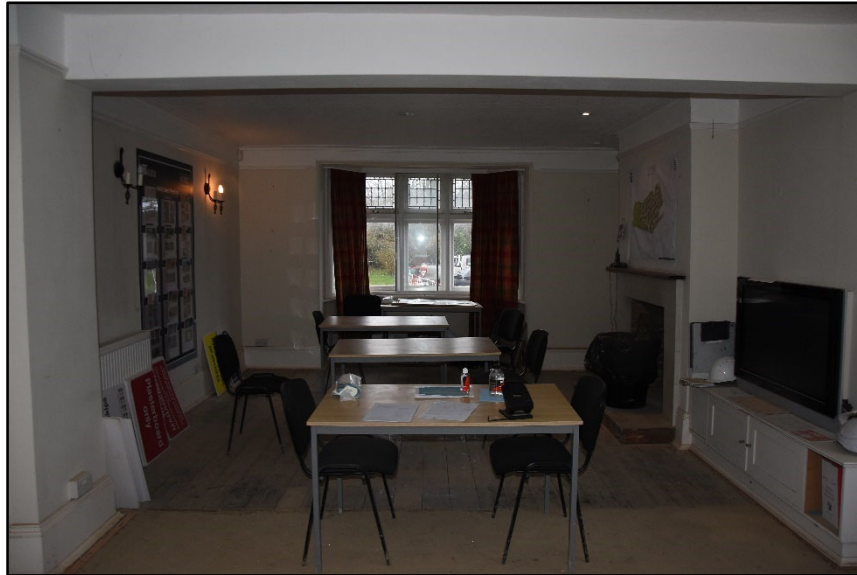
General view of GF04 from GF05, looking south-east Fig 38

To the east GF04 has floorboards laid north to south. This room has the same formal decoration as GF02. There is a high skirting rising to plaster walls and a picture rail (Fig 38). Above the rail a moulded cornice marks the ceiling which has a textured wallpaper. The bay window to the east wall is seen externally and matched in GF02. The bay opening has the same ovolo-moulded chamfer and stops. This bay window like its counterpart has brass handles and stay bars to the lower canted sections and stay bars to the upper square sections. The brass handles here are more decorative with reeded decoration (Fig 39). The chimney stack to the south walls has a plain surround with wooden shelf and raised tile hearth (Fig 40). This may have been replaced. To the west of the stack is a low cupboard with double doors which appears modern and straddles the divide between the two spaces.

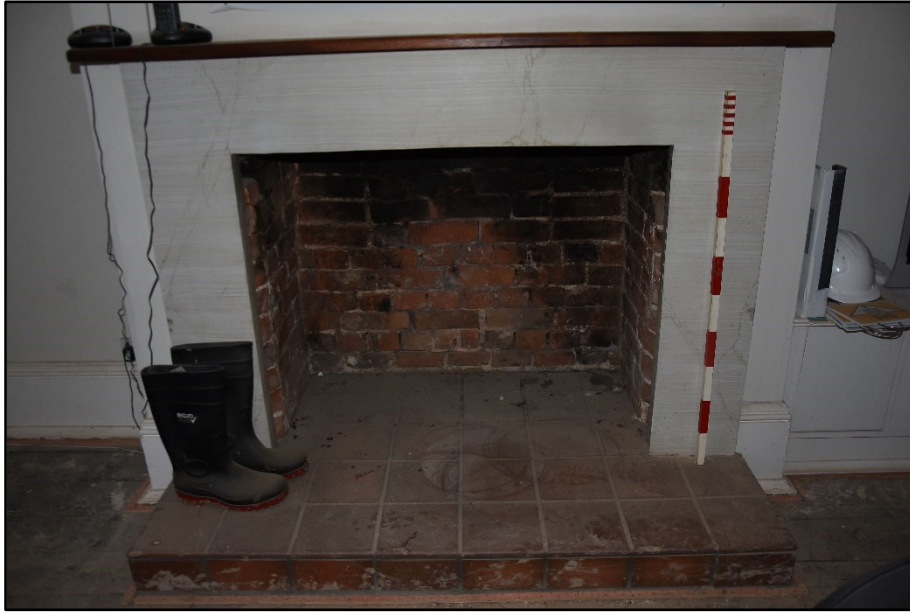
Fireplace in GF04, looking south-west Fig 40

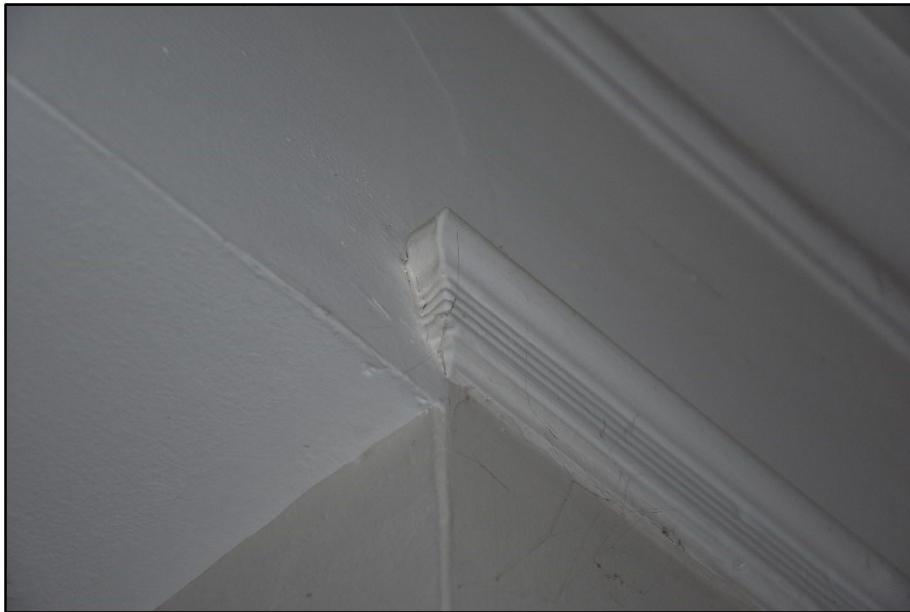
Fig 41

Picture rail returning along the partition between GF04 and GF05, looking west

The division between the two rooms is marked by a downstand and a column on the north wall. The picture rail returns a short distance to the south but does not appear cut or disturbed (Fig 41). The skirting also continues along this division, at least to the north where it is visible.

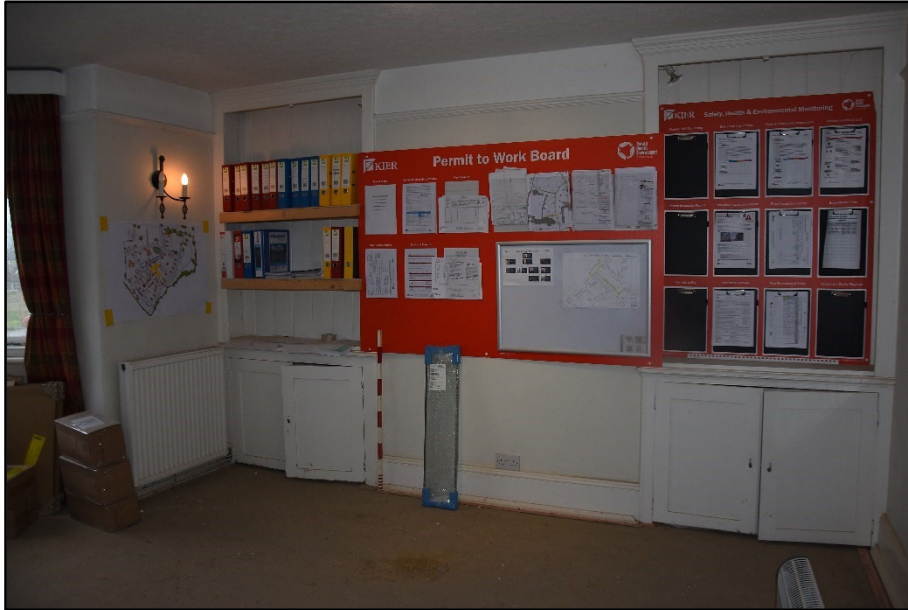
General view of GF05, looking west Fig 42

To the west GF05 has a concrete floor and is accessed from the entrance hall via the door type described above (Fig 42). There is a skirting, but this space lacks the picture

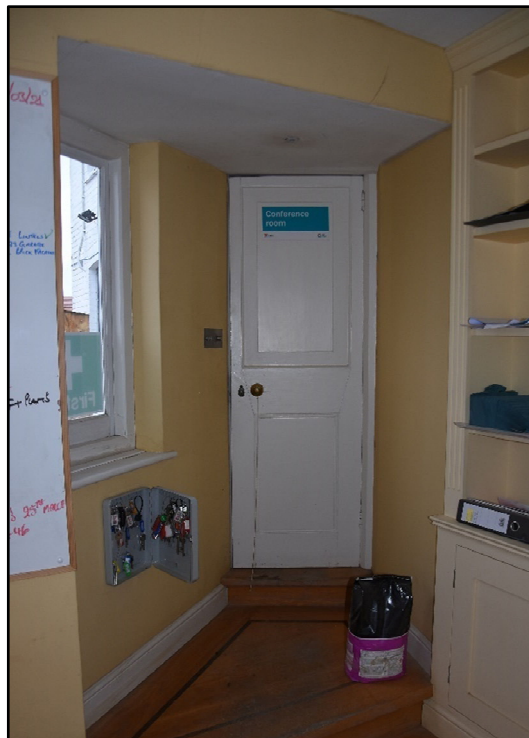
Door into GF06 from GF05, looking north-west Fig 44

The study is located in the southern extension which is awkwardly placed along the southern elevation of the building. The canted corner seen externally marks the access into the space from the reception rooms described above. The canted side of the bay window has been removed and this creates a short access corridor into the space (Fig 44).

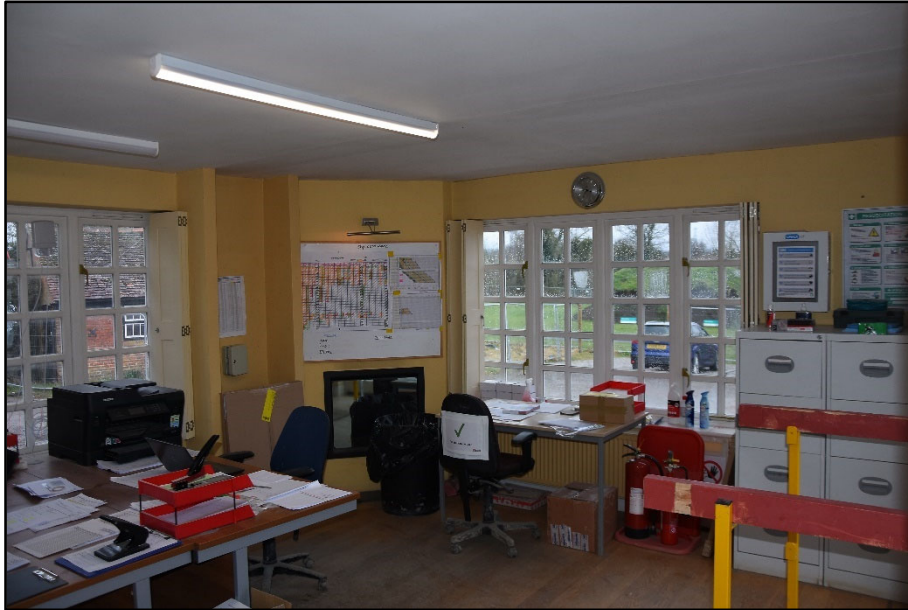
General view of GF06, looking south-east Fig 45

The room retains most of its original decorative features which can be placed sometime in the mid 20th century (Fig 45). The floor retains floorboards with a darker inlaid border which respects the fireplace, cupboards, and the steps into the room from GF05. There is a plain skirting and plaster walls and a plain plaster ceiling.

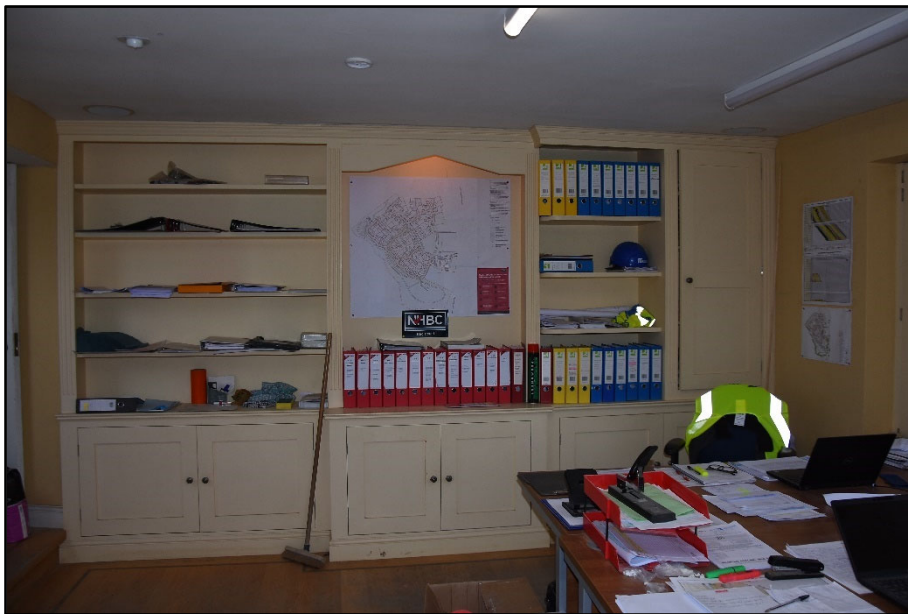
Series of bookcases in GF06, looking north Fig 46

To the north a series of fitted cupboards and shelves fill this wall (Fig 46). These comprise lower double-door cupboards with upper shelving and are original to this room.
